The Beauly Denny restoration – the role of the Scottish Government

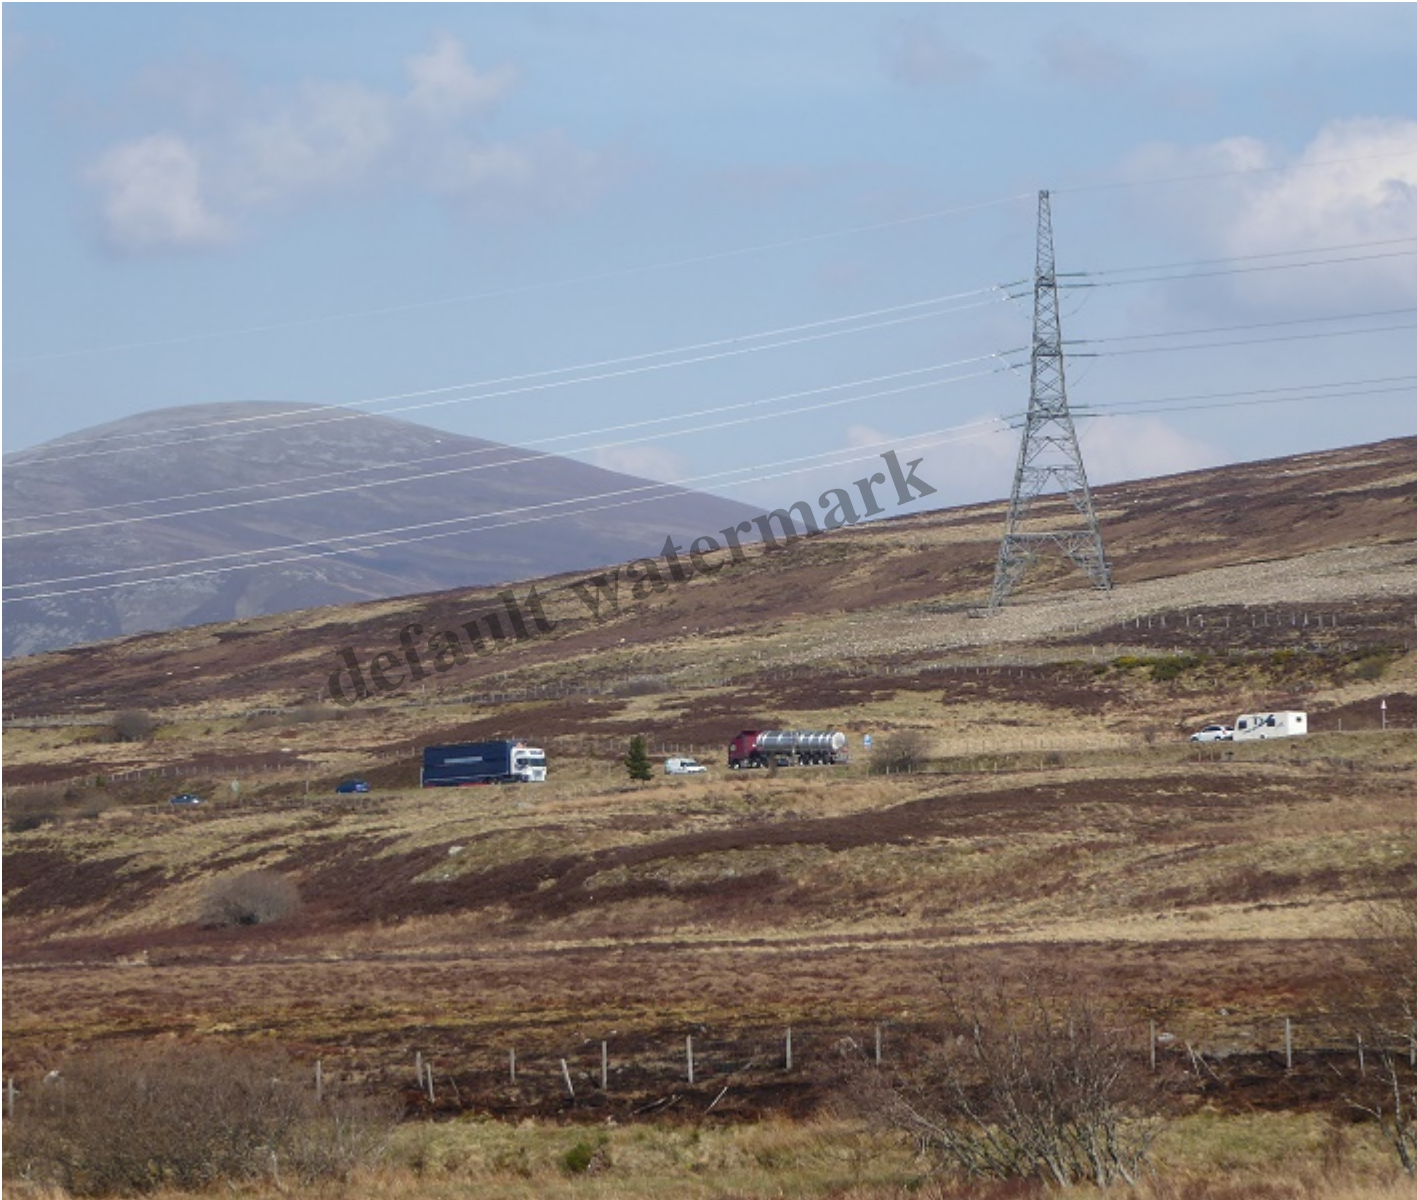
Beauly Denny restoration across A9 from A889 just north of Dalwhinnie. Meall Chuaich left background 1/5/17.

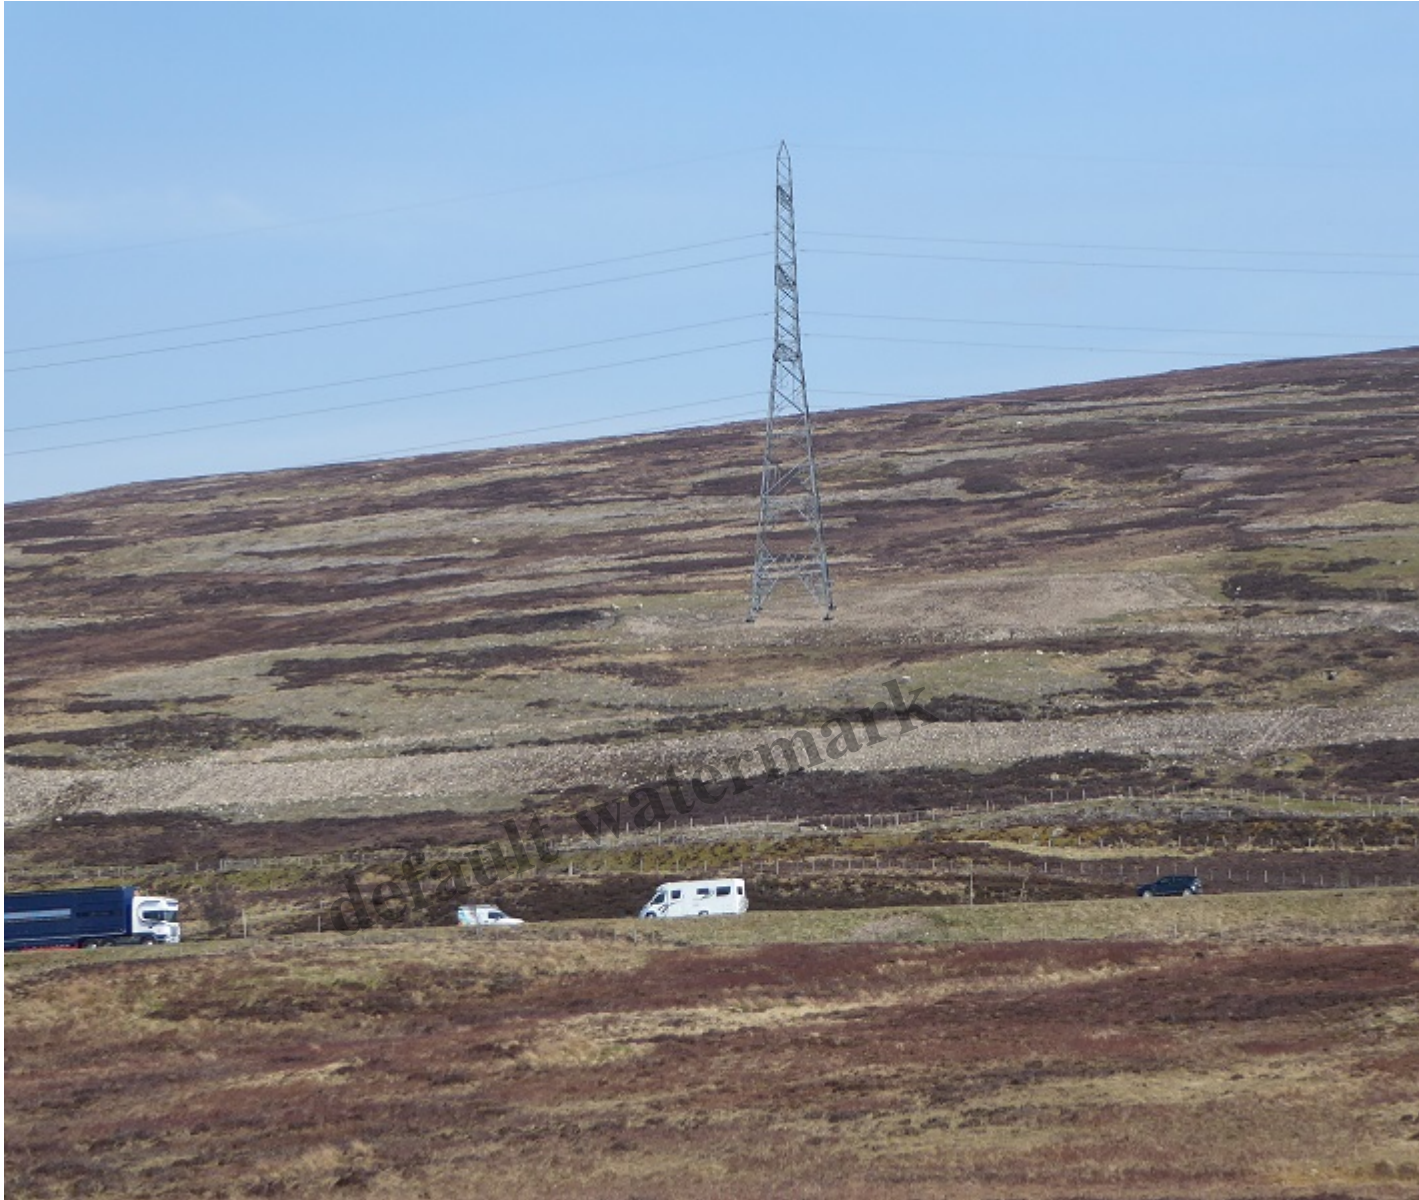
Next pylon south from that in top photo showing poor “restoration” around the tower and along the track. In the distance some of the landscape impact is reduced because of the large areas of muirburn but is likely to become more prominent as summer progresses.

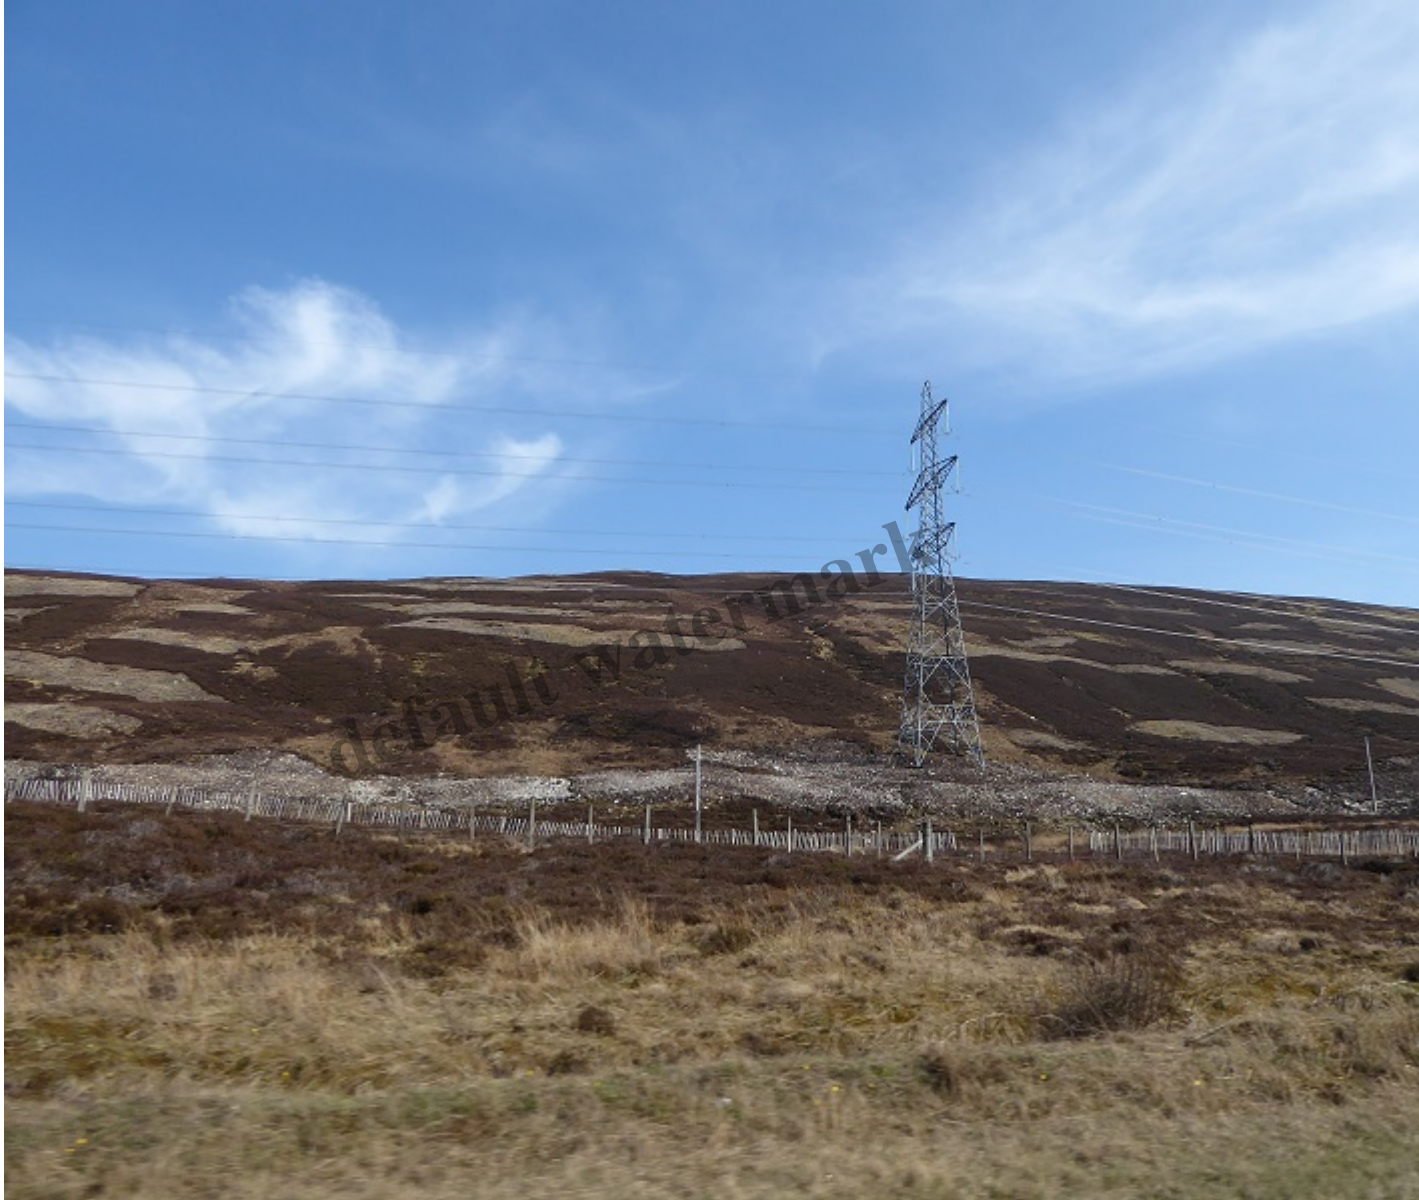
Travelling down the A9 on 1st May I took photos of almost every tower you can see from the road. The condition of soils and vegetation is not hard to see as with this pylon south of North Drumochter Lodge

While I have not yet been able to work out the numbers of all the pylons, in the monitoring produced in October 2016 SSE states that for almost all pylons on this section of line “Re-instatement of the soils is to an acceptable standard”. The photos I believe show otherwise and that the CNPA was completely right to raise concerns.

What's not in the public realm at present (as far as I have been able to ascertain) is whether the CNPA's concerns have been submitted to the Scottish Government, and if so what the Scottish Government's response has been. What is needed is join up between the Scottish Government's ECDU and the CNPA and SNH. While a first step would be joint monitoring meetings, I think there also needs to be a joint approach to remedying what has gone wrong.
