## The Beauly Denny restoration – the role of the Scottish Government

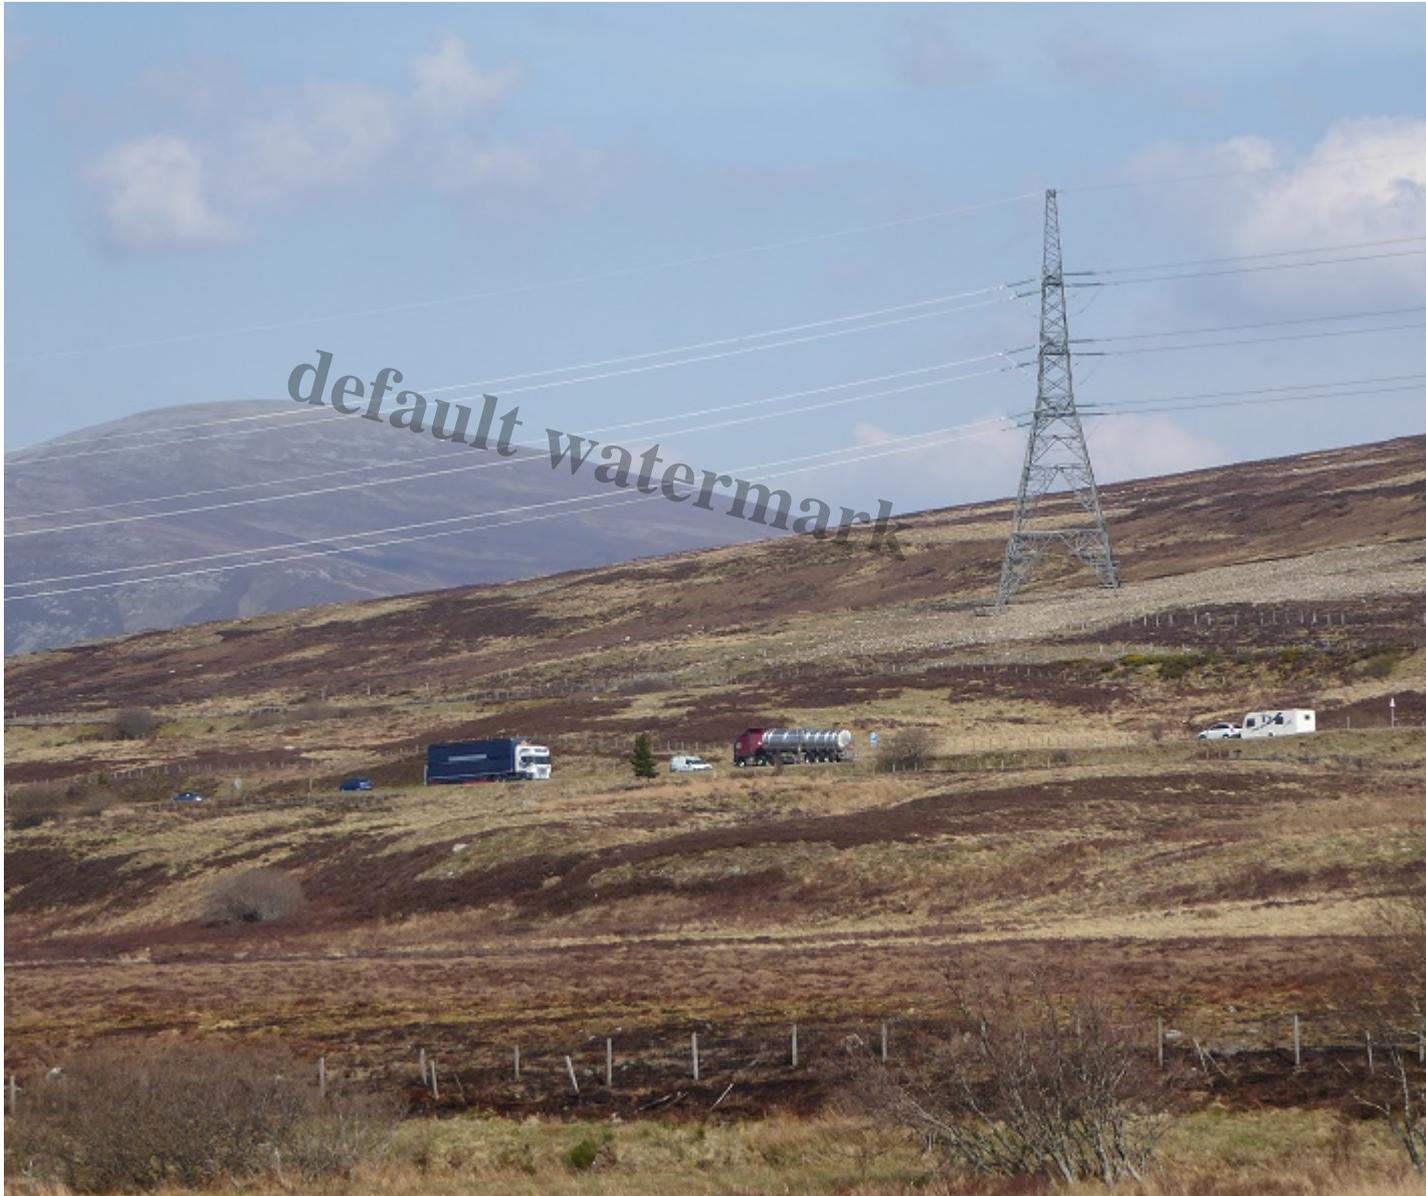
Beauly Denny restoration across A9 from A889 just north of Dalwhinnie. Meall Chuaich left background 1/5/17.

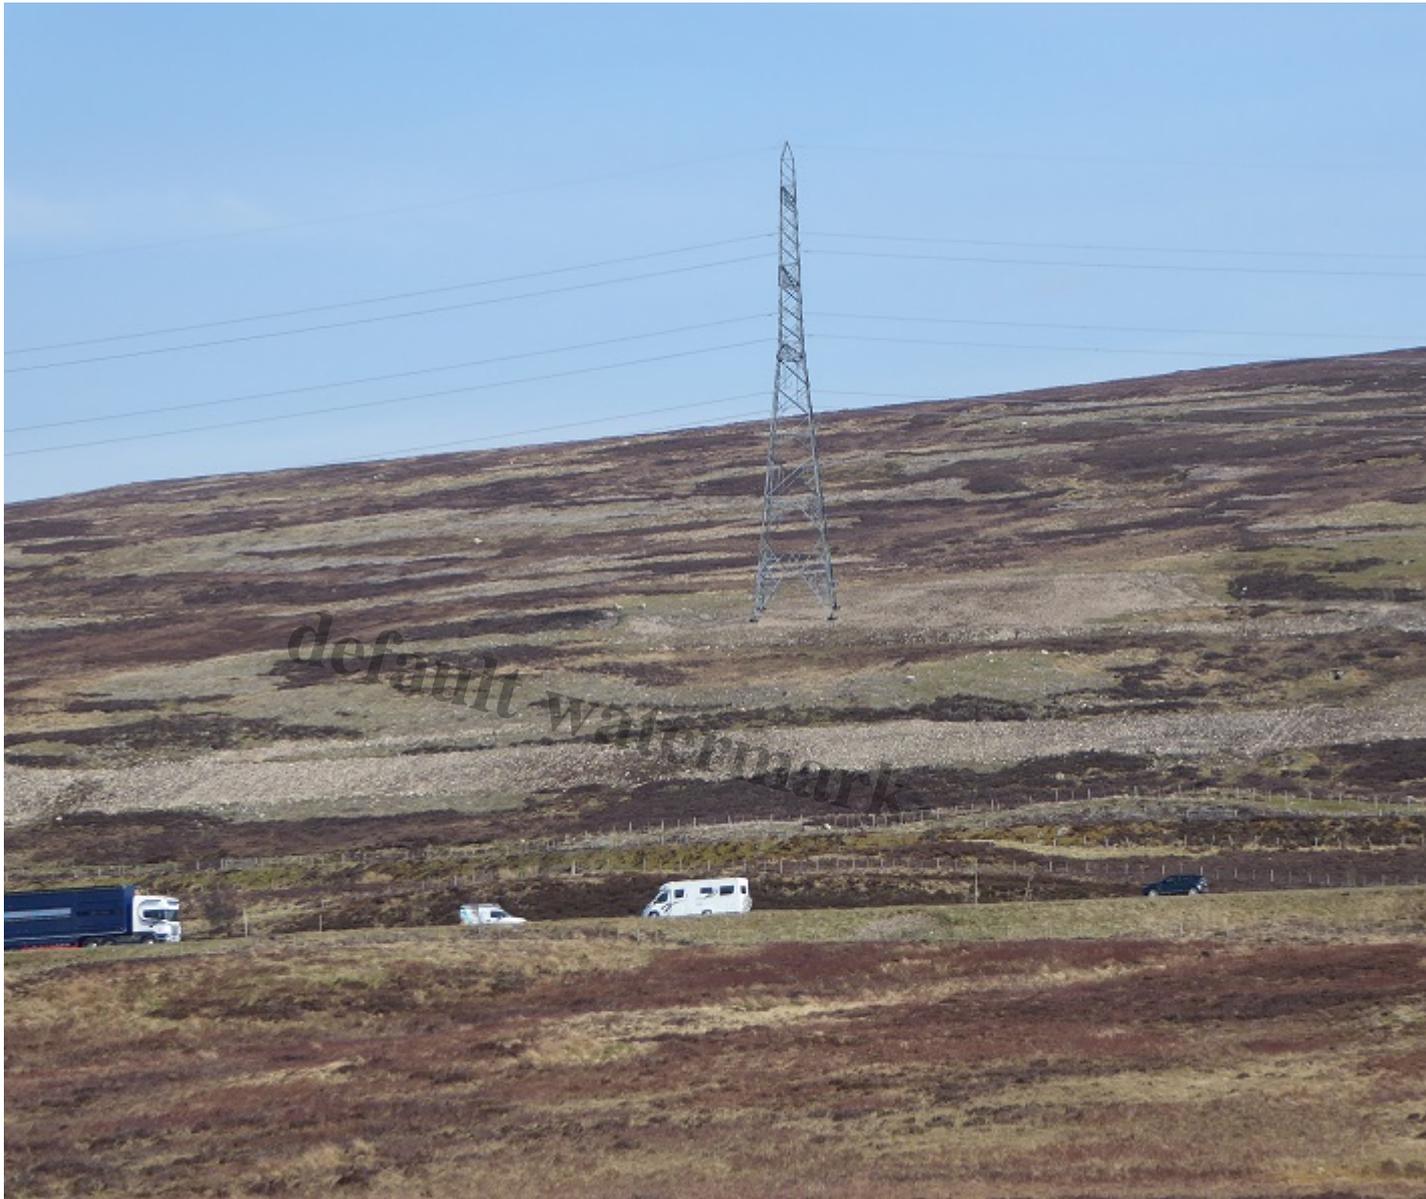
Next pylon south from that in top photo showing poor restoration around the tower and along road. From a distance some of the landscape impact is reduced because of the large areas of muirburn but this becomes more prominent as summer progresses.

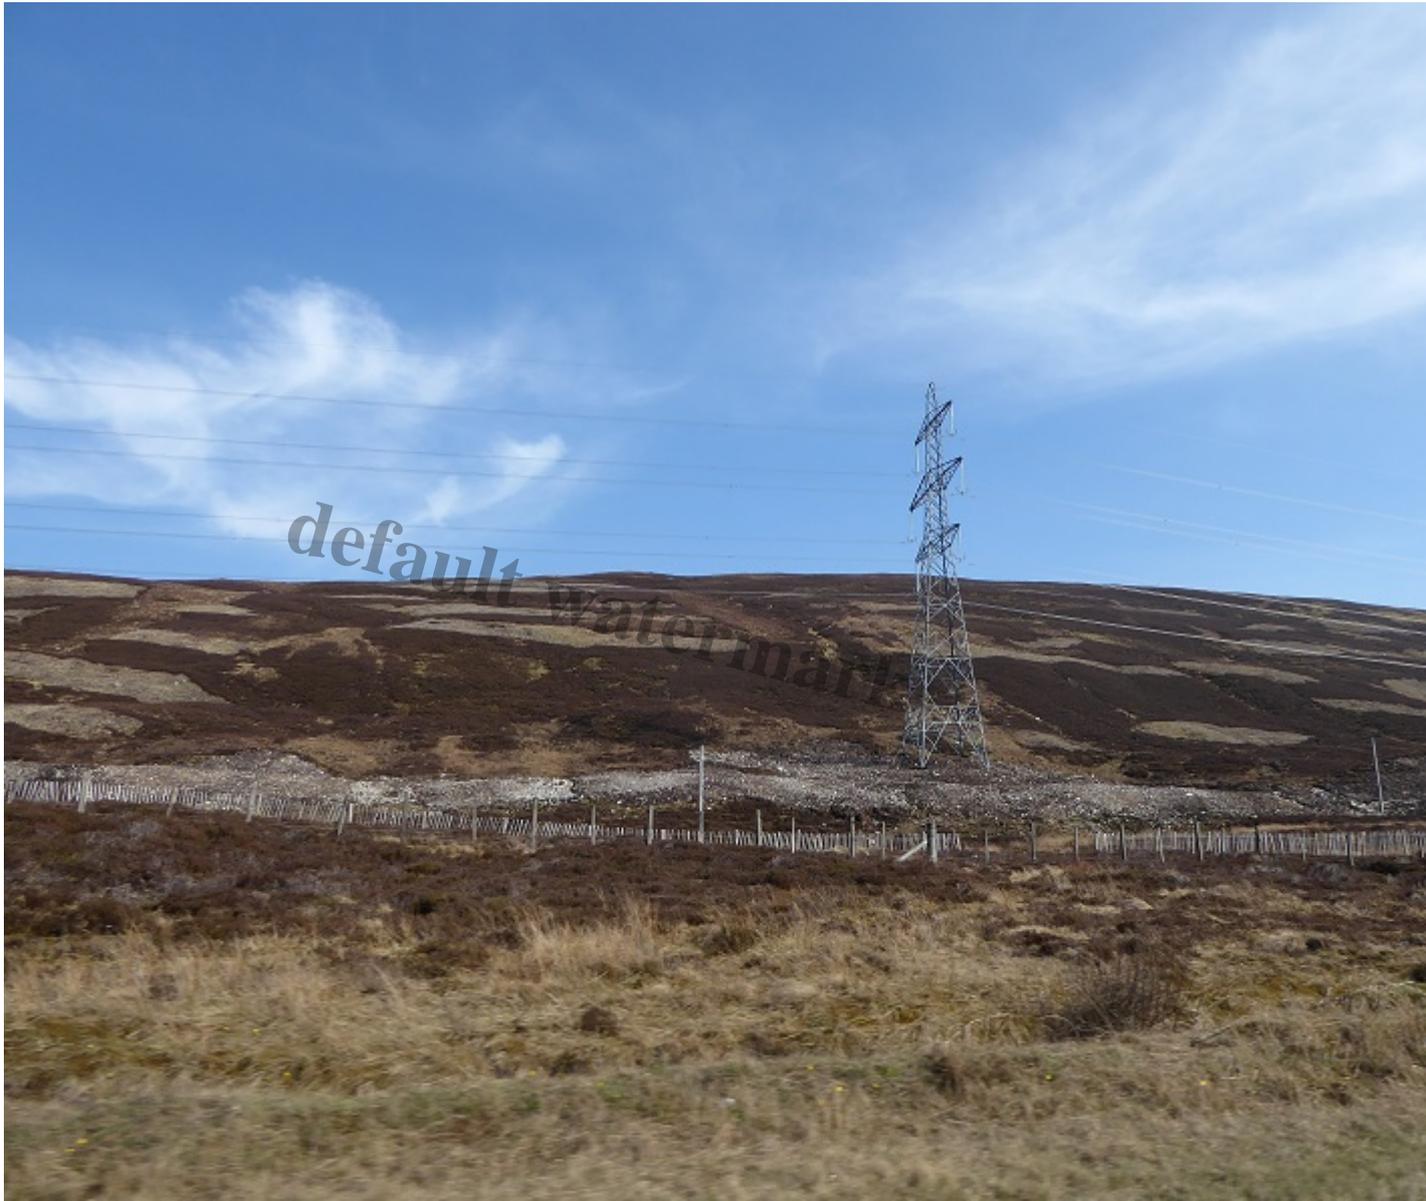
Travelling down the A9 on 1st May I took photos of almost every tower you can see from the road. The soils and vegetation is not hard to see as with this pylon south of North Drumochter Lodge

While I have not yet been able to work out the numbers of all the pylons, in the monitoring produced in October 2016 SSE states that for almost all pylons on this section of line “Re-instatement of the soils is to an acceptable standard”. The photos I believe show otherwise and that the CNPA was completely right to raise concerns.

What's not in the public realm at present (as far as I have been able to ascertain) is whether the CNPA's concerns have been submitted to the Scottish Government, and if so what the Scottish Government's response has been. What is needed is join up between the Scottish Government's ECDU and the CNPA and SNH. While a first step would be joint monitoring meetings, I think there also needs to be a joint approach to remedying what has gone wrong.
