## HIE's and Natural Retreats' works at Cairngorm – a catastrophe in the making

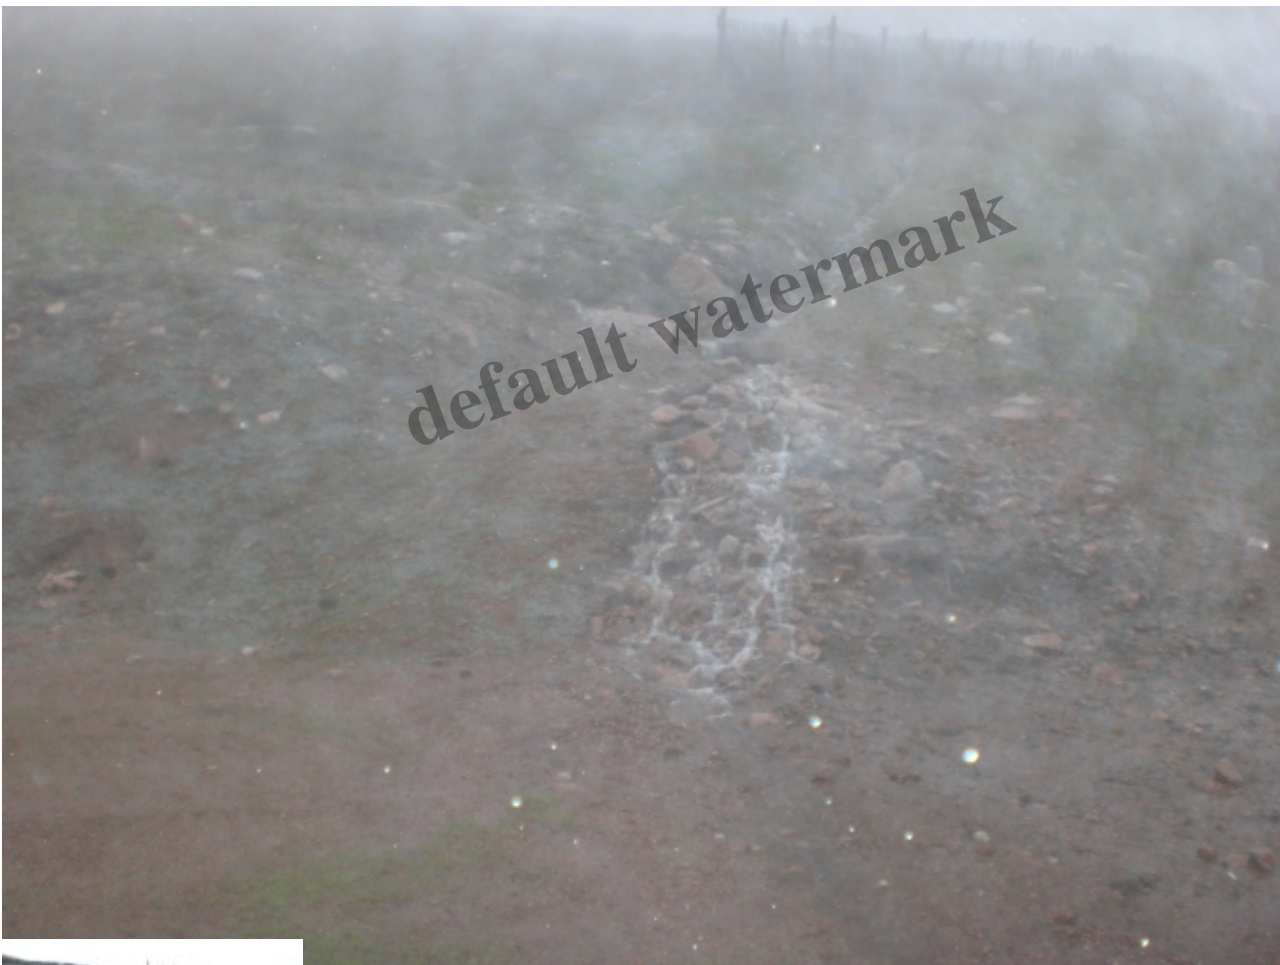
Water overflowing the drain created above the bulldozed slope and running down

beside the Cas Gantry. You can see why the green fertiliser pellets have been washed away. The

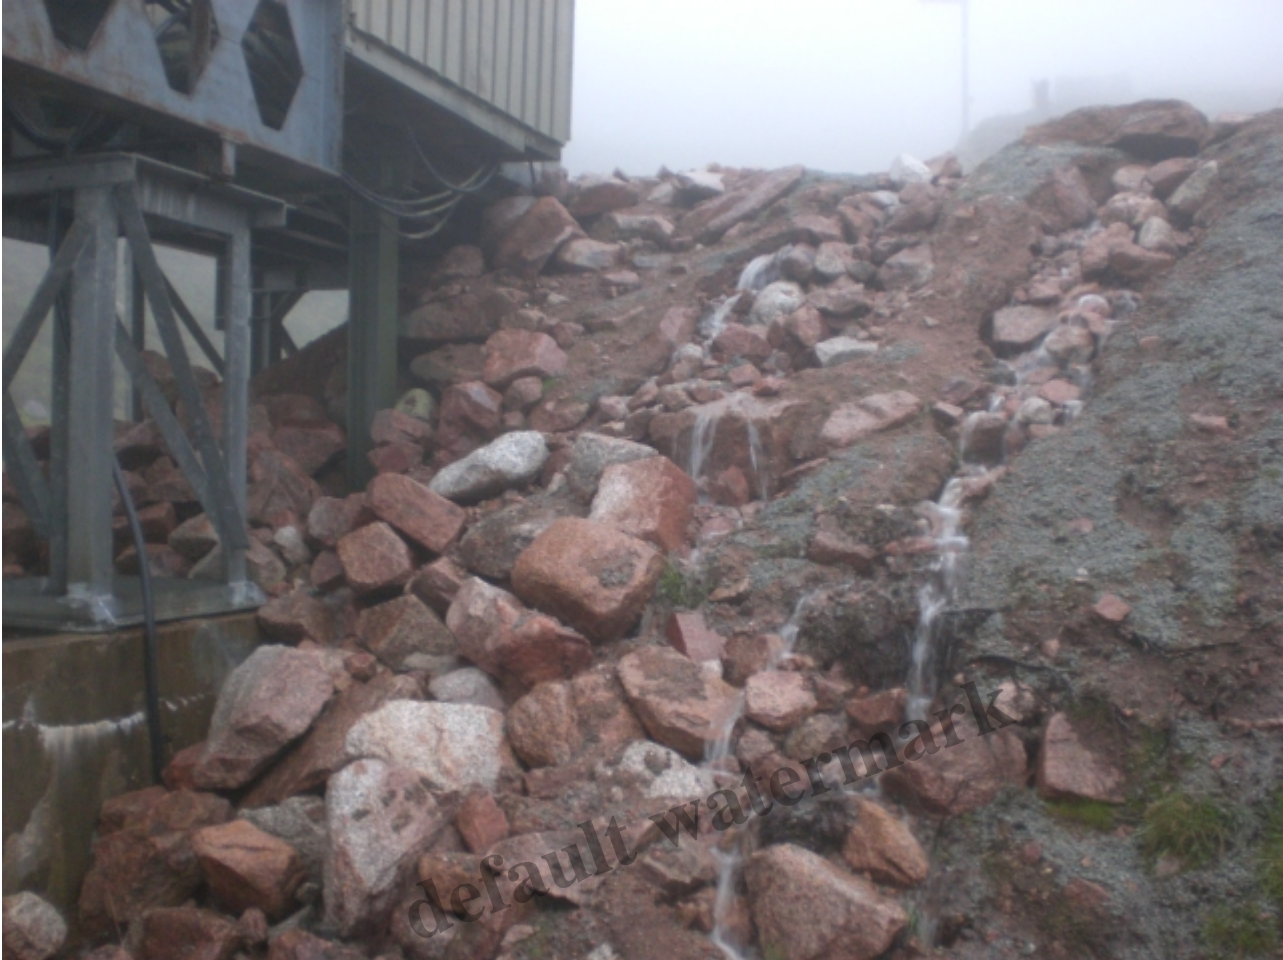
The erosion

is even worse directly adjacent to the Cas Gantry, where water has removed all the top soil (the hare found strangled last week was under the girders to left of photo). Before Natural Retreats was allowed to undertake any work here, full planning permission should have been required, including hydrological surveys.

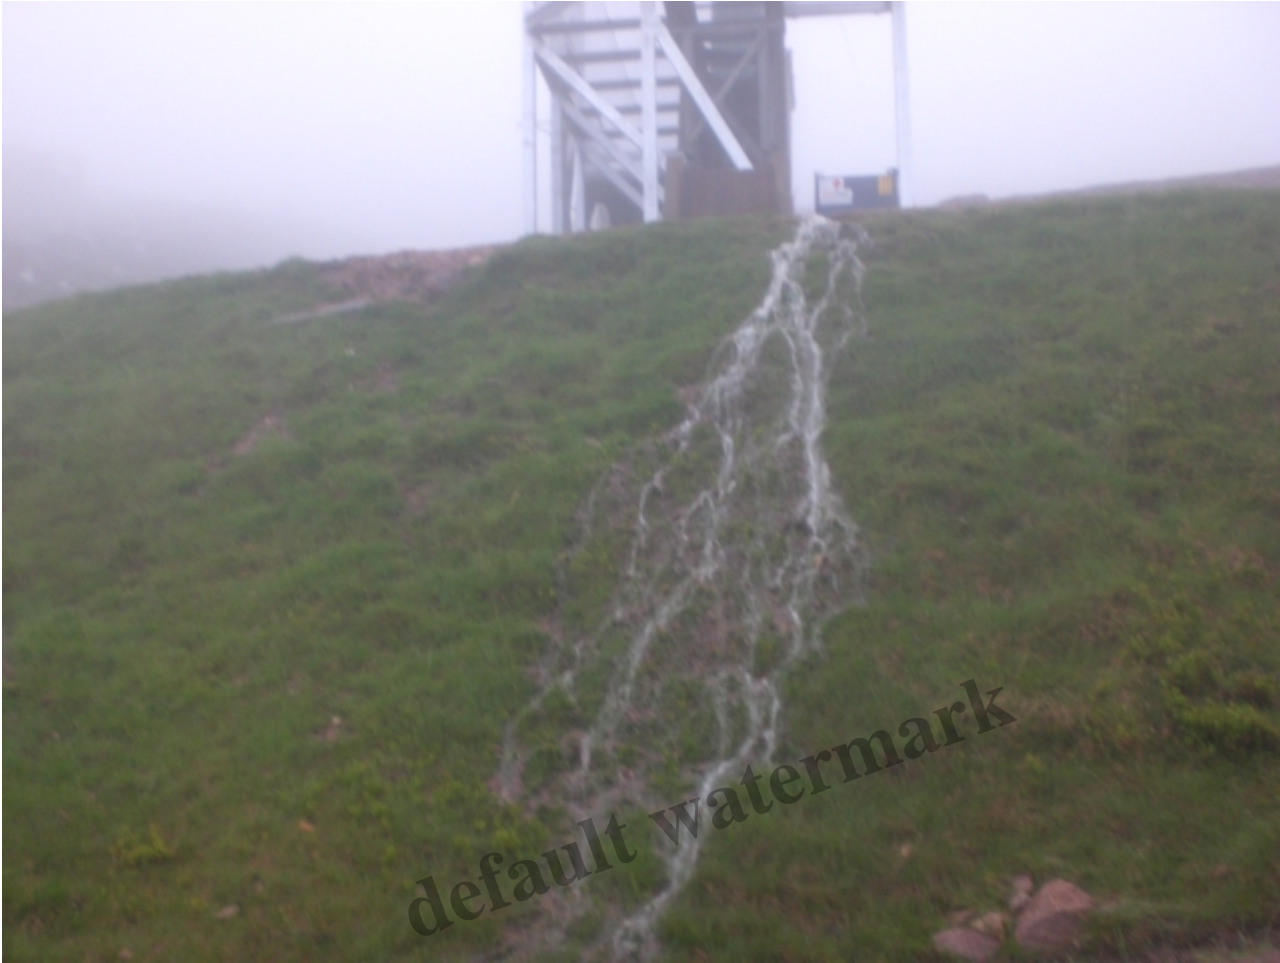
Below the gantry, the water runs down the bank which was re-seeded at an earlier date. This has helped limit the damage but for how long? No slope as steep as this will be able to withstand this amount of water for long. The problem is the works at Cairngorm have altered the pattern of water flows at Cairngorm, channelling water onto new ground which will not be able to withstand its erosive force.

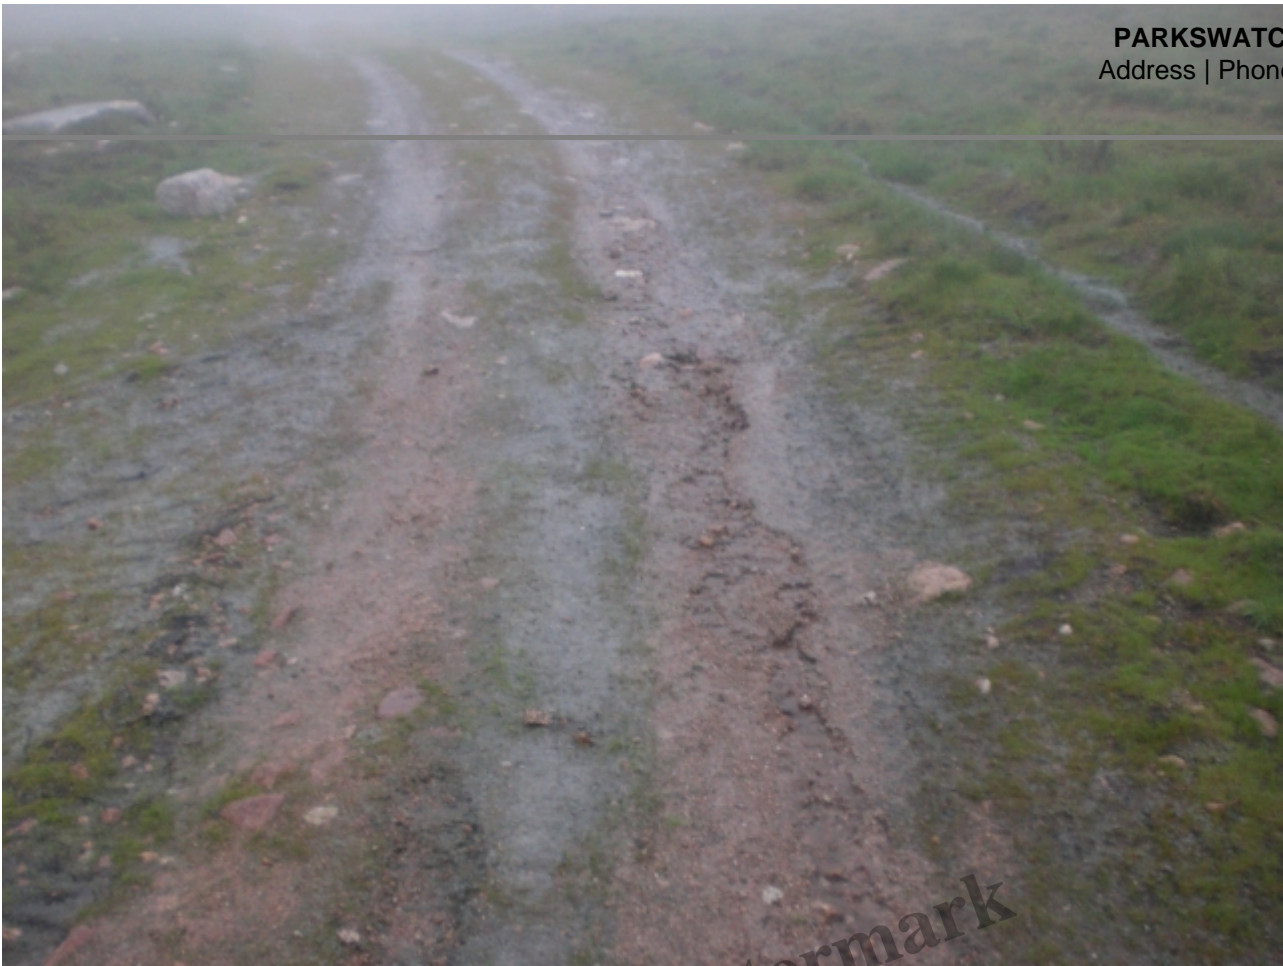
unlawfully created Shieling hill track is on the slope below the bank. As predicted water is running straight down it and, after the dry spring and winter, one downpour has been sufficient to erode the track. The CNPA was warned that a track here was not only too steep, contravening SNH's good practice guidance on hill tracks, but would serve to channel water more quickly off the hill, advice which it ignored. The suggestion from the North East Mountain Trust that the track be fully revegetated and that occasional use of vehicles over heather would do far less damage has so far been ignored.

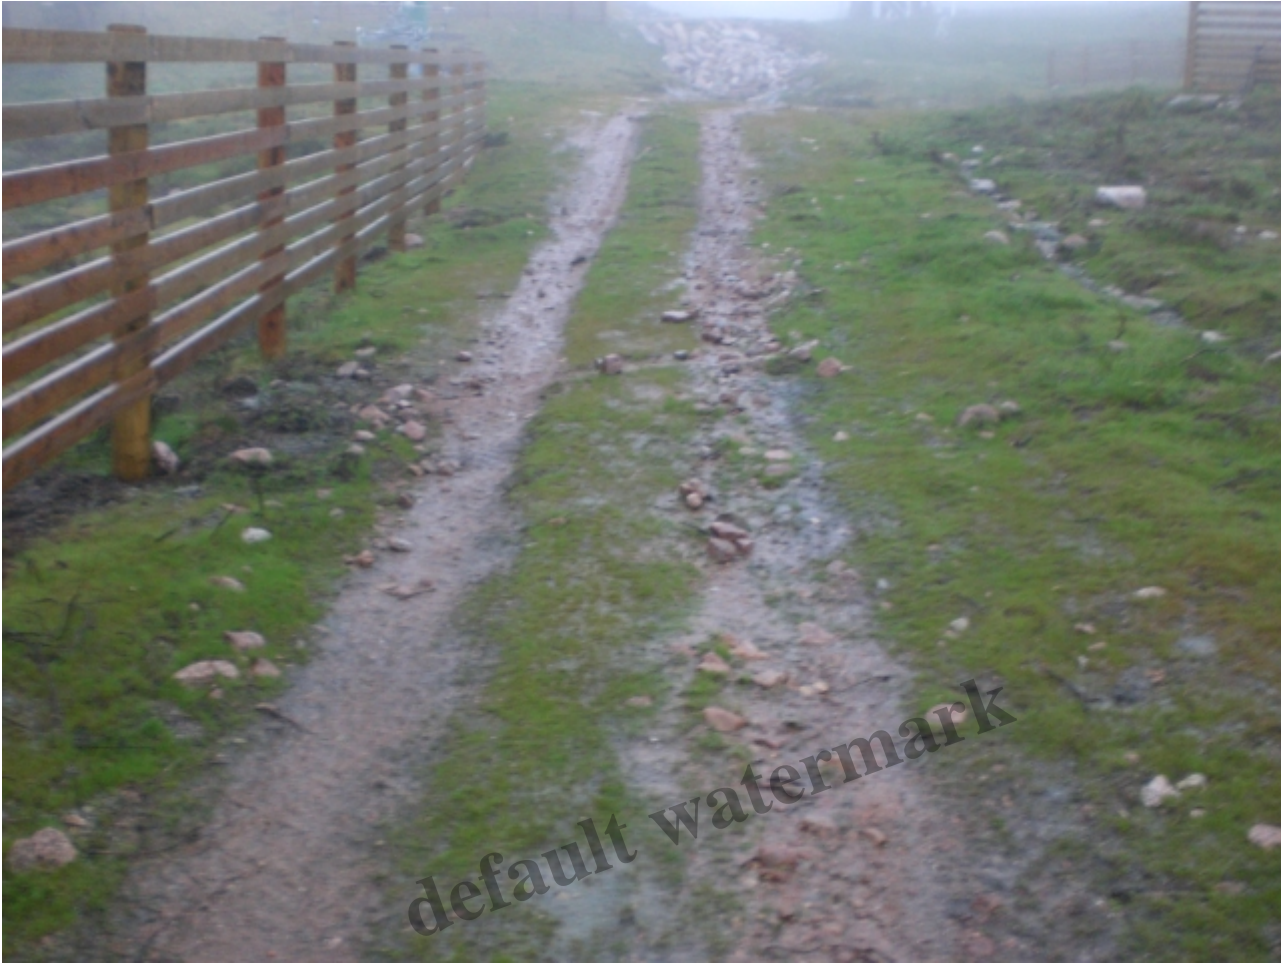
Washed out stones now litter the Shieling Hill Track.

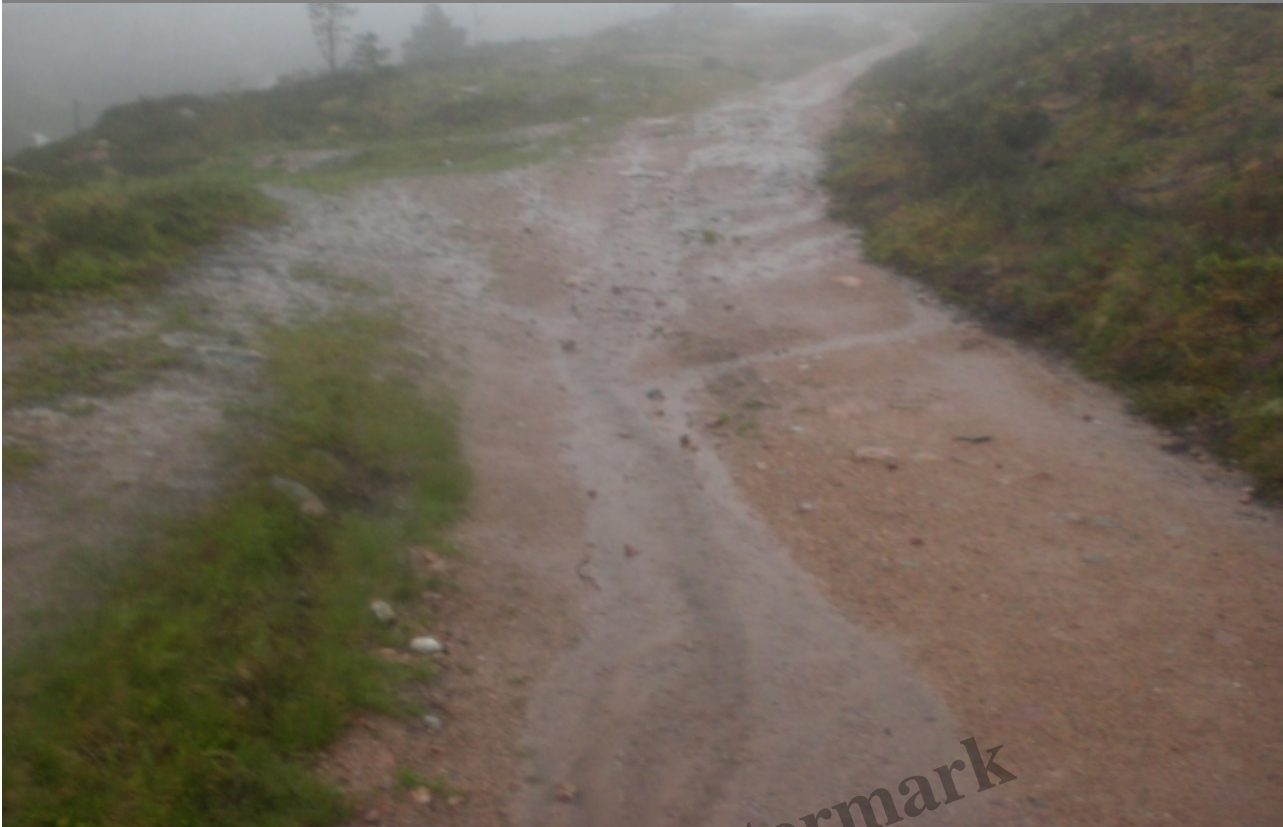
Below the

bottom of the Shieling rope tow (far distance) and by the unlawfully re-graded bank, the track has become a burn. You can see how water from the bank which Natural Retreats claimed they had “improved” is flowing onto the track. There is no way of measuring how this compares to what happened before, but the destruction of vegetation on the bank is likely to have increased the rate of water run-off.

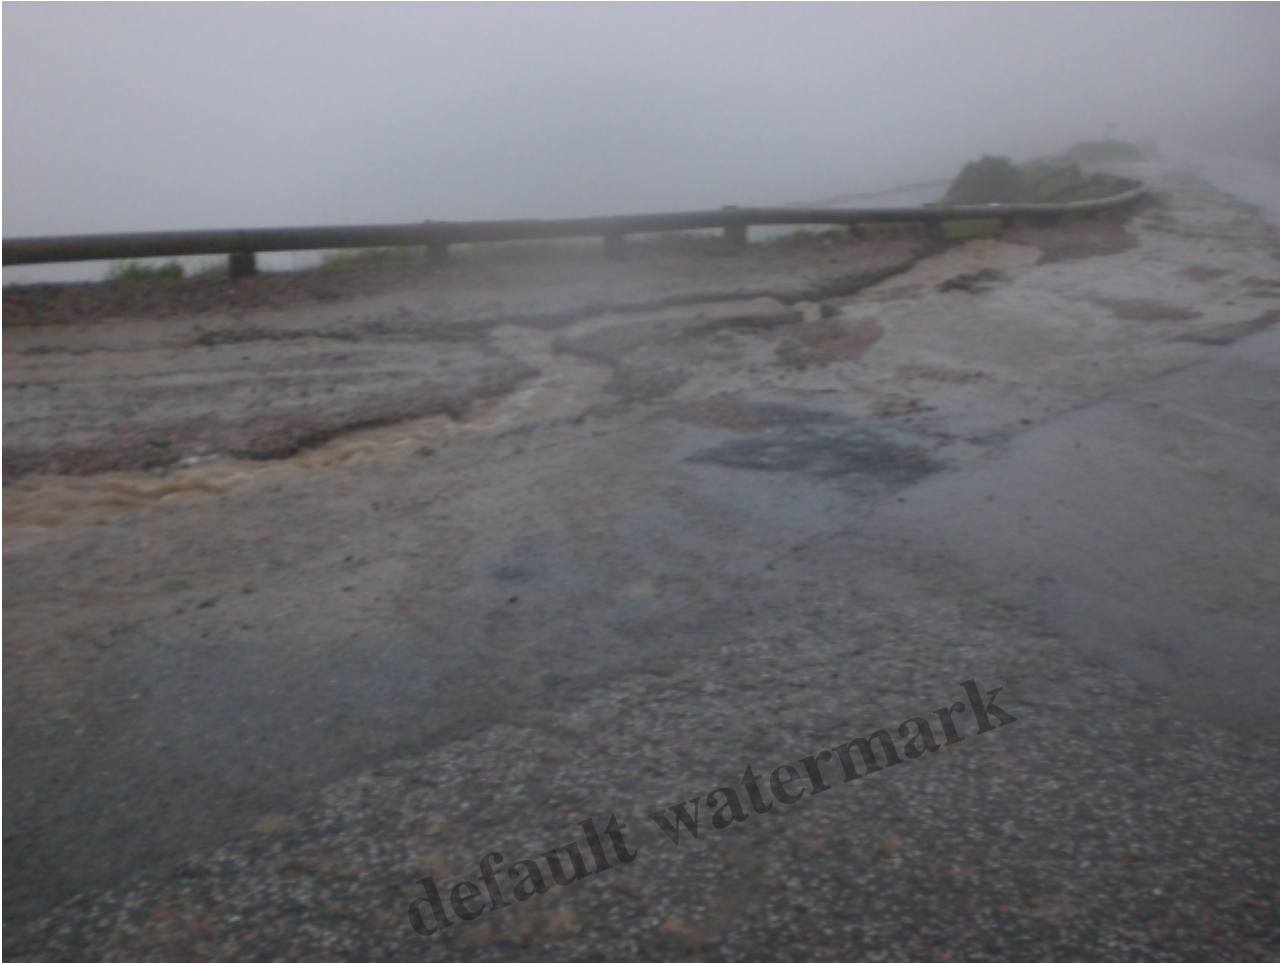
All this increased water run off is not only increasing erosion of the natural environment, its impacting on humans. The bottom of the Cas carpark was a raging torrent and is being washed away and down into the lower Cas carpark. Below that of course is the Allt Coire Cas and the people of Aviemore.
