## HIE's and Natural Retreats' works at Cairngorm – a catastrophe in the making

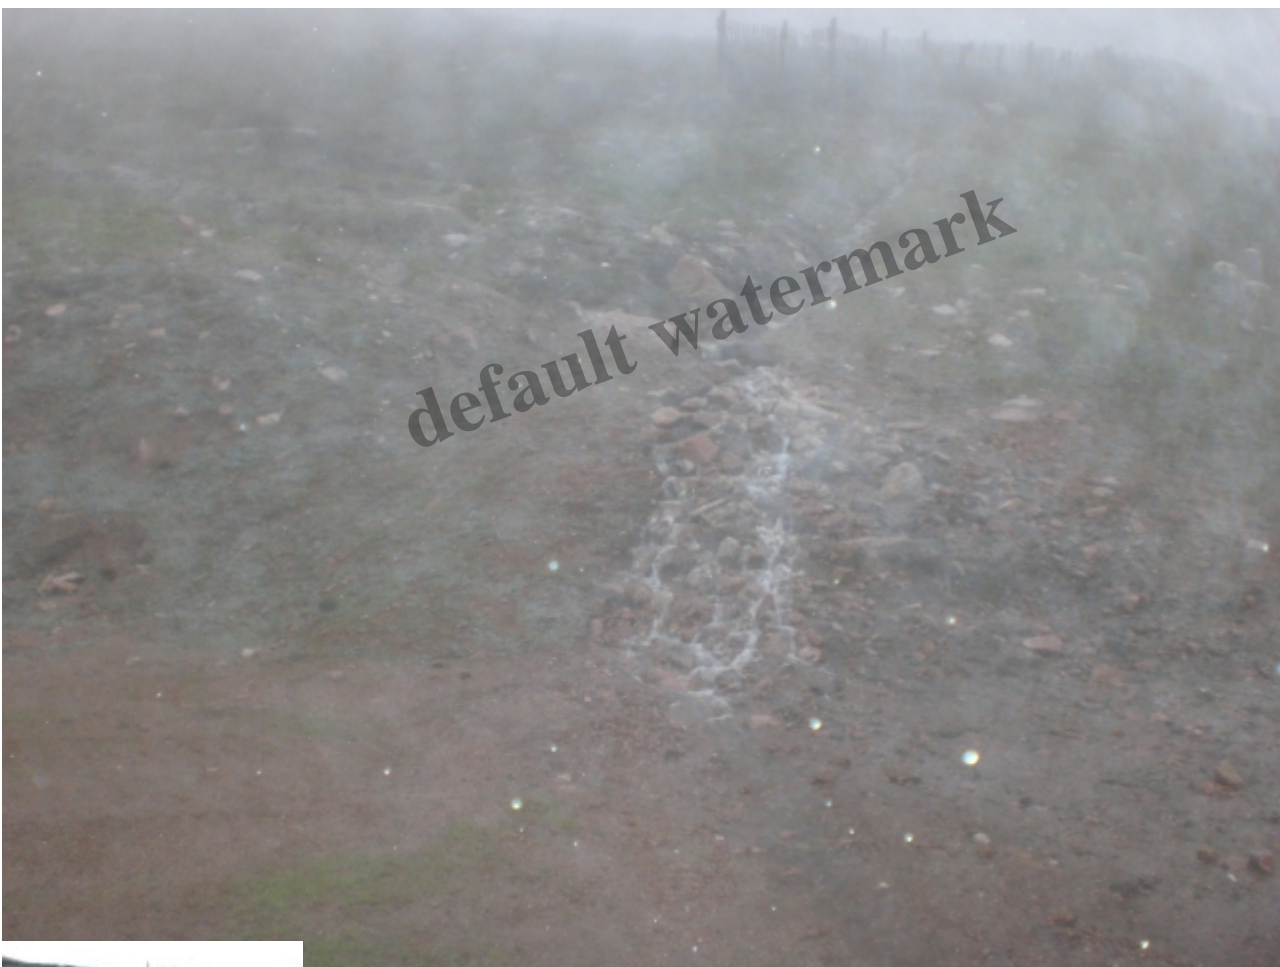
Water overflowing the drain created above the bulldozed slope and running down

beside the Cas Gantry. You can see why the green fertiliser pellets have been washed away. The Island

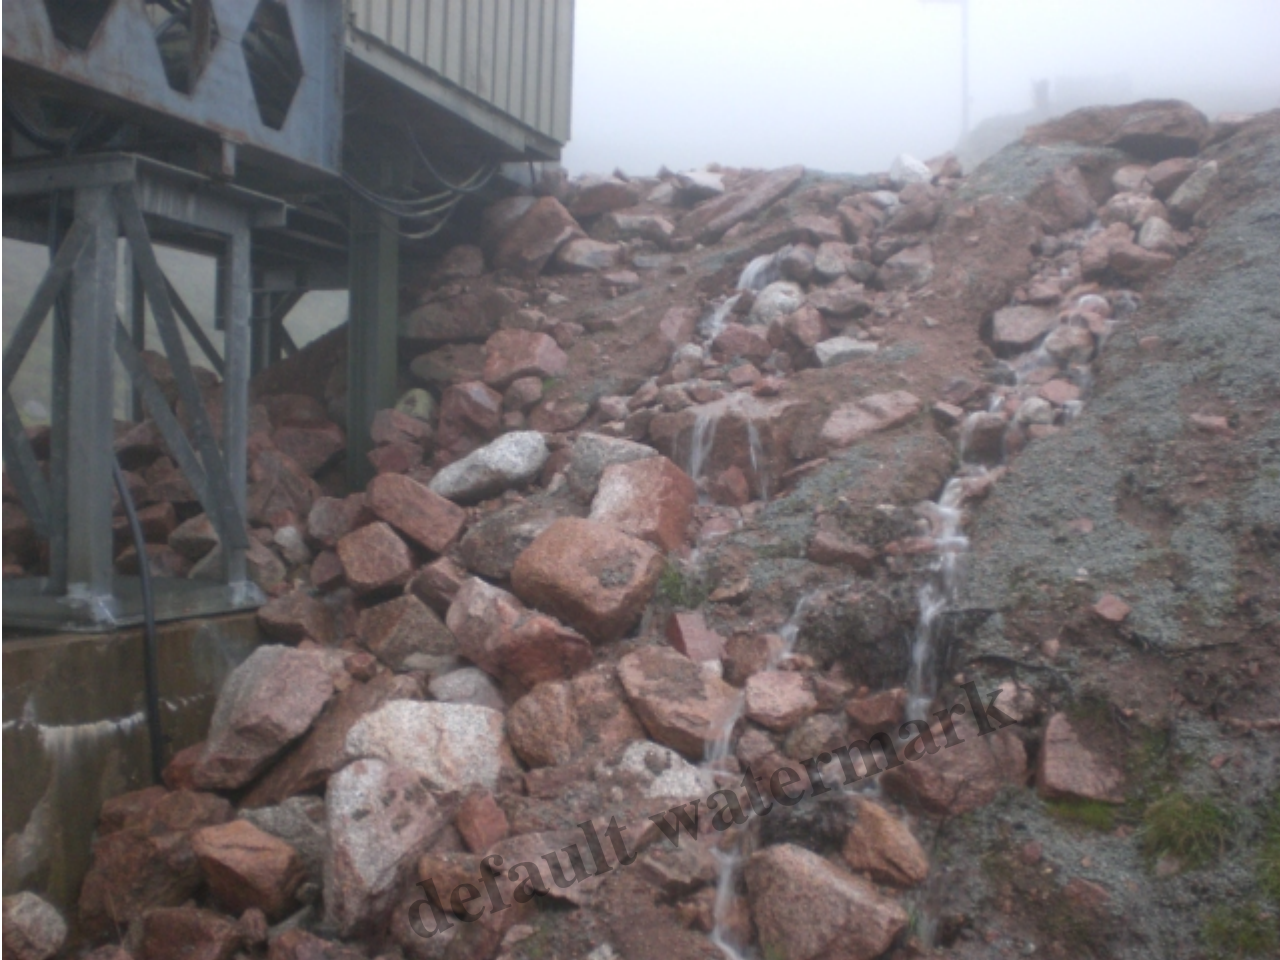
The erosion

is even worse directly adjacent to the Cas Gantry, where water has removed all the top soil (the hare found strangled last week was under the girders to left of photo). Before Natural Retreats was allowed to undertake any work here, full planning permission should have been required, including hydrological surveys.

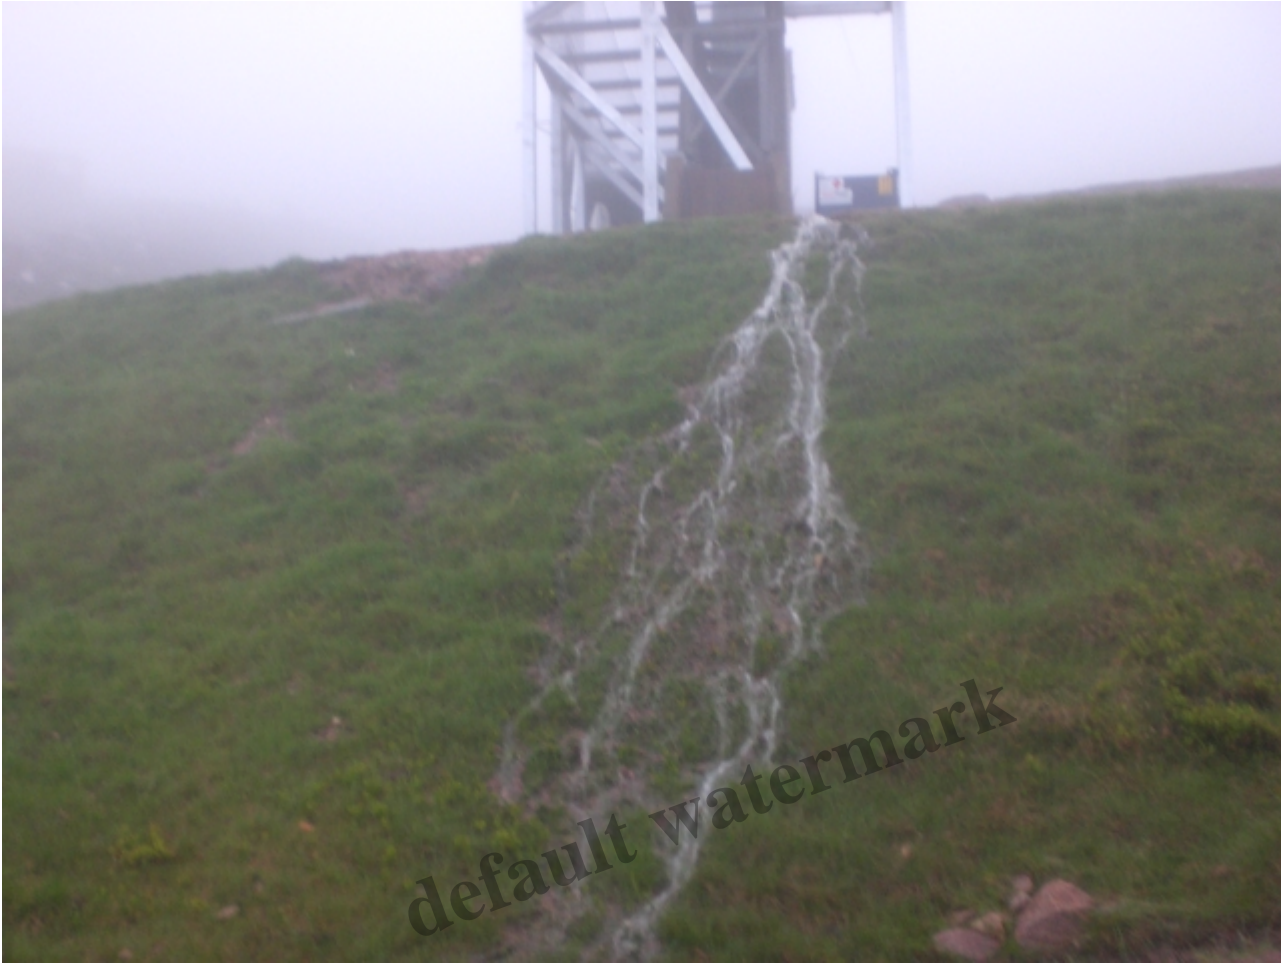
Below the gantry, the water runs down the bank which was re-seeded at an earlier date. This has helped limit the damage but for how long? No slope as steep as this will be able to withstand this amount of water for long. The problem is the works at Cairngorm have altered the pattern of water flows at Cairngorm, channelling water onto new ground which will not be able to withstand its erosive force.

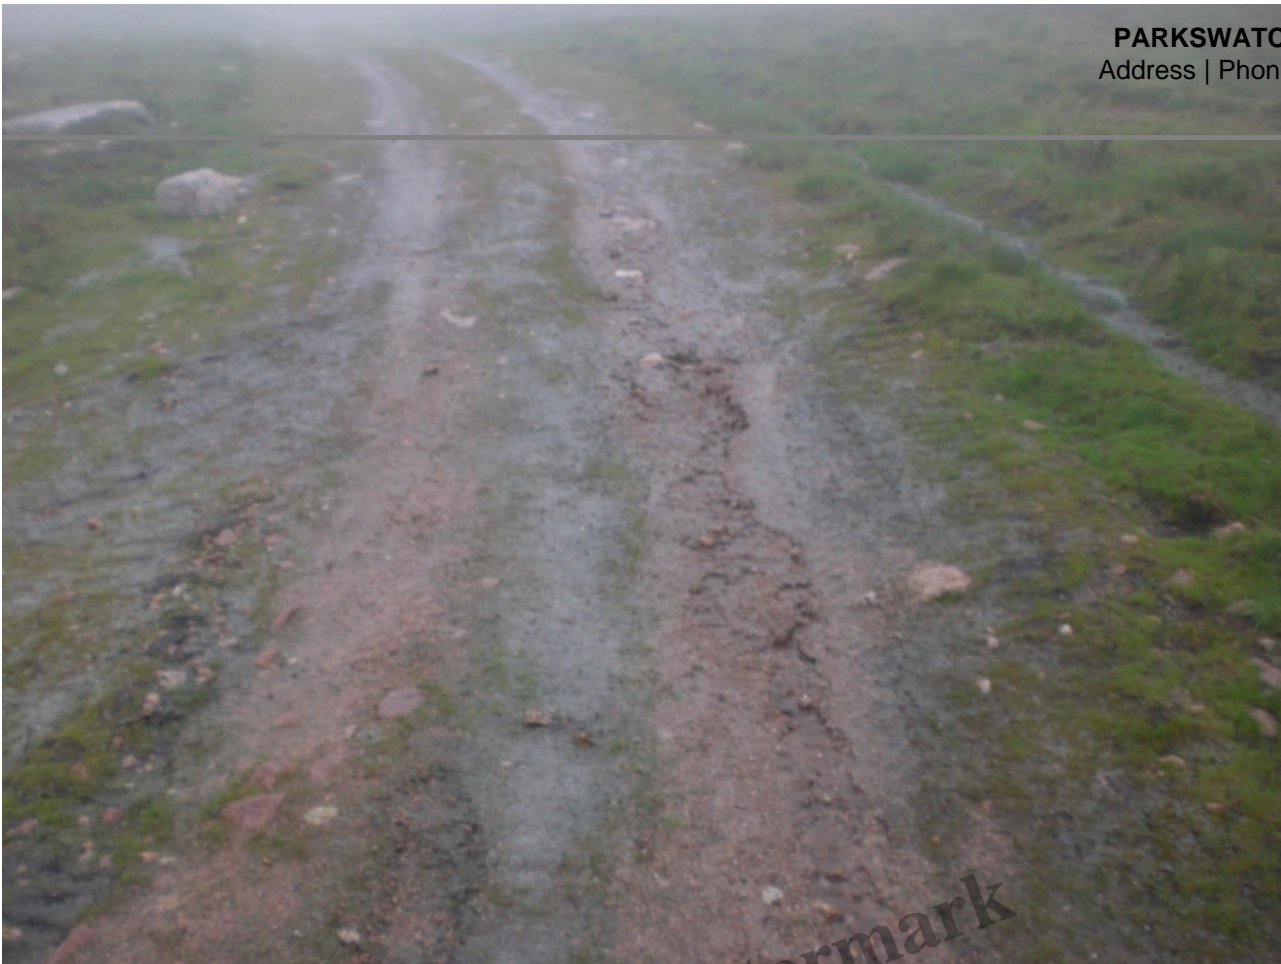
The

unlawfully created Shieling hill track is on the slope below the bank. As predicted water is running straight down it and, after the dry spring and winter, one downpour has been sufficient to erode the track. The CNPA was warned that a track here was not only too steep, contravening SNH's good practice guidance on hill tracks, but would serve to channel water more quickly off the hill, advice which it ignored. The suggestion from the North East Mountain Trust that the track be fully revegetated and that occasional use of vehicles over heather would do far less damage has so far been ignored.

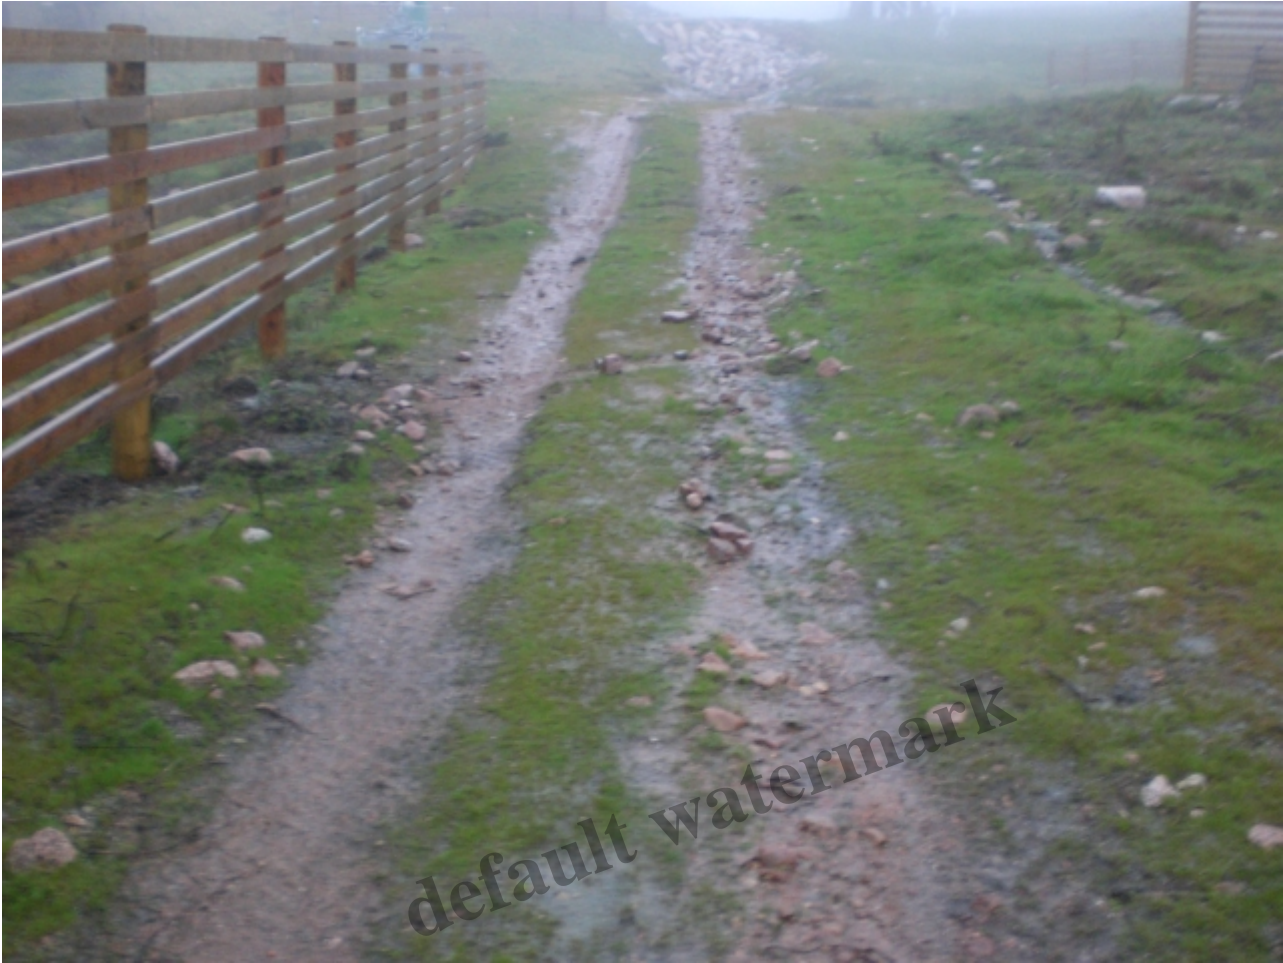
Washed out stones now litter the Shieling Hill Track.

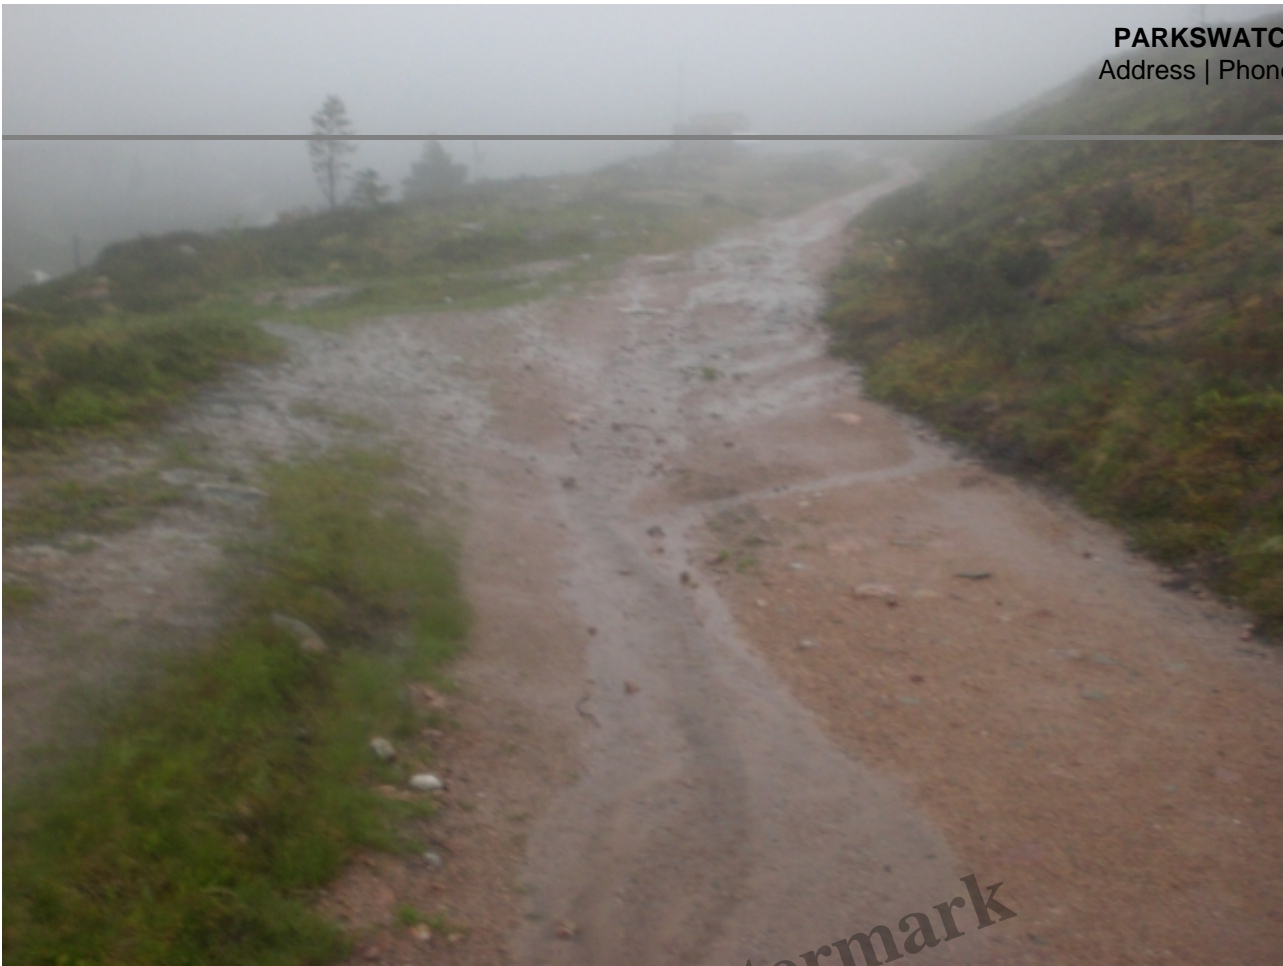
Below the

bottom of the Shieling rope tow (far distance) and by the unlawfully re-graded bank, the track has become a burn. You can see how water from the bank which Natural Retreats claimed they had “improved” is flowing onto the track. There is no way of measuring how this compares to what happened before, but the destruction of vegetation on the bank is likely to have increased the rate of water run-off.
