Coilessan hill track upgrade•

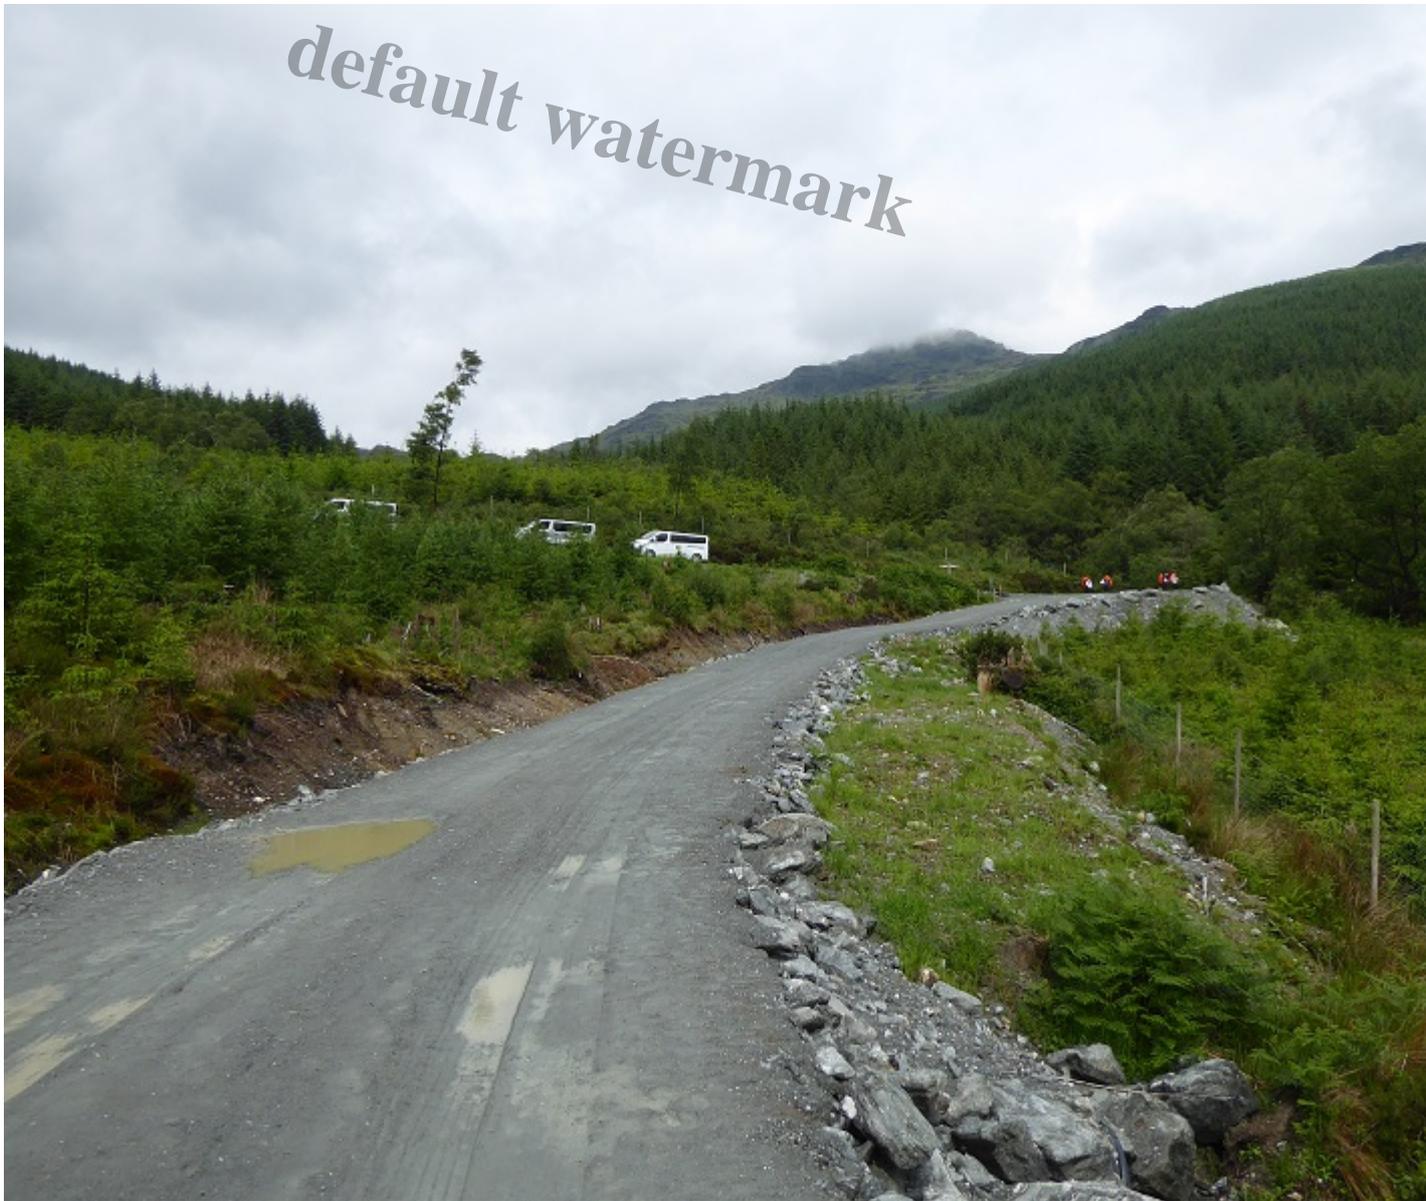
The upgraded track below the 'Dukes Path', the Coilessan burn is just beyond the Duke of Edinburgh Group centre right and the Brack behind

Instead FCS has upgraded part of the existing track network in Coilessan Glen by dumping aggregate on the earlier track. There is no planning application on the Loch Lomond and National Park Planning portal and the LINK Hill track group ([see here](#)) was not aware of the track through the prior notification system. While its possible the LINK hill track group missed the notification, its also possible that because this was an 'upgrade' to an existing track the Loch Lomond and Trossachs National Park Authority did not have to be notified (I will try and find out).

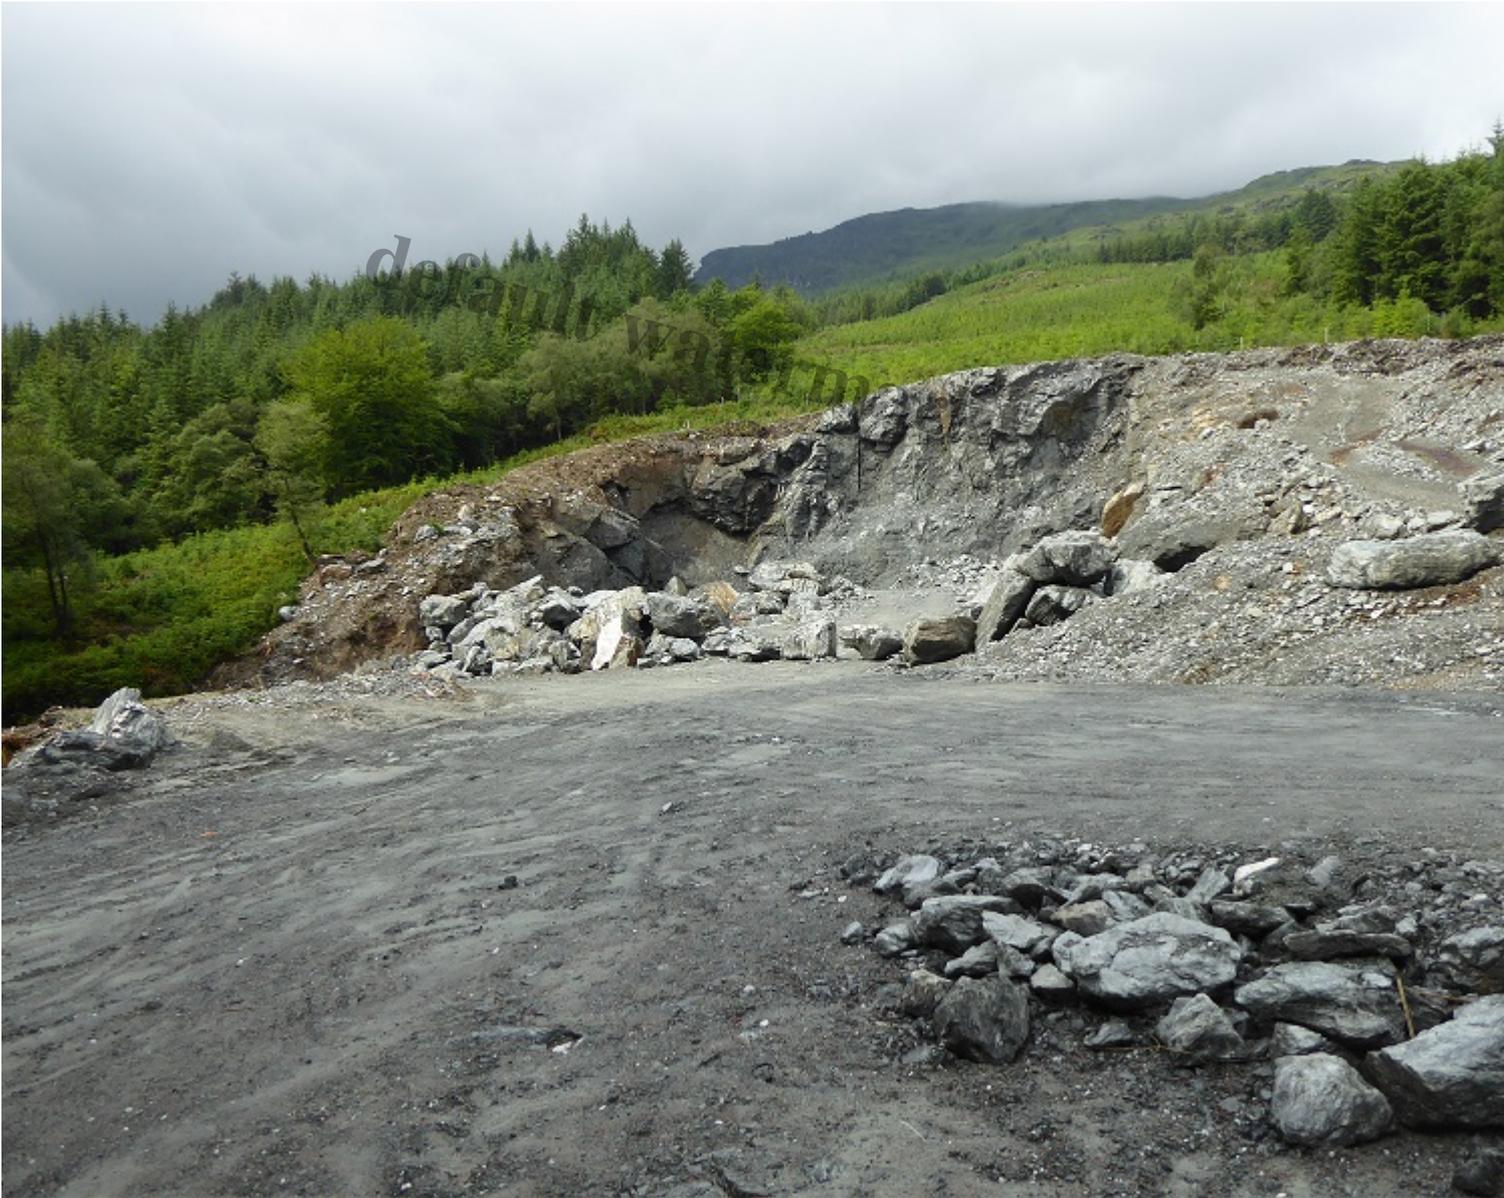
A sizeable new quarry has been created to source the new material for the track (the boulders in the middle ground are large) and gives some idea of how much aggregate has been dumped on top of the existing tracks. In my view this should have required planning permission in the National Park.

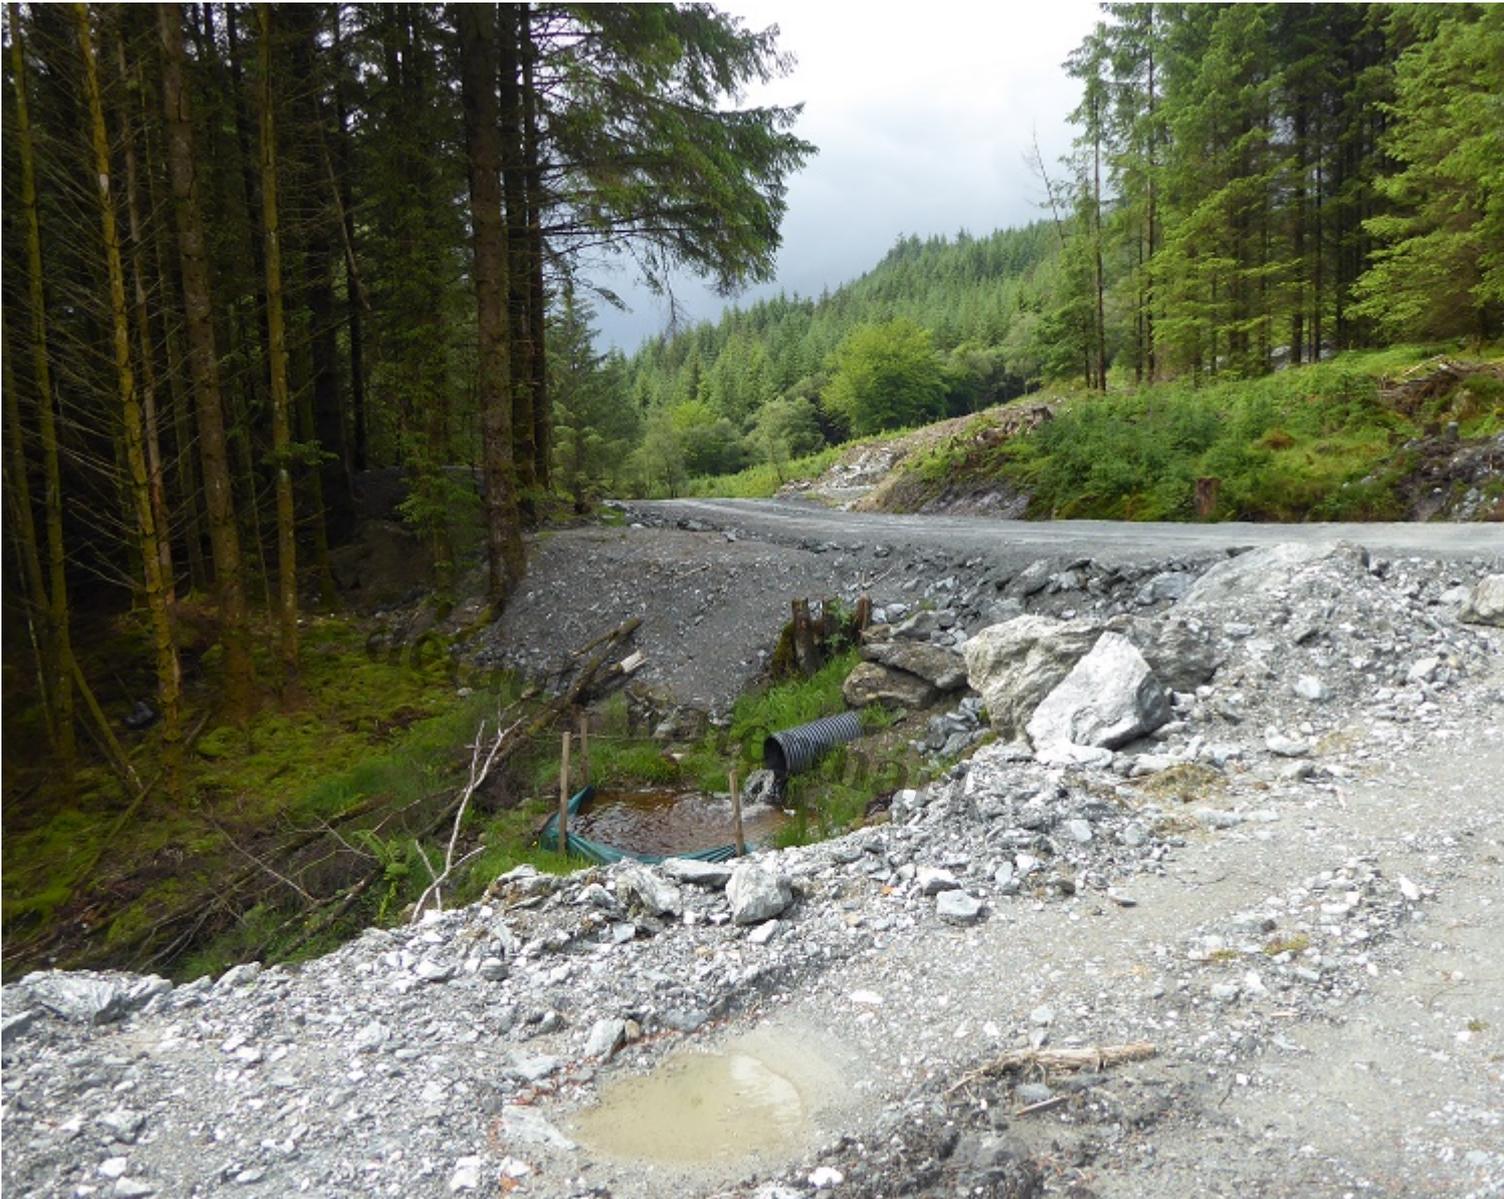
The quality of the finishing â?? there was no evidence that machines are still on site or that the work is not regarded as complete â?? is extremely poor. It might be more accurate to say non-existent in places. It does not appear likely that the FCS will try and extract trees up this corner so what is the argument for leaving it like this, apart from cost? This should not be acceptable in a National Park, whatever the commercial imperatives to extract timber.

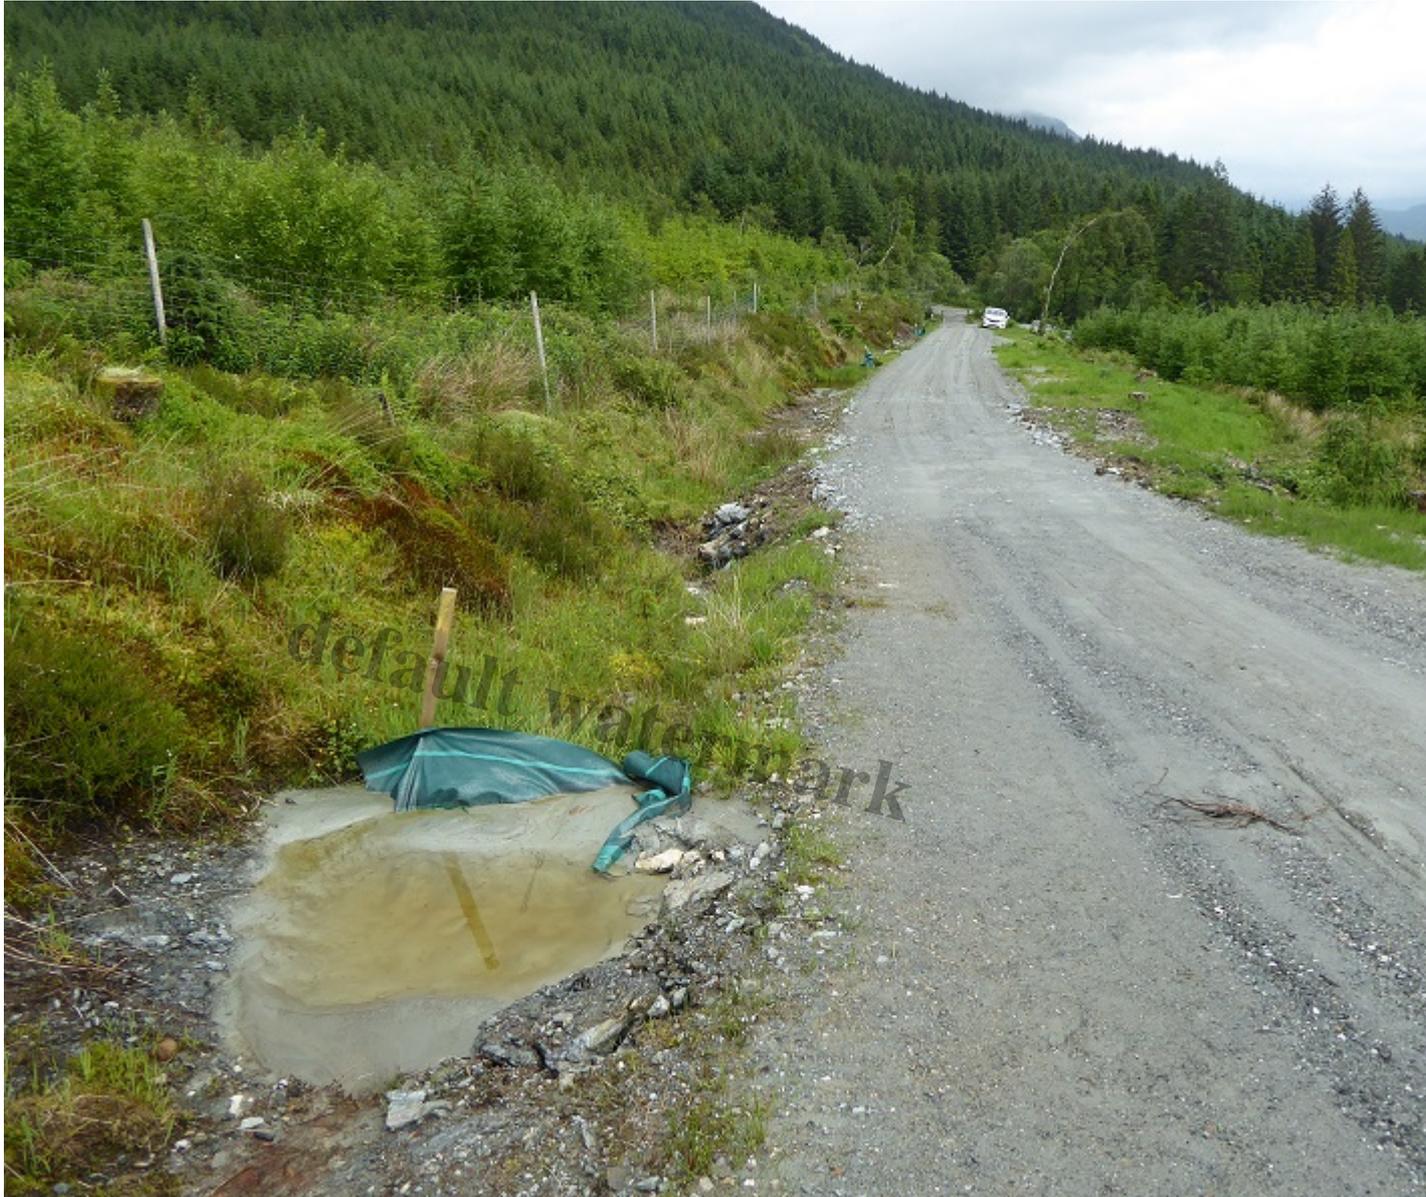
The Dukes path looking north. The turn off to lower track is just beyond the transit, while that to the upper track is just behind the viewer.

The Dukes Path has been spared the upgrading work so far and gives an idea of what the tracks looked like previously. The silt trap is to catch the silt that is being washed down from the new track just above. The crushed schist forms a very fine material which is likely to continue to wash out of the new track surface for some time.

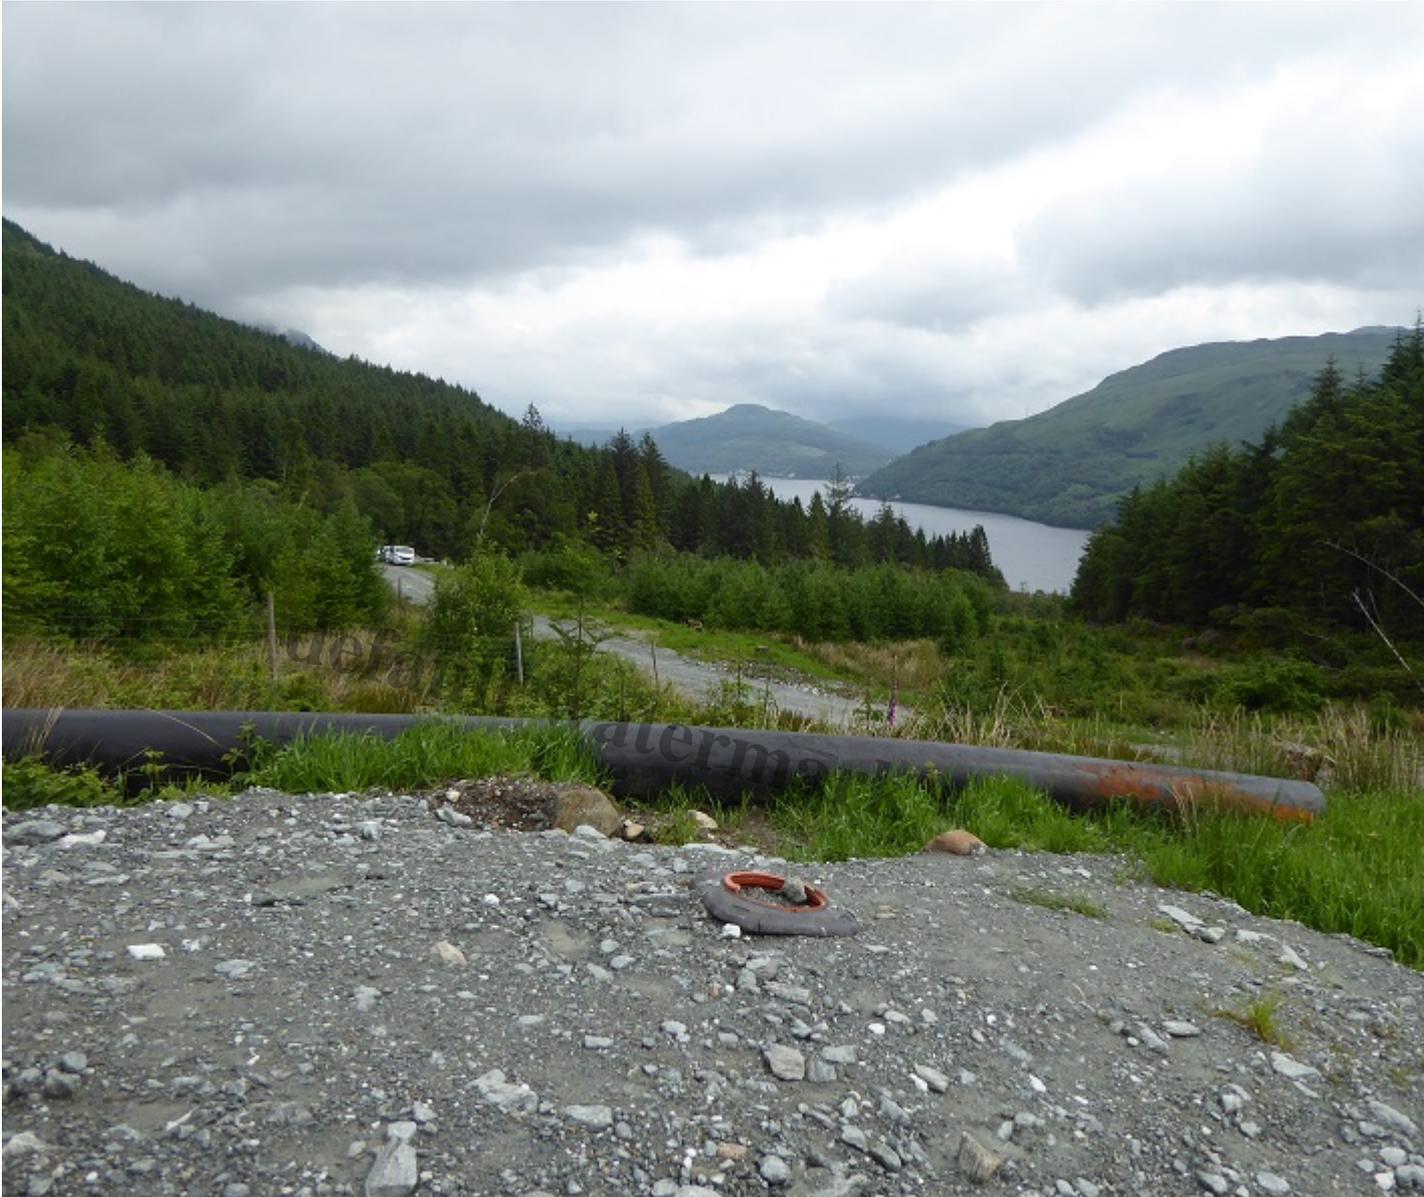
The Dukes path and Loch Long from start of the track as it heads up the glen

The lack of care for the landscape at the micro level is demonstrated not just by the abandoned pipe and decapitated cone but by the spoil heap at the side of the track. The lack of care at the landscape level is demonstrated by the conifer replanting either side of the Dukes Path. This was one of the few sections of the Dukes Path where the walker is not hemmed in by forest on either side but but instead of using the felling as an opportunity to create a more diverse landscape, the replanting will have obscured the view completely in another 20 years.

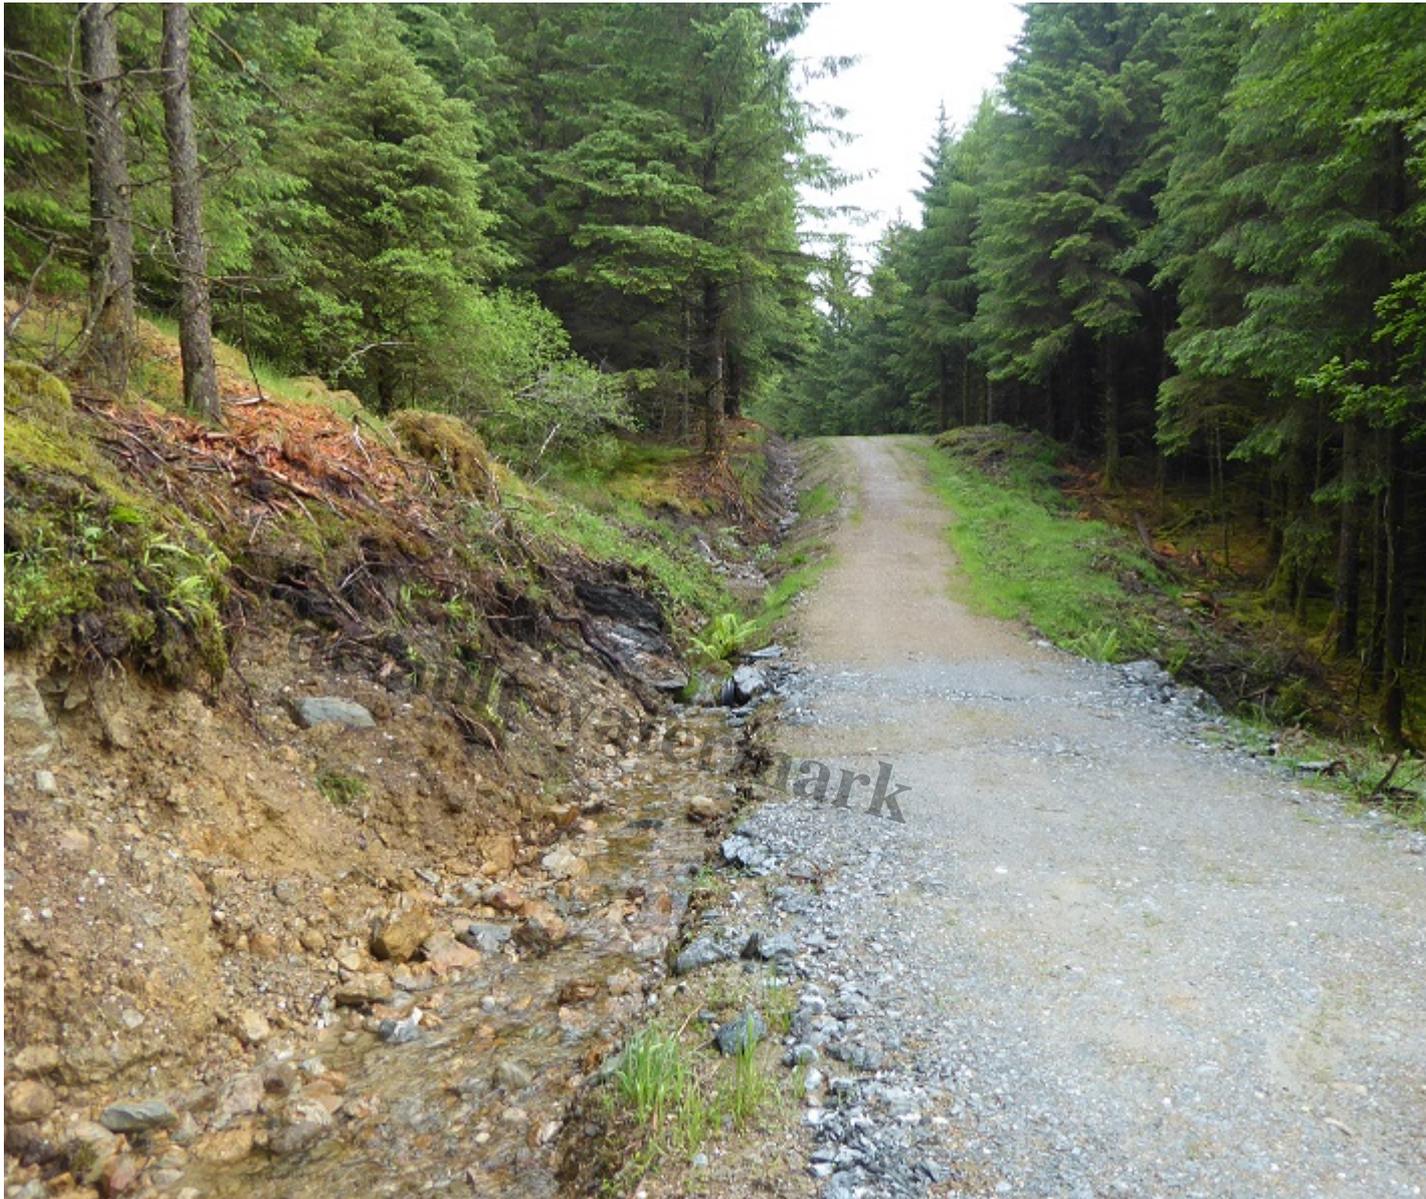
Section of Cat Craigs track north of Coilessan which offers no views.

This photo also illustrates difference between repairing a track surface compared to the upgrading work at Coilessan (below). The bare bank on left appears to date from original construction.

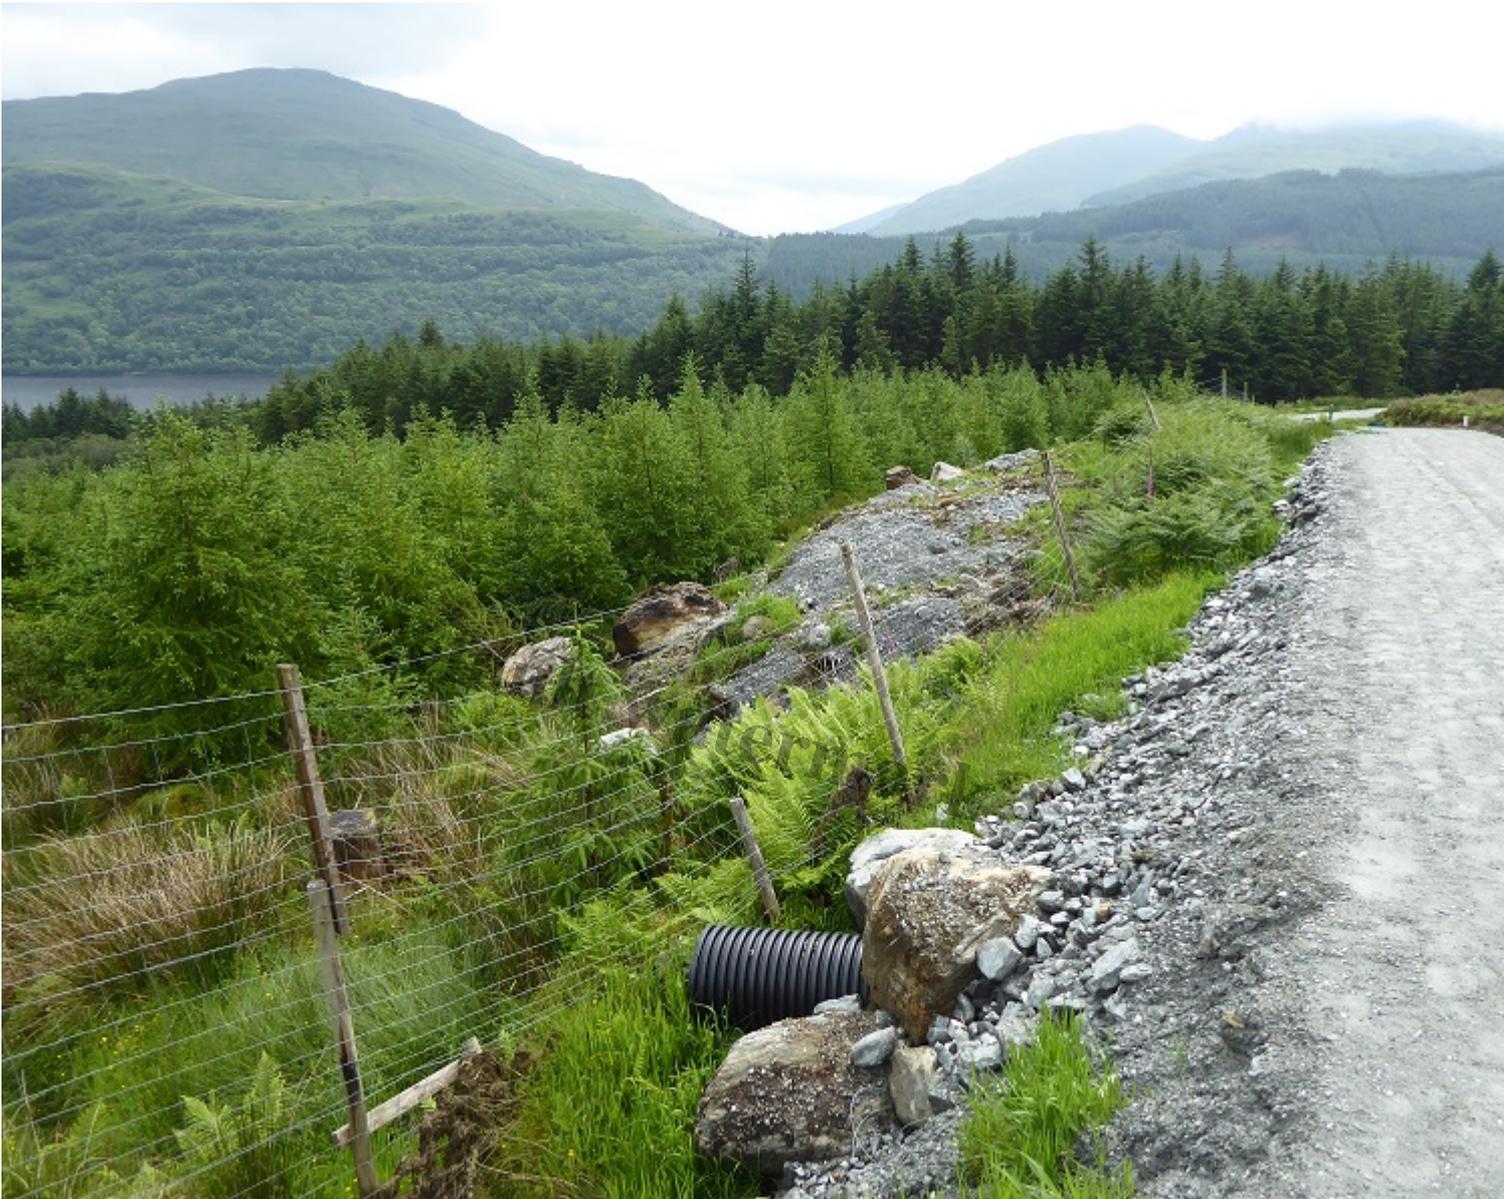
The history of a lack of care here is also demonstrated by the spoil to the left of the new track which has partly revegetated. It may date from earlier tree felling. Material from the new track will erode down the hillside.

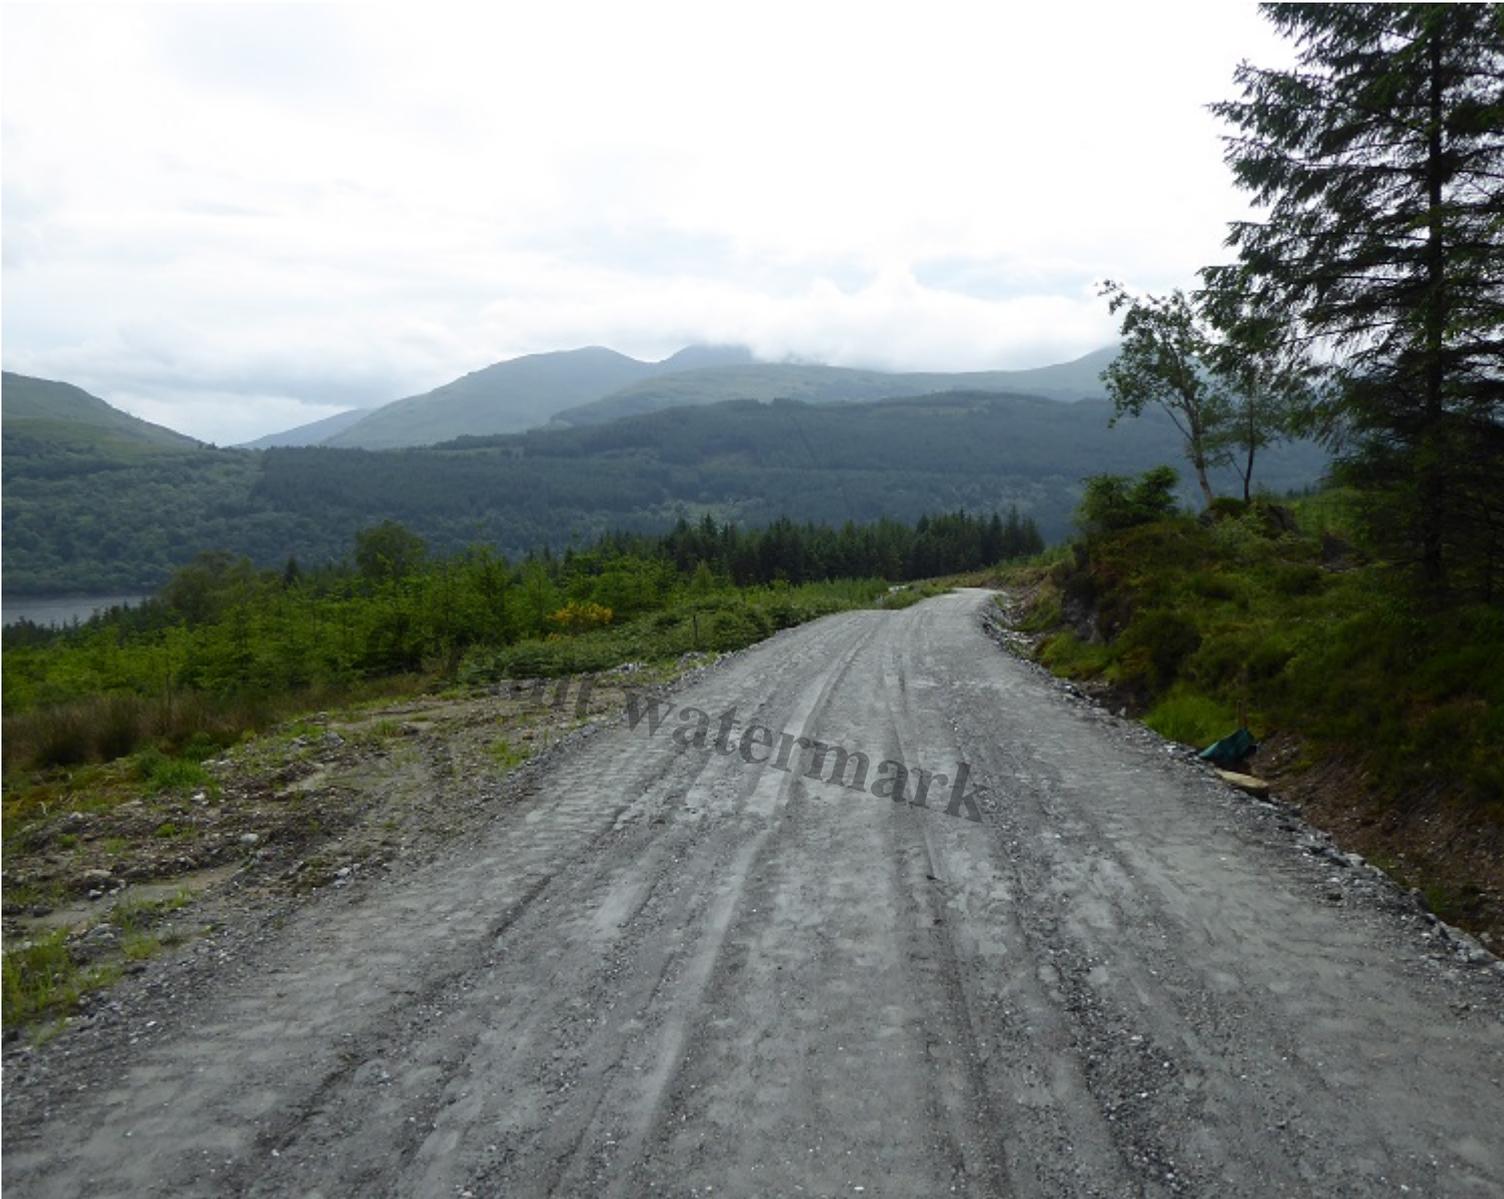
The surface of the track is now firmer than two months ago, when Rod McLeod took his photos, and appears to have consolidated to an extent. I passed the Duke of Edinburgh Group shortly after taking this photo and asked them to rate the track and the walking experience. "Terrible" was the response.

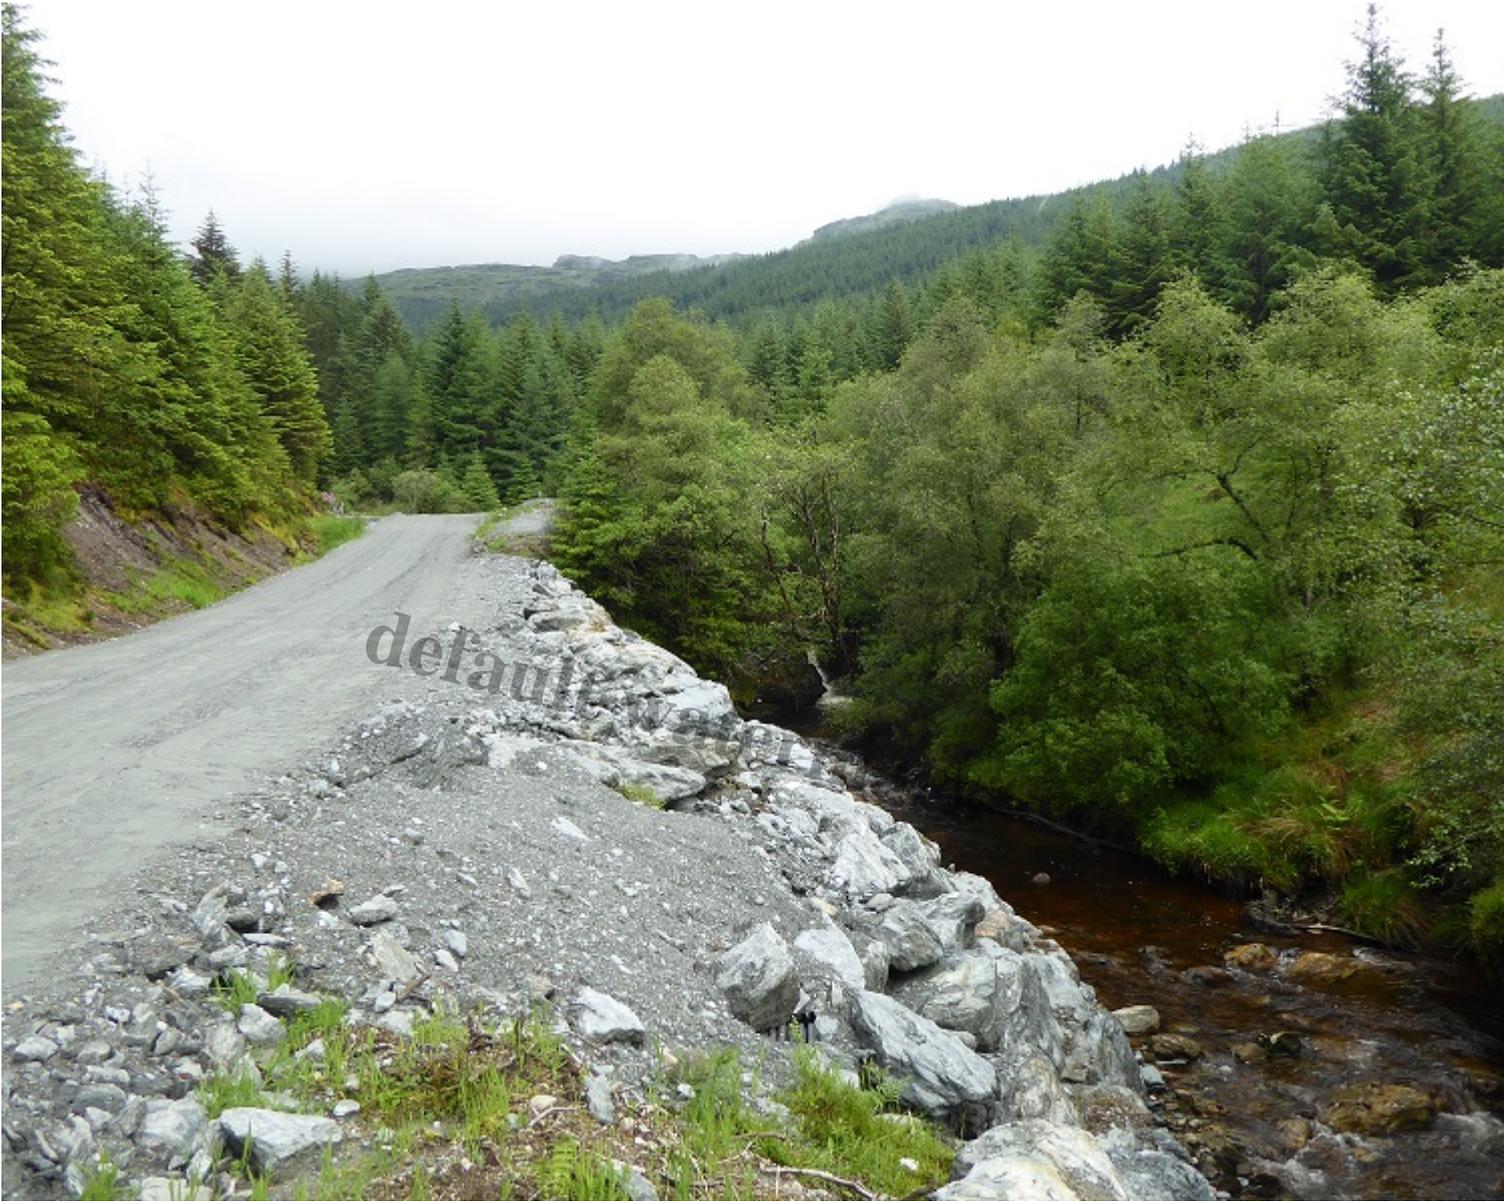
Is this the way we would be treating what was a fine section of burn?

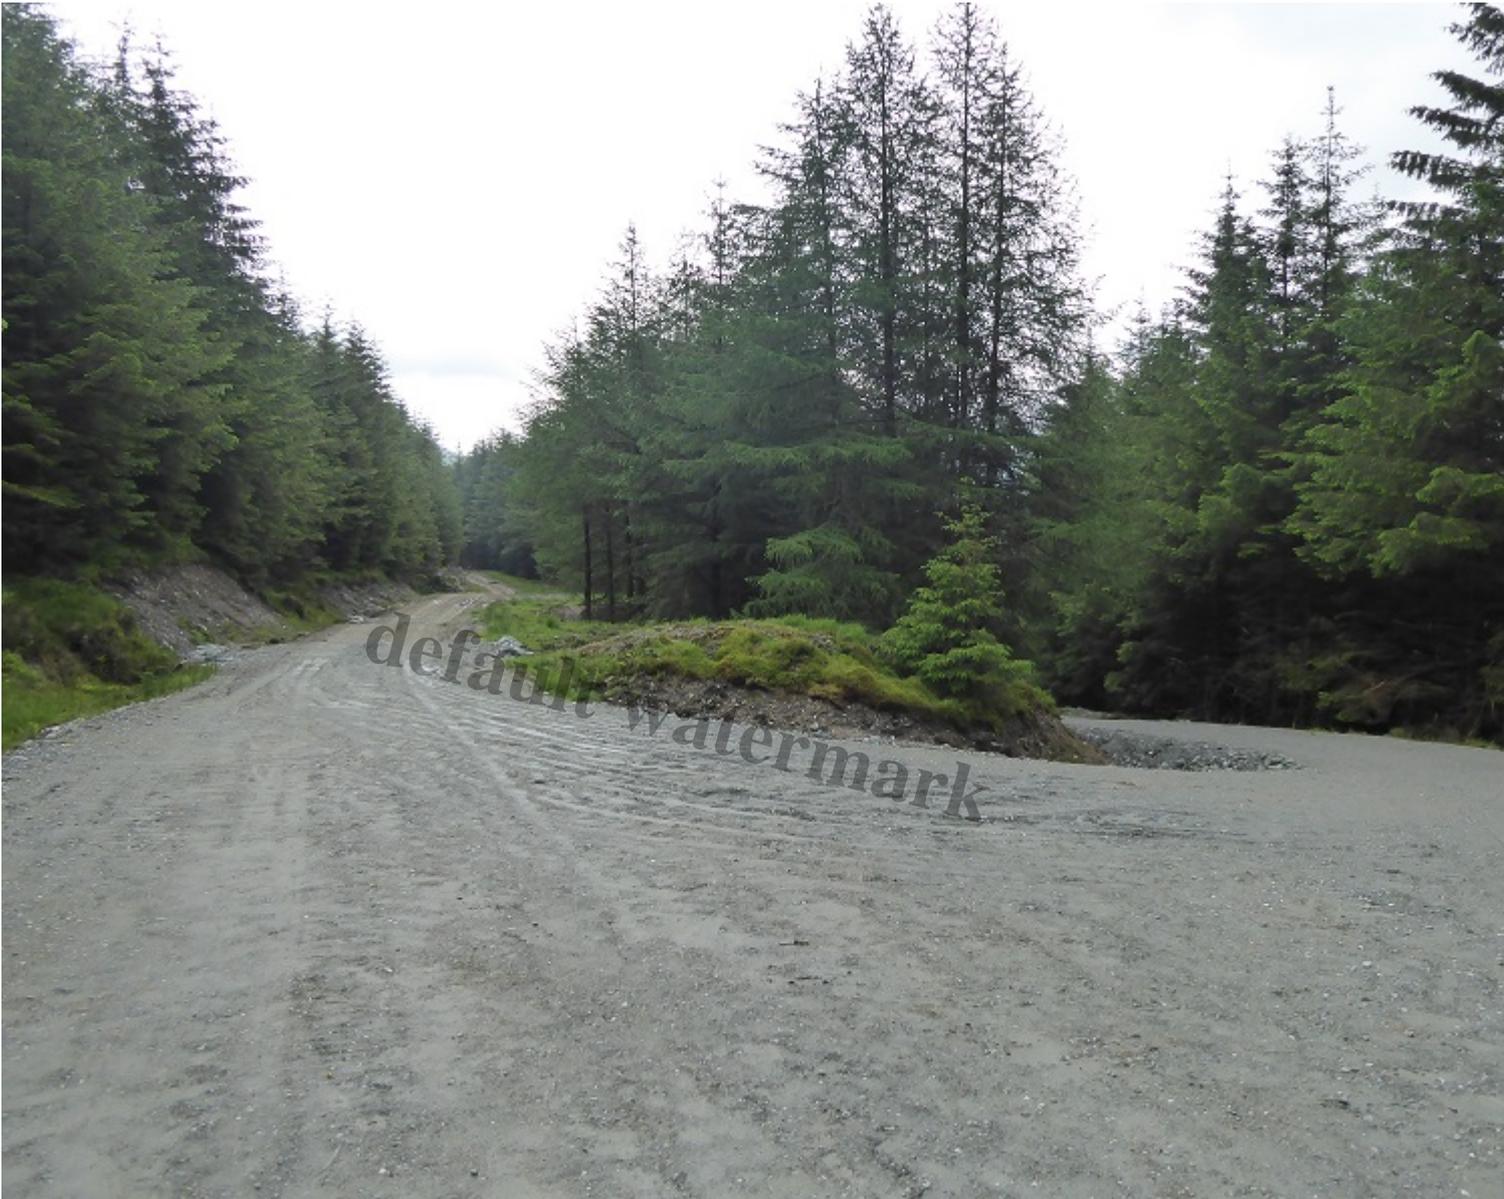
Compare the size of the former track on left with the upgraded one. Are bends this size really necessary?

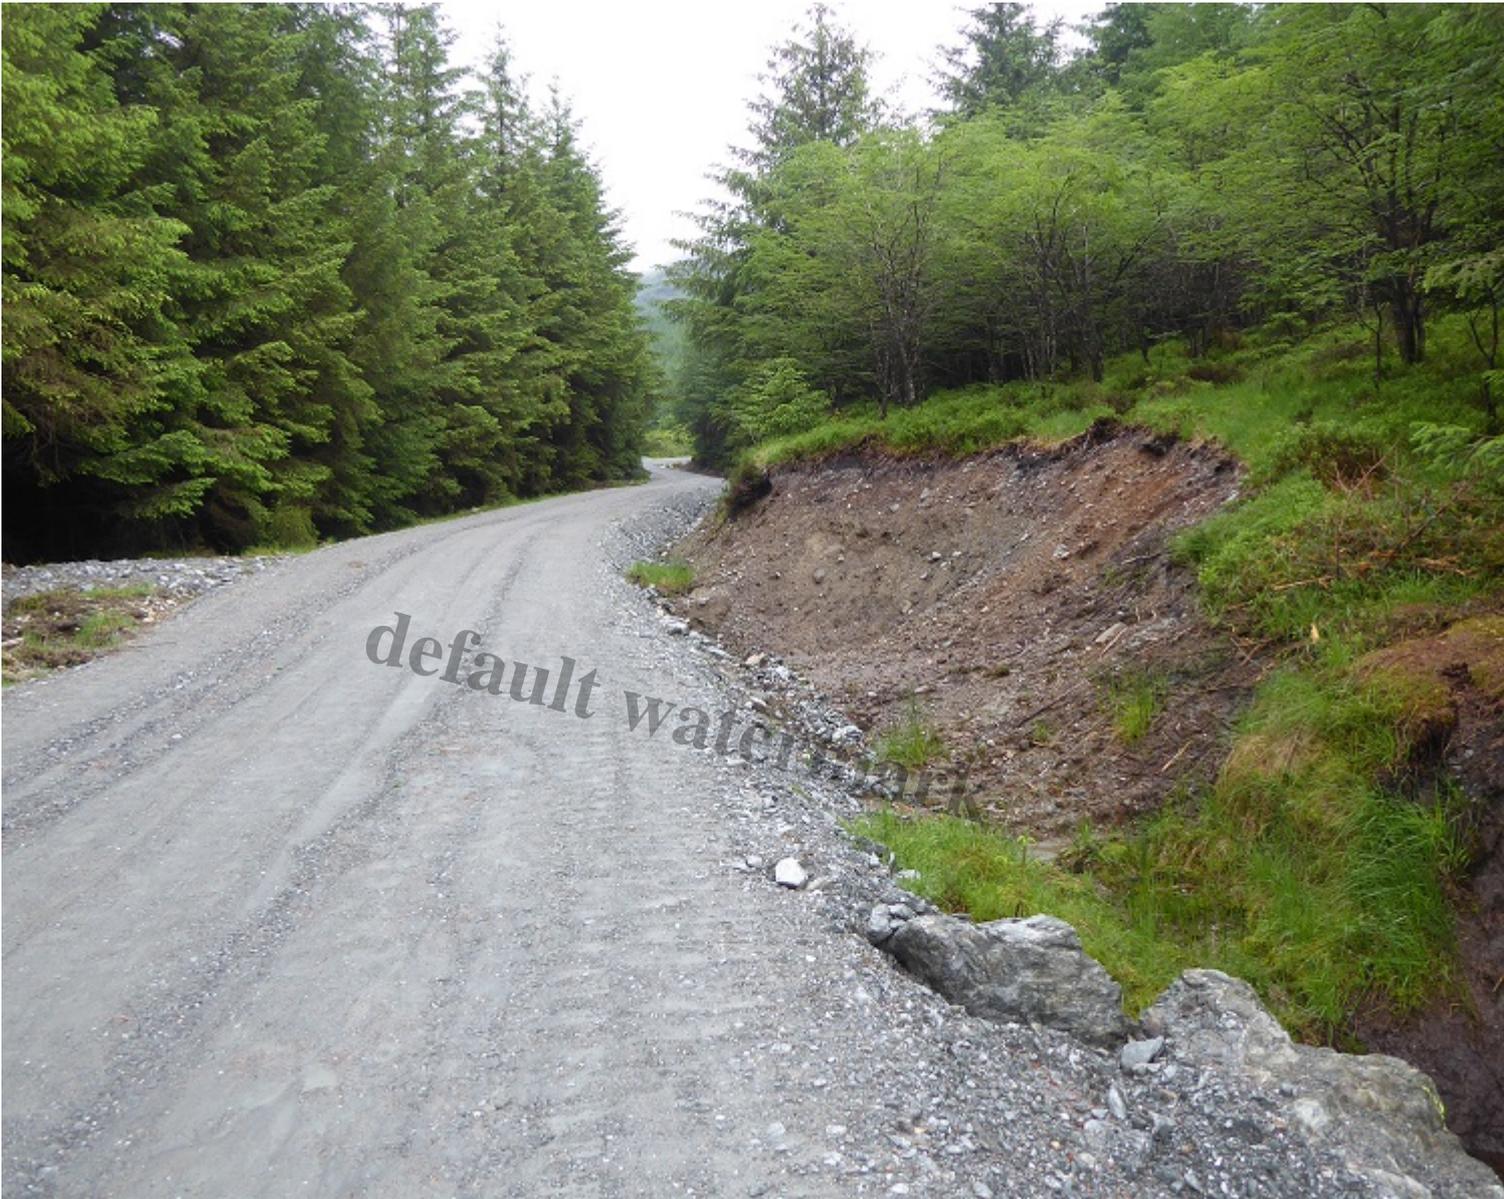
In order to widen the track, further excavation of banks and ditches has been undertaken in places. The vegetated area bottom right represents former bank, a section behind appears to have been scraped bank behind that vegetated. I could see not evidence that any attempt had been made to store and replace turf over excavated areas, even in places such as this where there are native trees behind which one would hope will be left in place during the felling. The LLTNPA rightly requires vegetation to be restored in hydro track construction â?? even if it does not happen much of the time â?? and similar standards should be applied to forest track construction.

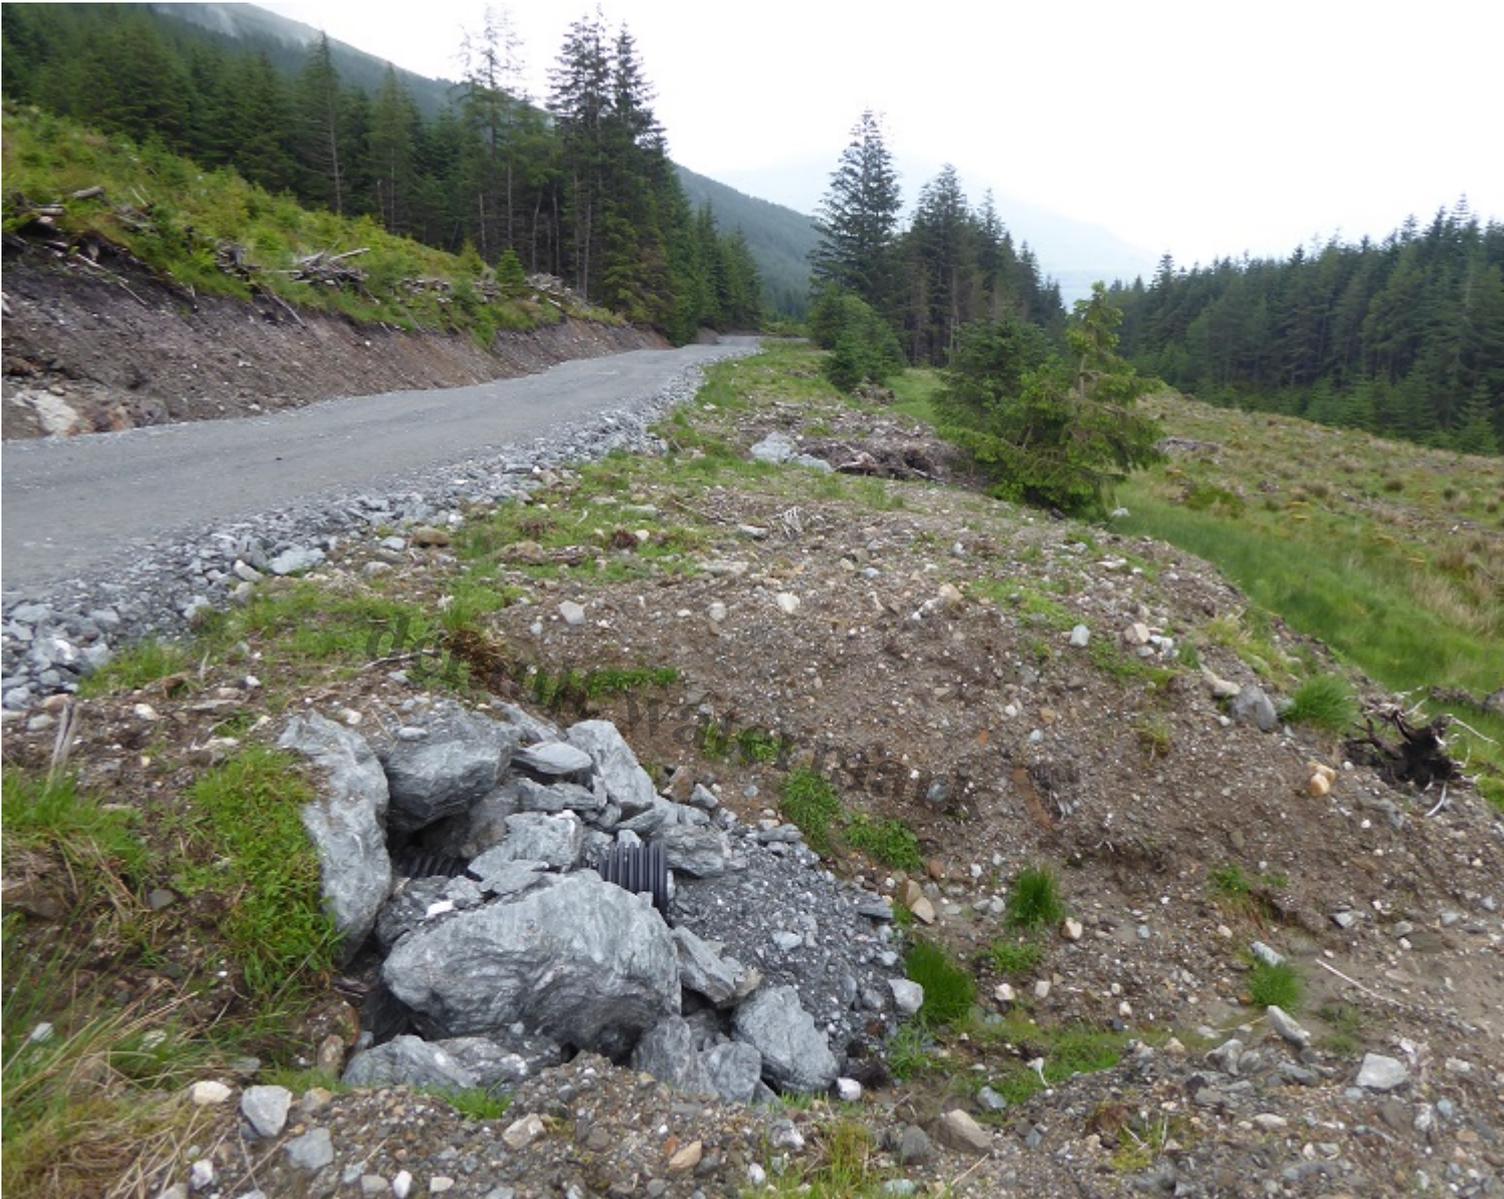
They have done very little to improve this section where felling is complete and indeed appears to have pre-dated the track. So, if the new track was not need for felling (top left) why is it needed now? Forest tracks have become larger and larger to accommodate bigger, heavier vehicles â?? just as in hydro track construction. The bigger the machines we use to work in the countryside, the bigger the tracks and the impact on landscape.
