Coilessan hill track upgrade•

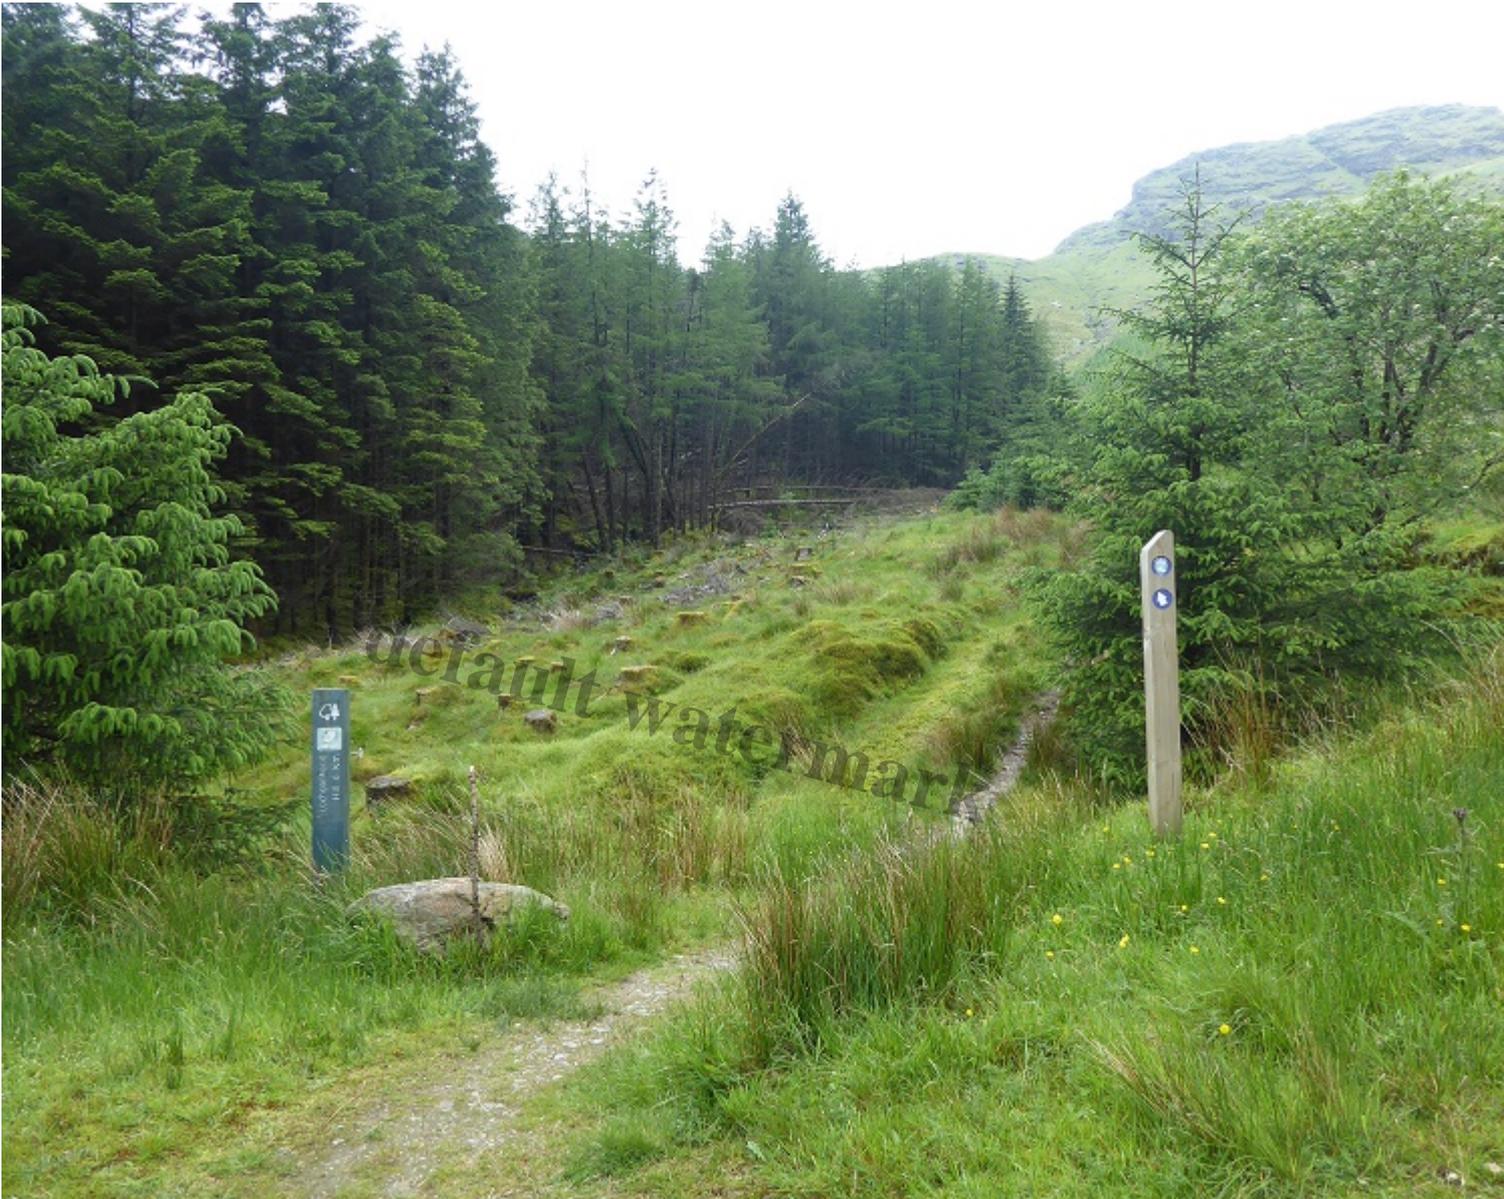
The contrast between the footpath construction in the upper part of the Glen and the track are quite stark. How can the FCS apply such difference standards? My 1980 1:50,000 map shows just a footpath, no track, up the Glen but now there is only a path in the upper part. A relief.

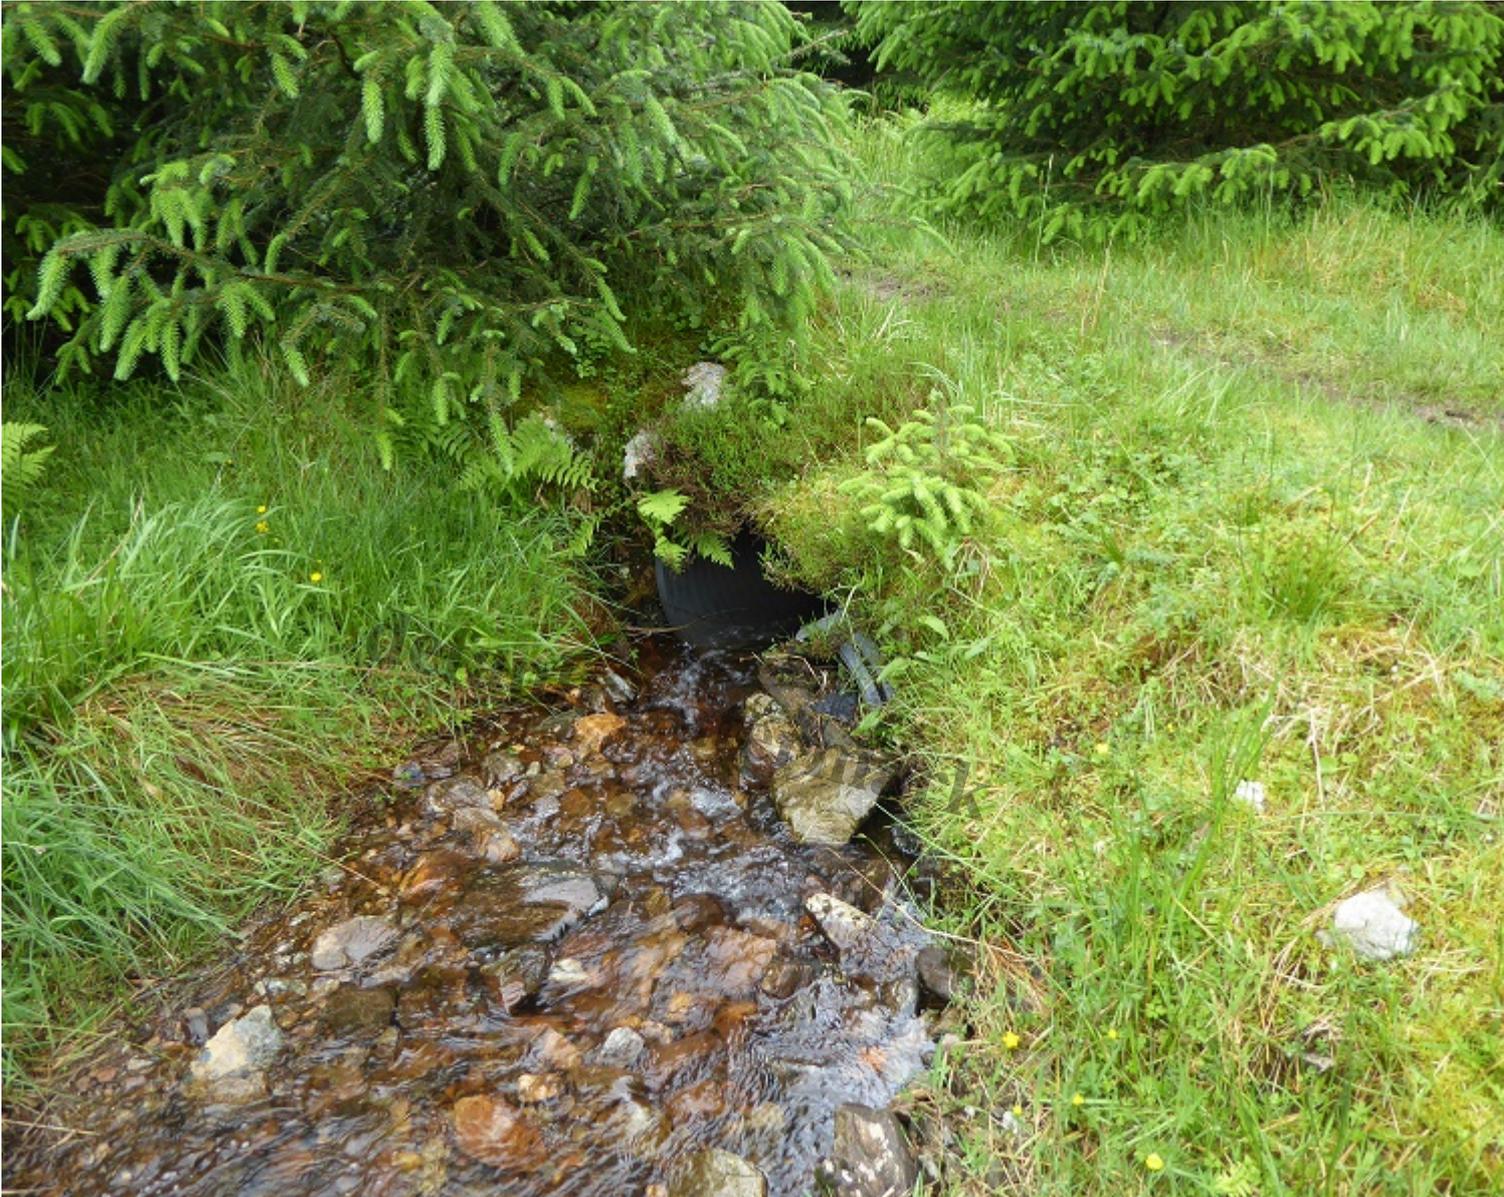
You can hardly see this plastic culvert under the path.

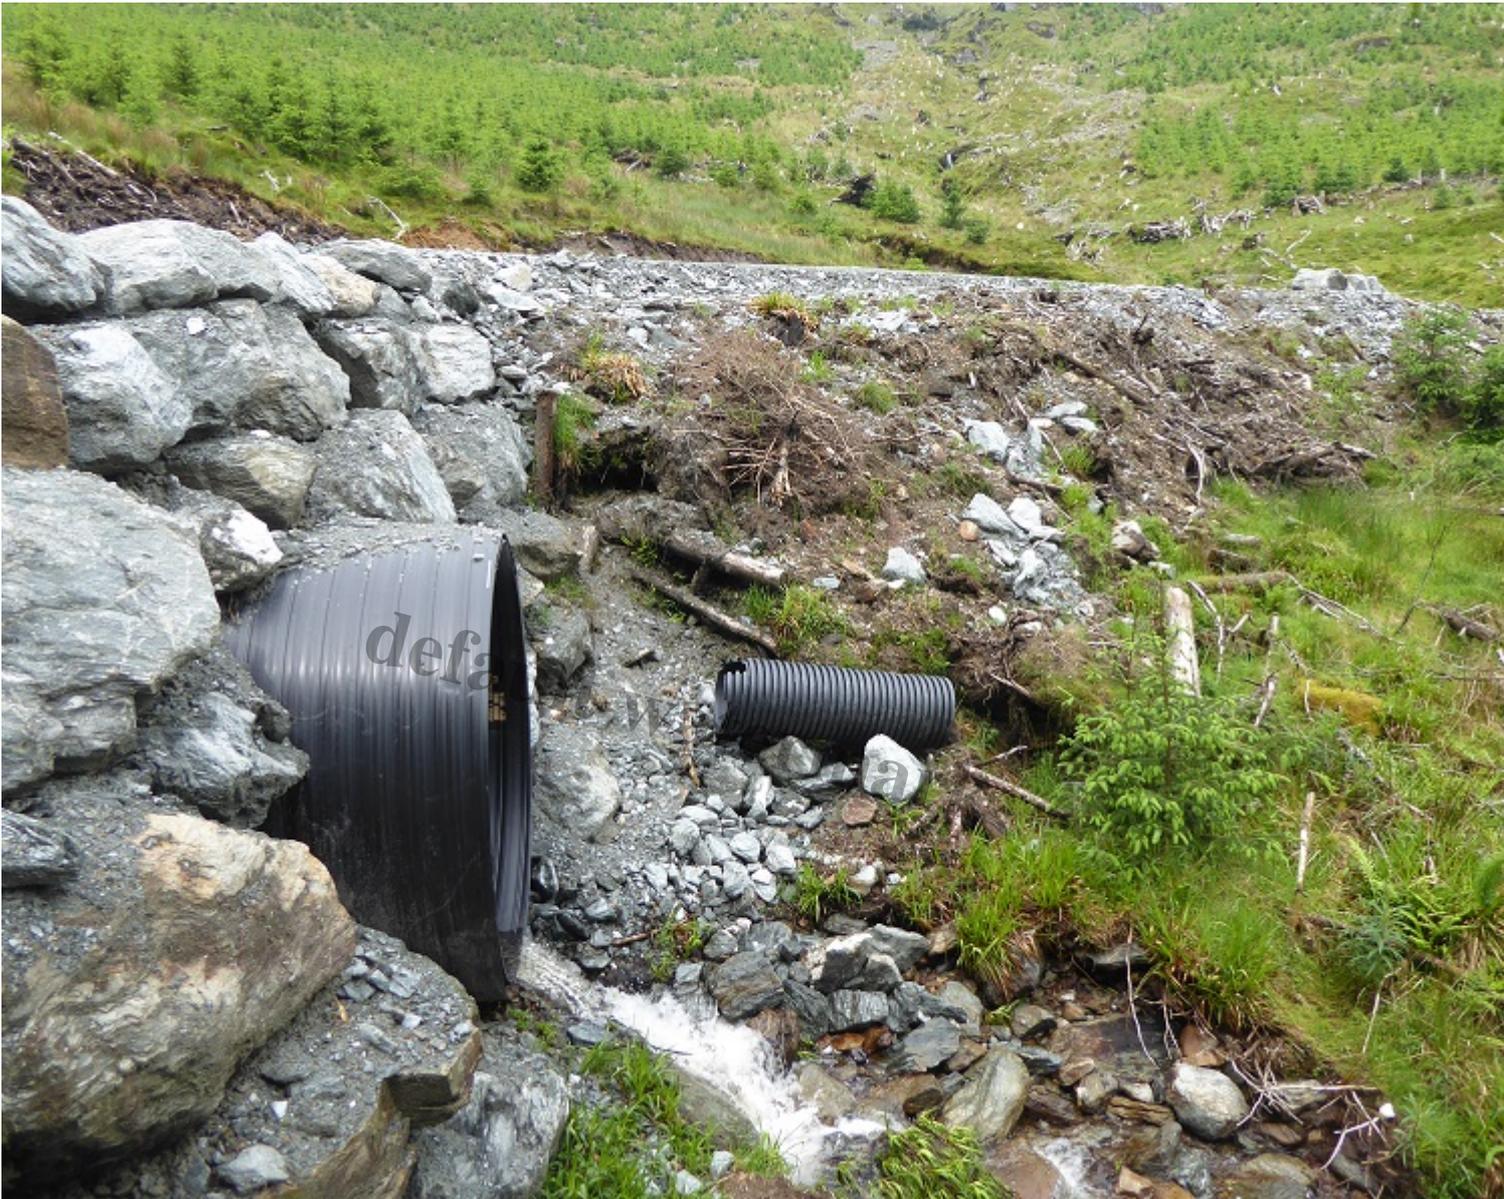
The care taken with the path contrast with the final section of the new track which finishes not far above.

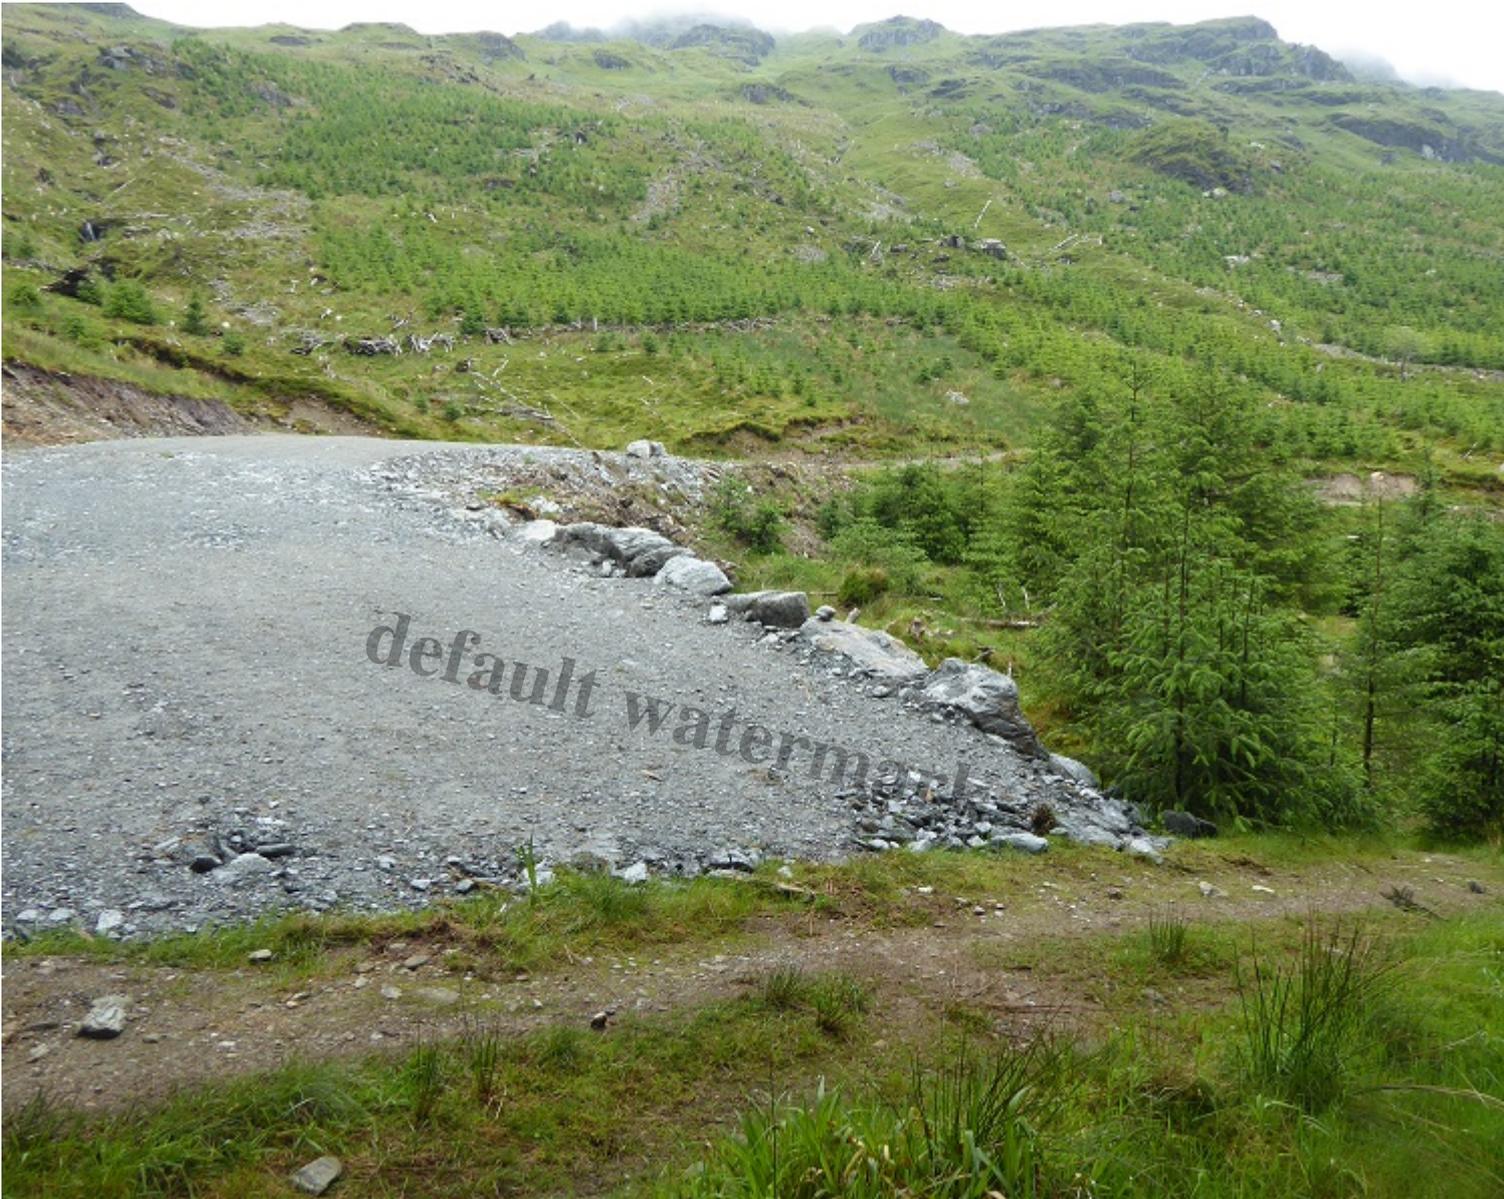
The felling and replanting in background (slopes of Brack) all took place without this track
• demonstrating that there was no need for works of anything like the extent of those that
have been undertaken.

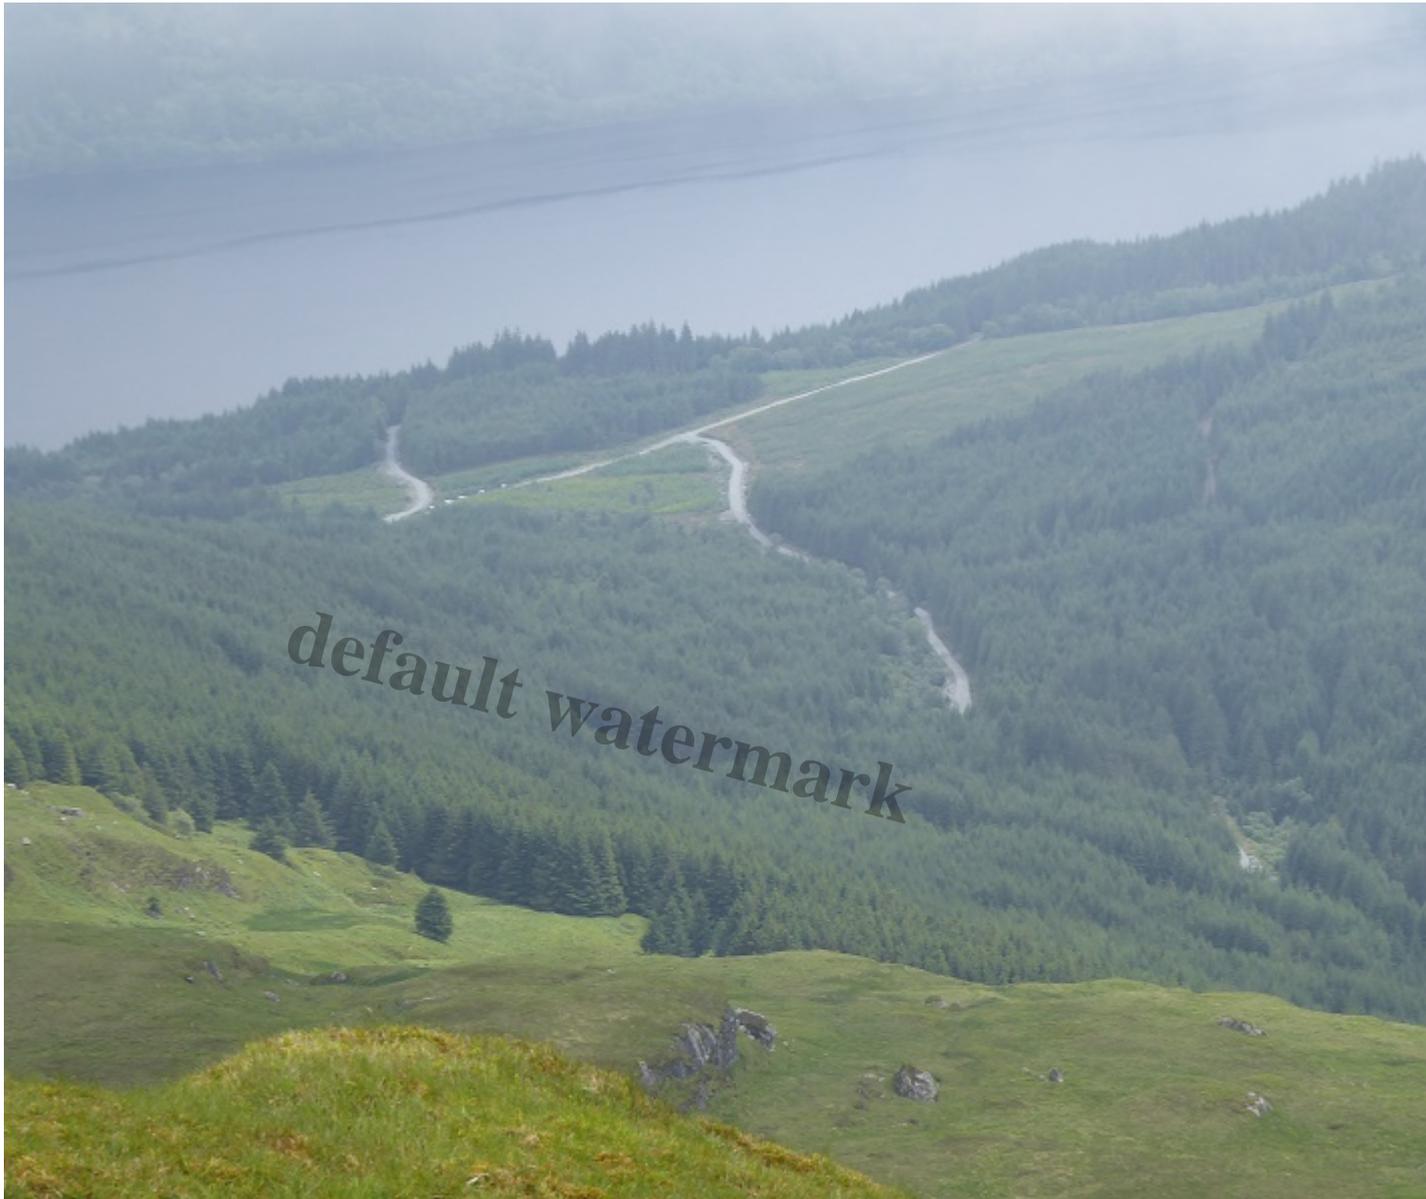
Lower sections of Coilessan Glen track from the Brack, Long Long behind

Even in the dense part of the forest, the upgraded track is visible from afar.
