## The new unlawful hill track at the head of Glen Prosen

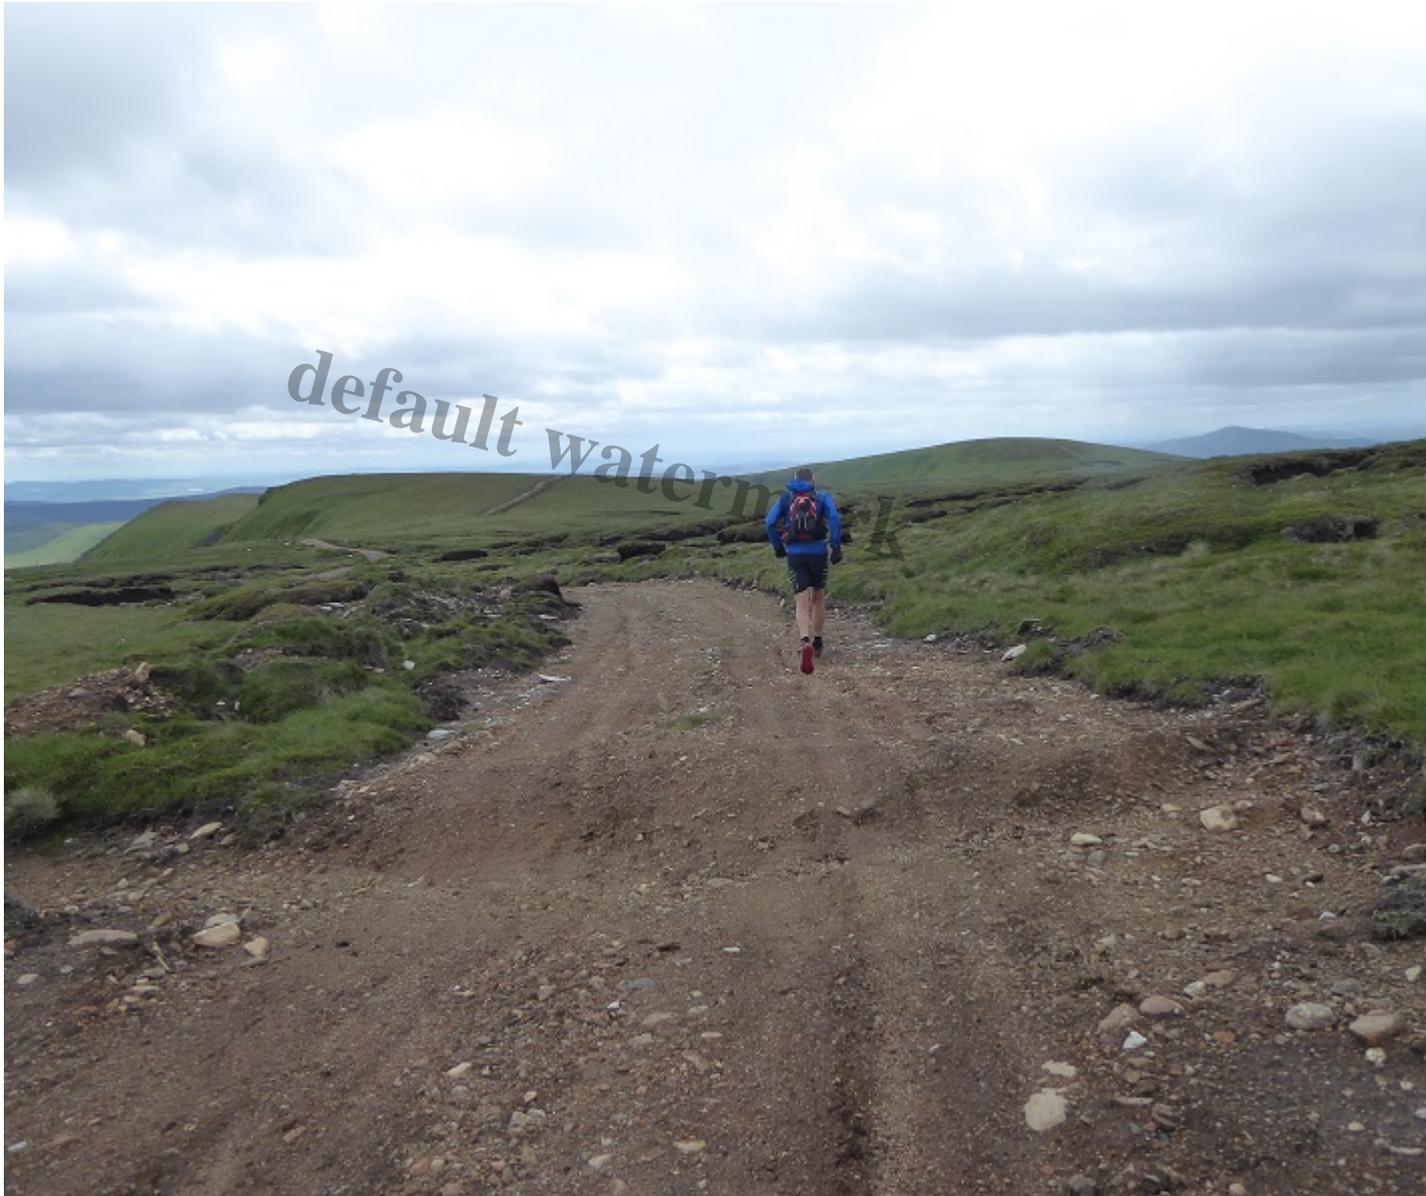
The new track runs round the head of Glen Prosen – here looking towards Bawhelps

During a round of the Glen Prosen watershed 10 days ago, I came across a bulldozed track on the plateau at the head of the Glen which appears to be just inside the boundary of the Glen Isla Estate and therefore created by that estate. The lack of vegetation on the surface – on what is a relatively fertile soil – and the state of the turves which have been piled by the track suggest the track is relatively recent. There is nothing about this track on the Cairngorms National Park Authority planning portal and it therefore would appear to have been constructed without planning permission.

I have reported the track featured here to the CNPA, asked them to confirm whether they were aware of it not and stated that it appears to have been constructed for sporting purposes and therefore should have required full planning permission. In my view the track should be removed. The CNPA in their new Partnership Plan, to their credit, have stated that there will be a presumption against new hill tracks within upland areas in the National Park. This one enters a Wild Land area to boot so there is every reason for them to take action. If the CNPA act fast, much of the damage could be restored quite quickly (because the turves removed to create the track are still usable) so I would urge them to do so.

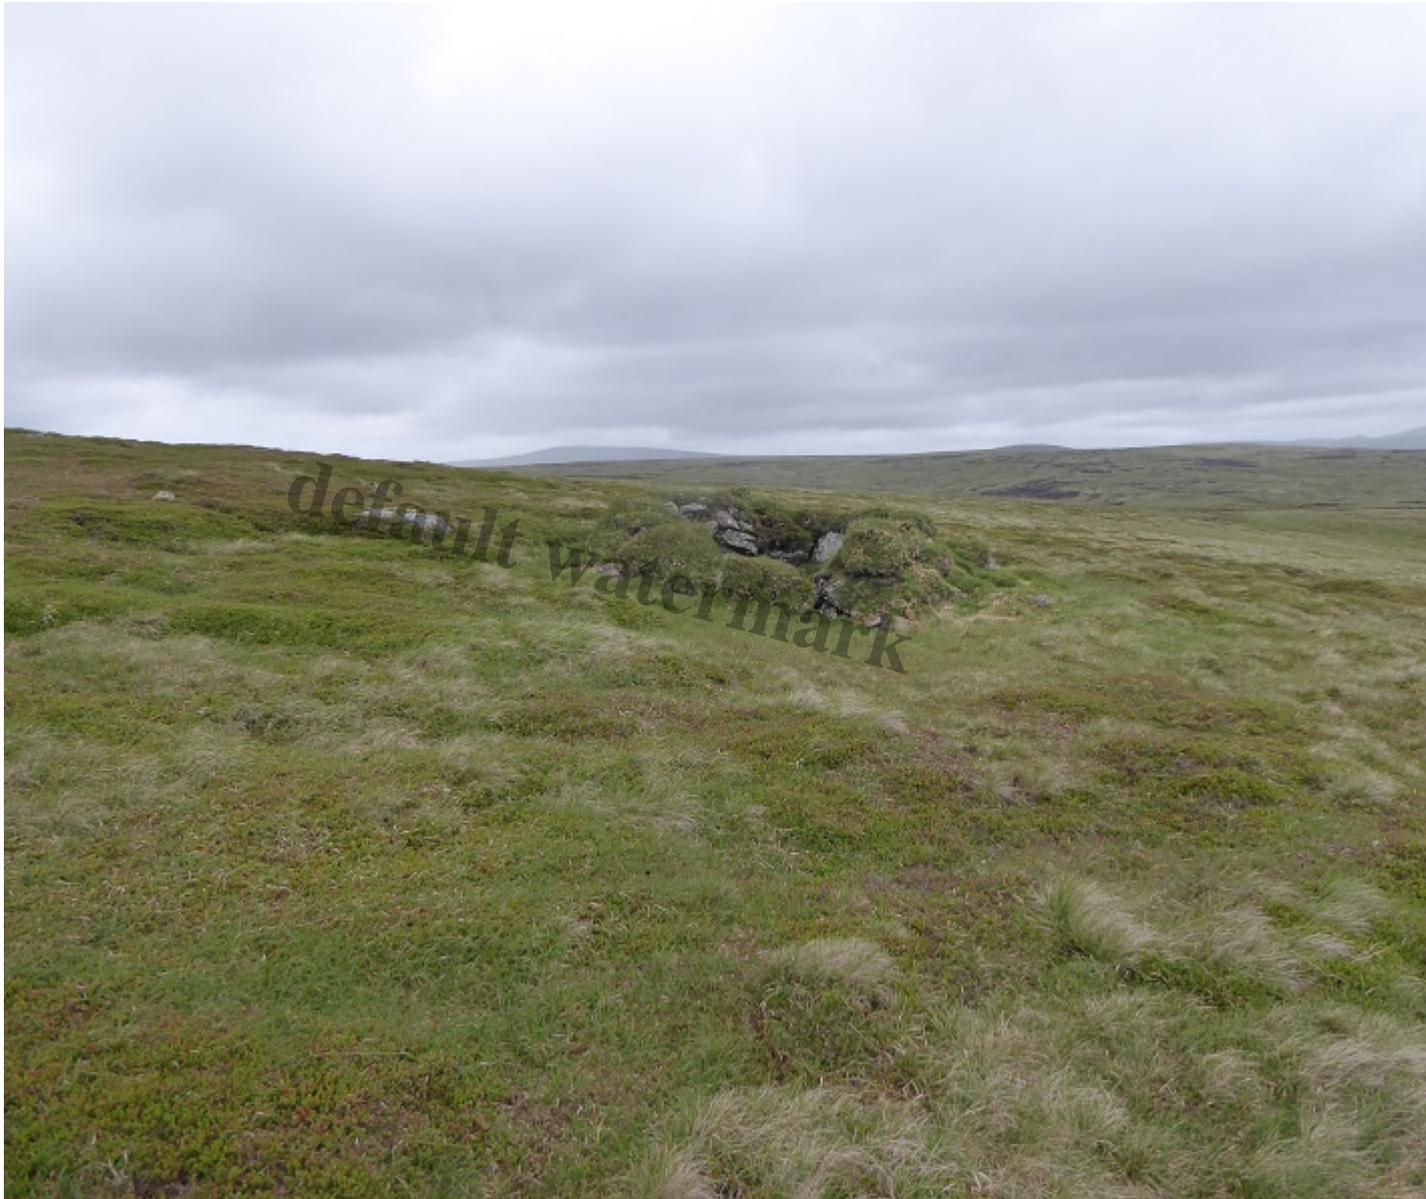
The plateau, the head of the Mayar burn is the lower ground on far right of photo, the track just to the left of the photo. While the grouse butt is well disguised, it indicates that this track was created for sporting purposes and therefore should have required full planning permission.

The creation of the track has removed much of the challenge of navigating across what was a featureless area of plateau. If you have ever tried to walk between Tom Buidhe and Mayar in the mist you will know what I mean. This quality of the plateau, so important to adventure, is also well described in the Wild Land statement:

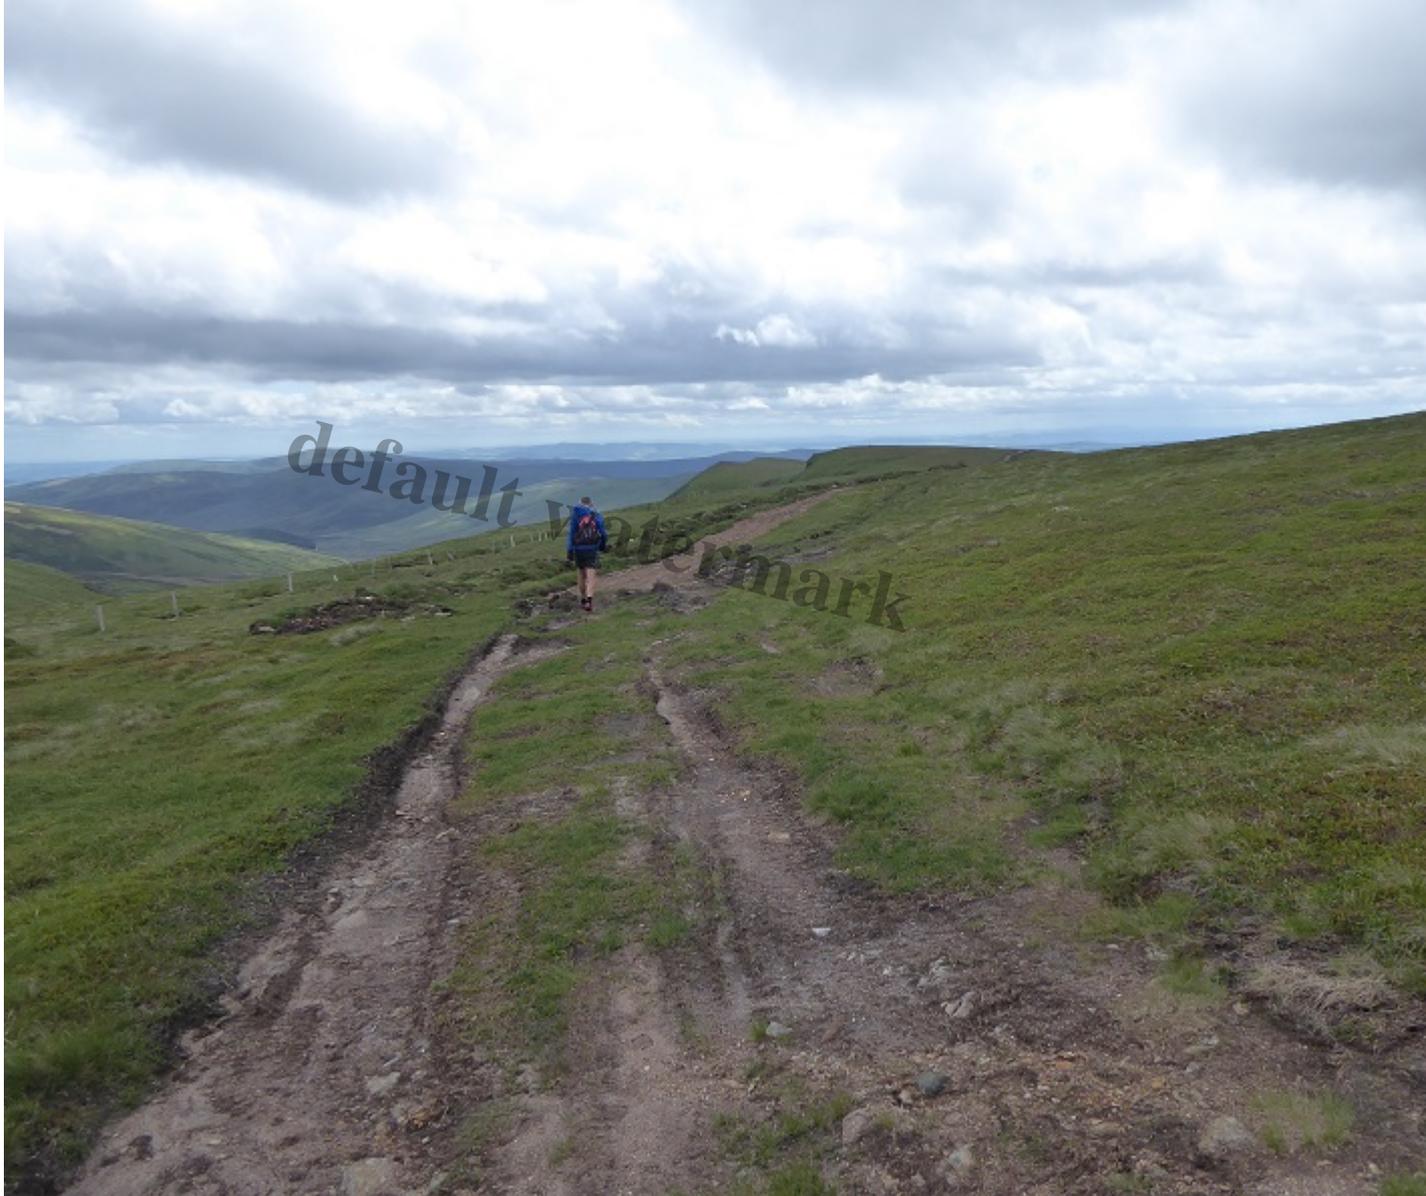
Looking towards South Craig at head of Glen Prosen. The track is intermittent in the sense that it is track eroded by regular vehicular use and new sections where the turf has been completely removed.

Because its intermittent, although the constructed sections predominate, its possible that the track was not created all at once but over time.

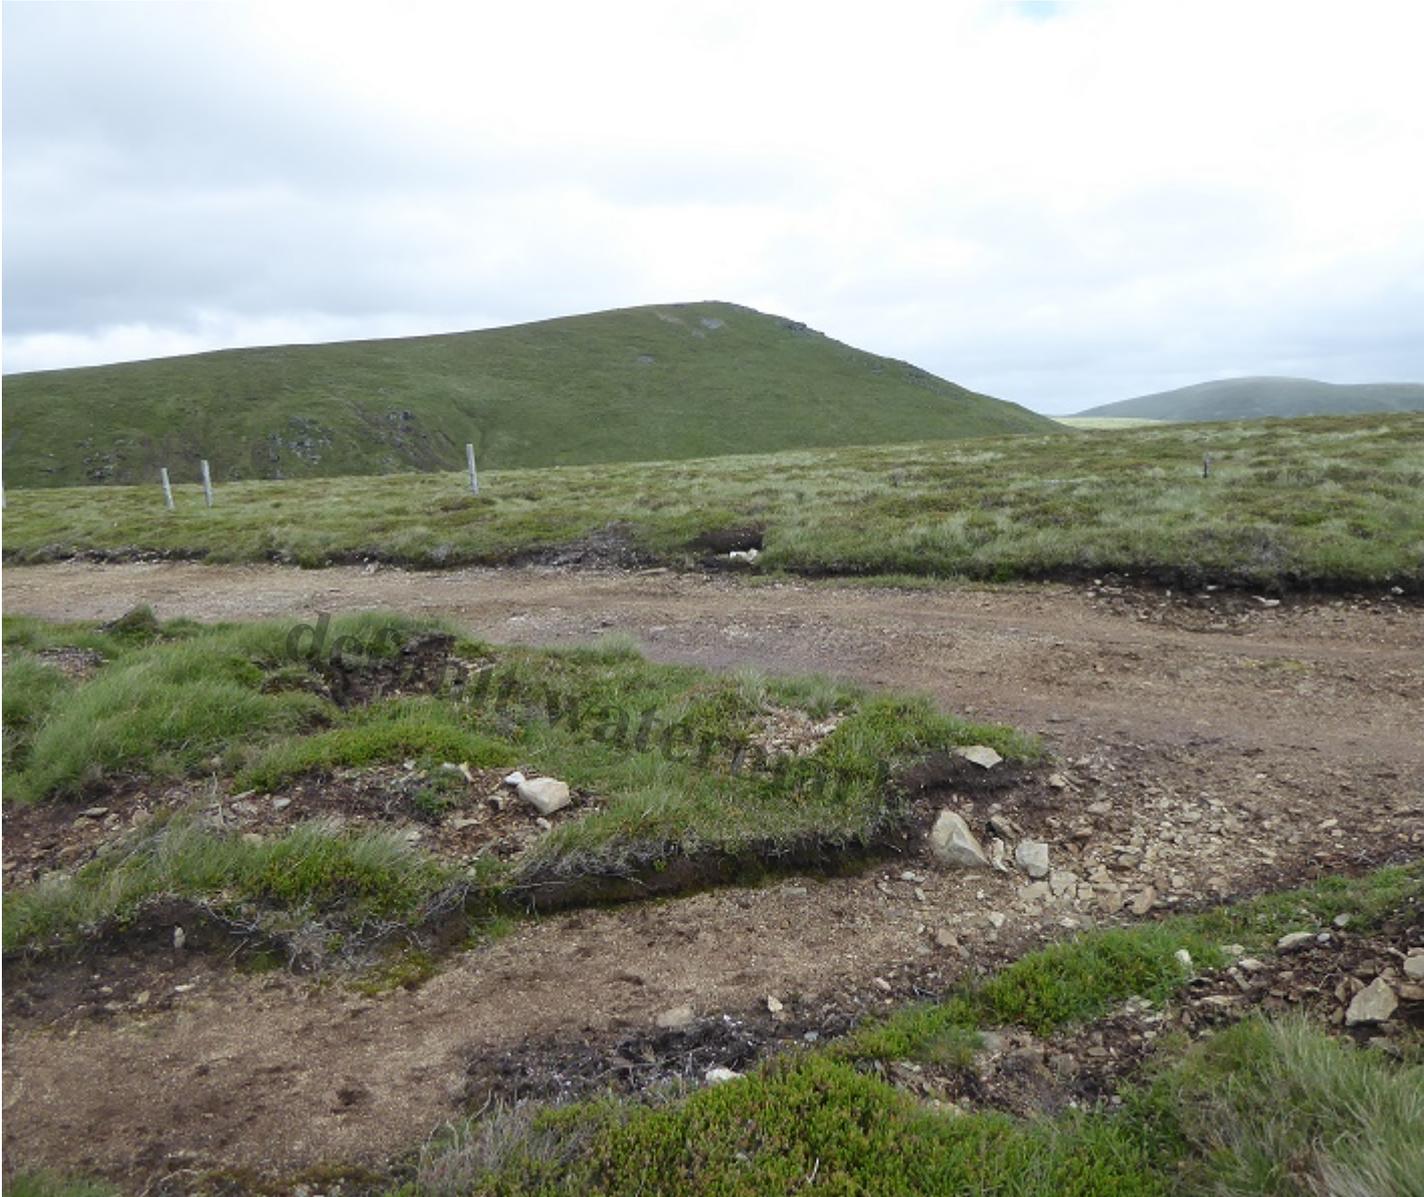
View across track to Mayar. The creation of drainage channels adds to the mess and impact on vegetation.

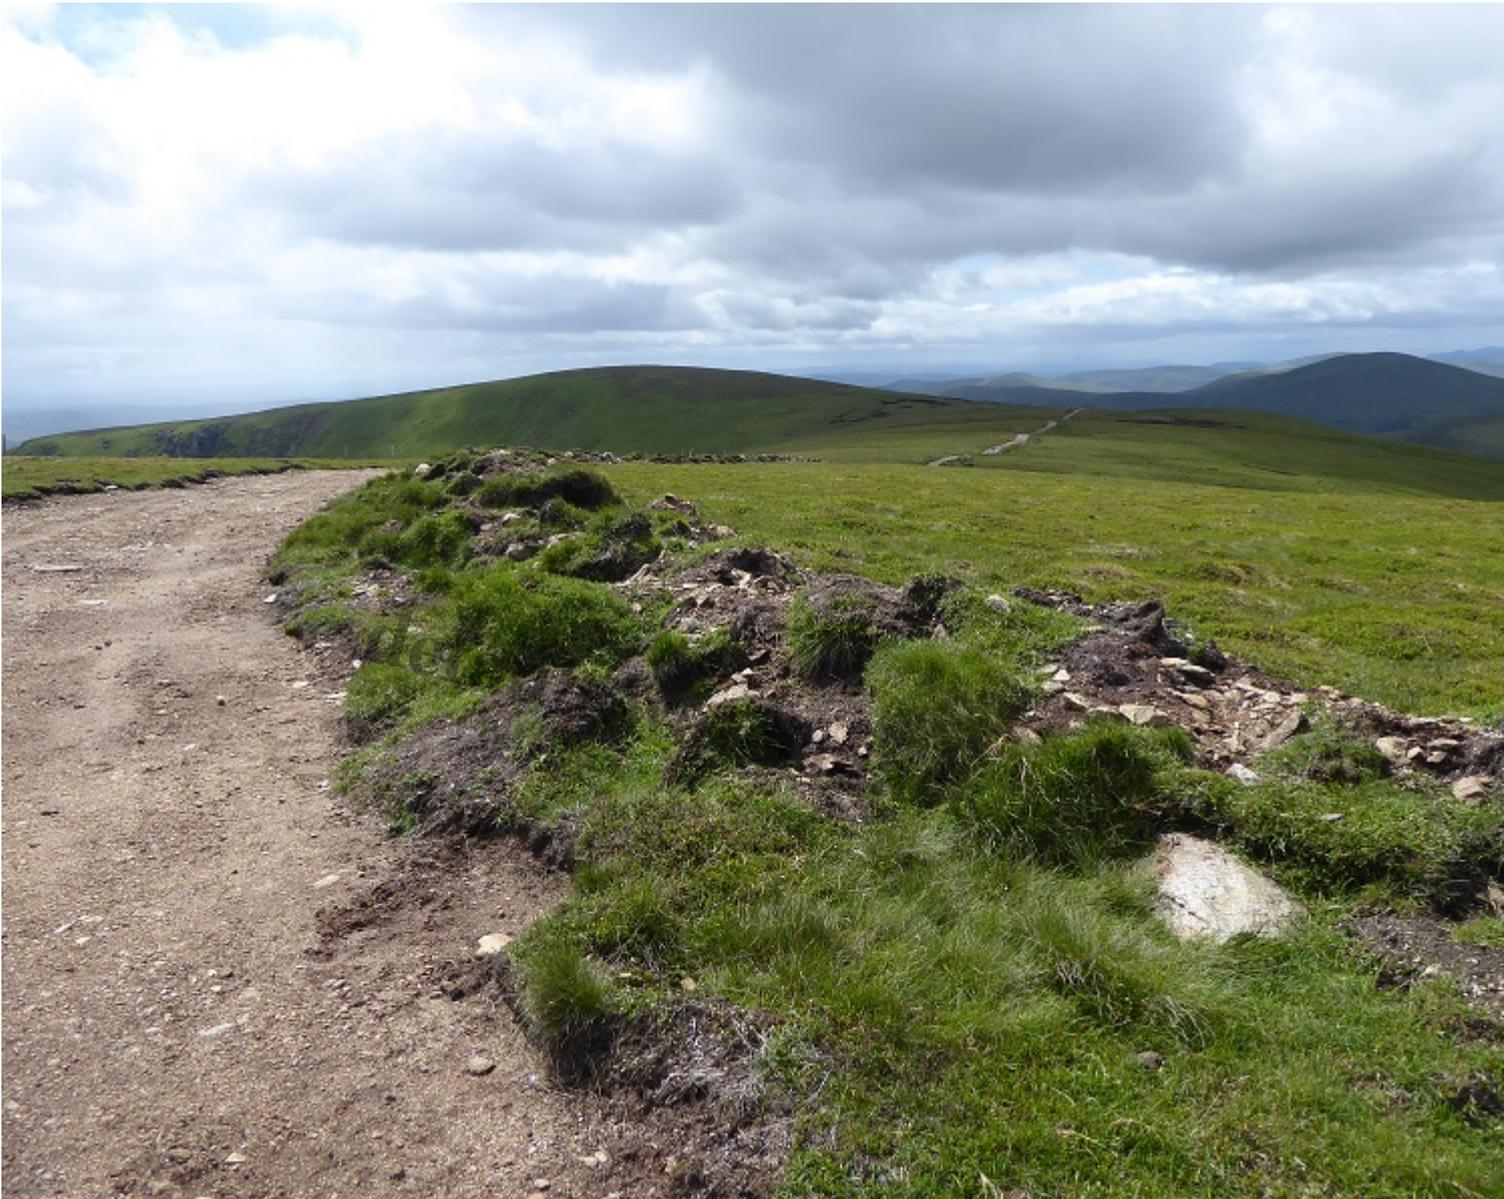
The track has been created by a digger scraping off the turf and dumping it by the side of the new track. The positive thing about this is it should make restoration of the track quite simple. All the estate would have to do is replace the turves and soil onto the bare surface.

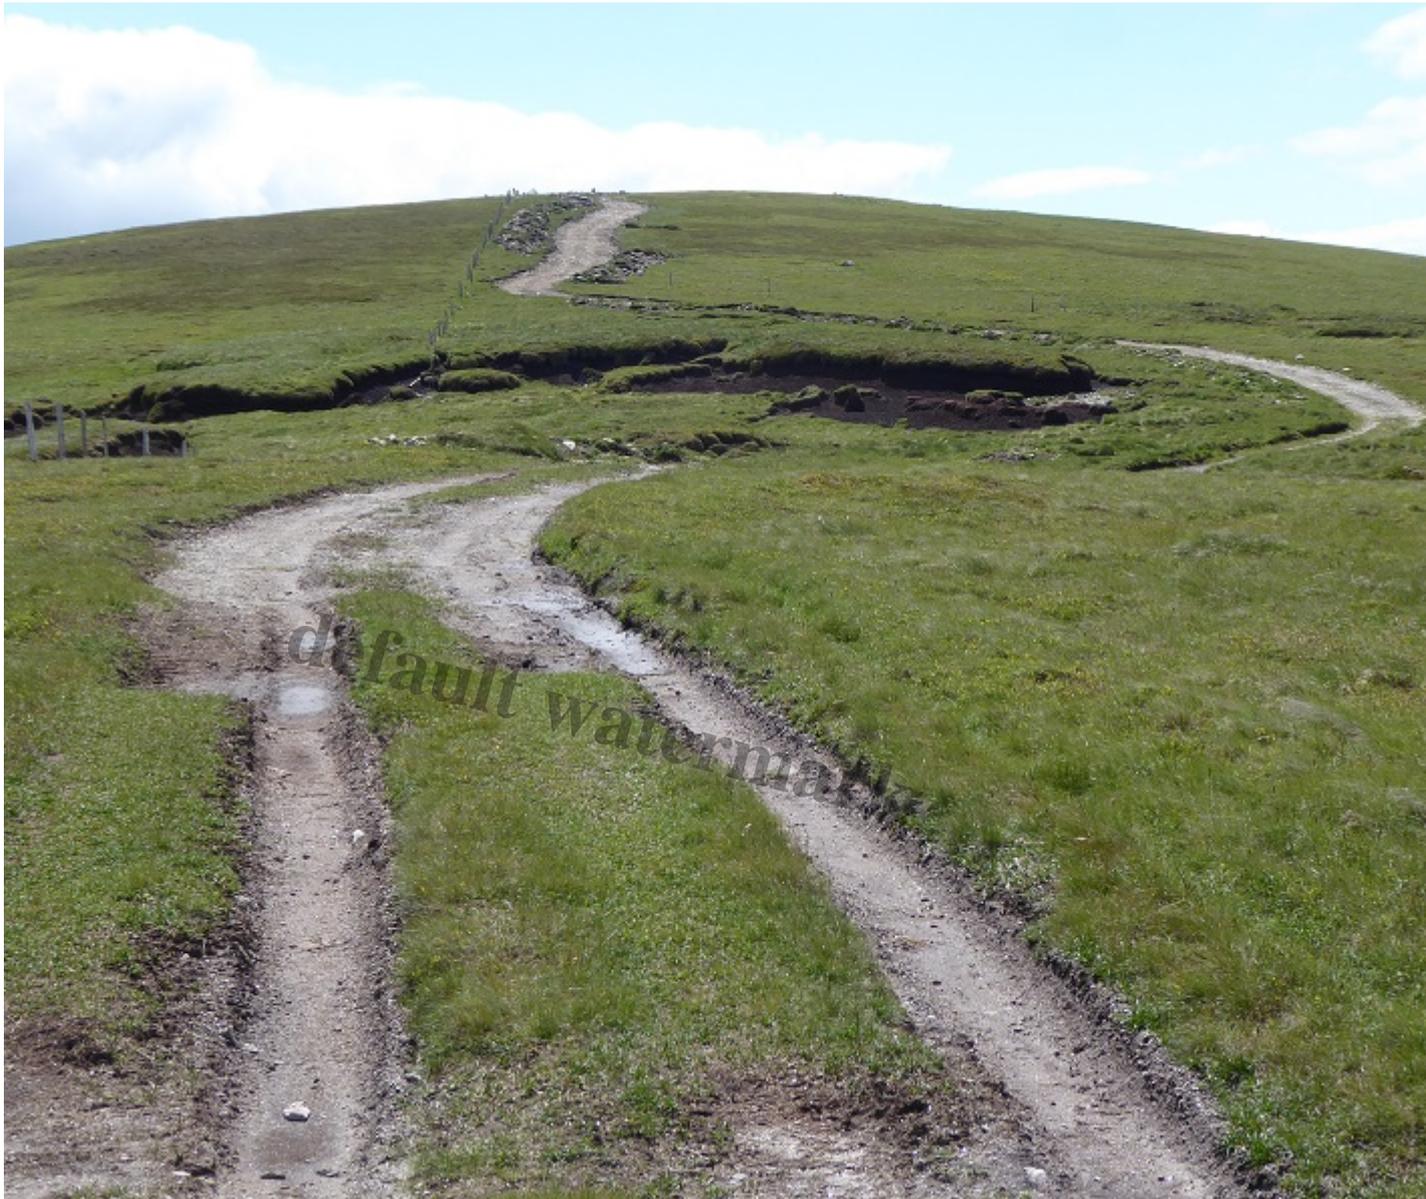
Intermittent section of track up Bawhelps

The older vehicle erosion shows that its not just constructed tracks which are the problem â?? its vehicle use. The CNPA should be addressing the issue of vehicular use on higher ground. A start would be to restrict the type of vehicles that can be used, ban heavier vehicles like landrovers and just allow quad bikes which are much lighter and, if used carefully, cause much less damage to vegetation. This could be done through the creation of conservation byelaws.

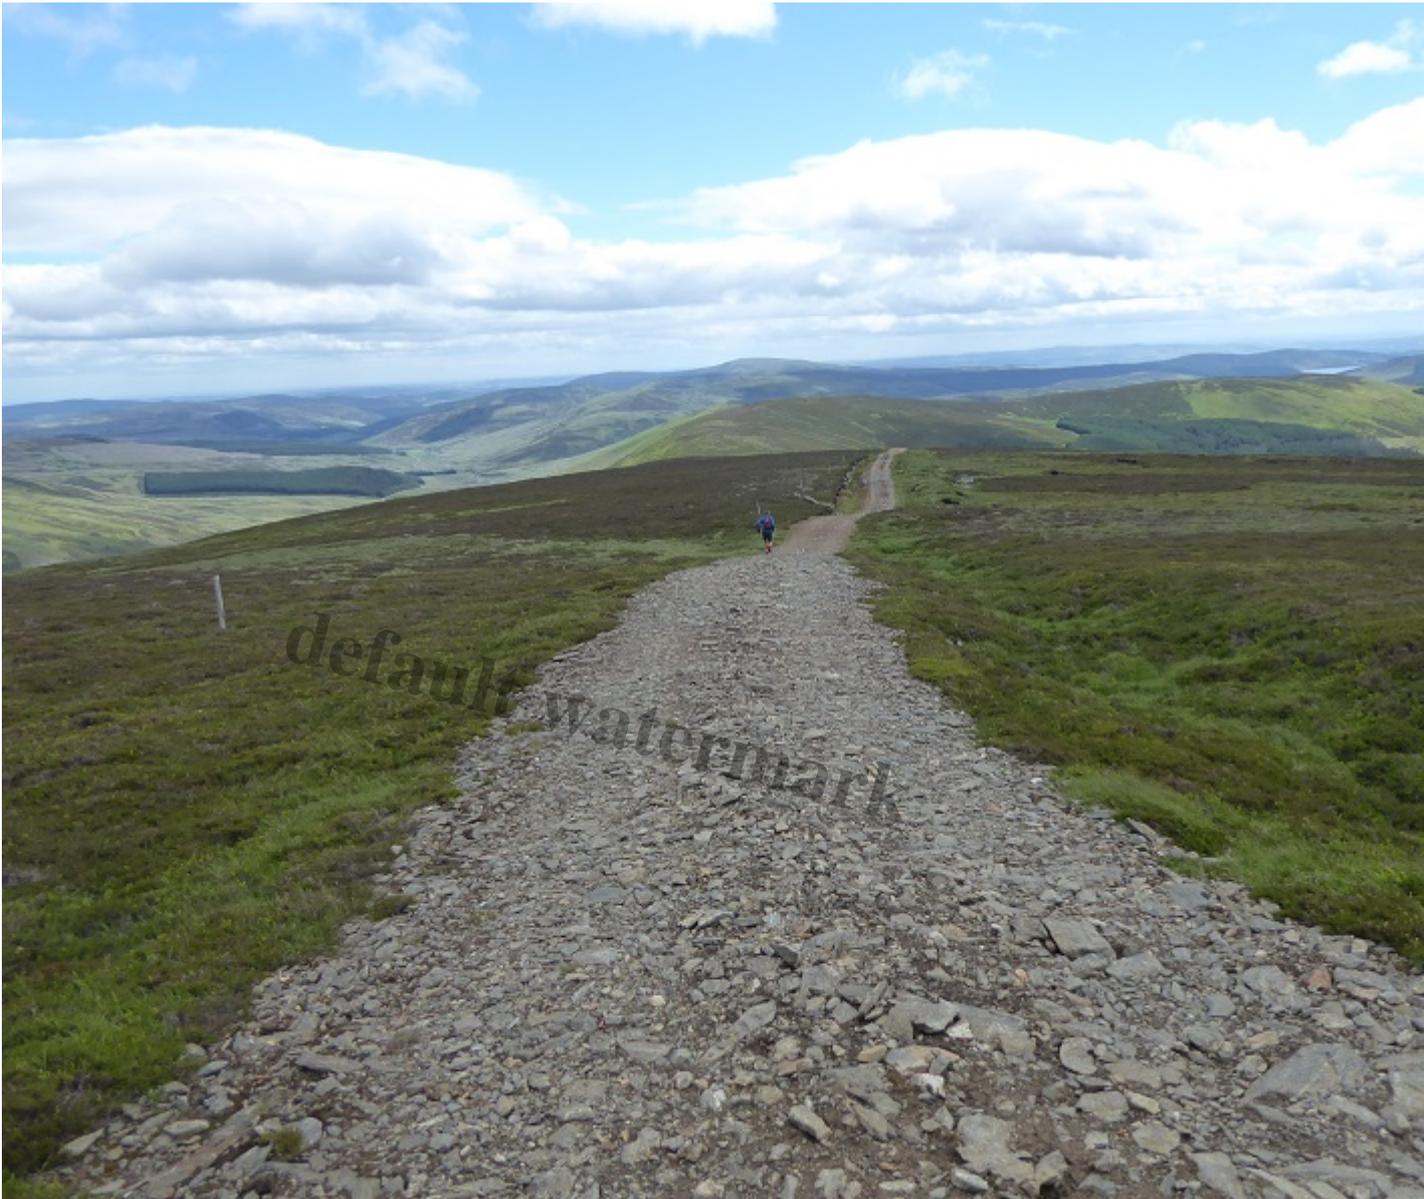
View along new spur to track which runs south east along Broom Hill, Craigie Thieves behind.

There is a short spur to the track down Broom Hill, which unlike other sections of track has been created by importing aggregate and dumping it on top of vegetation. This section of track will be much harder to restore.

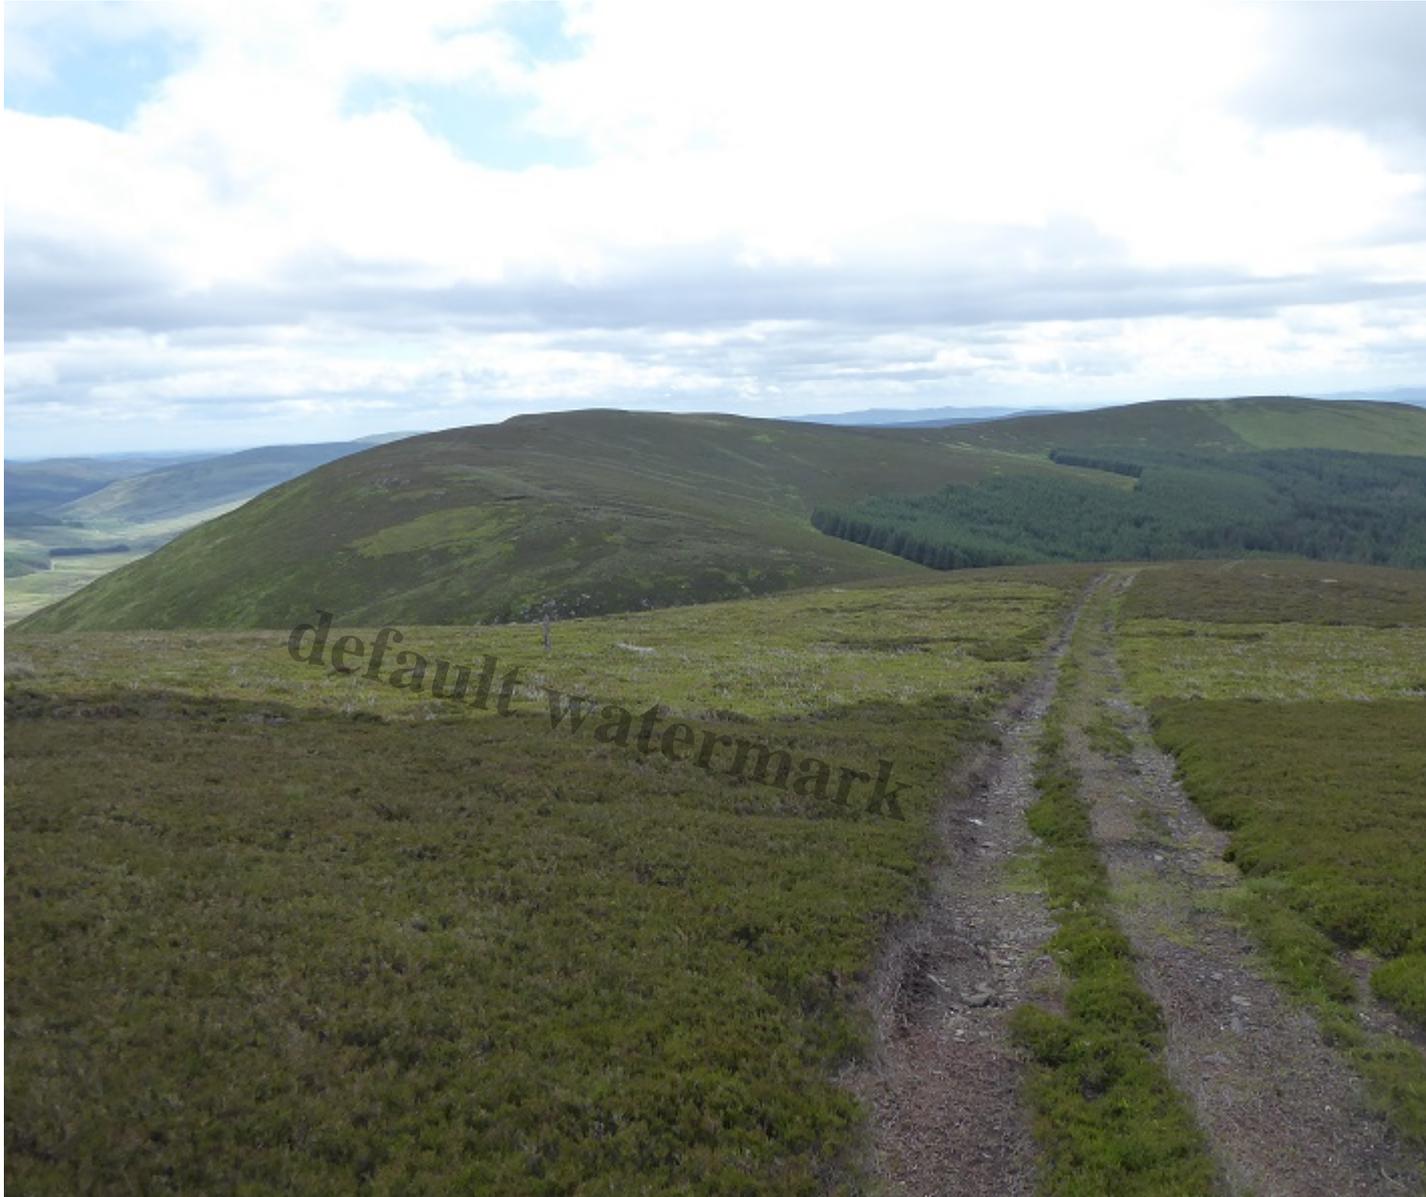
The spur then turns into a vehicle eroded track before ending completely before the bealach between and Craigie Thieves

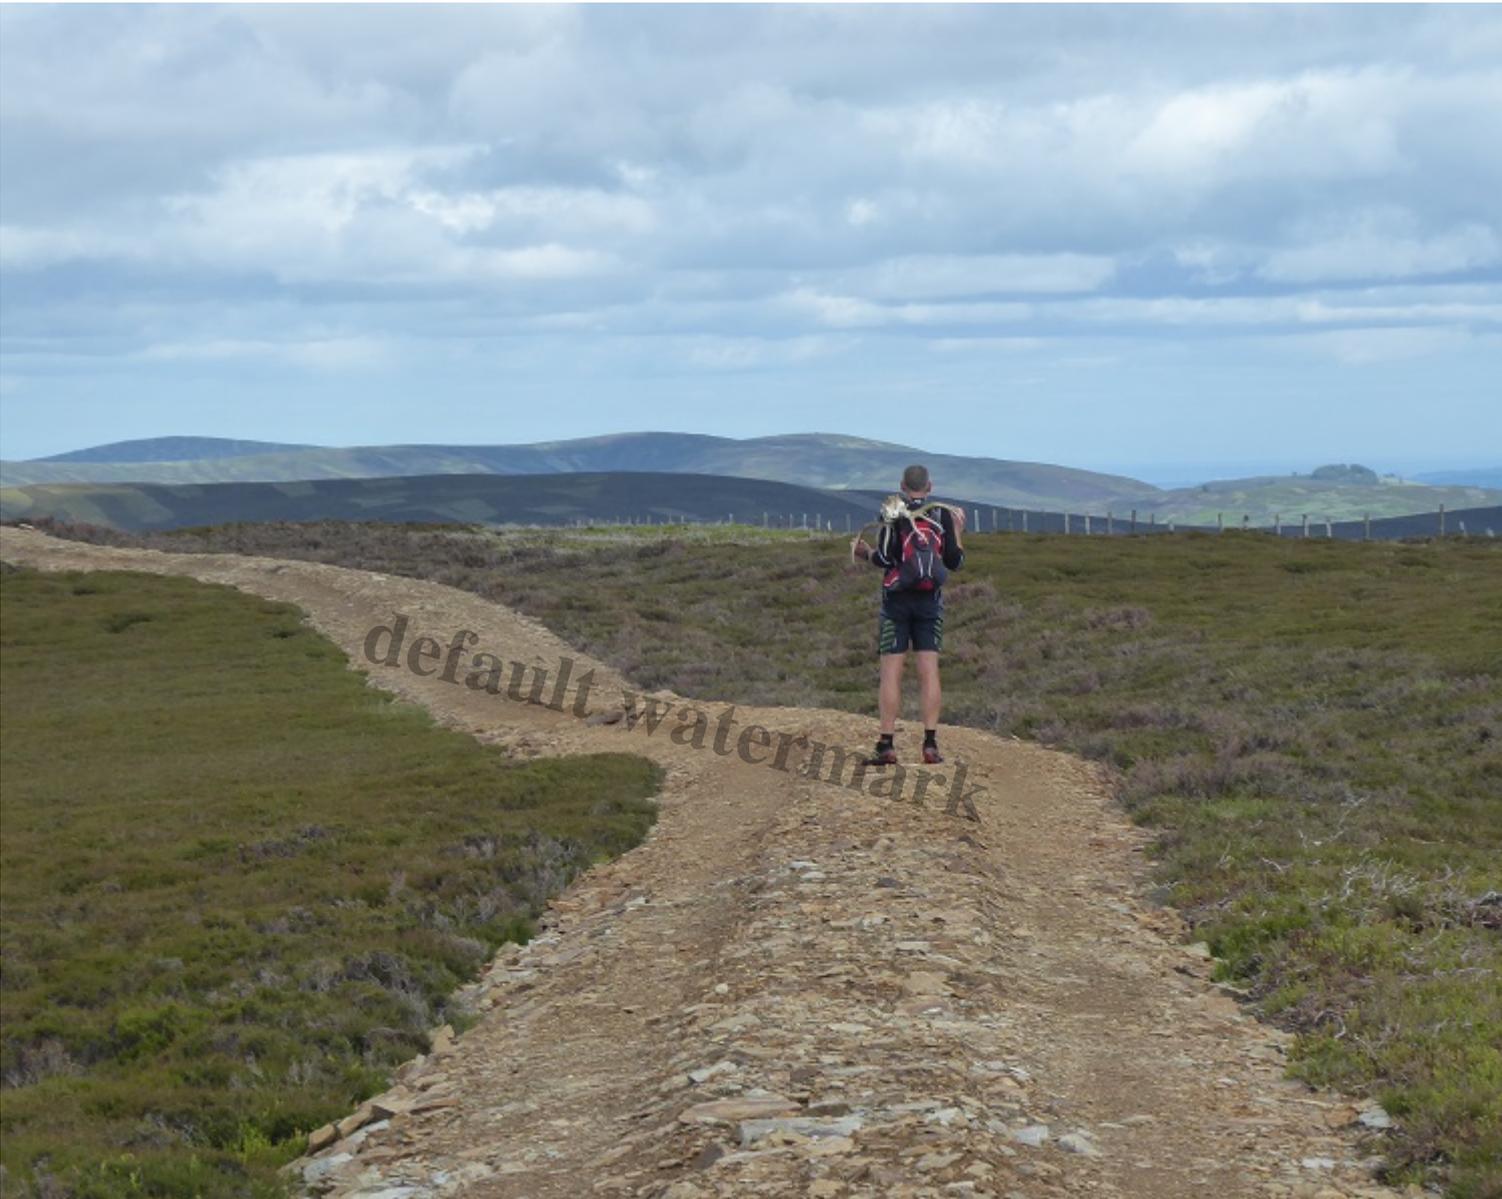
Until, that is, we came to this monstrosity on the Hill of Adenaich, well outside the CNPA boundary, and the responsibility of Angus Council to fix. Sadly, whether these tracks are created or not appears to have very little to do with the Planning Authority, its all determined by the landowner: most create tracks, some donâ??t. It would be good though if our National Parks became exemplars of good practice and the CNPA by its actions inspires Angus Council also to take action.
