Coire Cas report card – the HIE/Natural Retreats restoration and clear-up

After the extensive coverage parkswatch gave to the destruction caused by engineering works in Coire Cas last year ([see here for example](#)), at the end of August a small group of us went to have a look at how the restoration work was going. In my view while there have been some improvements, there is a long way to go. The purpose of this post is to illustrate some of the issues.

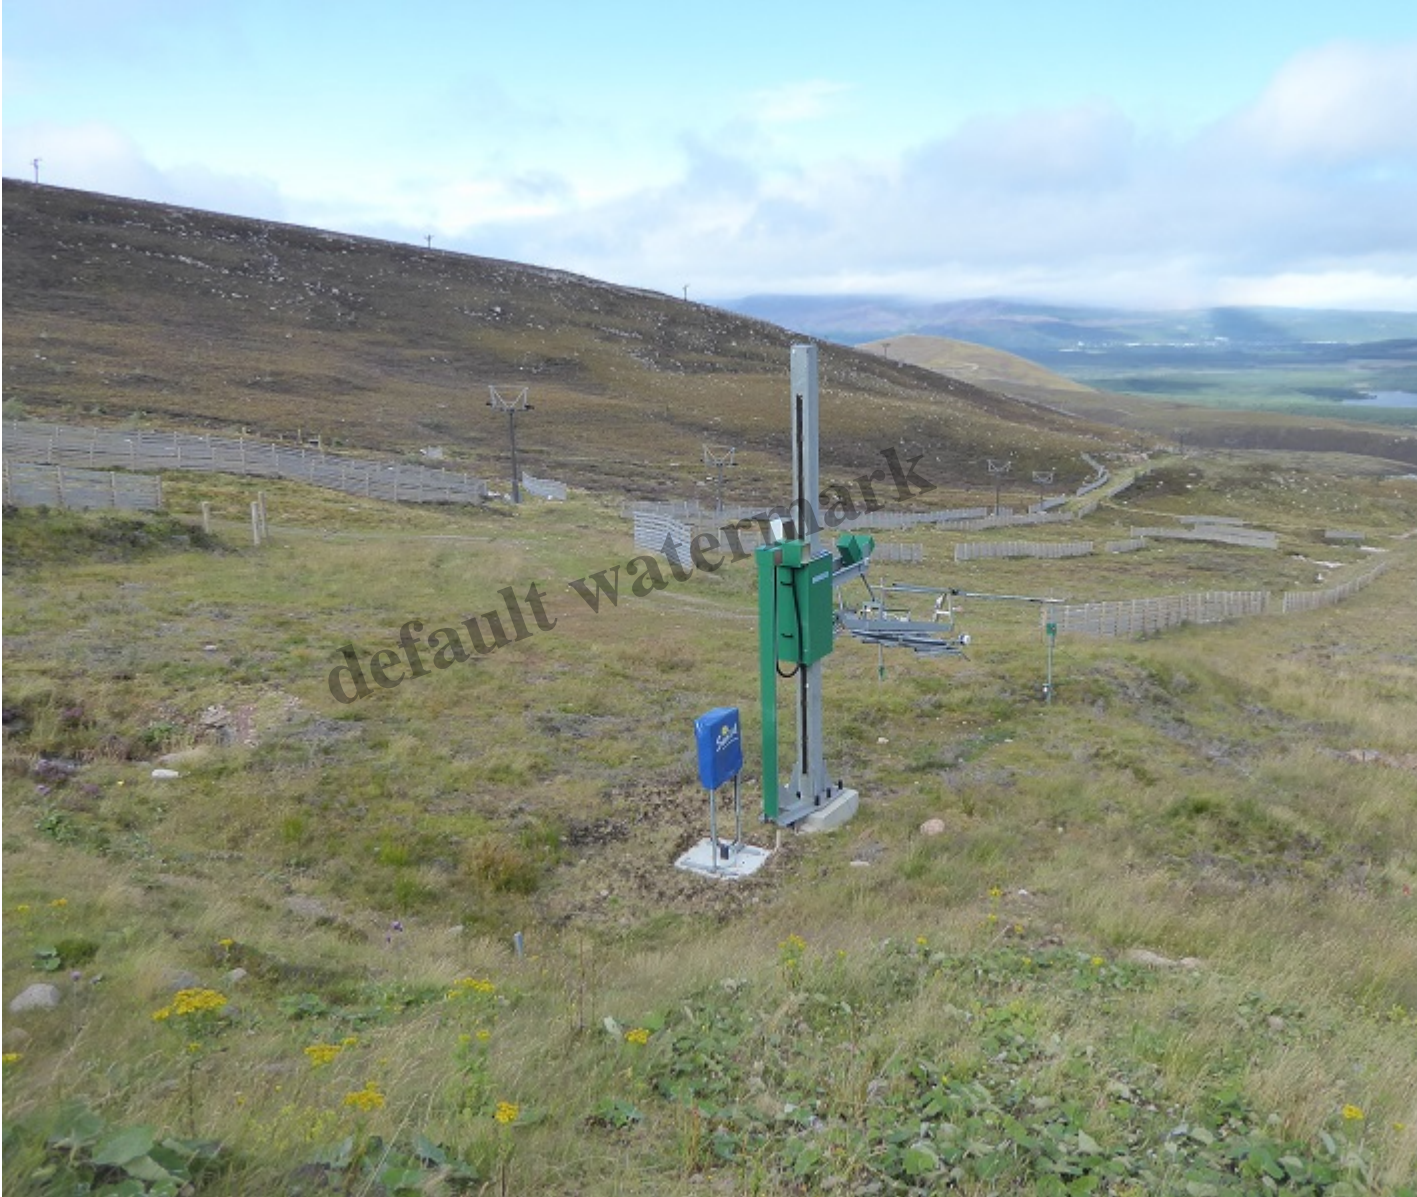
At a landscape scale, the impact of the work that was done to replace the shieling t-bar with a rope t-bar does not look too bad, with the most obvious change being the colour of the slope, which has changed from brown to green due to the replacement of heather by grasses. In the foreground you can see ragwort which has grown on the disturbed ground.

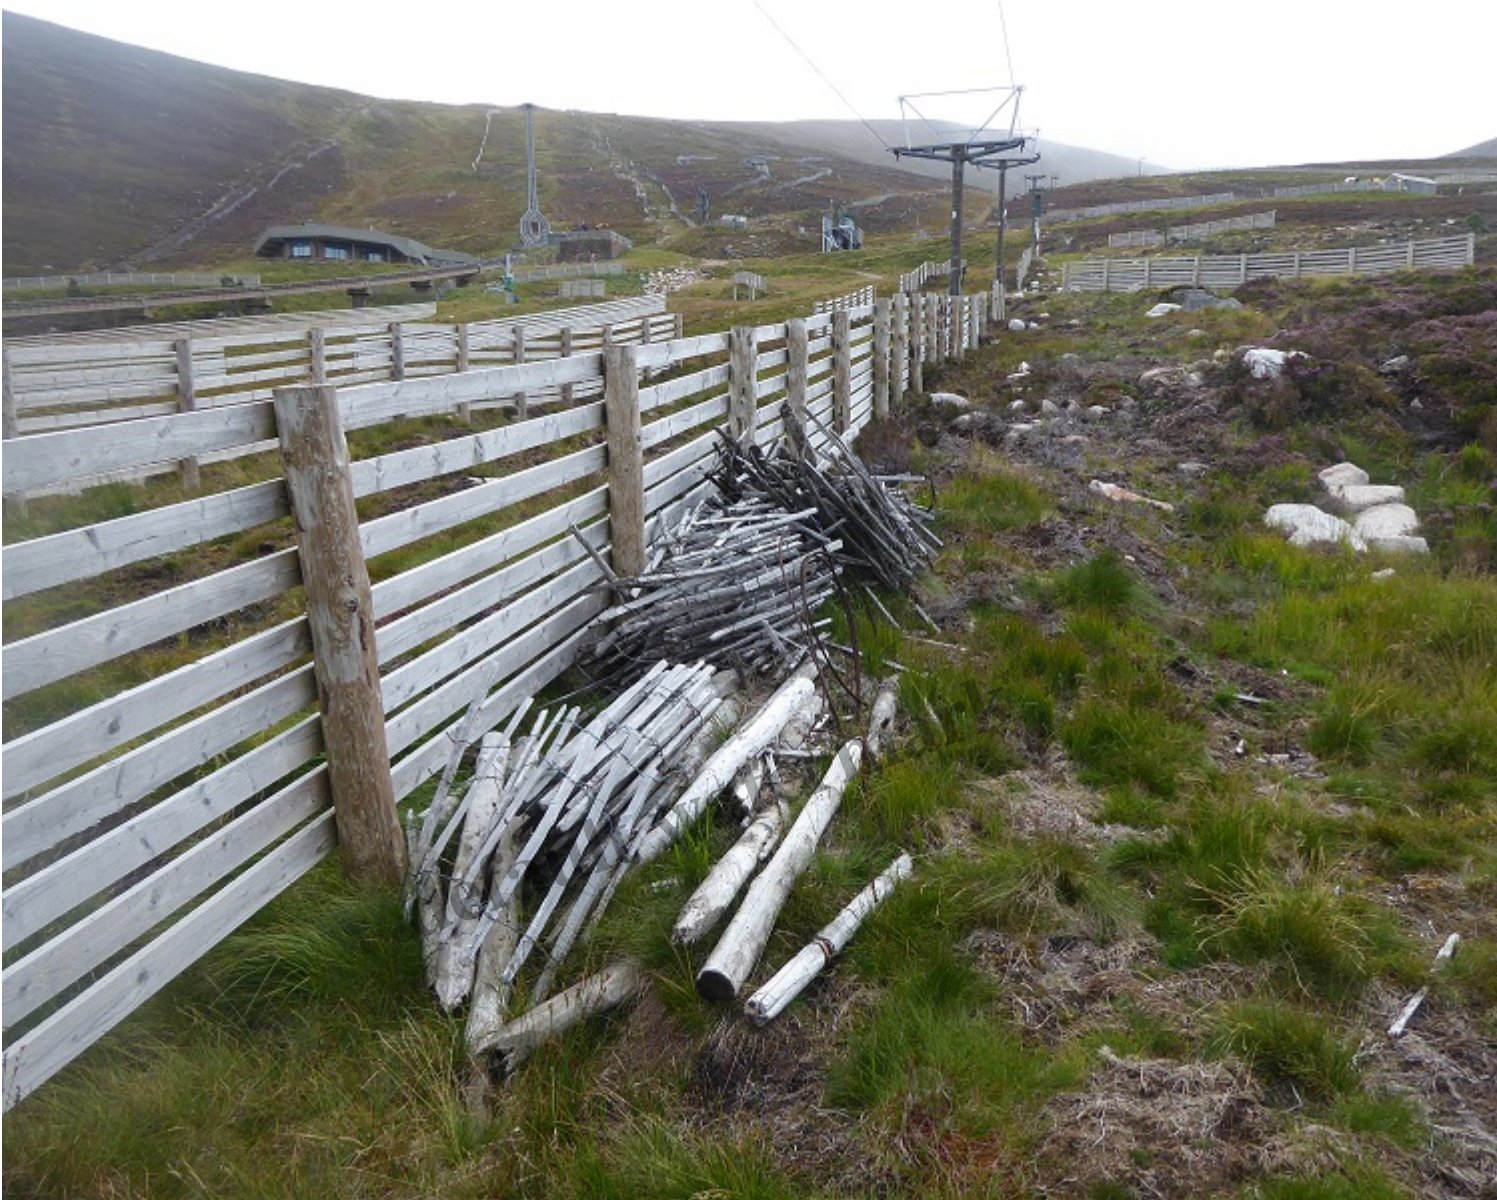
While a fair bit of rubbish has been removed from Coire Cas, including bits of pipe that must have been there 30 years, we did not have to look far to find more. The cynic in me wondered if it had been placed on this side of the fence so it could not be seen by passengers travelling in the funicular!

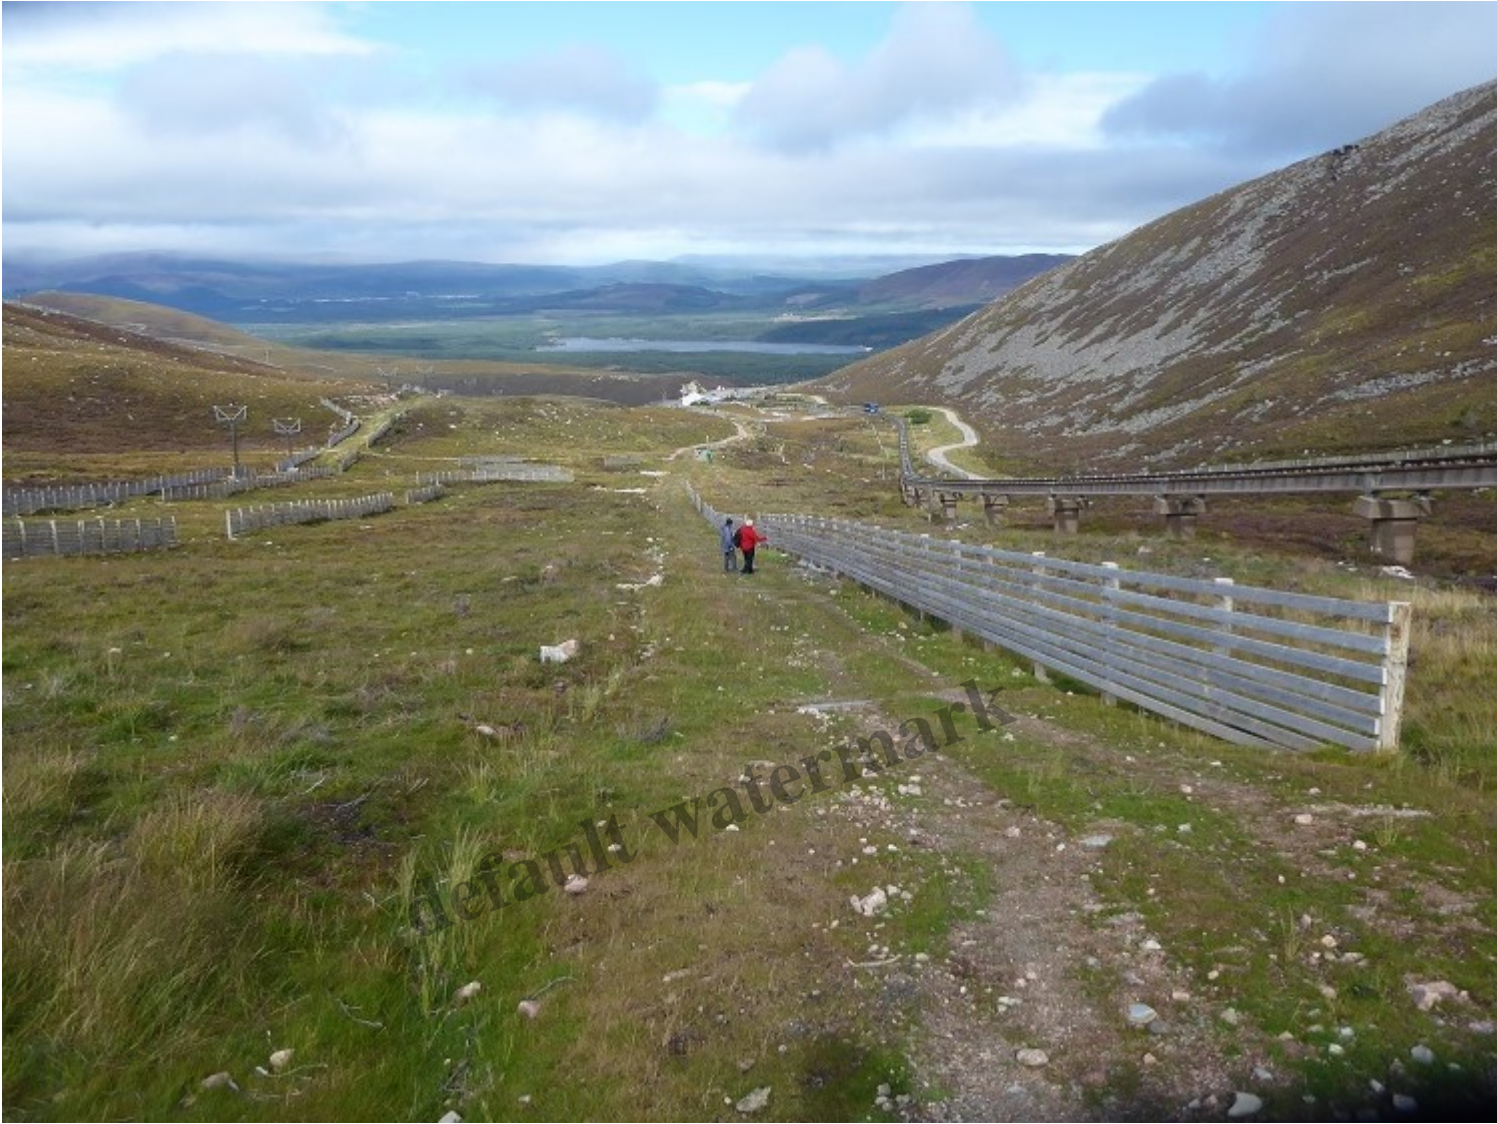
The shieling track, which had been created unlawfully and then granted retrospective planning permission by the Cairngorms National Park Authority ([see here](#)) looked far better than we had expected. The whole track surface, including wheel lanes, had been re-seeded which has helped to stabilise the ground and cross drains installed, as required by the CNPA. So, were conservationists wrong to oppose it? I don't think so. The reason why it looks this good is that it has not been used.. The question is what will happen if and when it does?

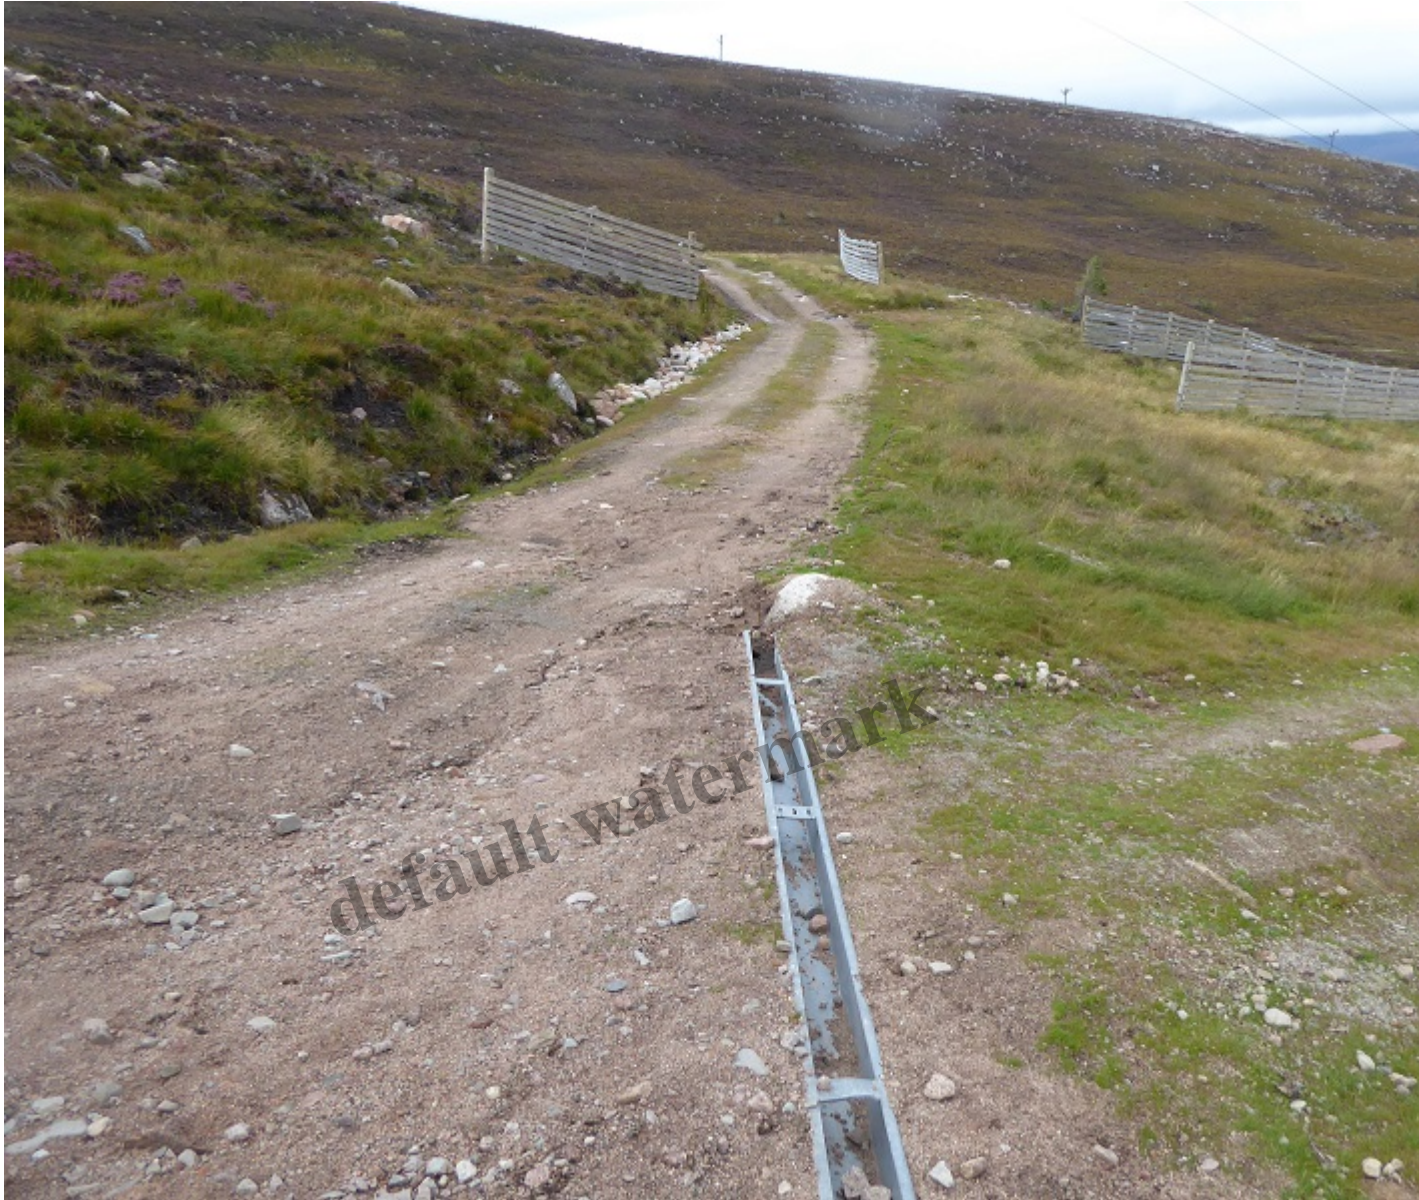
Poor track design. The cross drain empties onto the track beyond and while protecting the top of the shieling track (right) will increase the erosion on the track to the former Fiacail T-bar (left – and which incidentally has never been granted planning permission). Note the rut developing at the end of the cross drain.

There is evidence for what will happen this from the top of the shieling track (the start of the track is to the right of the cross drain in the photo). As soon as vehicles use this ground the re-seeded grass is likely to wear away and the surface of the track erode, as on the left side of photo. Since the shieling track is significantly steeper, exceeding at the top SNH's maximum recommended inclination for hill tracks, the erosion is likely to be worse.

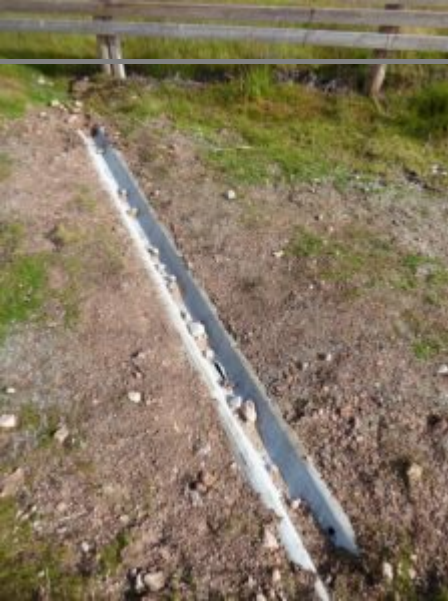
Cross drains have been installed along the Shieling track (left – a recycled Council road barrier is far cheaper than using natural materials) but the re-seeding has not stopped some sediment and stones being washed into them, a sign of continuing erosion.

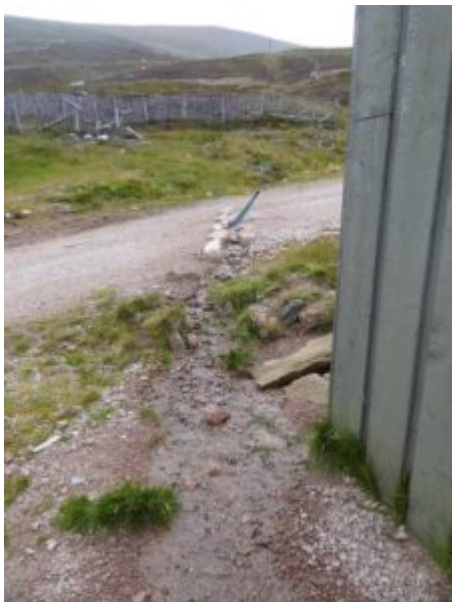
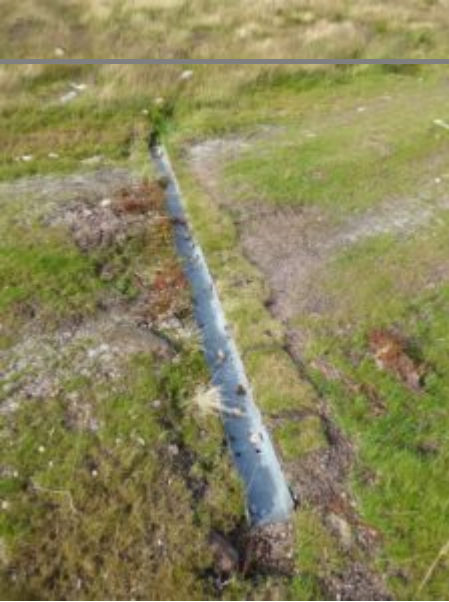
Who paid for the pump house?

We did see one example of a cross drain where a significant amount of

care had been taken (left). The turfs should help hold back and filter sediments. By contrast, above, was an example of Natural Retreats' incompetence (right). Water channelled against the wooden sides of the pump house building! Rotten to the core!

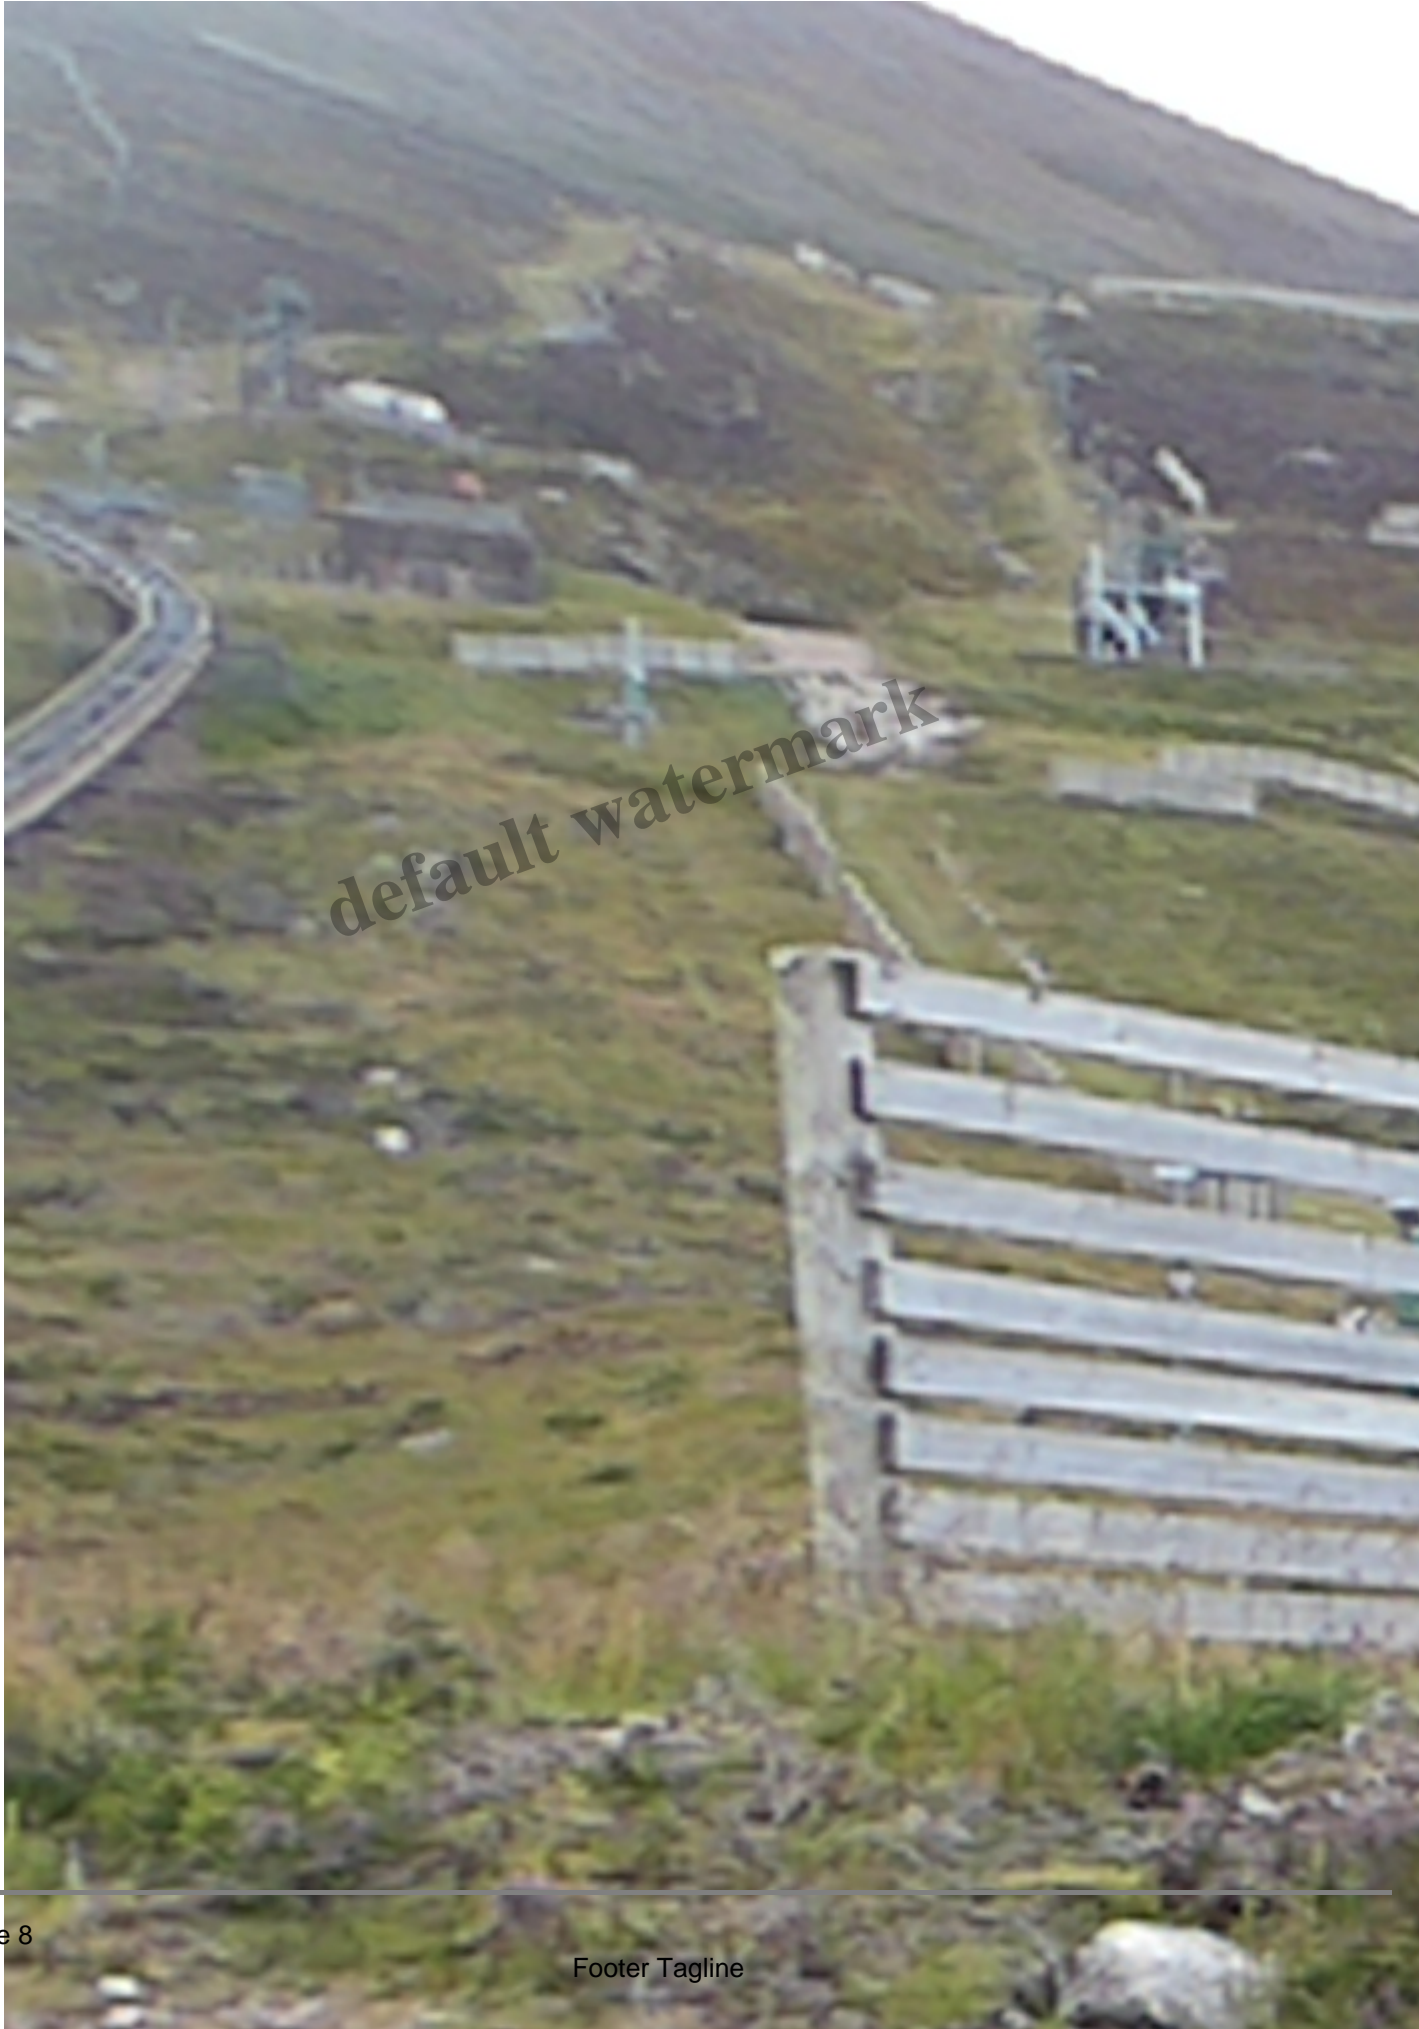
The area below the shieling rope tow outwith the area granted planning permission by the CNPA. The

The photo demonstrates the large area affected by the shieling works and where vegetation and turves were not retained prior to re-instatement, hence all the re-seeding (the green in the photo). While heather should re-colonise this area in time we will need to wait to see other longer term impacts, such as whether invasive species colonise some of the ground. The picture will be complicated because the CNPA required compensatory tree planting as a condition of the retrospective planning permission, although this had not started at the time of our visit and there is no mention of this on Cairngorm Mountain's "Behind the Scenes" blog (Autumn is a good time for planting).

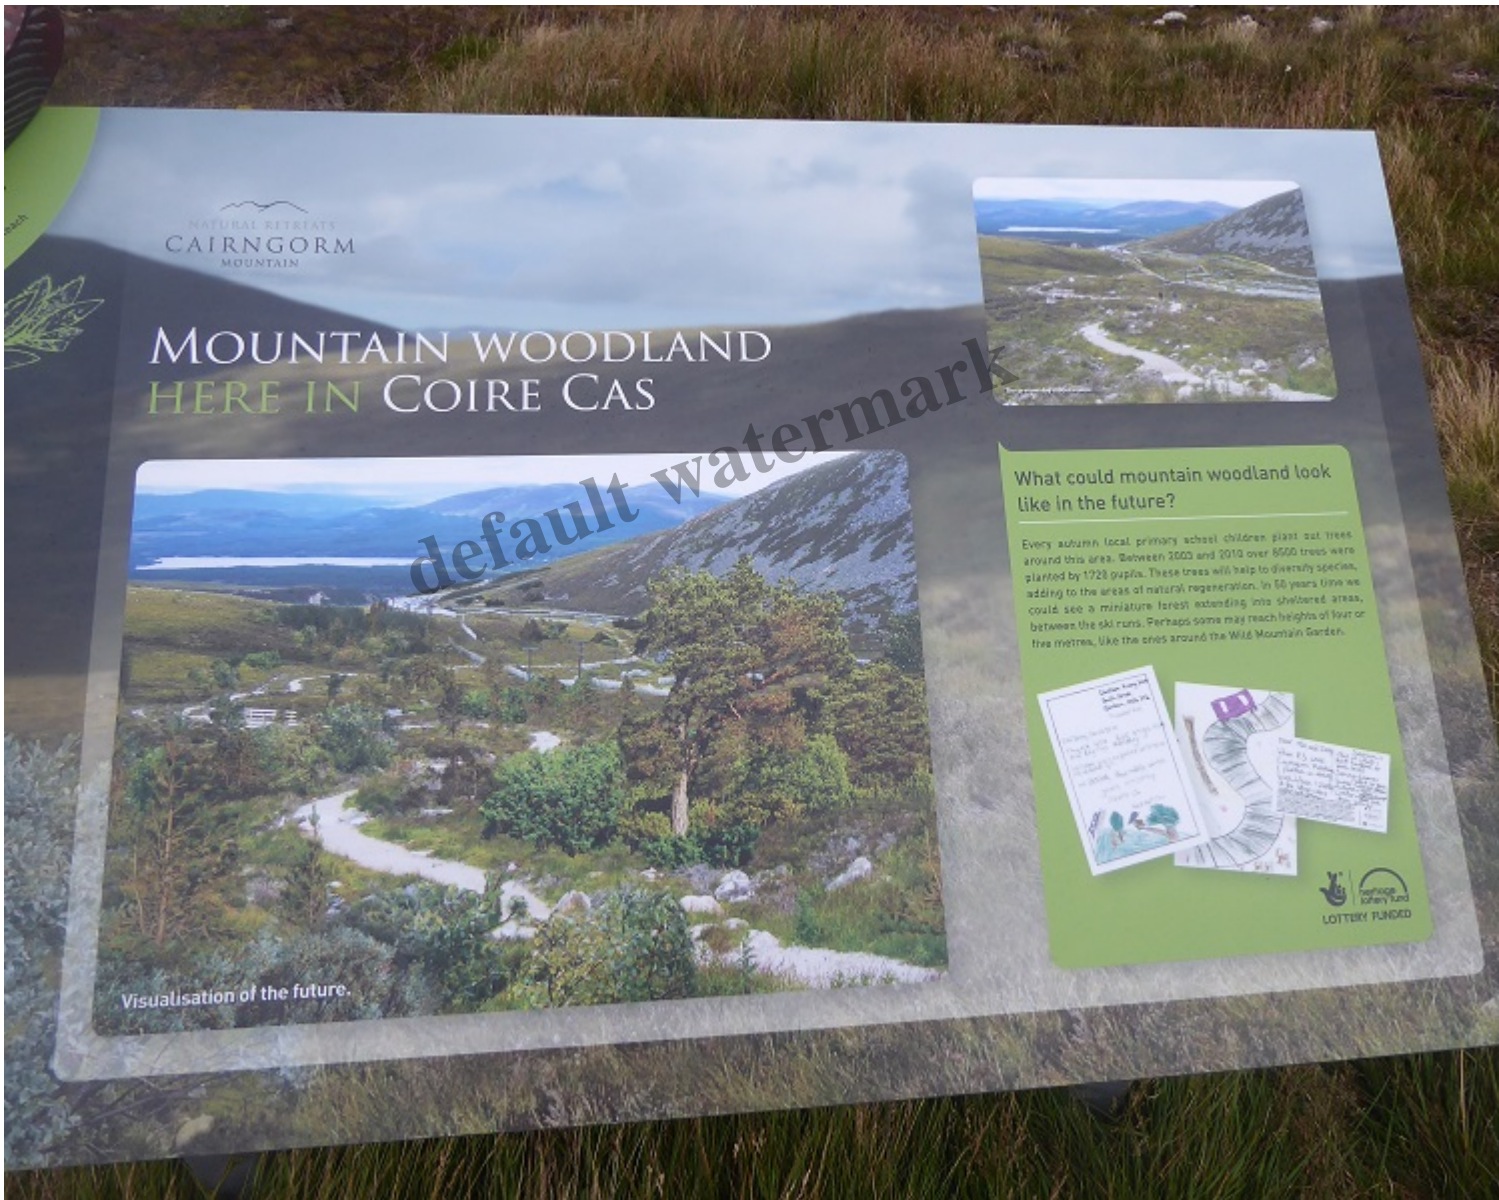
What was pleasing to see was the interpretation boards, which had fallen into utter disrepair, had been replaced. I suspect this was organised by the Ranger Service and perhaps by Nic Bullivant before he departed as head ranger. It appears this was funded by the lottery not Natural Retreats who appear to have no interest in this visualisation of the future. I believe this vision should be at the centre of an alternative plan for Cairngorm (with trees rather than snow fences collecting the snow). Unfortunately a number of trees were killed in the unlawful works that took place in Coire Cas and one reason there

are not more trees here, in contrast to the path round to Coire an-t-Sneachda – is that vehicles are allowed to drive willy nilly over the vegetation.

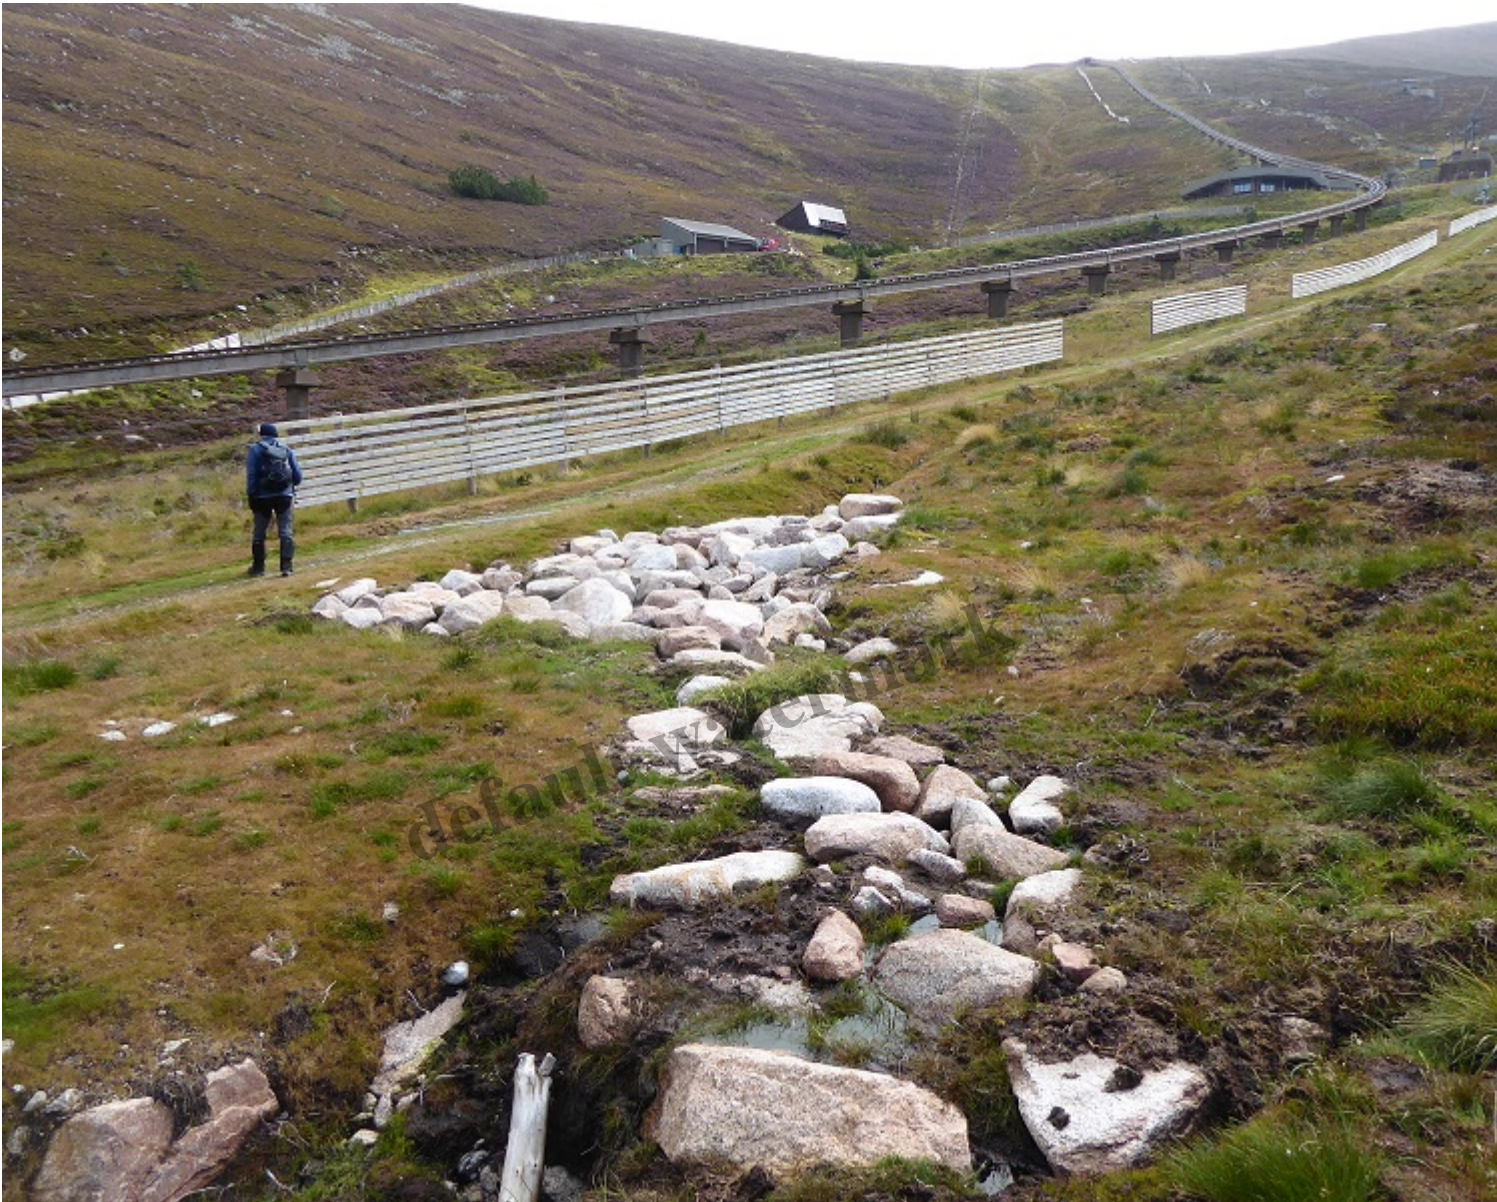
My biggest concern on the day was landscaping. The area with boulders is outwith that granted planning permission but has been subject to extensive engineering works and new drainage. It looks totally out of place and there has been no attempt to restore the slope to how it previously looked.

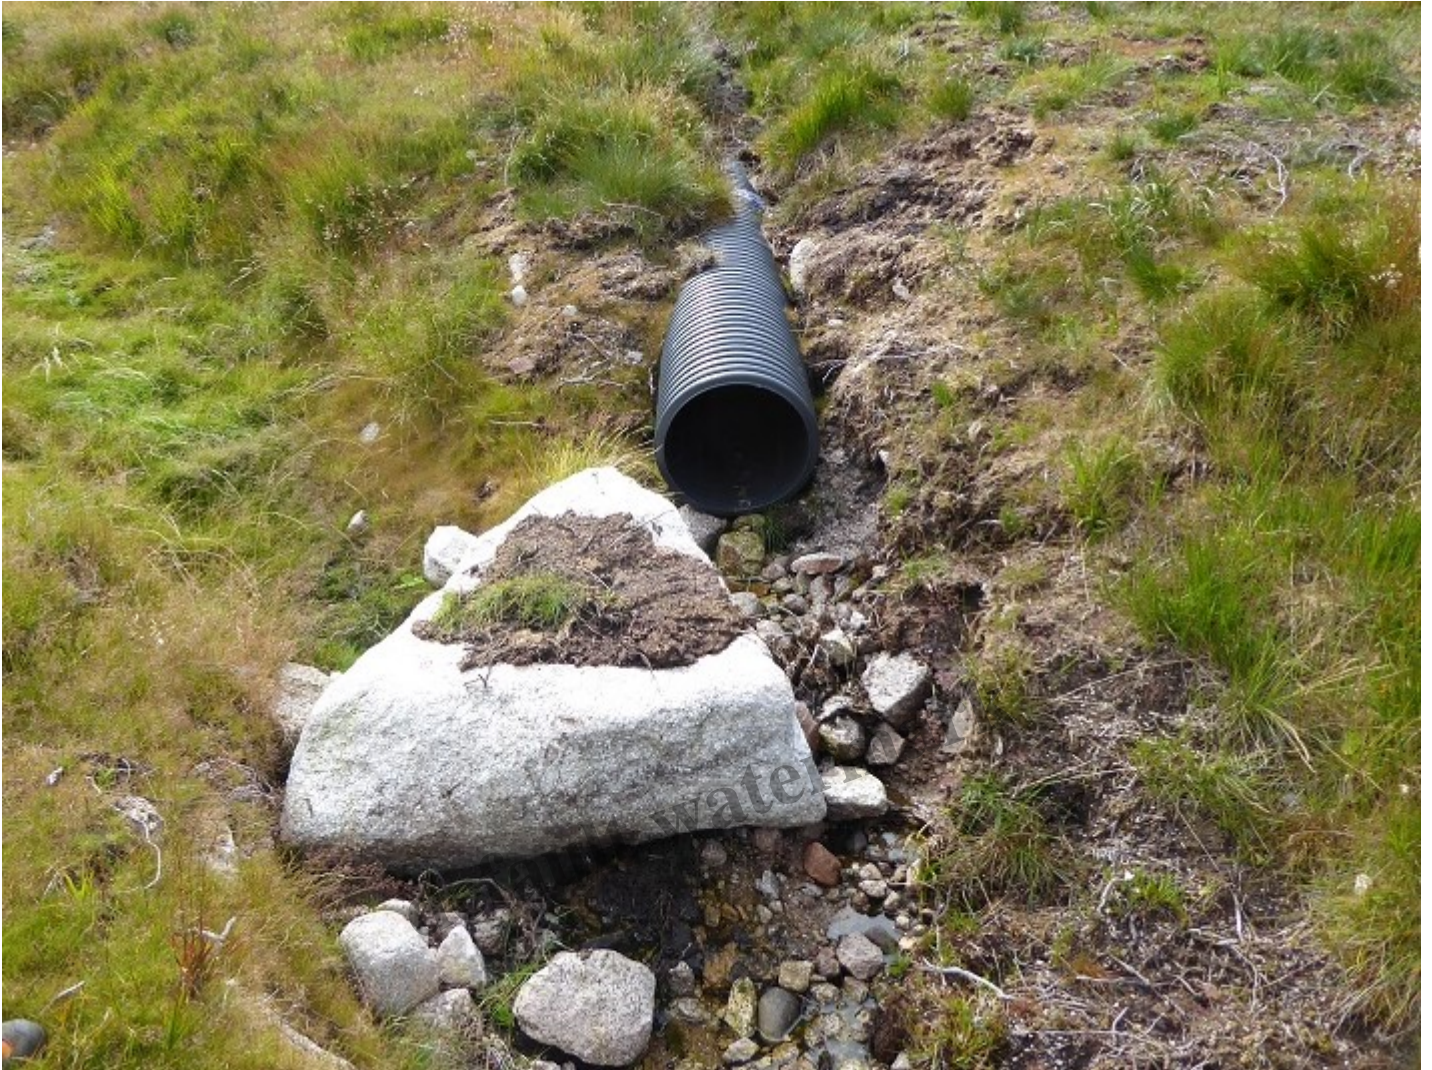
While culverts along the burn at the bottom of the shieling slope – which required permission from the Scottish Environment Protection Agency – have been finished well, other culverts which did have permission from SEPA, are right eyesores.

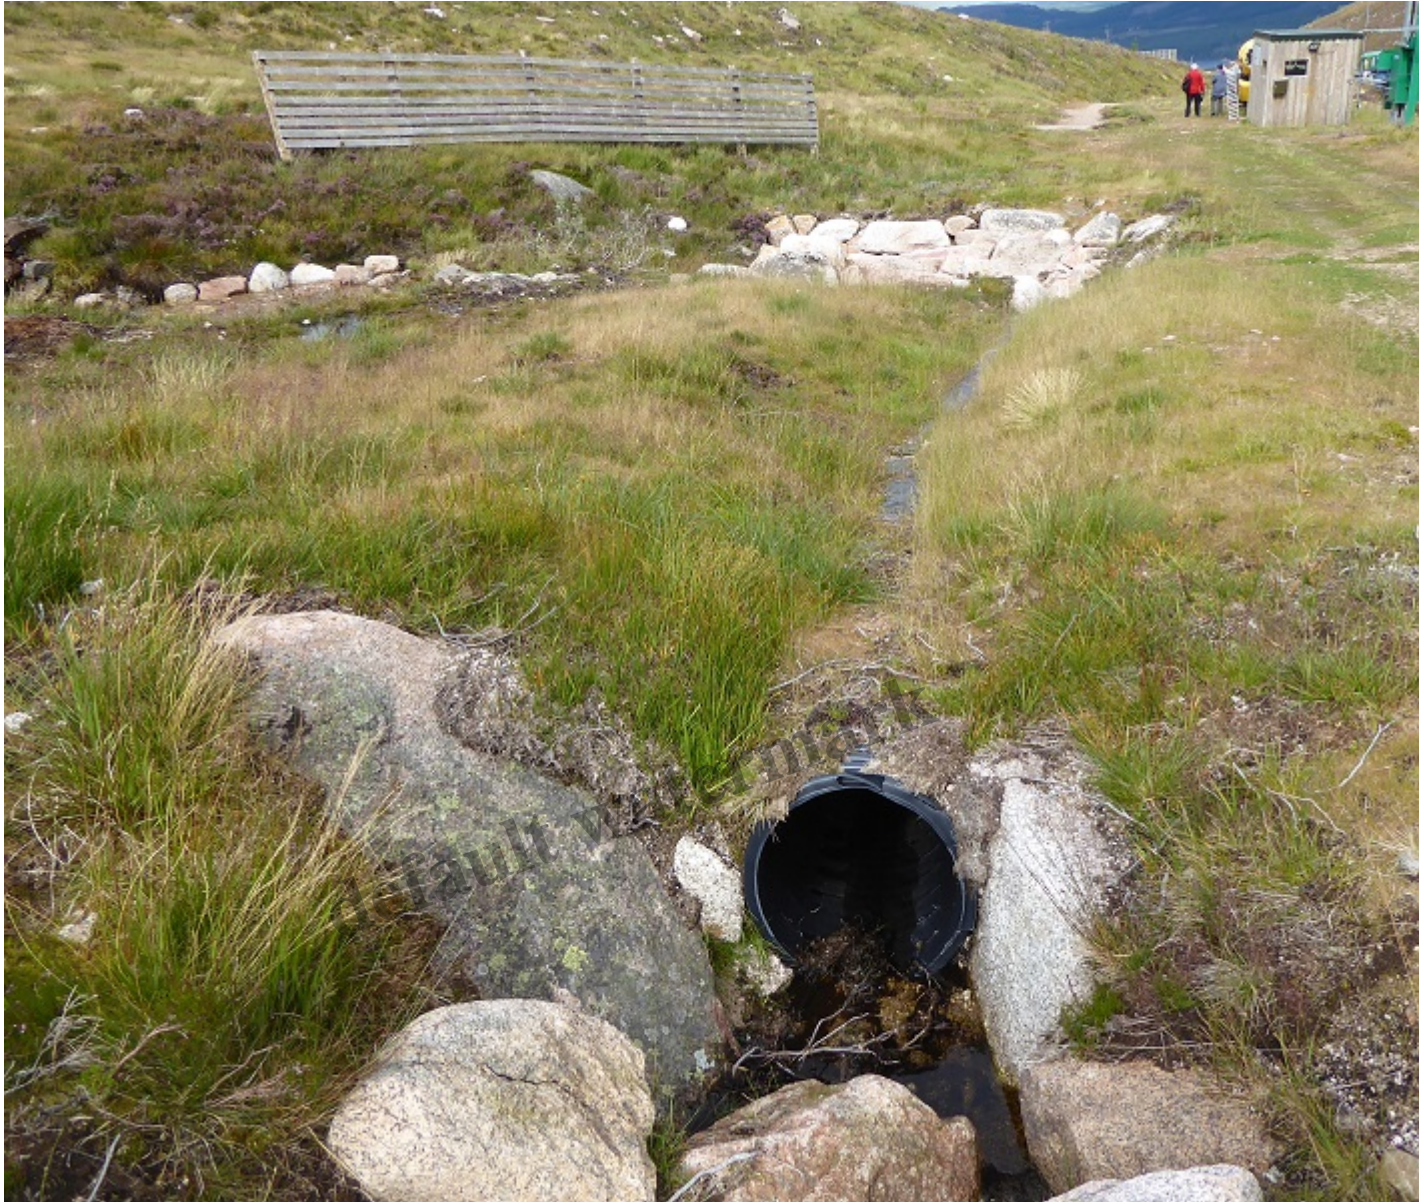
Natural Retreats did not retain enough soil/peat to replace vegetation on top of culvert, required to erode to cross over to the bottom of the new rope tow.

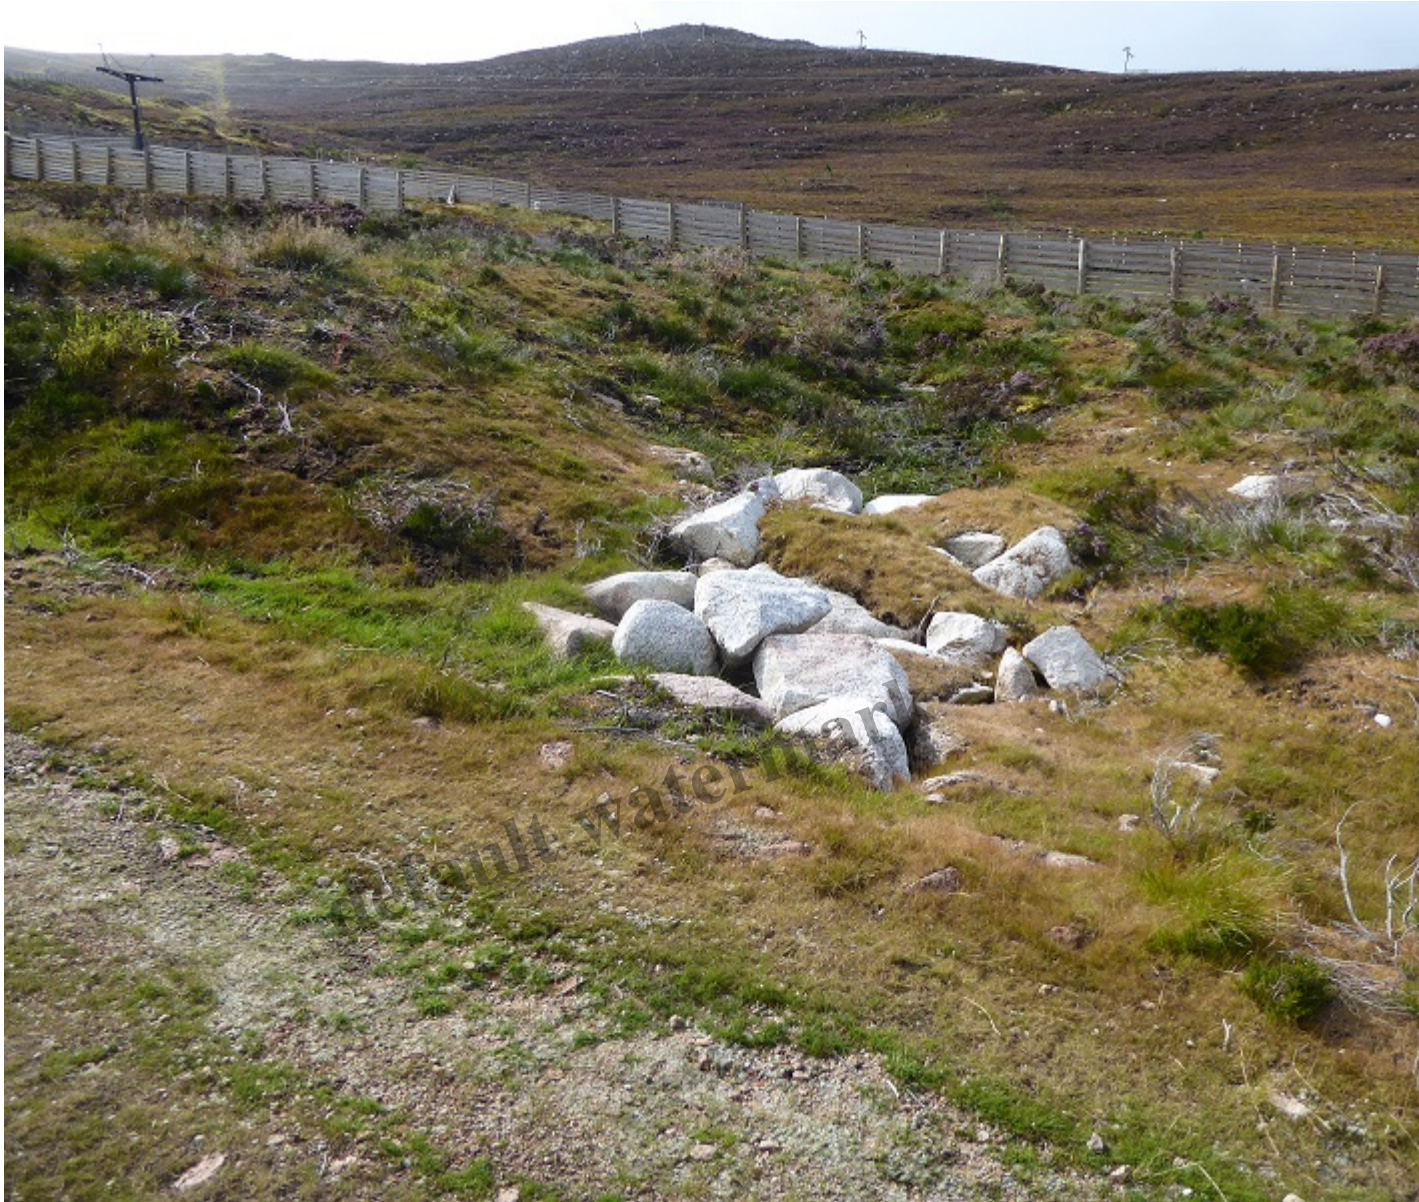
Natural Retreats has made half an attempt to conceal these boulders by the Shieling track

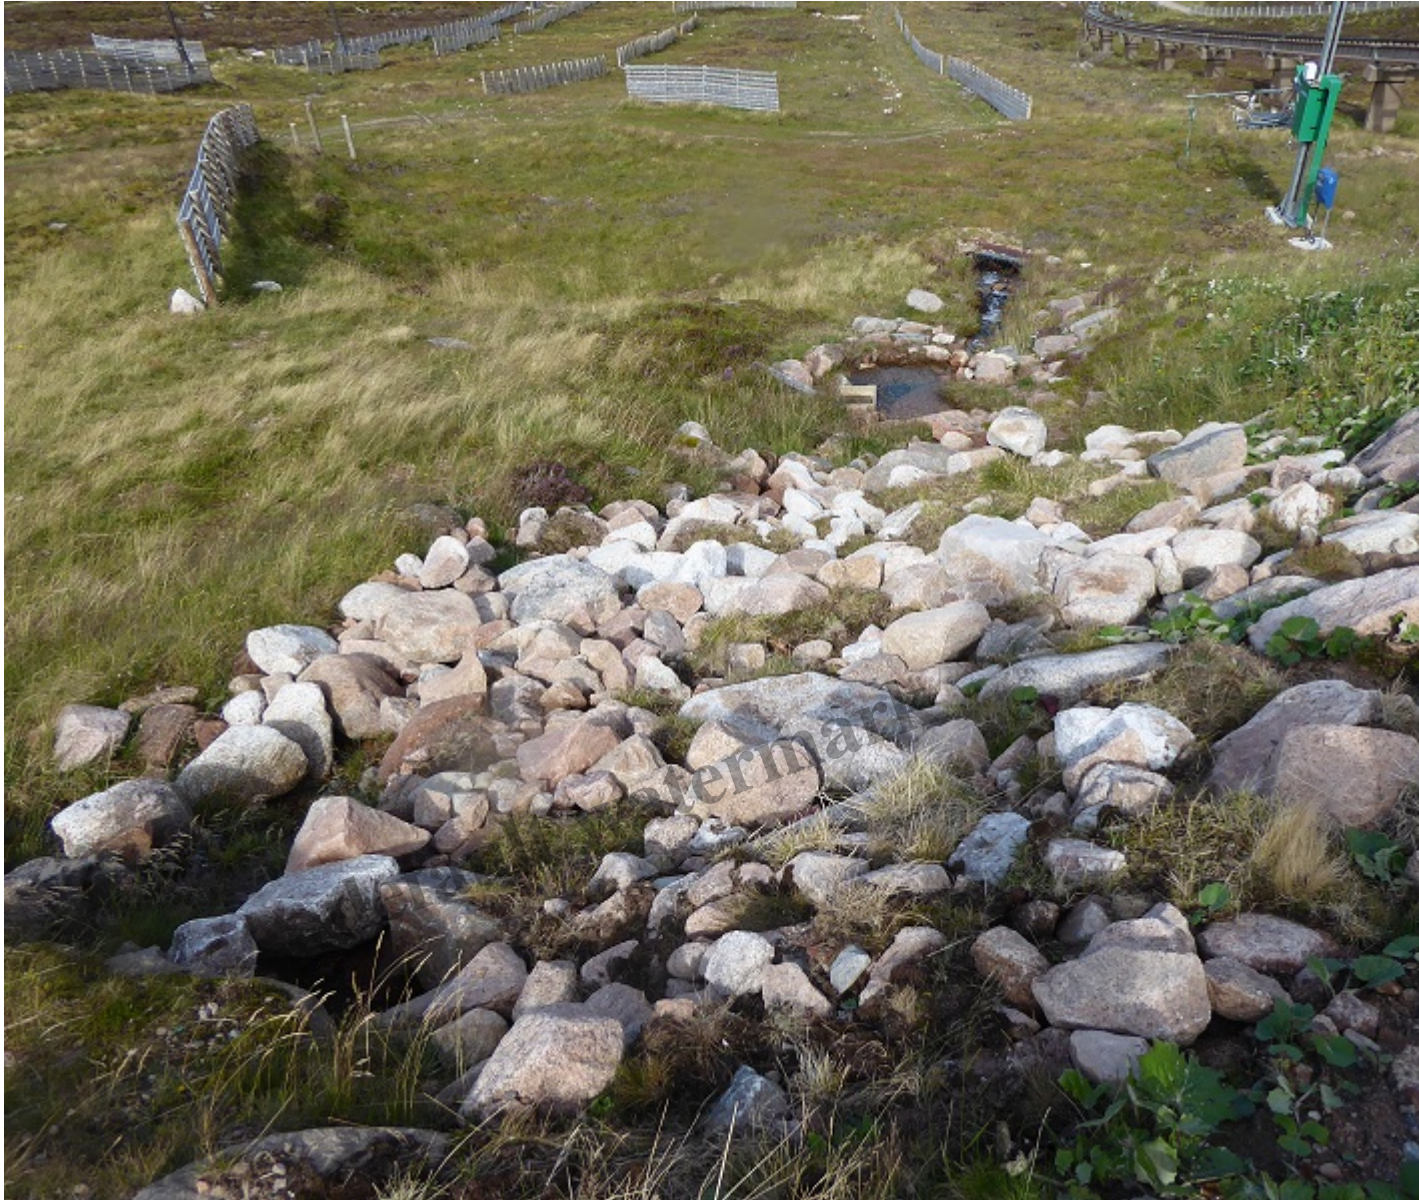
Above the shieling rope tow the boulder dumps are more visible from a distance

The shieling rope tow and surrounds was subject to planning permission from the Cairngorms National Park Authority and they therefore continue to have some influence (legally) on the restoration of this area. The three things I think they need to focus on are: restoration of vegetation, landscaping and the ecological impact of the changed drainage in the area.
