Coire Cas report card – the HIE/Natural Retreats restoration and clear-up

After the extensive coverage parkswatch gave to the destruction caused by engineering works in Coire Cas last year ([see here for example](#)), at the end of August a small group of us went to have a look at how the restoration work was going. In my view while there have been some improvements, there is a long way to go. The purpose of this post is to illustrate some of the issues.

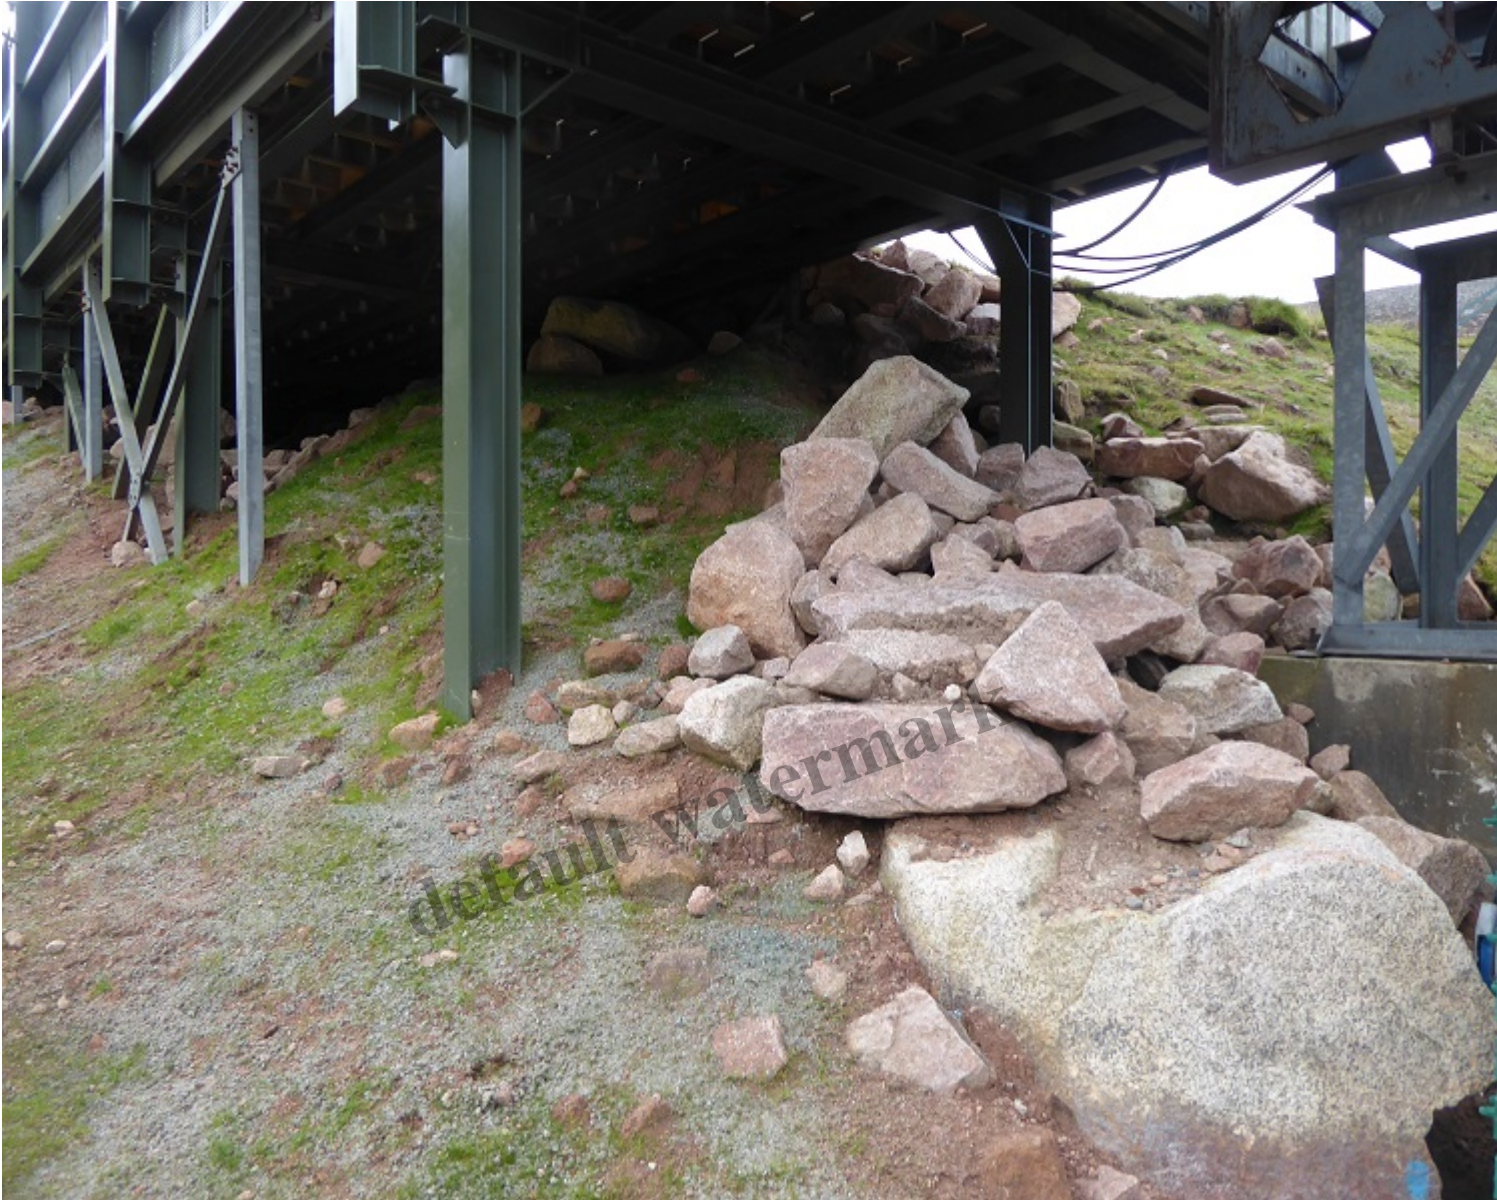
Some, but not all the boulders which were shoved under the gantry as a result of piste widening works (no planning permission) have been restored.

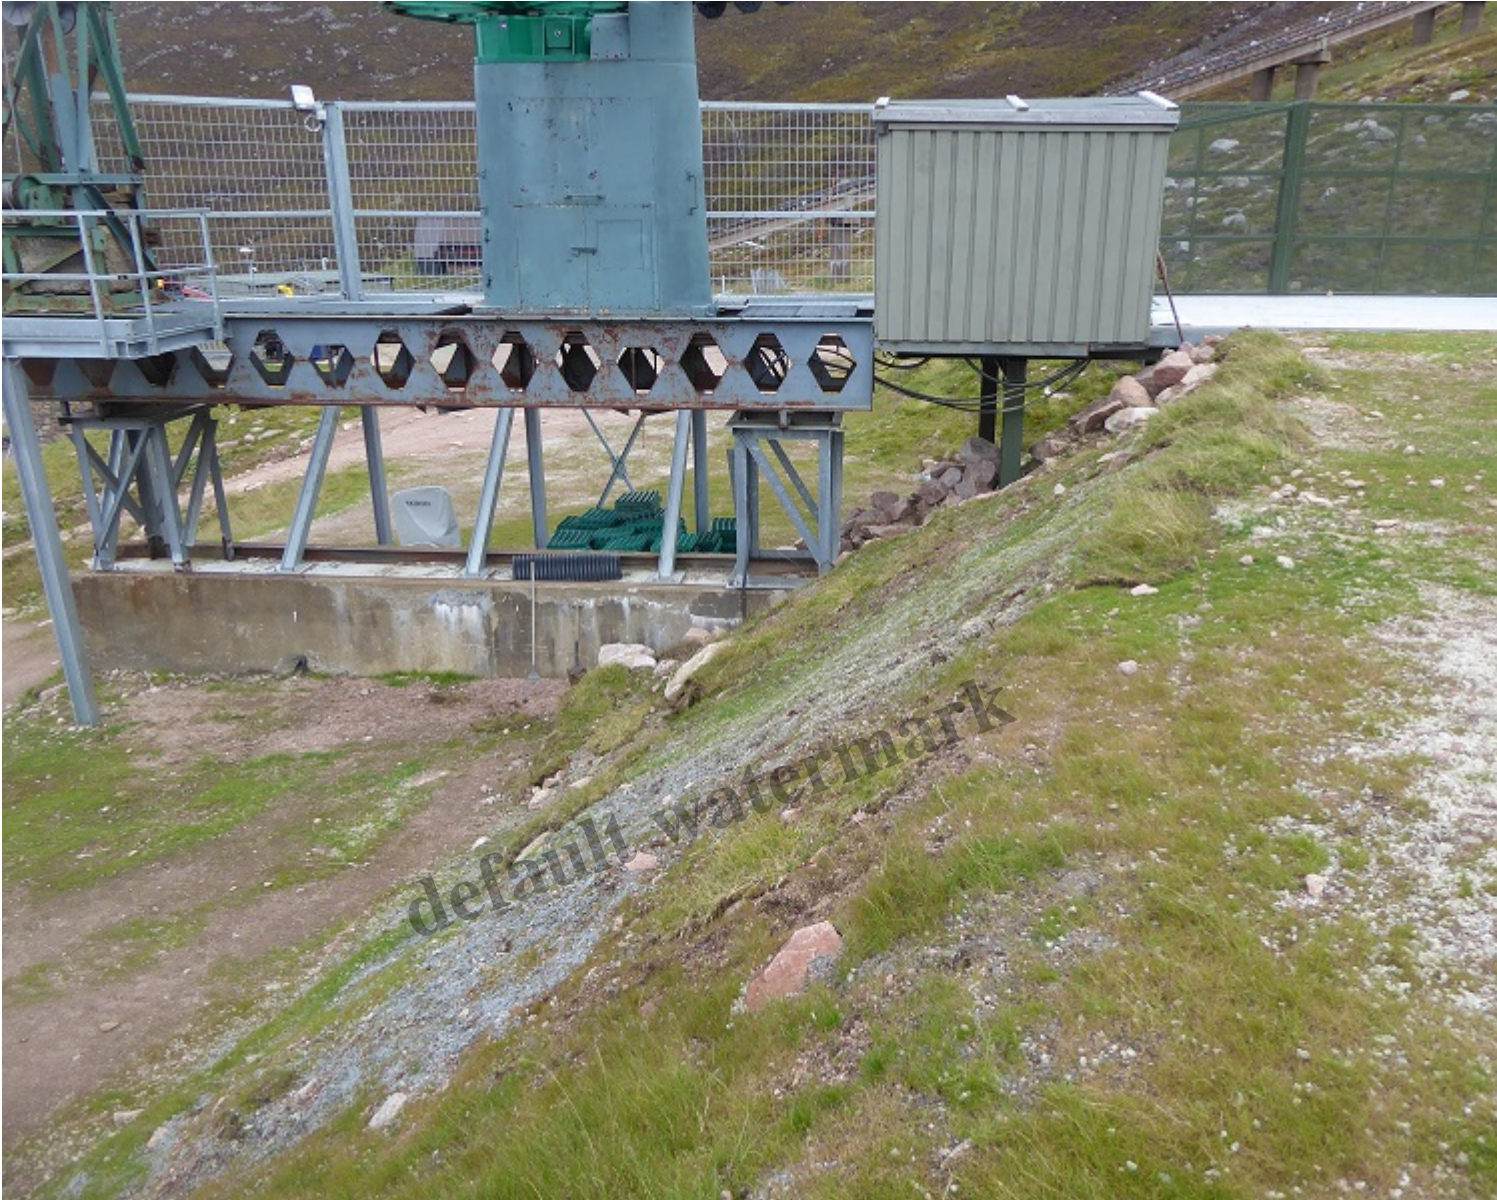
Turf has been placed along top of the slope which Natural Retreats excavated in order to try and prevent water flooding down it. The basic issue is the slope is too steep and no vegetation/turf was retained for restoration purposes. The bluish re-seeding pellets (left foreground) continue to get washed out and the risk is this slope will again be subject to severe erosion this winter.

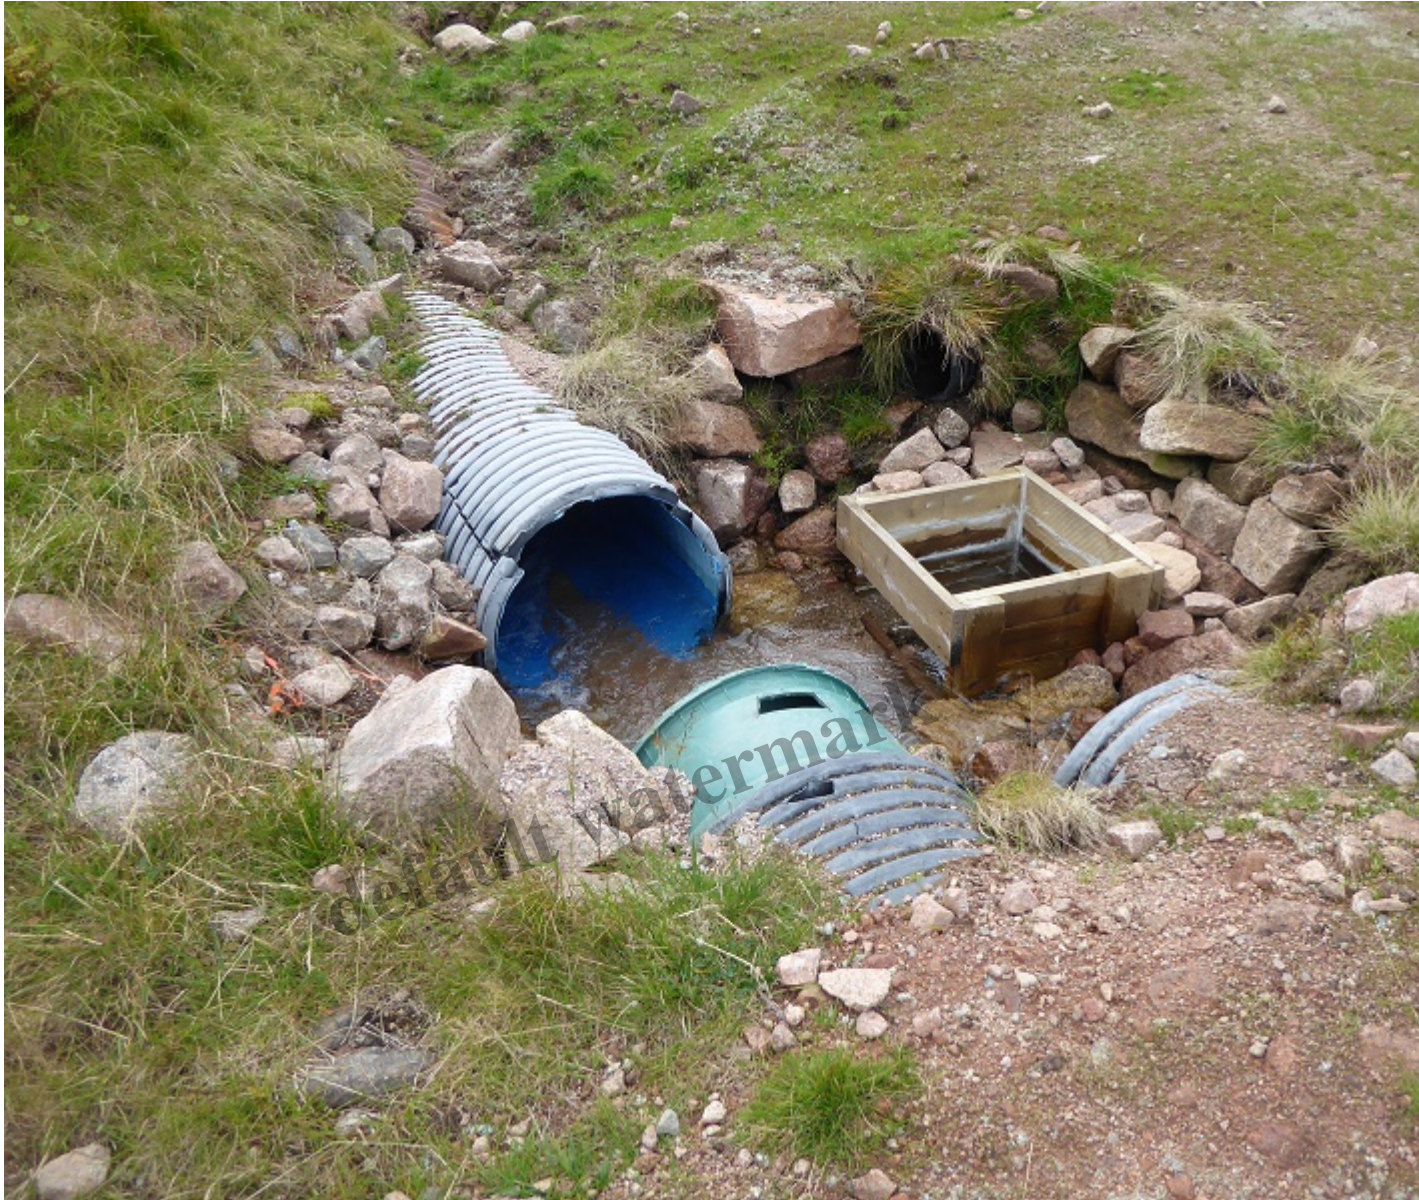
Culvert pipe chopped? to create pool to provide water for snow making machines. I understand the v on the right helps sediment in the water to settle out and prevents the snow making machines becom with silt.

The finishing of the culverts is very poor.

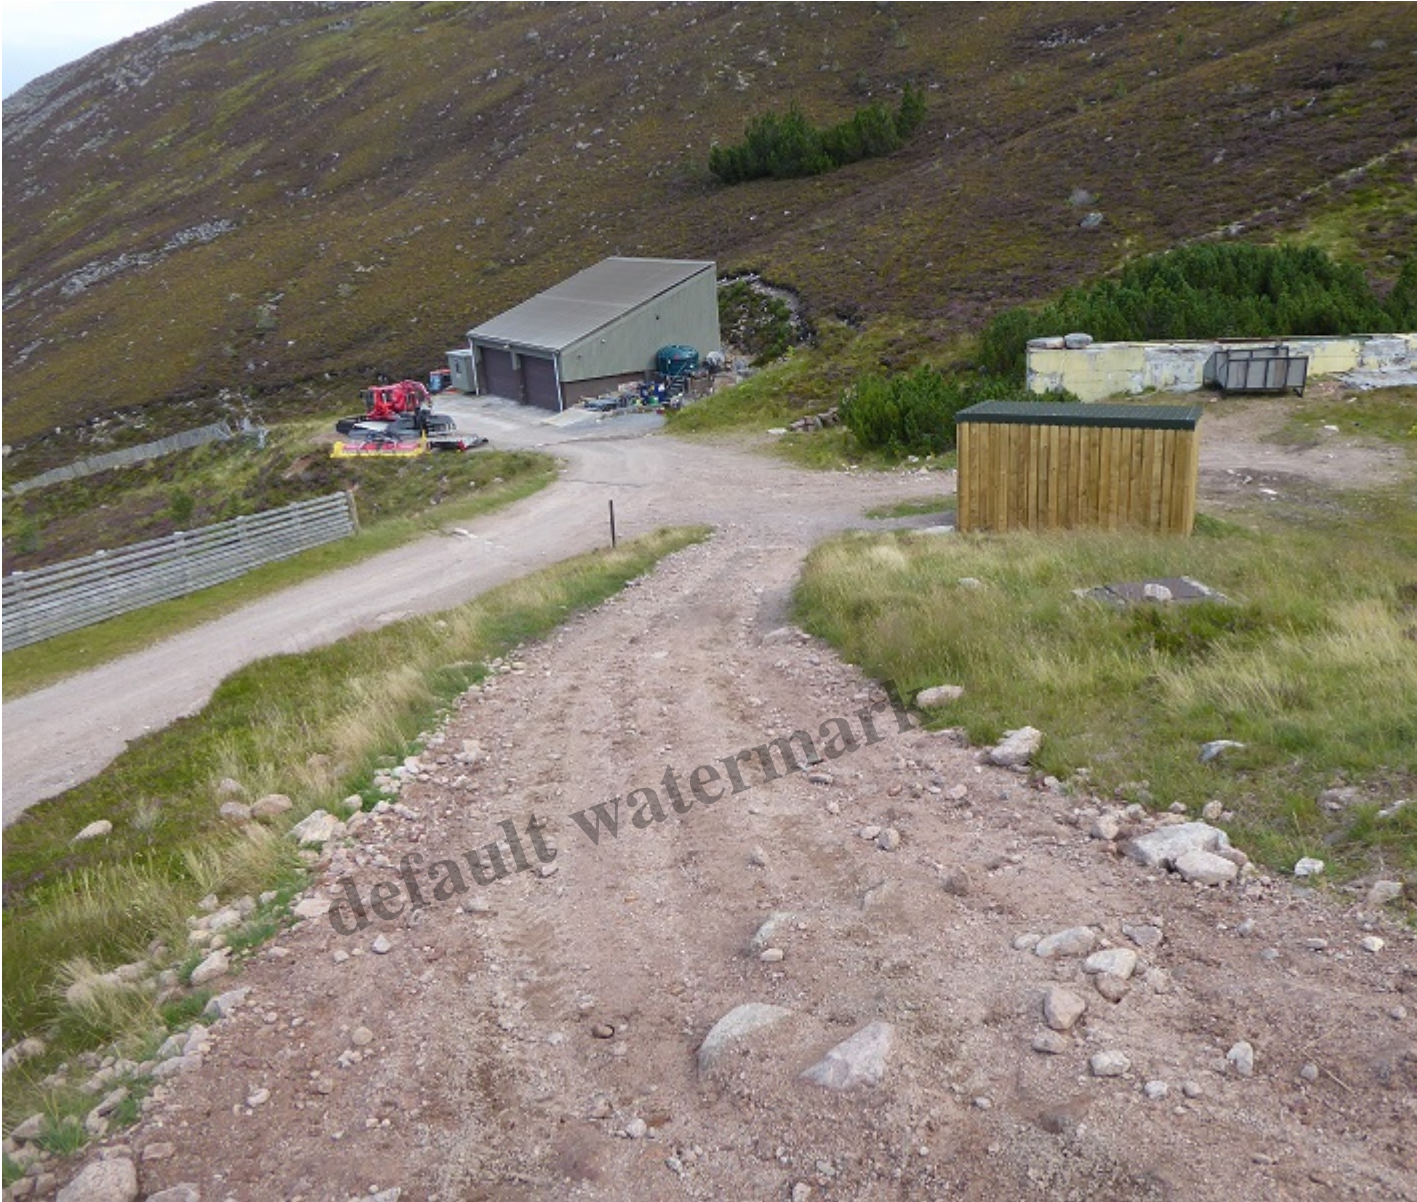
View down “track” from former shieling restaurant to recently renewed former Lifties hut.

Worst of all though is the uncontrolled use of vehicles. The track above never used to be there, has been created through vehicle use, is far too steep and is eroding badly. It has never been granted Planning Permission. Forest Enterprise Scotland provides Prior Notification for new tracks as short as 40m to Planning Authorities so HIE has no excuse for this.

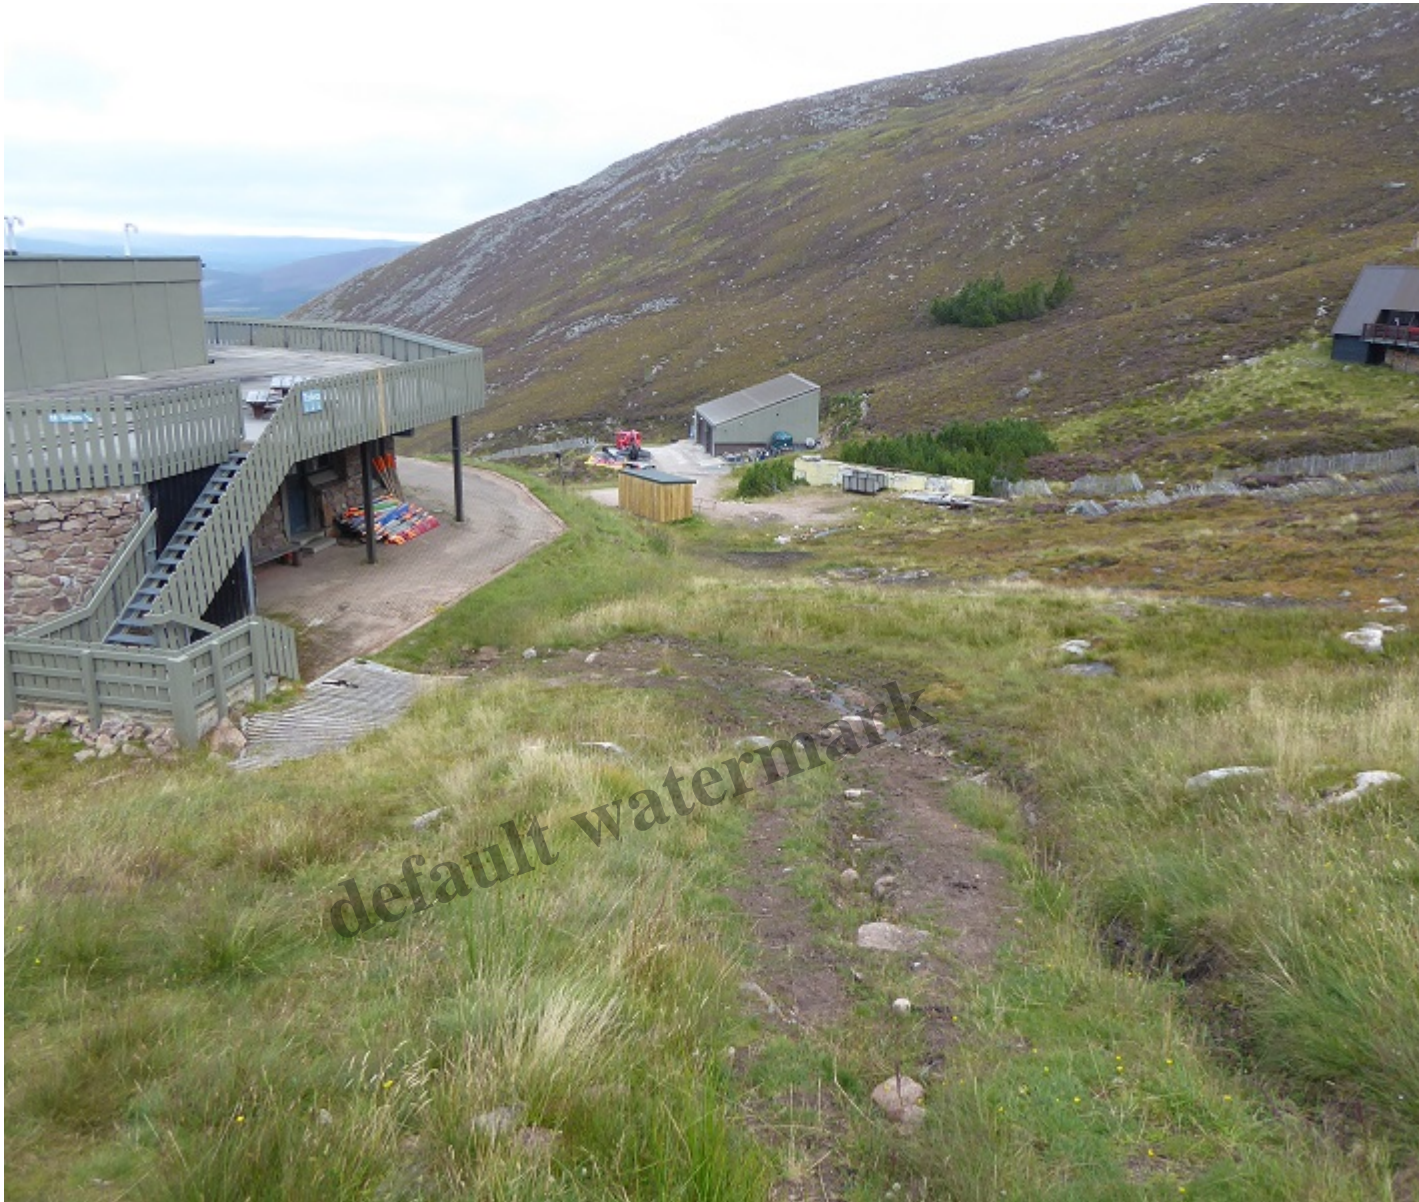
ATV tracks by the former shieling restaurant – there is a second track on the right running parallel to the centre.

Off track use of vehicles at Cairngorm used to be strictly controlled but is now seen as unnecessary bureaucracy.
