## Coire Cas report card â?? the HIE/Natural Retreats restoration and clear-up

## The restoration of the shieling track

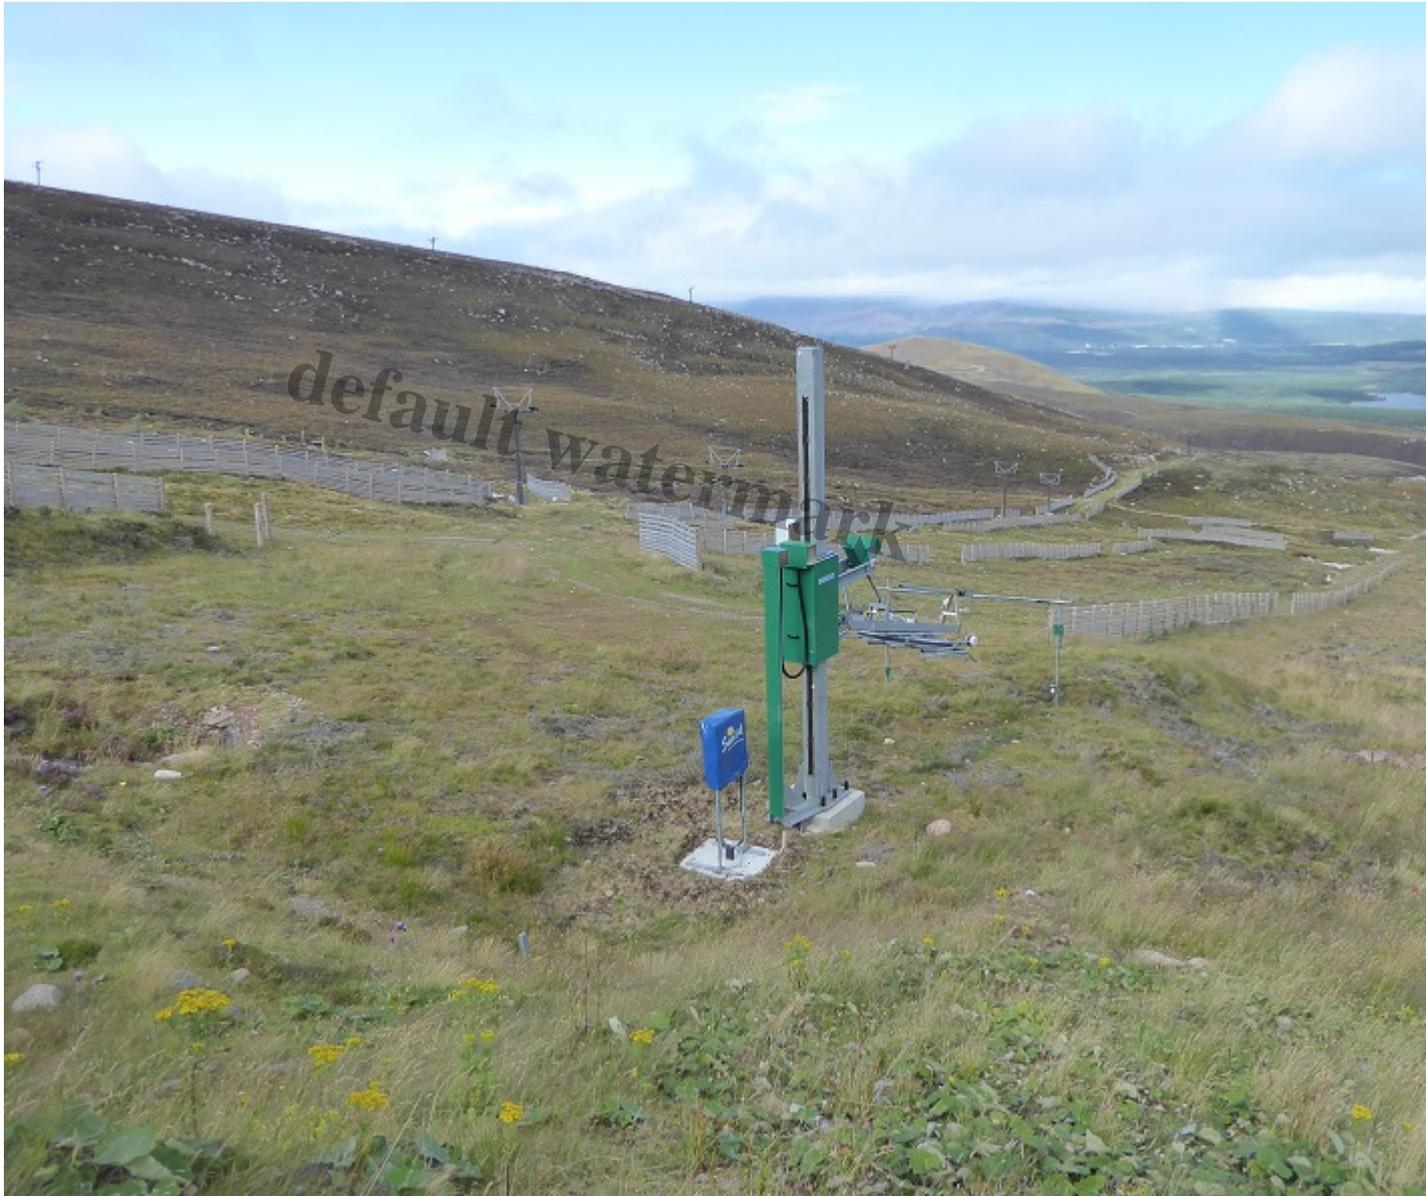
At a landscape scale, the impact of the work that was done to replace the shieling t-bar with a rope t-bar does not look too bad, with the most obvious change being the colour of the slope, which has changed from brown to green due to the replacement of heather by grasses. In the foreground you can see ragwort which has grown on the disturbed ground.

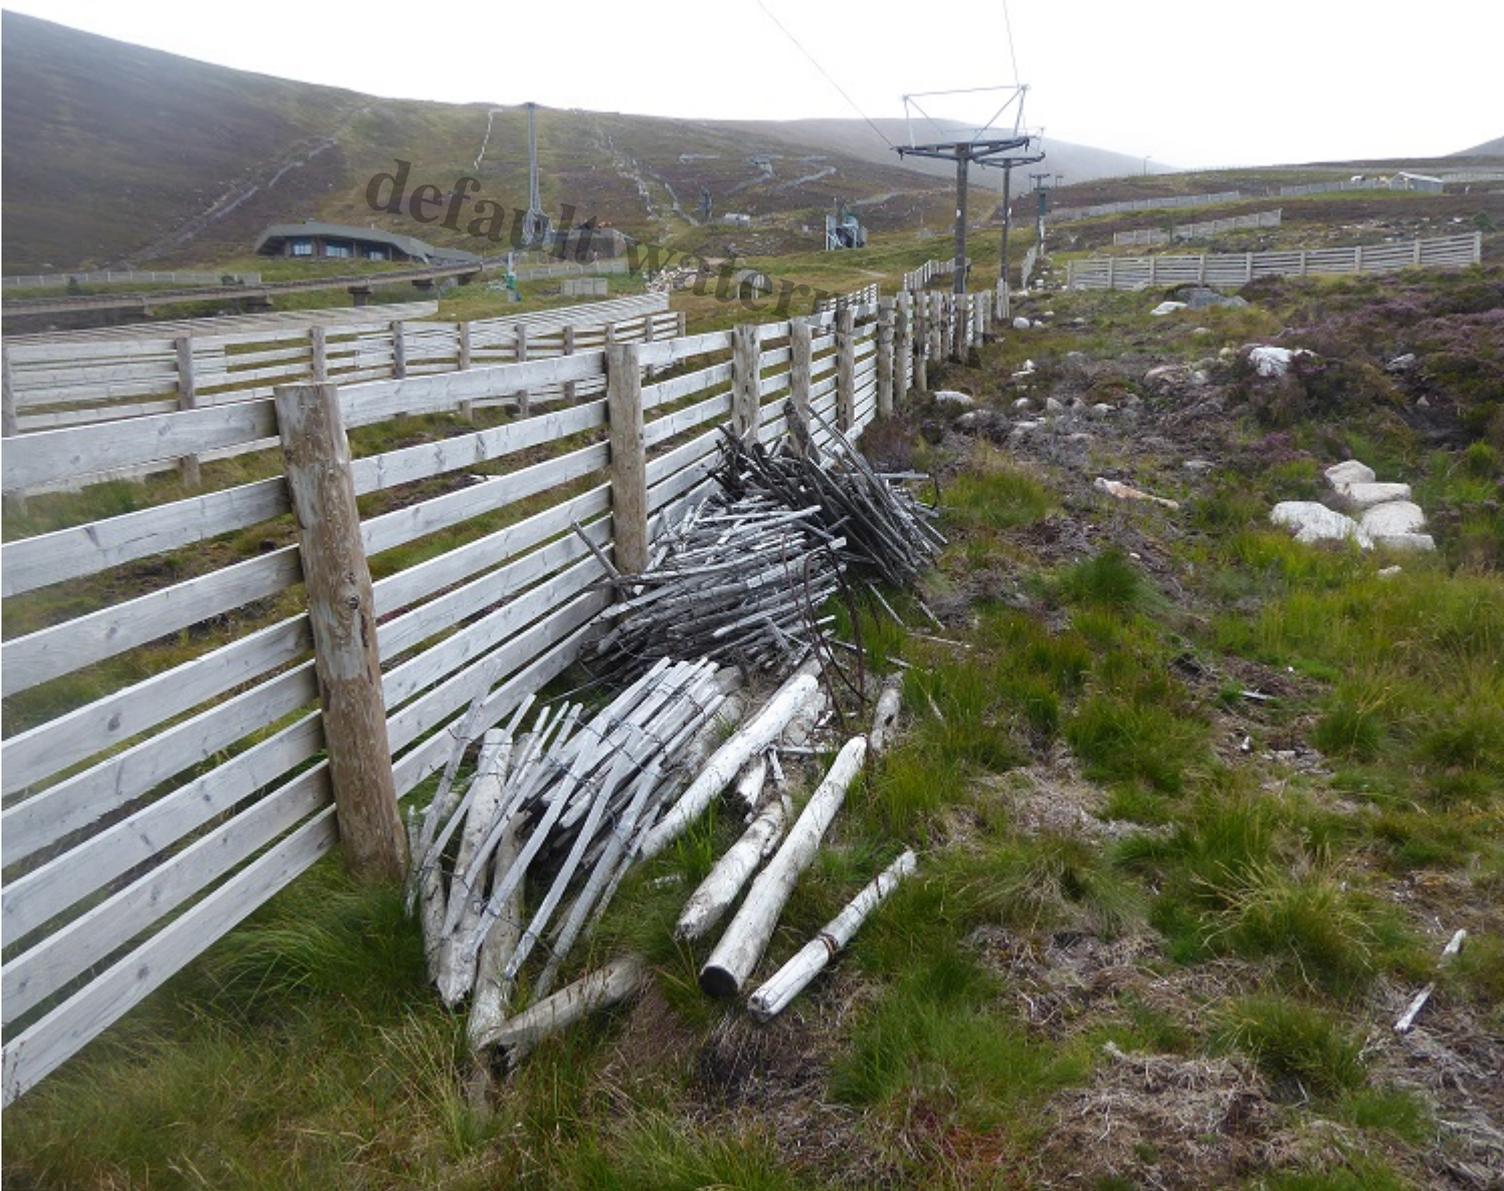
While a fair bit of rubbish has been removed from Coire Cas, including bits of pipe that must have been there 30 years, we did not have to look far to find more. The cynic in me wondered if it had been placed on this side of the fence so it could not be seen by passengers travelling in the funicular!

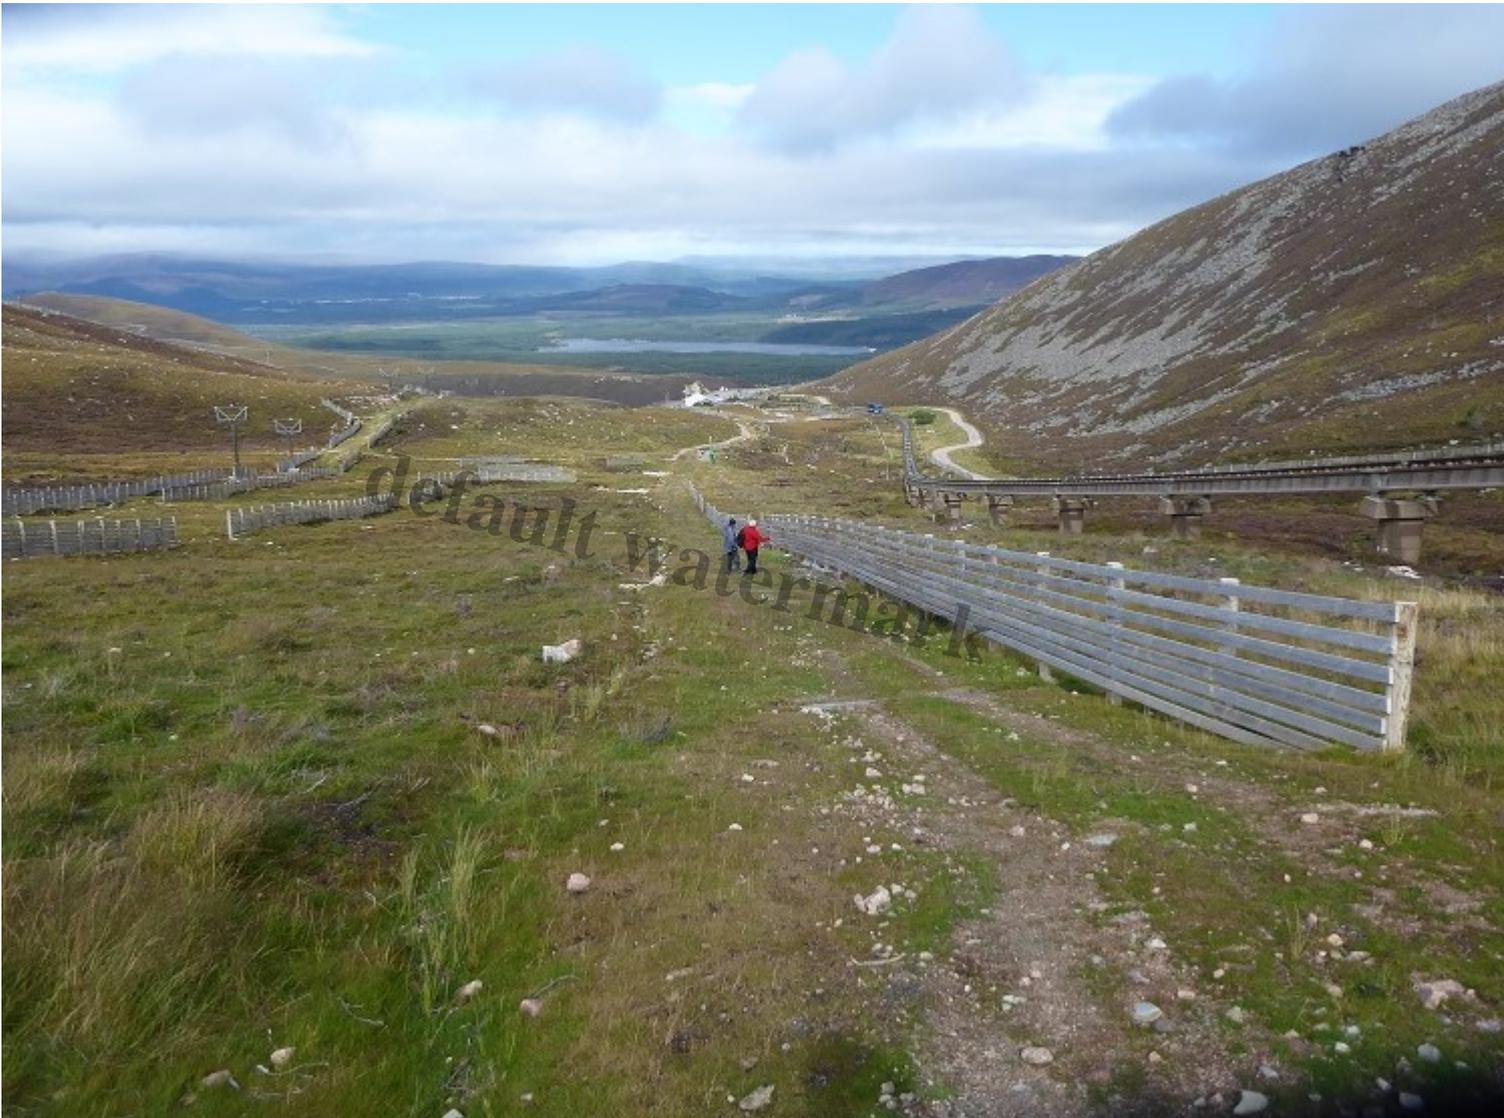
The shieling track, which had been created unlawfully and then granted retrospective planning permission by the Cairngorms National Park Authority ([see here](#)) looked far better than we had expected. The whole track surface, including wheel lanes, had been re-seeded which has helped to stabilise the ground and cross drains installed, as required by the CNPA. So, were conservationists wrong to oppose it? I don't think so. The reason why it looks this good is that it has not been used.. The question is what will happen if and when it does?

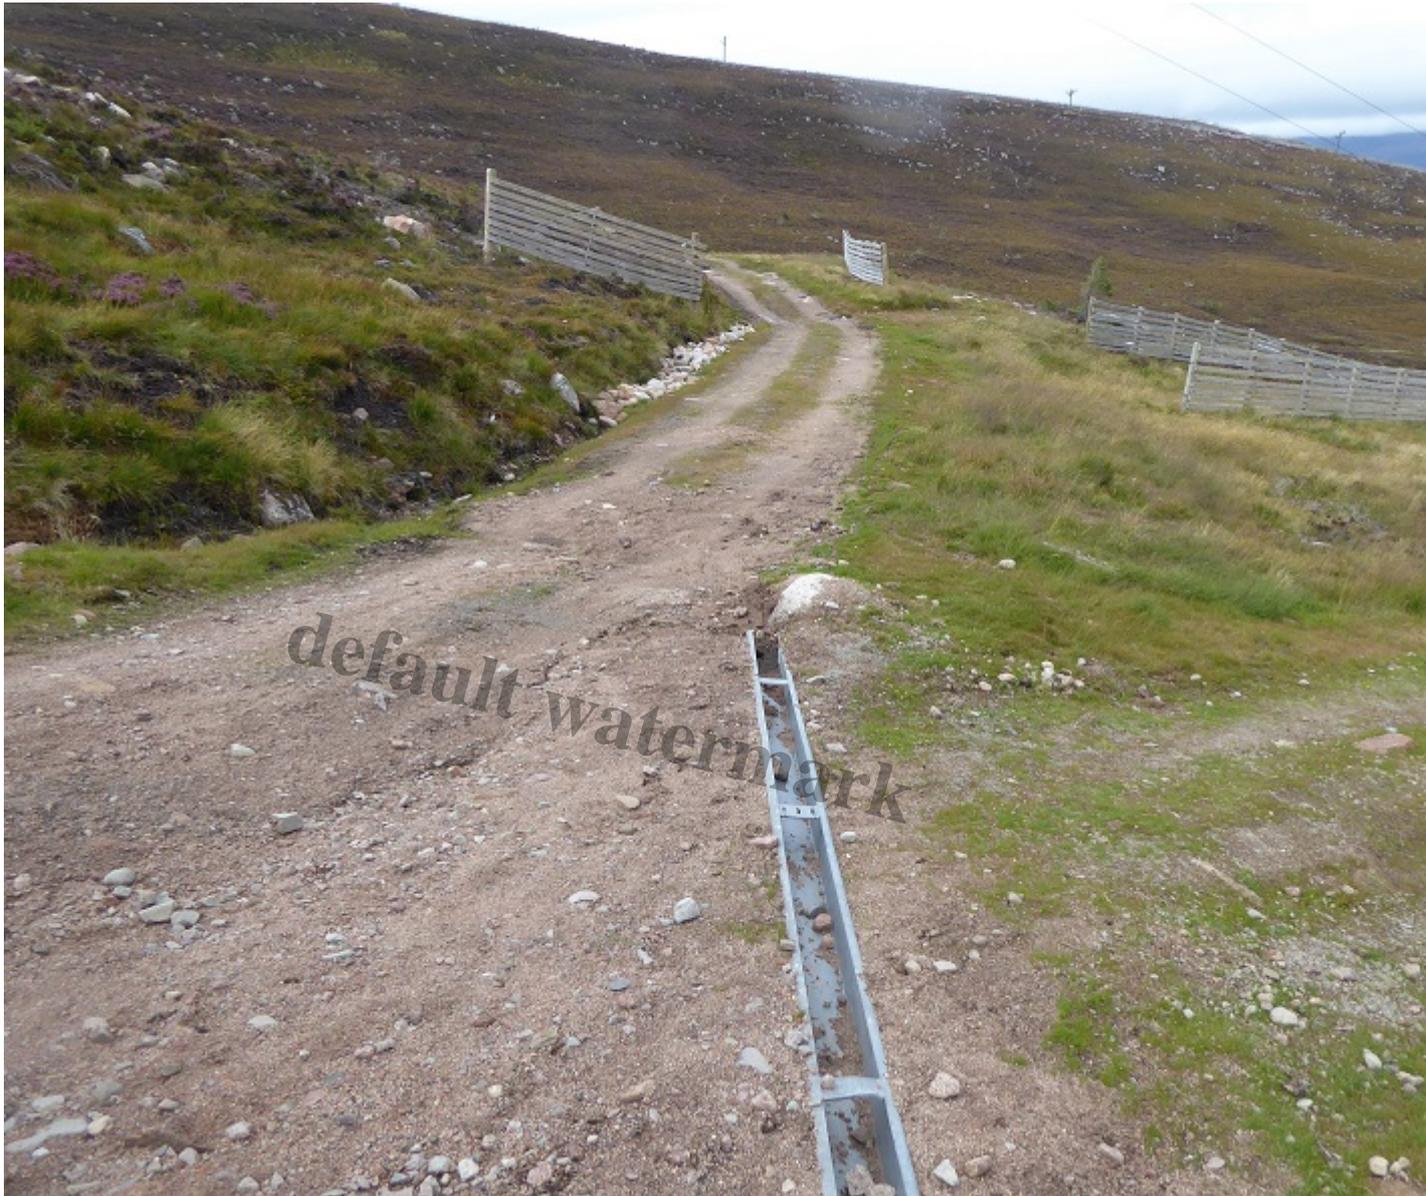
Poor track design. The cross drain empties onto the track beyond and while protecting the top of the track (right) will increase the erosion on the track to the former Fiacaill T-bar (left and which incidentally has never been granted planning permission). Note the rut developing at the end of the cross drain.

There is evidence for what will happen this from the top of the shieling track (the start of the track is to the right of the cross drain in the photo). As soon as vehicles use this ground the re-seeded grass is likely to wear away and the surface of the track erode, as on the left side of photo. Since the shieling track is significantly steeper, exceeding at the top SNH's maximum recommended inclination for hill tracks, the erosion is likely to be worse.

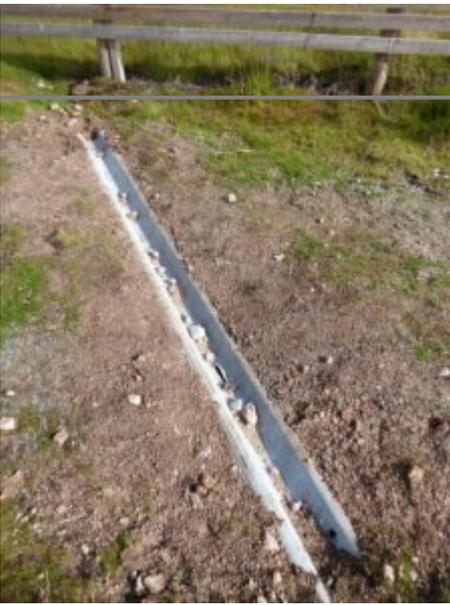
Cross drains have been installed along the Shieling track (left â?? a recycled Council road barrier is far cheaper than using natural materials) but the re-seeding has not stopped some sediment and stones being washed into them, a sign of continuing erosion.

its not used. Perhaps the CNPA should have followed the advice of the North East Mountain Trust who suggested heather should have been re-established across the entire shieling slope and that the uptrack under the rope tow could have been used for occasional vehicle use?

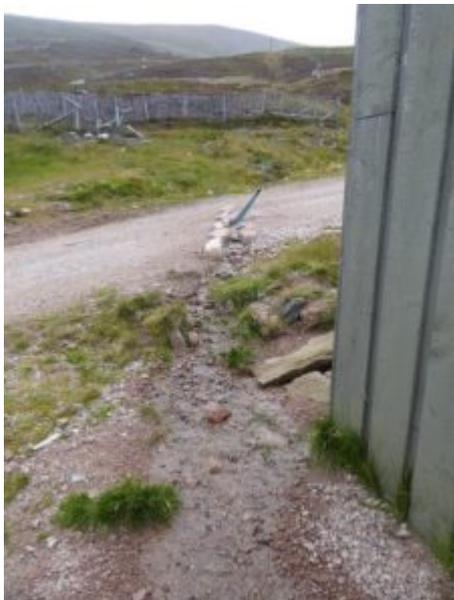
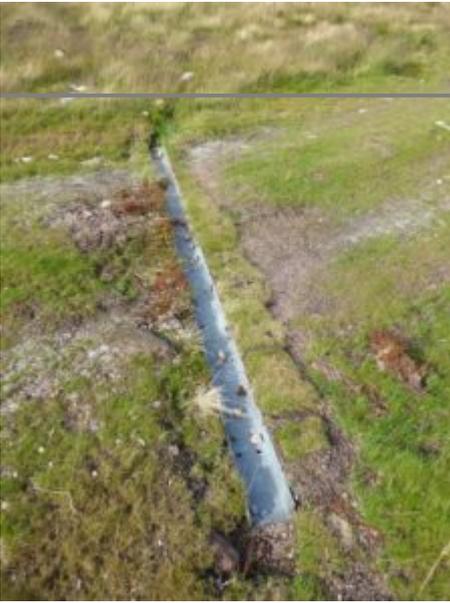
We did see one example of a cross drain where a significant amount of

care had been taken (left). The turfs should help hold back and filter sediments. By contrast, above, was an example of Natural Retreats's incompetence (right). Water channelled against the wooden sides of the pump house building! Rotten to the core!

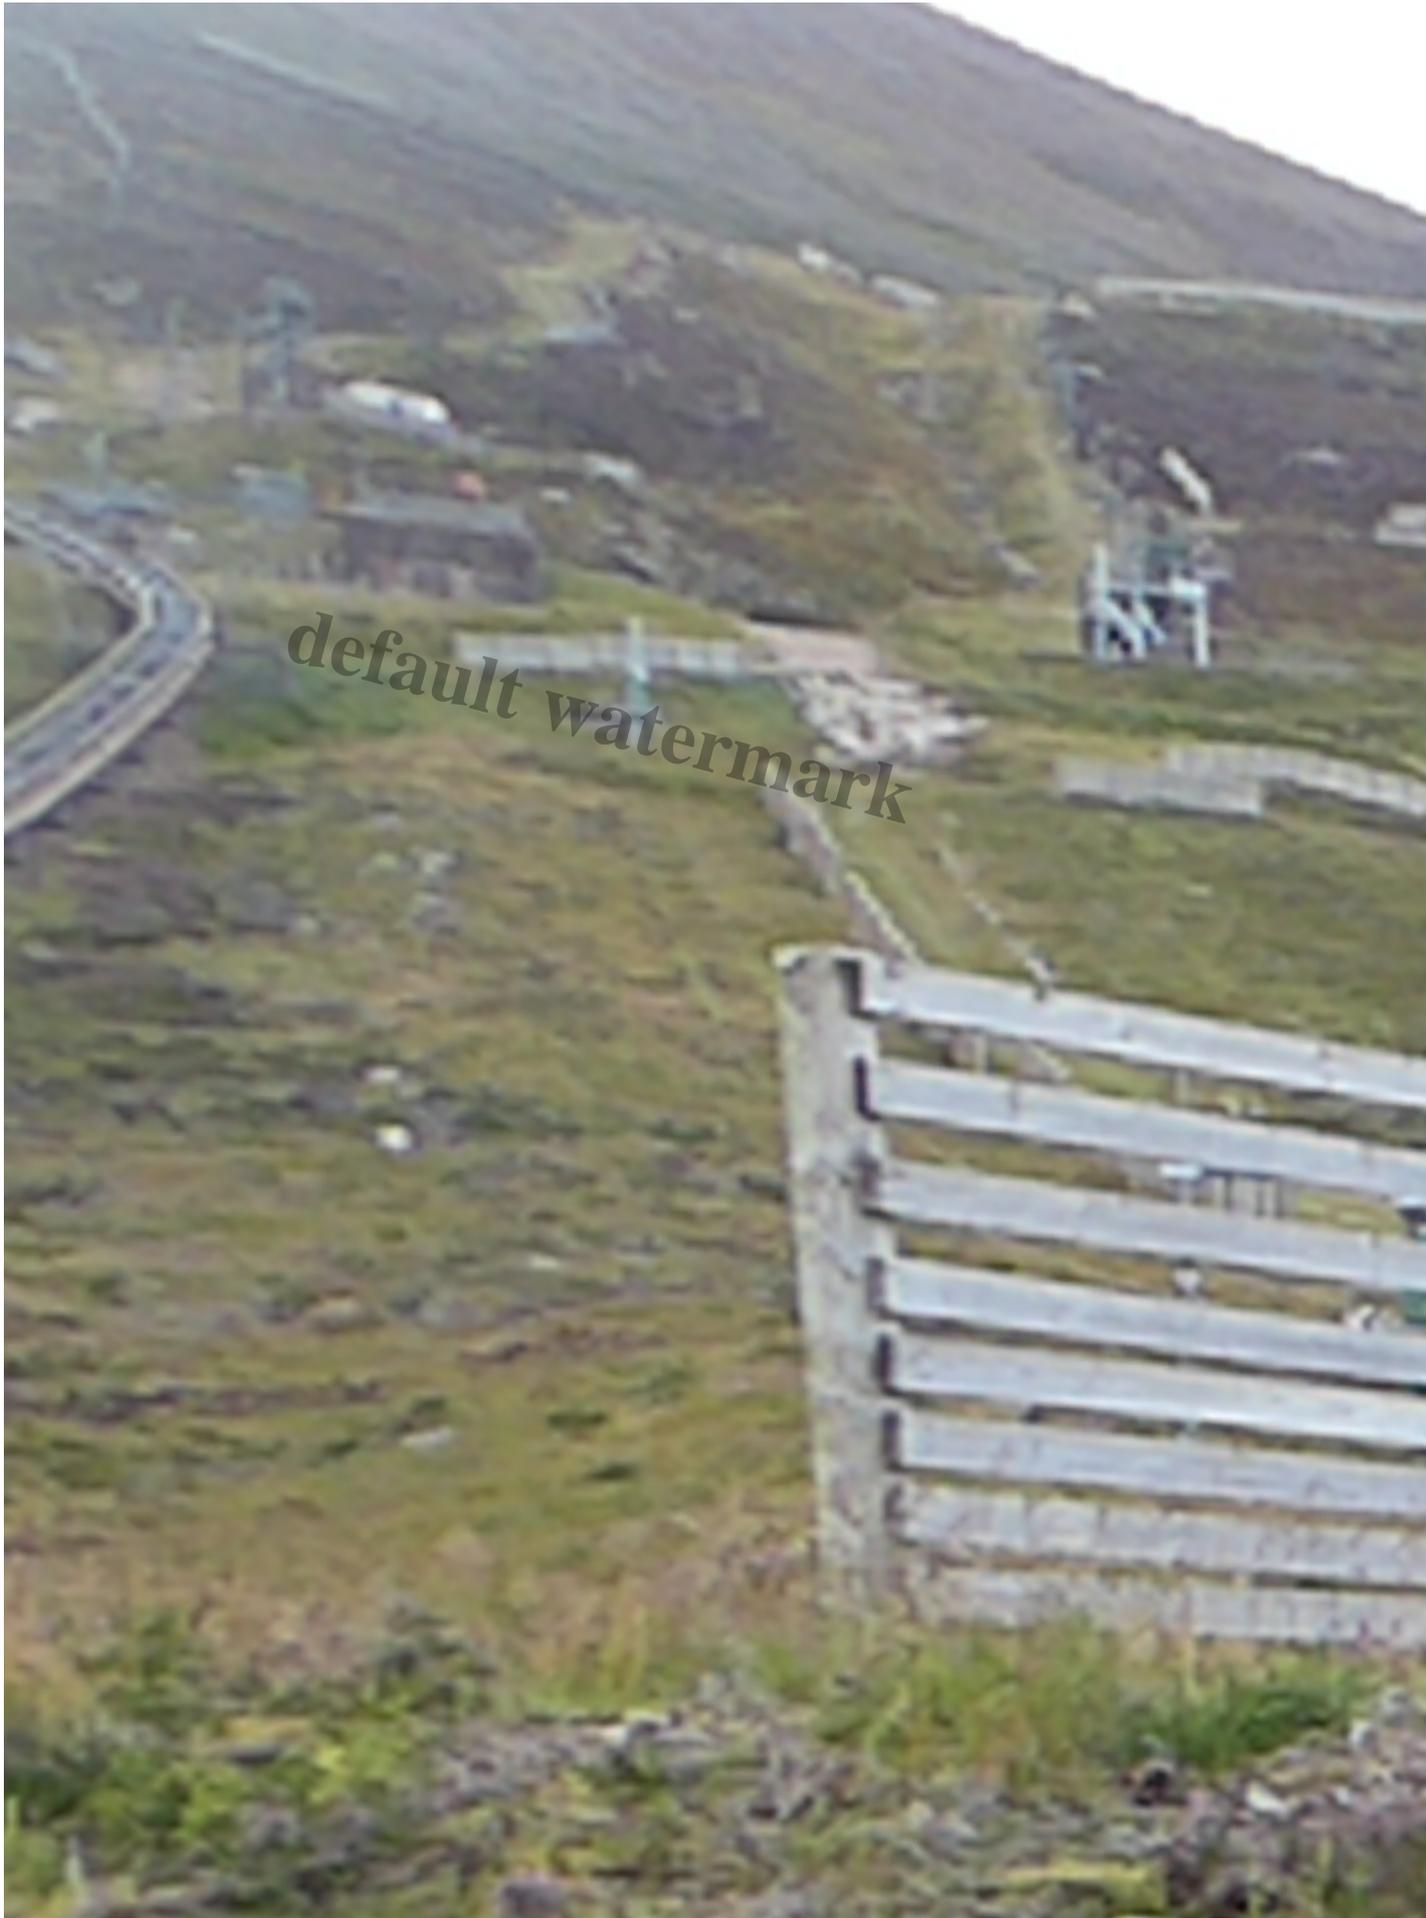
The area below the shieling rope tow outwith the area granted planning permission by the CNPA. The

The photo demonstrates the large area affected by the shieling works and where vegetation and turves were not retained prior to re-instatement, hence all the re-seeding (the green in the photo). While heather should re-colonise this area in time we will need to wait to see other longer term impacts, such as whether invasive species colonise some of the ground. The picture will be complicated because the CNPA required compensatory tree planting as a condition of the retrospective planning permission, although this had not started at the time of our visit and there is no mention of this on Cairngorm Mountain's "Behind the Scenes" blog (Autumn is a good time for planting).

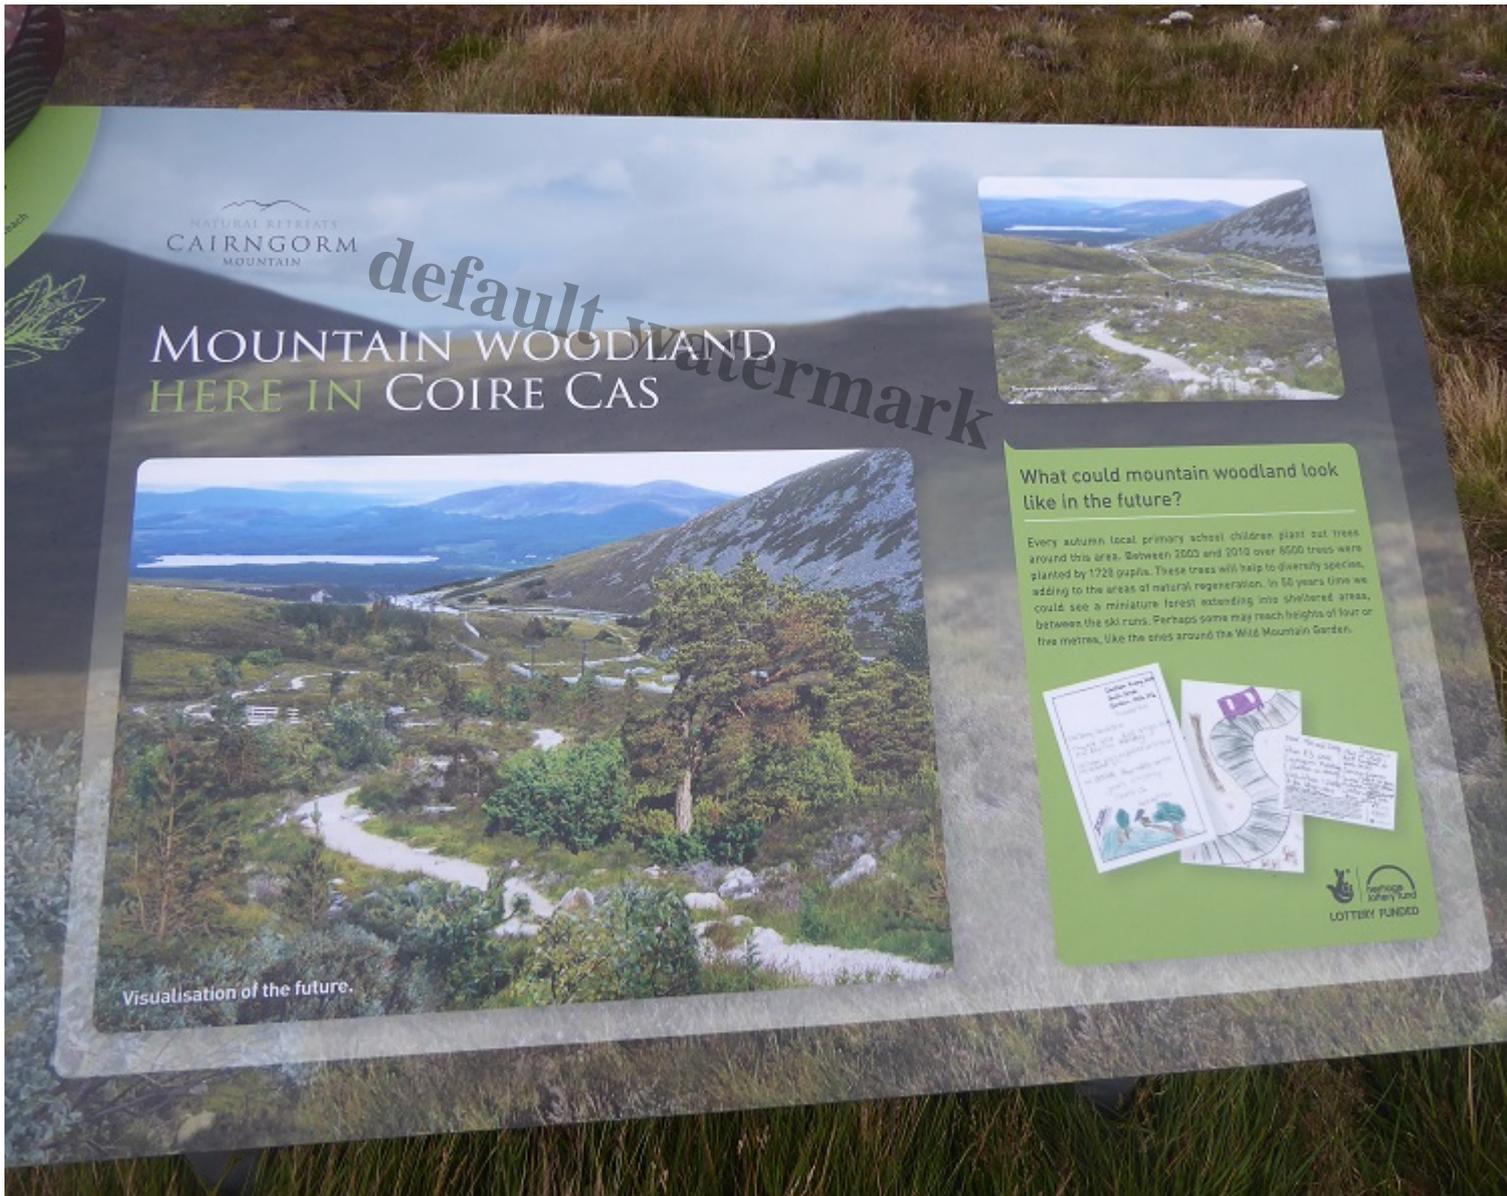
What was pleasing to see was the interpretation boards, which had fallen into utter disrepair, had been replaced. I suspect this was organised by the Ranger Service and perhaps by Nic Bullivant before he departed as head ranger. It appears this was funded by the lottery not Natural Retreats who appear to have no interest in this visualisation of the future. I believe this vision should be at the centre of an alternative plan for Cairngorm (with trees rather than snow fences collecting the snow). Unfortunately a number of trees were killed in the unlawful works that took place in Coire Cas and one reason there are

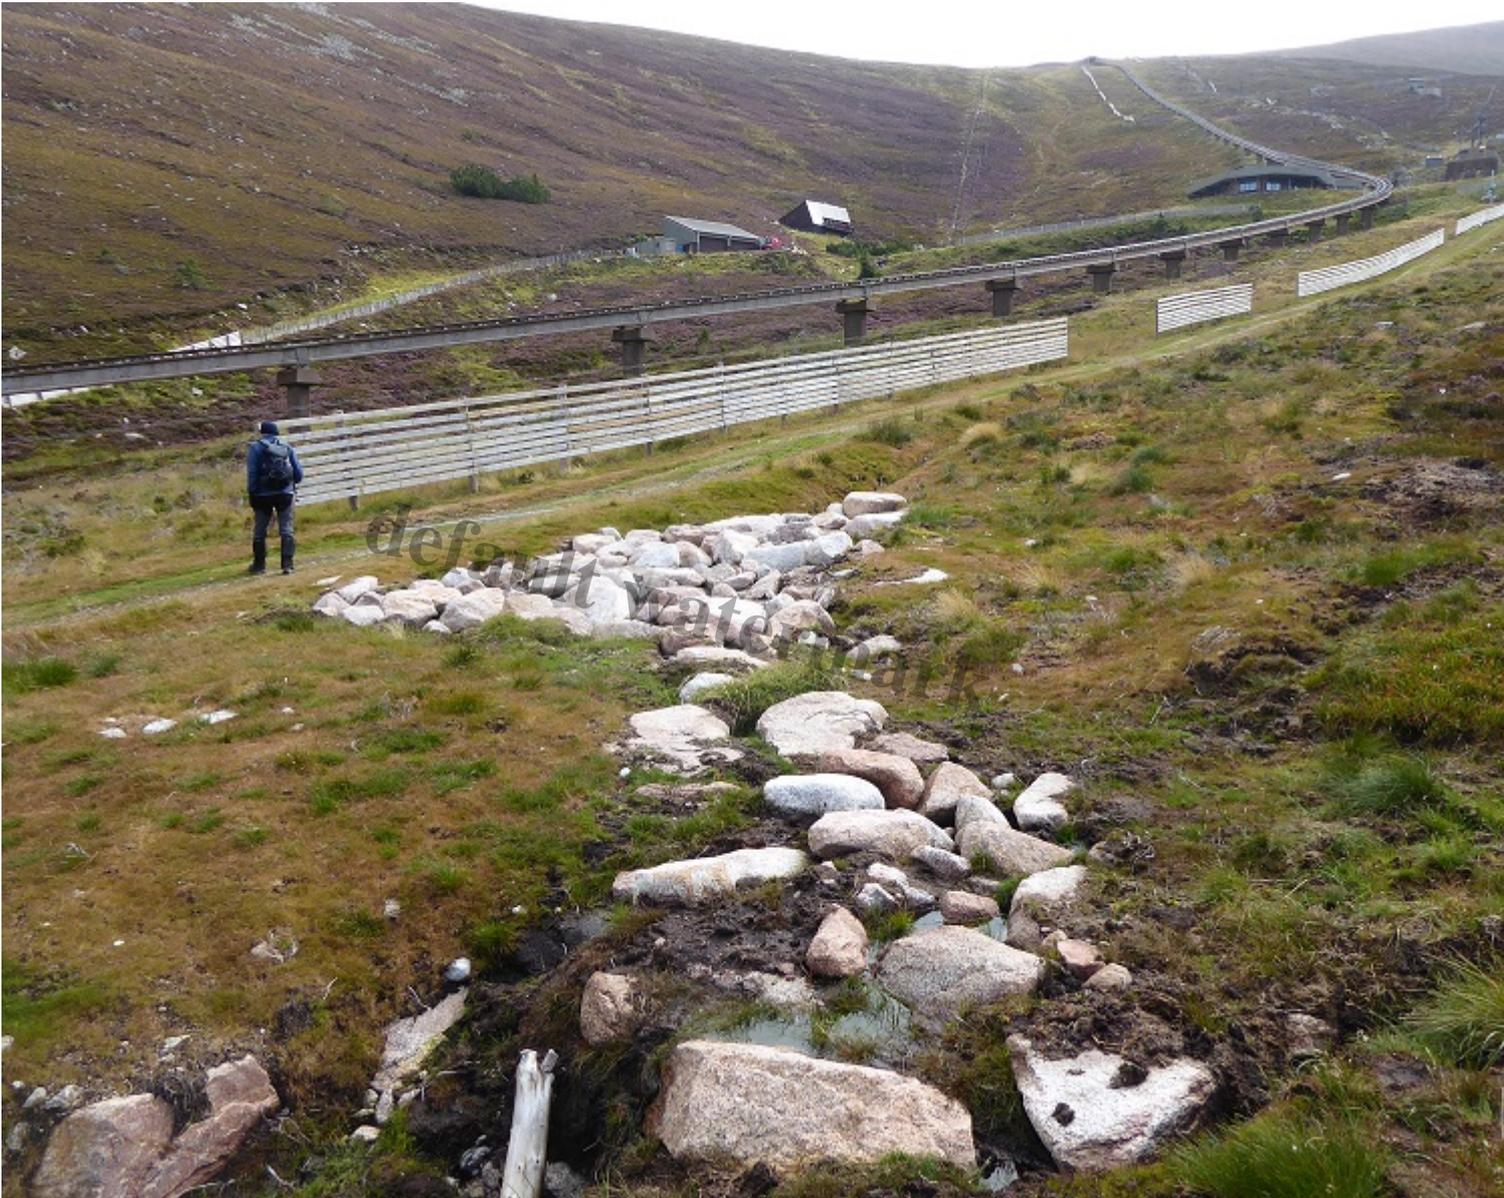
My biggest concern on the day was landscaping. The area with boulders is outwith that granted planning permission but has been subject to extensive engineering works and new drainage. It looks totally out of place and there has been no attempt to restore the slope to how it previously looked.

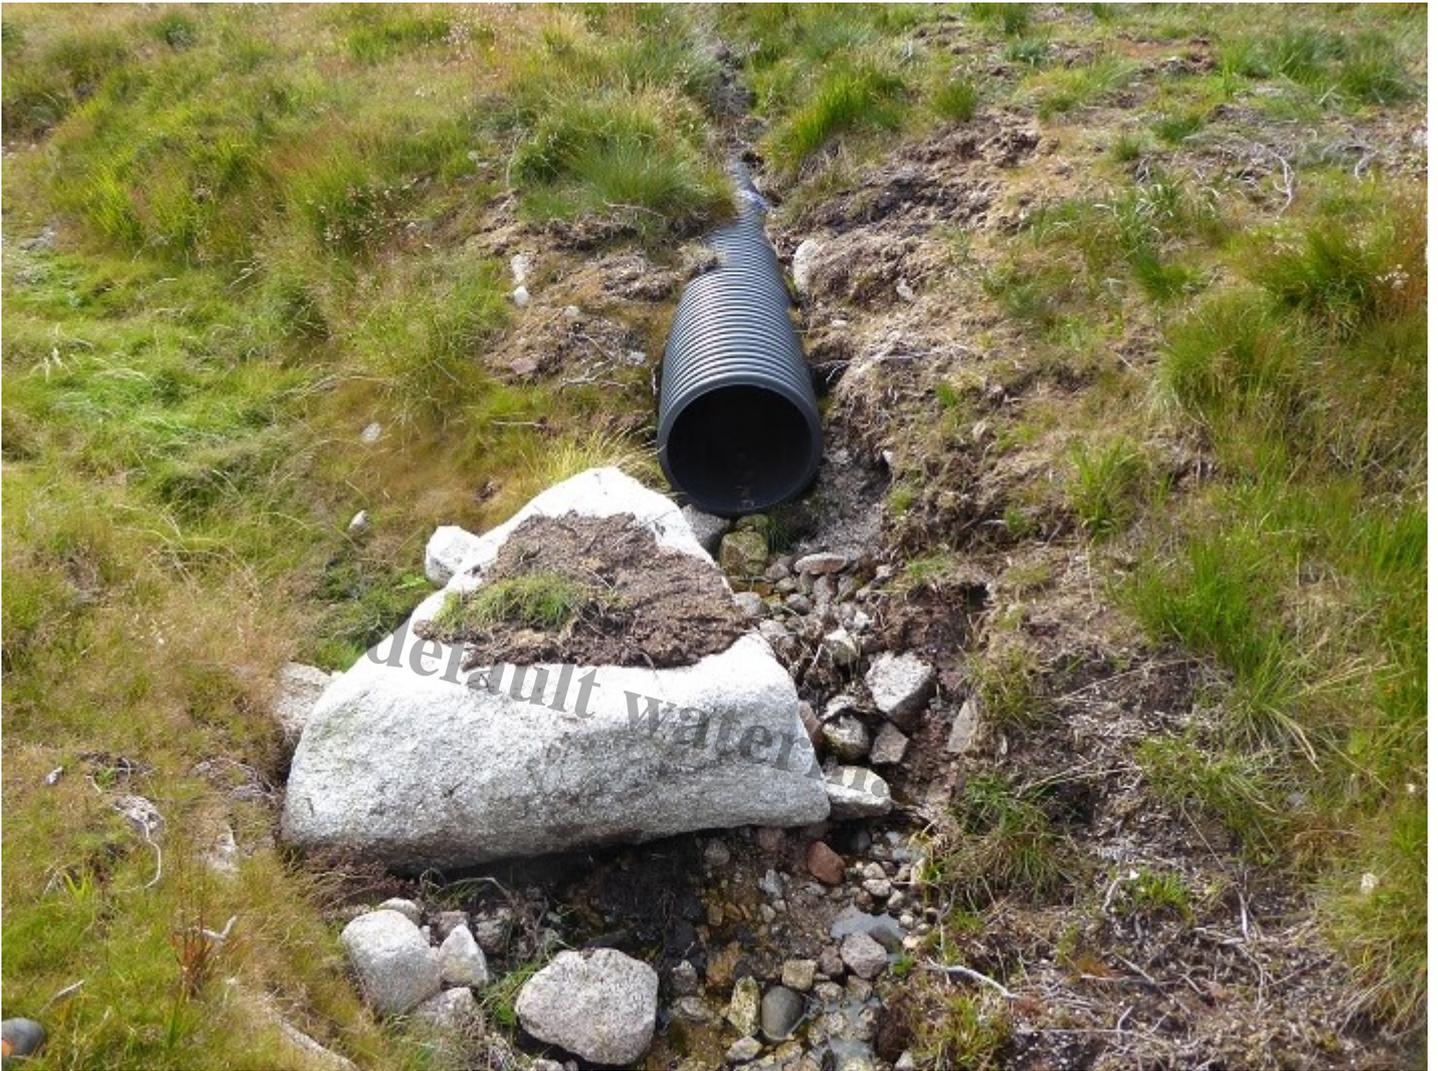
While culverts along the burn at the bottom of the shieling slope â?? which required permission from the Scottish Environment Protection Agency â?? have been finished well, other culverts which did have permission from SEPA, are right eyesores.

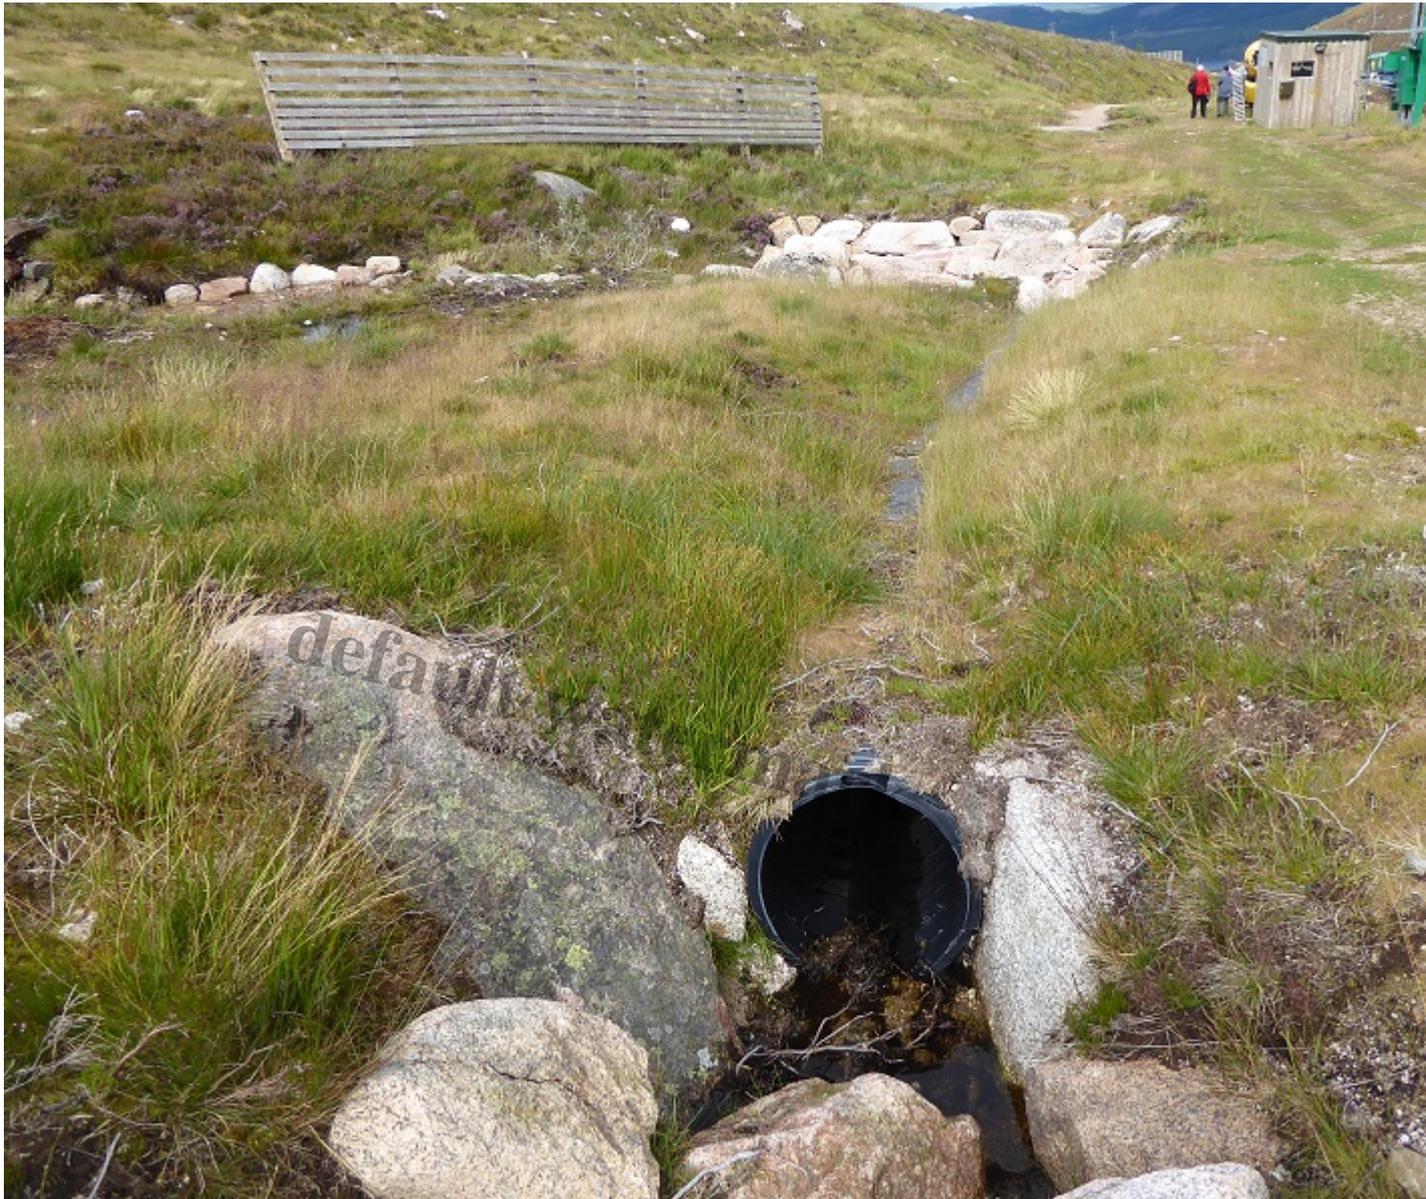
Natural Retreats did not retain enough soil/peat to replace vegetation on top of culvert, required to erode to cross over to the bottom of the new rope tow.

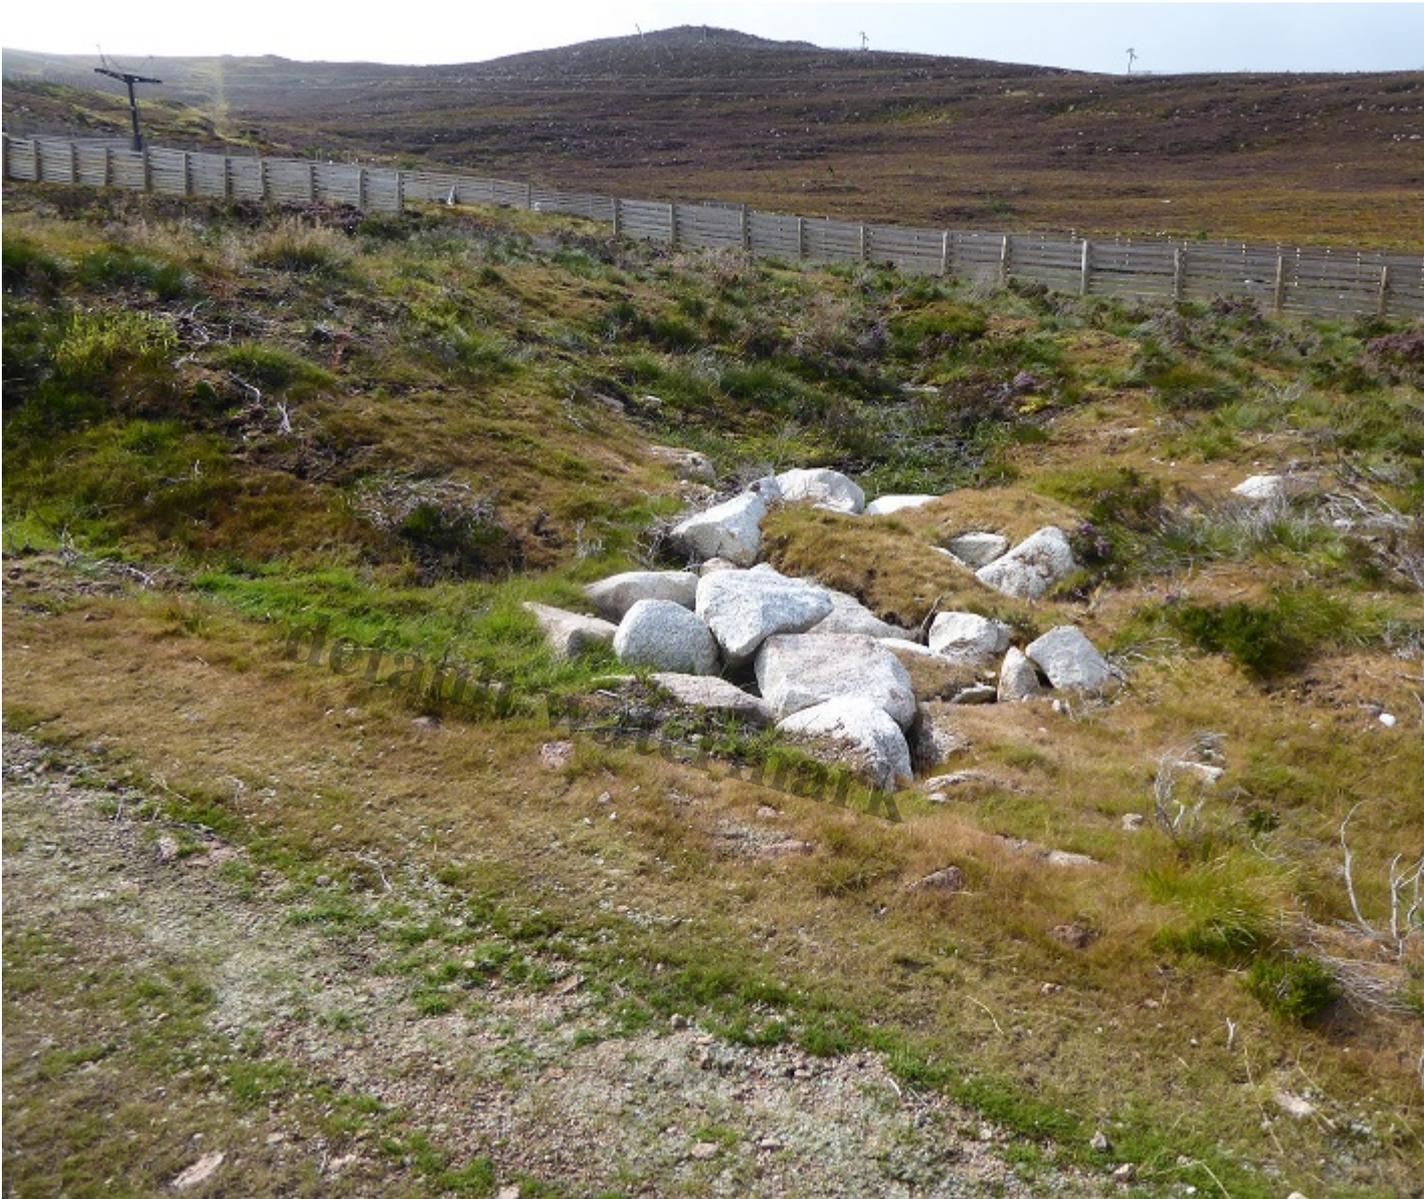
Natural Retreats has made half an attempt to conceal these boulders by the Shieling track

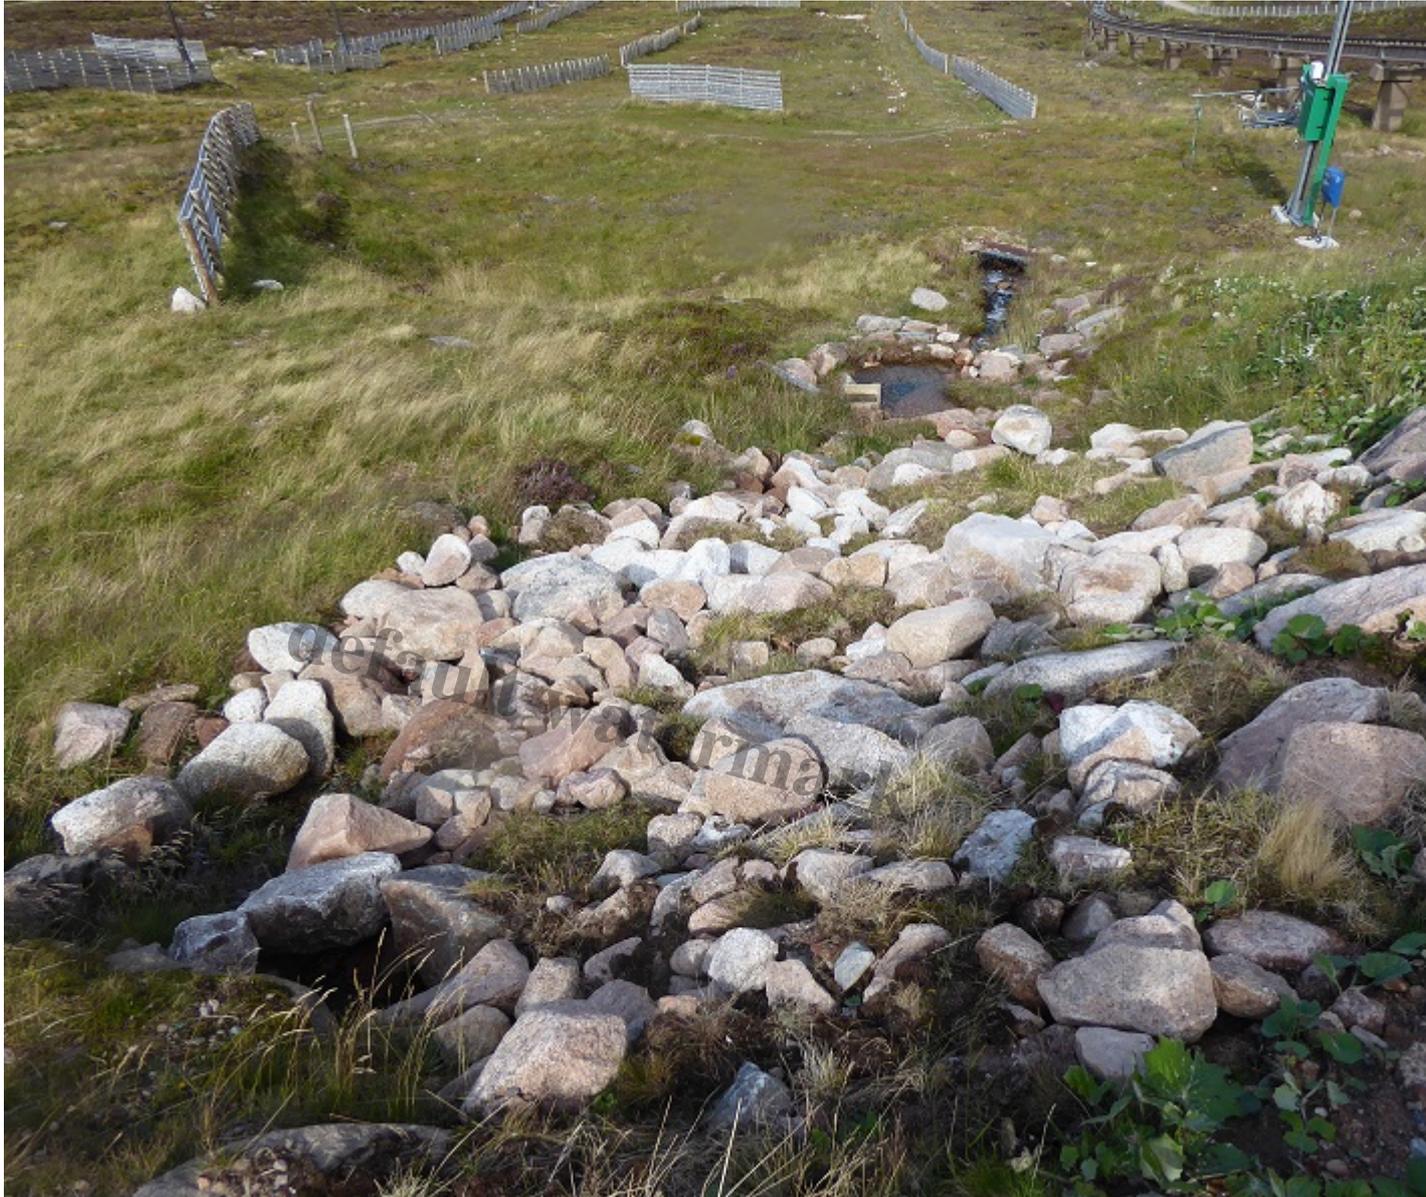
Above the shieling rope tow the boulder dumps are more visible from a distance

The shieling rope tow and surrounds was subject to planning permission from the Cairngorms National Park Authority and they therefore continue to have some influence (legally) on the restoration of this area. The three things I think they need to focus on are: restoration of vegetation, landscaping and the ecological impact of the changed drainage in the area.
