## Coire Cas report card â?? the HIE/Natural Retreats restoration and clear-up

## The restoration of the shieling track

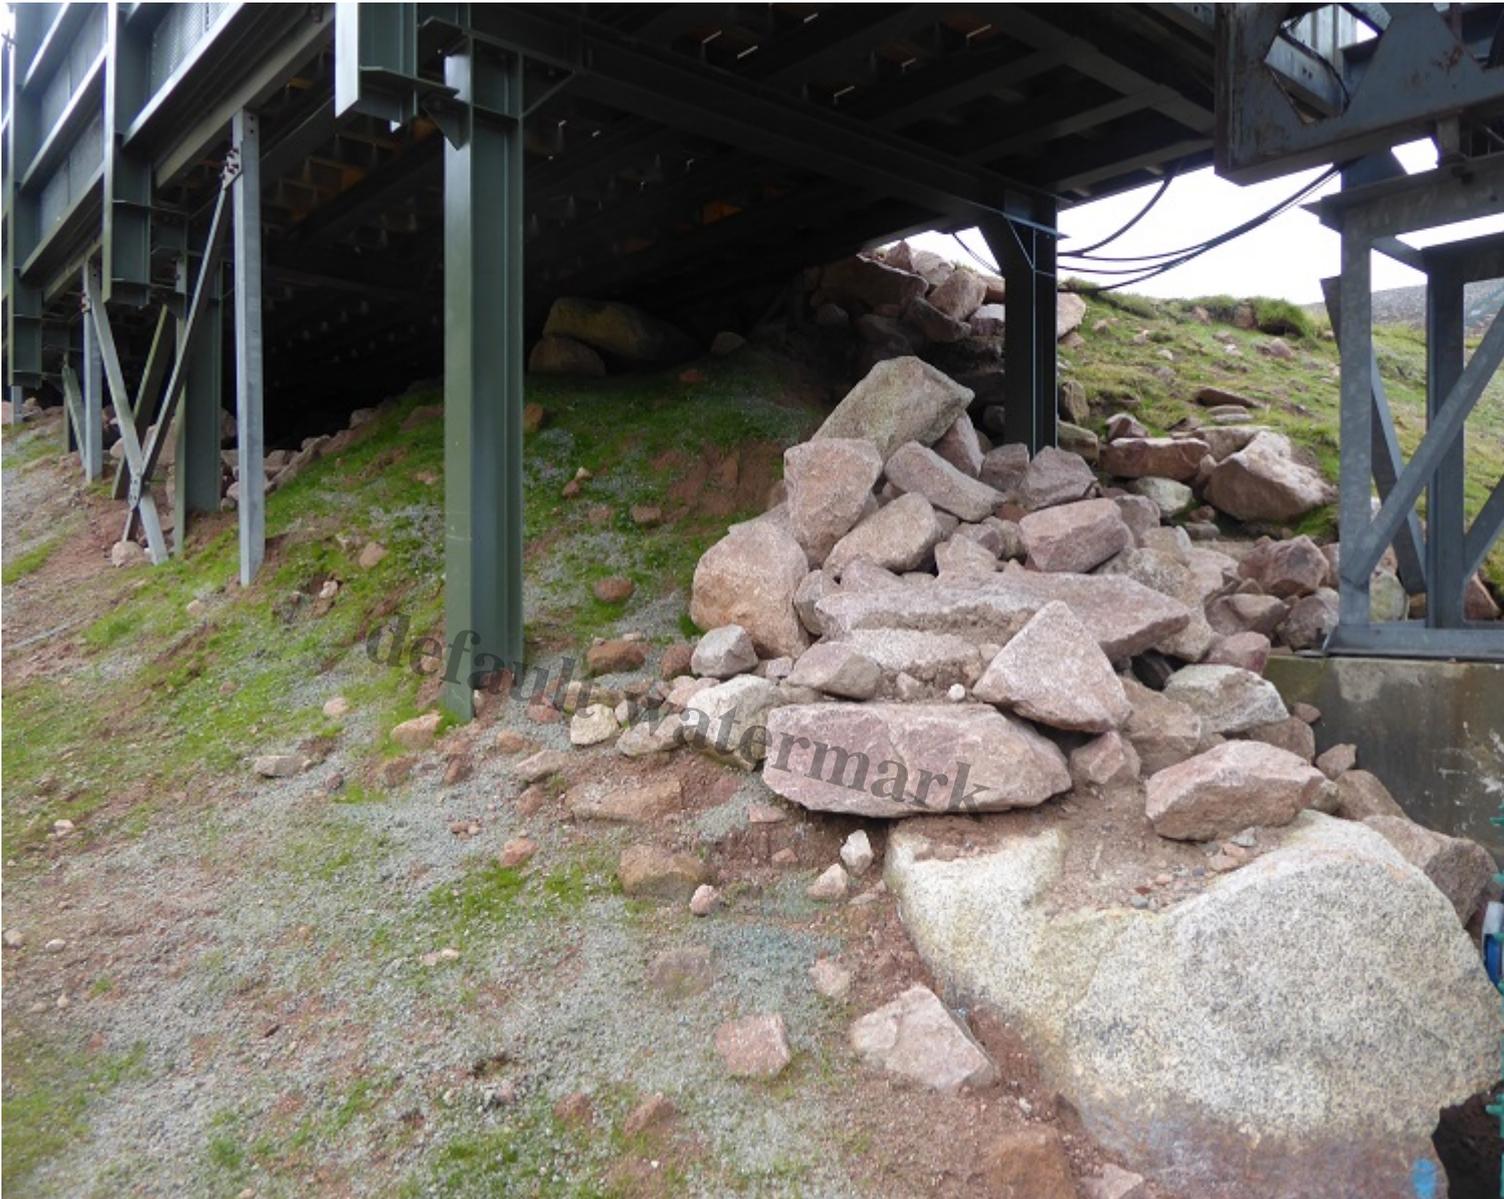
Some, but not all the boulders which were shoved under the gantry as a result of piste widening works (no planning permission) have been restored.

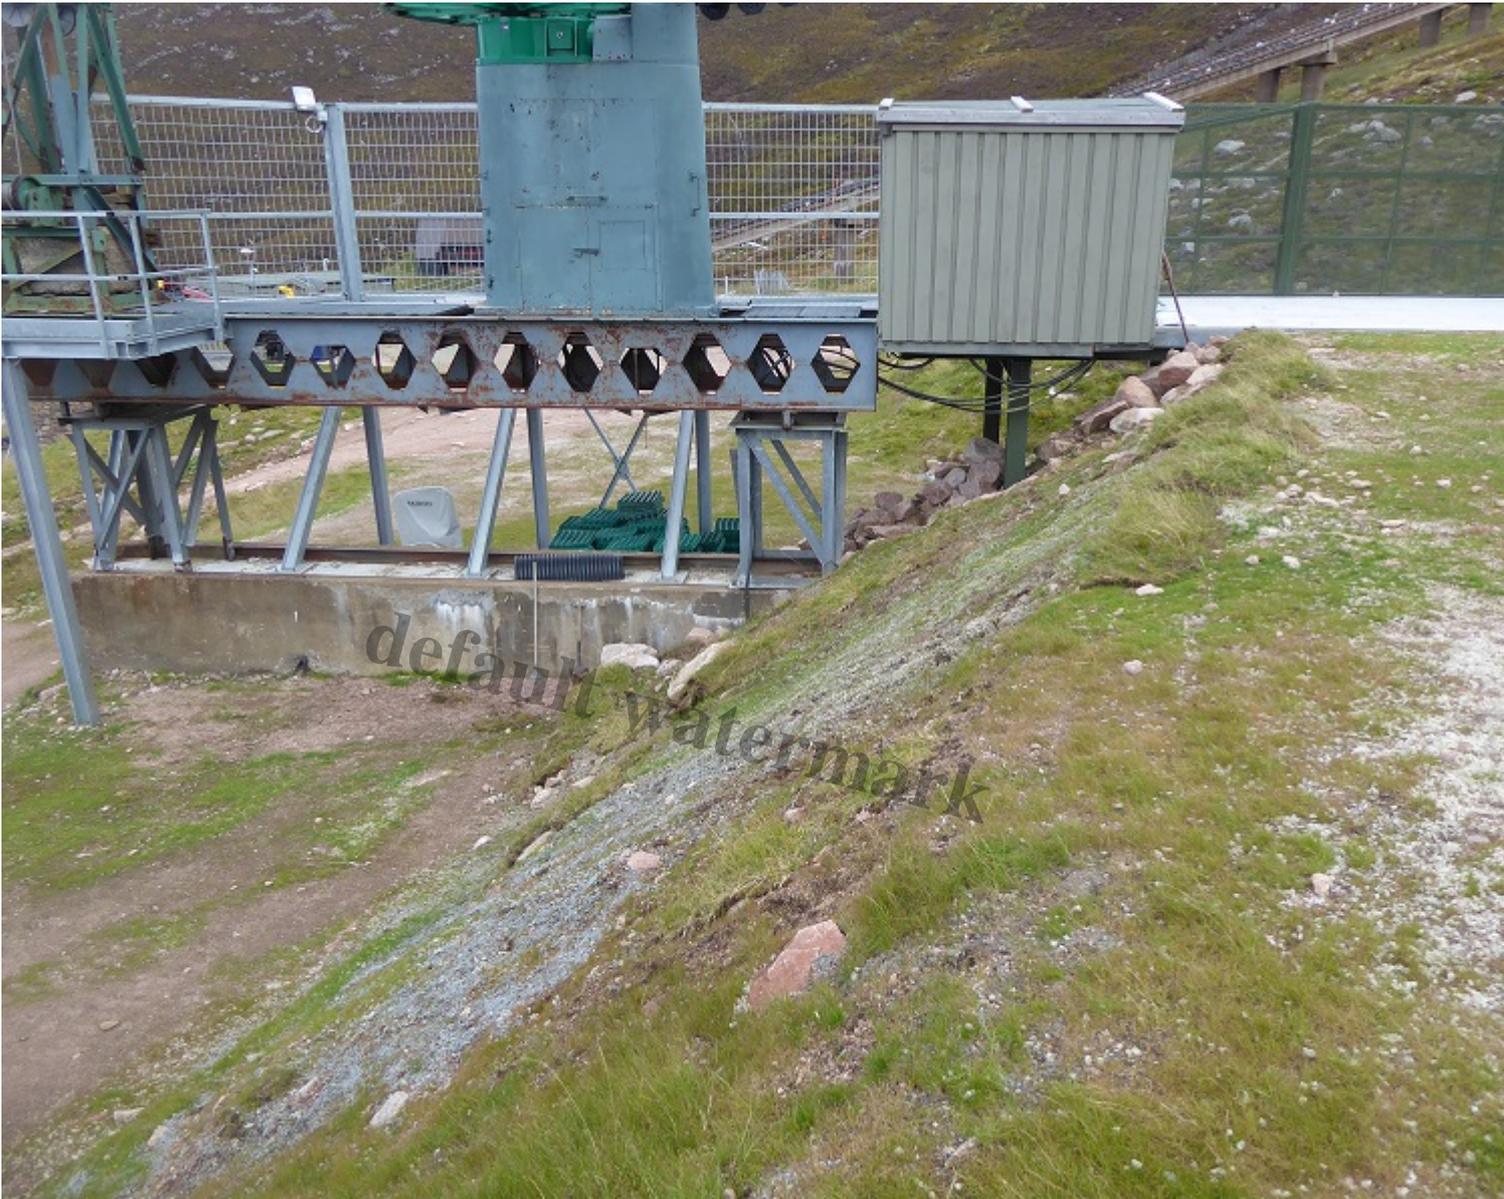
Turf has been placed along top of the slope which Natural Retreats excavated in order to try and prevent water flooding down it. The basic issue is the slope is too steep and no vegetation/turf was retained for restoration purposes. The bluish re-seeding pellets (left foreground) continue to get washed out and the risk is this slope will again be subject to severe erosion this winter.

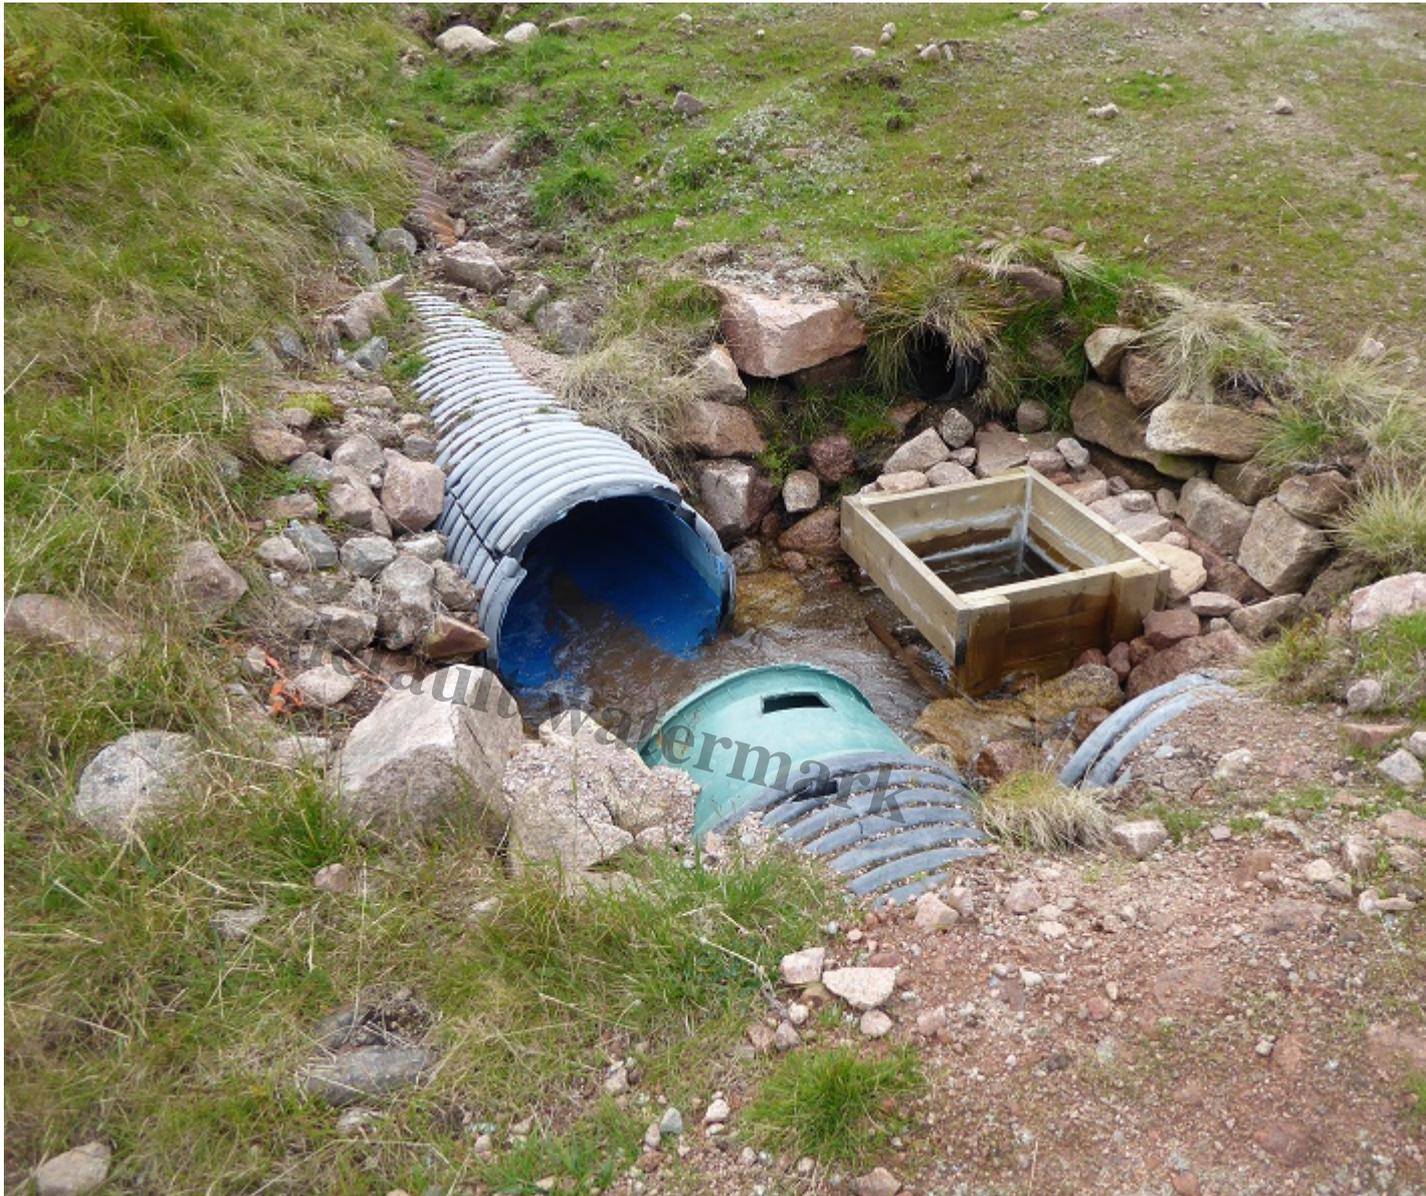
Culvert pipe chopped? to create pool to provide water for snow making machines. I understand the v on the right helps sediment in the water to settle out and prevents the snow making machines becoming with silt.

The finishing of the culverts is very poor.

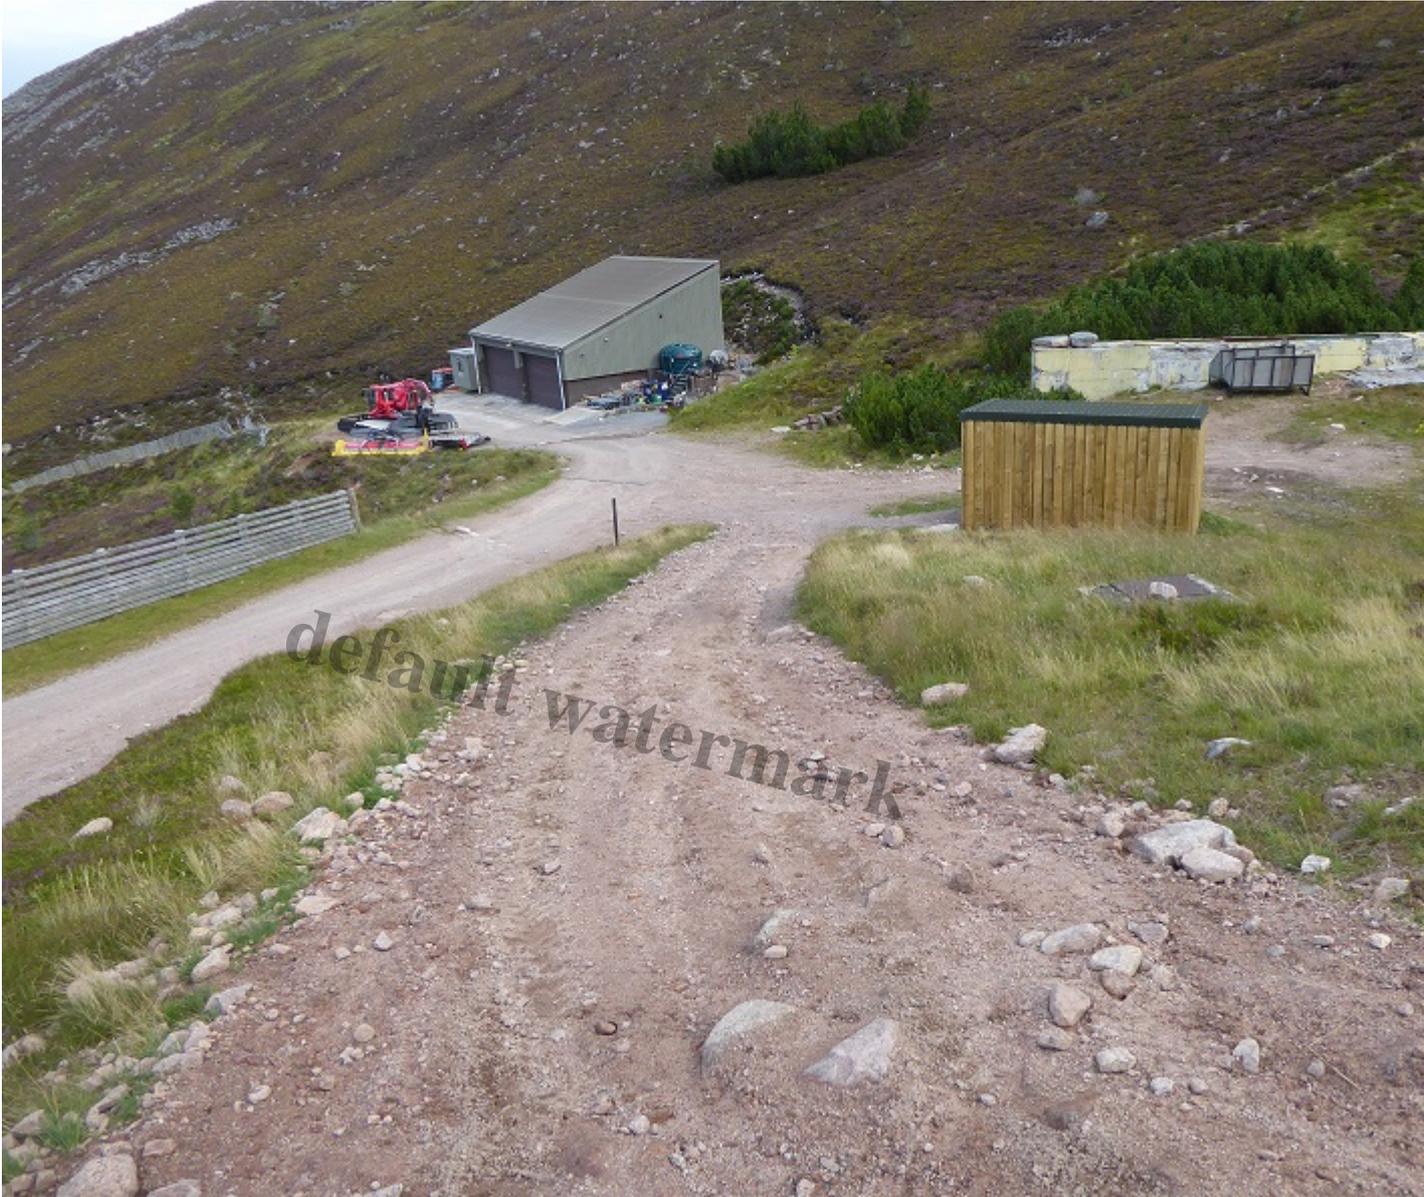
View down the track from former shieling restaurant to recently renewed former Lifties hut.

Worst of all though is the uncontrolled use of vehicles. The track above never used to be there, has been created through vehicle use, is far too steep and is eroding badly. It has never been granted Planning Permission. Forest Enterprise Scotland provides Prior Notification for new tracks as short as 40m to Planning Authorities so HIE has no excuse for this.

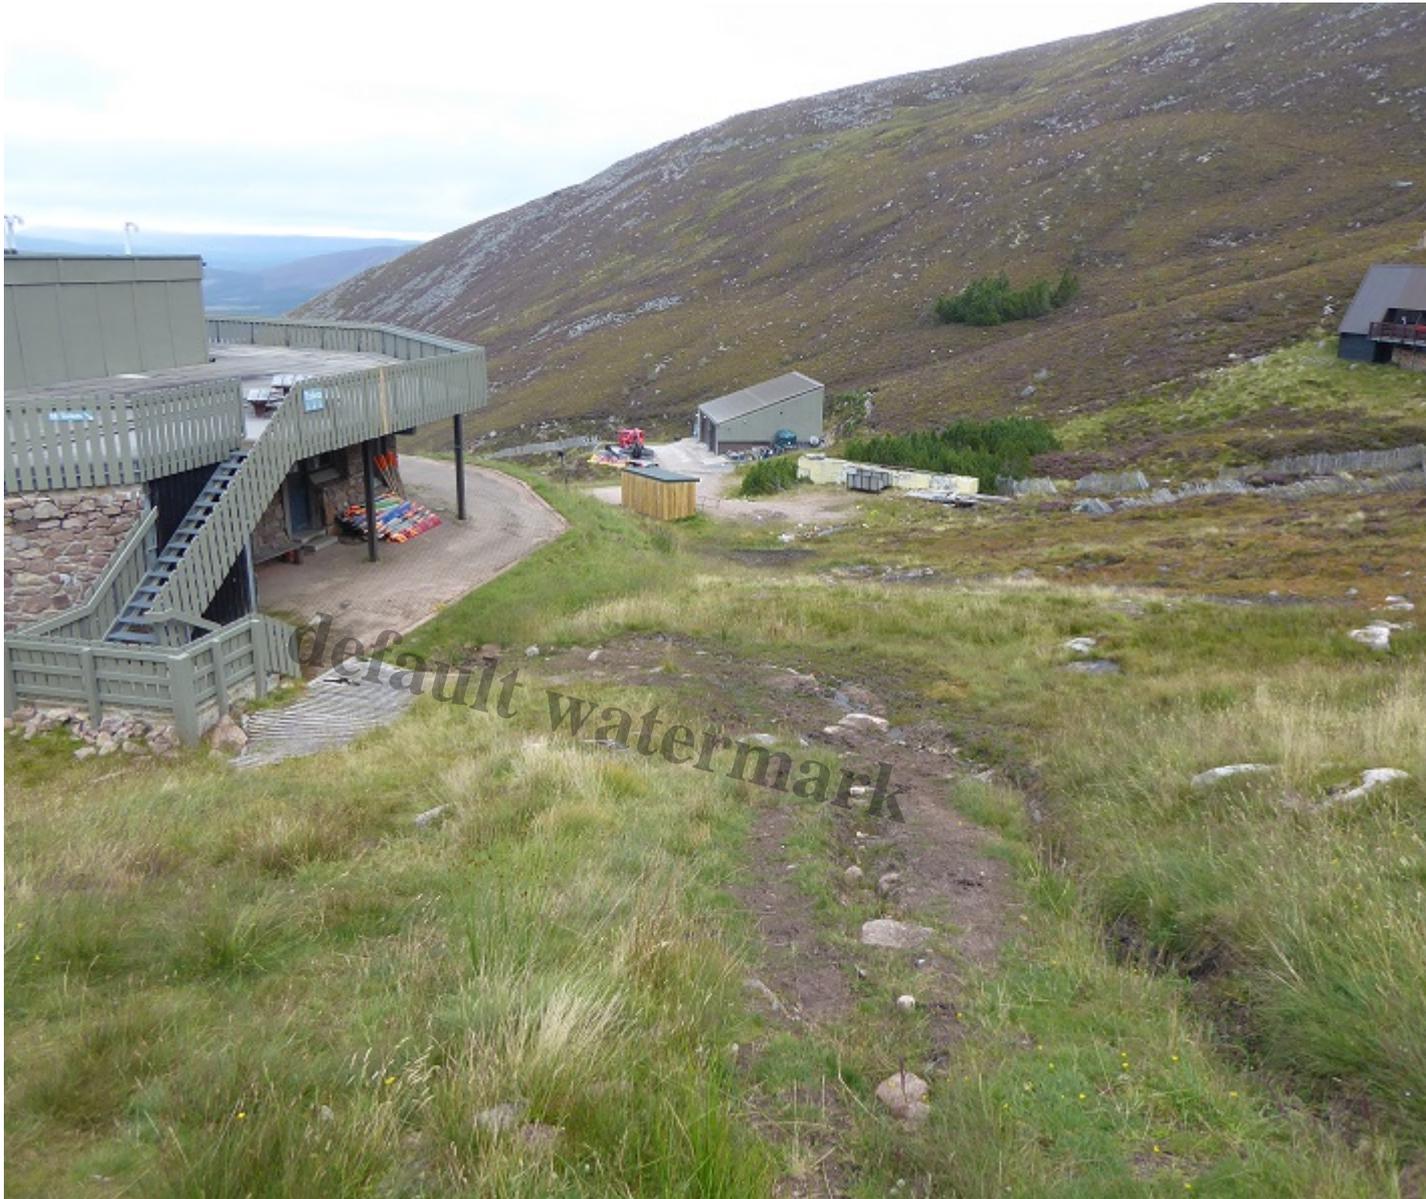
ATV tracks by the former shieling restaurant – there is a second track on the right running parallel to the centre.

Off track use of vehicles at Cairngorm used to be strictly controlled but is now seen as unnecessary bureaucracy.
