## The CNPA takes action at Drumochter – is it enough?

The second “Drumochter” item considered by the December meeting of the Planning Committee was an update report on SSE’s restoration of the Beauly Denny [Item10AABeaulyDennyUpdate](#).

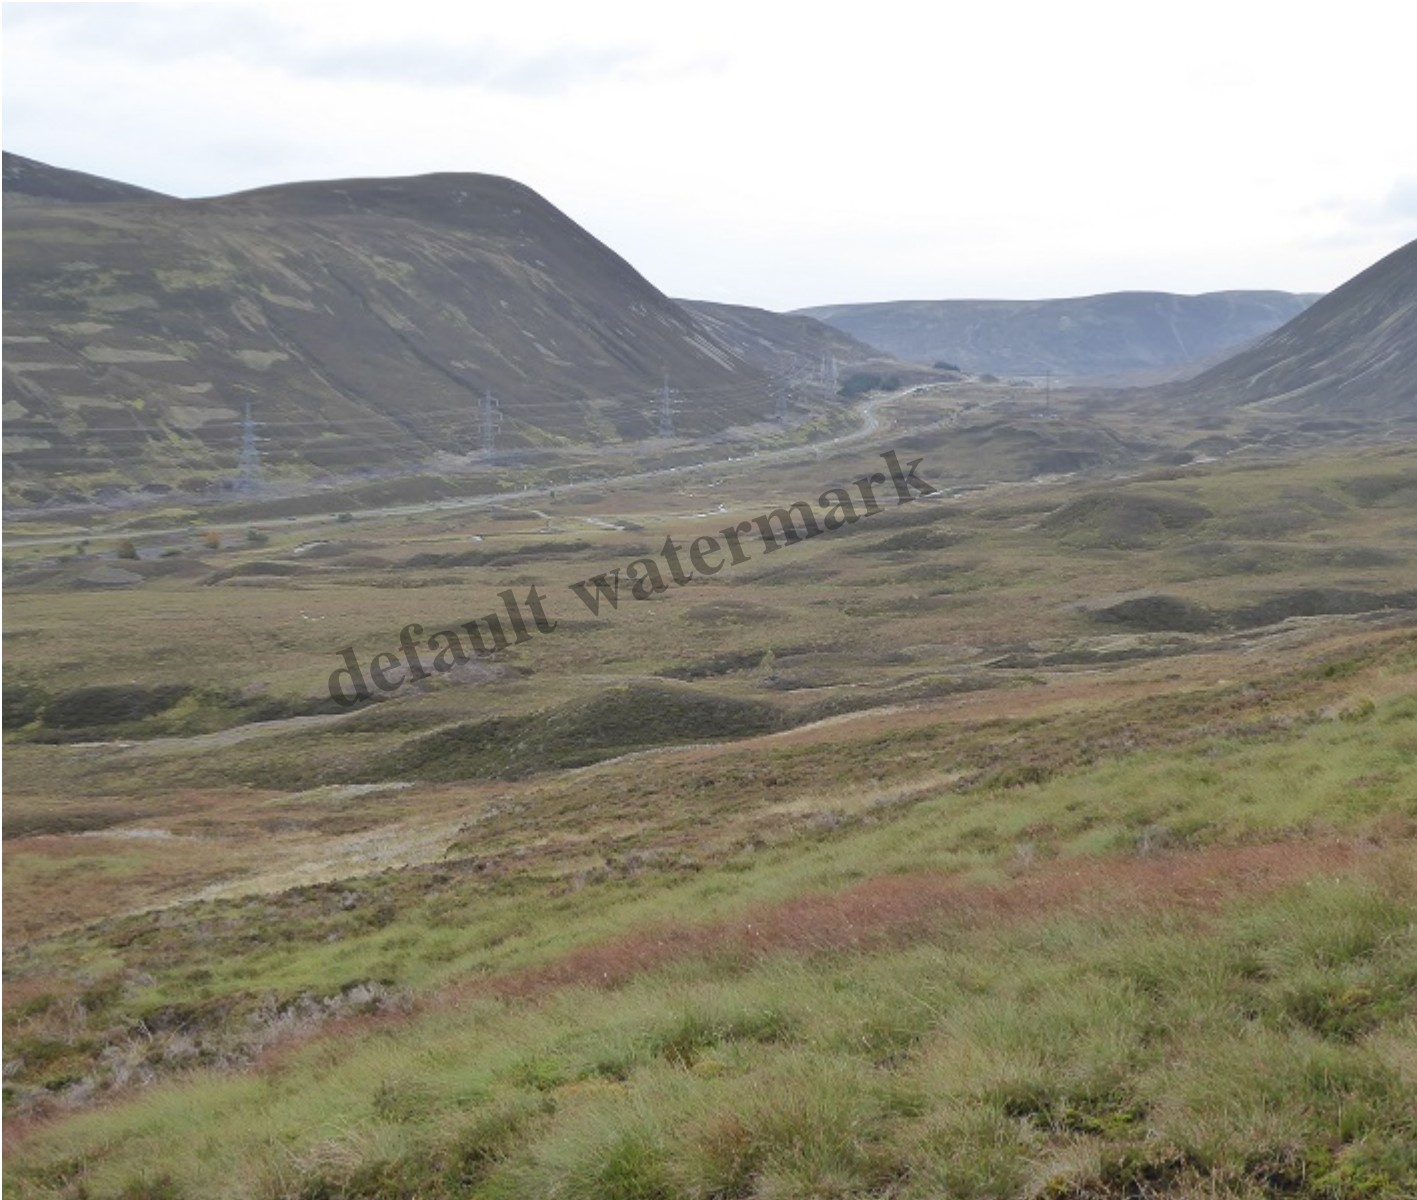
The Drumochter, a fine landscape forming a gateway between north and south, marred by development. A line of the “restored” Beaulieu Denny construction track is marked by the scar behind the pylons

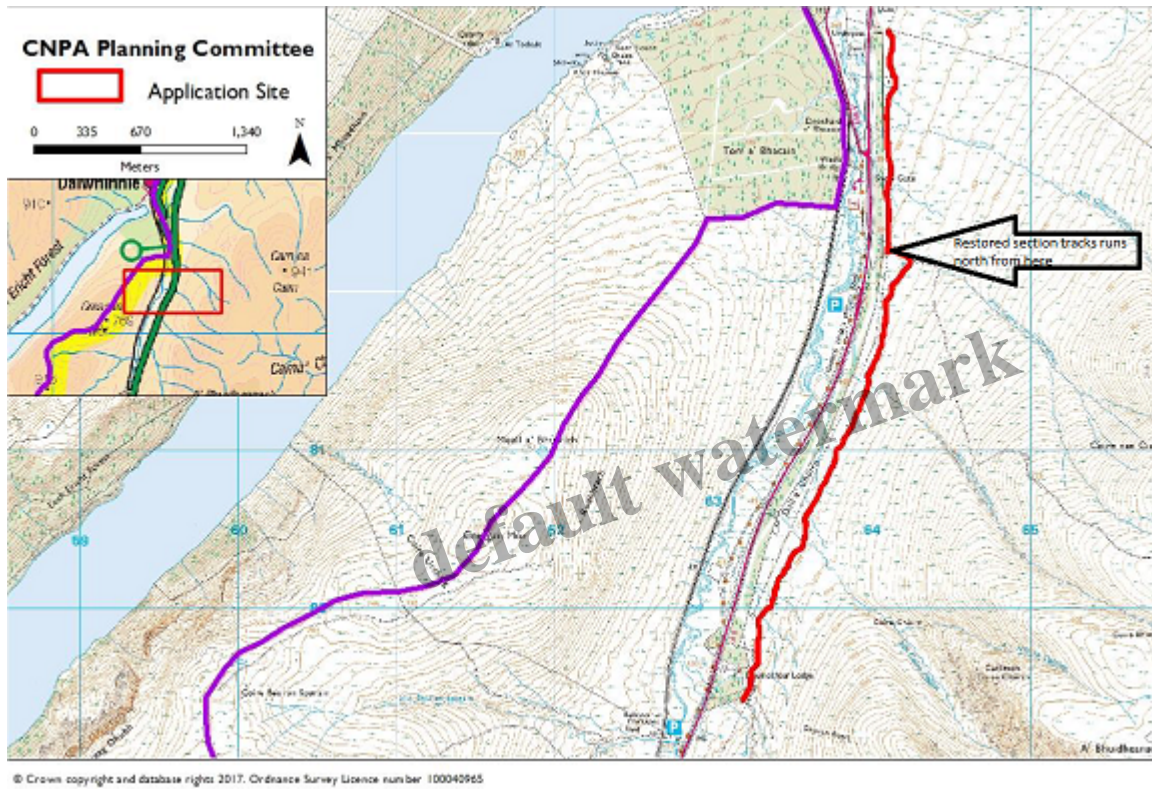
CNPA gave consent to the North Drumochter Estate to retain a section of the Beaully Denny construction track outwith the Drumochter Hills Special Area of Conservation and Special Protection Area (above in red) on the condition that the track was narrowed and a belt of native trees was planted alongside it. The restoration, with the exception of the shelter belt was due to be completed by June 2016.

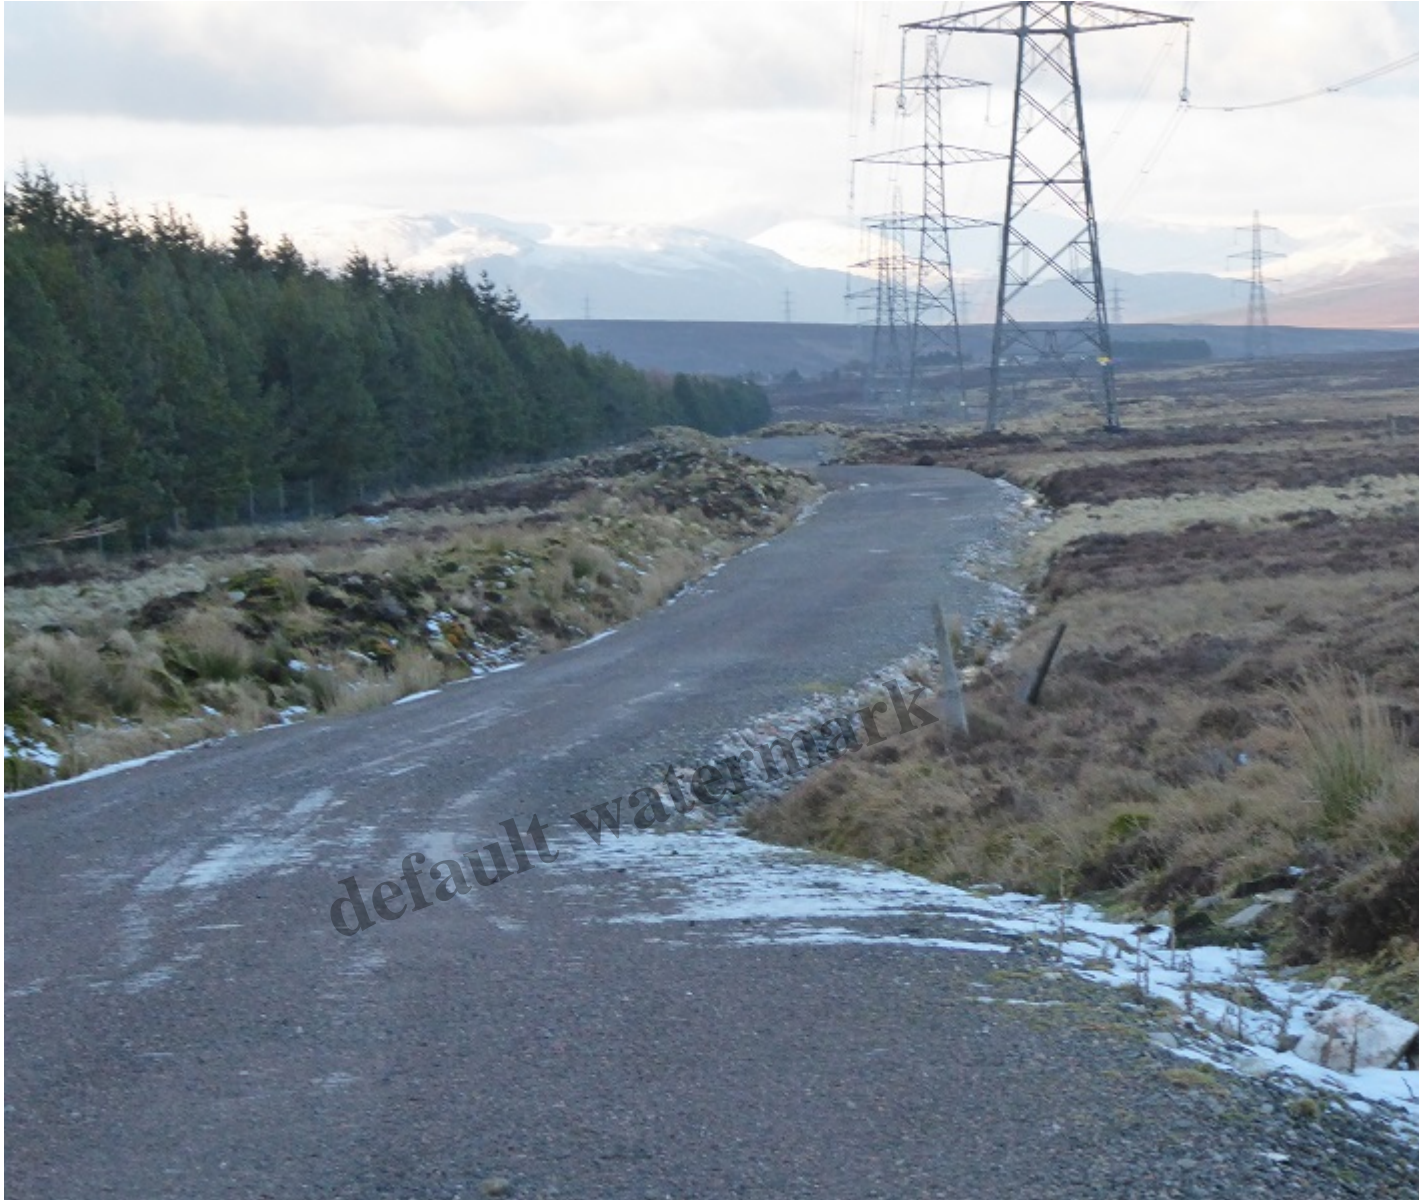
The start of the northern section of the Beaully Denny construction track (as indicated by arrow in map) it appeared in February 2016. Note the ridge of vegetation covered spoil running along the left side of

A year ago the restoration had not started but sometime between then and August 2017, when I next visited, the northern section of the track (above my arrow) was restored. The work was done by McGowan, who provided the specification for the track which was submitted to the Planning Committee, and has generally been completed to a high standard, much higher than is usual for hill tracks or for most of the Beaully Denny restoration work to date:

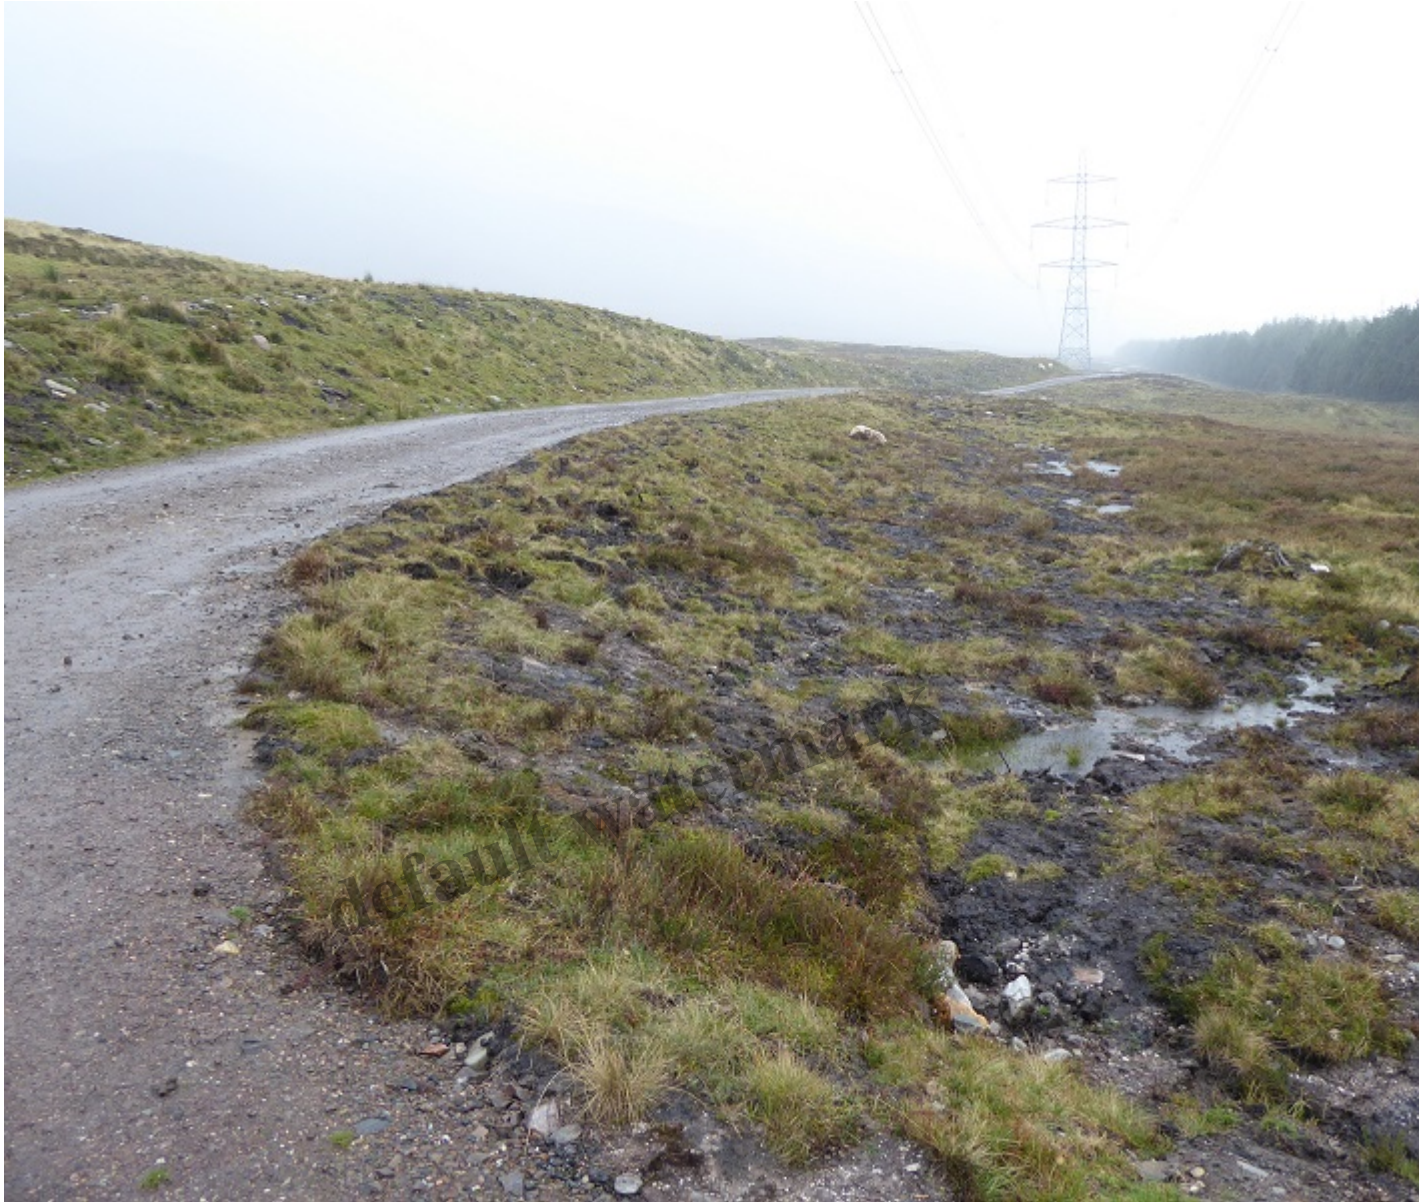
The northernmost end of the track. Note how the low angle of the embankment above the track has vegetation to recover quickly while stored turfs have been effectively used to restore the ground below track. October 2017.

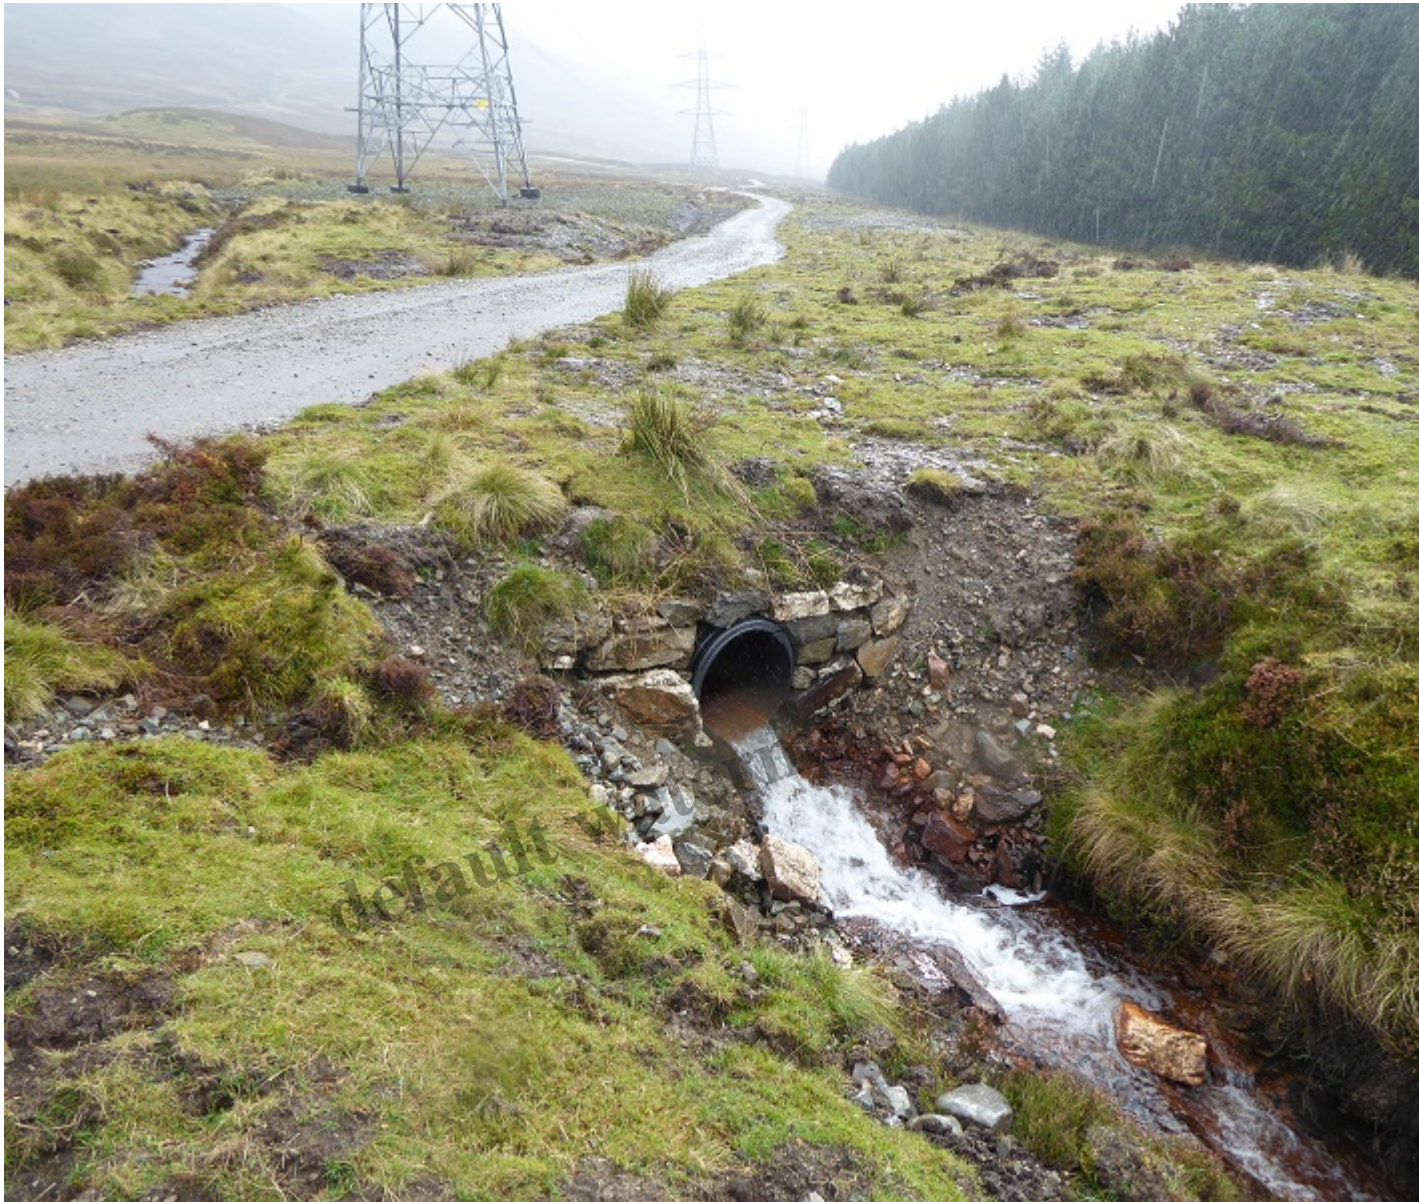
Before restoration, the track extended almost to the edge of the culvert. The bare banks on either side of the culvert appear the consequence of insufficient turf being stored for restoration purposes and are at high risk of erosion. October 2017.

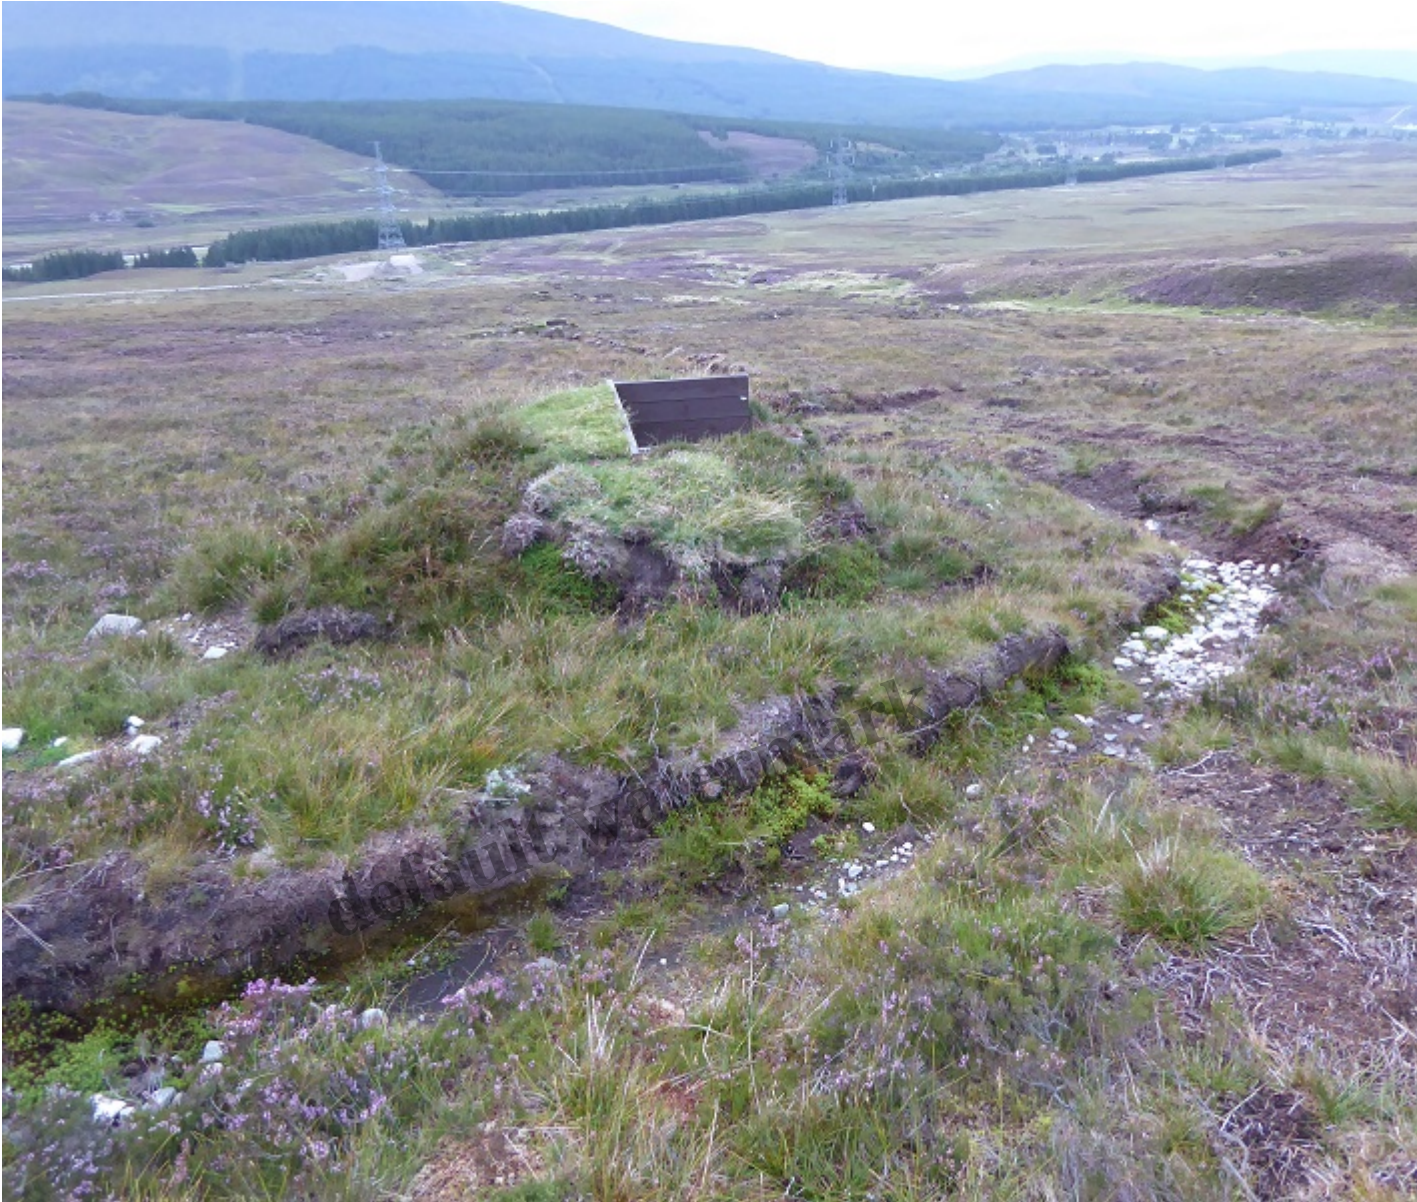
Looking back down a line of new grouse butts – which appear to have been installed without the appropriate consents and have caused significant damage to vegetation – to the restored section of track which is to the right of the first pylon. The track is hardly detectable from this distance compared to the unrestored section to the left of the pylon. August 2017.

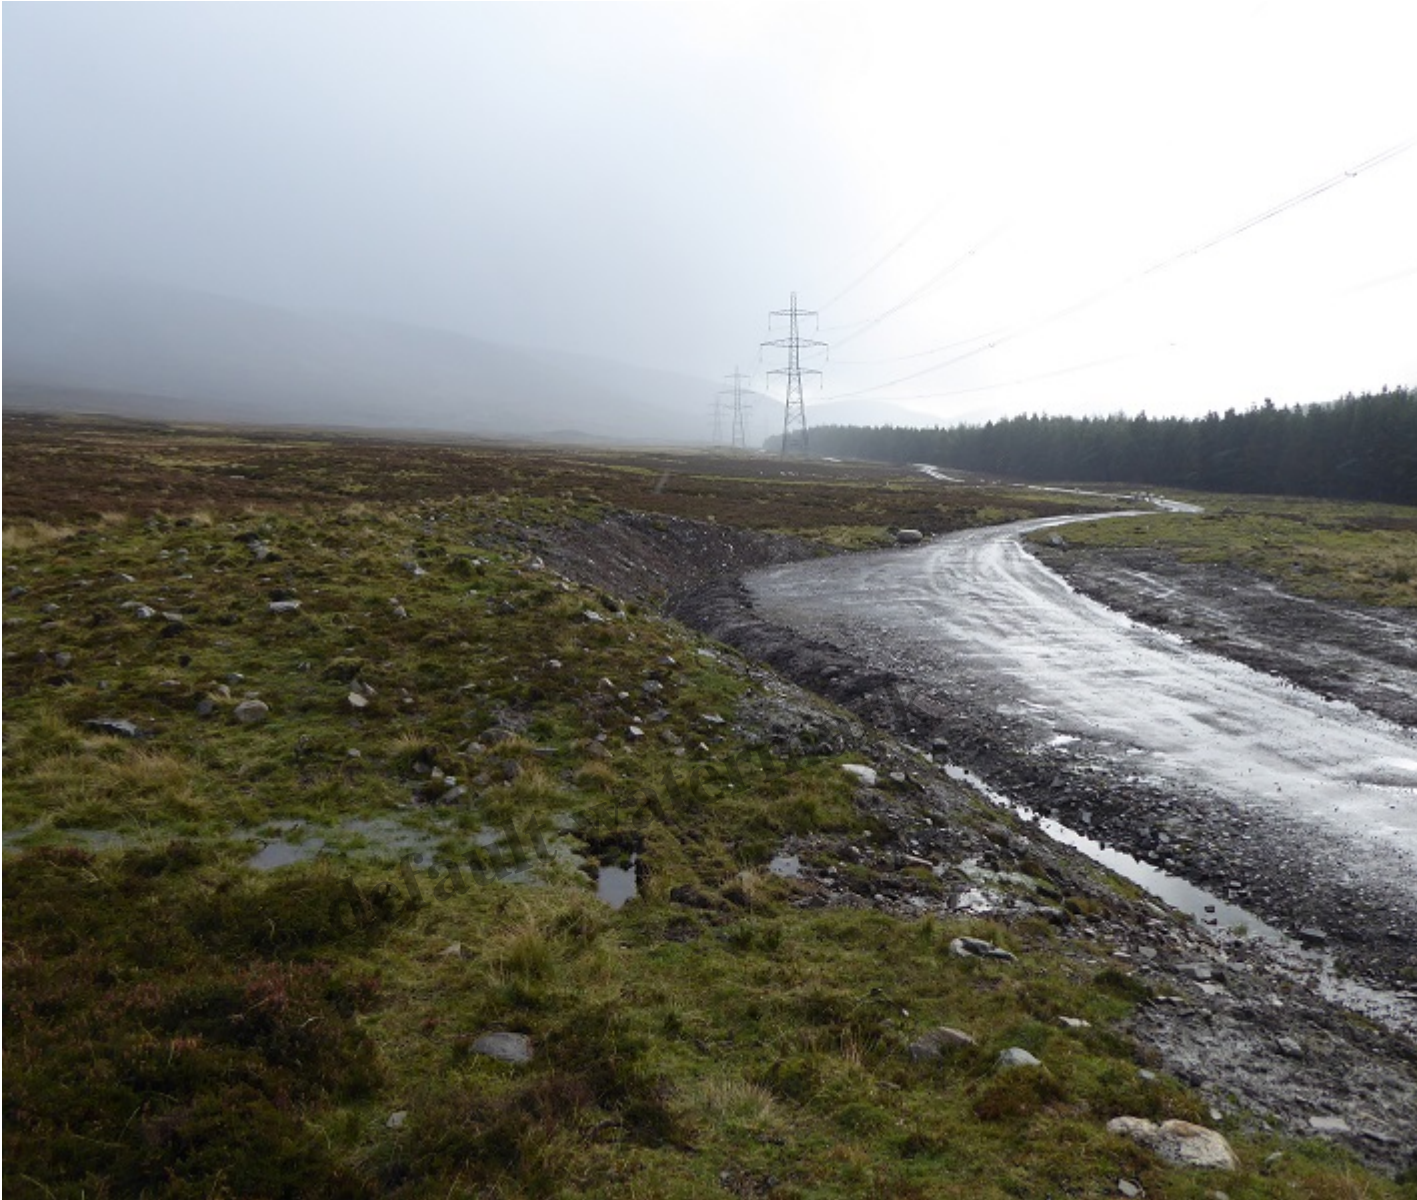
While generally the sides of the track have been well restored in places there appears to have been vegetation to do this: here there is an unvegetated section of ground to the right of the track while the unnecessarily large passing place appears to be another solution to this lack of material (which was responsibility).

The reason for this appears to be that insufficient turves were stored for restoration purposes so that there wasn't enough material available to restore the track to the required width. I don't think matters too much here because the track is hidden from a distance and because of the proposals to plant native trees to help conceal it. However, it provides yet more evidence of why planning authorities need to monitor very closely any requirements that developers store turves properly when restoration of construction tracks is required. This in my view has been the key failure of the Beaully Denny construction.

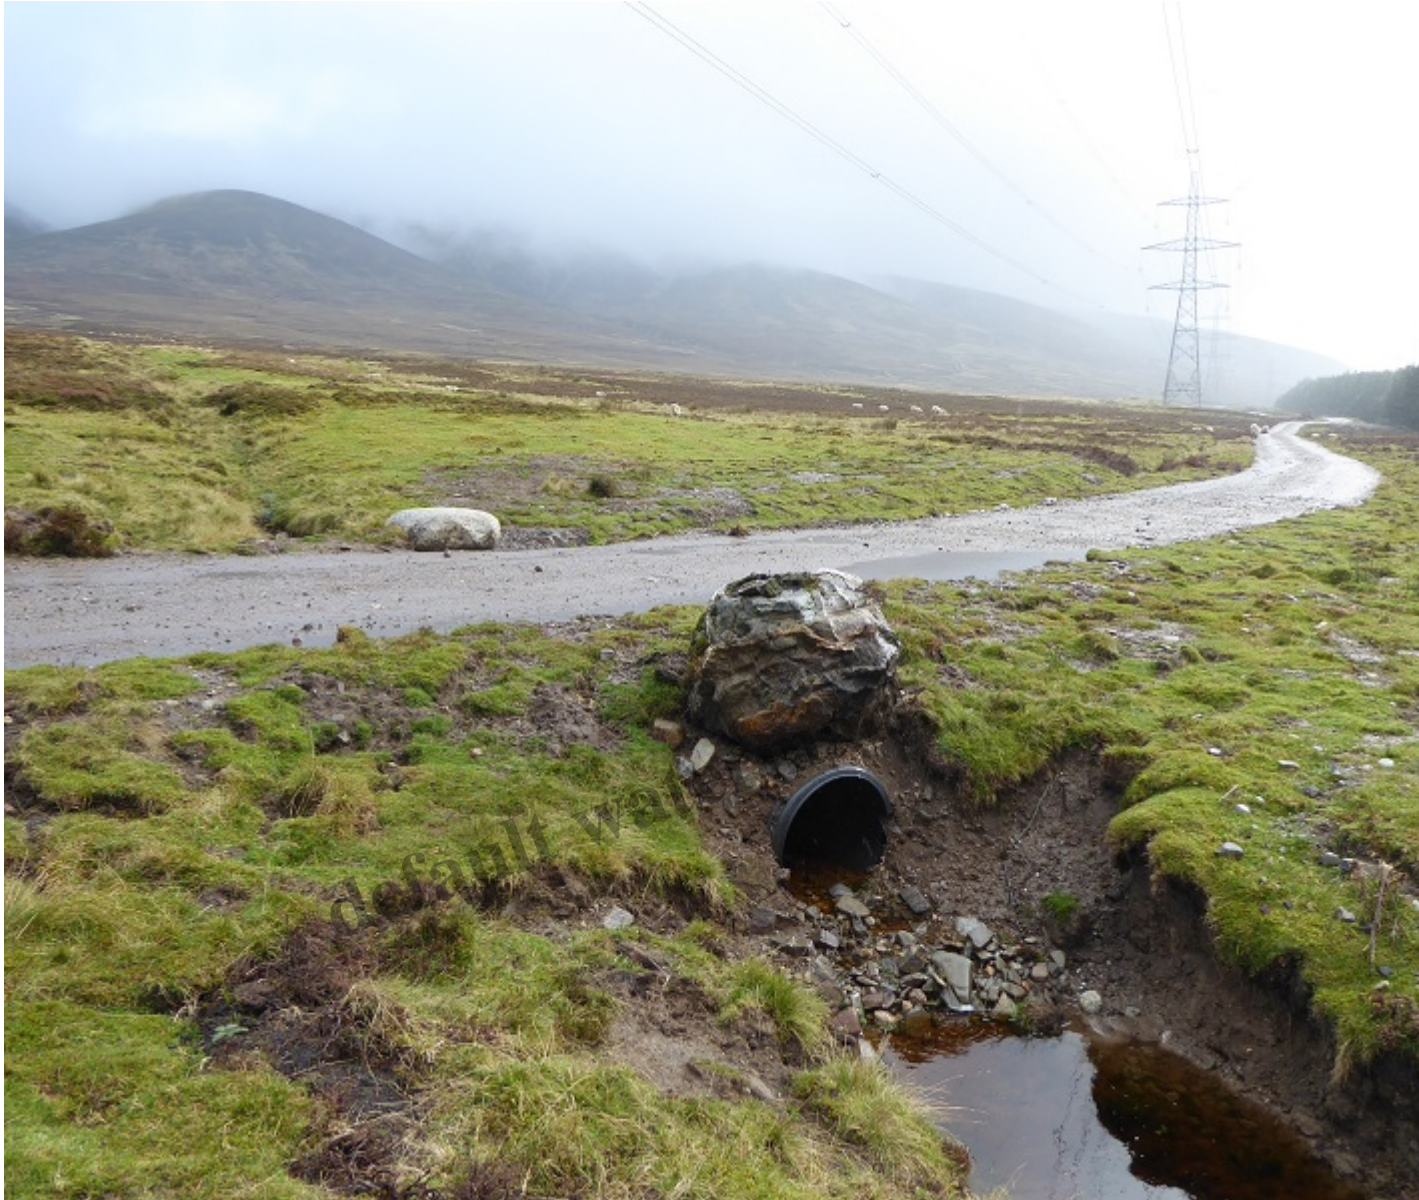
Poorly finished culvert which is fairly typical of this section of track – the dry stone finishing in the photo was the exception. Note the grouse tick mops in the background.

My main grouse – an appropriate word here as that is the main wildlife you are likely to see? – is that most of the culverts have not been properly finished. This I hope is something which will be pursued by the CNPA.

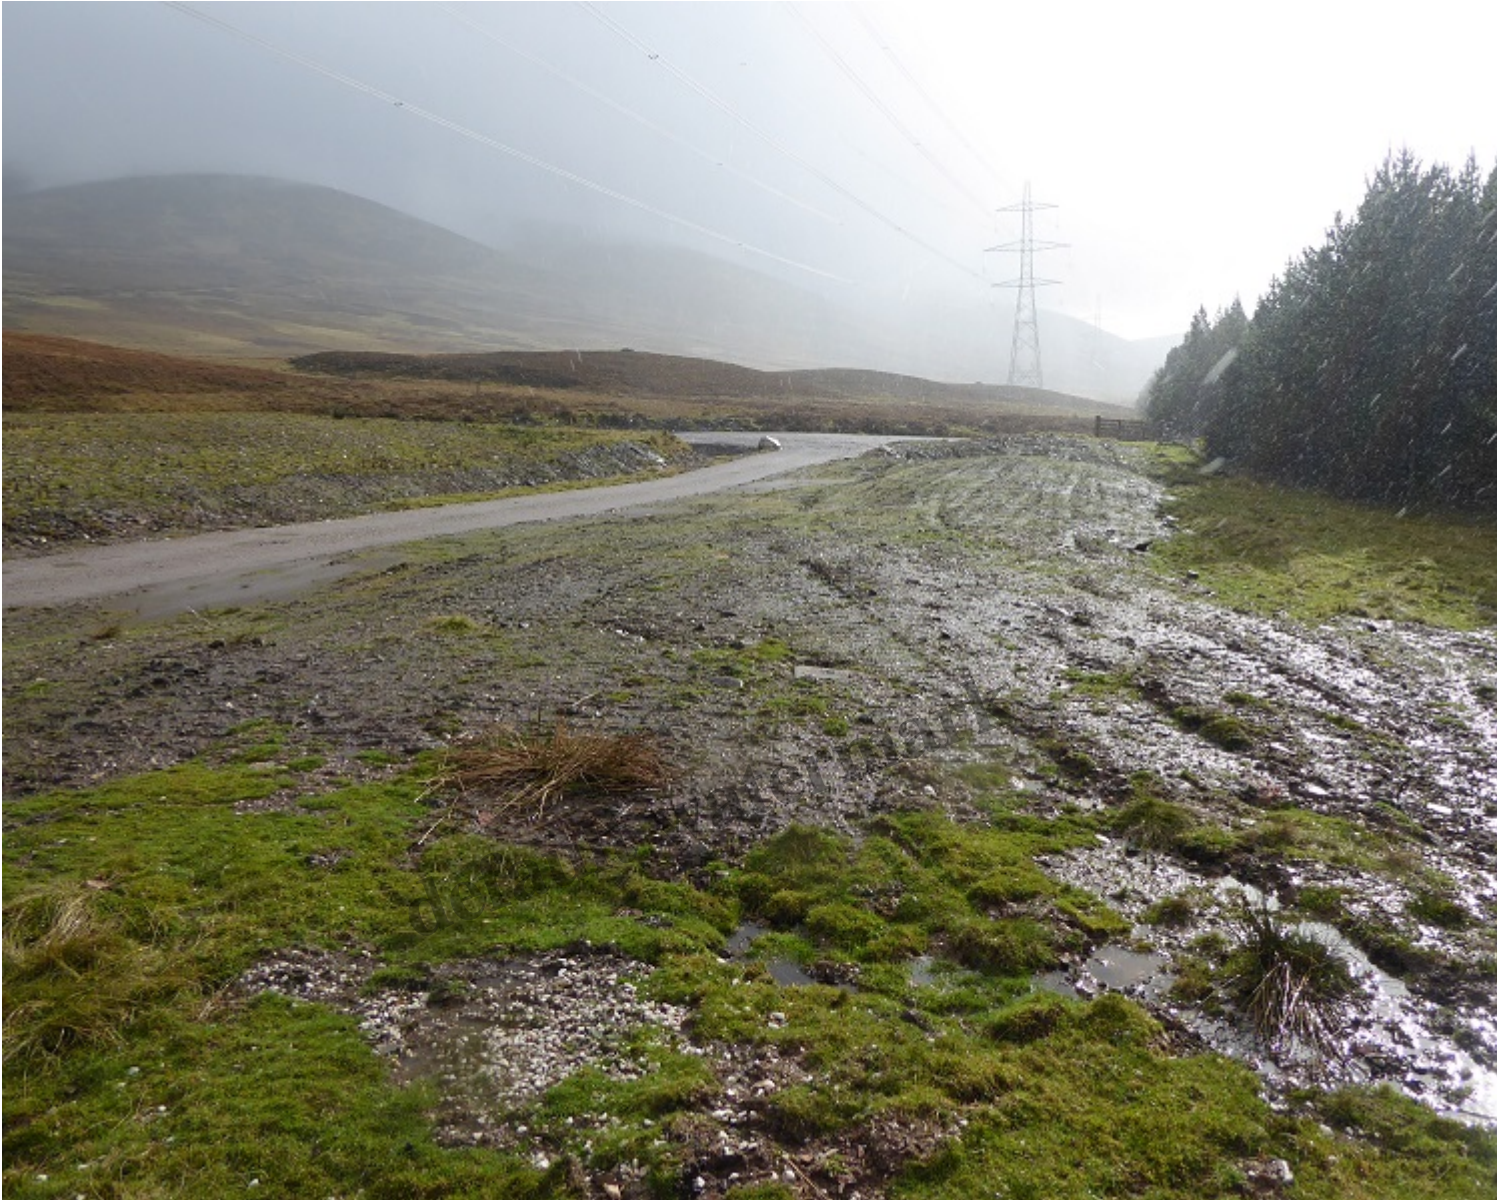
Another more minor grouse is that vehicles continue to be driven over areas which have been “restored” adversely affecting vegetation recovery.

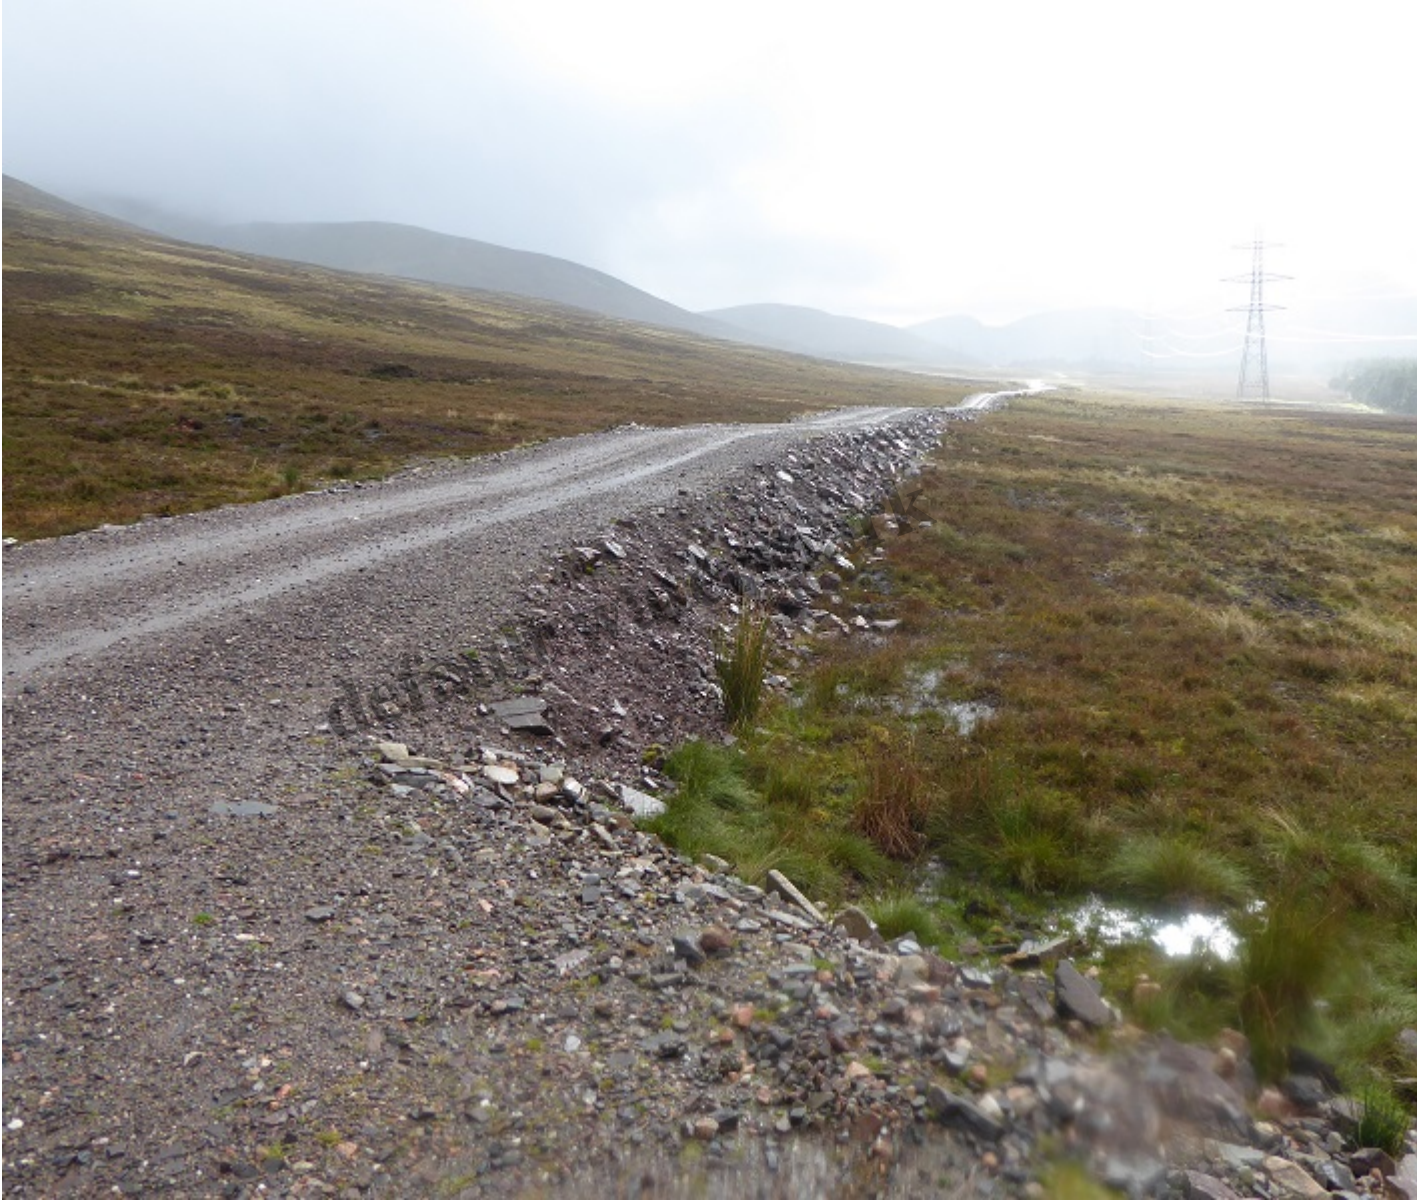
To construct this section of track Balfour Beatty as the main contractors allowed imported material to be dumped on the moor without any apparent attempt to save the vegetation beneath (there is no evidence of vegetation being stored

Further south, along the section of track which remains to be restored, the native trees will fulfil a far more important landscaping function as the track runs higher across the hill away from the existing A9 shelterbelt and is highly visible. The restoration of this middle section of the track poses considerable technical challenges as it has basically been floated across the moor. In my view the best solution would be to remove all the excess aggregate from site – rather than trying to bury it under vegetation – and use it for the construction of the new A9. Perhaps the CNPA could persuade Transport Scotland

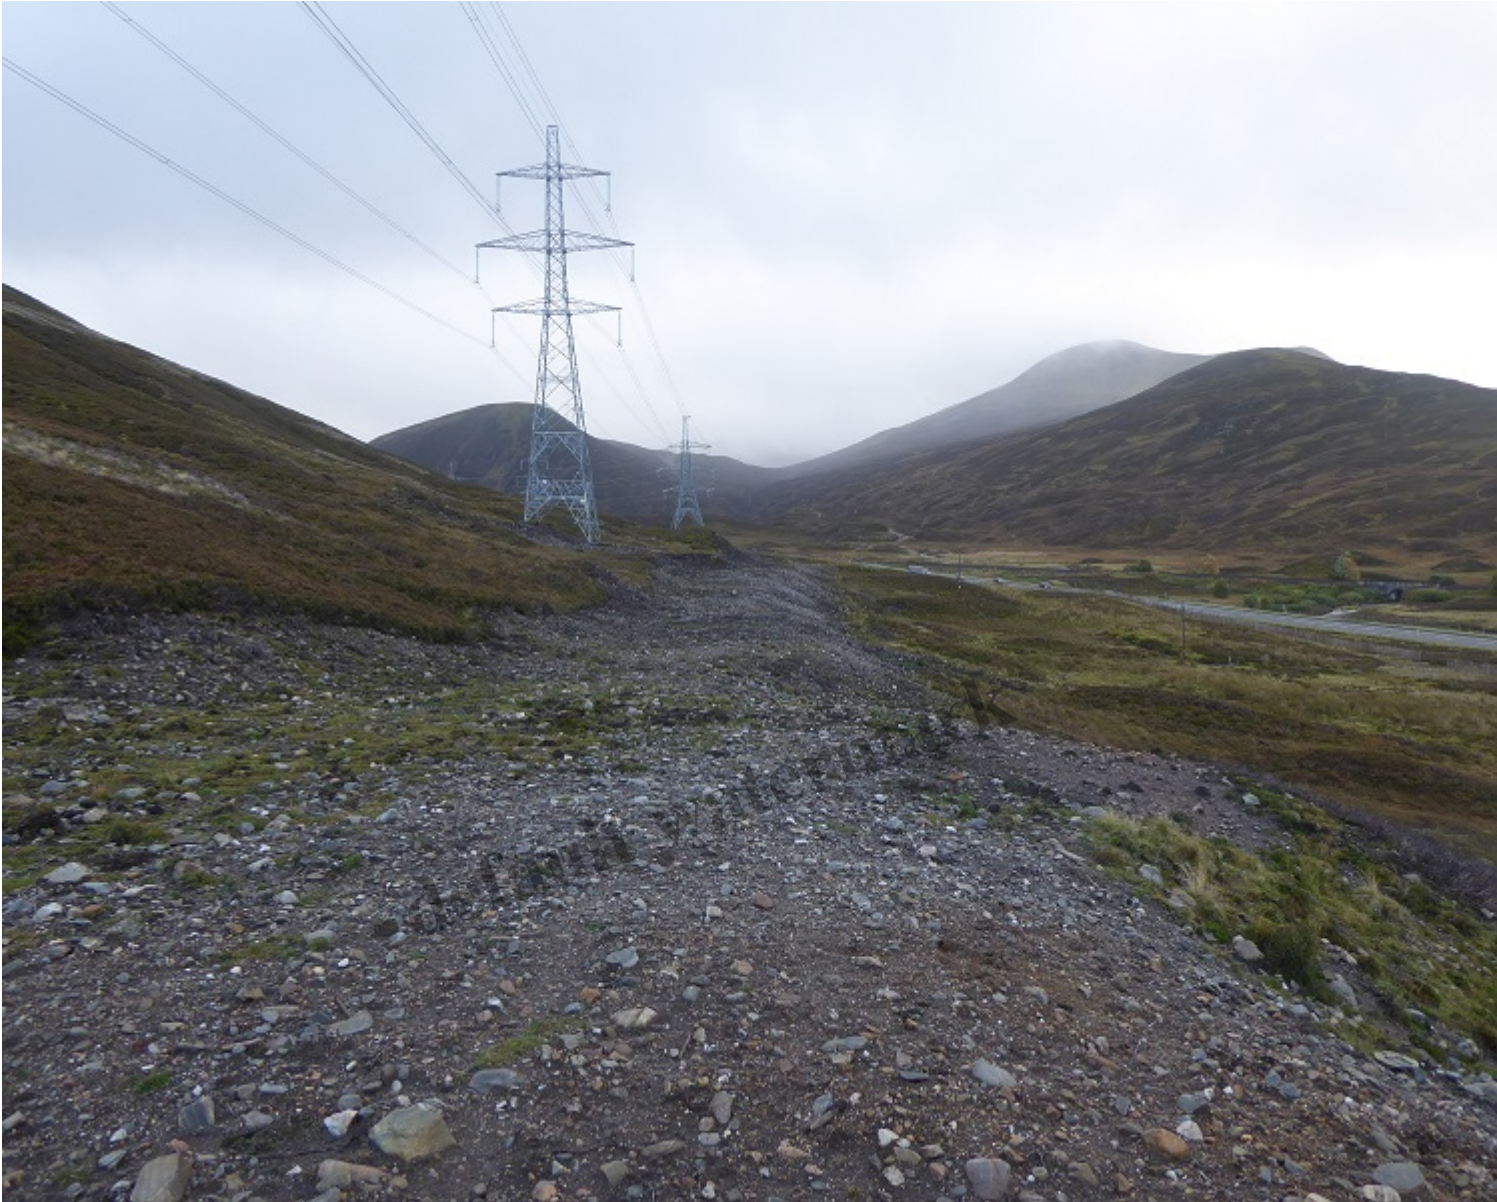
SSE provided a summary report of this year's survey results ([see here](#)) for the Planning Committee. This contains no analysis of what caused the problems while the solutions it is proposing to pilot in 2018 – some re-seeding and fencing off of ground – are minimalistic. The entire focus of the report is on vegetation. There is no mention of the landscape issues and more specifically of the failure of SSE to ensure that where the track was removed, the land was restored to its existing form as required by the original planning consent. This has left large "benches" cut across the hillside (photo above) which are still being used as estate tracks (below) and have a considerable landscape impact:

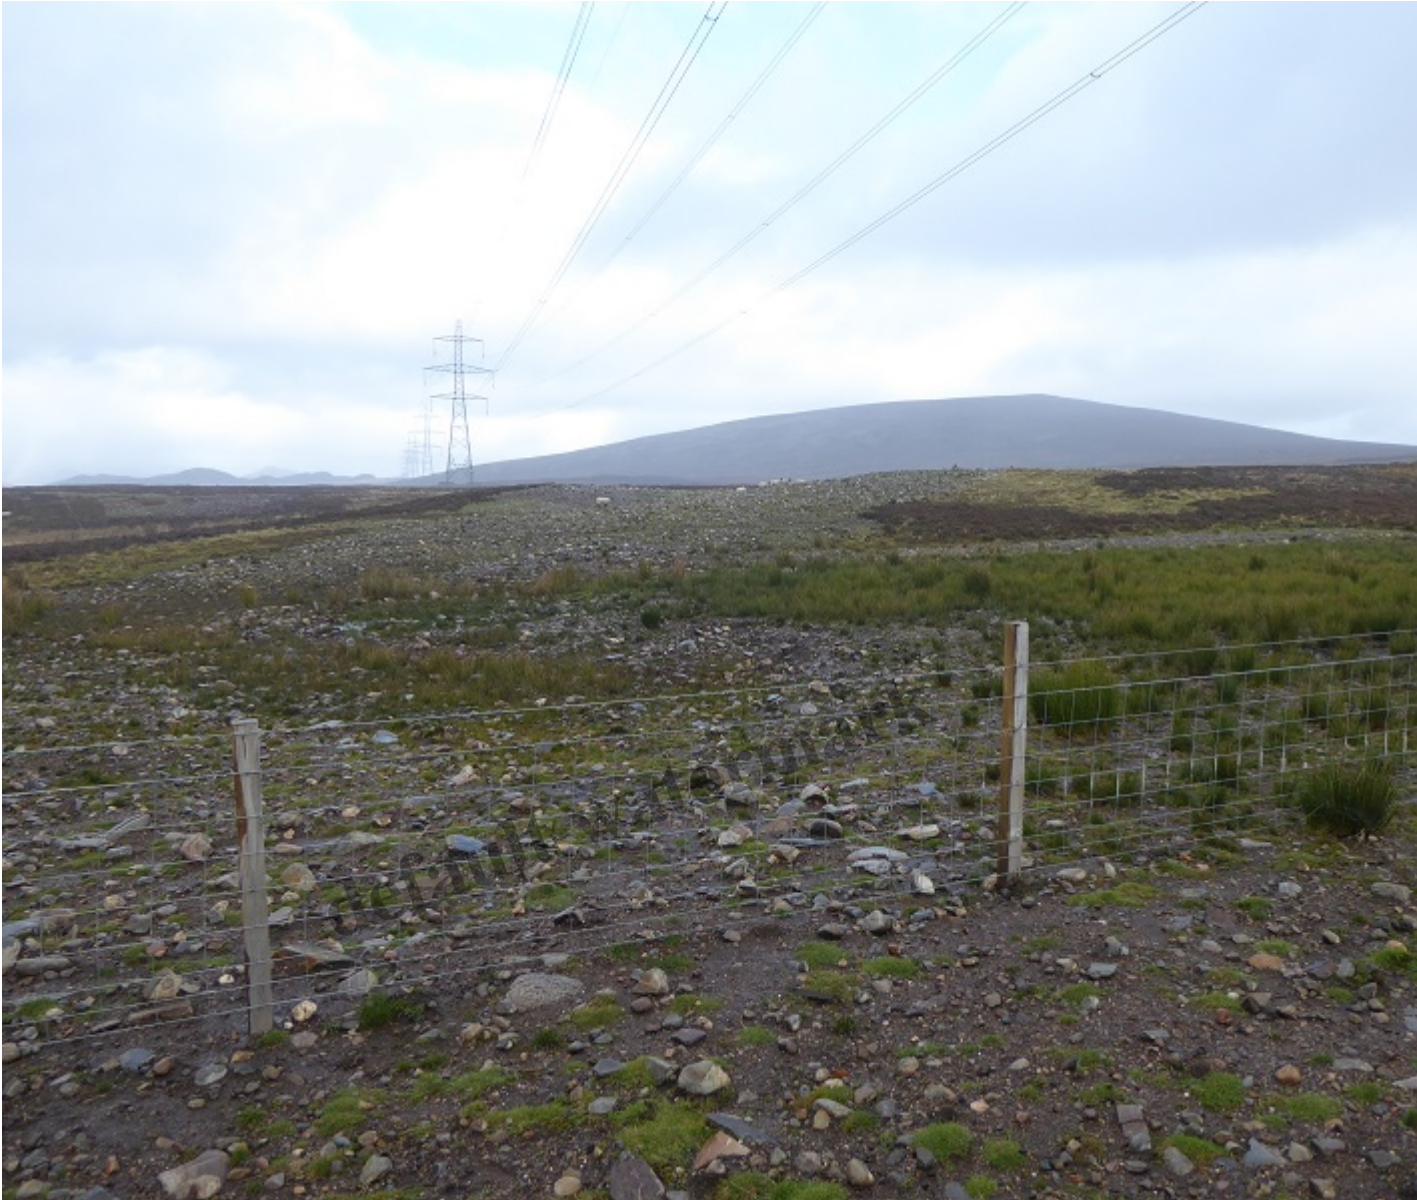
*There appear to be two main reasons for this. Firstly, in some areas, the soil management and handling during construction as well as restoration was poorly executed, leaving little soil material or very wet ground and secondly, there has been no clear management for grazing sheep and deer. It is clear that even where some regrowth has occurred it is heavily cropped by mammals.*

A great swathe of moorland just north of the track as “restored” under SSE’s aegis. There has been an attempt to keep vegetation separate from the stony substrata with the result there is now a boulder field like the one created by the Glen Bruar hydro
