## The CNPA takes action at Drumochter – is it enough?

The second “Drumochter” item considered by the December meeting of the Planning Committee was an update report on SSE’s restoration of the Beauly Denny [Item10AABeaulyDennyUpdate](#).

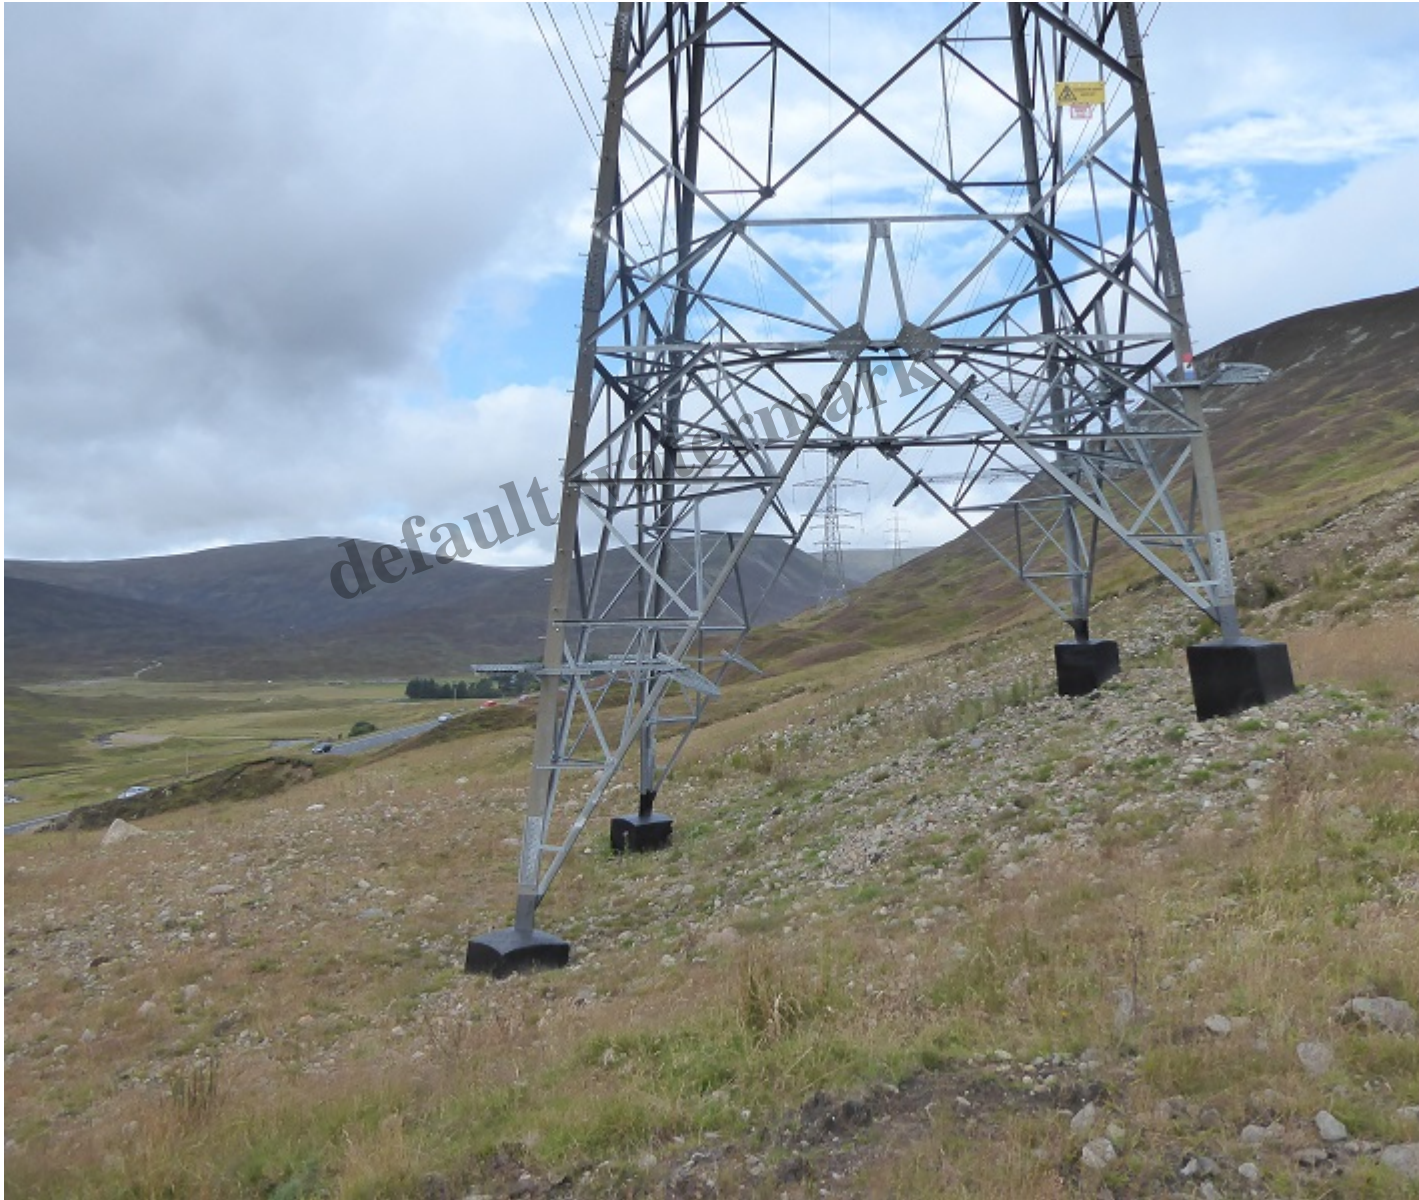
Tower south of Dalnaspidal. Some revegetation has taken place but because soils have been so disturbed not replaced properly grass and rush have replaced heather (as seen beyond the tower).

While I don’t doubt that grazing is having an impact on the ability of vegetation to re-colonise bare ground, this is not the fundamental issue. Because of the way the ground has been disturbed, SSE has created more mineral soils which will promote vegetation that is good for animals to eat. Couple

that with the large number of deer in the southern part of the National Park and you have a problem. The proposed solution to fence off areas, avoids the issue. It would be far better for SSE to be asked to finance deer culls and compensate the estate for removing sheep from the area and aid vegetation recovery that way.
