The CNPA takes action at Drumochter – is it enough?

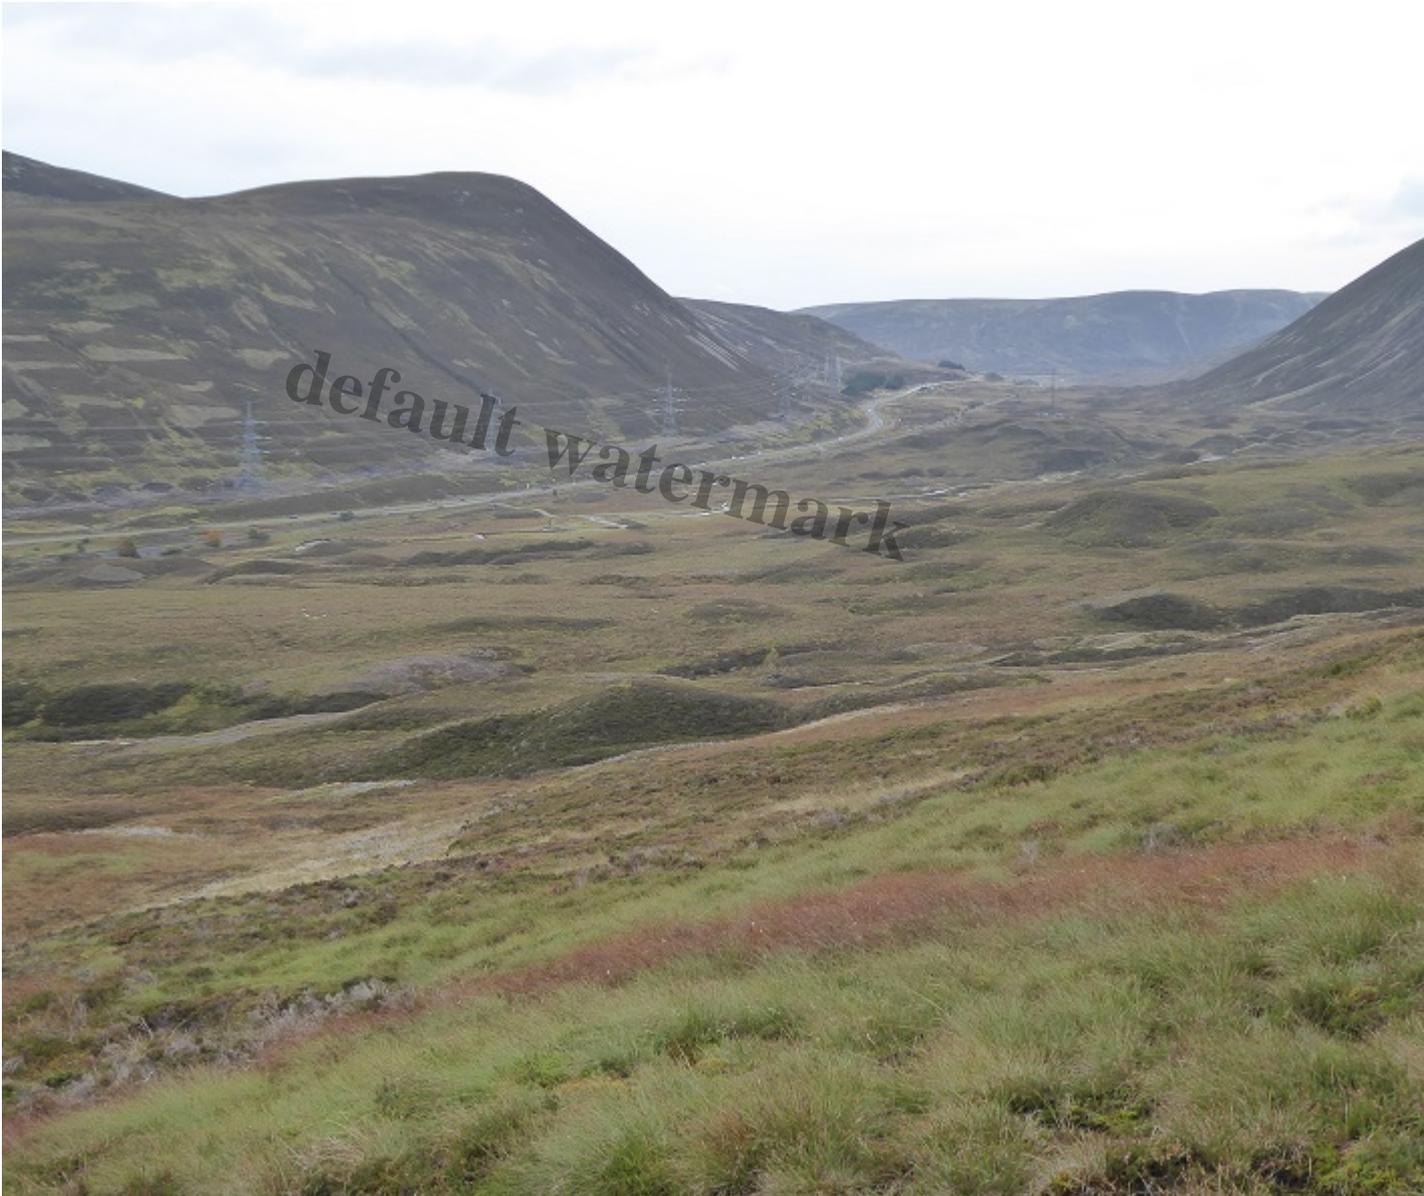
The Drumochter, a fine landscape forming a gateway between north and south, marred by development. The line of the restored Beaulieu Denny construction track is marked by the scar behind the pylons.

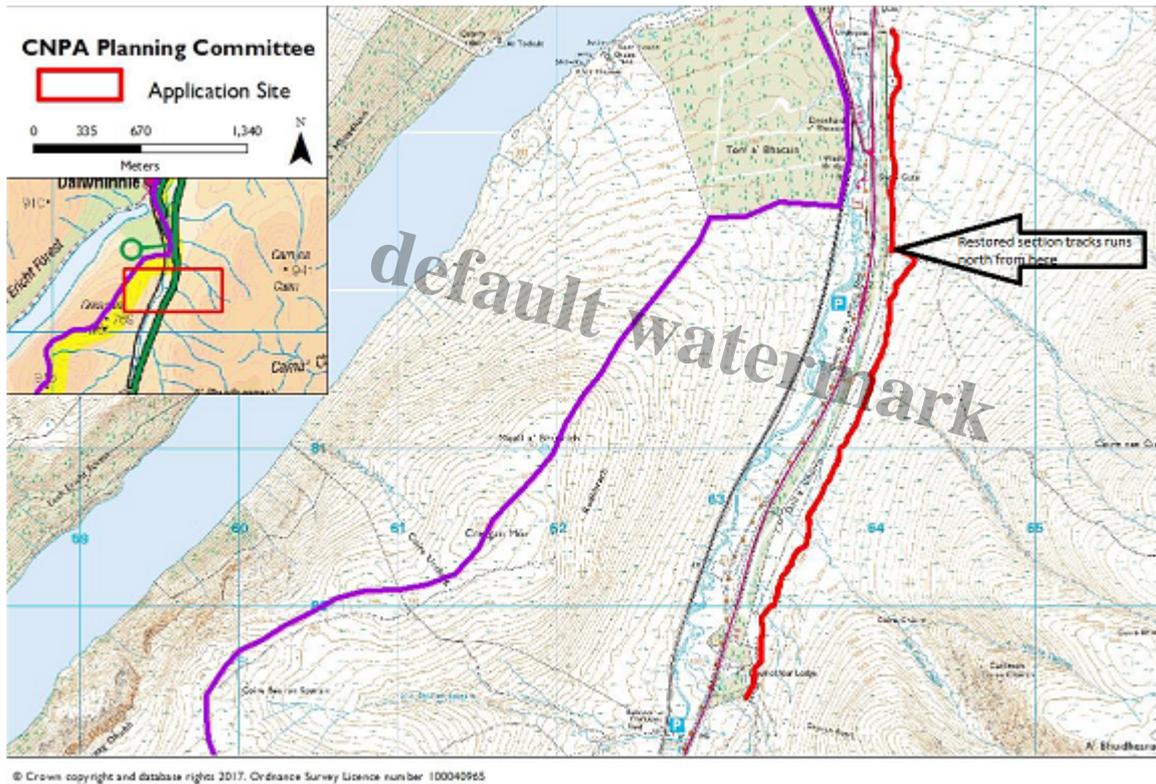
CNPA gave consent to the North Drumochter Estate to retain a section of the Beaully Denny construction track outwith the Drumochter Hills Special Area of Conservation and Special Protection Area (above in red) on the condition that the track was narrowed and a belt of native trees was planted alongside it. The restoration, with the exception of the shelter belt was due to be completed by June 2016.

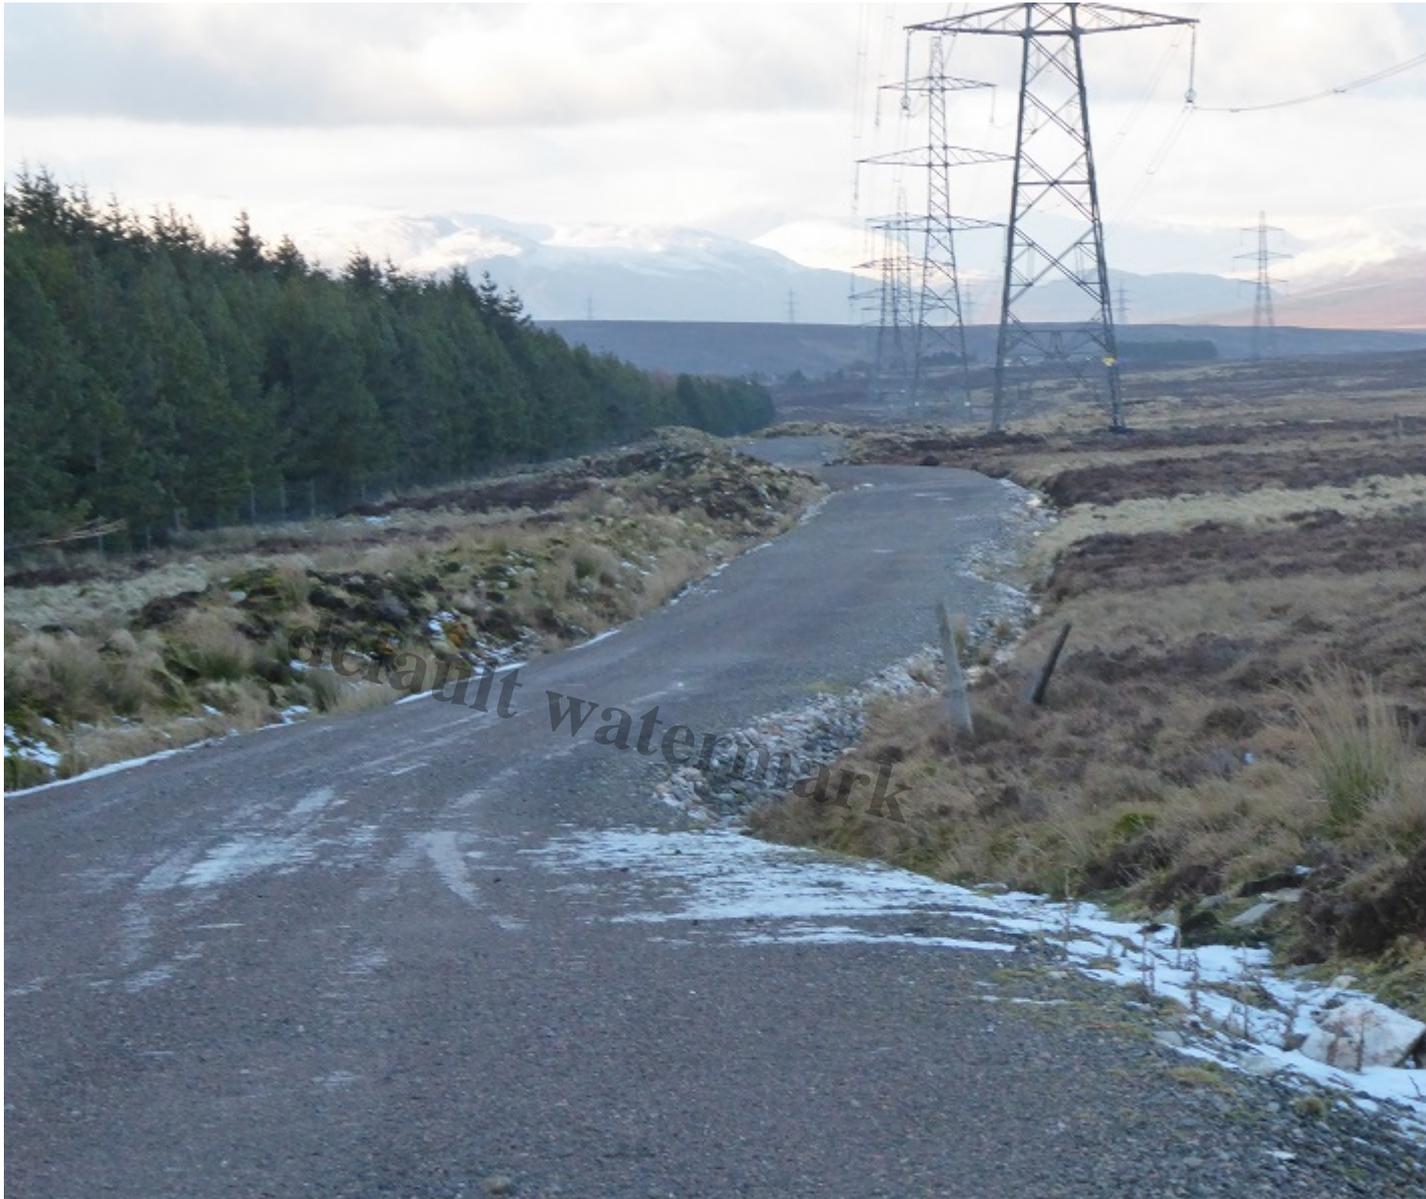
The start of the northern section of the Beauly Denny construction track (as indicated by arrow in map) as it appeared in February 2016. Note the ridge of vegetation covered spoil running along the left side of the track.

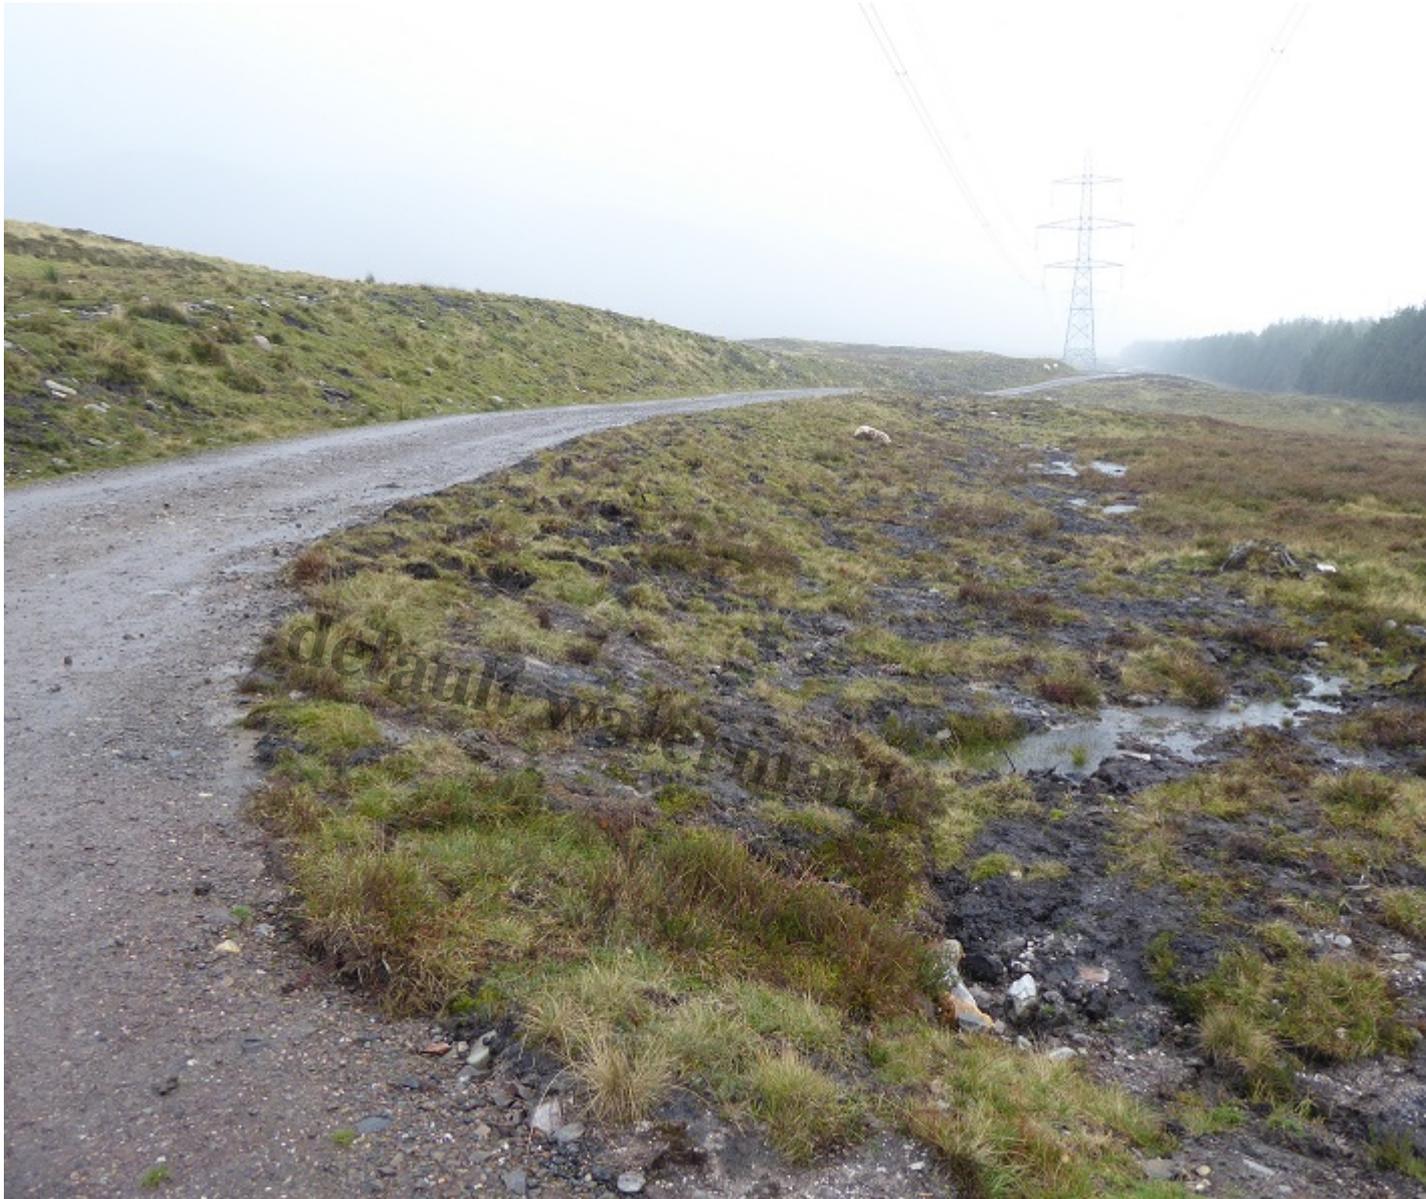
The northernmost end of the track. Note how the low angle of the embankment above the track has vegetation to recover quickly while stored turfs have been effectively used to restore the ground below. October 2017.

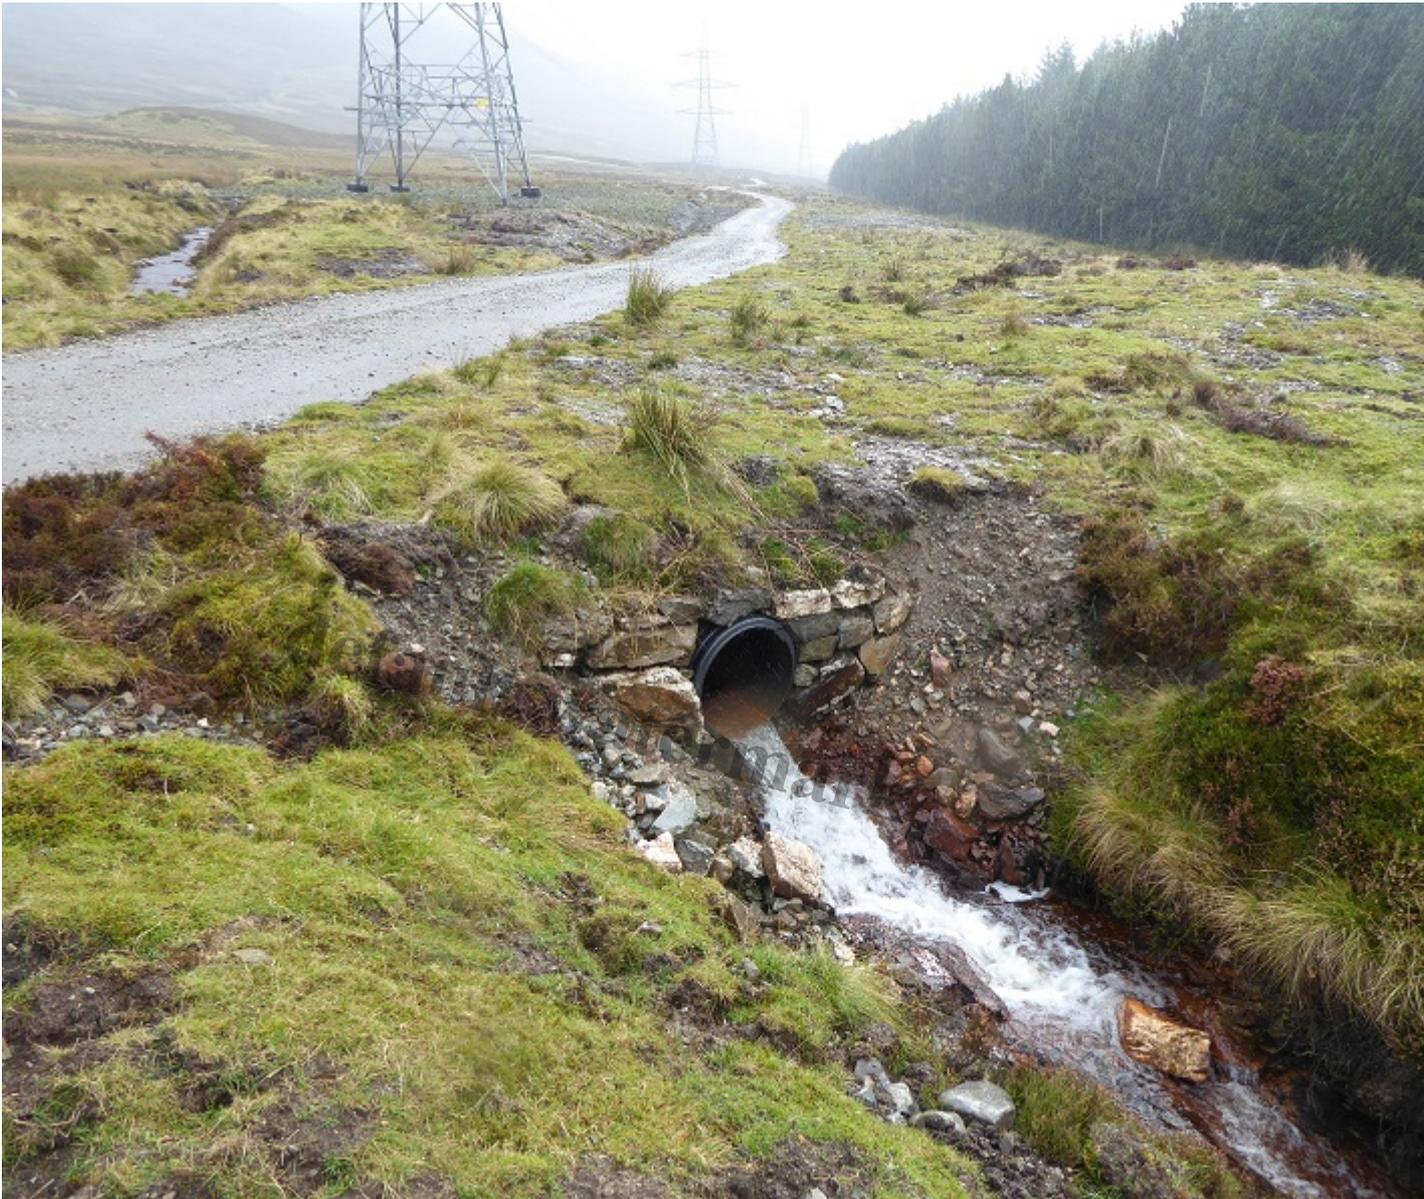
Before restoration, the track extended almost to the edge of the culvert. The bare banks on either side of the culvert appear the consequence of insufficient turf being stored for restoration purposes and are at high risk of erosion. October 2017.

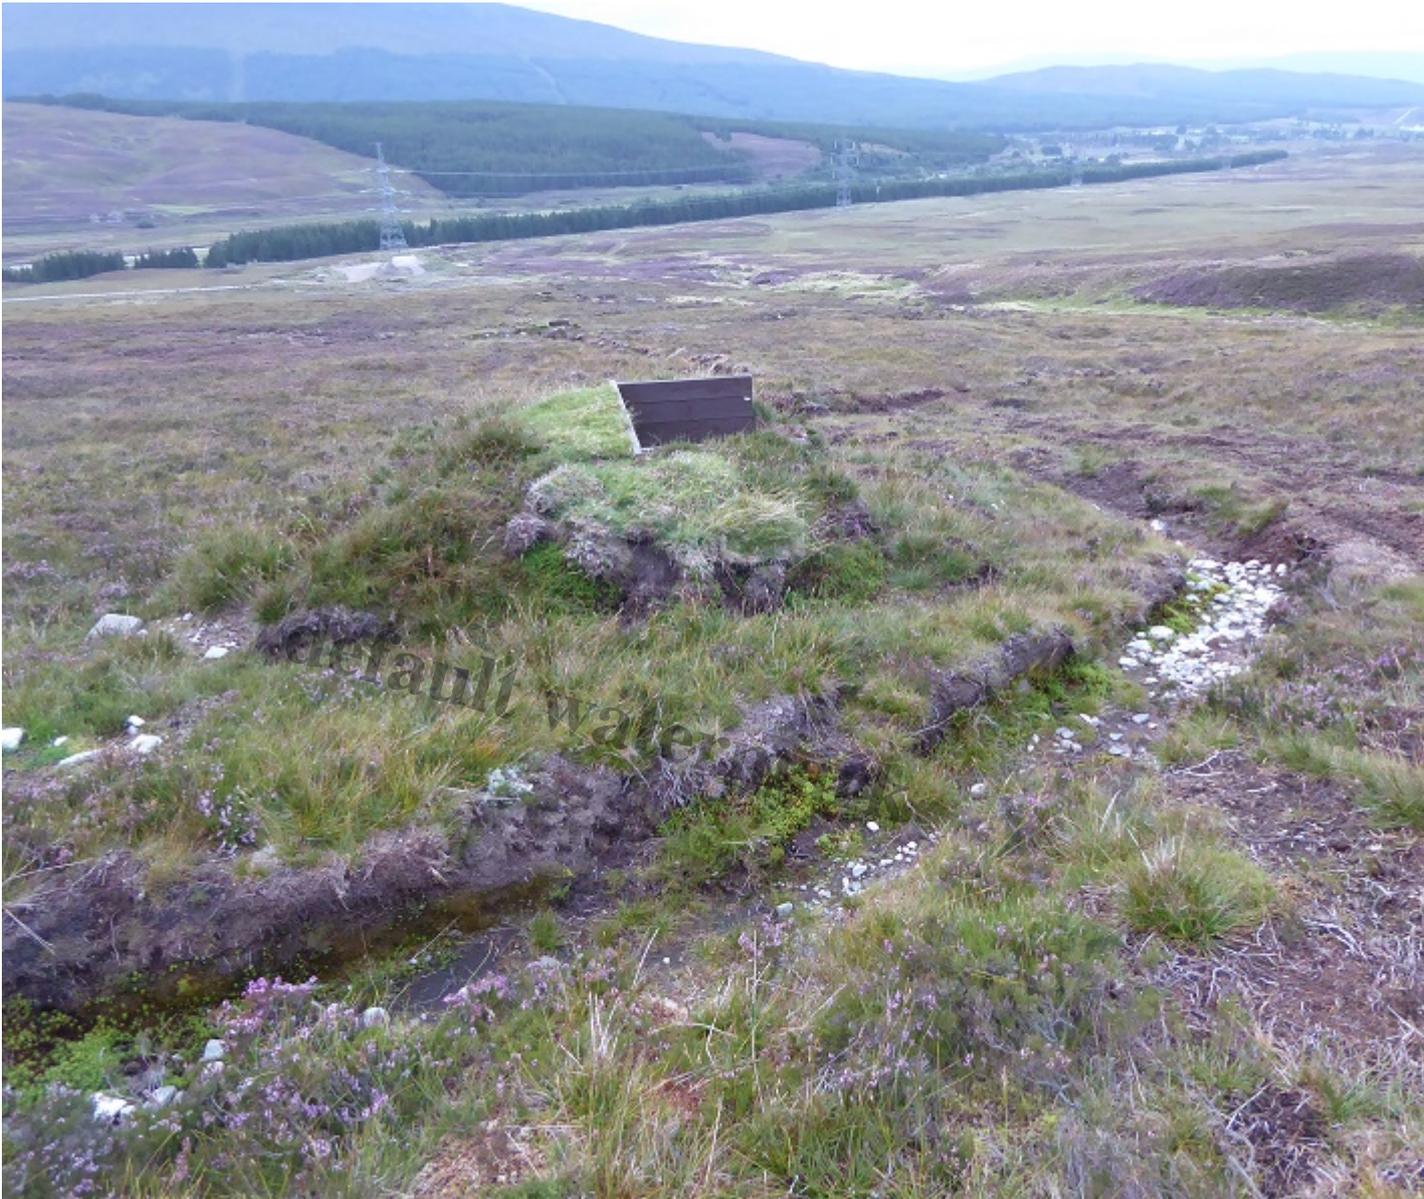
Looking back down a line of new grouse butts which appear to have been installed without the appropriate consents and have caused significant damage to vegetation to the restored section of track which is to the right of the first pylon. The track is hardly detectable from this distance compared to the unrestored section to the left of the pylon. August 2017.

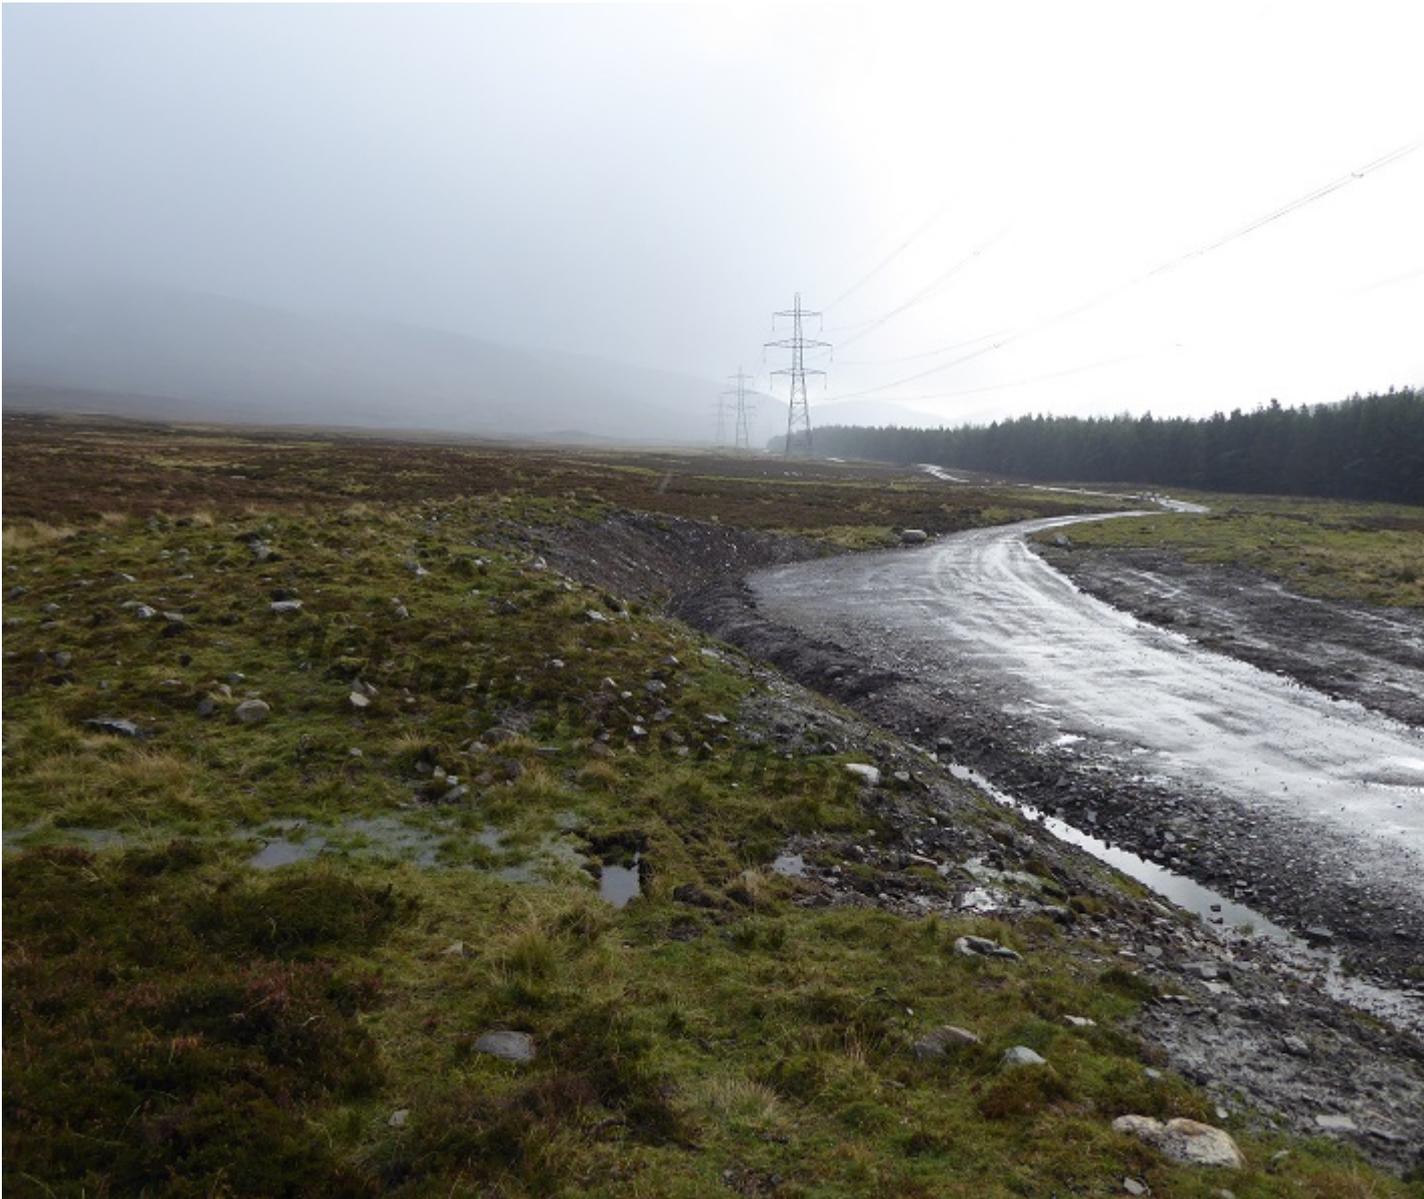
While generally the sides of the track have been well restored in places there appears to have been vegetation to do this: here there is an unvegetated section of ground to the right of the track while the unnecessarily large passing place appears to be another solution to this lack of material (which was responsibility).

The reason for this appears to be that insufficient turves were stored for restoration purposes so that there wasn't enough material available to restore the track to the required width. I don't think matters too much here because the track is hidden from a distance and because of the proposals to plant native trees to help conceal it. However, it provides yet more evidence of why planning authorities need to monitor very closely any requirements that developers store turves properly when restoration of construction tracks is required. This in my view has been the key failure of the Beaully Denny construction.

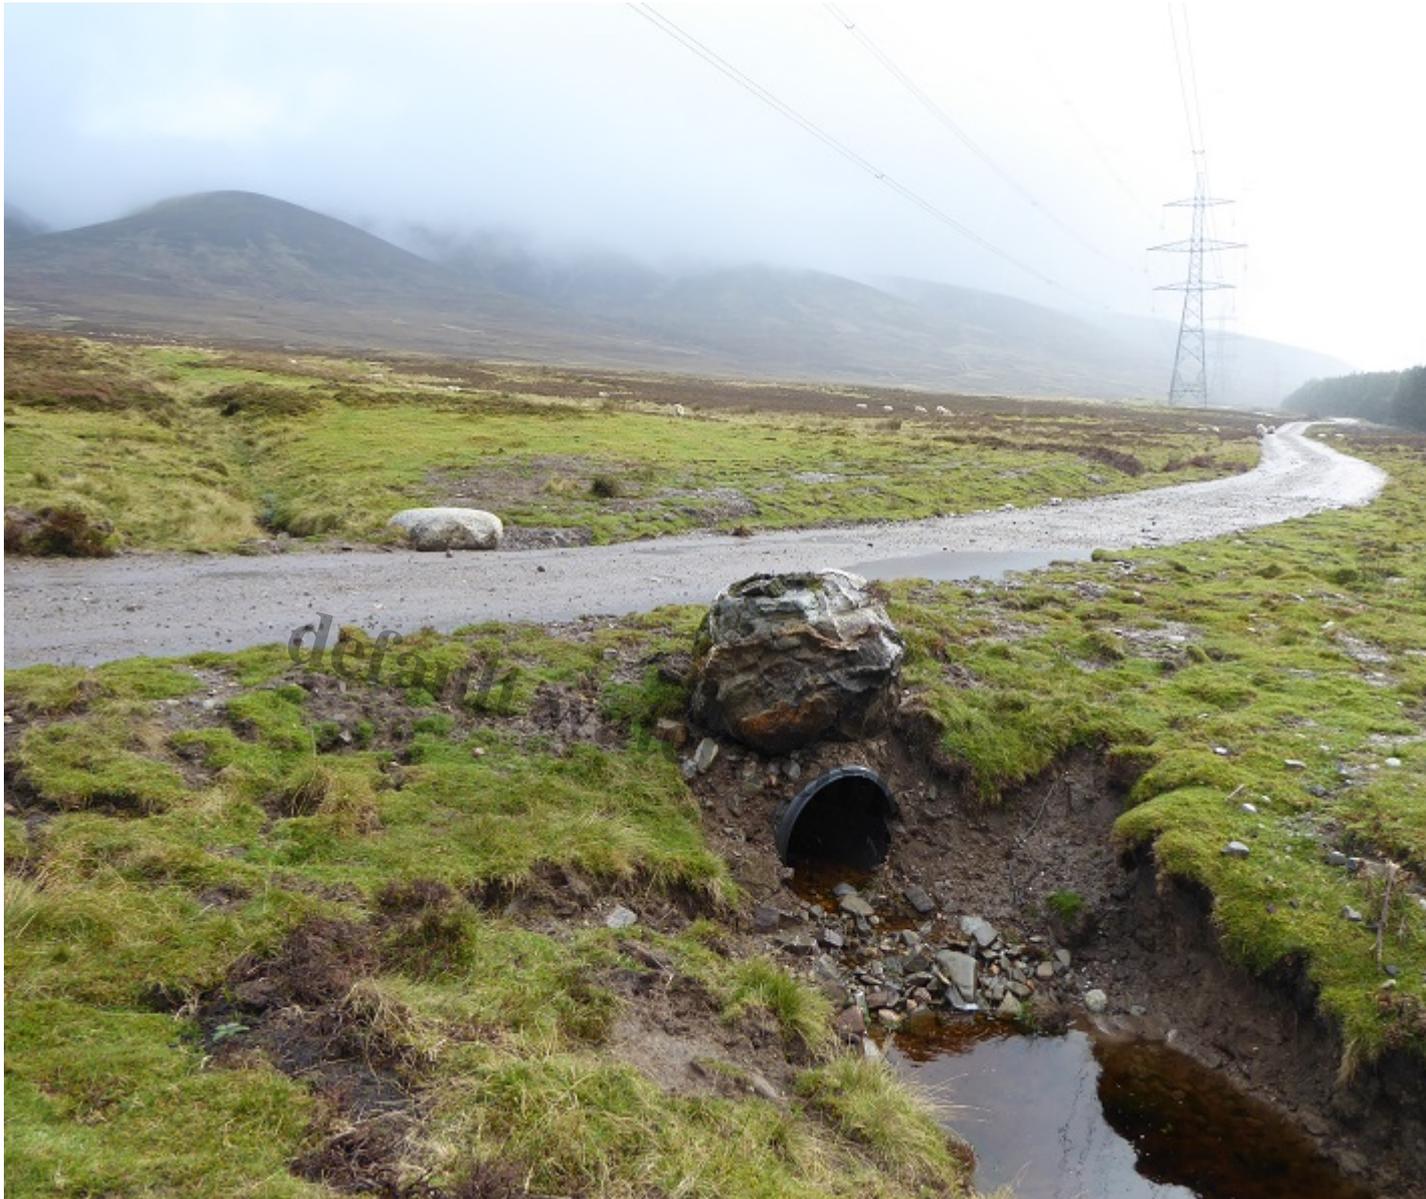
Poorly finished culvert which is fairly typical of this section of track â?? the dry stone finishing in the p was the exception. Note the grouse tick mops in the background.

My main grouse â?? an appropriate word here as that is the main wildlife you are likely to see? â?? is that most of the culverts have not been properly finished. This I hope is something which will be pursued by the CNPA.

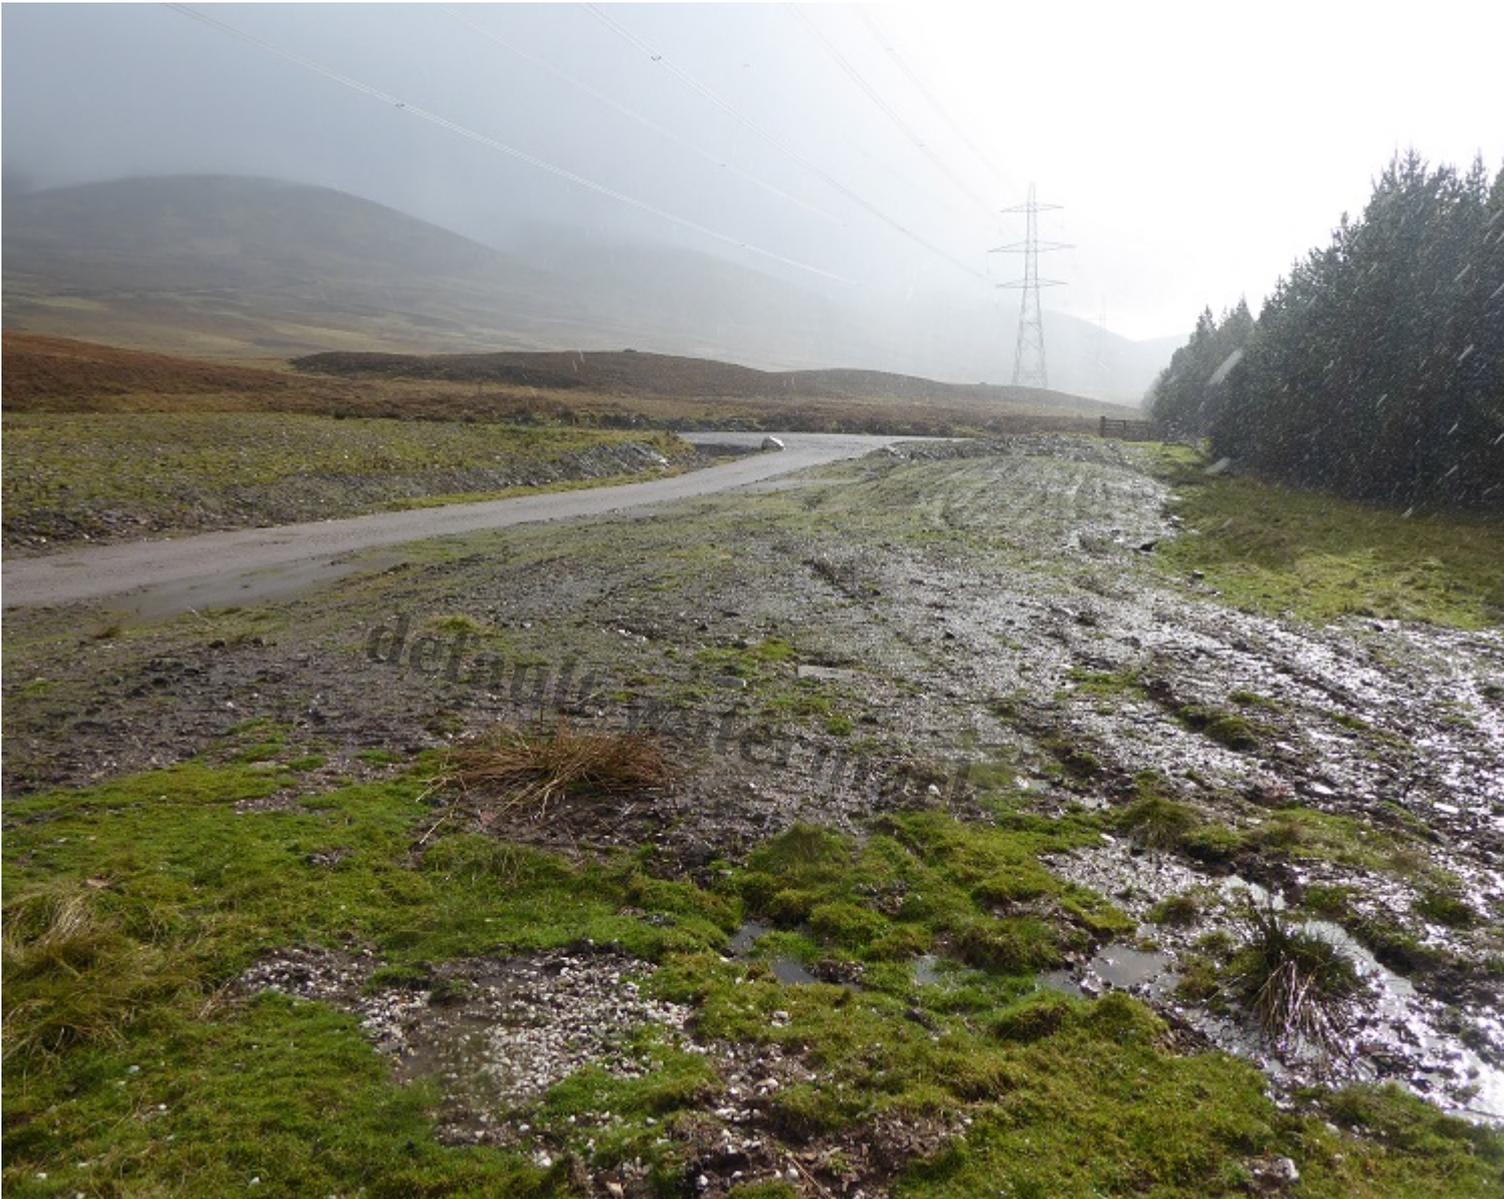
Another more minor grouse is that vehicles continue to be driven over areas which have been “restored” adversely affecting vegetation recovery.

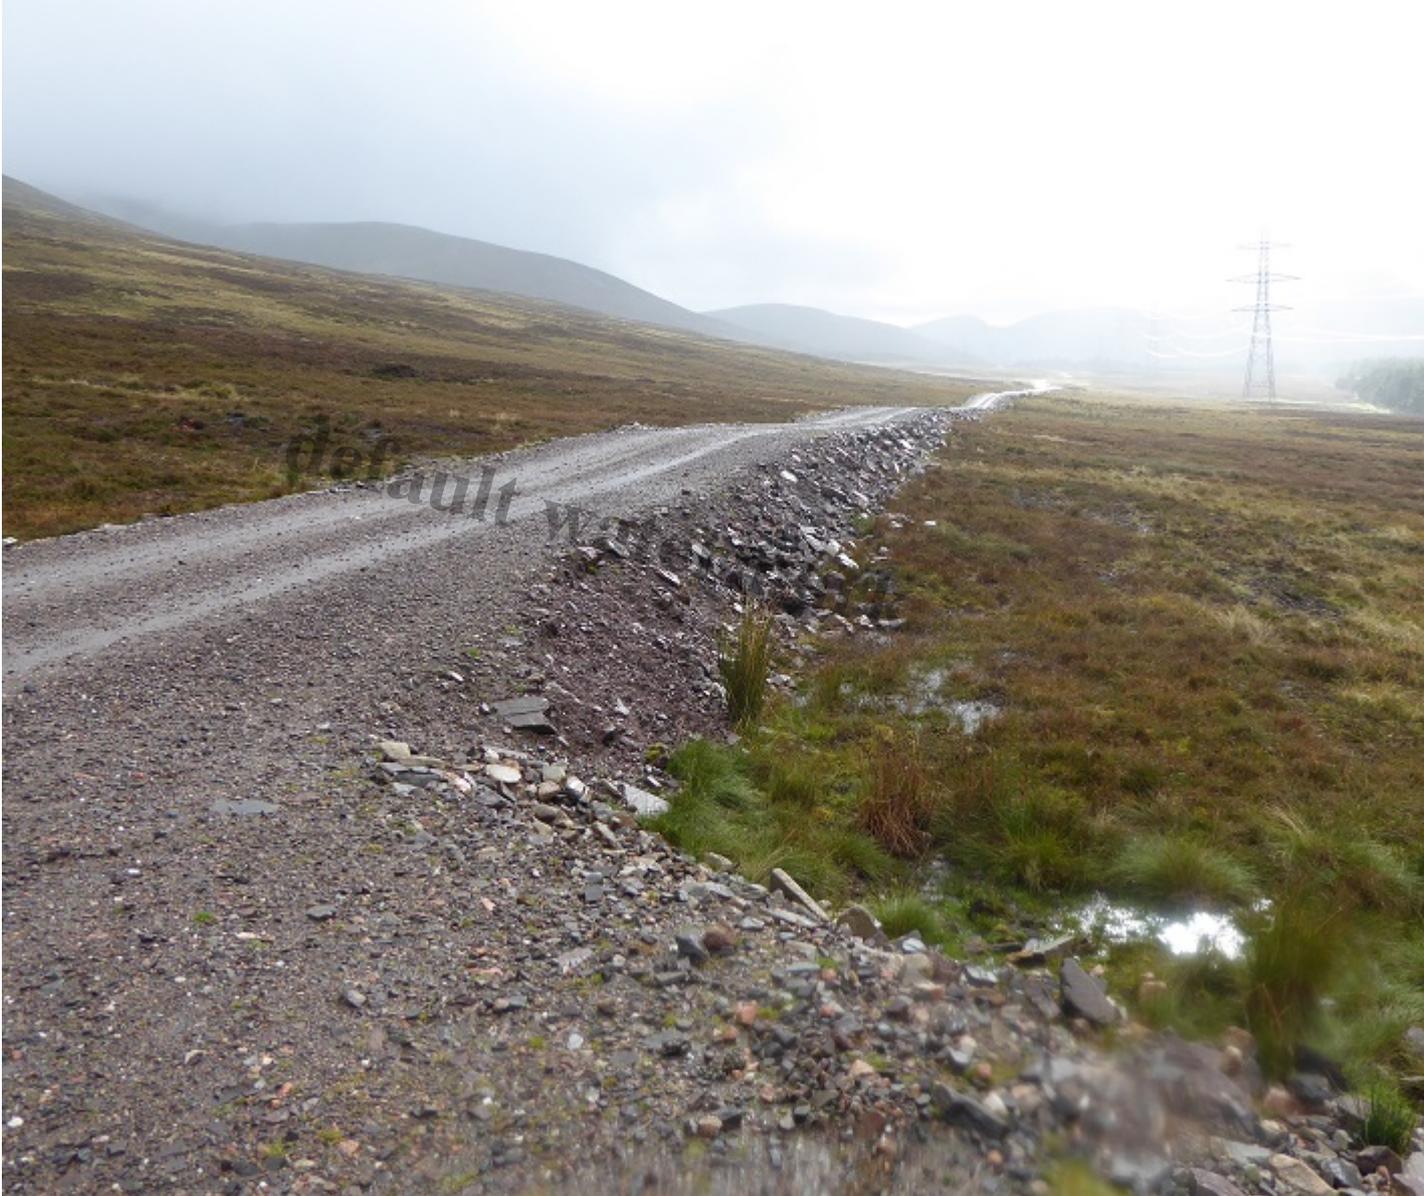
To construct this section of track Balfour Beatty as the main contractors allowed imported material to be dumped on the moor without any apparent attempt to save the vegetation beneath (there is no evidence of vegetation being stored

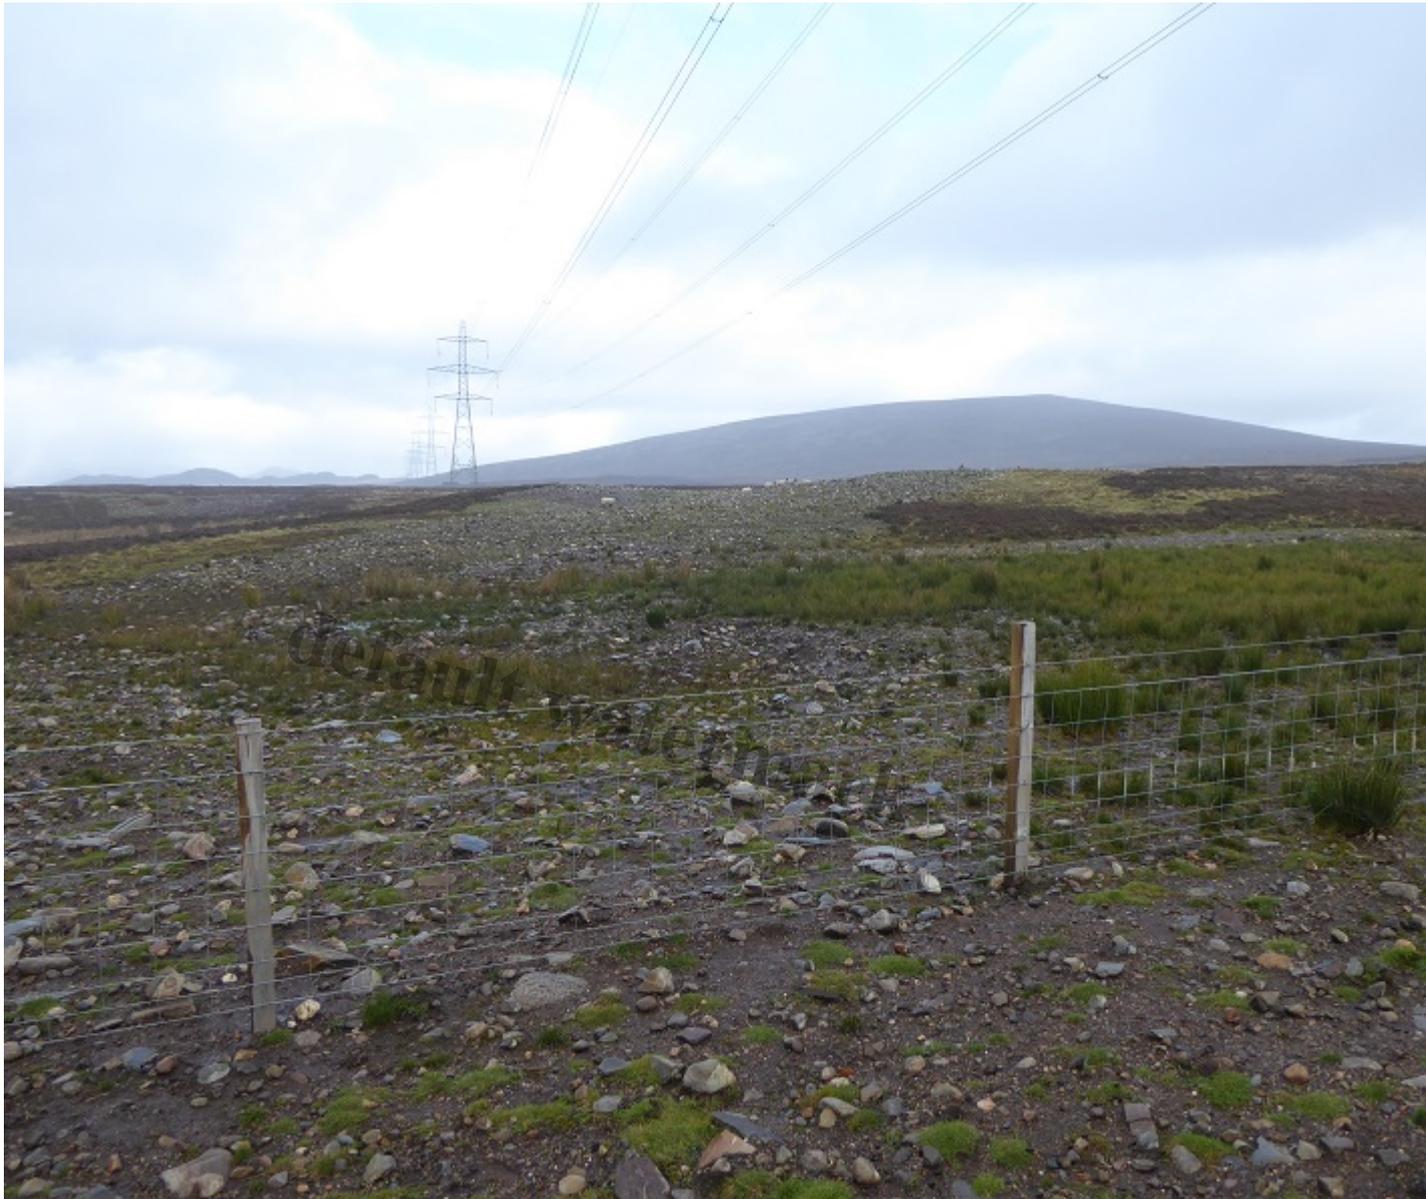
A great swathe of moorland just north of the track as ‘restored’ under SSE’s aegis. There has been an apparent attempt to keep vegetation separate from the stony substrata with the result there is now a mosaic just like the one created by the Glen Bruar hydro

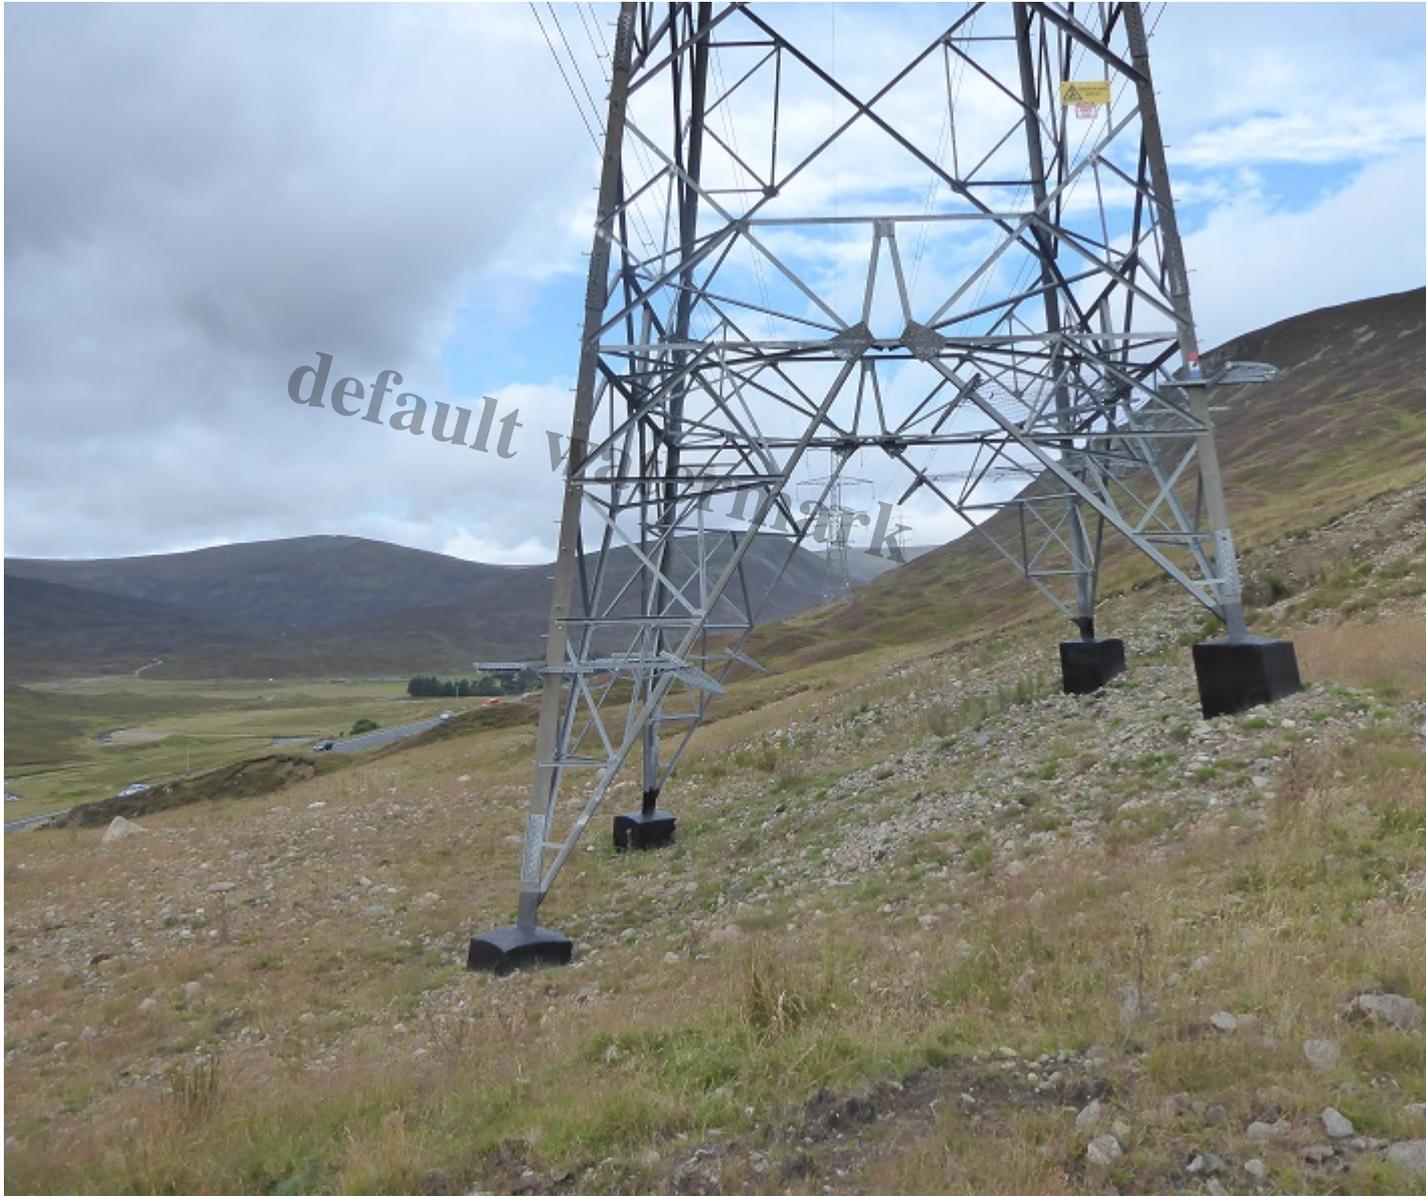
Tower south of Dalnaspidal. Some revegetation has taken place but because soils have been so disturbed not replaced properly grass and rush have replaced heather (as seen beyond the tower).

While I don't doubt that grazing is having an impact on the ability of vegetation to re-colonise bare ground, this is not the fundamental issue. Because of the way the ground has been disturbed, SSE has created more mineral soils which will promote vegetation that is good for animals to eat. Couple that with the large number of deer in the southern part of the National Park and you have a problem. The proposed solution to fence off areas, avoids the issue. It would be far better for SSE to be asked to finance deer culls and compensate the estate for removing sheep from the area and aid vegetation
