The unlawful Glen Clova hill tracks – time for action

Two weeks ago, when I was in Glen Clova, I went to take a closer look at some of the tracks I had seen while doing a round of the Glen Prosen skyline ([see here](#)). This post takes a further look at what has been happening. None of the five tracks featured here appears on the OS Map used on either the Cairngorms National Park Authority or Angus Council Planning Portals:

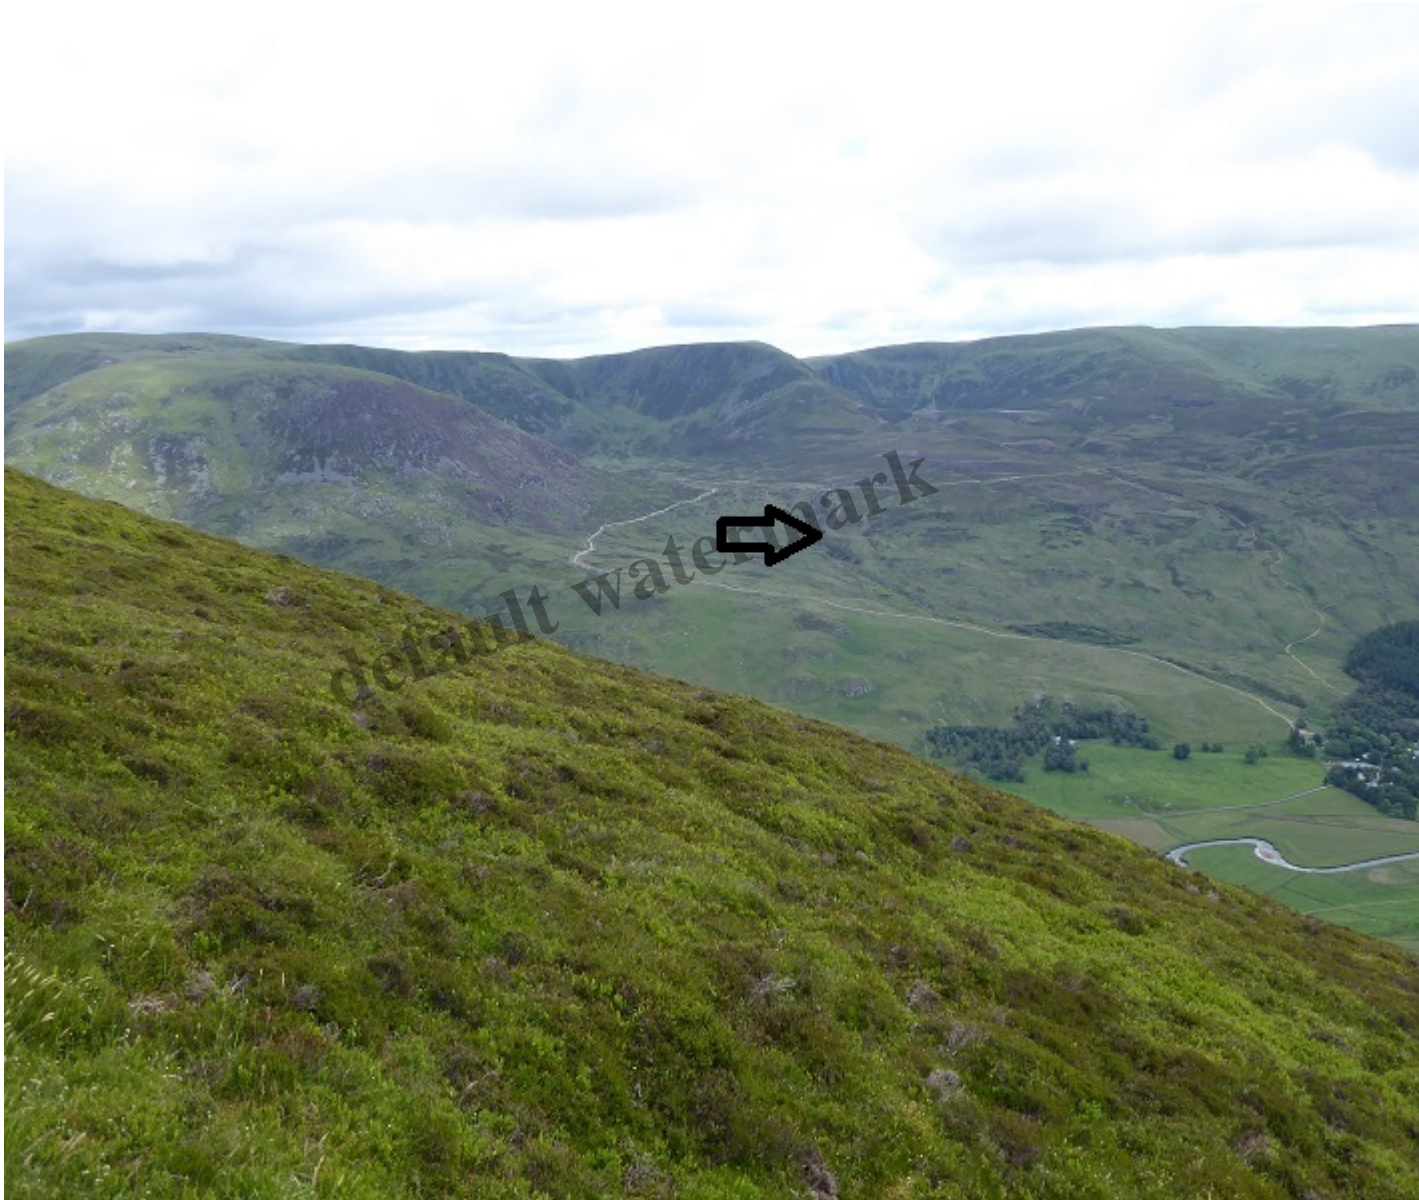
The track above the Clova Hotel as photographed in June 2017. The faint horizontal line across the the arrow marks the pipeline connecting two hydro intakes and is not a constructed track as I had though used by All Terrain Vehicles. The black arrow indicates the top section of the buried pipeline.

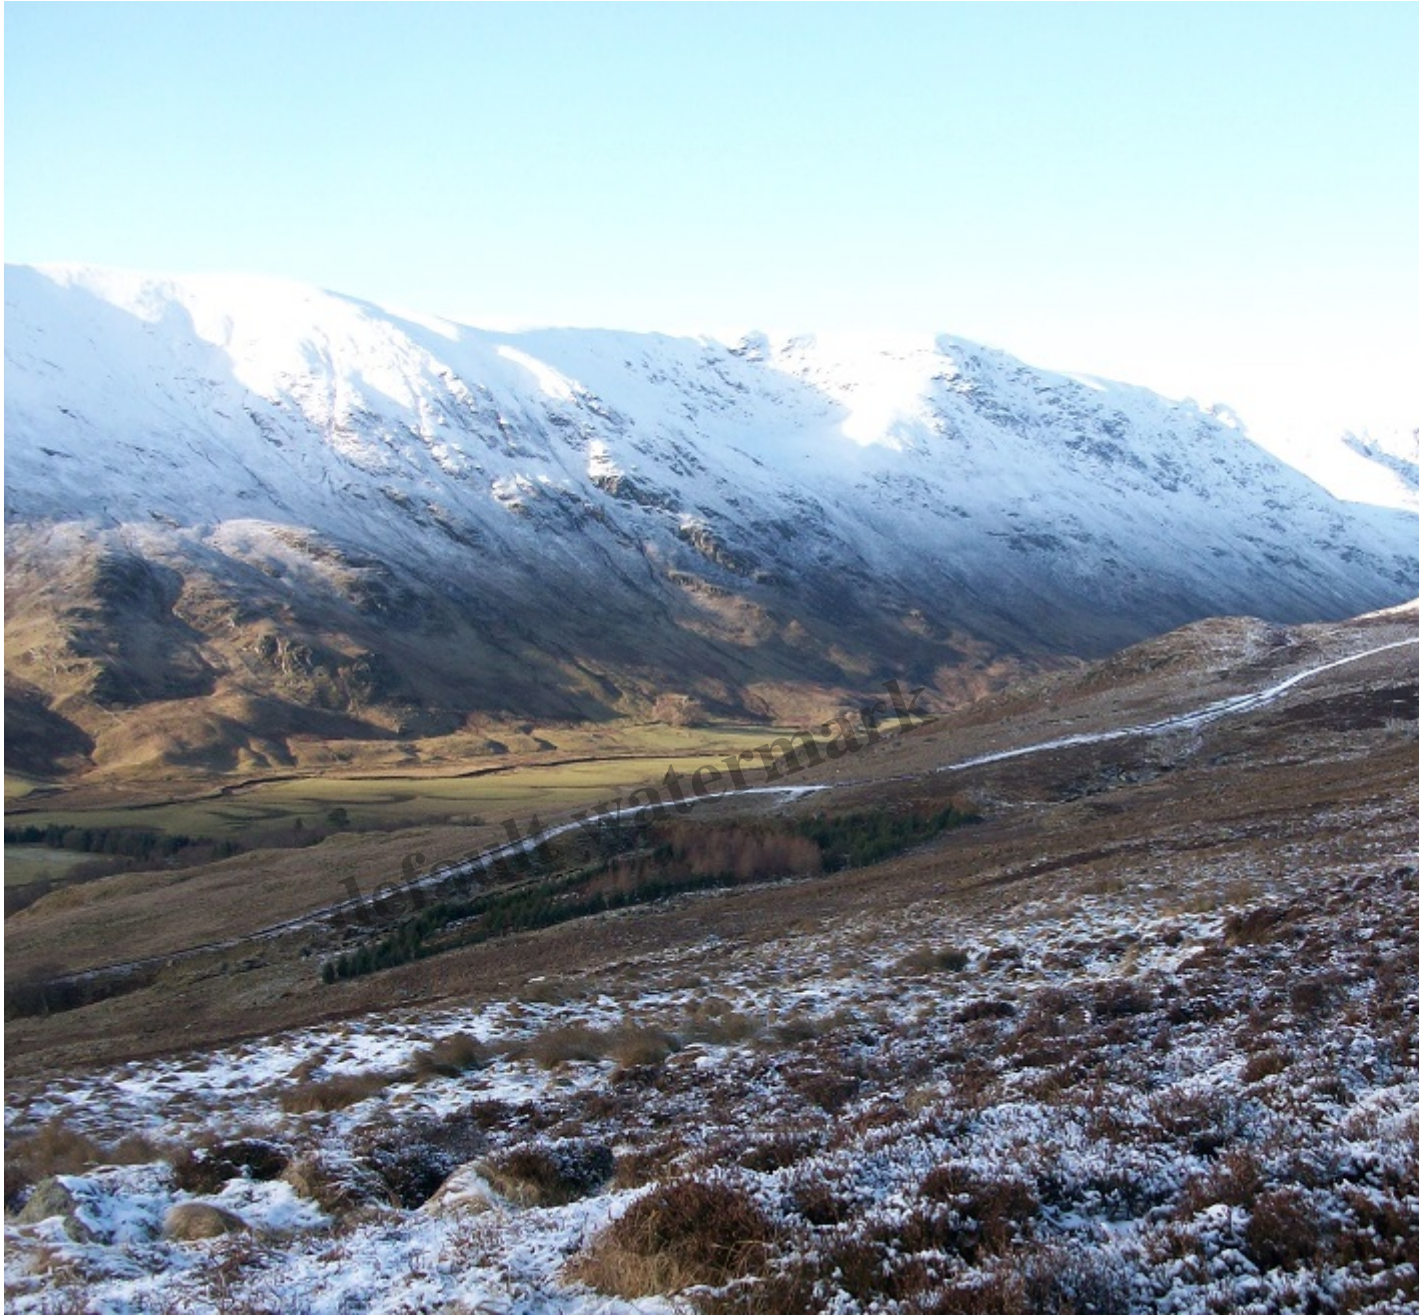
Track 1 – Track above Clova Hotel

Track viewed from Loch Brandy path above hotel – Photo Credit Helen Todd, Scottish LINK hill track

I had wrongly thought (see top photo) that this track had been created in order to construct the hydro scheme above the Glen Clova Hotel. (The consent for the hydro scheme was given to Clova Farms Ltd who appear to be owned by the same people who own the Clova Hotel). No track was consented for that scheme because construction of the two hydro intakes was to be by helicopter and while vehicles were used, the CNPA has kindly confirmed to me in the last two weeks that the track was constructed afterwards and negotiations are still taking place with the landowner.

The track is highly visible from all directions and because of this the CNPA should insist that it is removed. While not built to construct the hydro scheme above the Glen Clova Hotel , it is very clear that it is being used to access the first intake:

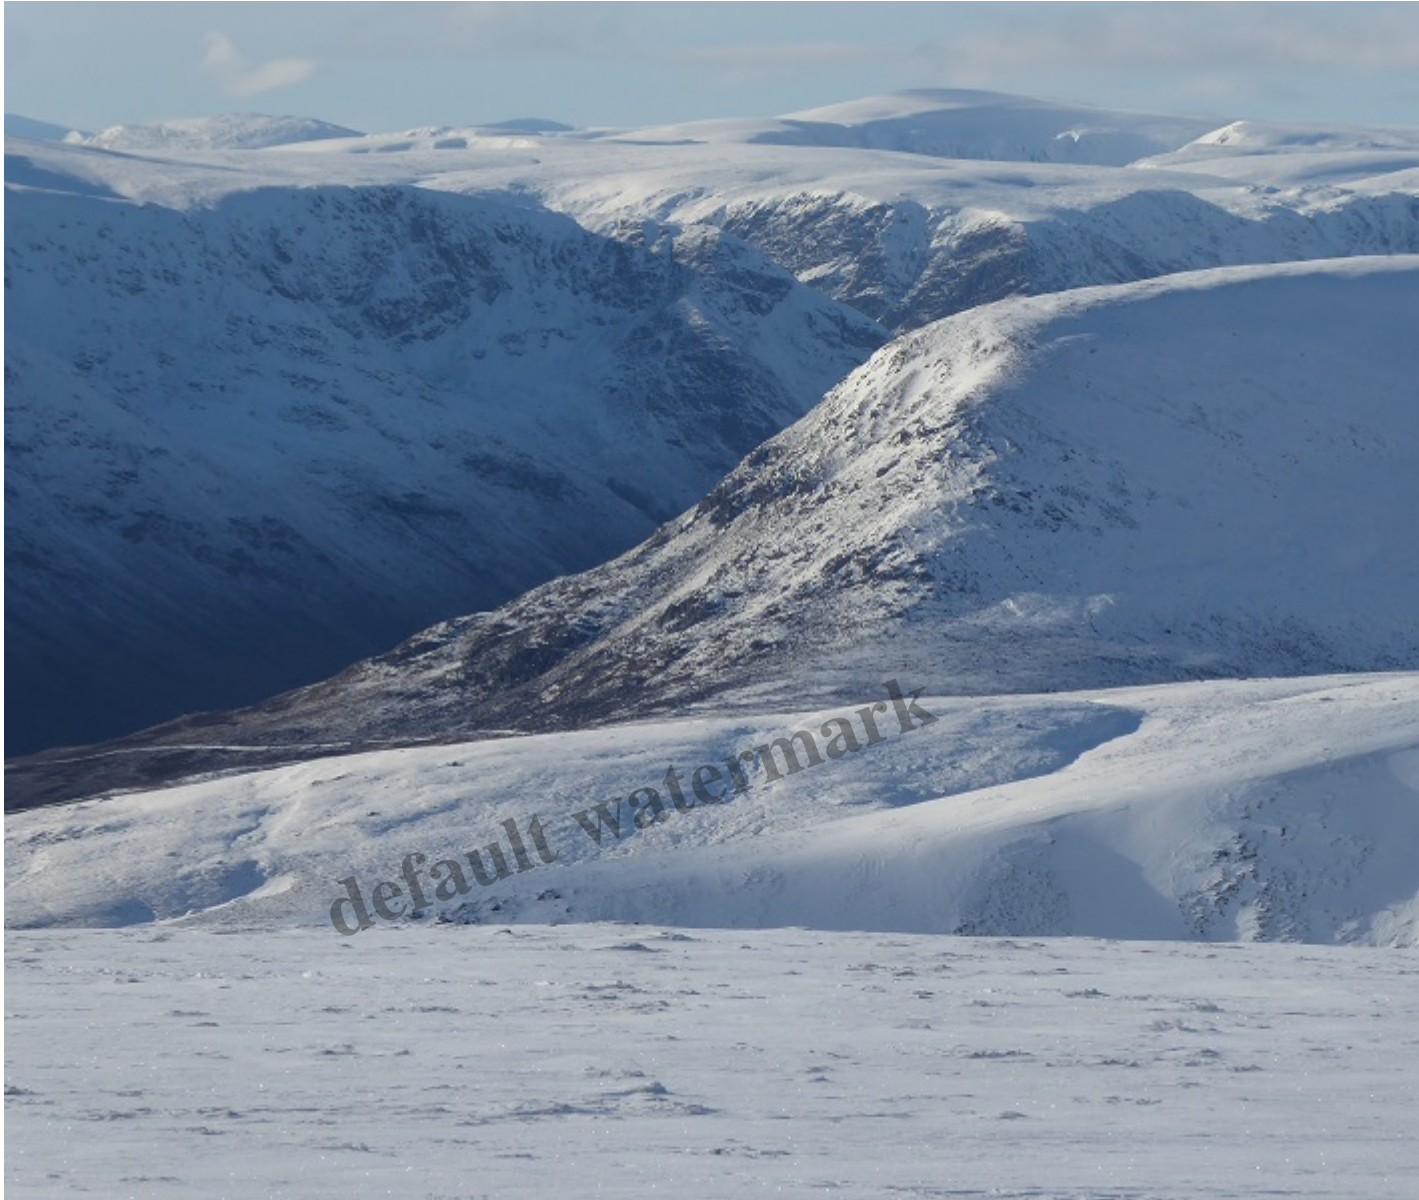
Track viewed from slopes of Ben Tirran

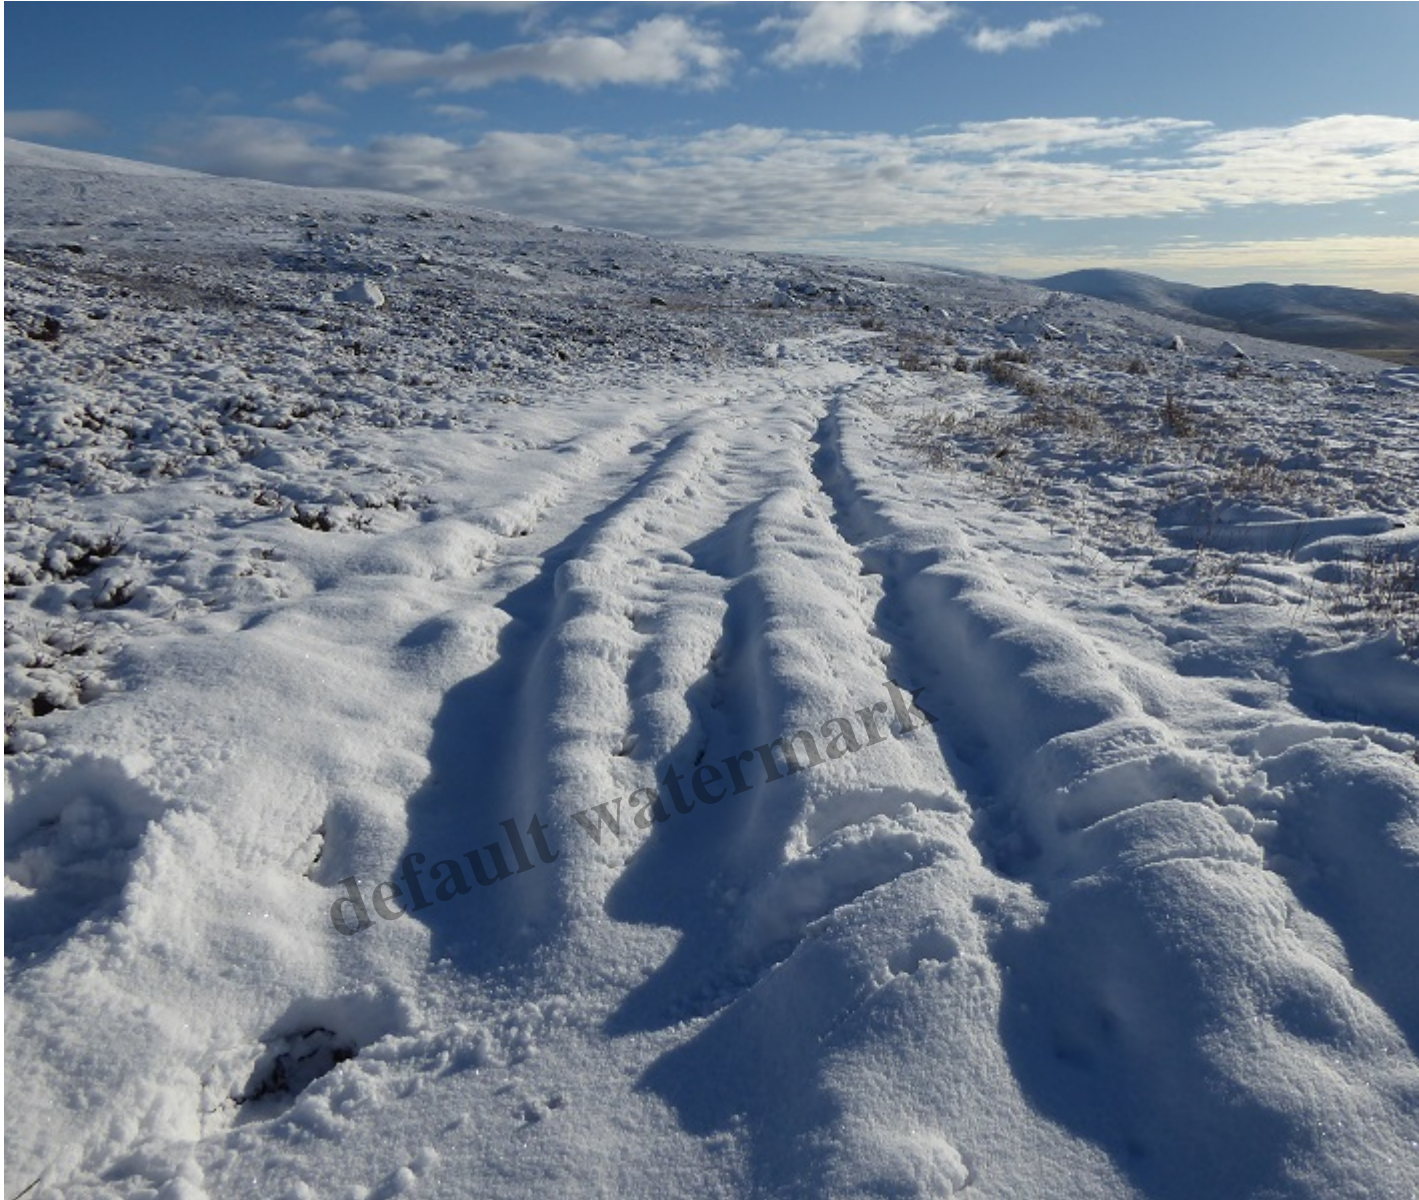
Erosion caused by ATVs driving from the top of the constructed track to the first hydro intake.

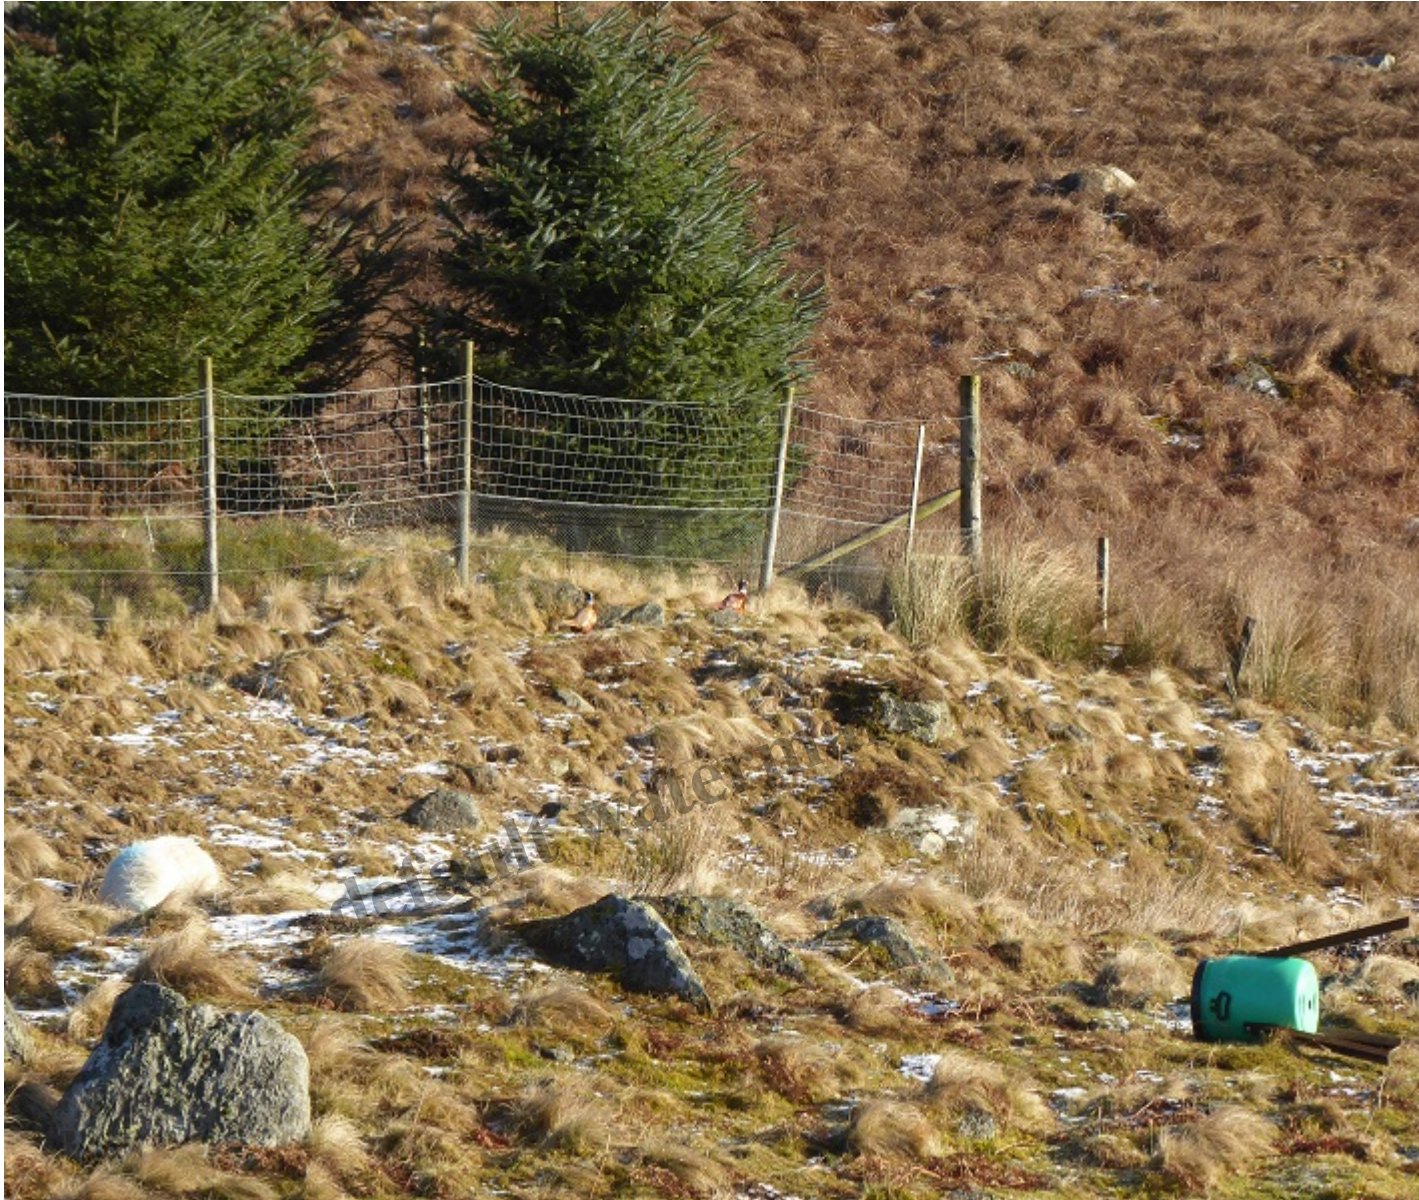
Overtaken feeder and pheasants – there were two feeders by the plantation accessed by an ATV track off the main track

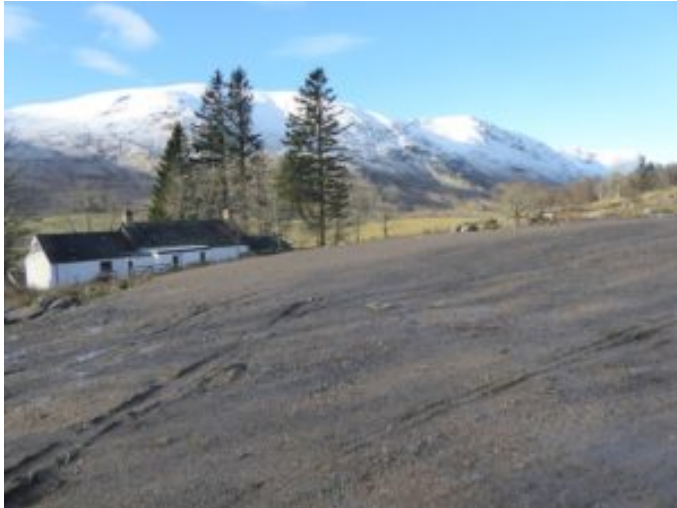
Large area, purpose unknown, at start of track

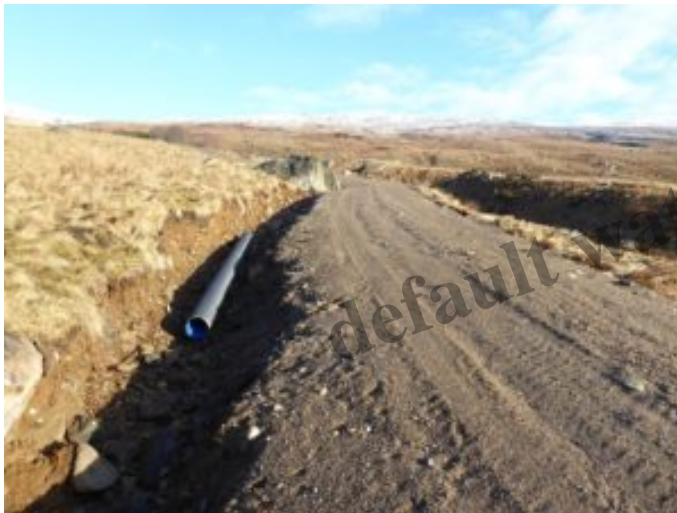
Poorly constructed ditch and abandoned?
section of pipe

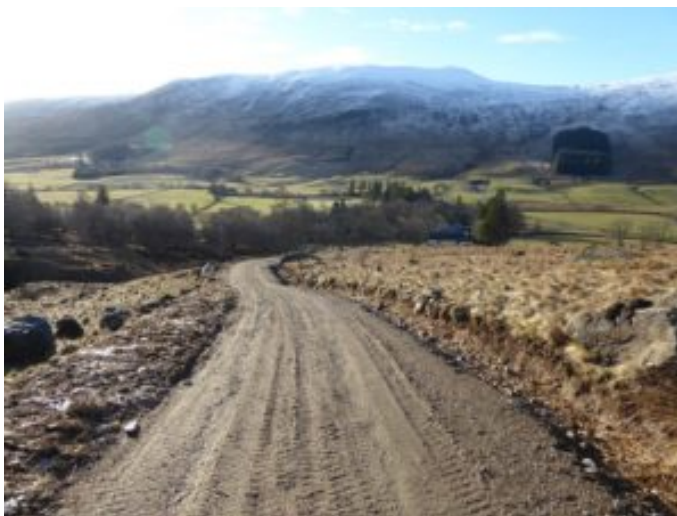
As well as being highly prominent, sections of the track are far too steep and will erode

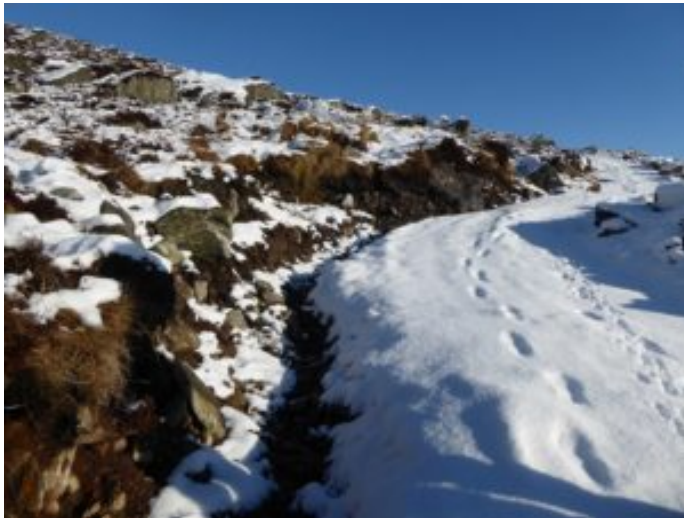
While the upper part of the track was under snow, there was still evidence of very poor construction

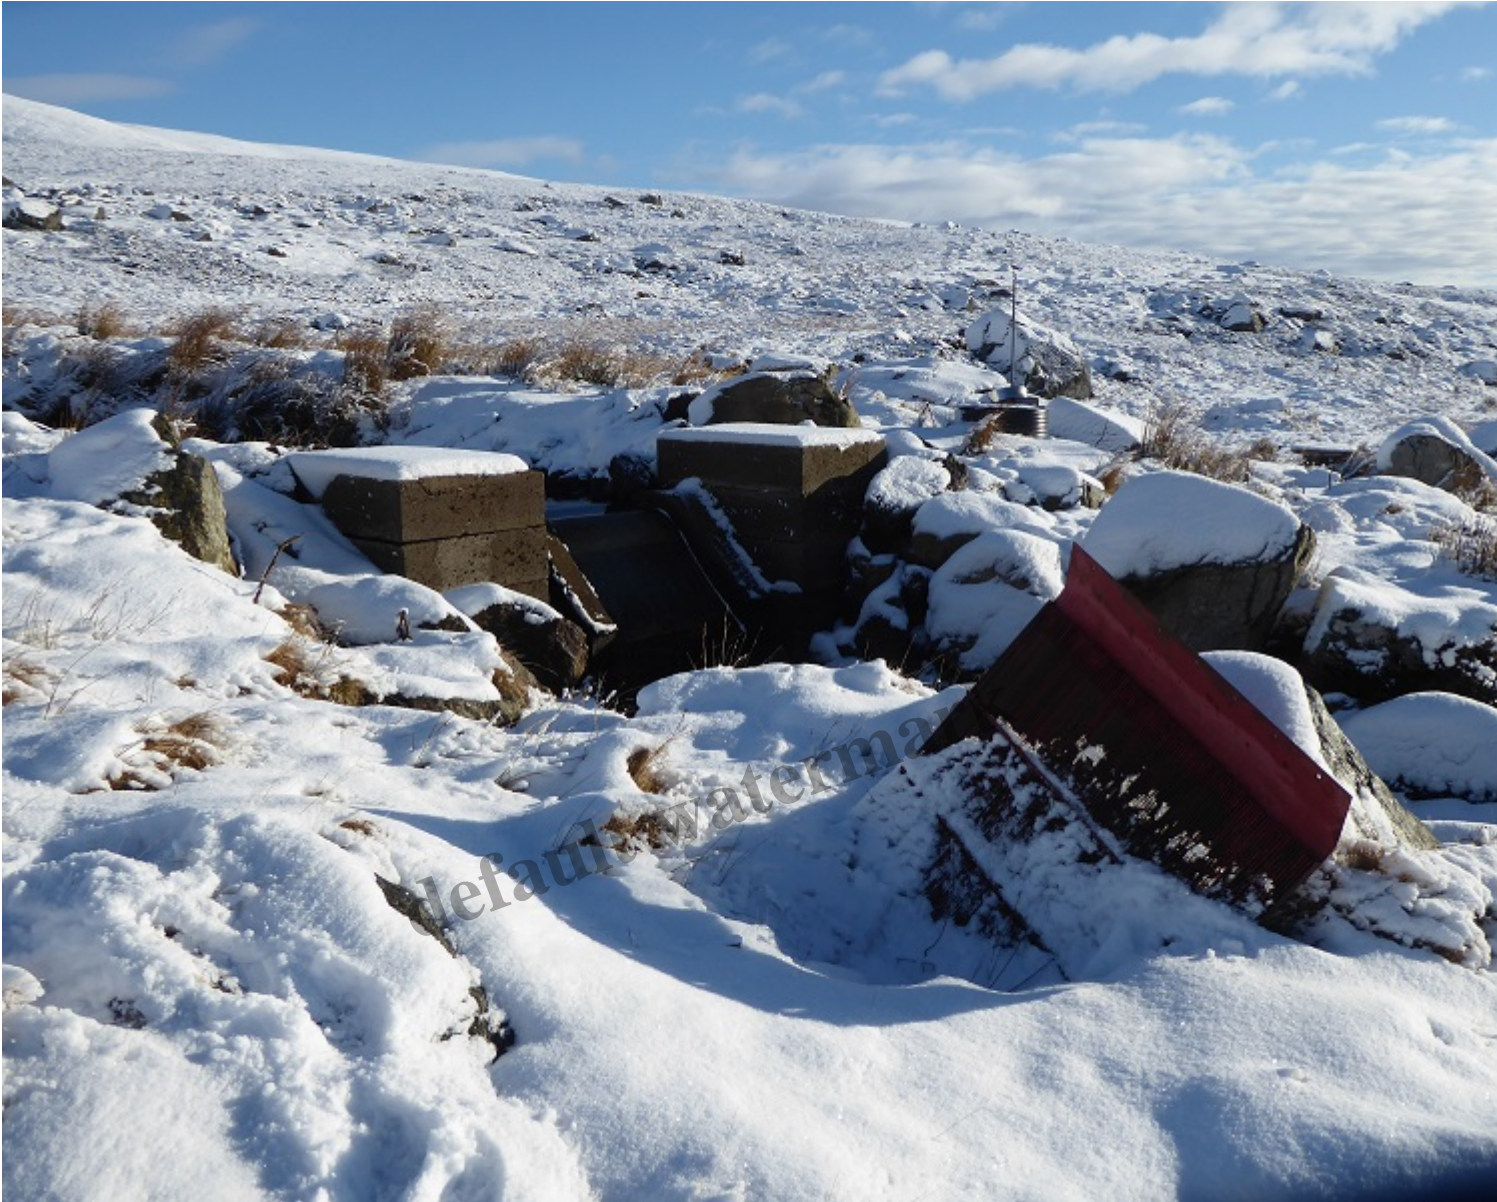
The original intake screen for the hydro – its a tiny intake and I suspect dries up in summer – has already been replaced but instead of removing the old red screen its been left dumped on the site.

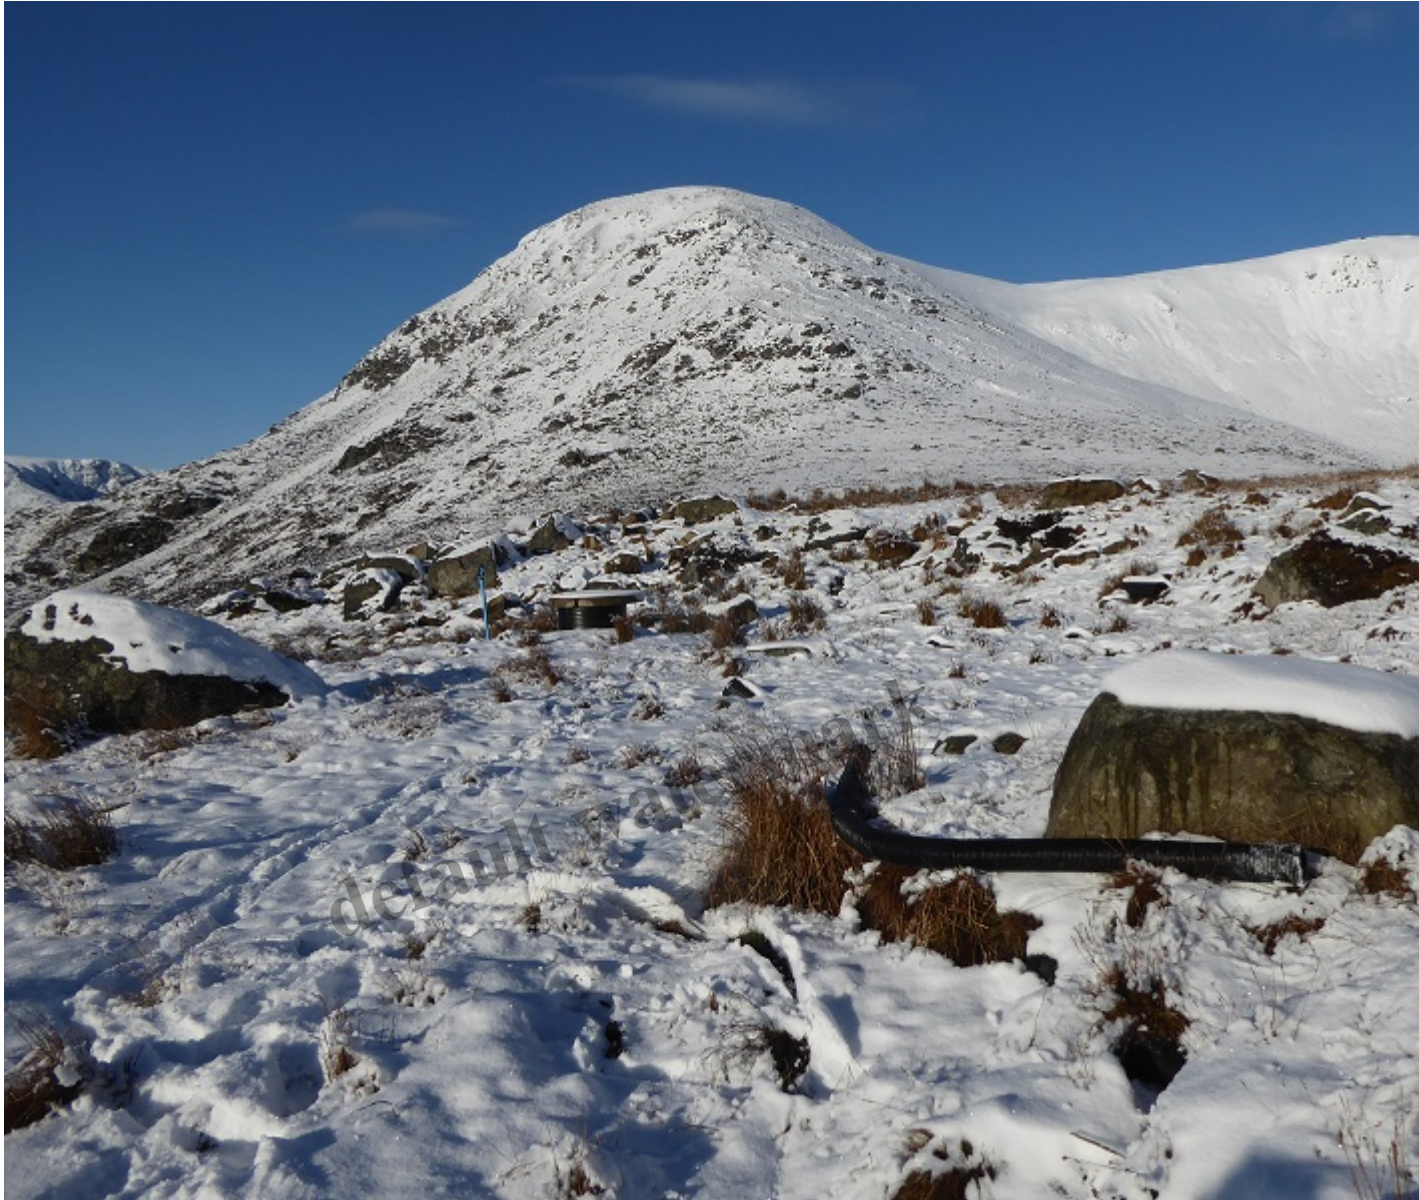
The line of the pipeline is marked by our footprints.

Besides being poorly designed – you can make out a bright “Lomond” blue pipe and concrete lid to pipe access – we walked by several sections of abandoned pipe. I don’t know if the Cairngorms National Park Authority have visited the intakes but they need to order a clear-up.

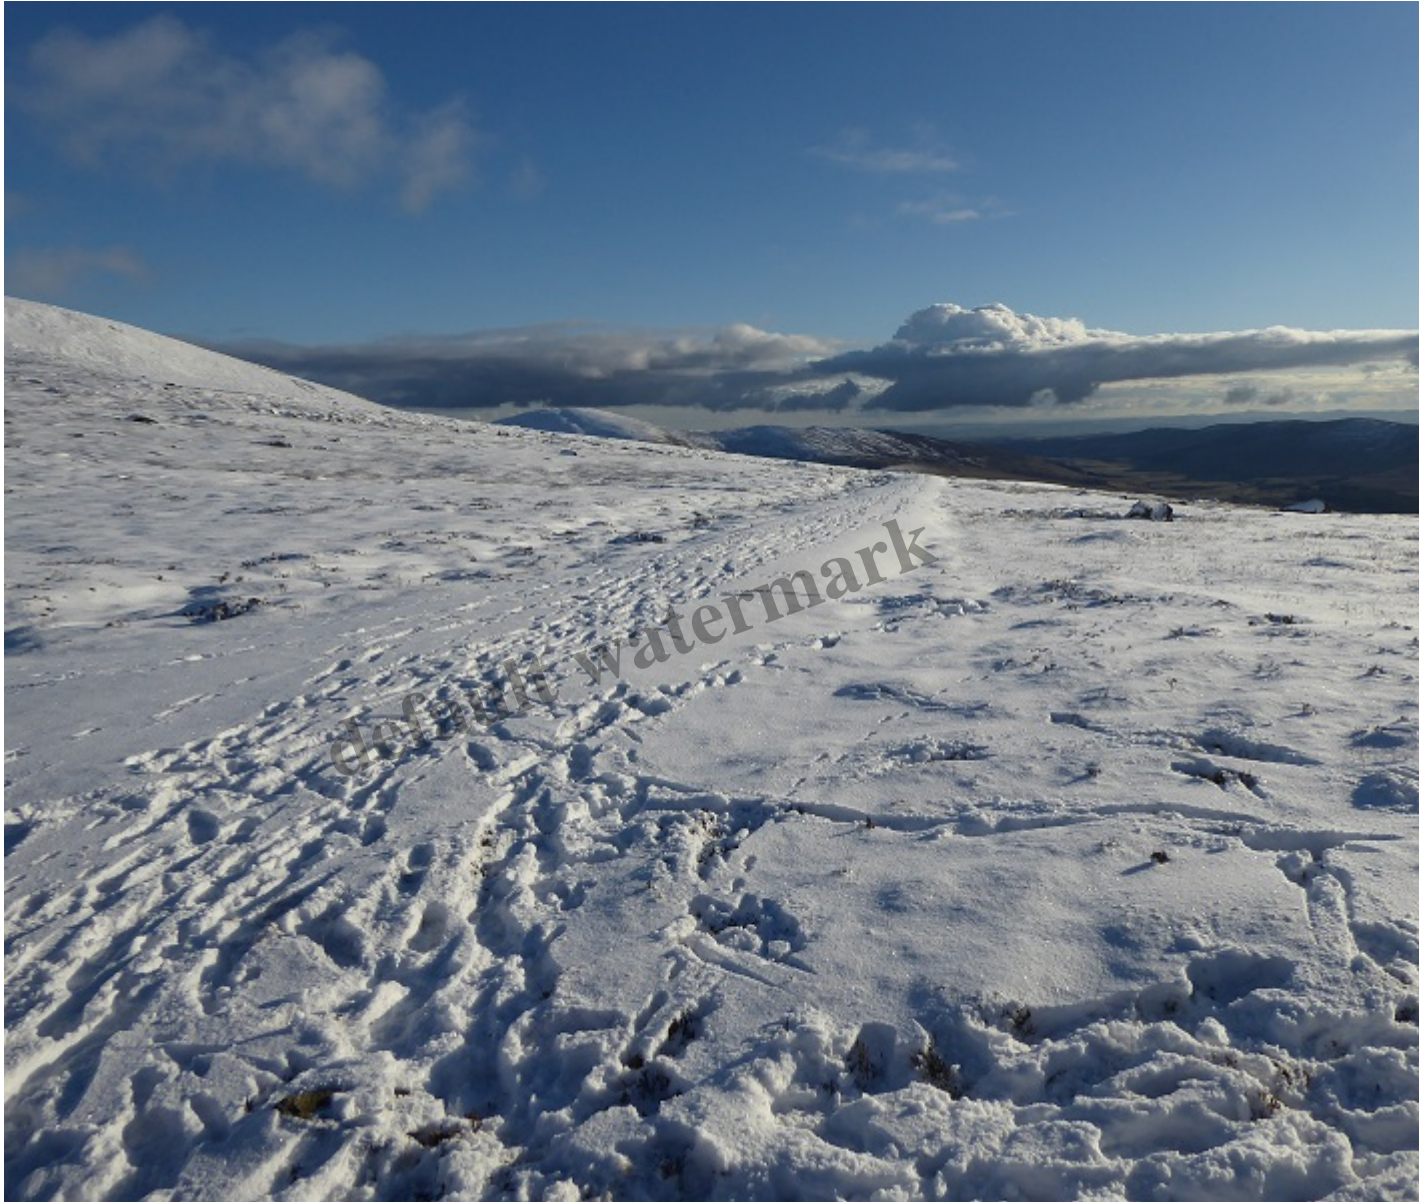
Top of Track 2 which ends at Loch Wharral

I did not walk along Track 2 which follows the line of the old path up to Loch Wharral and a newly constructed bothy but even under snow you could see it forms a prominent way across the moor.

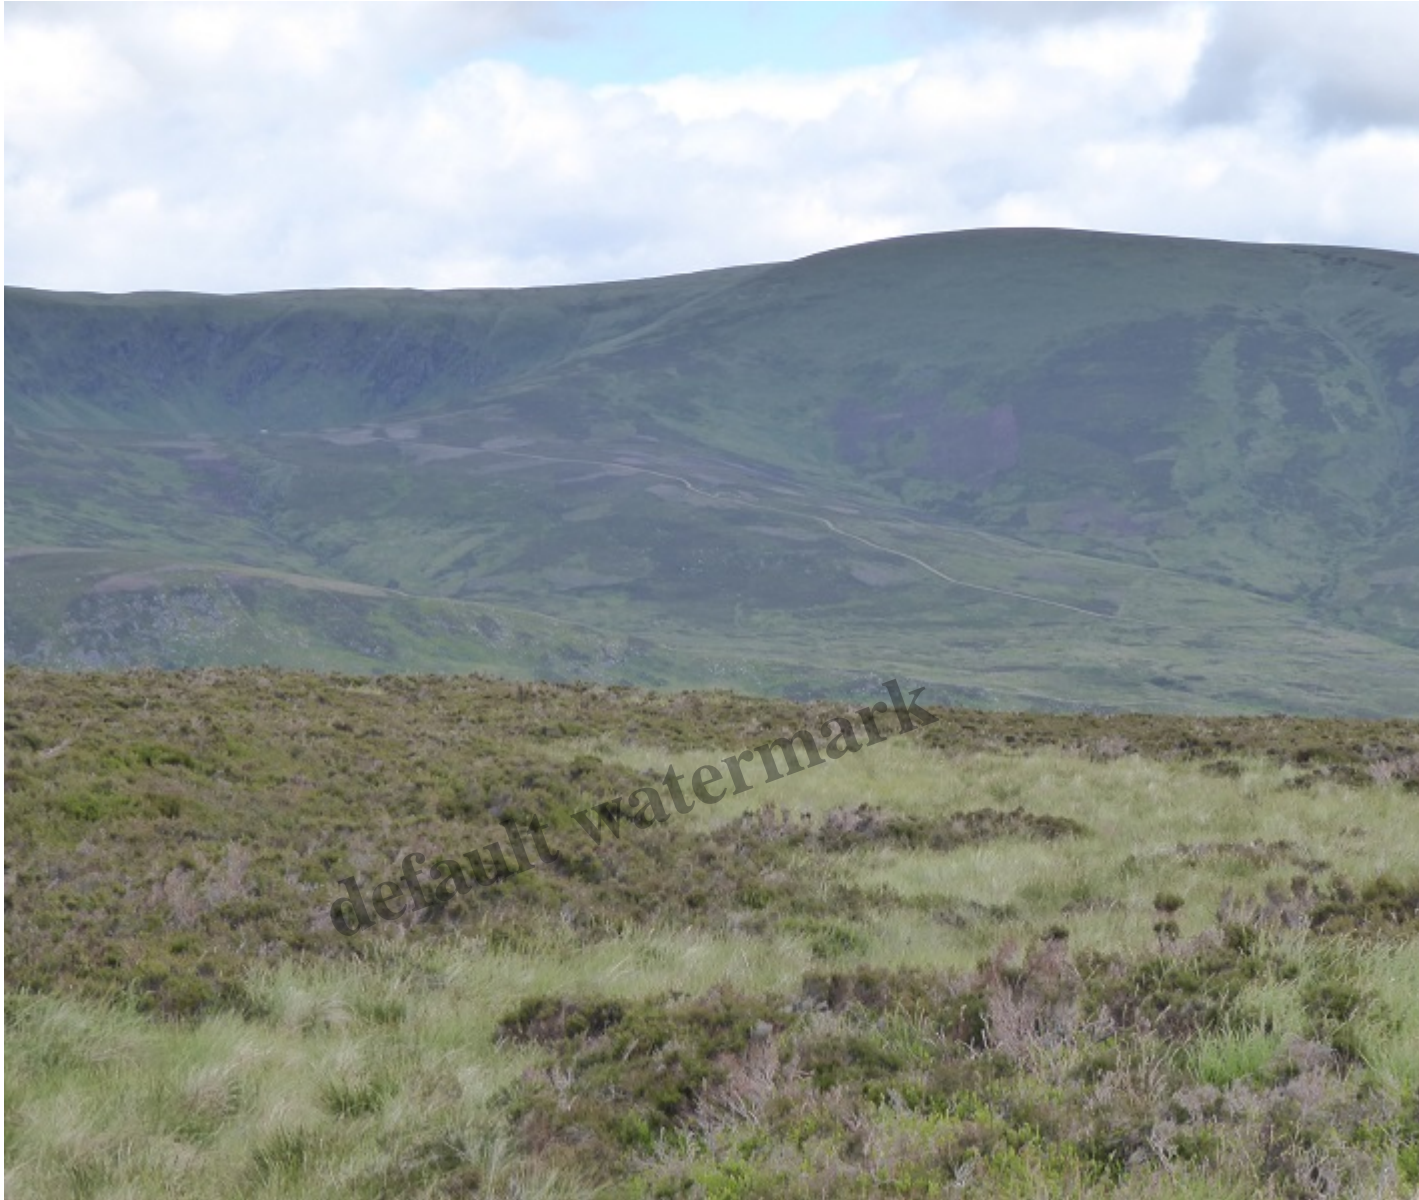
The track to Loch Wharral, the tiny whitish spot at the end of the track and on the bottom of the coire – photo June 2016

This track is on the Rottal estate, which has been responsible for creating several further tracks outside the National Park Boundary (which runs up Ben Tirran, the hill on the right). According to the Cairngorms National Park Authority the track had been created by 2012 at latest while the bothy – there had been a ruin here before apparently though its not on my old map – was built sometime between 2008 and 2014. Neither had planning permission.

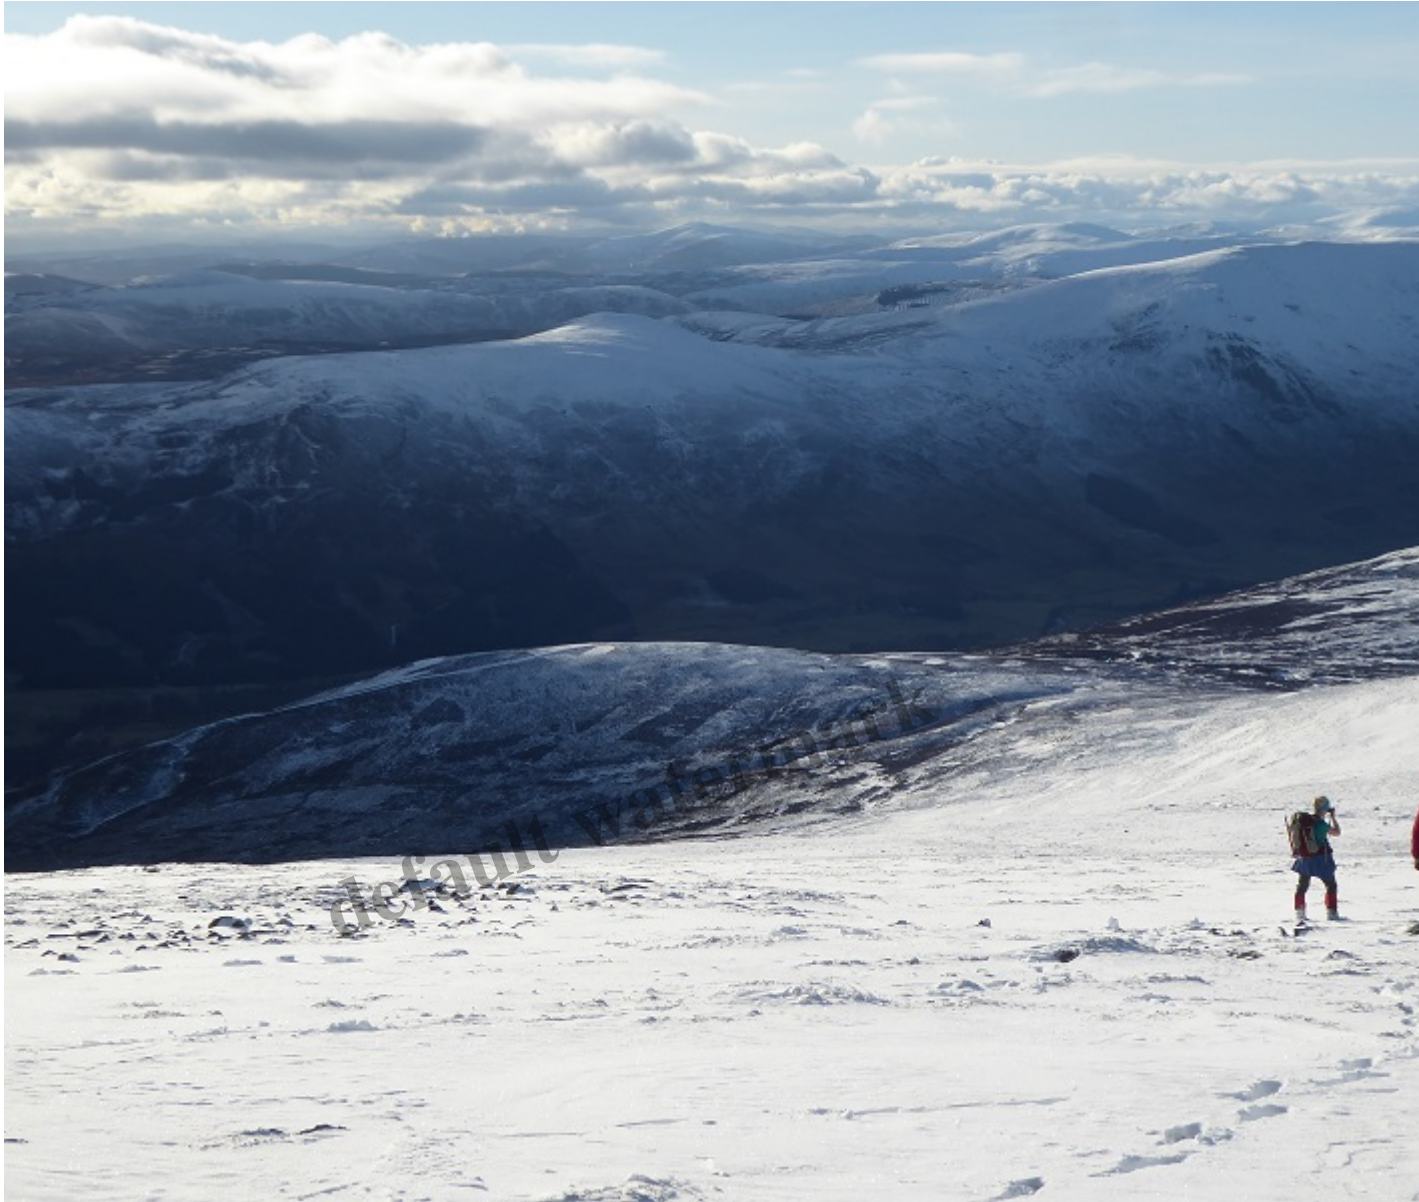
The track over Rough Craigs, the ridge on the near side of Glen Clova, from west slopes of Ben Tirra

According to the CNPA, the track over Rough Craig had also been constructed by 2012 and is therefore outside planning enforcement time limits. Following as it does the crest of the ridge and being built up above the surrounding moor it forms another very prominent landscape scar.

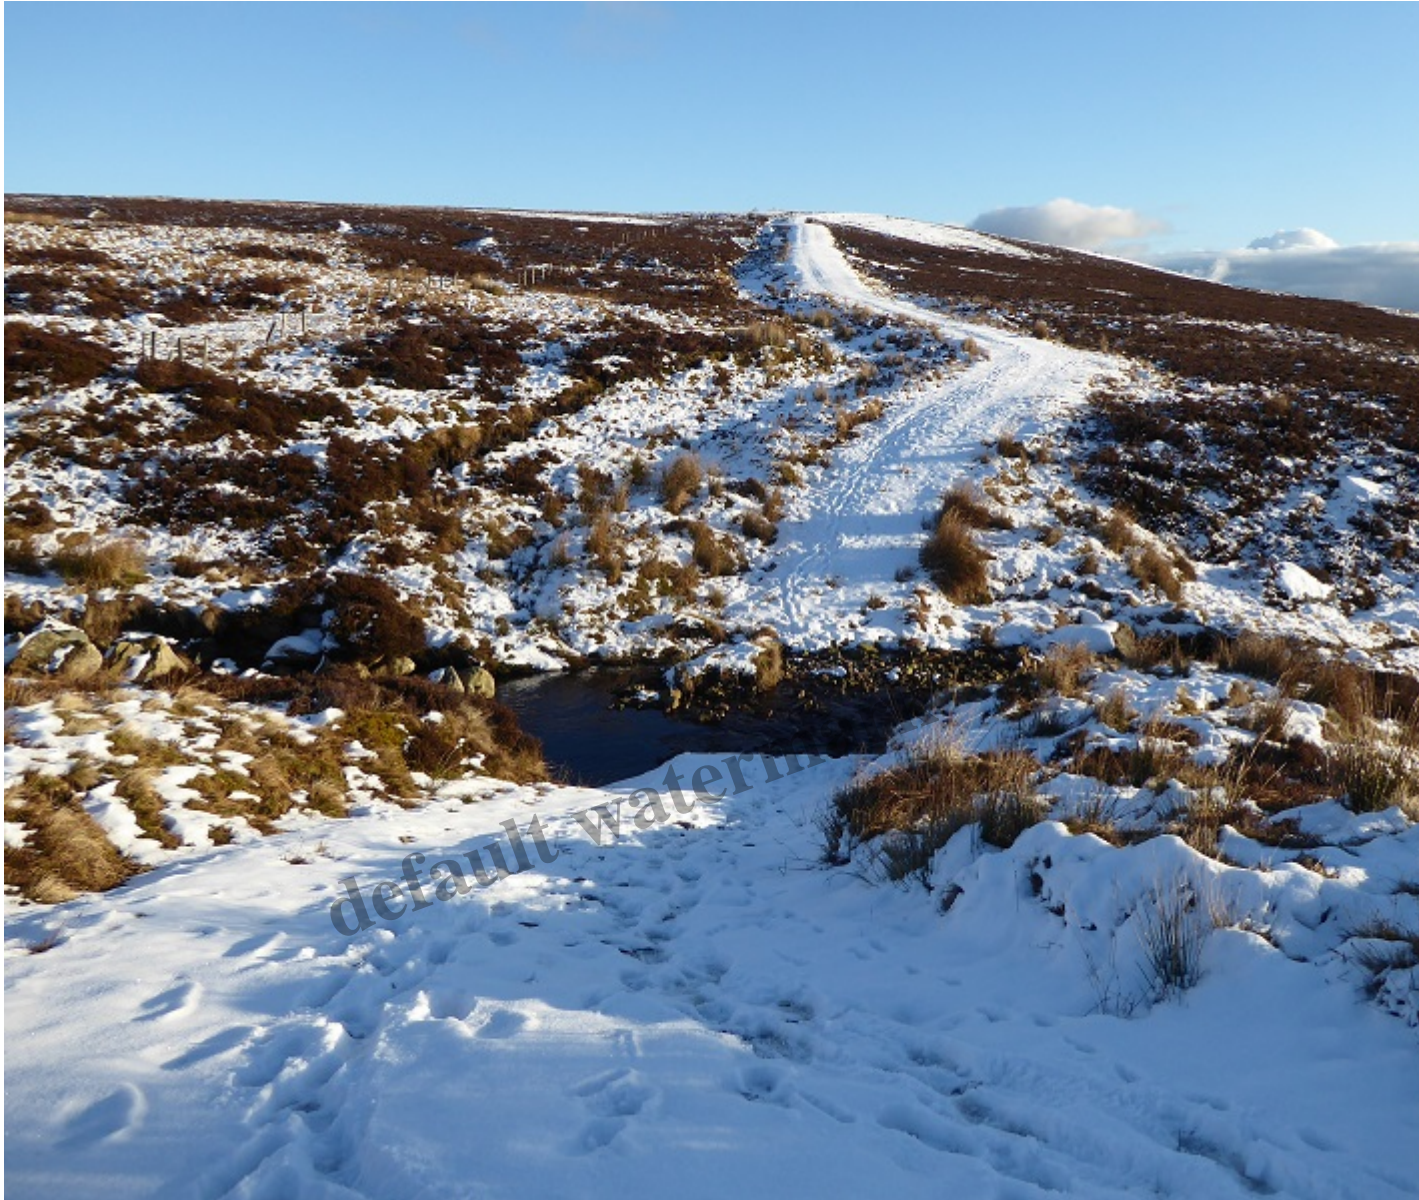
The northern end of the Rough Craigs track close to the estate boundary, and electric fence, where i
