The unlawful Glen Clova hill tracks – time for action

Two weeks ago, when I was in Glen Clova, I went to take a closer look at some of the tracks I had seen while doing a round of the Glen Prosen skyline ([see here](#)). This post takes a further look at what has been happening. None of the five tracks featured here appears on the OS Map used on either the Cairngorms National Park Authority or Angus Council Planning Portals:

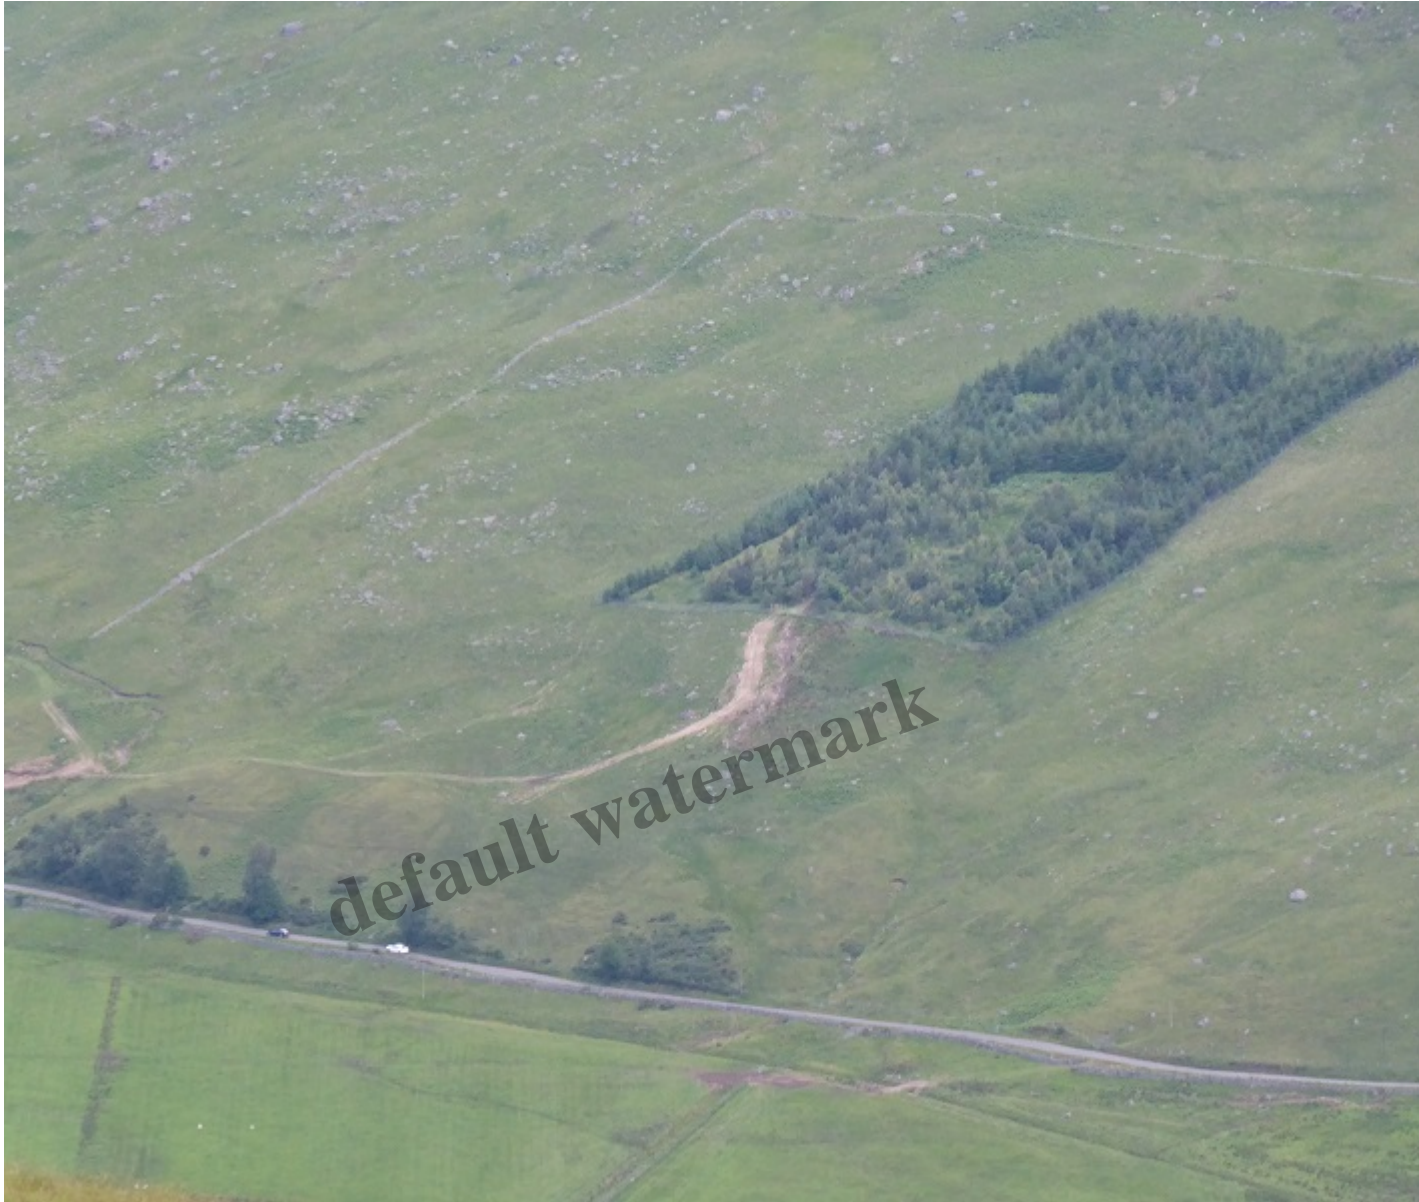
I did not have time to visit Track 4 which is highly prominent when you are driving up Glen Clova and from a distance. While significantly shorter than other tracks, this track is a good demonstration of the impact “forest” tracks can have when crossing open ground and why all forest tracks should require full planning permission. I have no information of when this track was constructed but unless its been since December 2014, when the Prior Notification was introduced, the CNPA is very unlikely to be able to take any enforcement action.

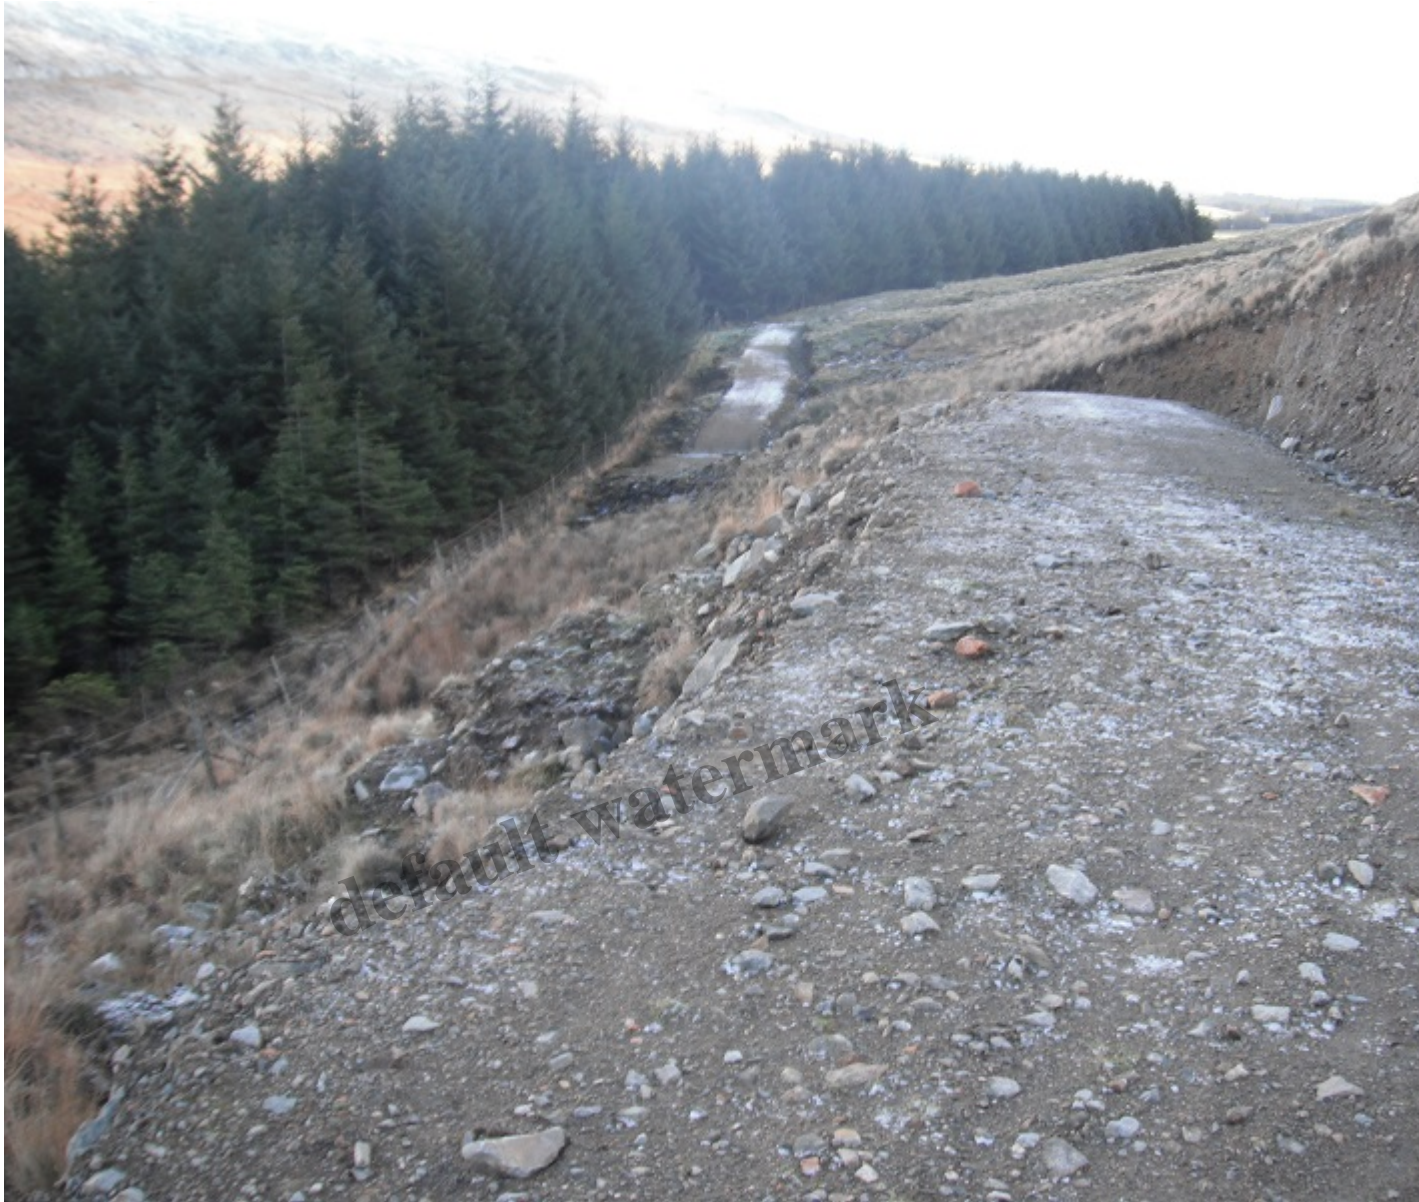
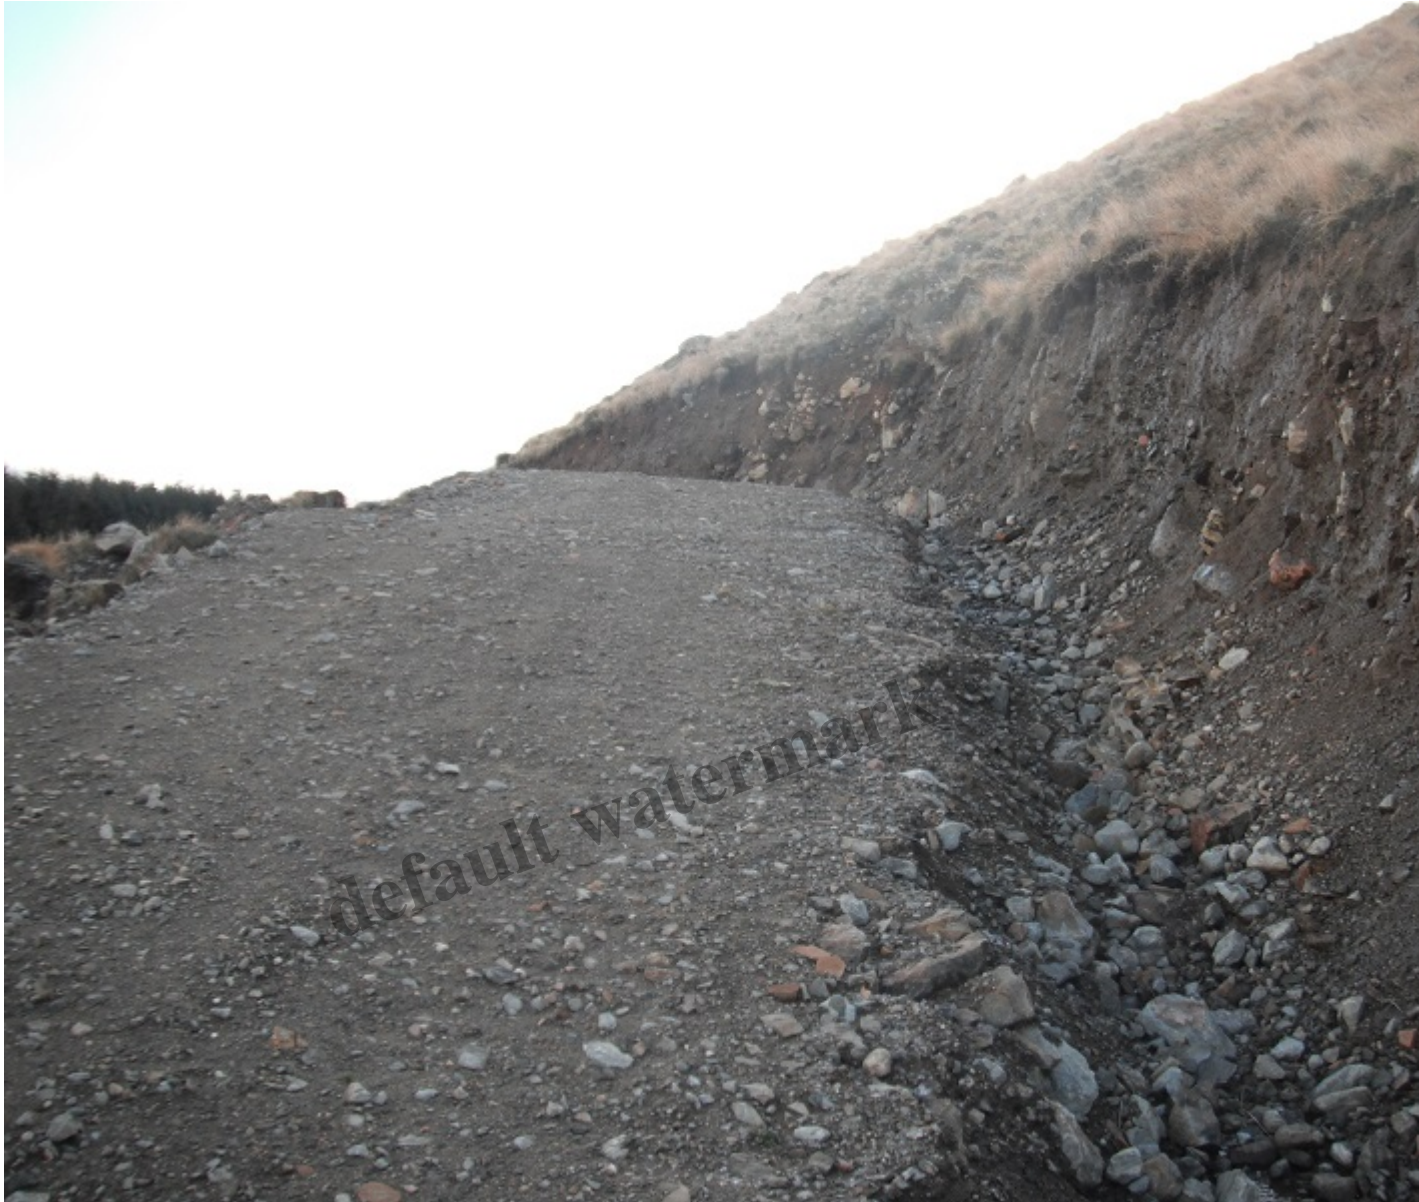
Track 5

Across the glen, on the west side of the river, north of the hotel, behind a plantation so not visible from the road, there is yet another track which George Allan told me about. Again I have not visited but George reported it to the CNPA and it apparently pre-dates the Prior Notification system, so yet again no action can be taken, although in terms of construction its the most shocking of all the tracks:

Our National Parks also need new powers to ensure that older hill tracks, which could not now be removed even if the law changes, are of a good standard of design and construction.

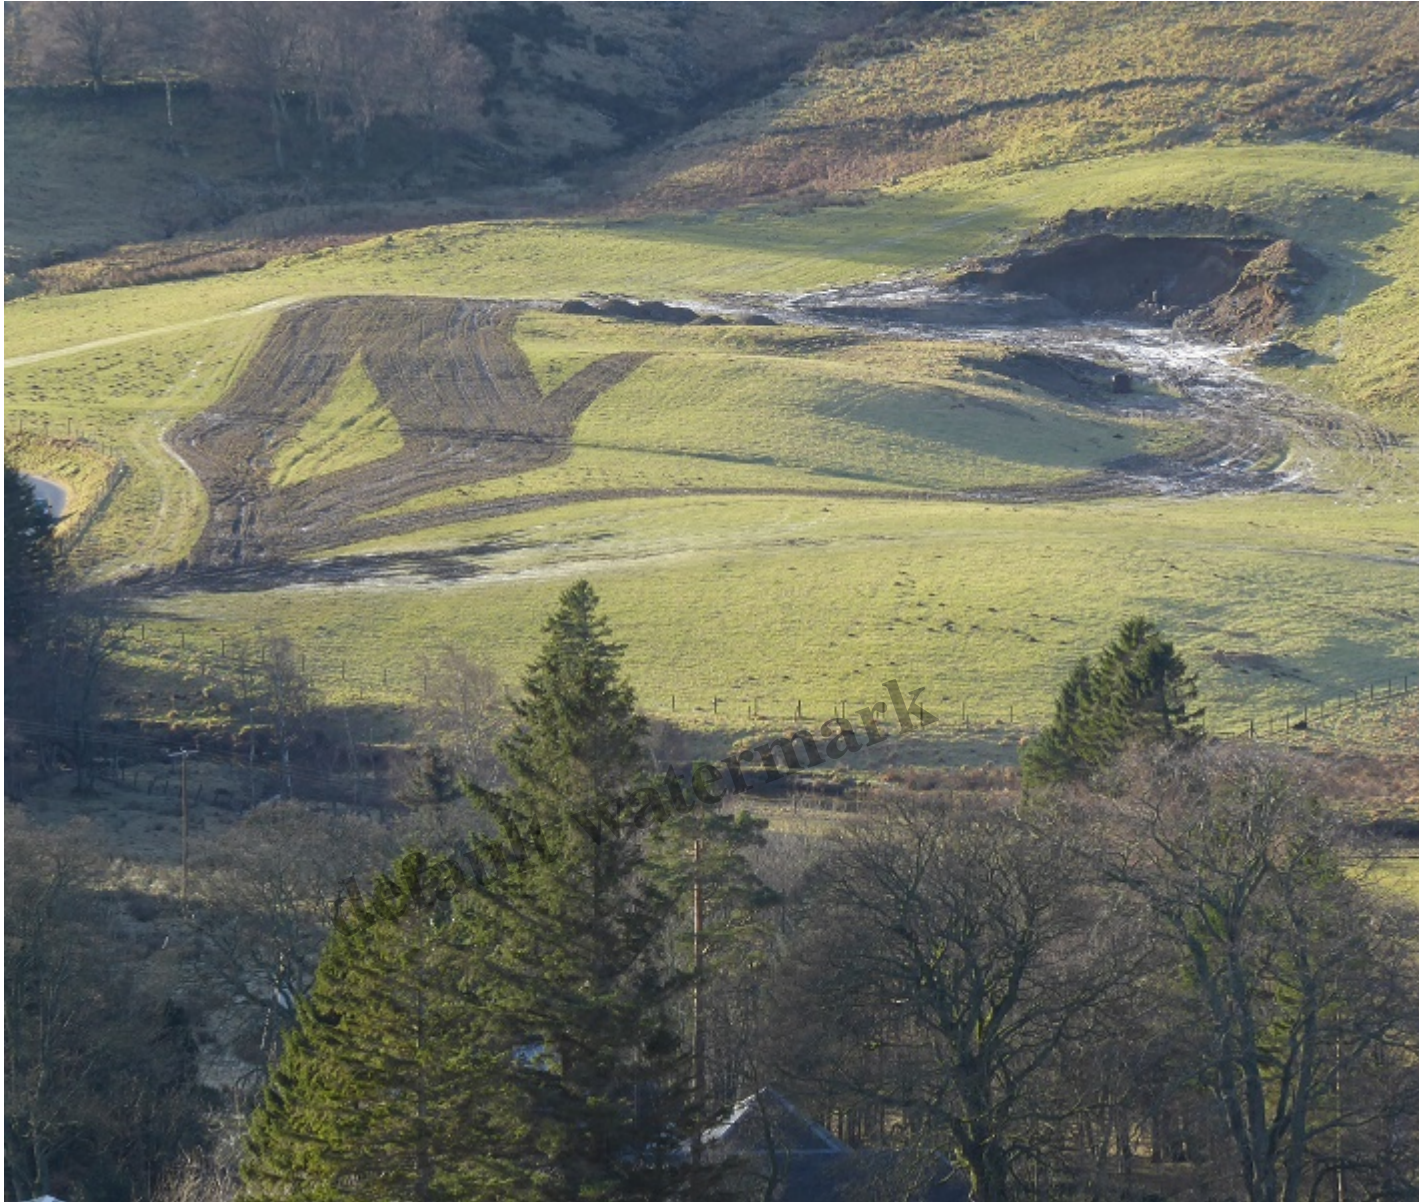
Earthworks opposite Glen Clova Hotel

Here is a photo of work currently going on in the glen. There have been historic issues in Glen Clova with landforms being altered without appropriate permissions and this has been reported to the CNPA. We will see what happens but if you see earthworks or earth moving equipment in the National Park report it!
