The unlawful Glen Clova hill tracks â?? time for action

Track 1 â?? Track above Clova Hotel

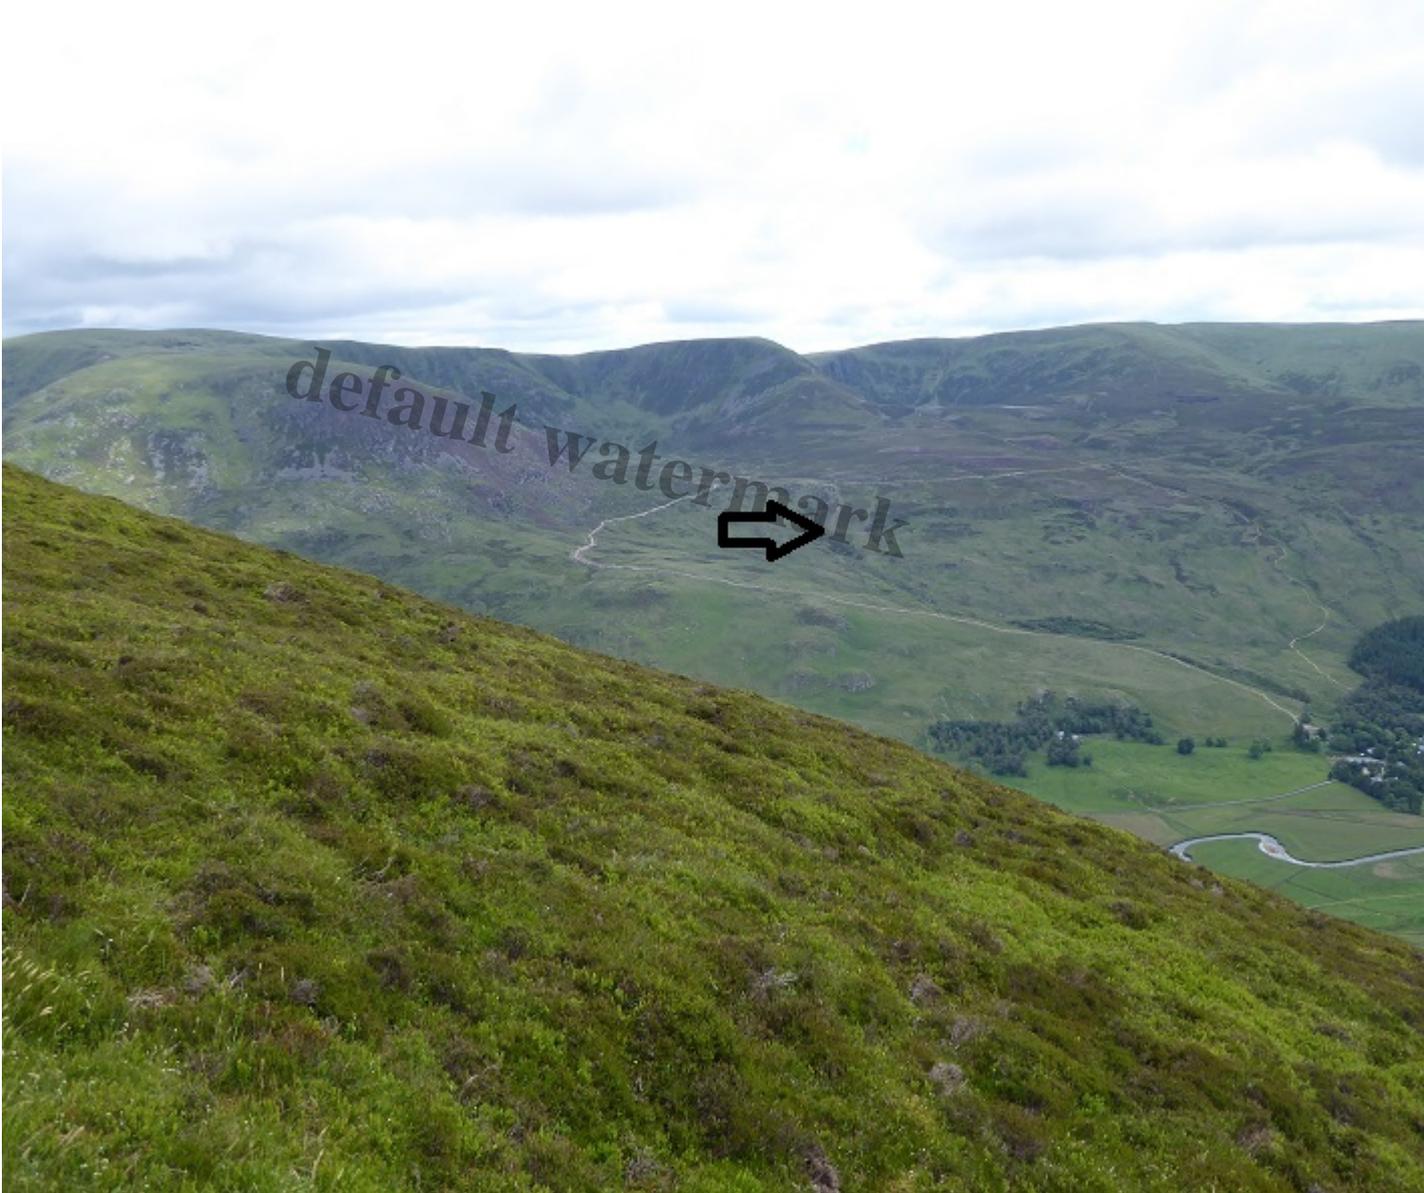
The track above the Clova Hotel as photographed in June 2017. The faint horizontal line across the the arrow marks the pipeline connecting two hydro intakes and is not a constructed track as I had the used by All Terrain Vehicles. The black arrow indicates the top section of the buried pipeline.

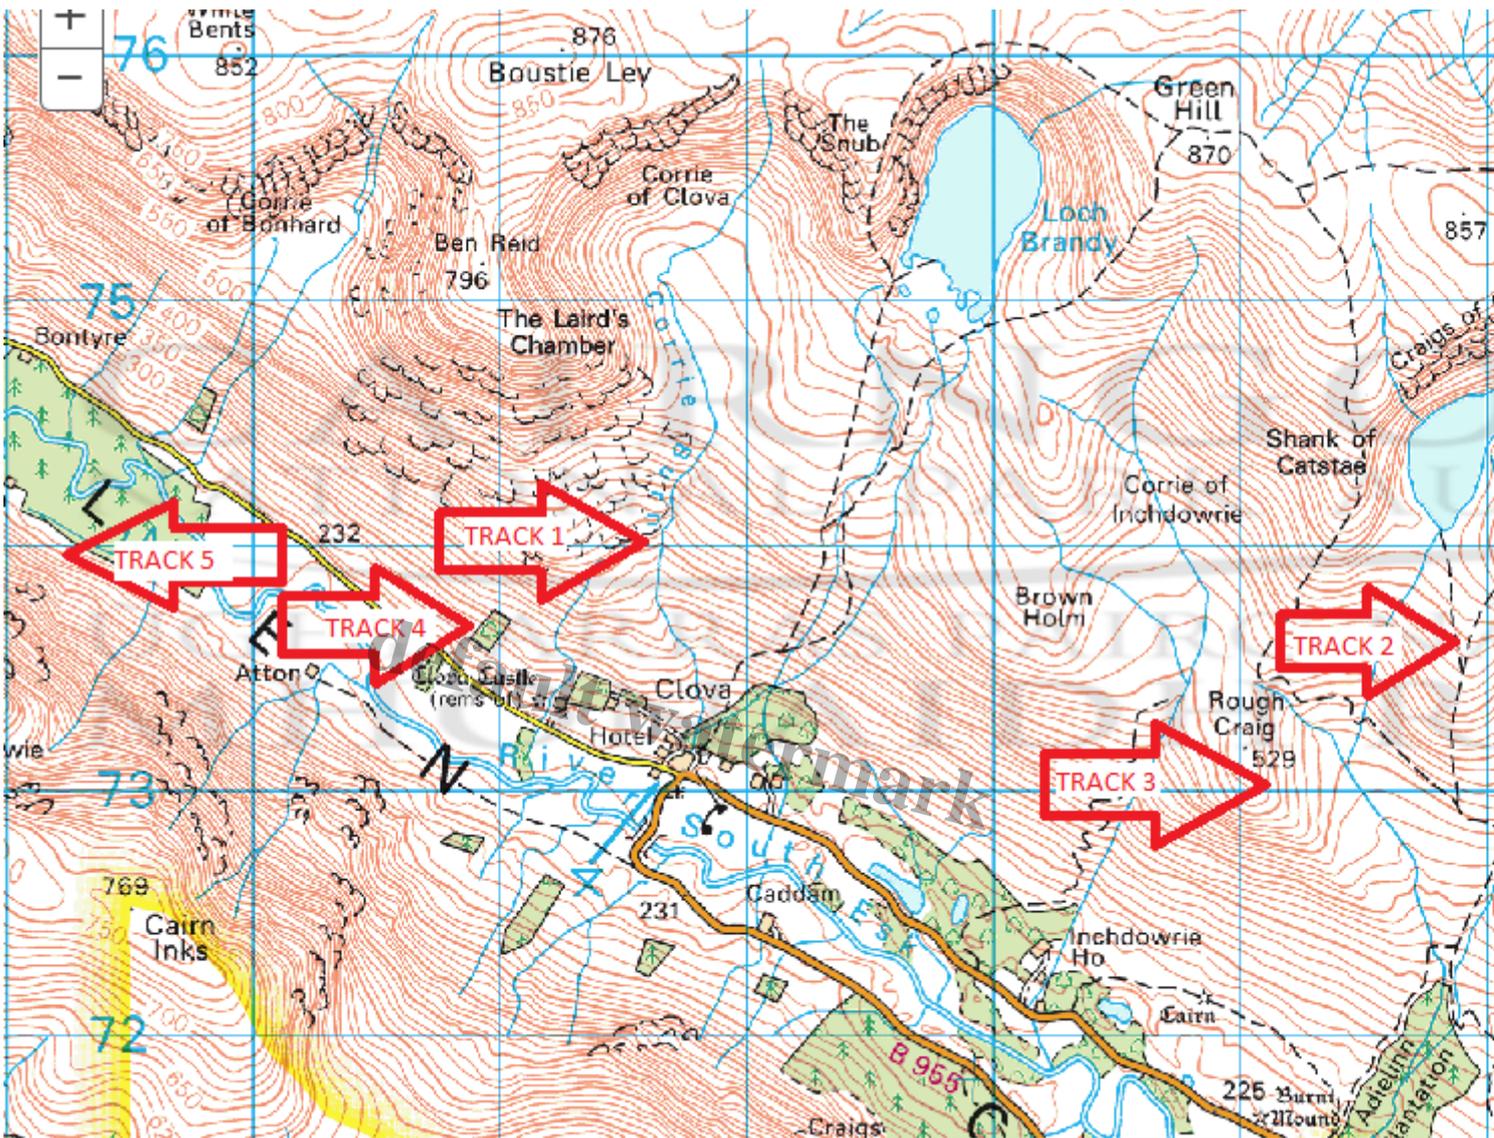
Two weeks ago, when I was in Glen Clova, I went to take a closer look at some of the tracks I had seen while doing a round of the Glen Prosen skyline ([see here](#)). This post takes a further look at what has been happening. None of the five tracks featured here appears on the OS Map used on either the Cairngorms National Park Authority or Angus Council Planning Portals:

If you zoom in further on the map to the level that shows planning applications, there are none at all for these tracks or for the new bothy by Loch Wharral at the top of Track 2. While it is arguable that Track 4 was constructed for forestry purposes, and therefore did not need any type of planning permission before the introduction of Prior Notification system in 2014, in my view all the other tracks should have required full planning permission. Whatever the legal position, in my view an extremely fine area of landscape within a National Park has been trashed in a very short period of time without any public debate and without the consent of the Cairngorms National Park Authority. What even more appalling is that, apart from Track 1, there is very little the Cairngorms National Park Authority can do about it.

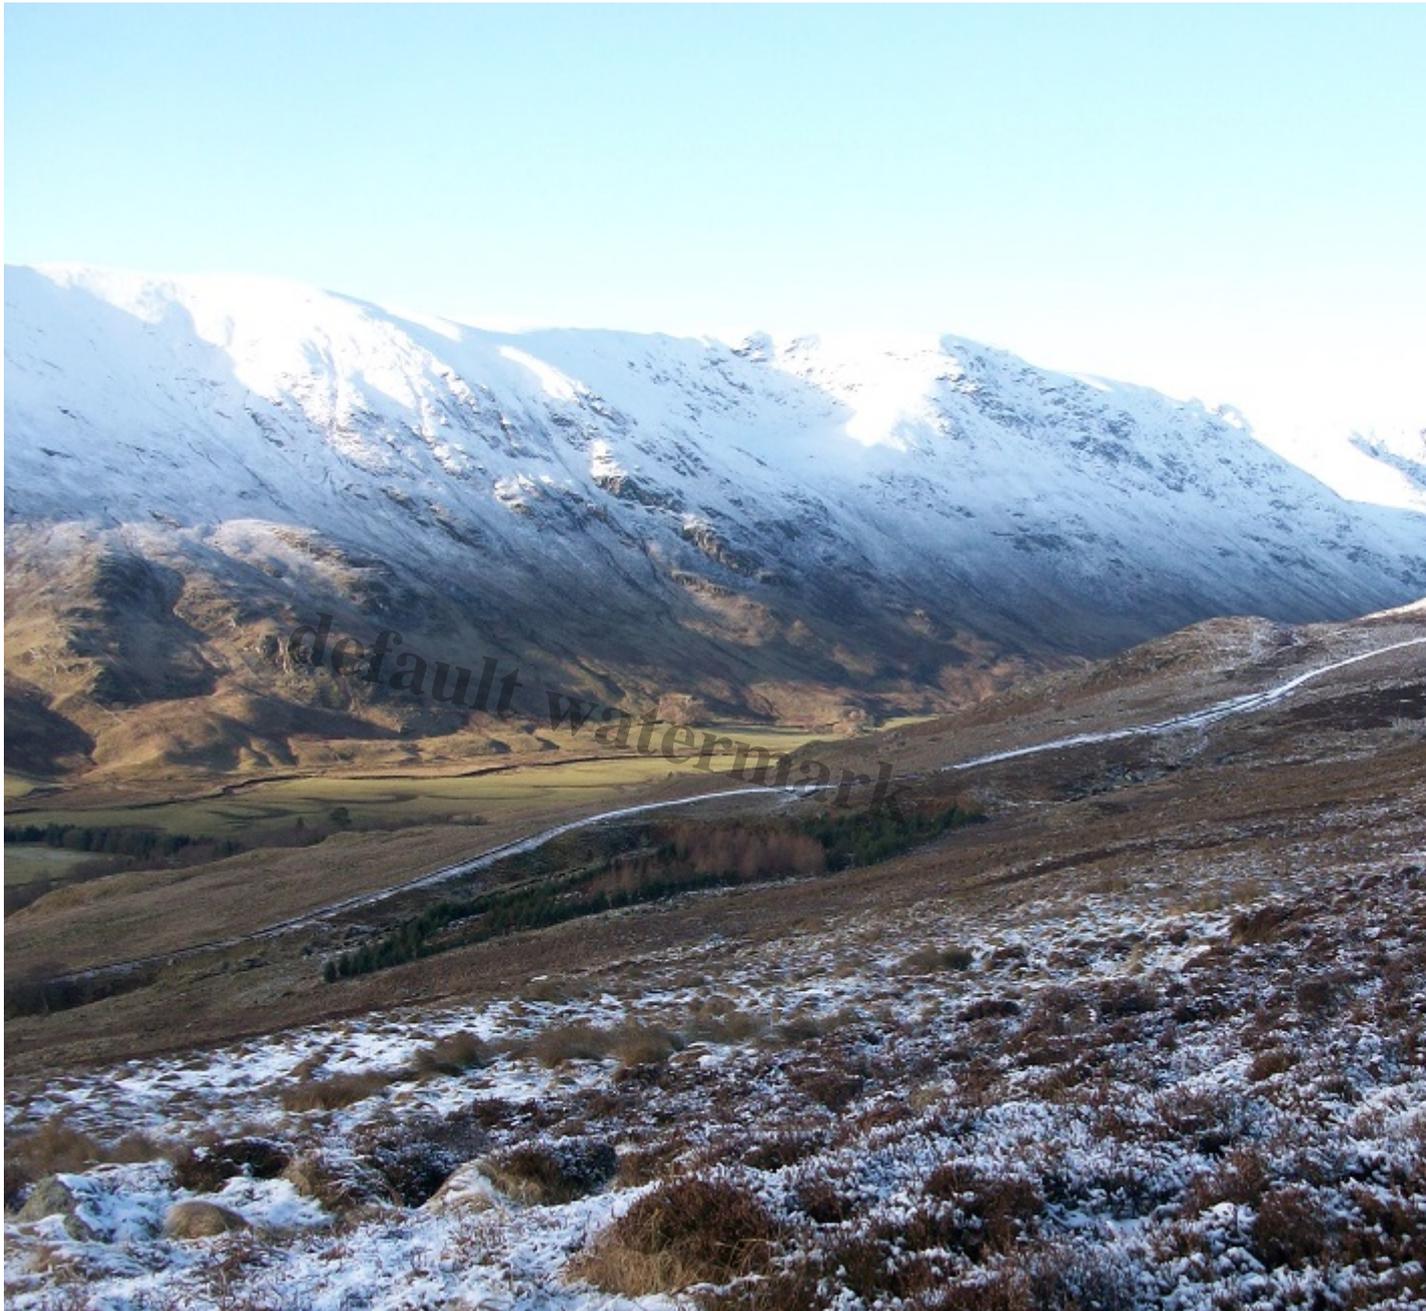
Track viewed from Loch Brandy path above hotel â?? Photo Credit Helen Todd, Scottish LINK hill tra

I had wrongly thought (see top photo) that this track had been created in order to construct the hydro scheme above the Glen Clova Hotel. (The consent for the hydro scheme was given to Clova Farms Ltd who appear to be owned by the same people who own the Clova Hotel). No track was consented for that scheme because construction of the two hydro intakes was to be by helicopter and while vehicles were used, the CNPA has kindly confirmed to me in the last two weeks that the track was constructed afterwards and negotiations are still taking place with the landowner.

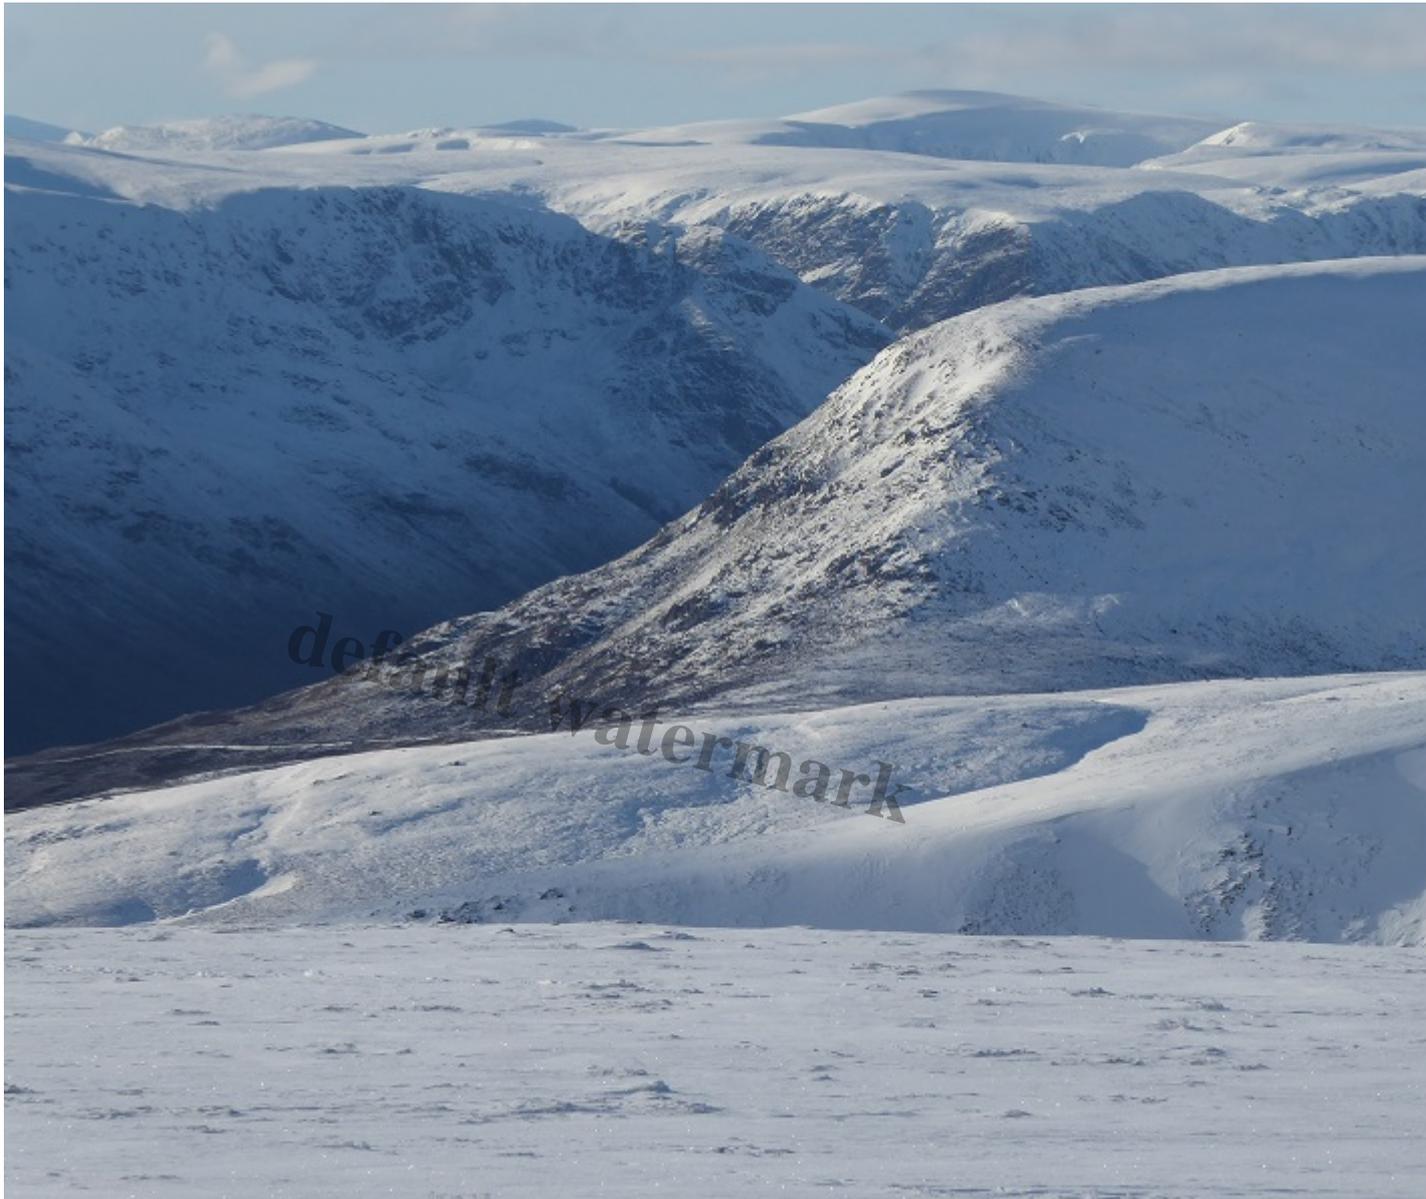
Track viewed from slopes of Ben Tirran

The track is highly visible from all directions and because of this the CNPA should insist that it is removed. While not built to construct the hydro scheme above the Glen Clova Hotel , it is very clear that it is being used to access the first intake:

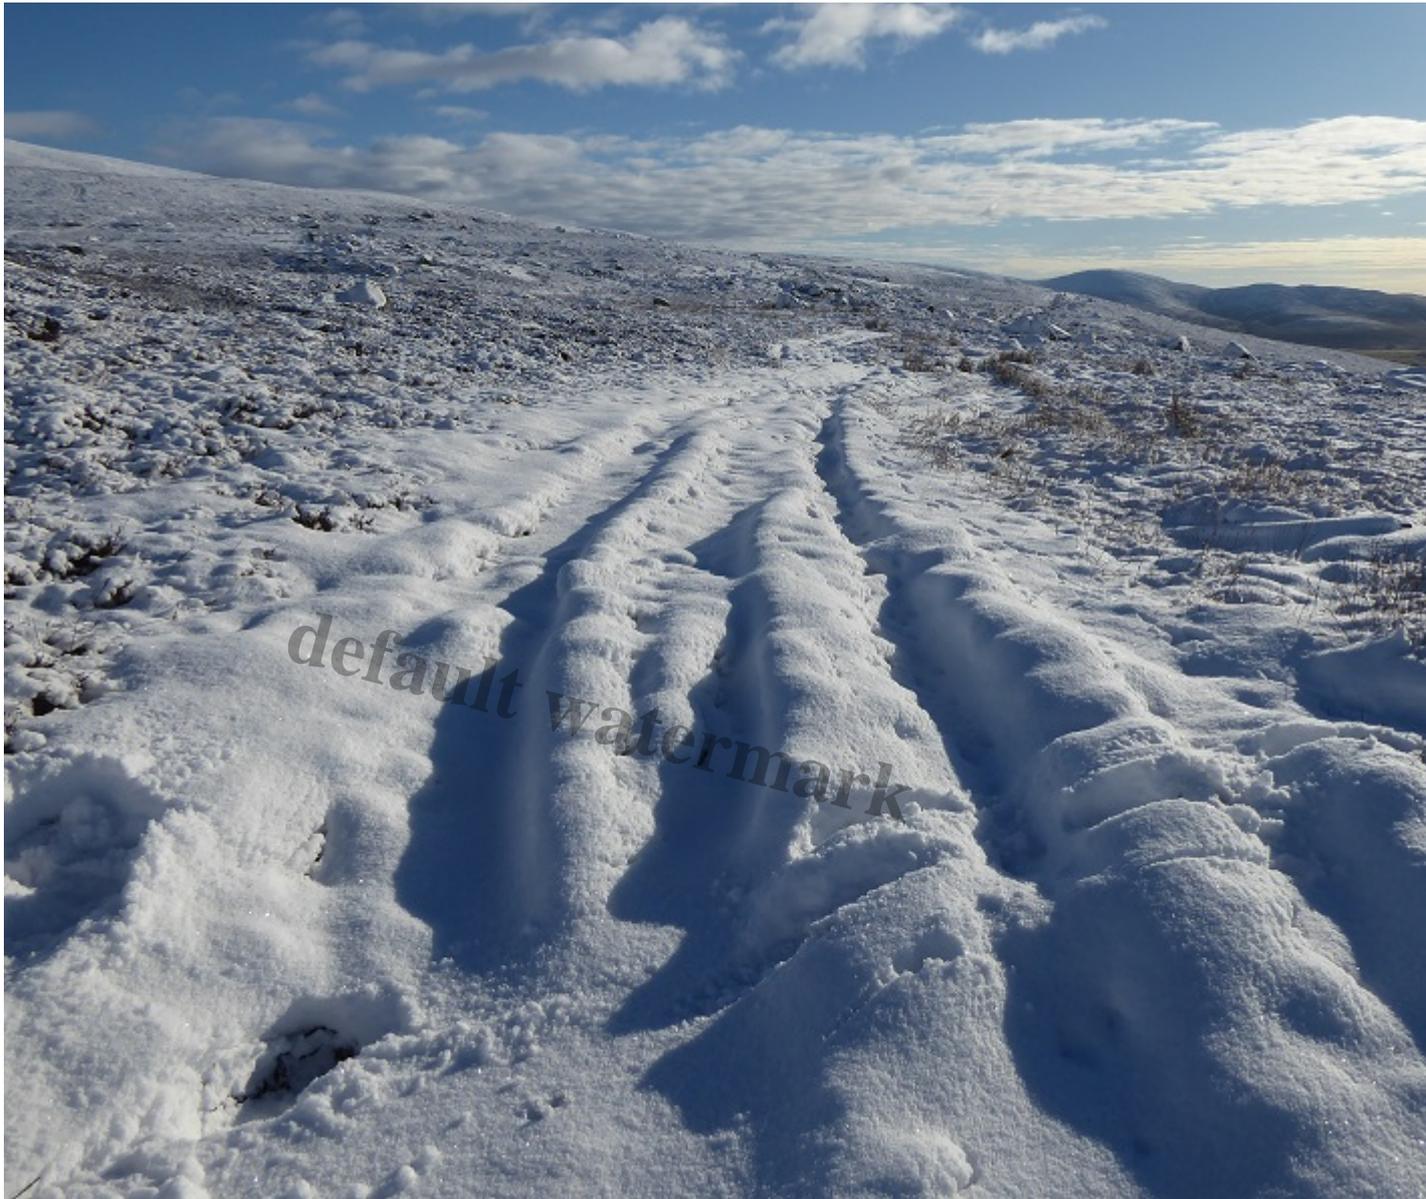
Erosion caused by ATVs driving from the top of the constructed track to the first hydro intake.

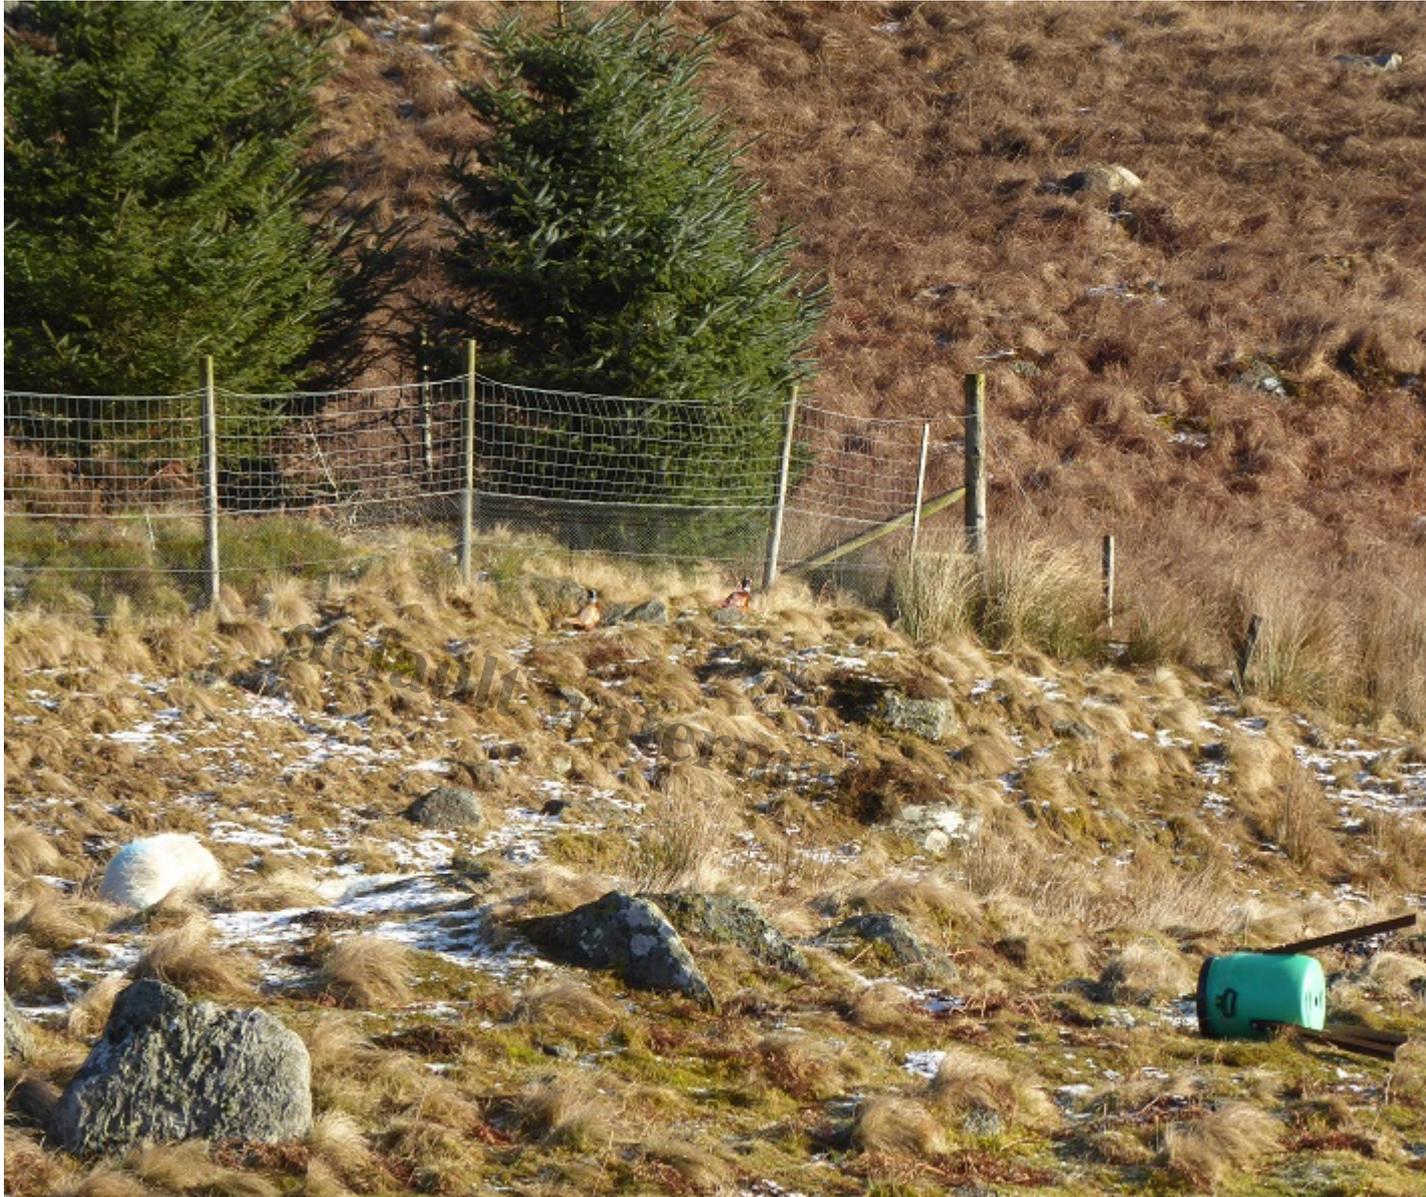
Overtaken feeder and pheasants - there were two feeders by the plantation accessed by an ATV leading off the main track

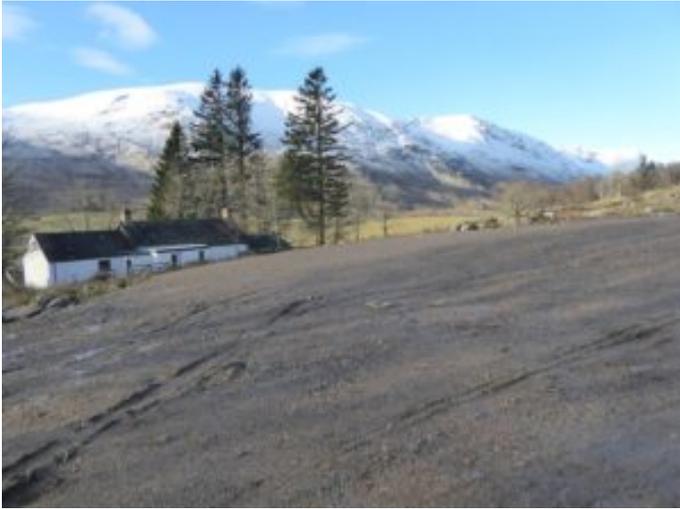
Large area, purpose unknown, at start of track

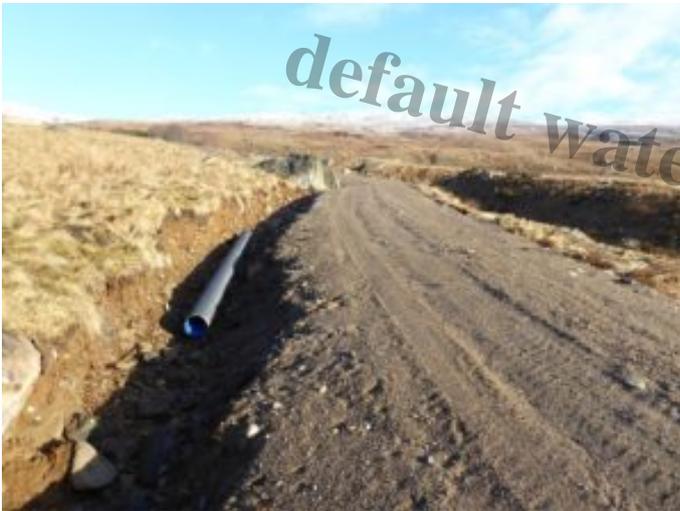
Poorly constructed ditch and abandoned?
section of pipe

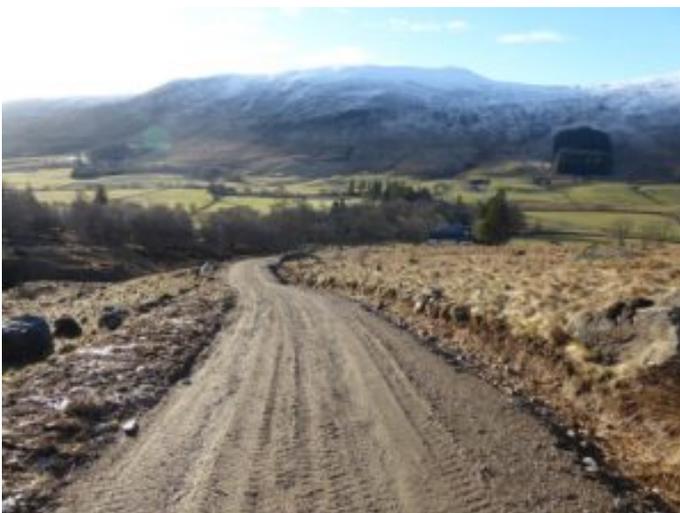
As well as being highly prominent, sections of the track are far too steep and will erode

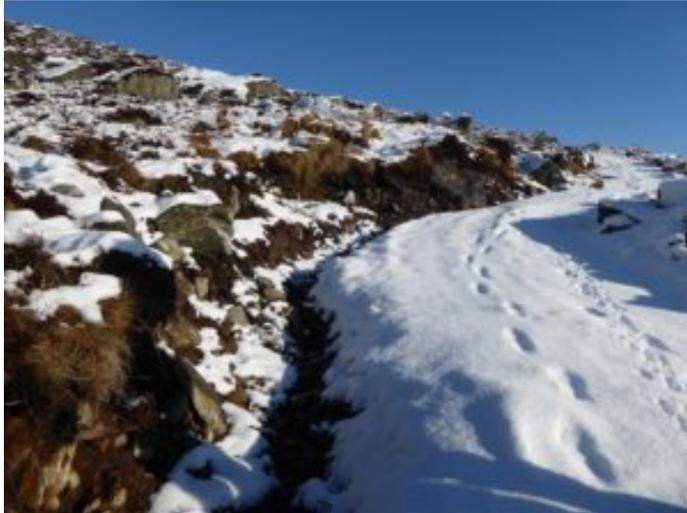
While the upper part of the track was under snow, there was still evidence of very poor construction

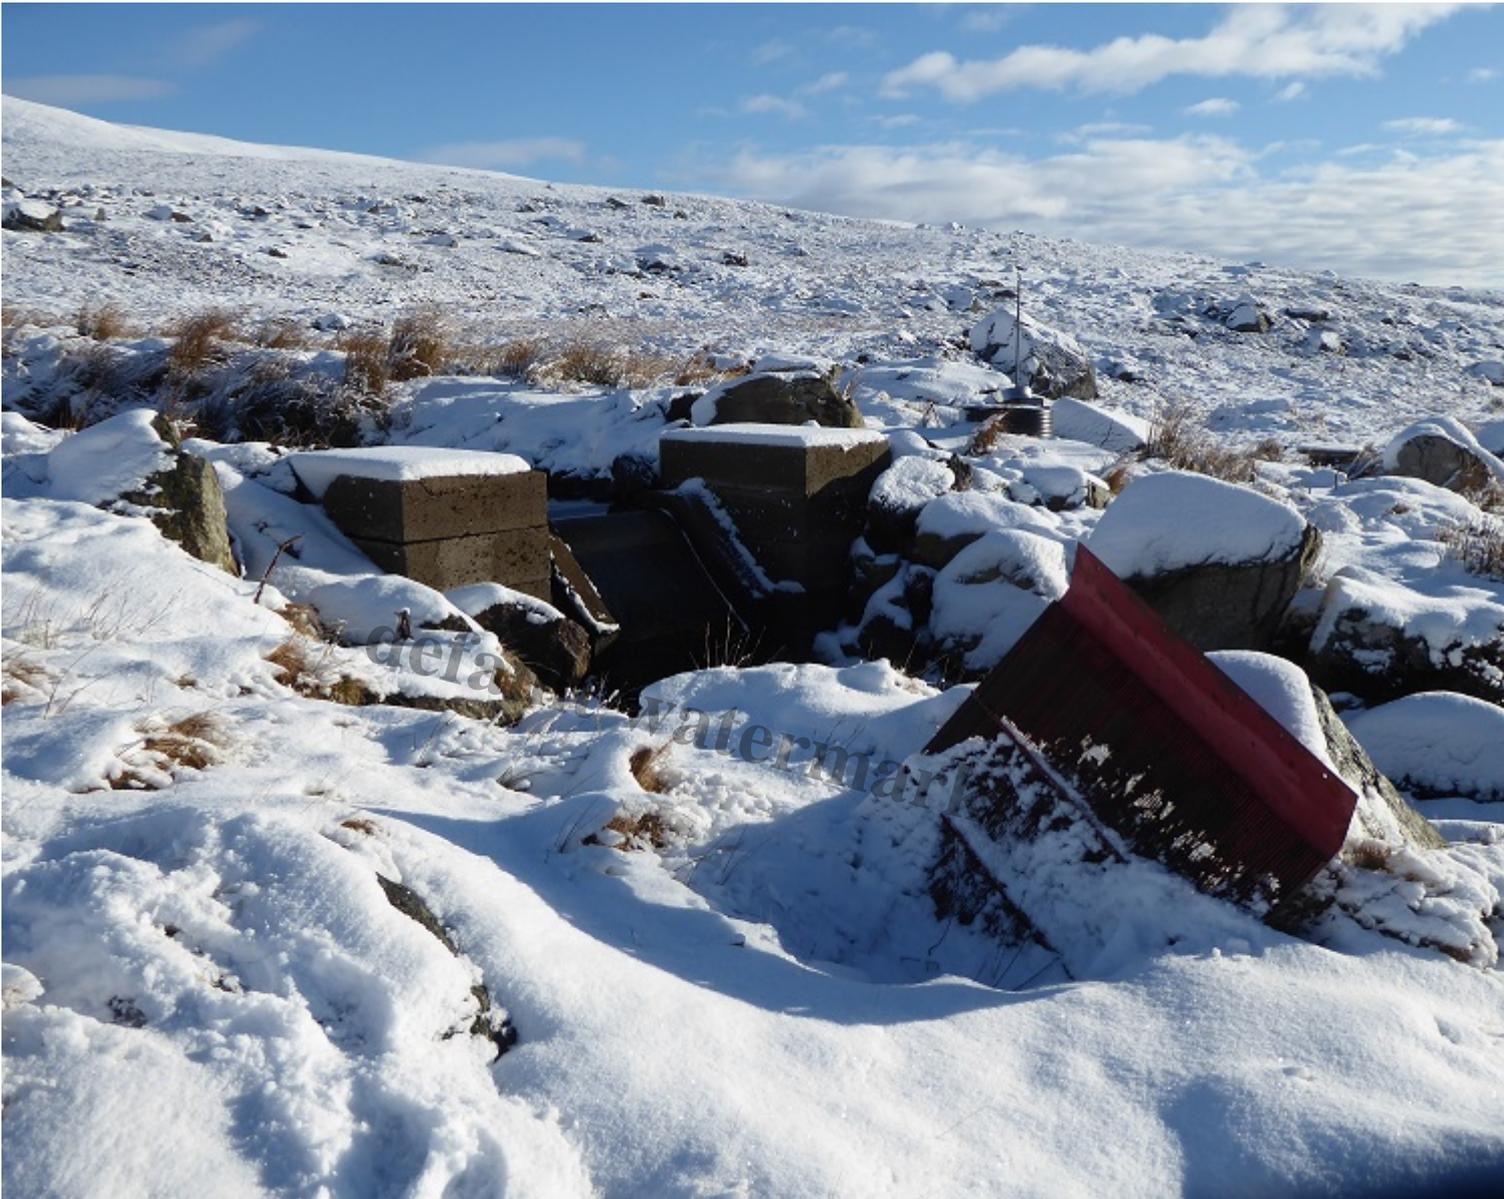
The original intake screen for the hydro â?? its a tiny intake and I suspect dries up in summer â?? has already been replaced but instead of removing the old red screen its been left dumped on the site.

Besides being poorly designed â?? you can make out a bright â??Lomondâ?• blue pipe and concrete lid to pipe access â?? we walked by several sections of abandoned pipe. I donâ??t know if the Cairngorms National Park Authority have visited the intakes but they need to order a clear-up.

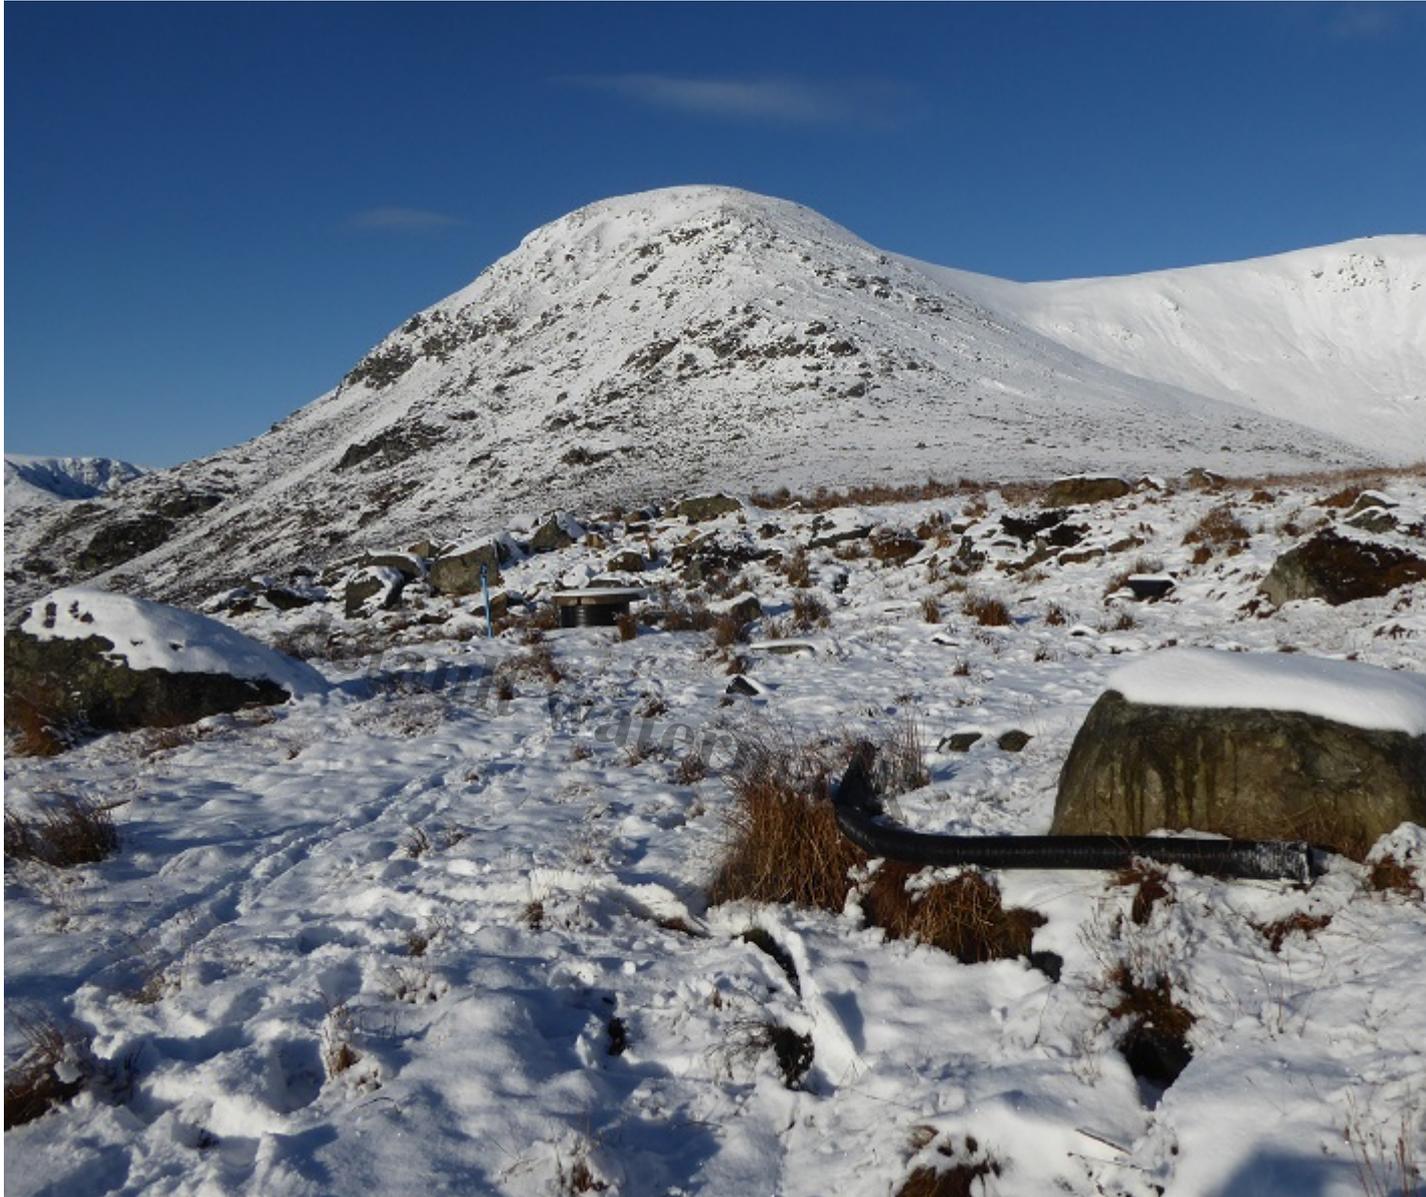
The line of the pipeline is marked by our footprints.

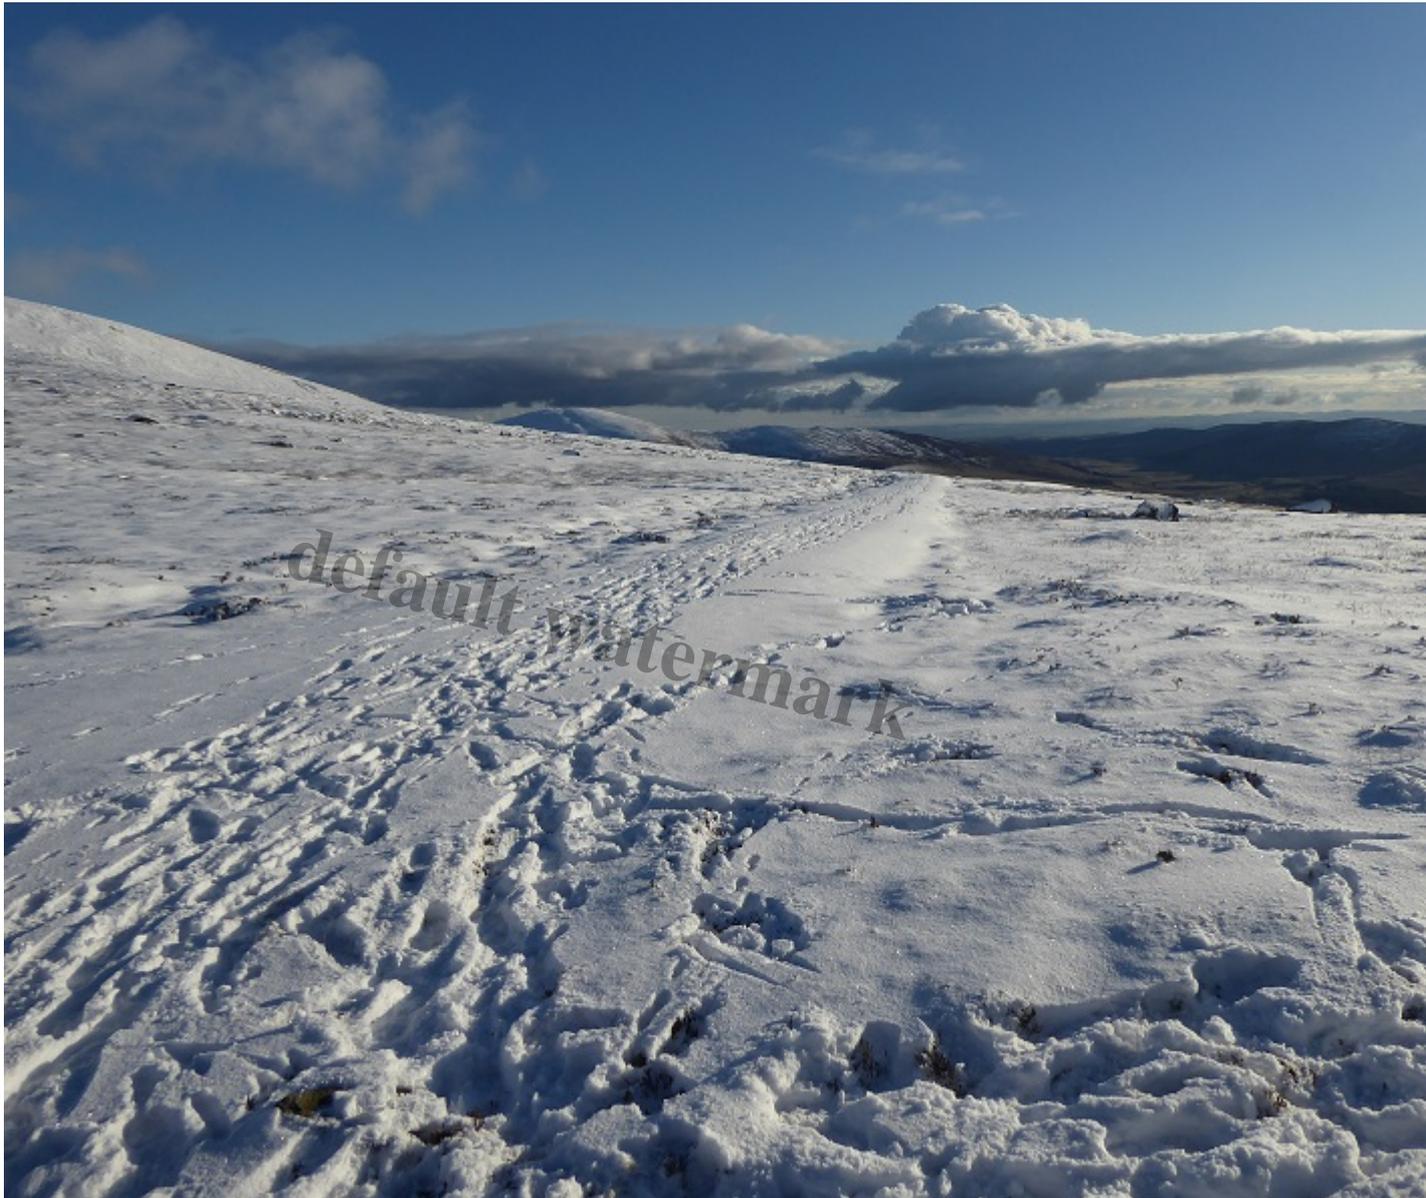
Top of Track 2 which ends at Loch Wharral

I did not walk along Track 2 which follows the line of the old path up to Loch Wharral and a newly constructed bothy but even under snow you could see it forms a prominent way across the moor.

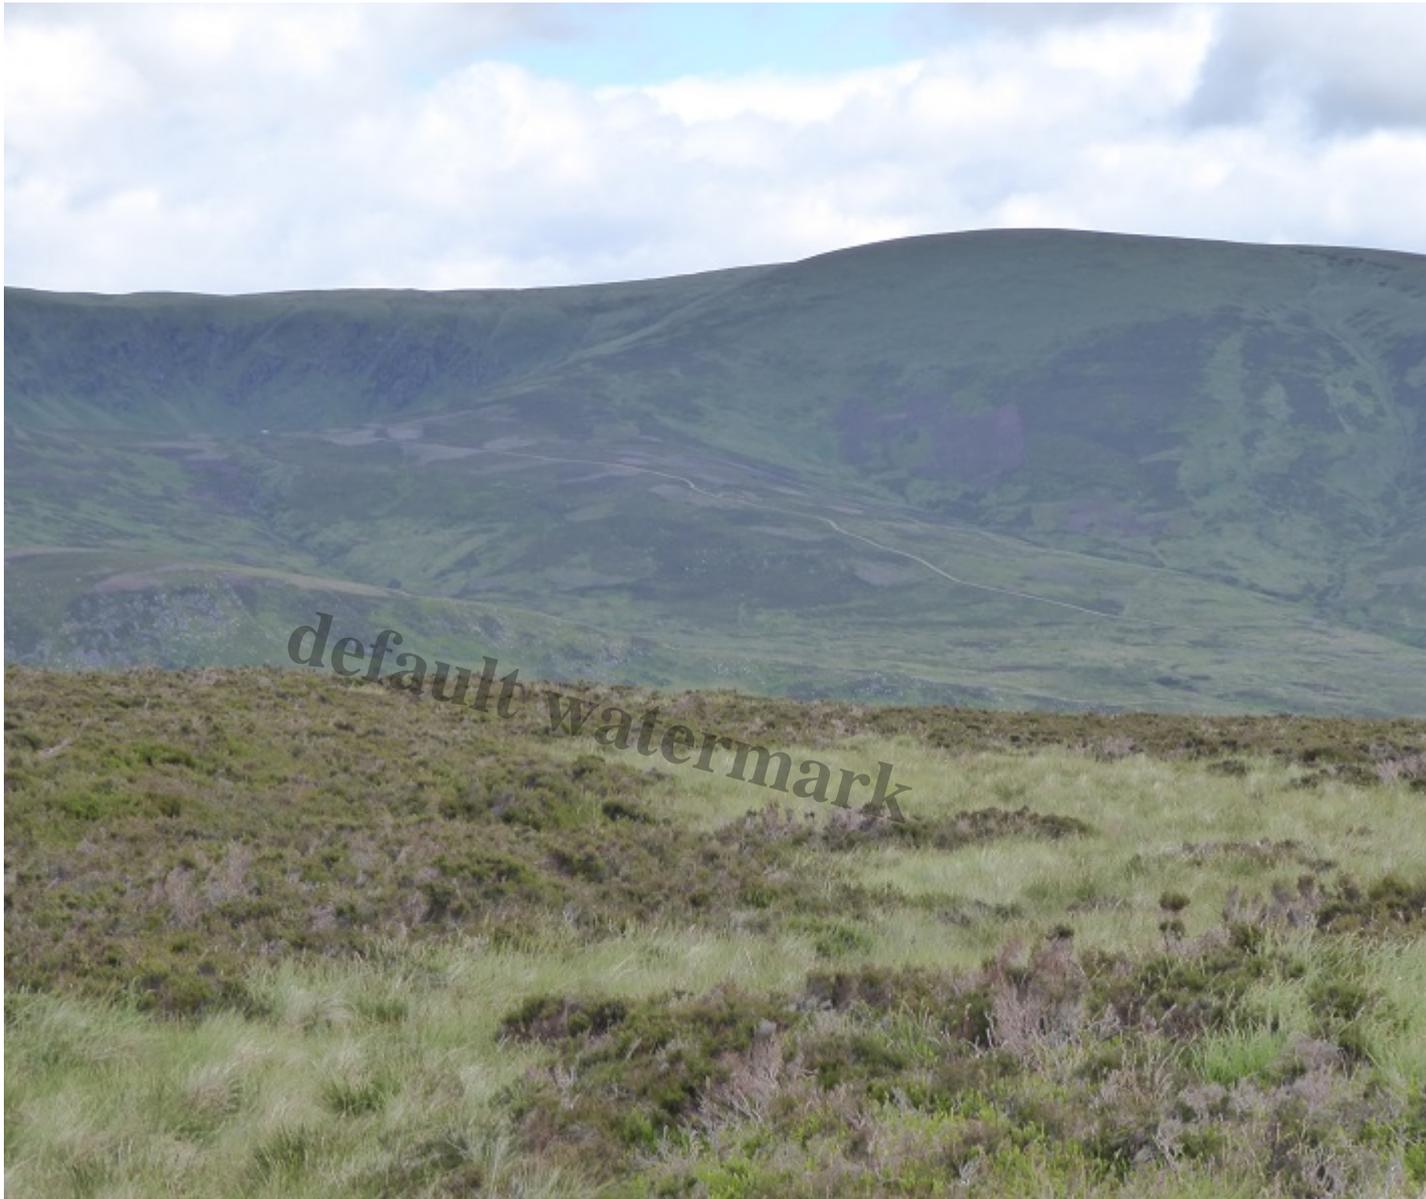
The track to Loch Wharral, the tiny whitish spot at the end of the track and on the bottom of the coire
â?? photo June 2016

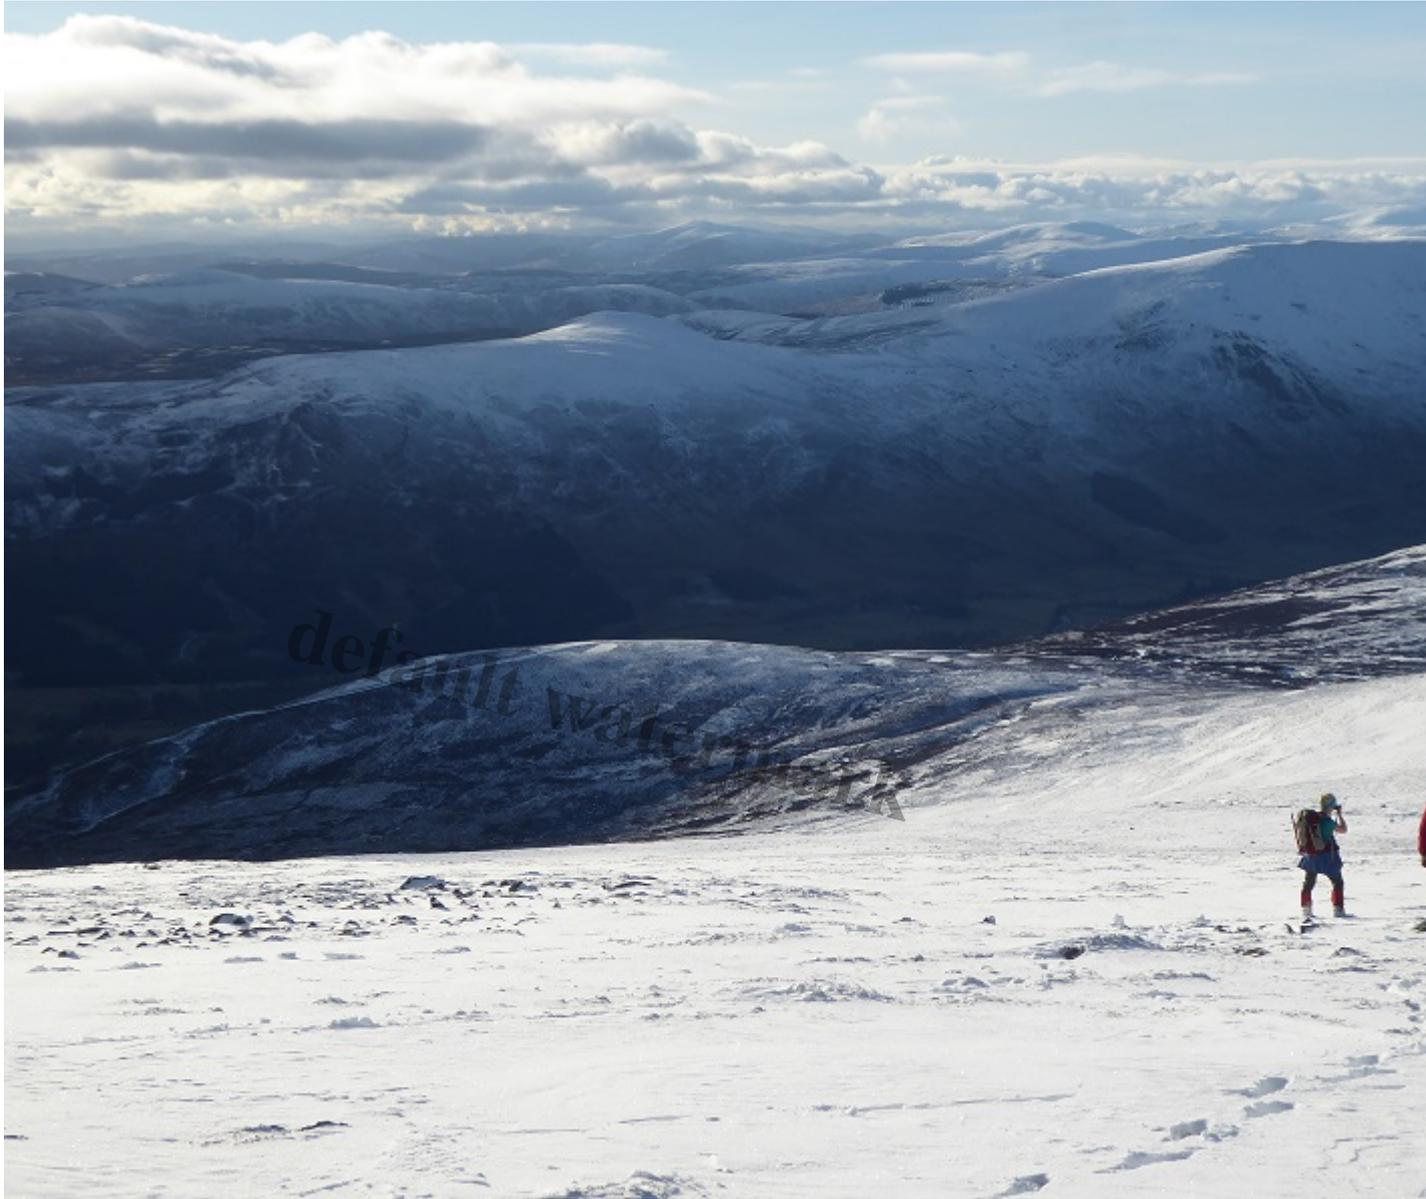
The track over Rough Craigs, the ridge on the near side of Glen Clova, from west slopes of Ben Tirma

According to the CNPA, the track over Rough Craig had also been constructed by 2012 and is therefore outside planning enforcement time limits. Following as it does the crest of the ridge and being built up above the surrounding moor it forms another very prominent landscape scar.
