The unlawful Glen Clova hill tracks â?? time for action

Track 1 â?? Track above Clova Hotel

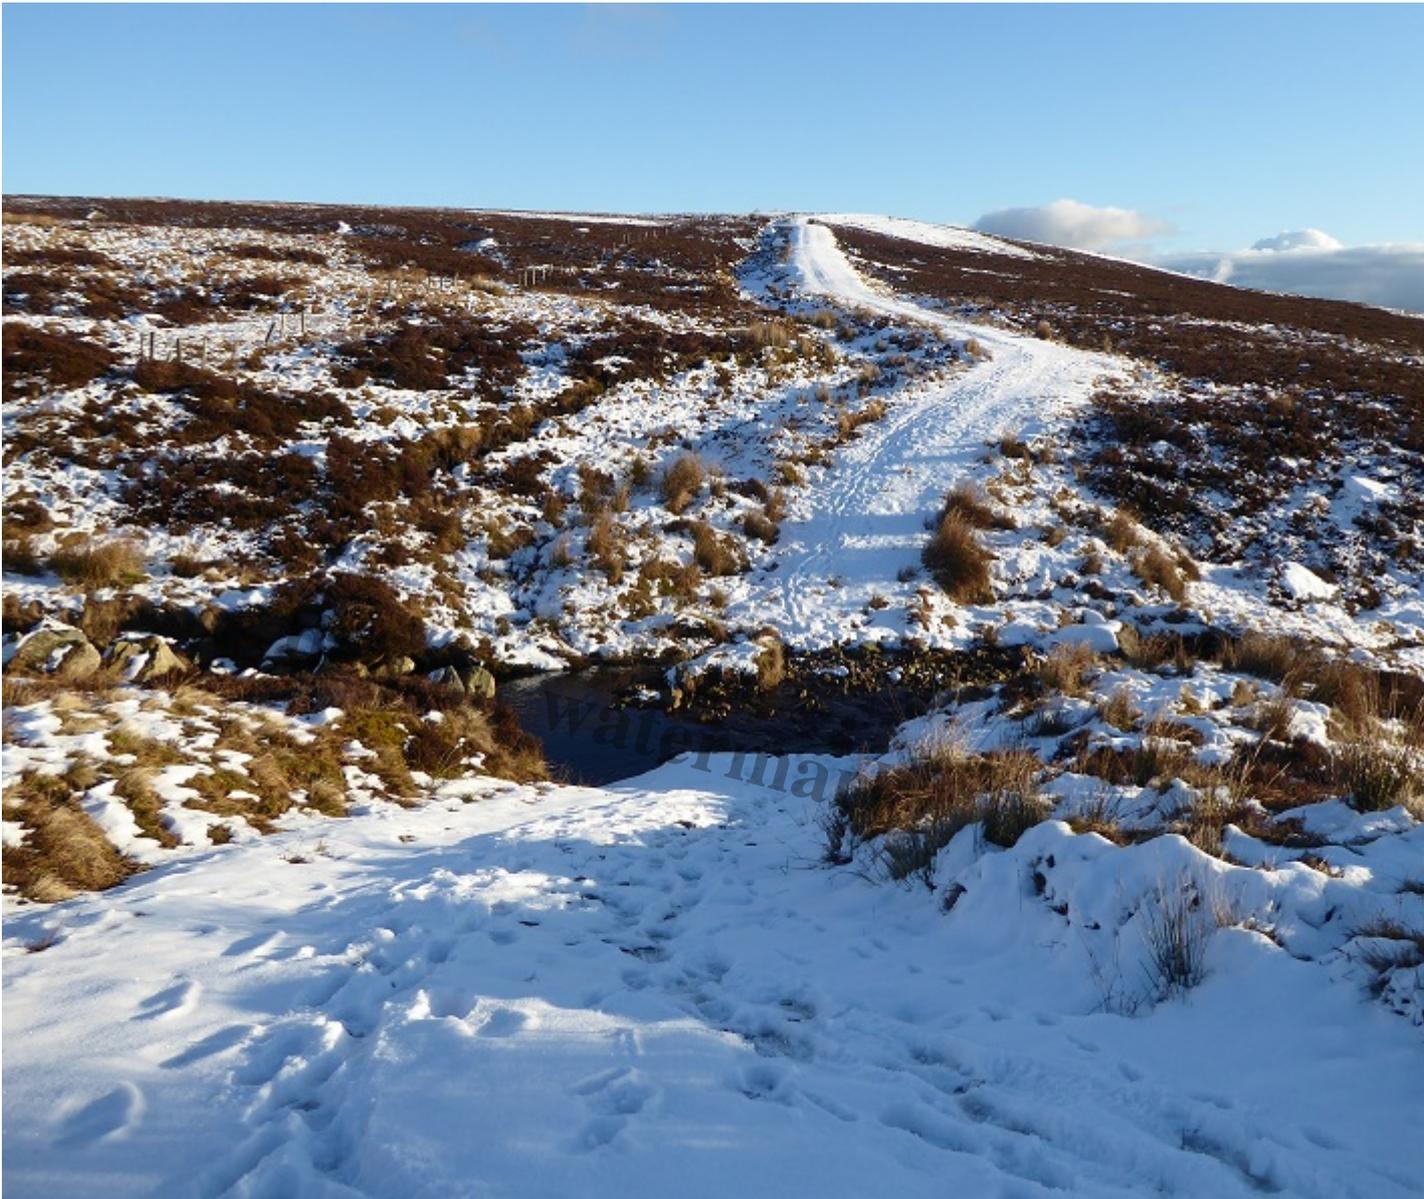
The northern end of the Rough Craigs track close to the estate boundary, and electric fence, where i

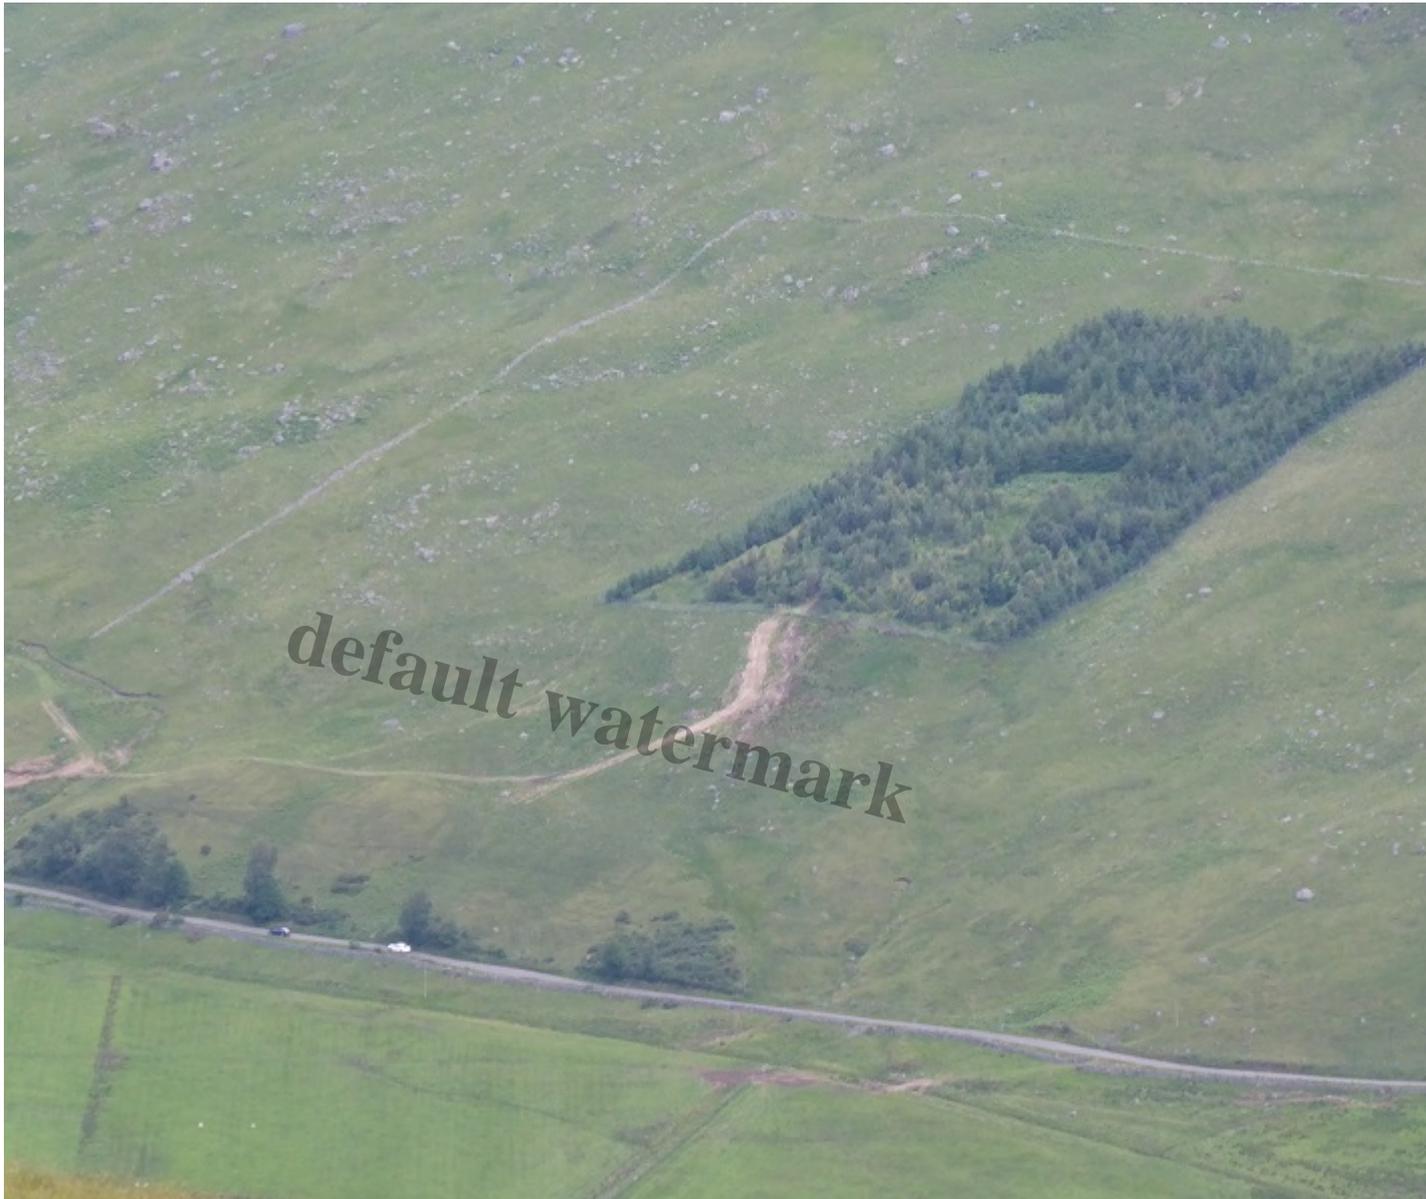
Photo June 2017

I did not have time to visit Track 4 which is highly prominent when you are driving up Glen Clova and from a distance. While significantly shorter than other tracks, this track is a good demonstration of the impact of forest tracks can have when crossing open ground and why all forest tracks should require full planning permission. I have no information of when this track was constructed but unless it has been since December 2014, when the Prior Notification was introduced, the CNPA is very unlikely to be able to take any enforcement action.

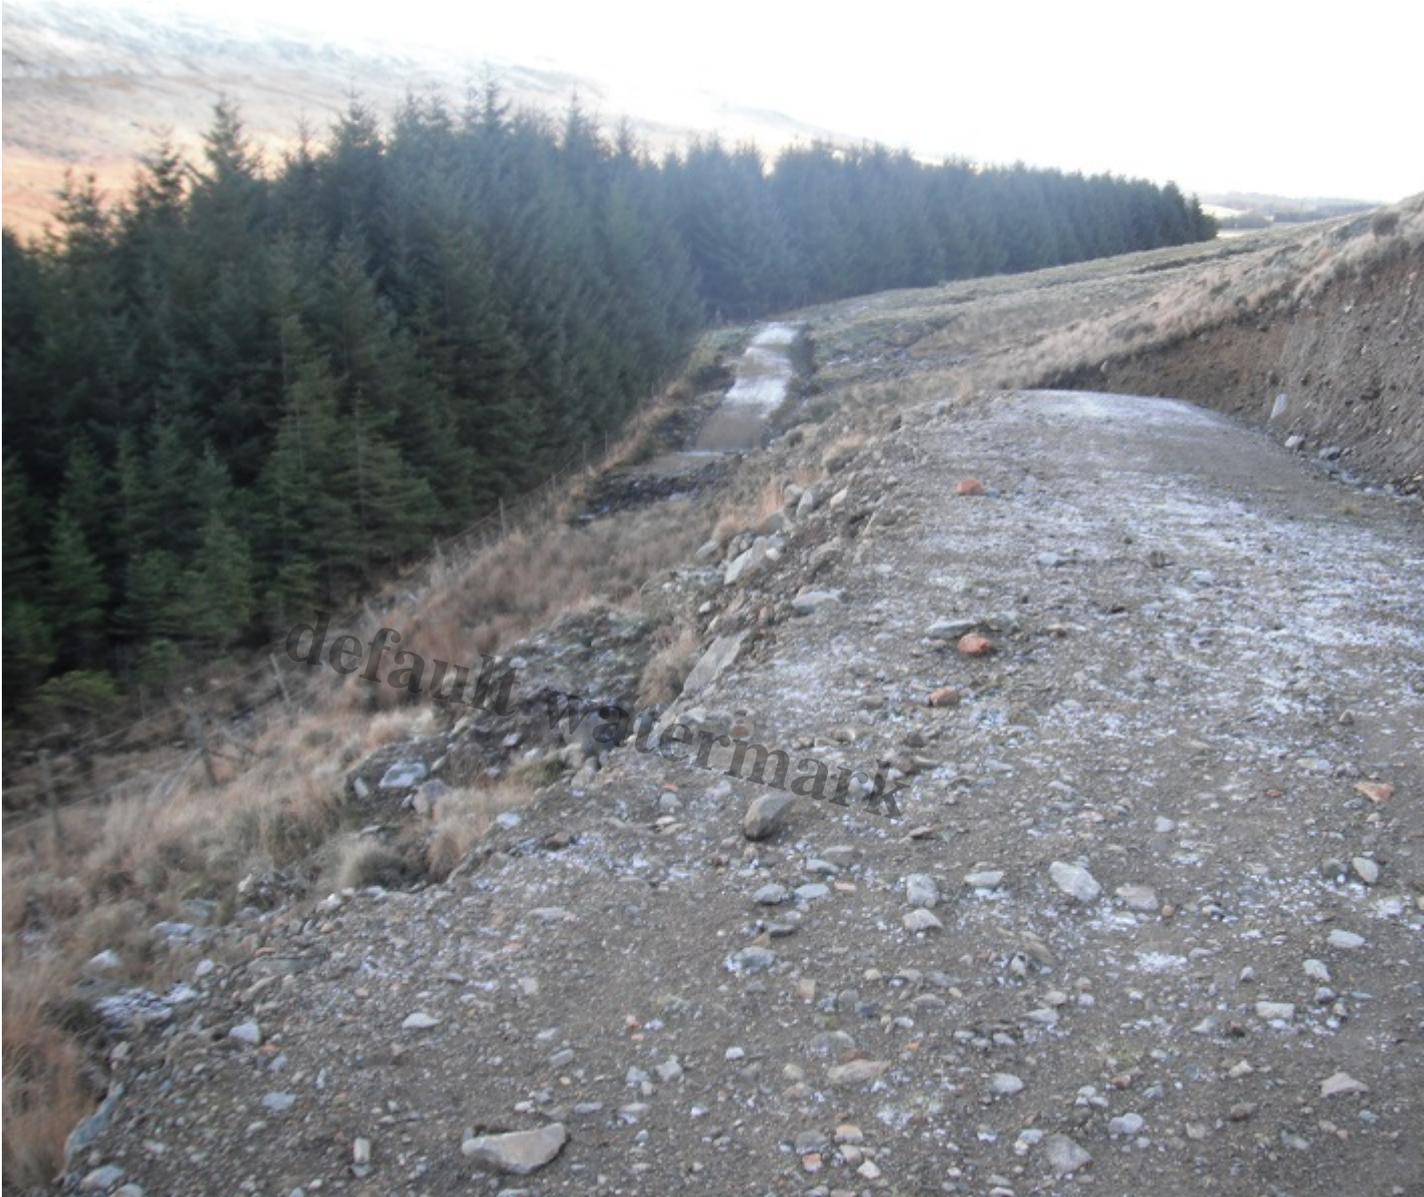
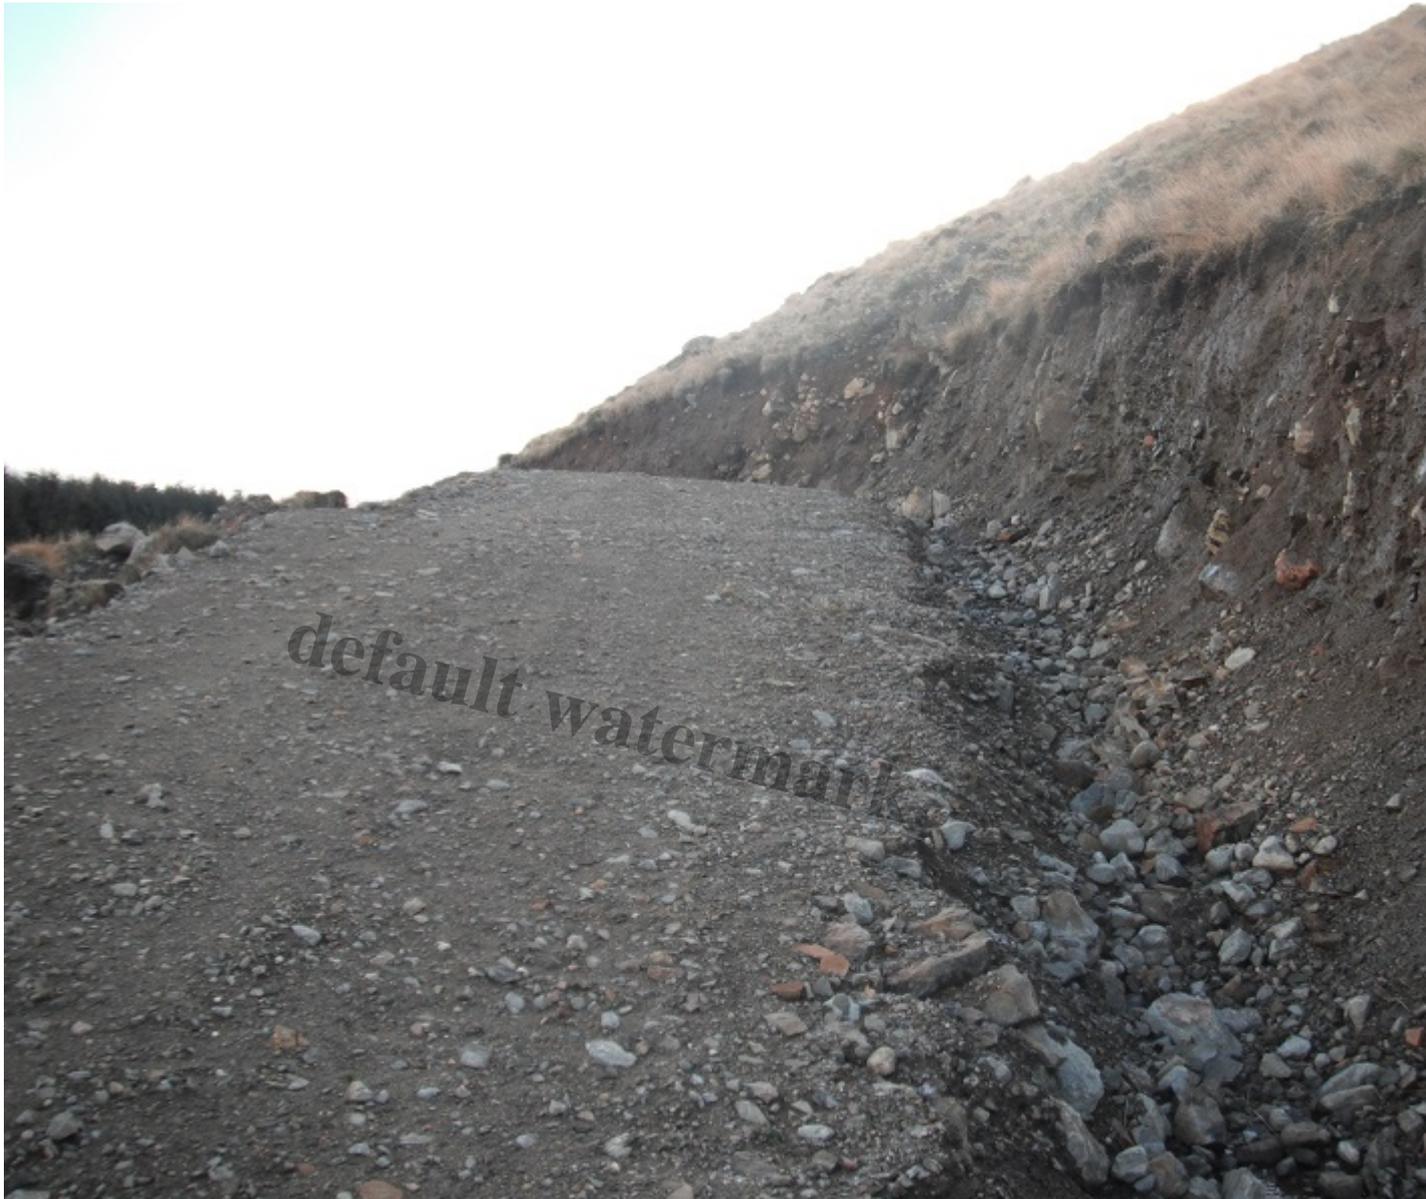
Across the glen, on the west side of the river, north of the hotel, behind a plantation so not visible from the road, there is yet another track which George Allan told me about. Again I have not visited but George reported it to the CNPA and it apparently pre-dates the Prior Notification system, so yet again no action can be taken, although in terms of construction its the most shocking of all the tracks:

Our National Parks also need new powers to ensure that older hill tracks, which could not now be removed even if the law changes, are of a good standard of design and construction.

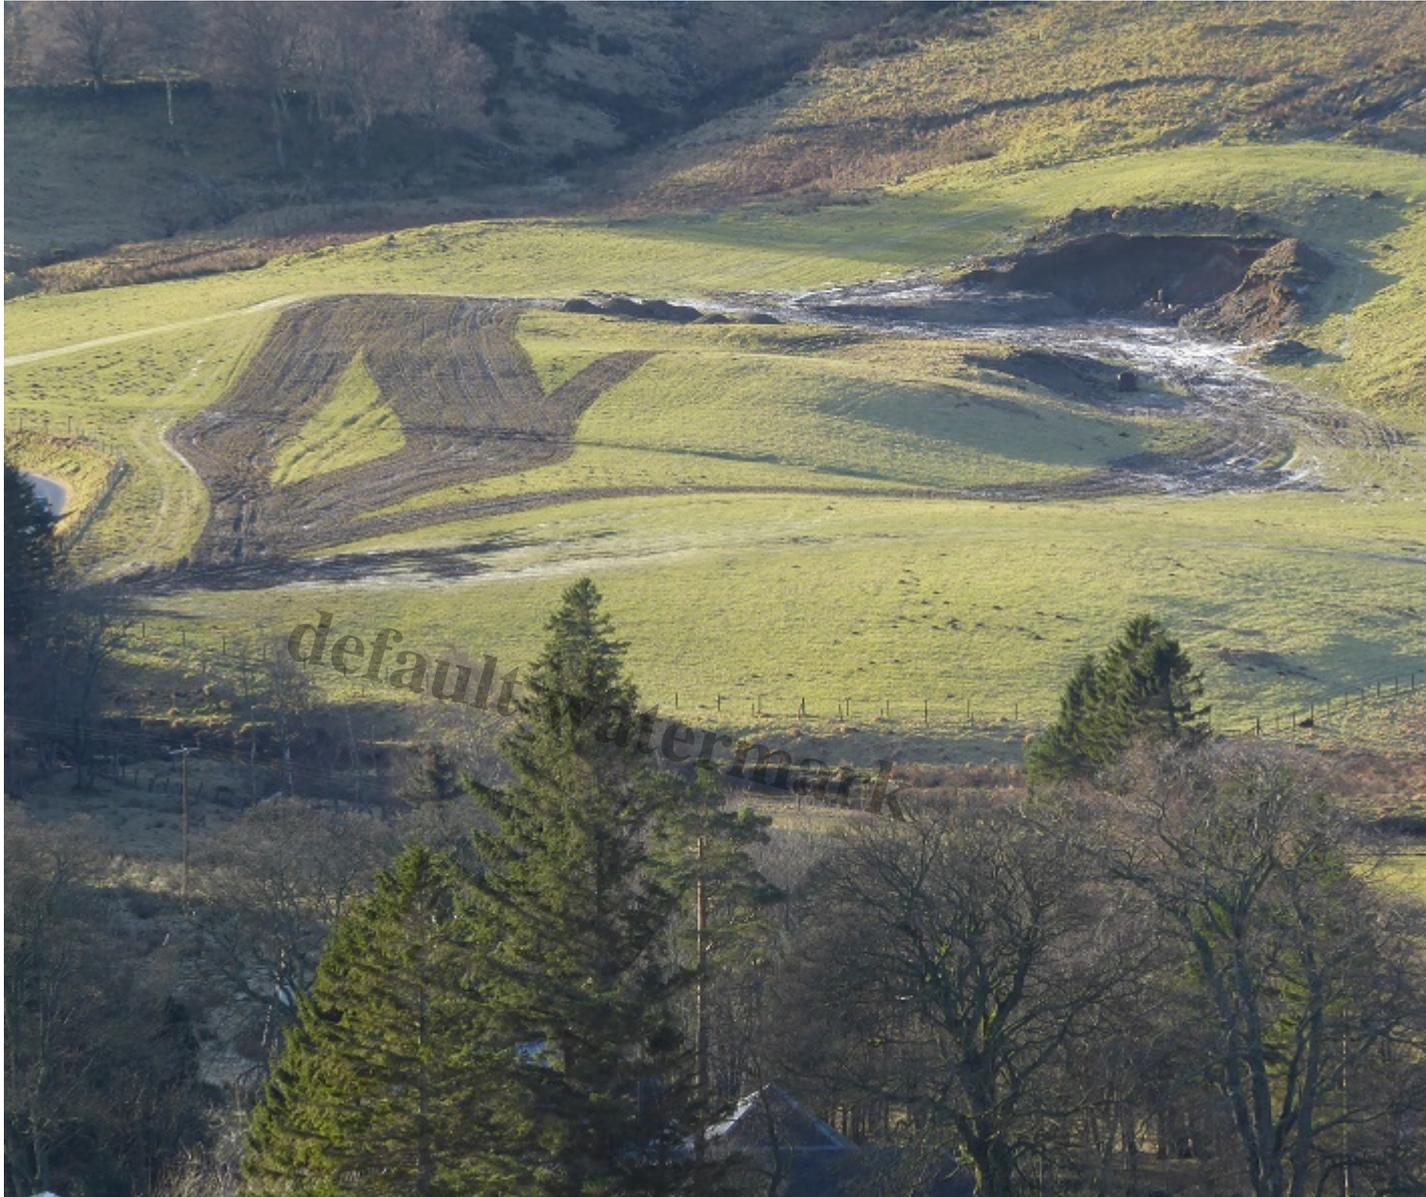
Earthworks opposite Glen Clova Hotel

Here is a photo of work currently going on in the glen. There have been historic issues in Glen Clova with landforms being altered without appropriate permissions and this has been reported to the CNPA. We will see what happens but if you see earthworks or earth moving equipment in the National Park report it!
