SSE's breach of Scottish Government planning requirements at Drumochter

The Beaully Denny energy consent required the Drumochter SAC to be fully restored

The Dalnacardoch Track

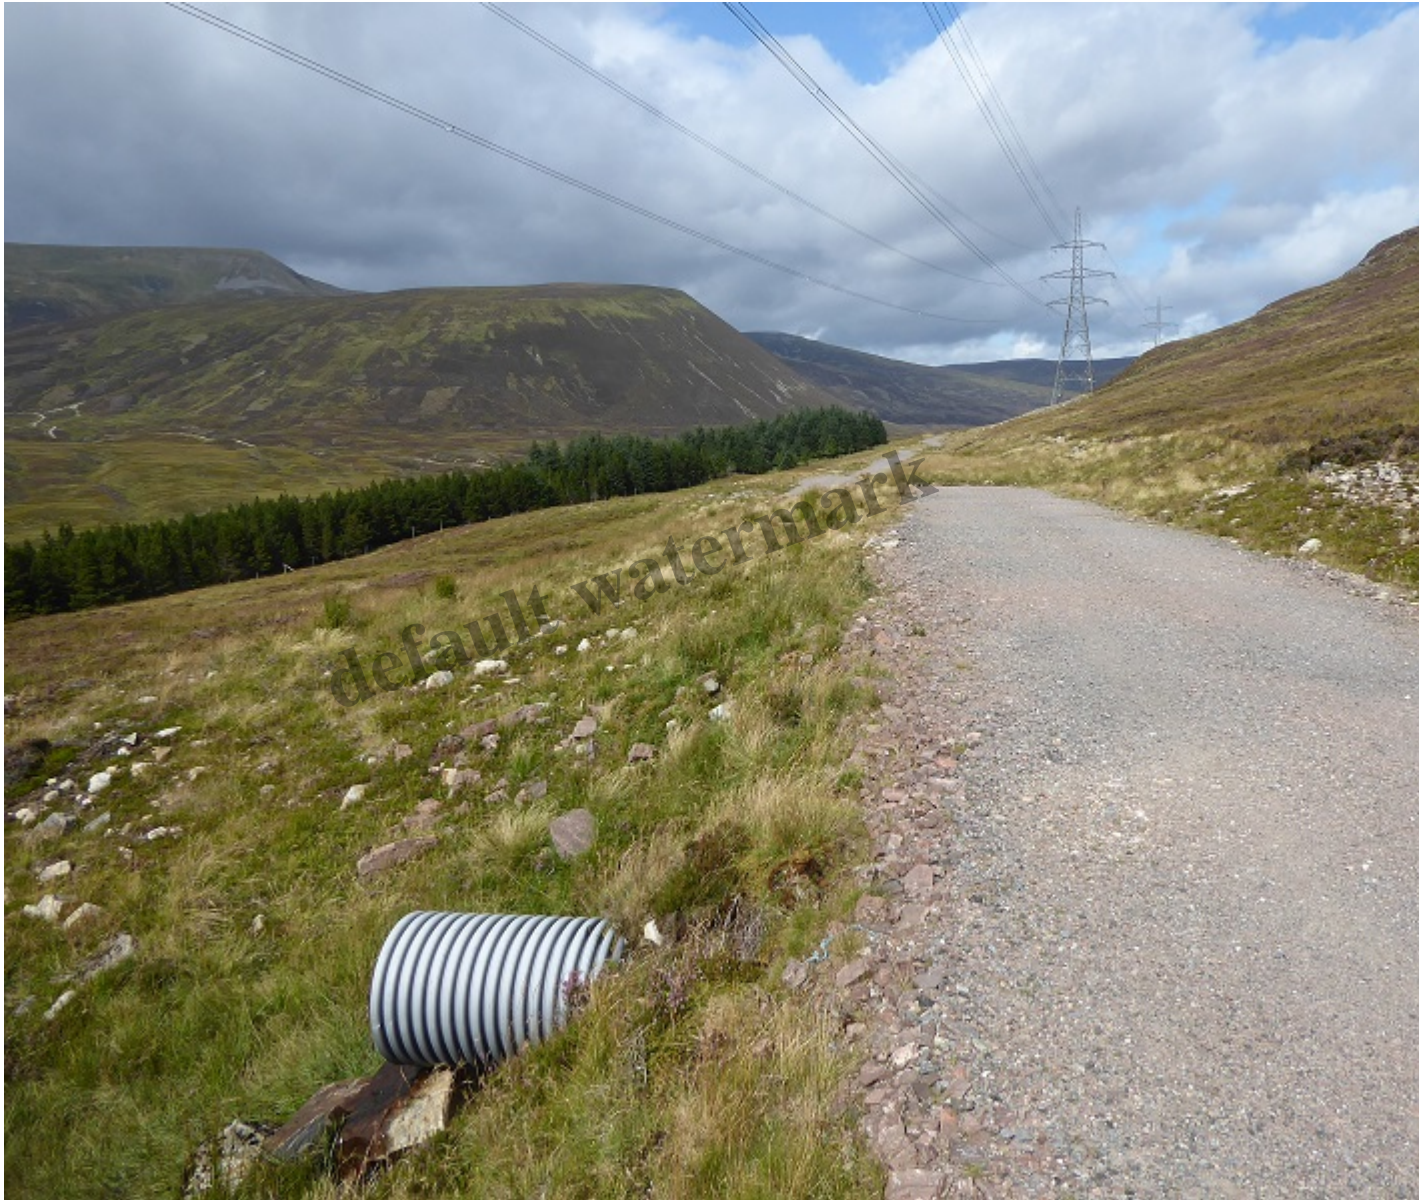
Last section of unrestored construction track heading towards pass of Drumochter and concealed by

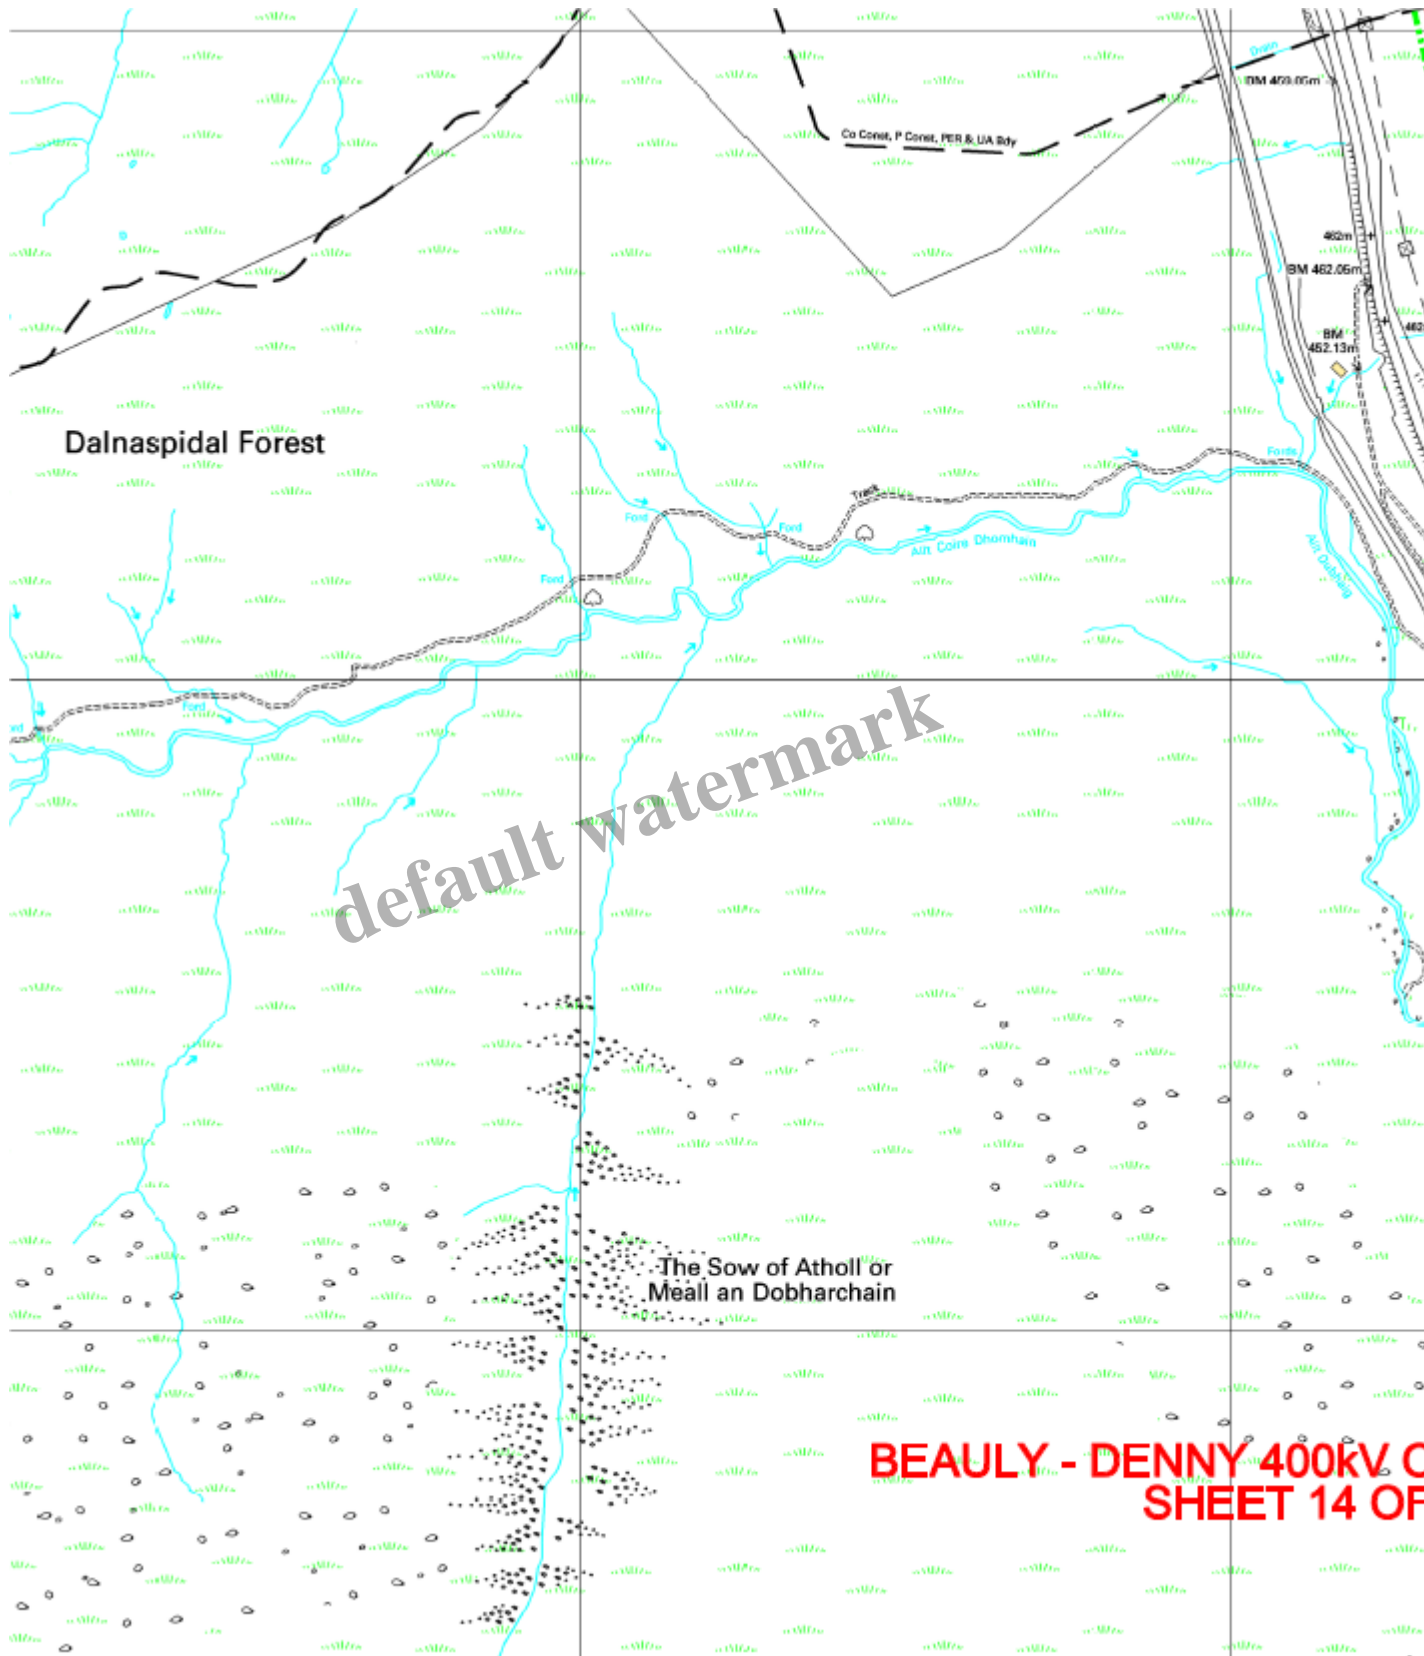
The pink line shows the line of the proposed Wade's Rd upgrade – map supplied by SSE after my or

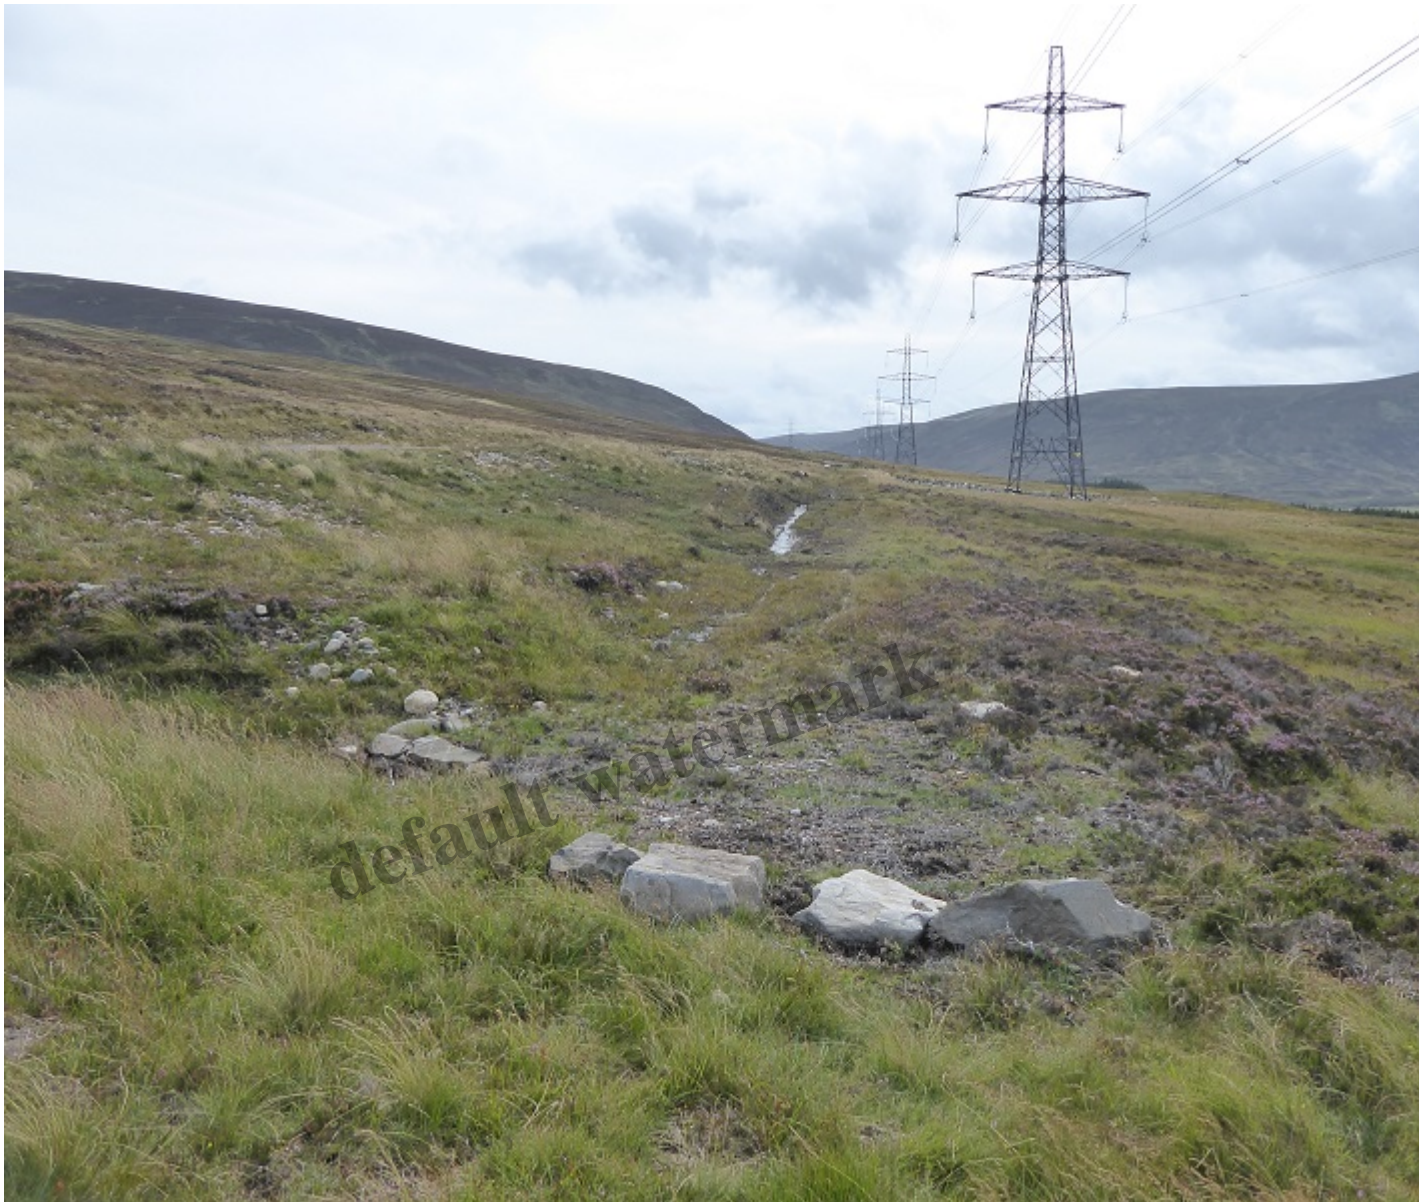
A section of Wade Rd on the Dalnacardoch estate, you can see the line of the new track above and The row of boulders appears to be to prevent vehicle access while to the left of them the stones mark a culvert that has, bizarrely in this swathe of destruction, been restored.

According to the planning consent all new tracks for construction purposes in the SAC should have been fully restored in order to avoid loss of habitat. This has failed to happen at Dalnacardoch.

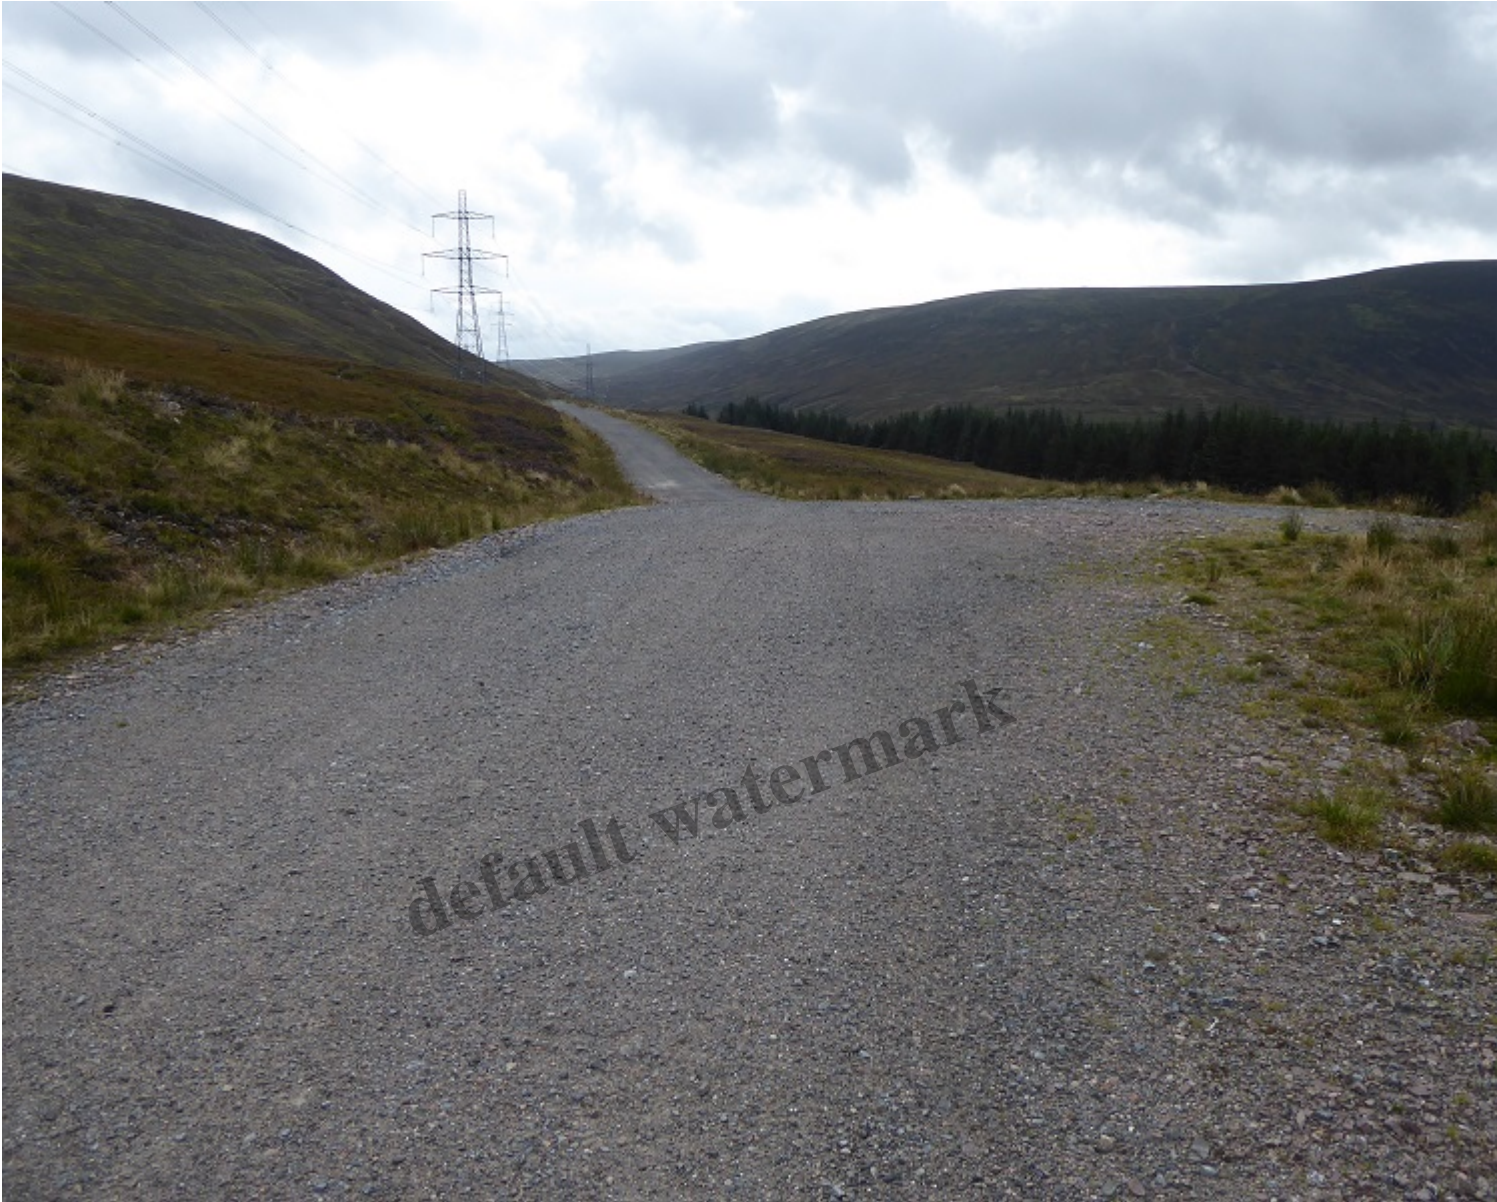
Secondly, in other places a totally new track appears to have been constructed over and on the line of the Wade's Rd and as a result sections of track like that above may represent the "upgrade". These sections are clearly far more than an upgrade and have resulted in the destruction of a swathe of protected habitat. The fact that they have also been constructed to a poor standard suggests they may originally have been to be temporary but have ended up just being left in place. This is a contravention of Scottish and EU Law on the protection of the natura site habitats.

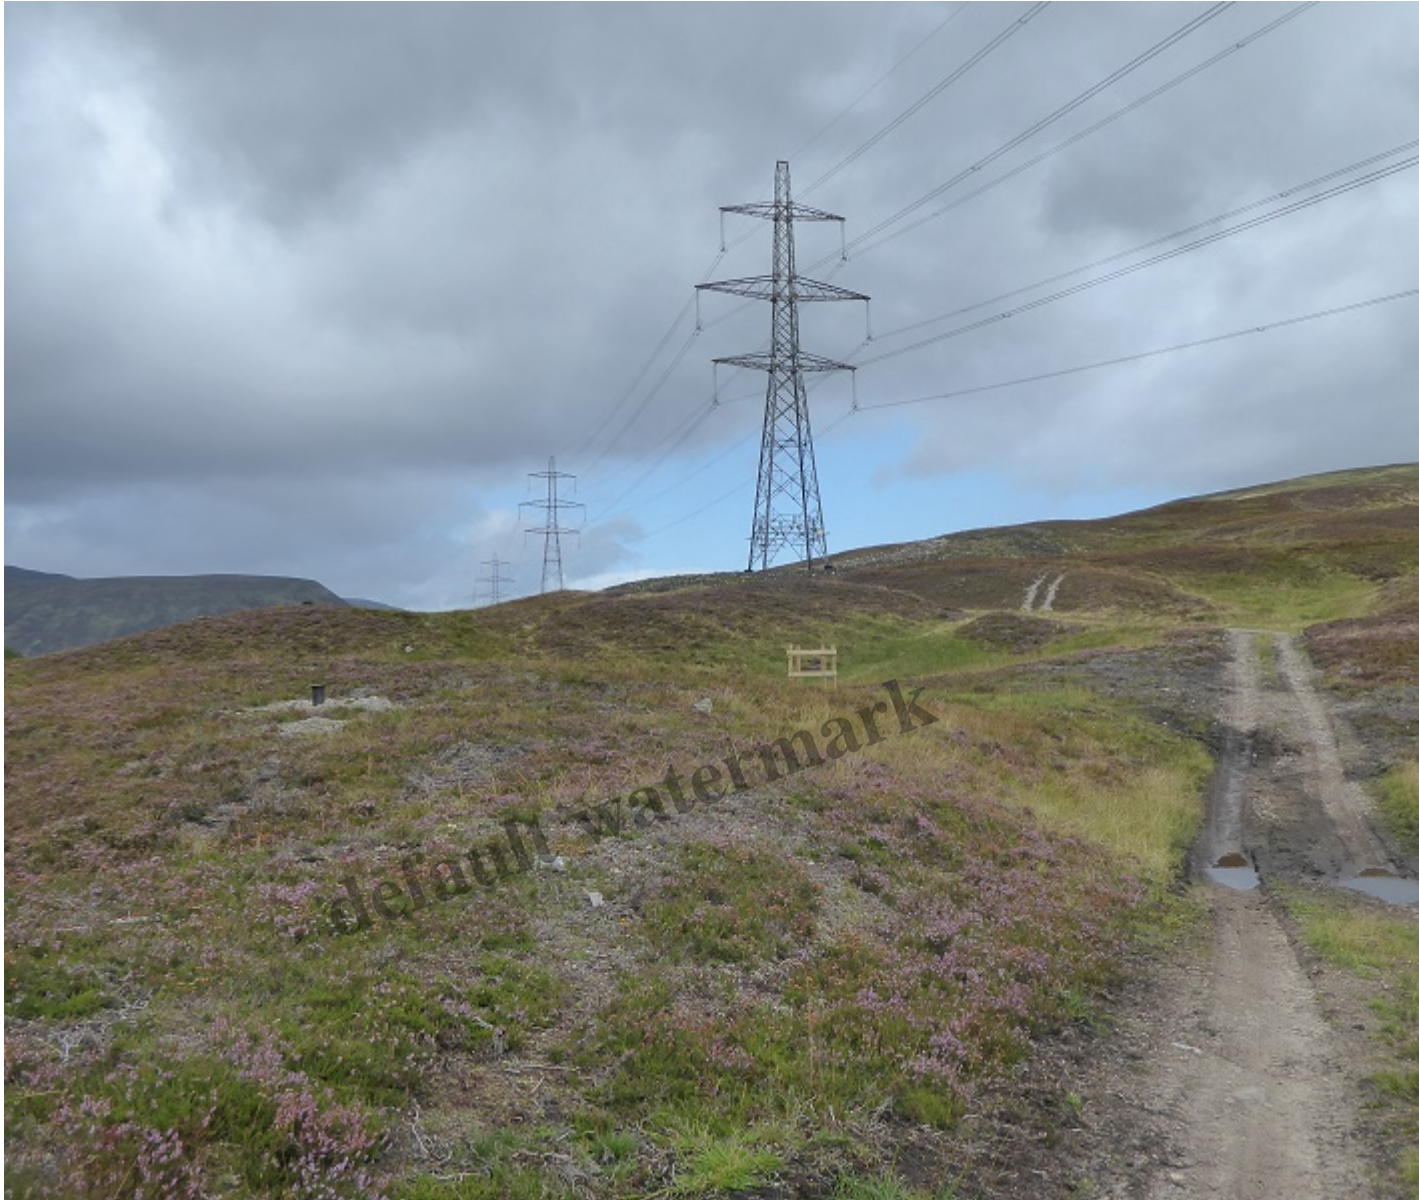
The southern end of the Dalnacardoch track above Dalnaspidal before the section which has been “ which starts by the first tower

Further evidence that planning requirements have been breached comes from the above photo which shows how the upgraded construction track should have looked if properly restored. I don't know if this short section which leads up to the new Dalnacardoch track was ever used for construction purposes but it looks and has a totally different impact to the track beyond.

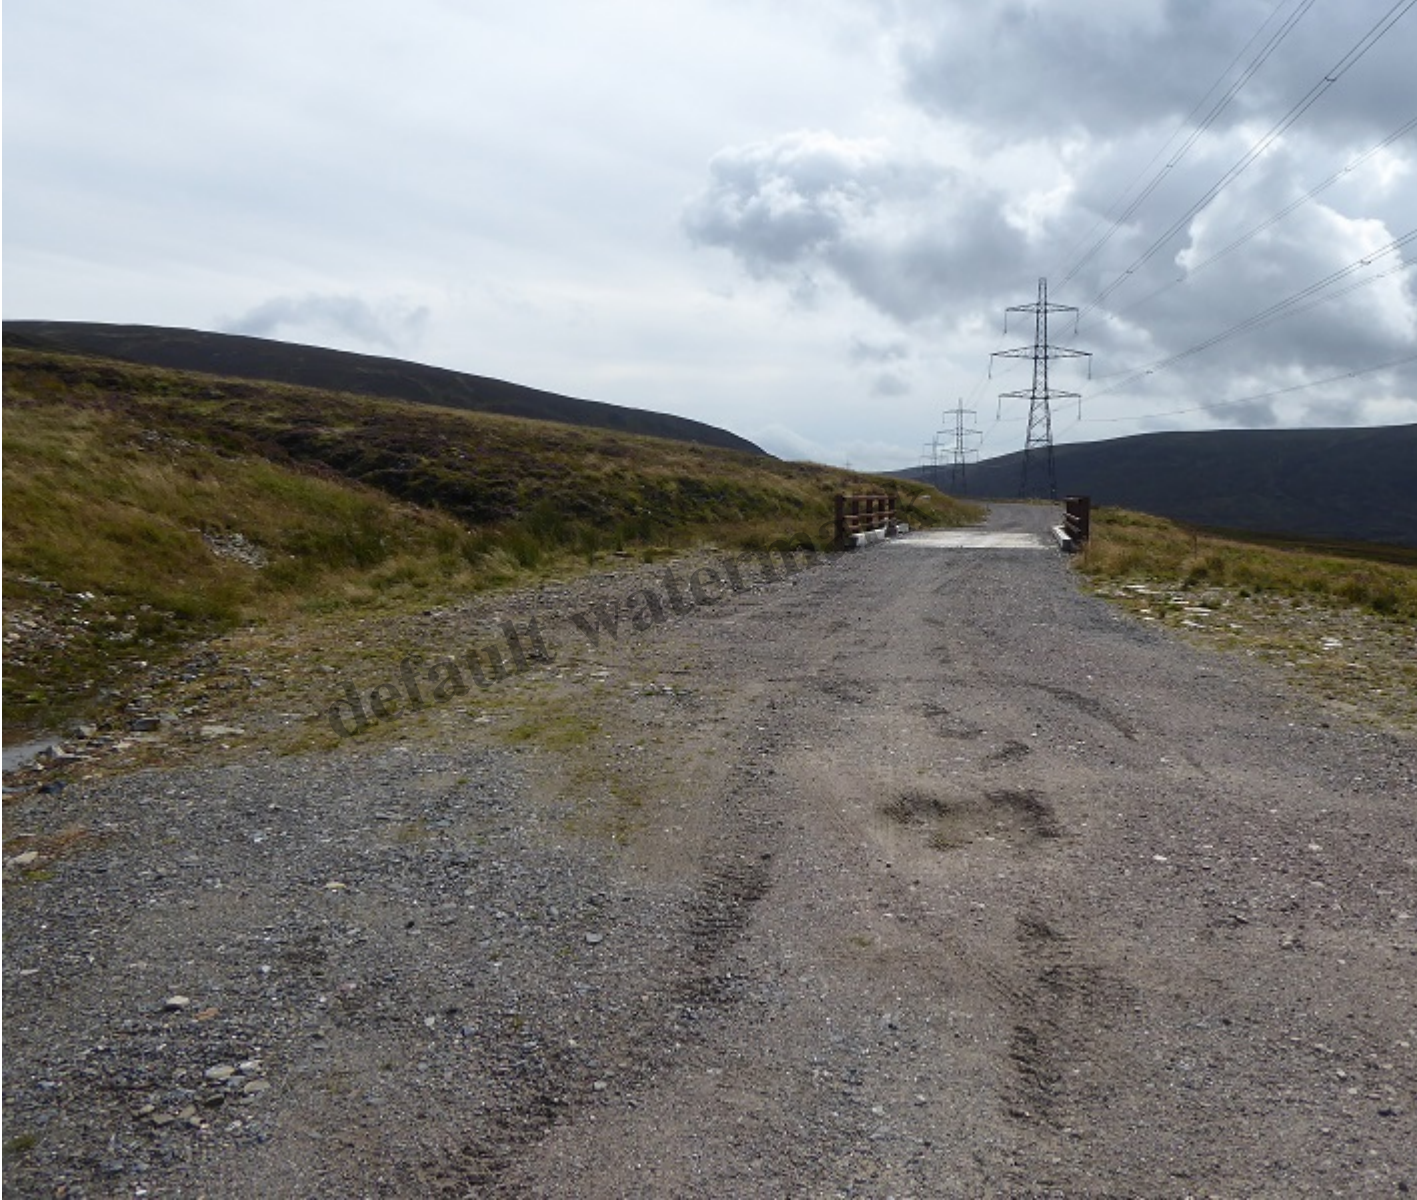
Its quite frankly incredible that there is no mention of the impact of track 26b on the SAC in the 2017 Monitoring report

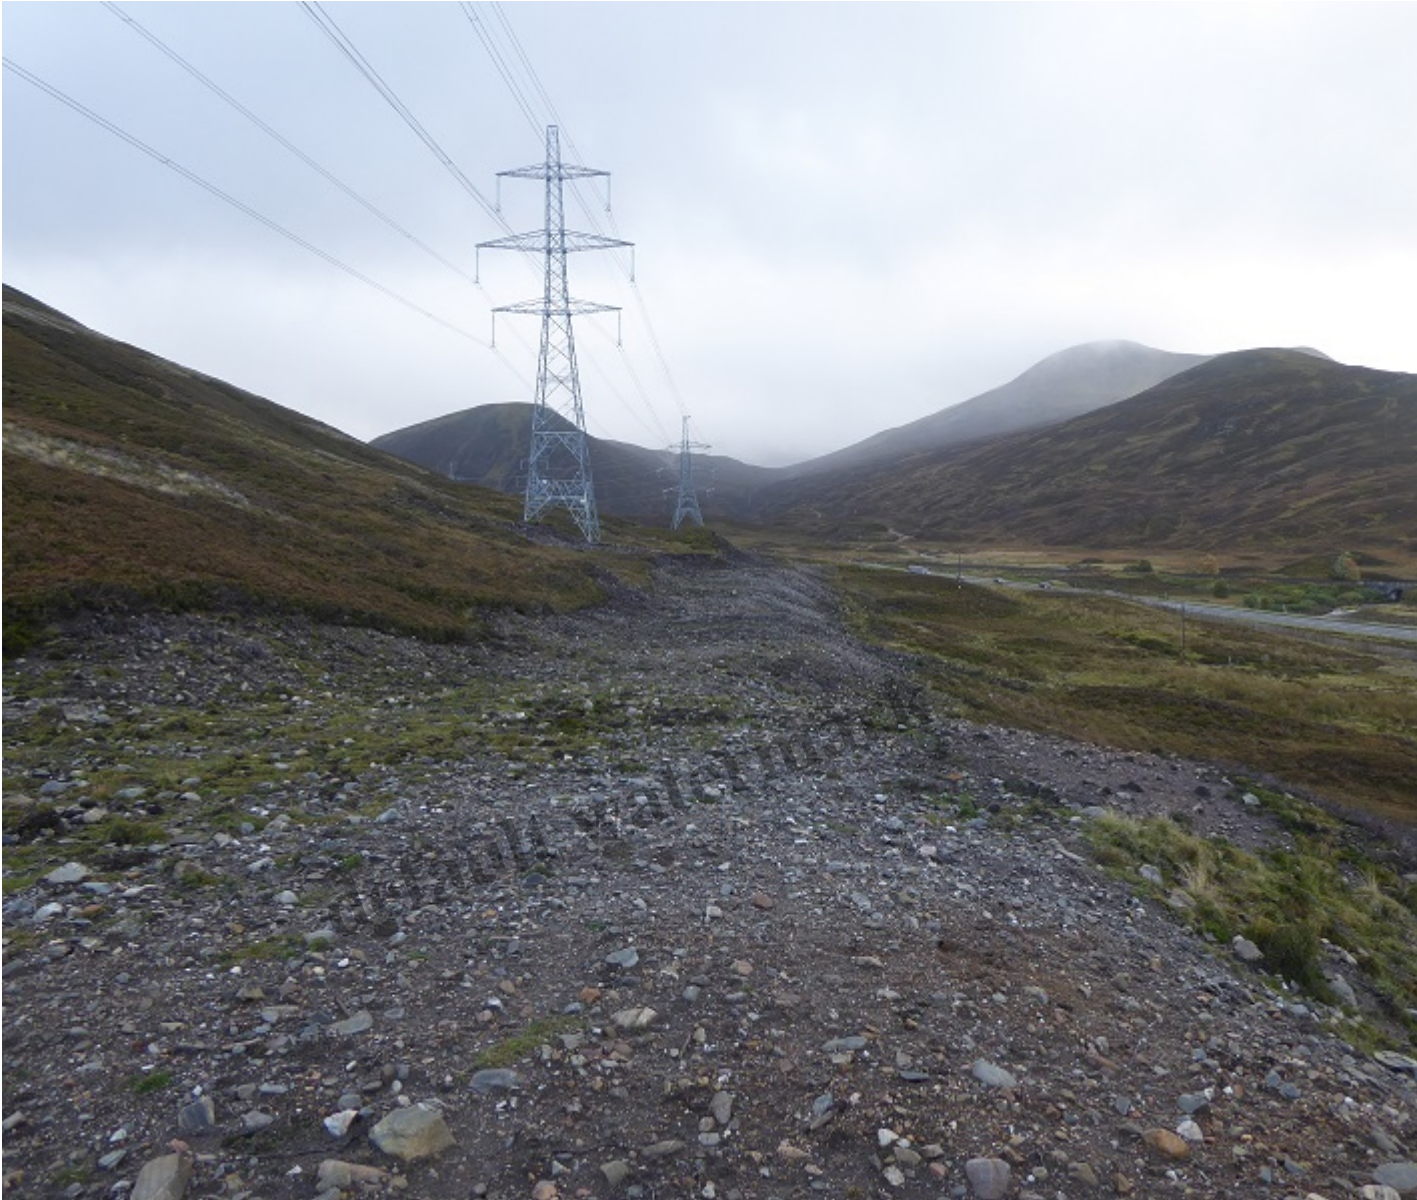
A section of “restored” track on the north Drumochter estate

The SSE Restoration monitoring reports are focussed on recovery of vegetation and are based on the premise that this should regenerate naturally (to their credit CNPA staff have raised concerns about this). The bigger issue though is SSE’s current approach is contrary to the original planning consent which required landforms to be properly restored – there has been NO landscape restoration of the scar cut into the hillside by the temporary construction track (photo above) – and for turves and other vegetation to be properly stored before being replaced. Having changed the composition of the soils by mixing peat with stone, any natural regeneration that takes place here – and its being impeded by continued vehicle use of the “former” track – is likely to lead to a change in species composition. The Scottish Government therefore now need to require SSE to commission an independent restoration plan, involving SNH and the CNPA, which first set out how the landscape will be restored so the line of the construction track disappears and then how vegetation can be restored (drawing on the

evidence of the successful restoration of Glen Bruar after the initial disaster there ([see here](#)). They then need to ensure this happens.
