SSE's restoration of the Beaully Denny construction tracks at Drumochter

Restoration on North Drumochter Estate section of the Beaully Denny

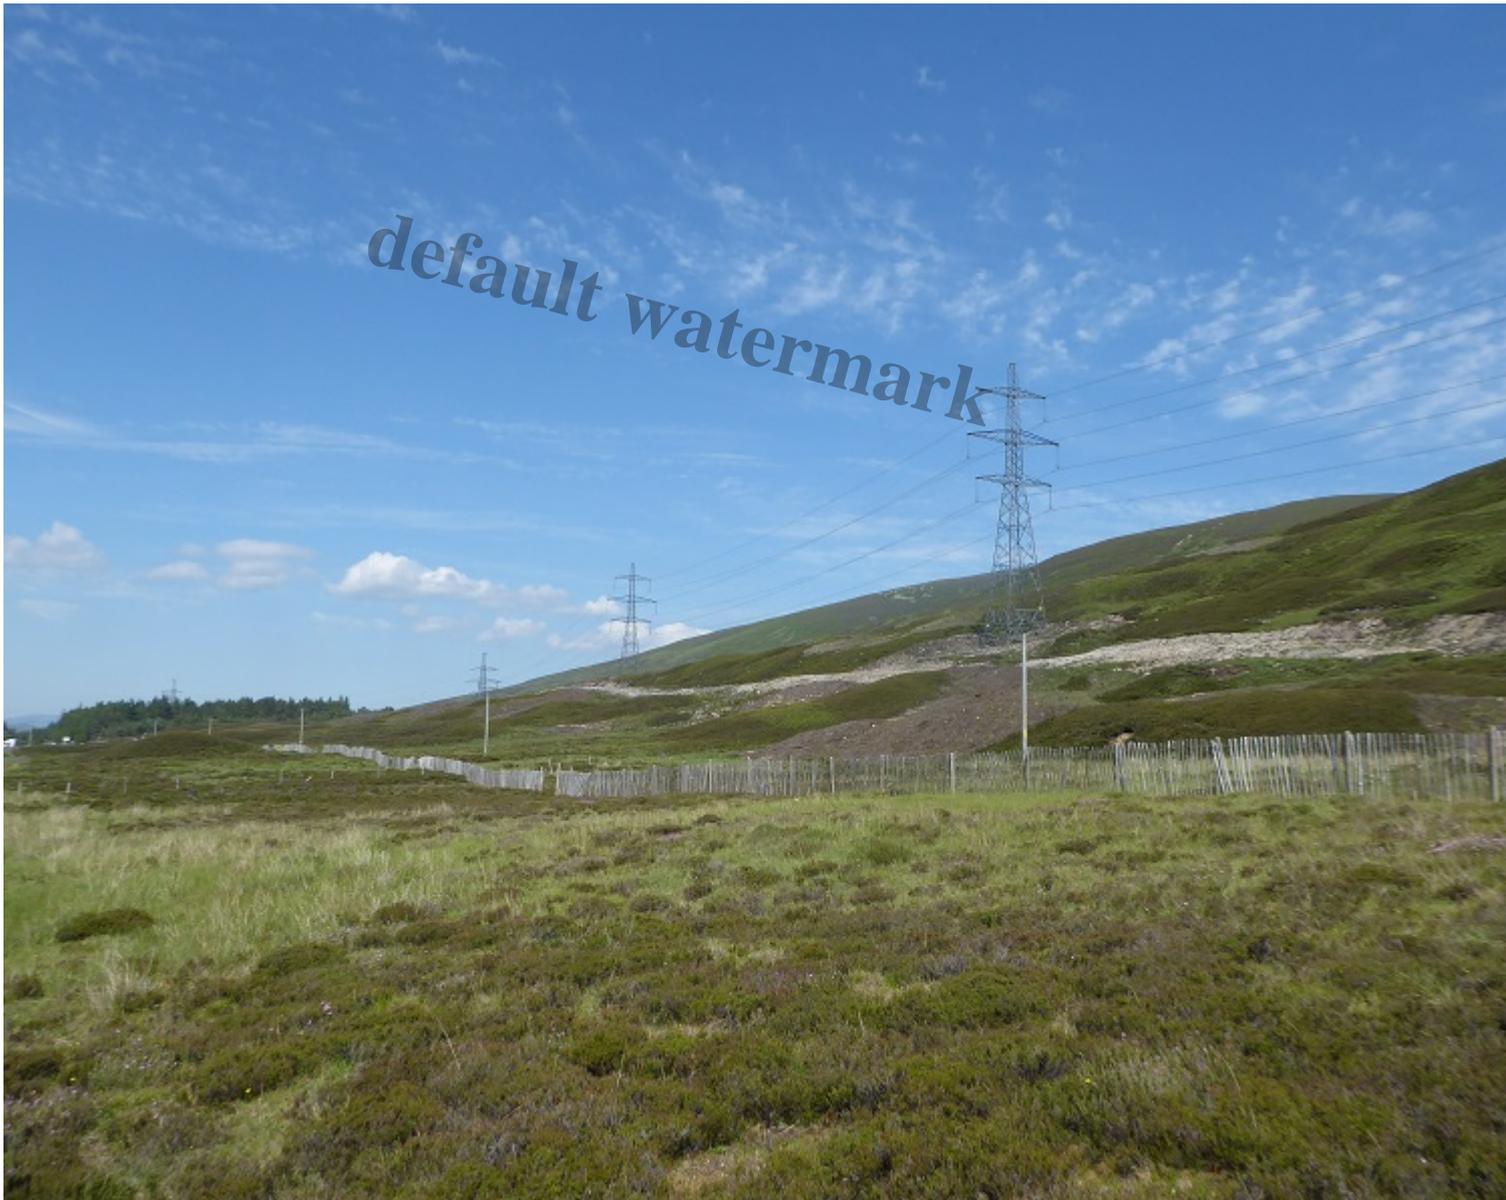
Anyone who has driven along the A9 recently and taken a passing look out the window will be aware of the extensive scars across the hillside north of Drumochter summit, scars created by the Beaully Denny construction tracks which SSE were supposed to have fully restored. Take a closer look and it is also evident that there is a considerable area of "unrestored" ground around the base of each pylon.

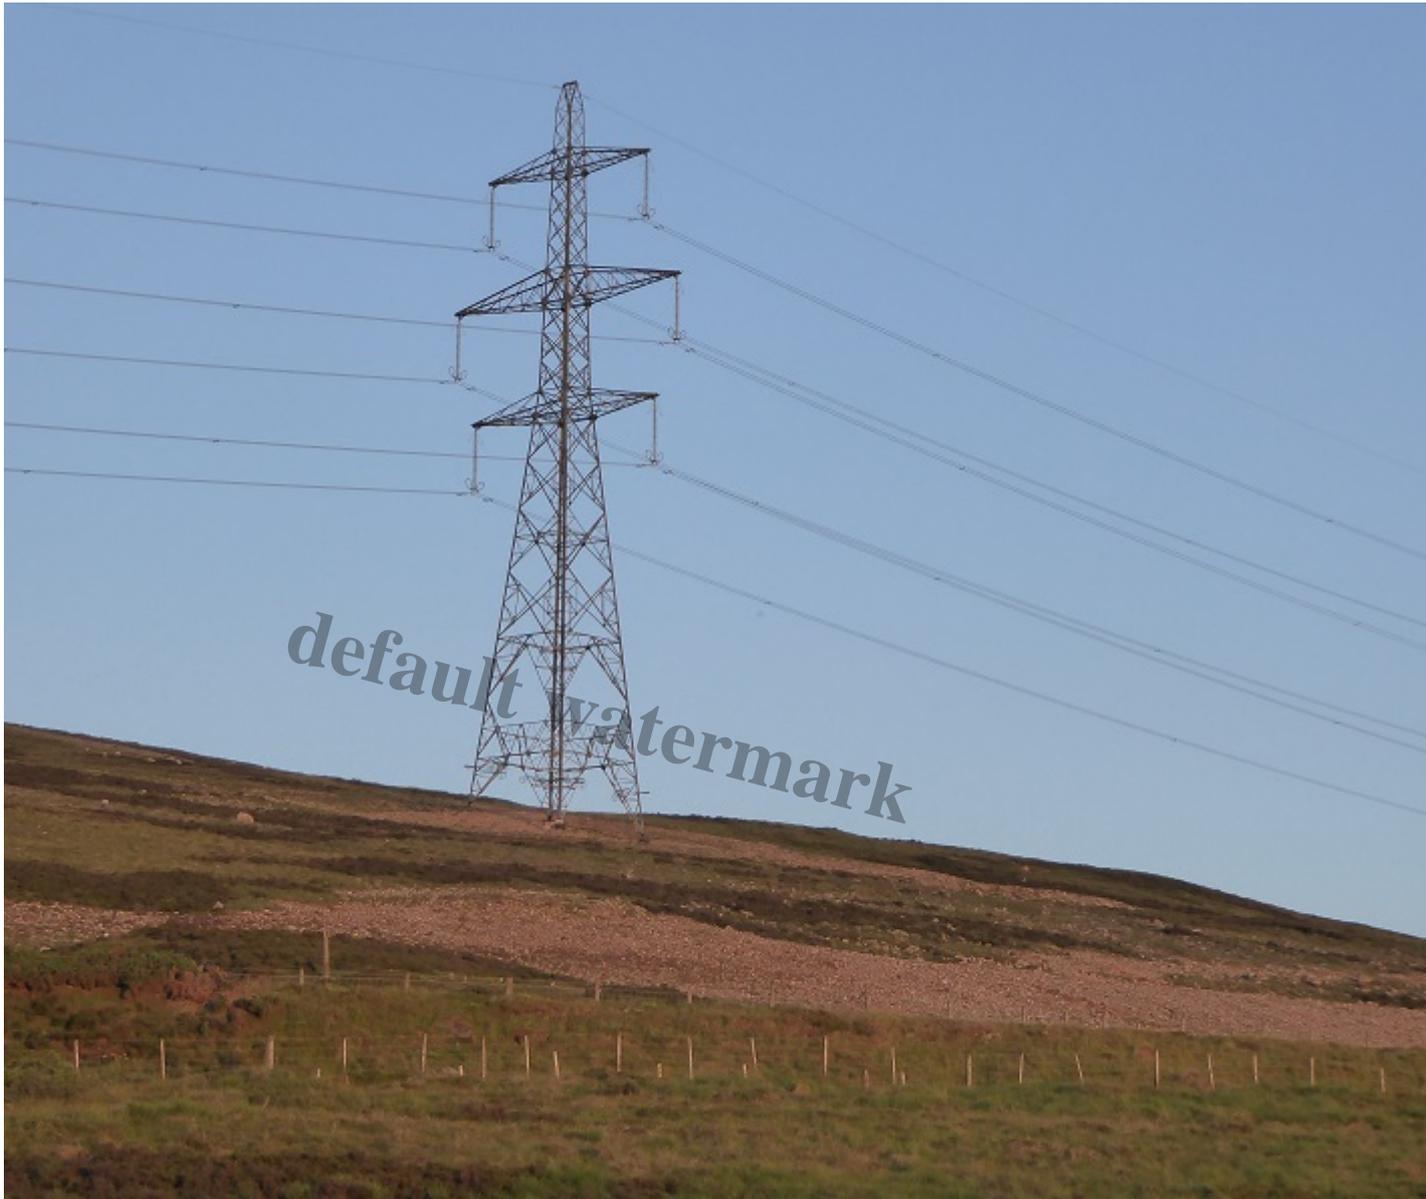
Damage caused by track and pylon construction illuminated in the sunset

The impact of the failure by SSE and the Scottish Government – who were the Planning Authority for the Beaulieu Denny – to supervise the construction work properly has had a significant landscape cost. Instead of storing the vegetation and peat removed to create the tracks and towers, they have allowed peat and vegetation to be mixed in with the rocky soils beneath, and then replaced with scant regard to the pre-existing landscape forms. In the hot dry weather the exposed soils have dried out and what little vegetation there was has died off.

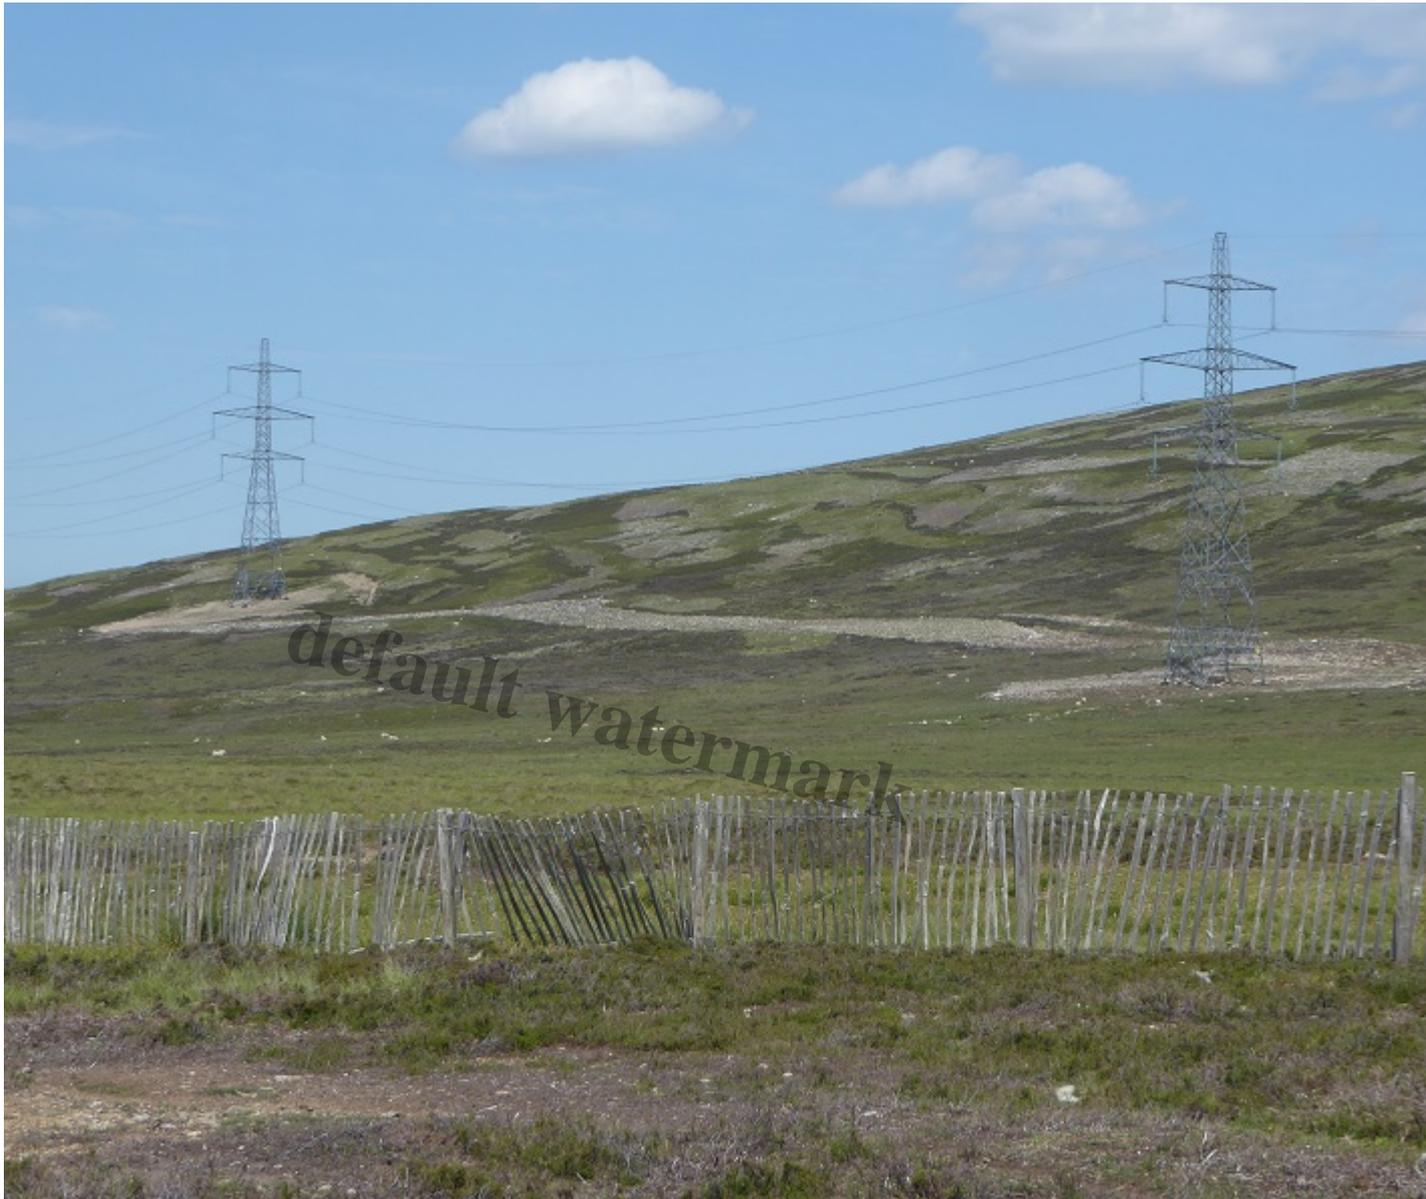
Muirburn dries out the soil but as this photo shows the impact of construction has been even greater

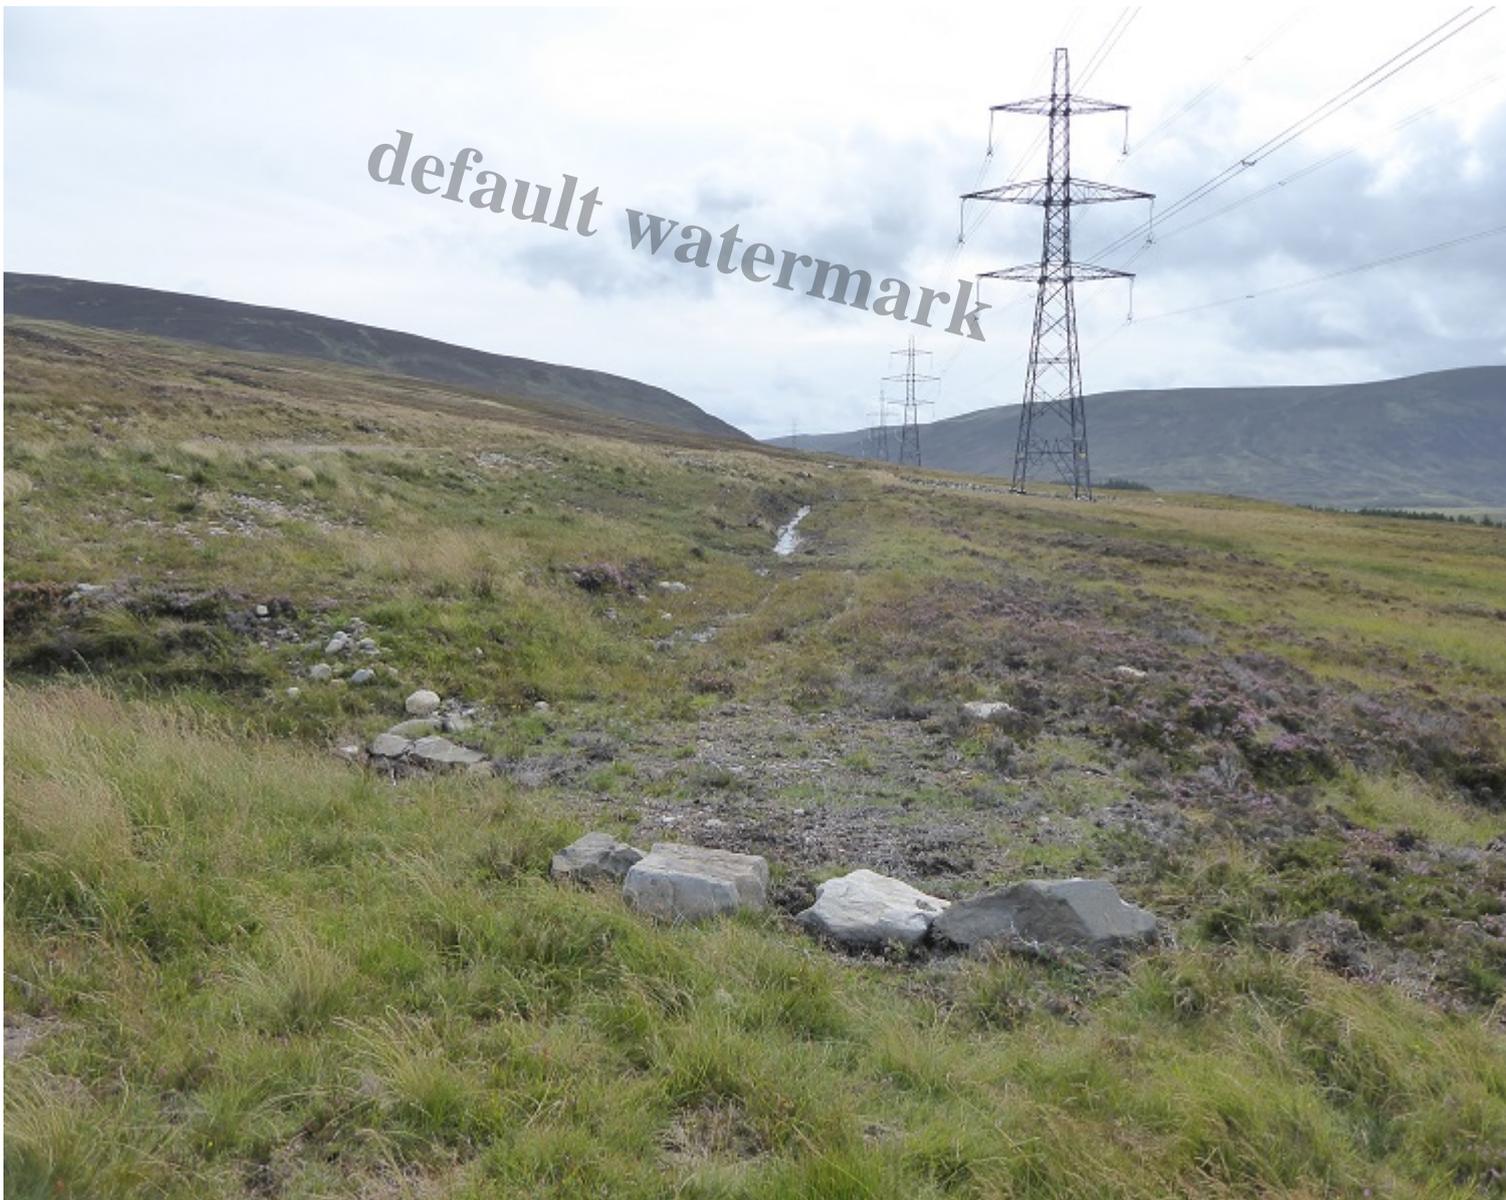
The CNPA and SNH met with SSE on site last month and have established that while most of the construction track did run along the Wade's Rd, as required by the Planning Consent, it has not been properly restored to resemble the landrover track which was here previously and is far too wide (up to 7 metres) for most of its length. The CNPA has clarified that formal responsibility for enforcement of these planning conditions lies with the Scottish Government – another failure there then – but have become involved in an area that is not their formal responsibility. I think this shows the type of leadership one might hope for and expect from a National Park and its I believe its really positive that the CNPA has put scarce resources into trying to address this issue. Having done so, SSE has now apparently agreed that the Dalnacardoch track needs to be restored. Well done to all the staff involved and also to the Board, who have long been concerned about the poor restoration of the Beaully Denny and who are planning another site visit in the Autumn.

Looking south down the old Wade Military Rd with the edge of the new construction track just visible as a line above on the left.

- The only effective way to restore the land here is for SSE to remove all the imported aggregate it dumped over the moorland to create the track. This will cost a lot of money although, with the dualling of the A9, there is an opportunity to re-use this material on road construction.
- There is at least one section where the construction track failed to follow the line of the Wade Rd as required by the planning consent and one question is whether this should be retained to allow preservation of what is a historic monument. That may be decided through a new retrospective planning application to the CNPA to retain the new section of track. A more radical alternative would be to stop vehicles driving beyond this section of track and return it to a walking route.

- And then there is the question of how, without any spare vegetation, the ground below the aggregate can be restored and the track narrowed. CNPA has told me they are going to consider using vegetation removed by the A9 dualling construction. An opportunity perhaps not just for SSE, SNH and the CNPA to try out and demonstrate new restoration techniques which could then be applied to the section of track on the North Drumochter estate.
