SSE's "restoration" of the Beaully Denny construction tracks at Drumochter

Restoration on North Drumochter Estate section of the Beaully Denny

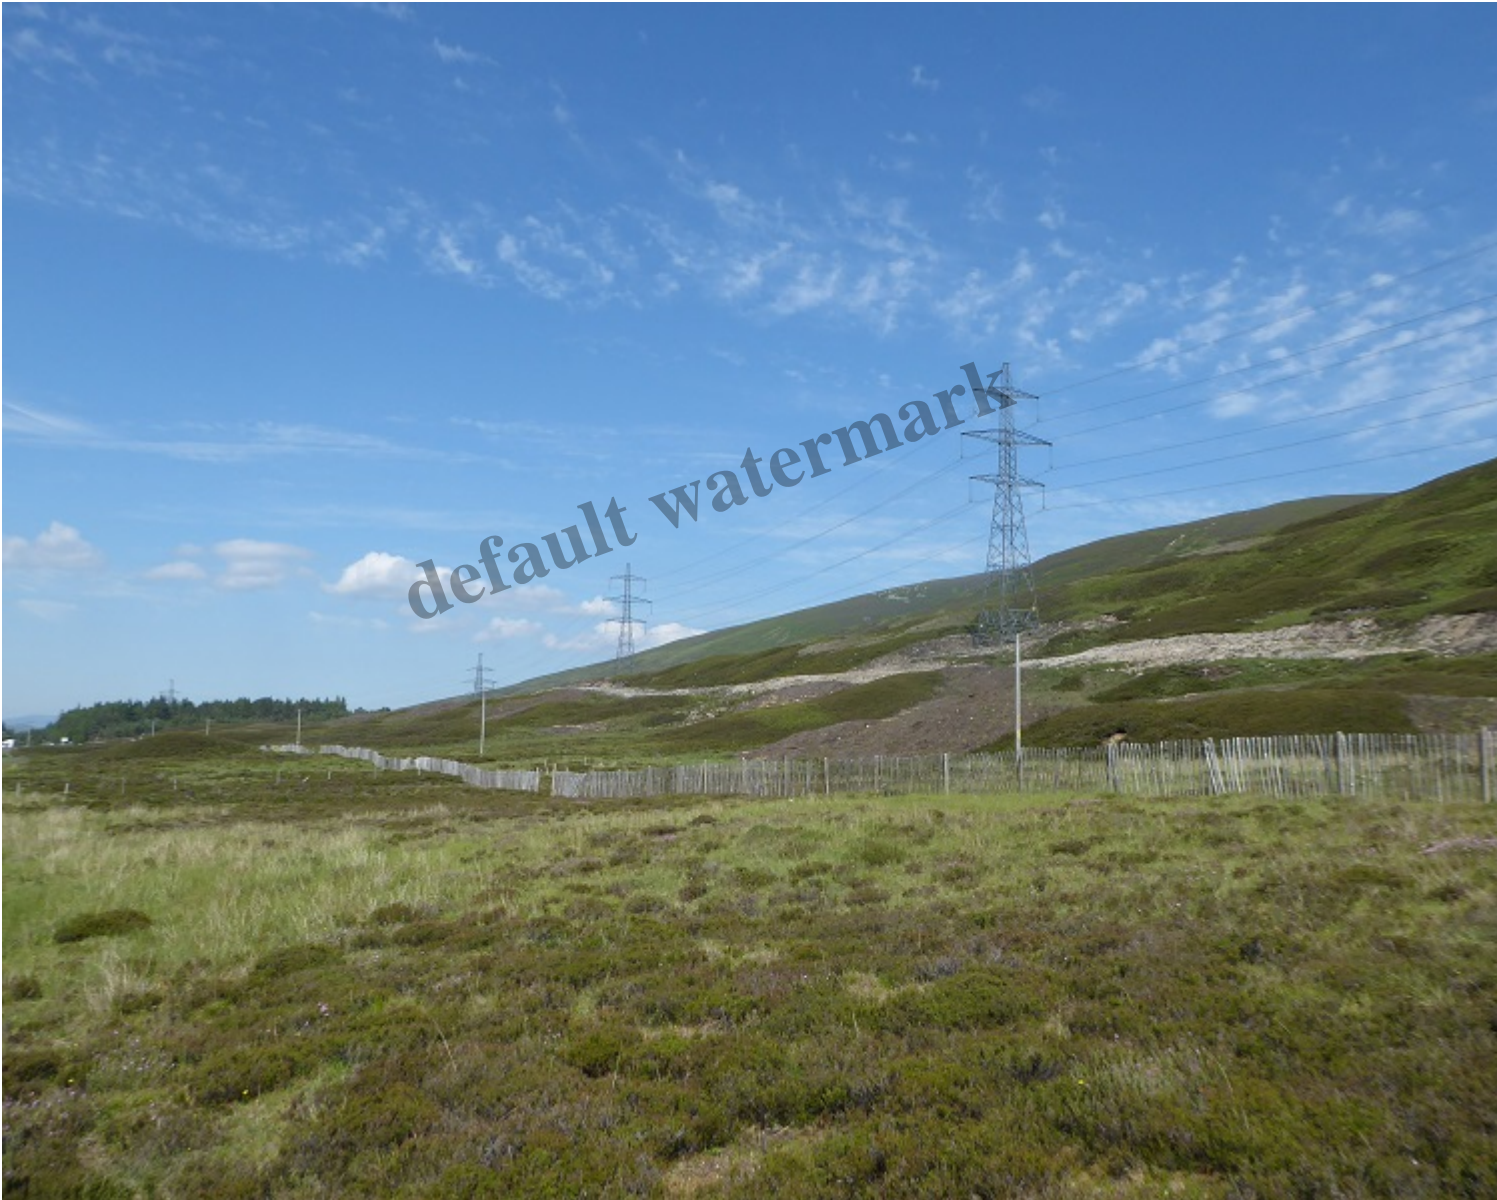
Anyone who has driven along the A9 recently and taken a passing look out the window will be aware of the extensive scars across the hillside north of Drumochter summit, scars created by the Beaully Denny construction tracks which SSE were supposed to have fully restored. Take a closer look and it is also evident that there is a considerable area of "unrestored" ground around the base of each pylon.

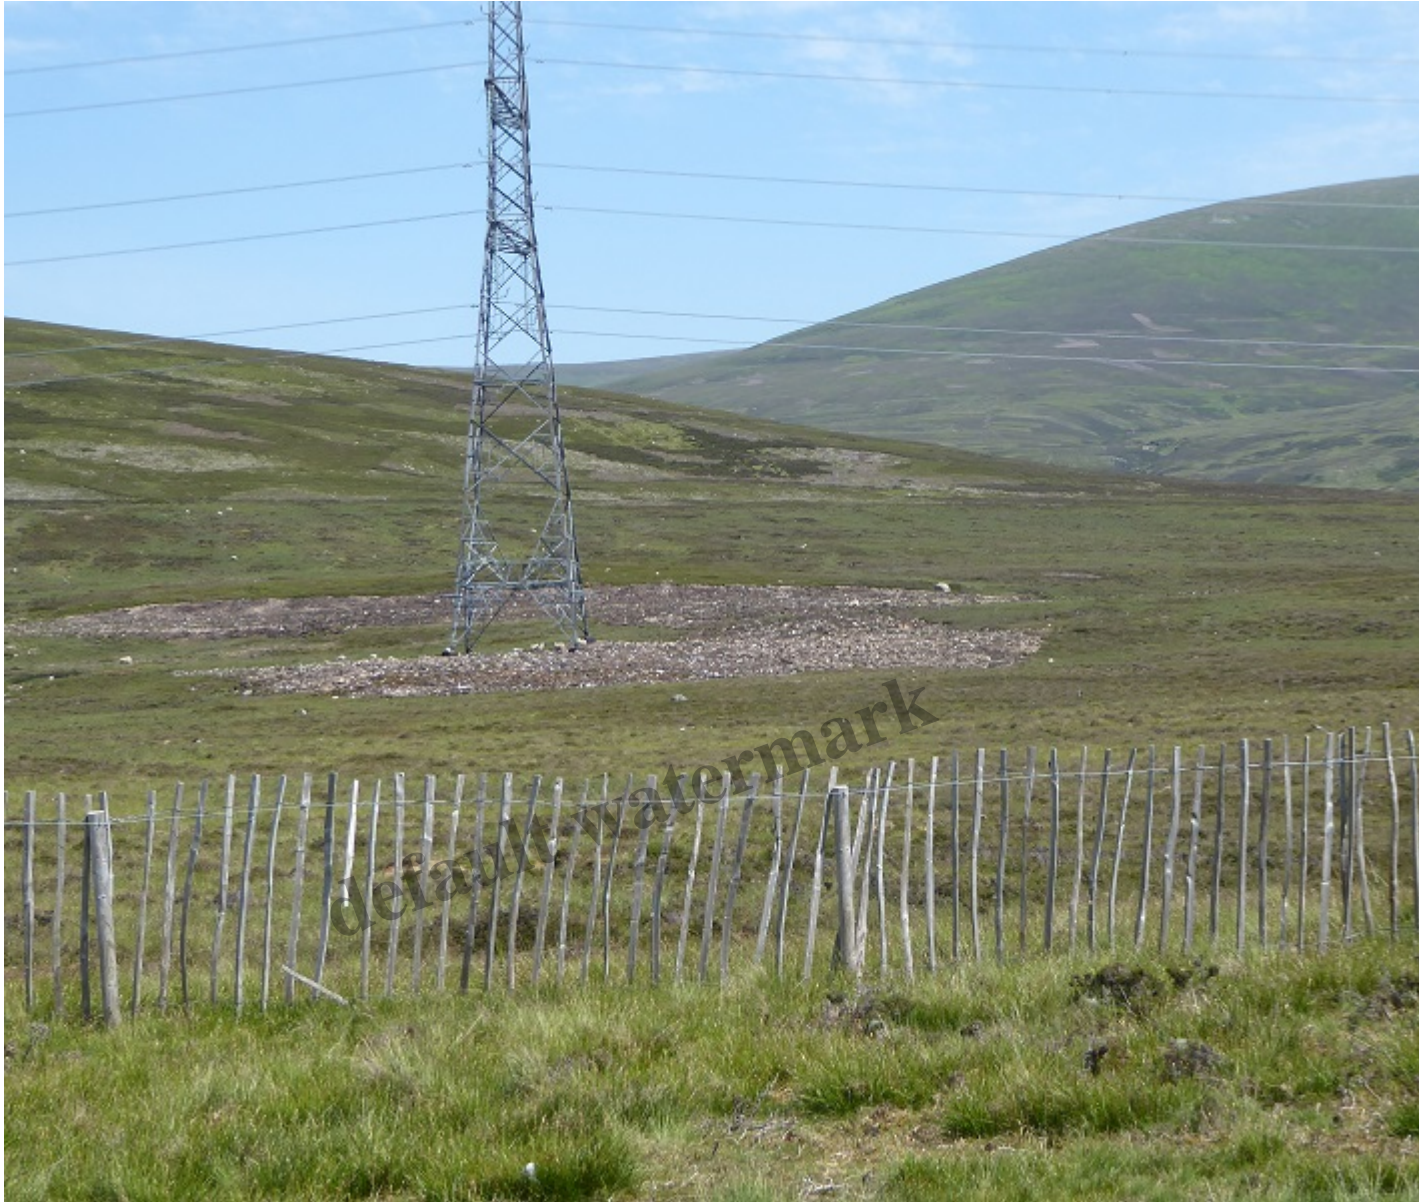
Pylon across A9 from Dalwhinnie

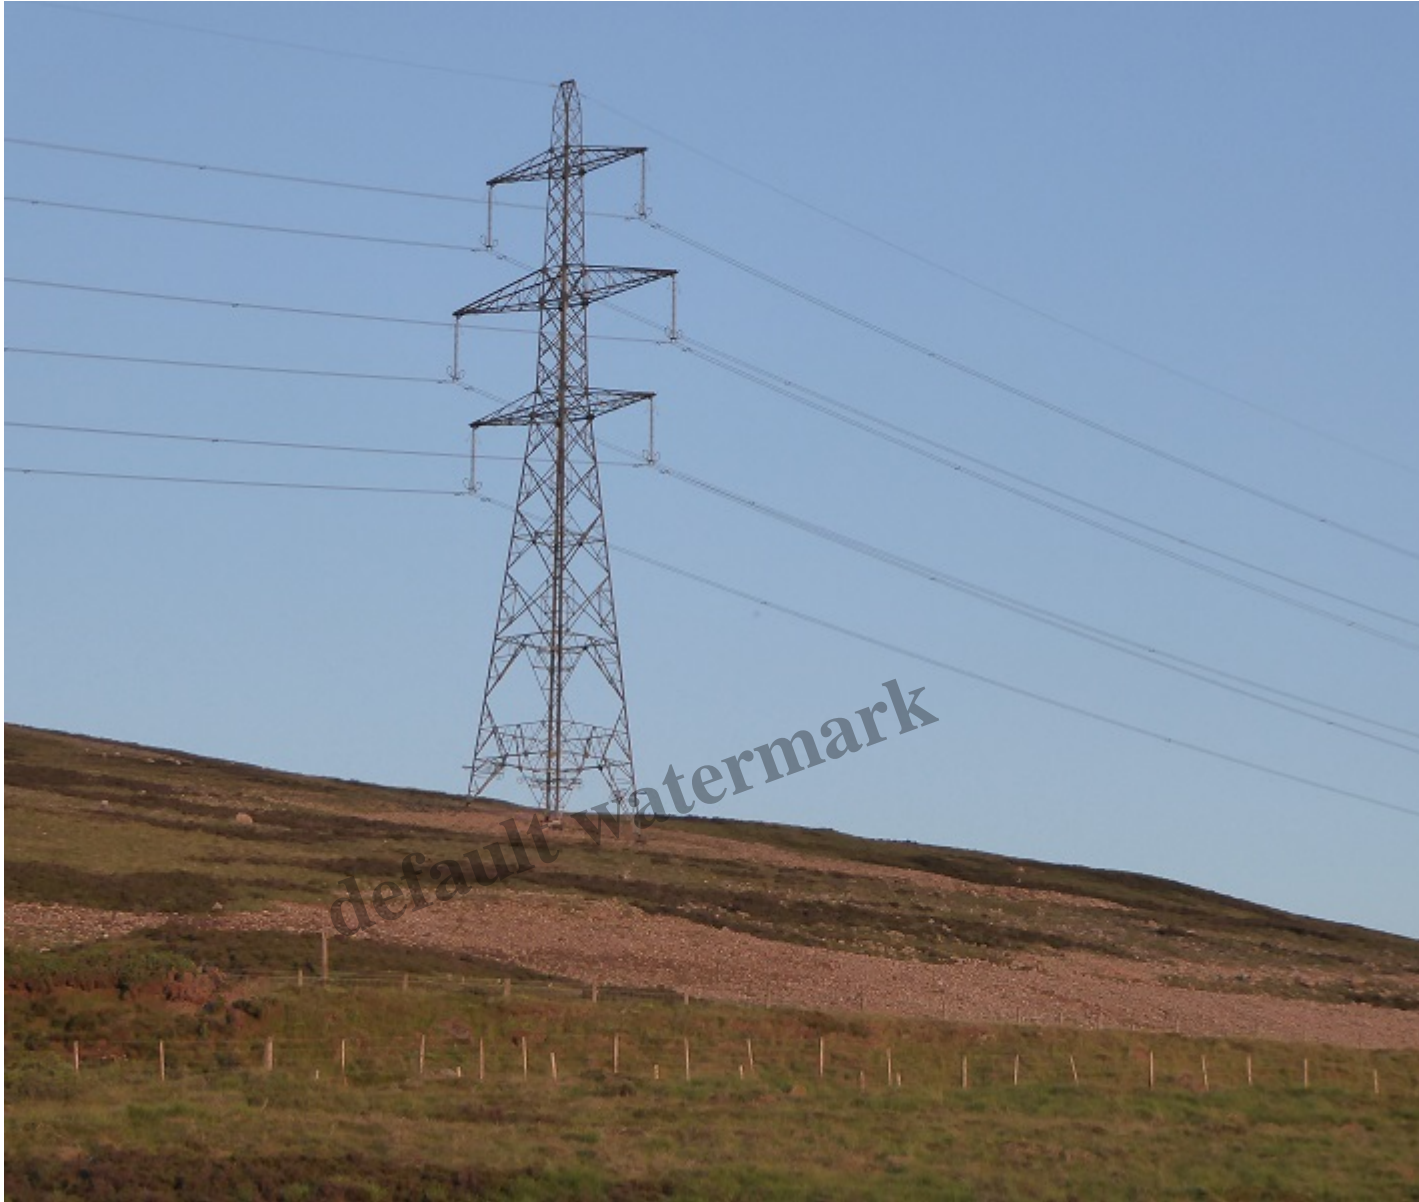
Damage caused by track and pylon construction illuminated in the sunset

The impact of the failure by SSE and the Scottish Government – who were the Planning Authority for the Beaully Denny – to supervise the construction work properly has had a significant landscape cost. Instead of storing the vegetation and peat removed to create the tracks and towers, they have allowed peat and vegetation to be mixed in with the rocky soils beneath, and then replaced with scant regard to the pre-existing landscape forms. In the hot dry weather the exposed soils have dried out and what little vegetation there was has died off.

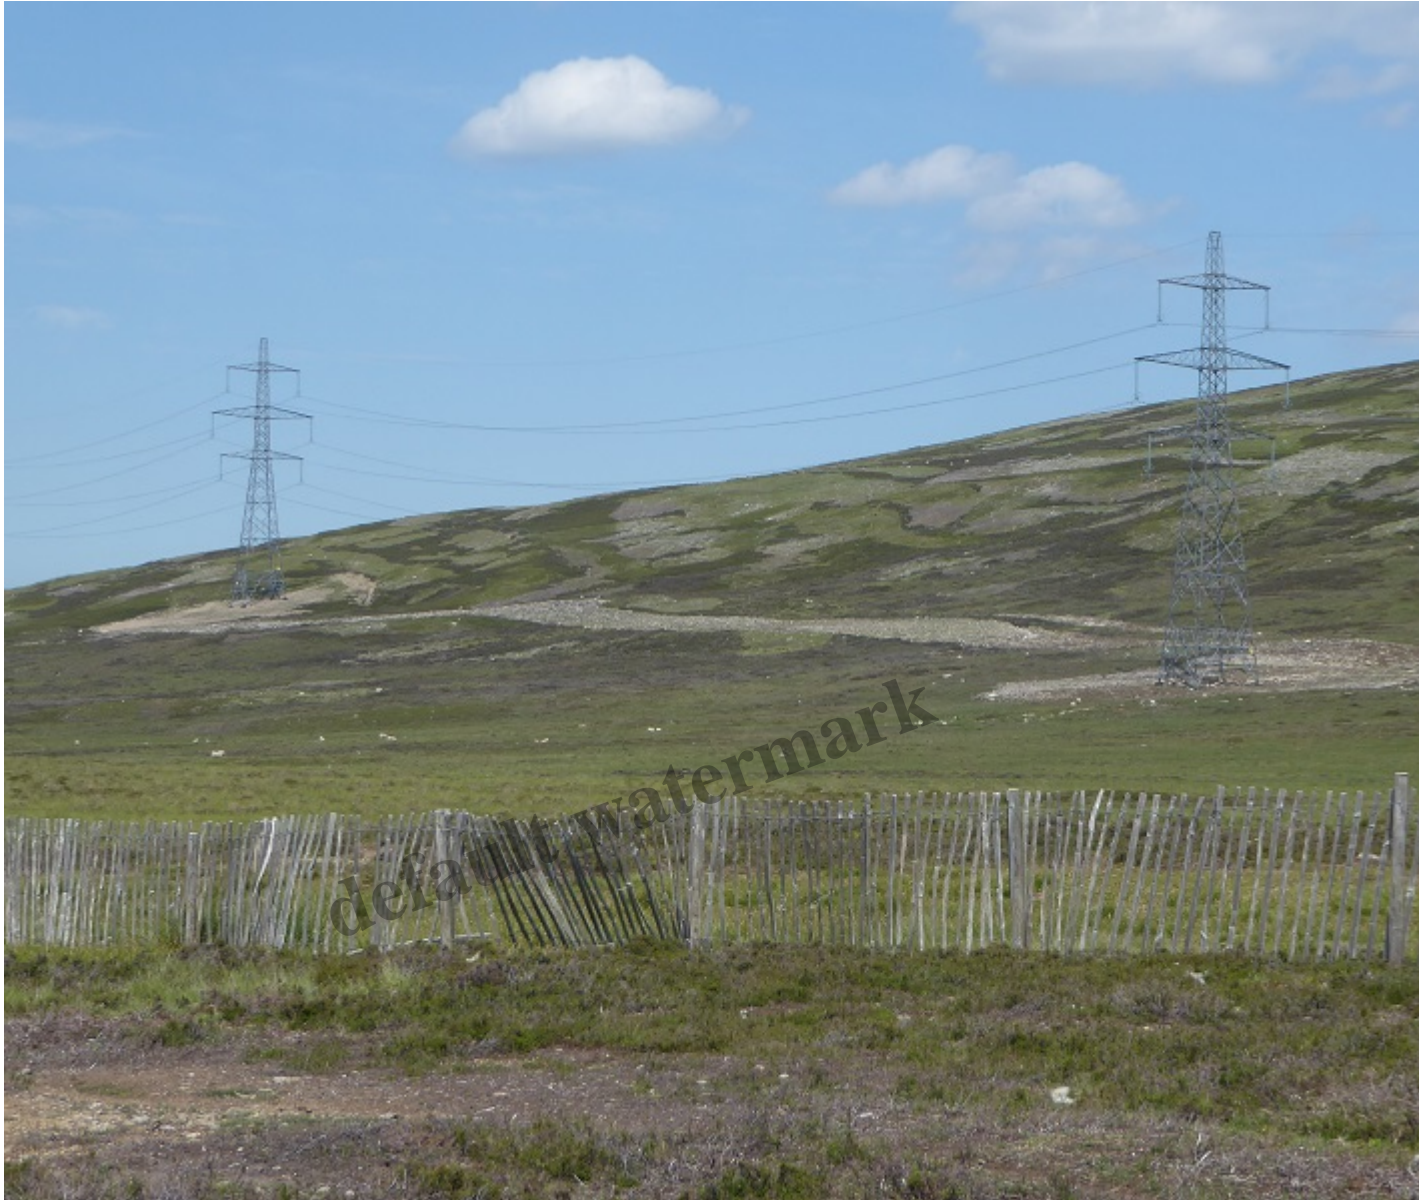
Muirburn dries out the soil but as this photo shows the impact of construction has been even greater

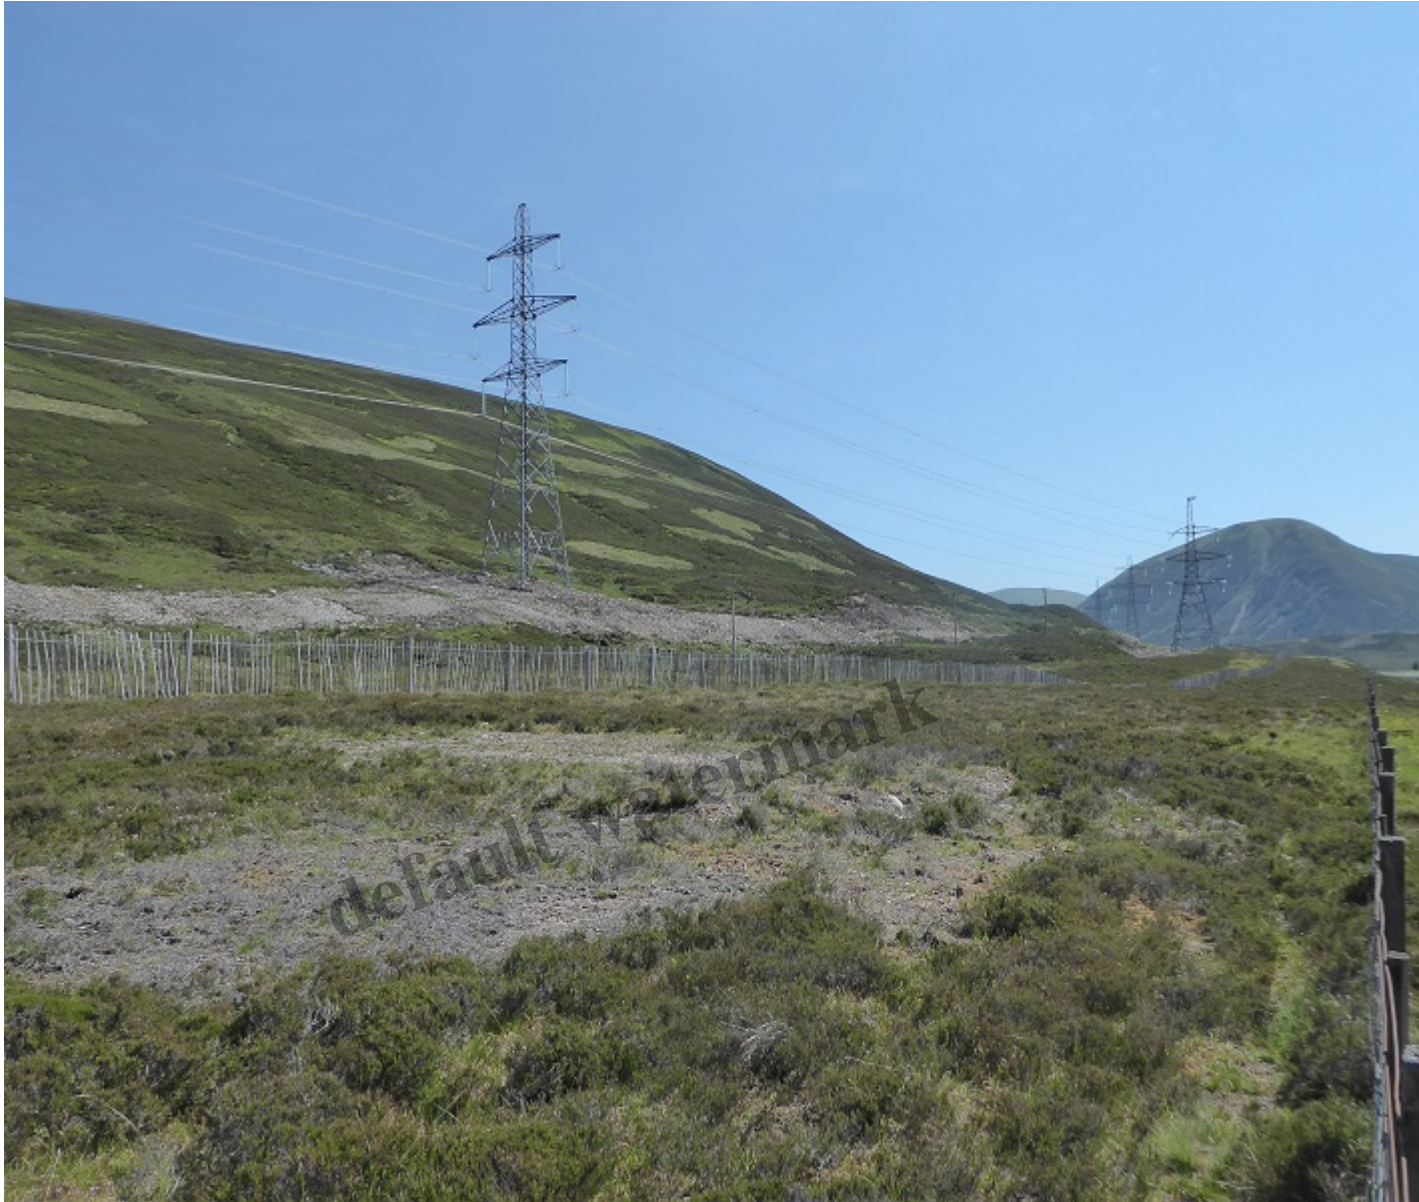
Looking south towards Drumochter summit and the Sow of Atholl

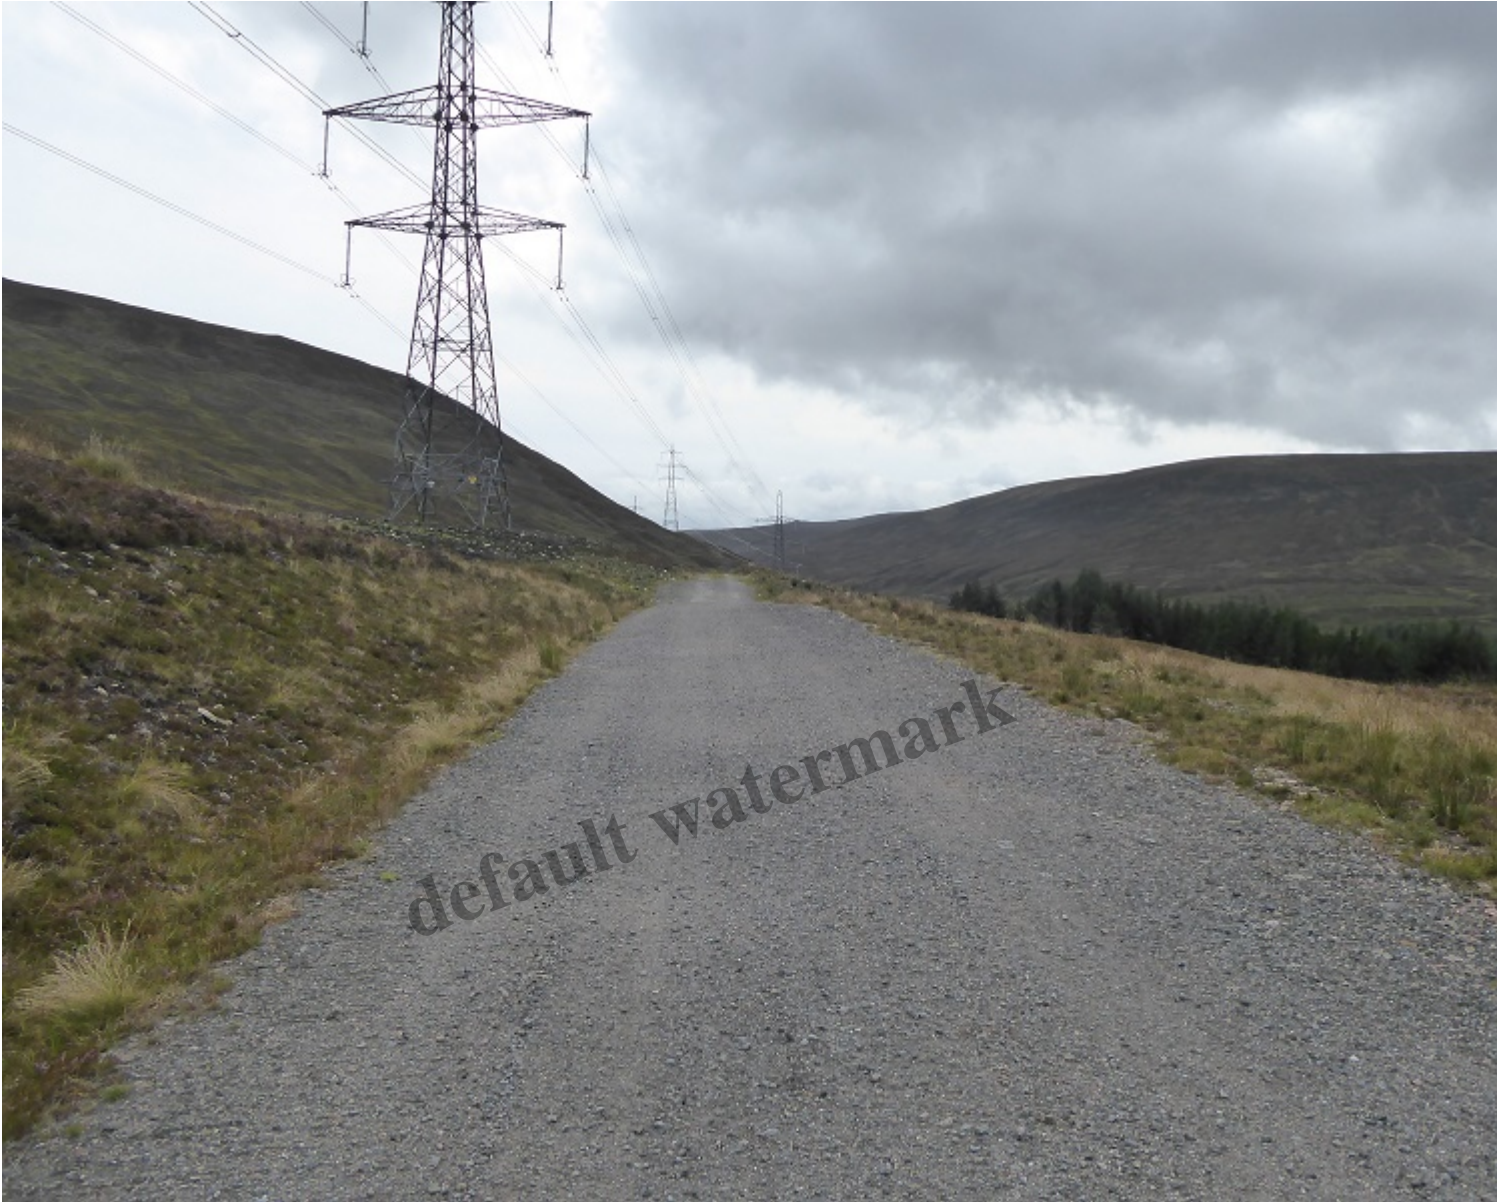
The Dalnacardoch section of construction track

In contrast to North Drumochter, I have had welcome news from planning staff at the Cairngorms National Park Authority about the section of track on the Dalnacardoch track which had been unlawfully left in place by SSE contrary to planning requirements ([see here](#)).

The CNPA and SNH met with SSE on site last month and have established that while most of the construction track did run along the Wade's Rd, as required by the Planning Consent, it has not been properly restored to resemble the landrover track which was here previously and is far too wide (up to 7 metres) for most of its length. The CNPA has clarified that formal responsibility for enforcement of these planning conditions lies with the Scottish Government – another failure there then – but have become involved in an area that is not their formal responsibility. I think this shows the type of leadership one might hope for and expect from a National Park and its I believe its really positive that the CNPA has put scarce resources into trying to address this issue. Having done so, SSE has now apparently agreed that the Dalnacardoch track needs to be restored. Well done to all the staff involved and also to the Board, who have long been concerned about the poor restoration of the Beaulieu Denny and who are planning another site visit in the Autumn.

- The only effective way to restore the land here is for SSE to remove all the imported aggregate it dumped over the moorland to create the track. This will cost a lot of money although, with the dualling of the A9, there is an opportunity to re-use this material on road construction.
- There is at least one section where the construction track failed to follow the line of the Wade's Rd as required by the planning consent and one question is whether this should be retained to allow preservation of what is a historic monument. That may be decided through a new retrospective planning application to the CNPA to retain the new section of track. A more radical alternative would be to stop vehicles driving beyond this section of track and return it to a walking route.

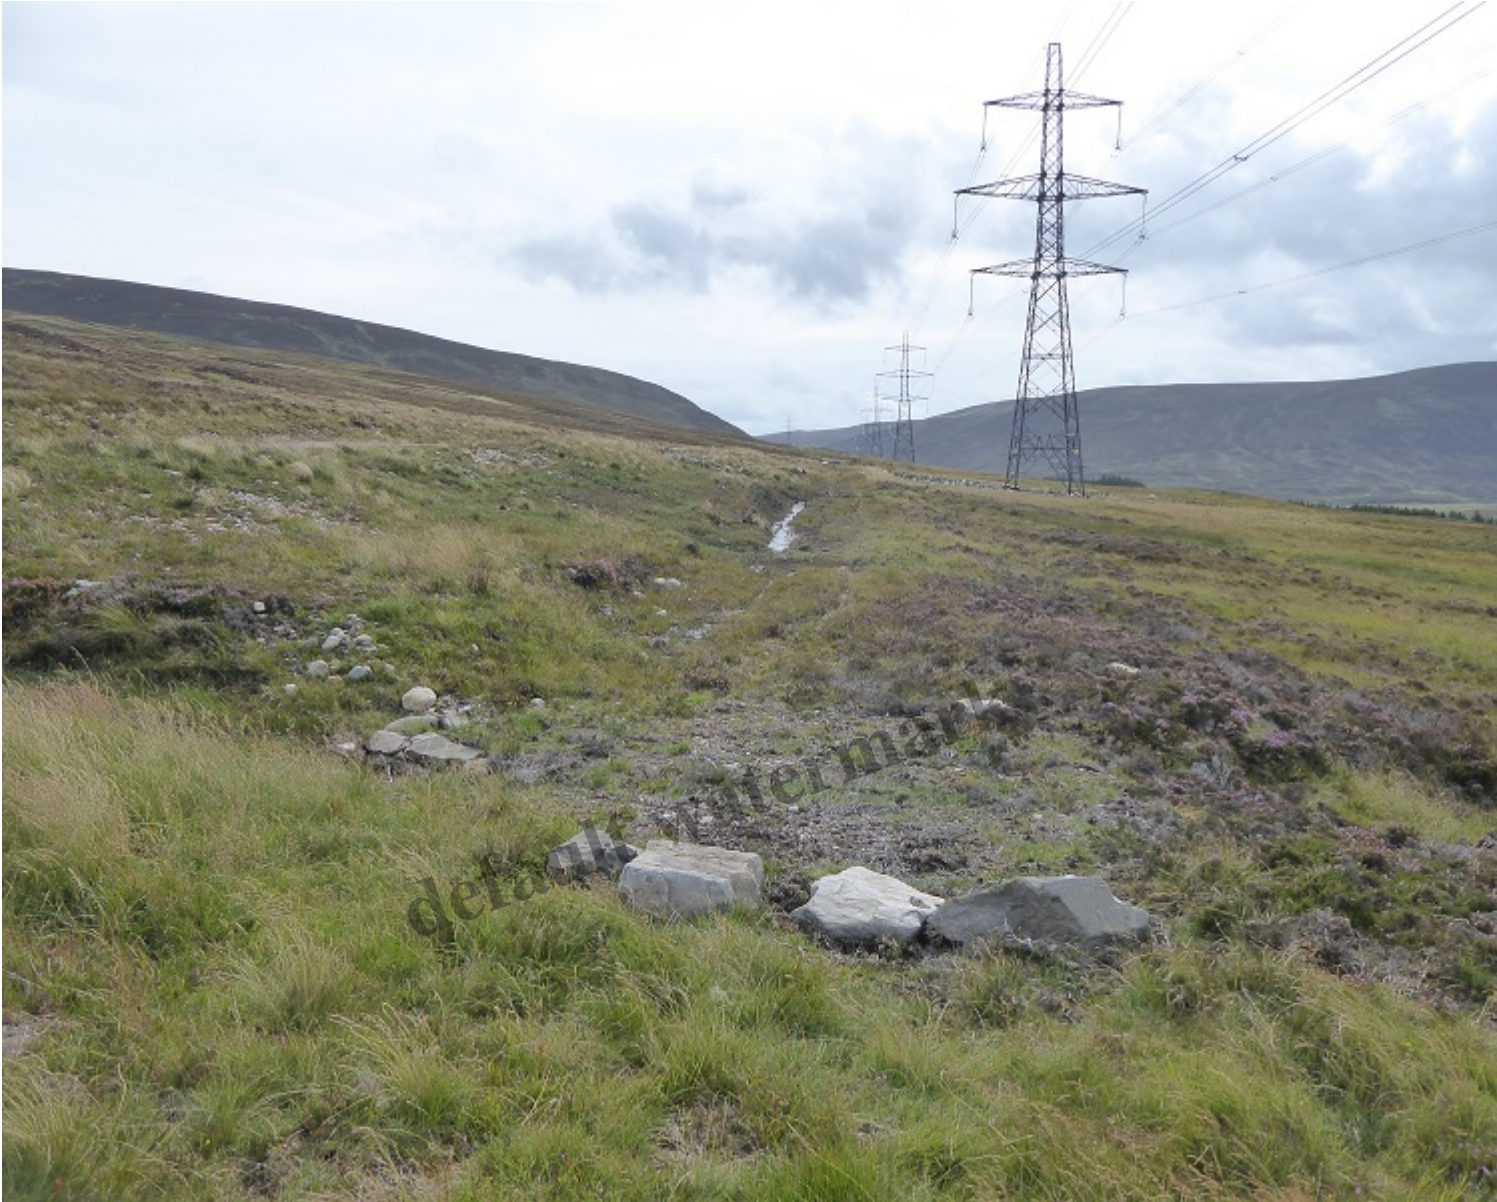
Looking south down the old Wade Military Rd with the edge of the new construction track just visible as a line above on the left.

- And then there is the question of how, without any spare vegetation, the ground below the aggregate can be restored and the track narrowed. CNPA has told me they are going to consider using vegetation removed by the A9 dualling construction. An opportunity perhaps not just for SSE, SNH and the CNPA to try out and demonstrate new restoration techniques which could then be applied to the section of track on the North Drumochter estate.
