The state of Cairngorm under Natural Retreats management (2)

Coire na Ciste T-bar

Carpark T-Bar Top Station

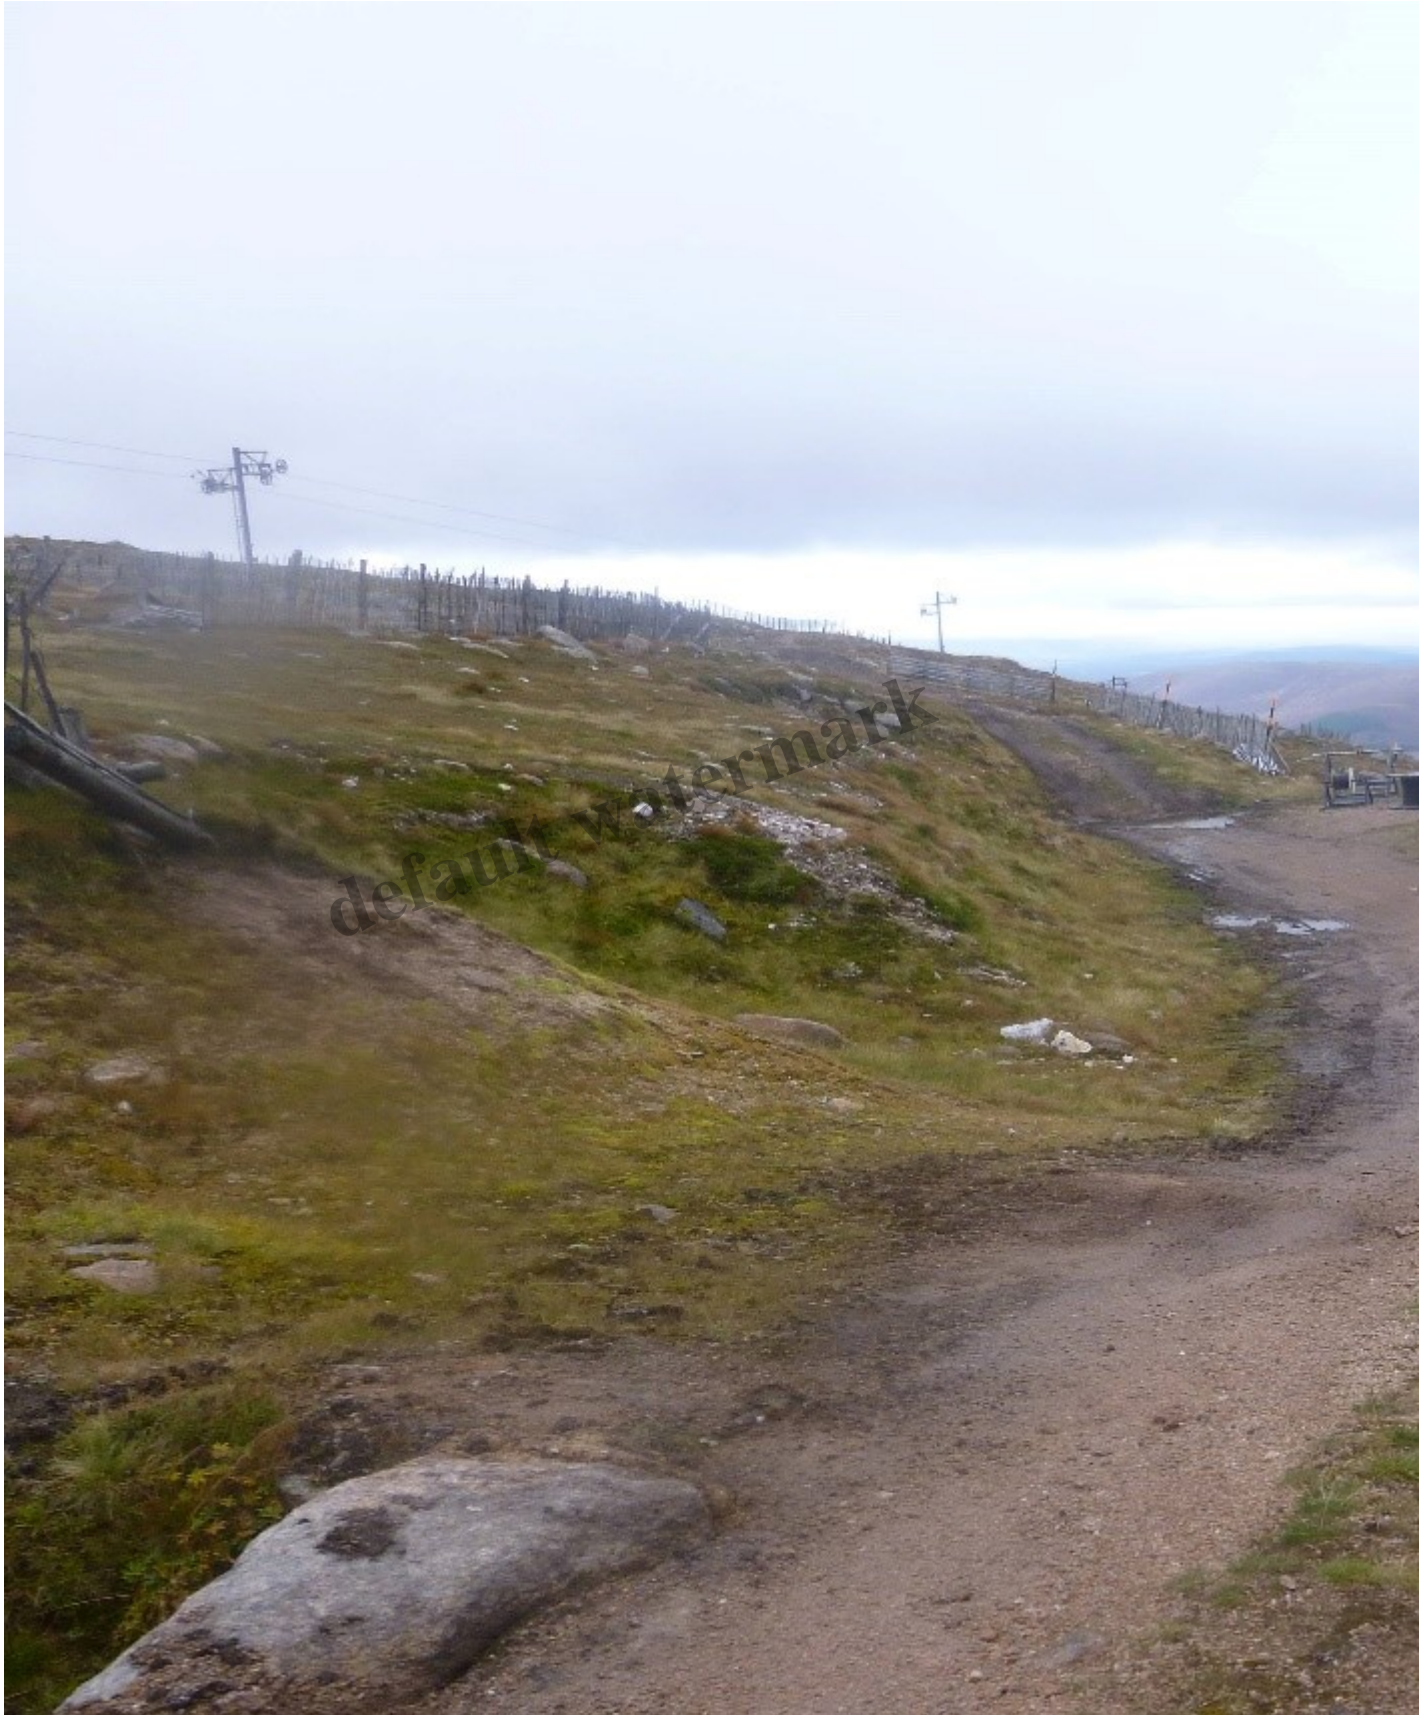
Coire na Ciste t-bar September 2017 – Photo Credit Terry Smith

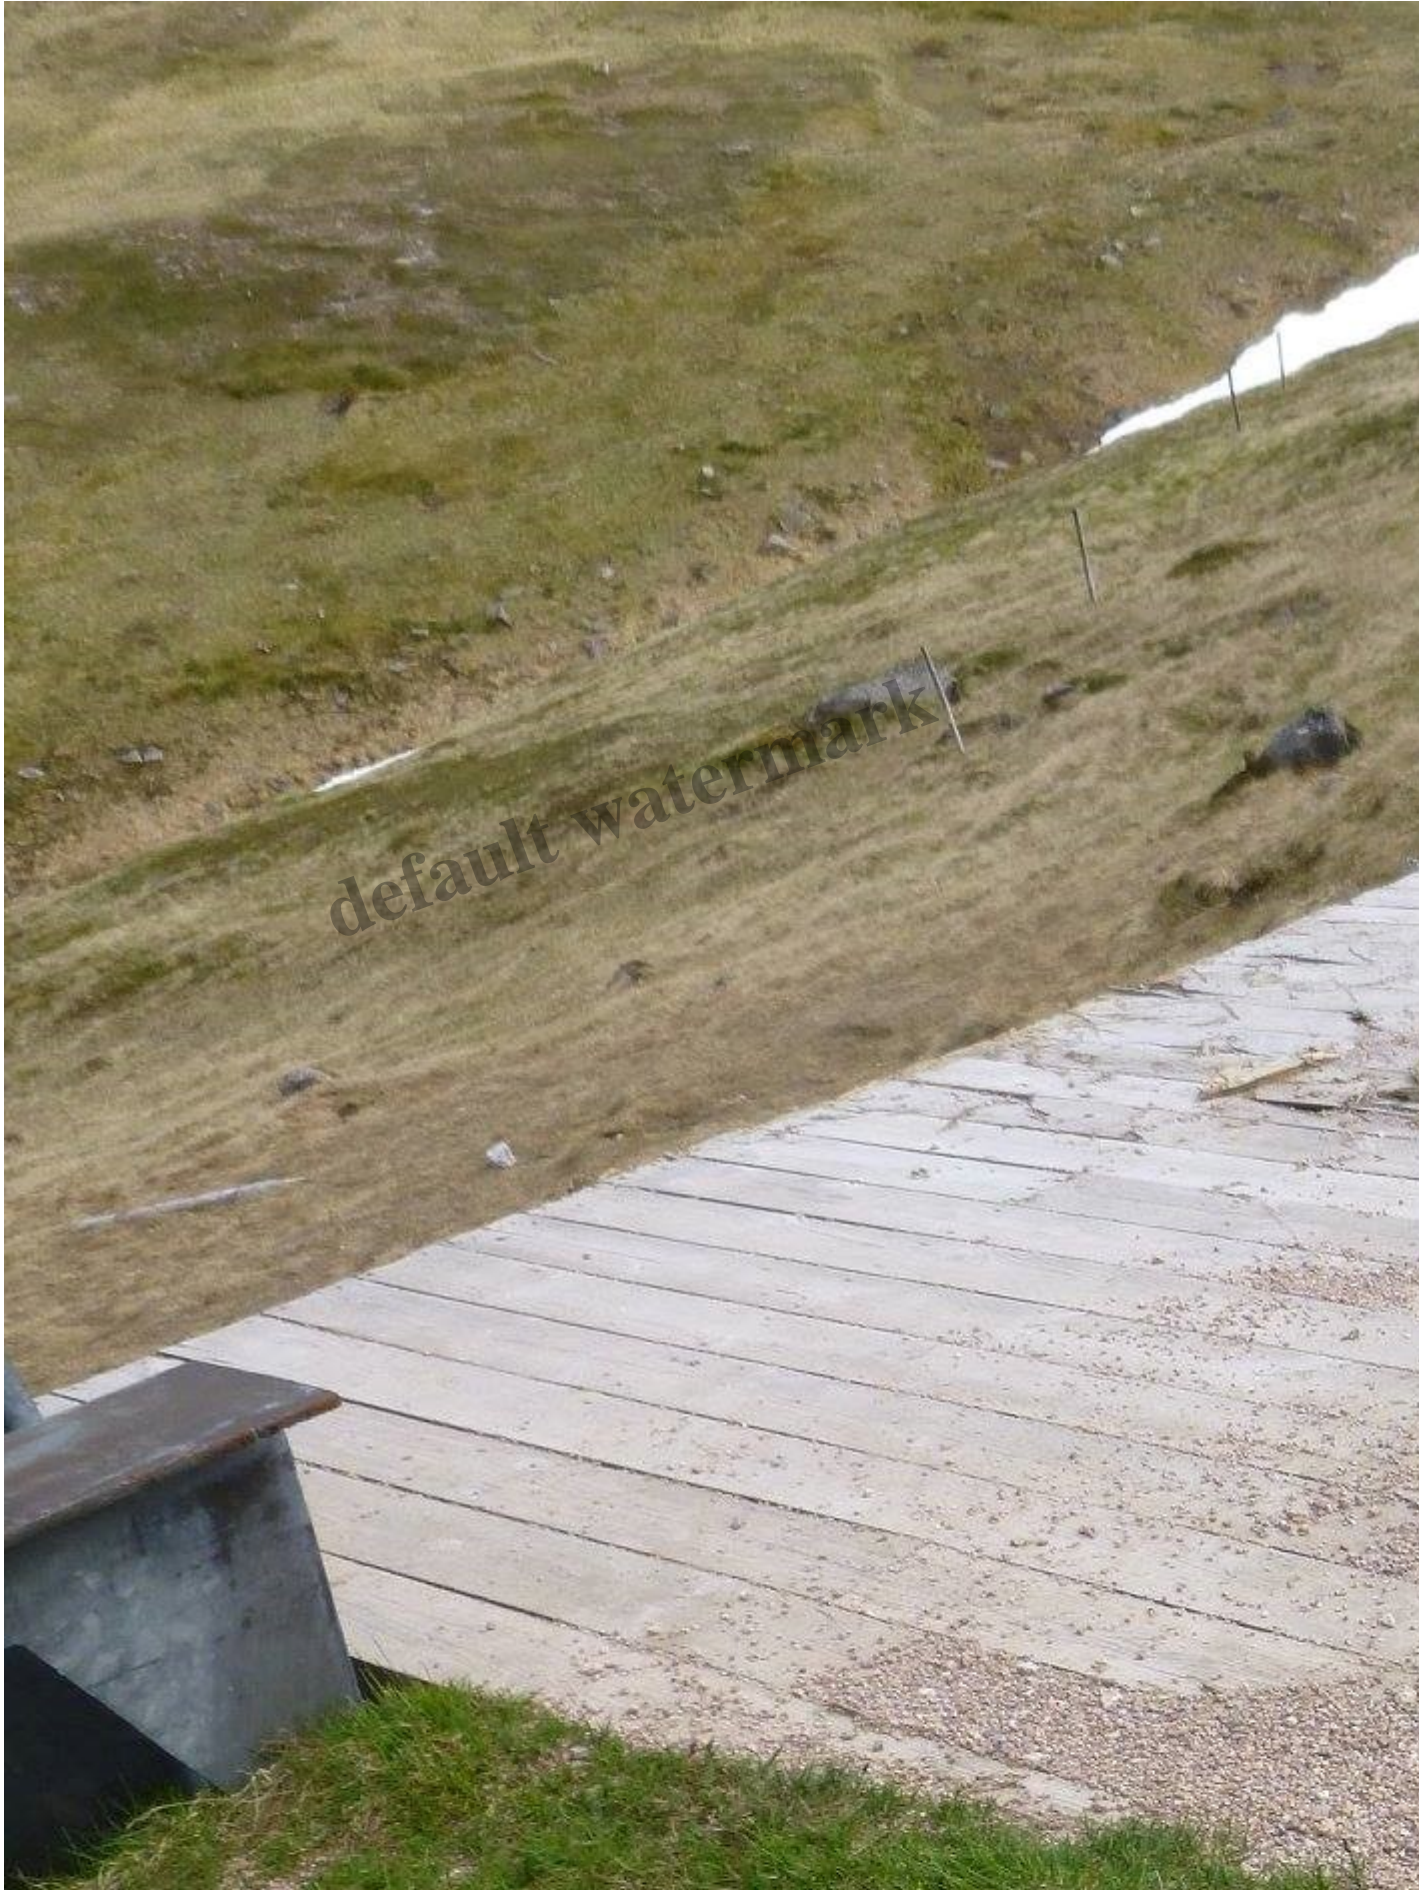
Coire Cas T-Bar platform in June 2016 in “good and safe working order”? – Photo Credit Terry Smith

The ADAC structures report picked up on the state of the Coire Cas T-Bar platform – it hardly takes an expert to see this was unsafe – in its report published in December 2016:

*The timber platform was seen to be broken – possibly due to vehicle access – **this needs to be replaced before the coming season**. This was discussed with CML staff at the time and assurances that it would be done were received”.*

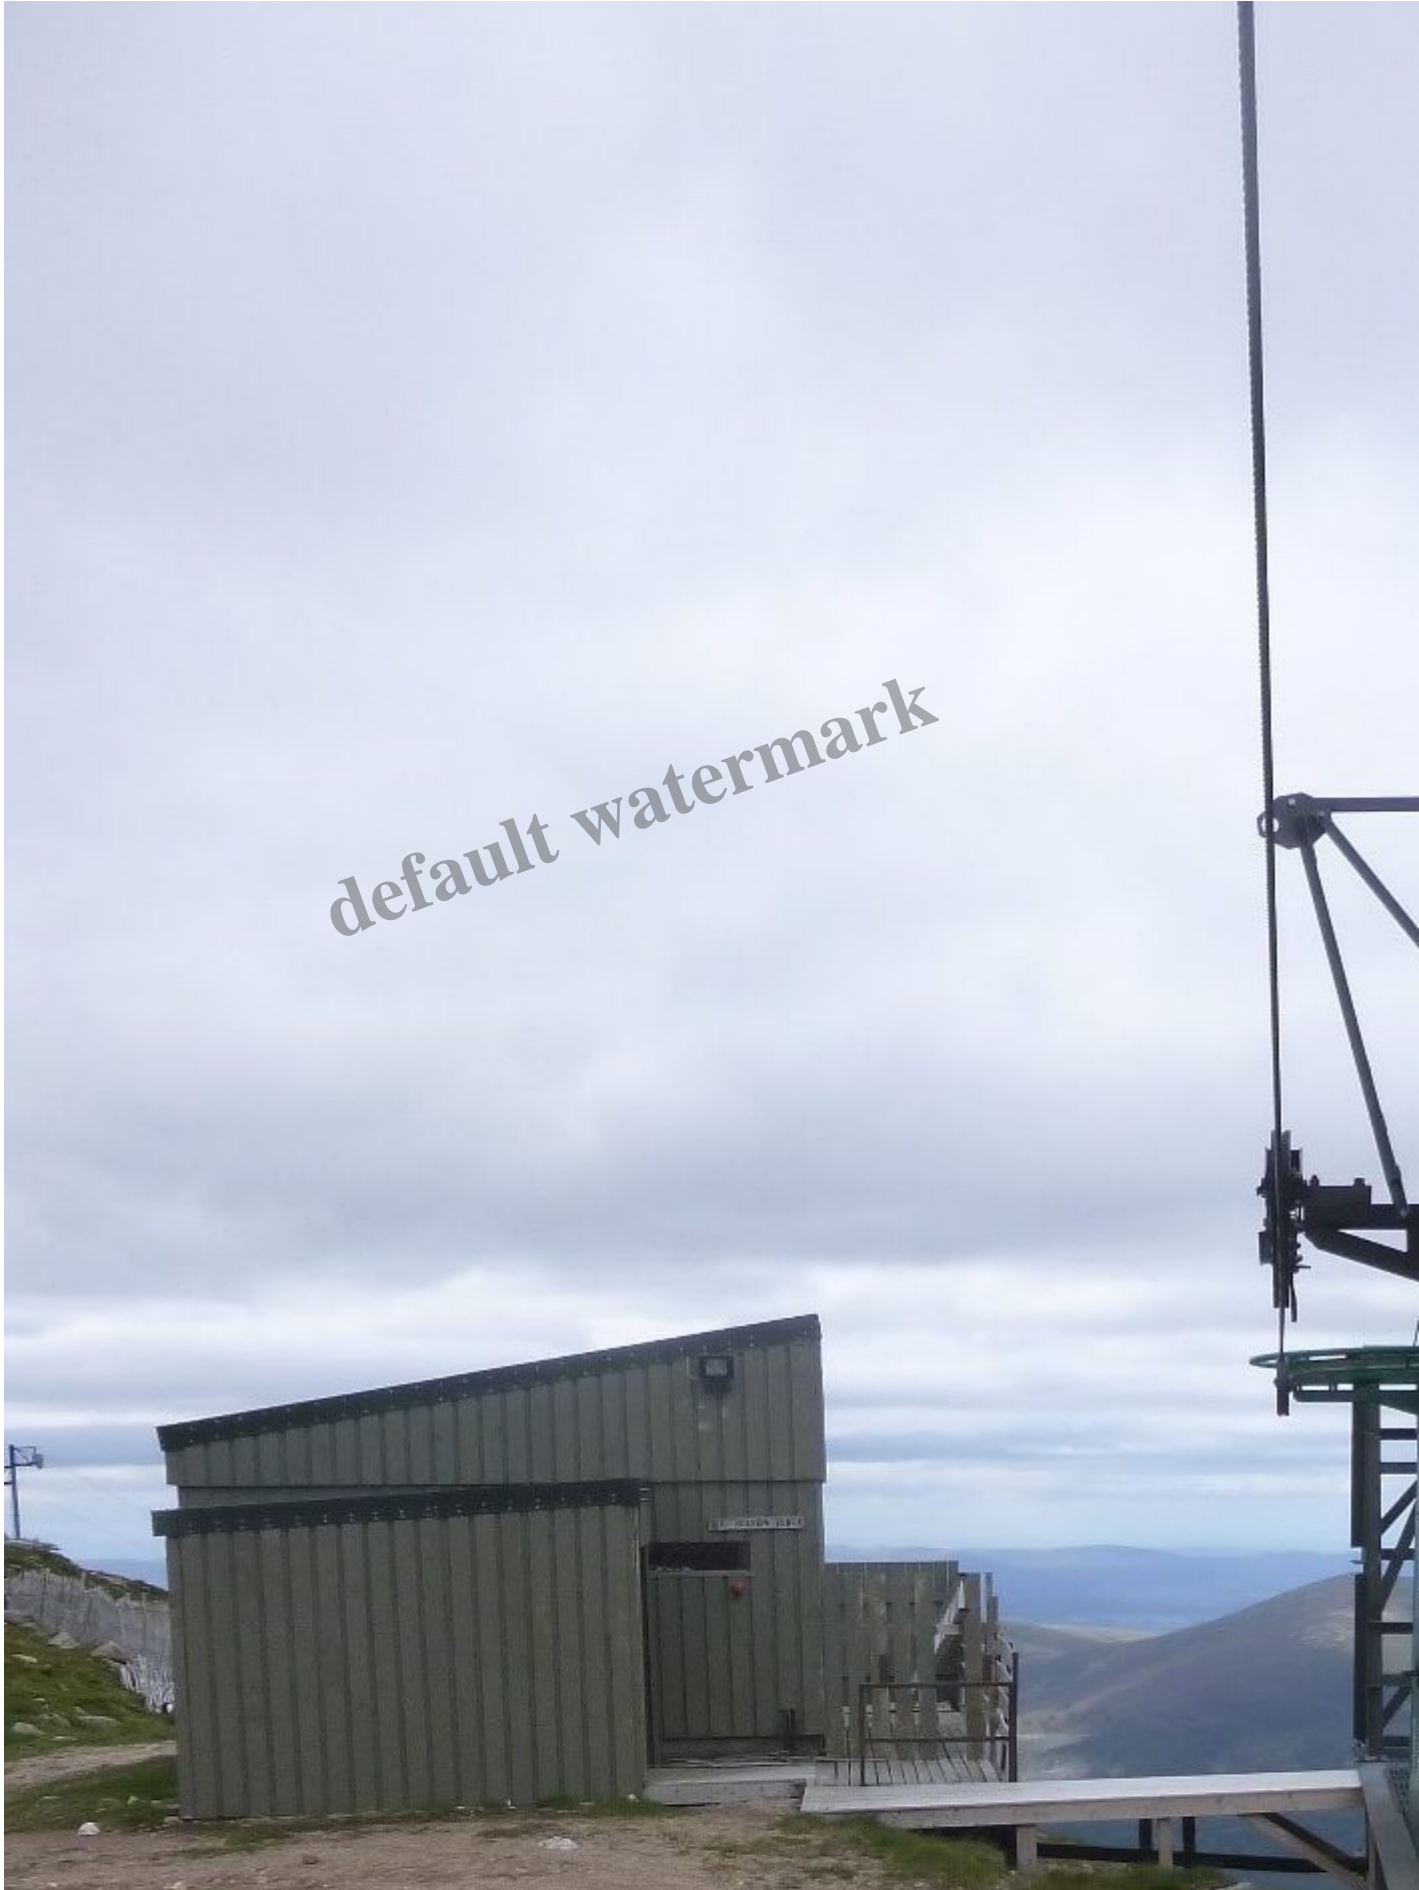
The following pictures were taken in June 2018 and it can be clearly seen that the operator has still not adequately maintained the Coire na Ciste loading platform by failing to make the necessary repairs.

“This was discussed with CML staff at the time (2016) and assurances that it would be done were re

As a consequence, this breaches lease conditions 2.1.1 and 2.1.2 despite its condition being brought to Natural Retreats and HIE’s attention in December 2016.

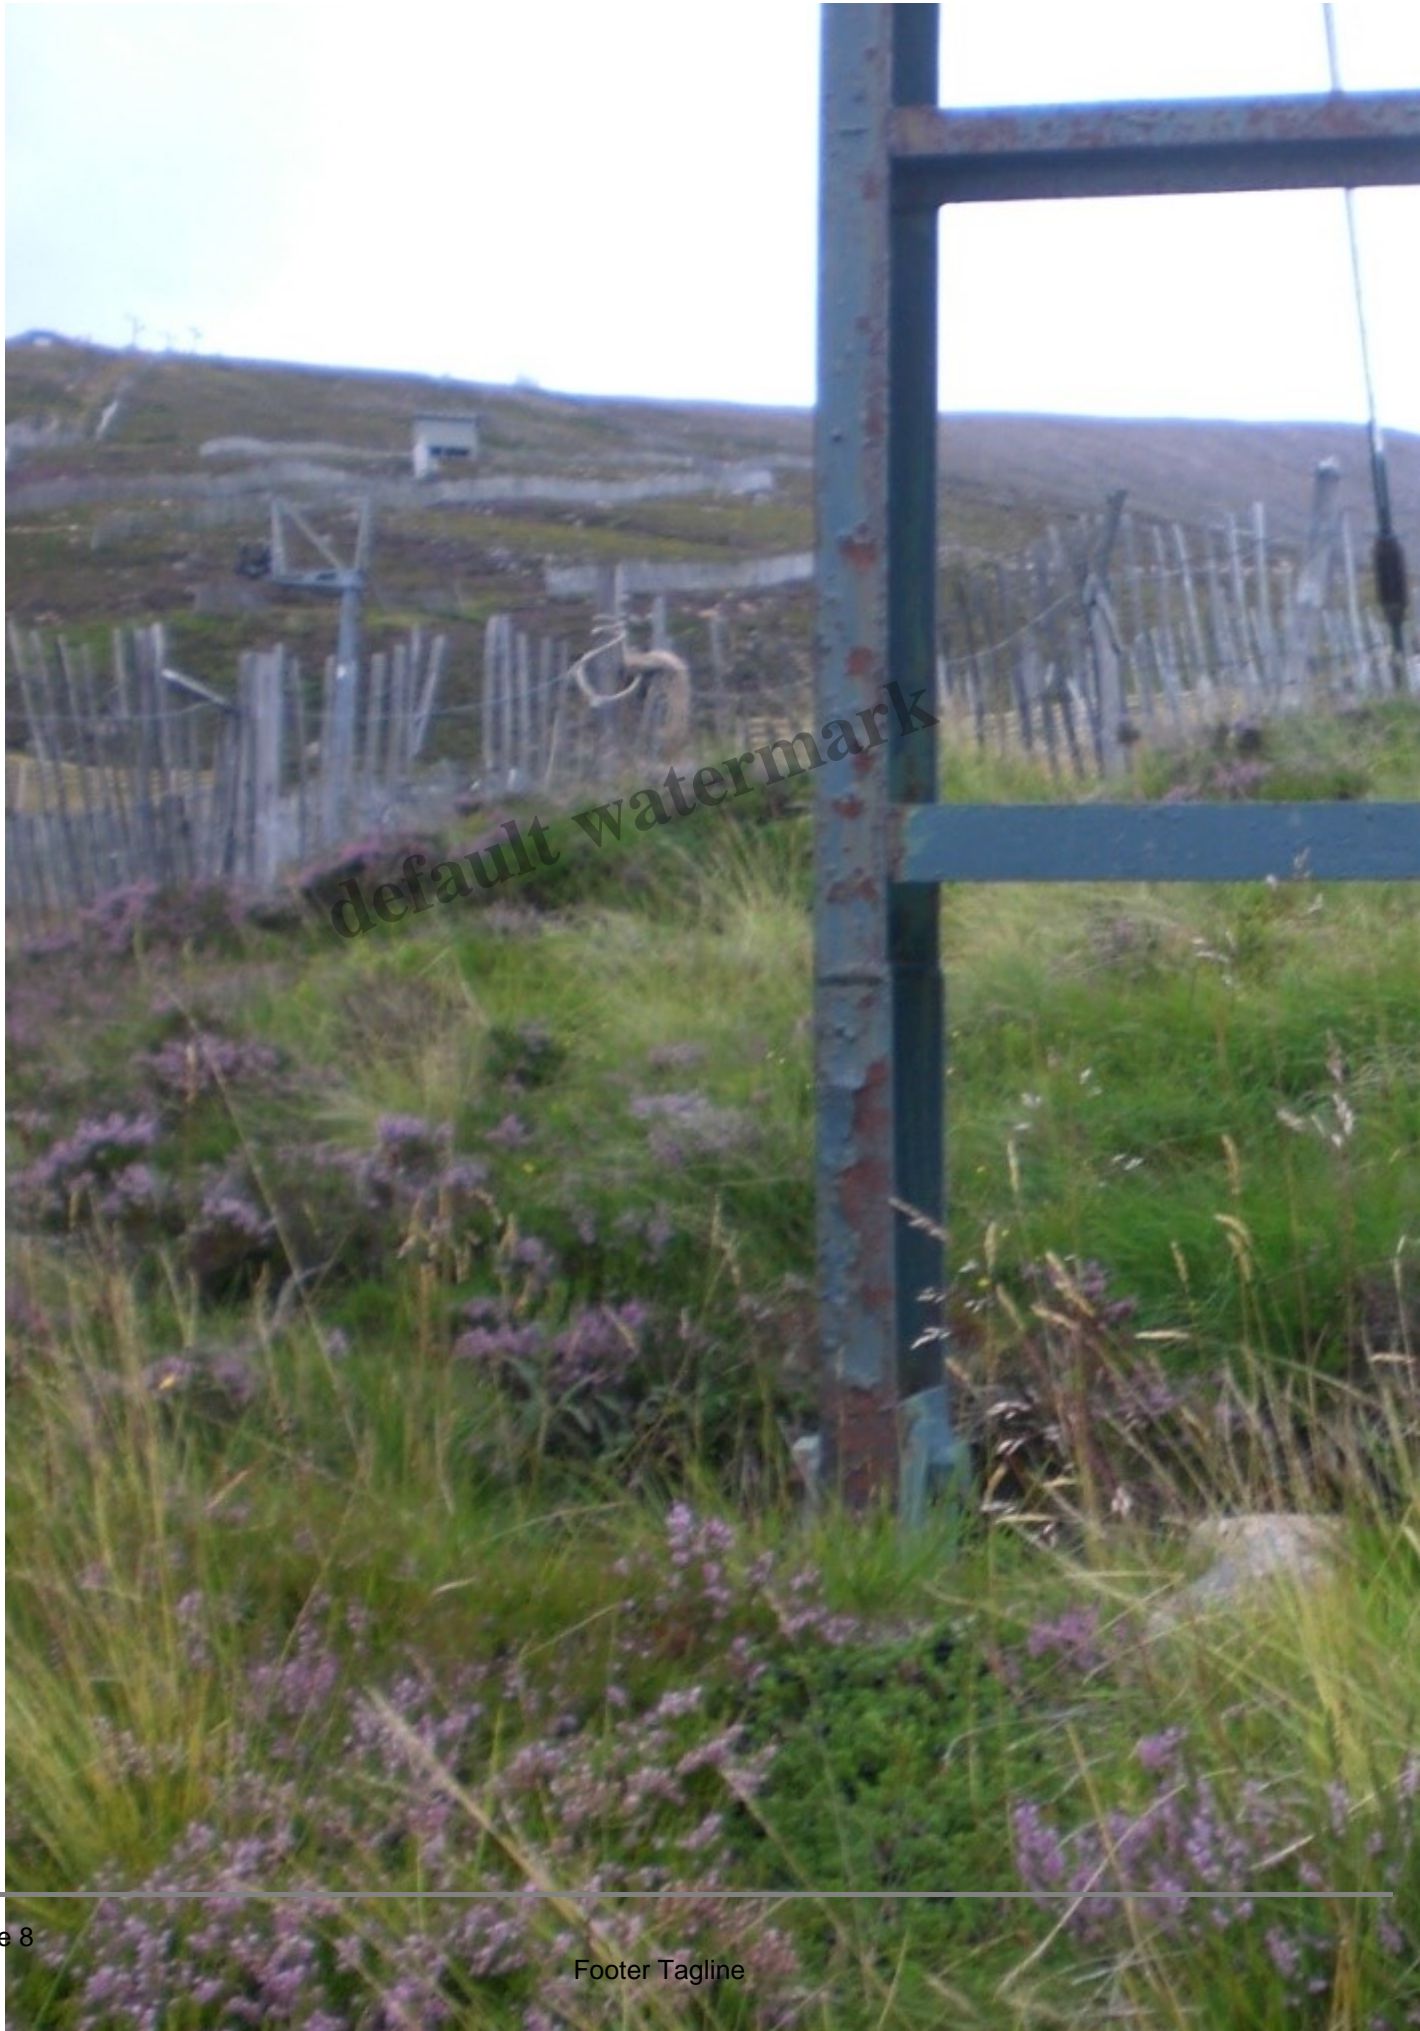
4.4.2 Top Station. Painted Frame, paint system has failed and surface corrosion is extensive, **the corrosion system should be renewed if this steelwork is expected to last for much longer**. There are buried mild steel parts, **these should be exposed and inspected**.

“the corrosion system should be renewed if this steelwork is expected to last for much longer” Photo

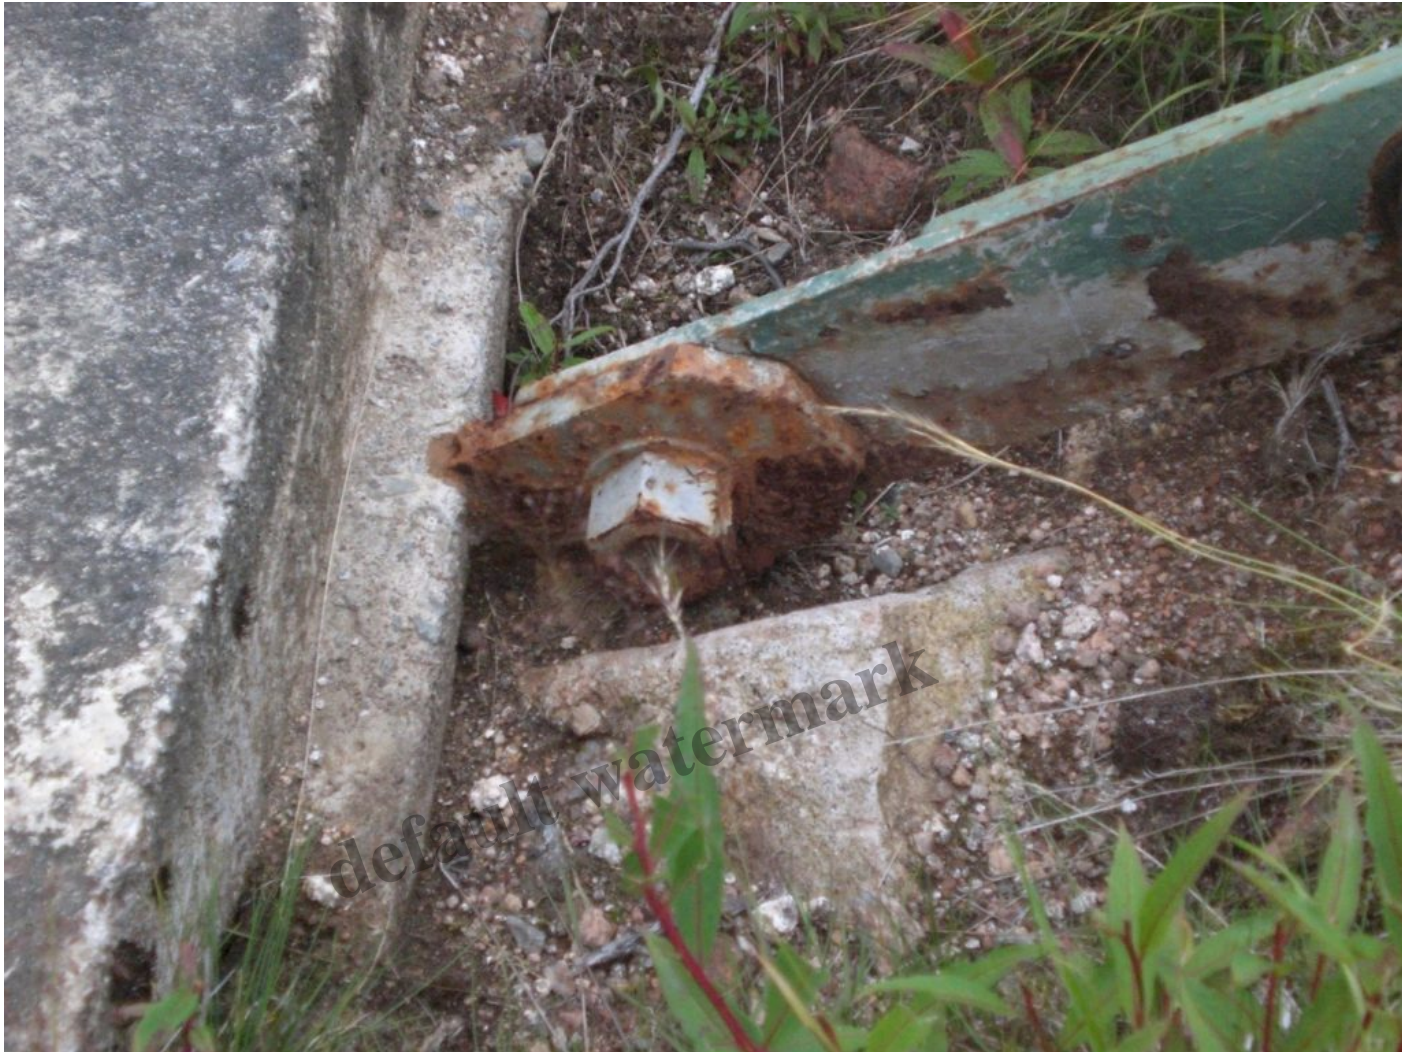
“Buried mild steel parts should be exposed and protected” – photo credit Alan Bratley

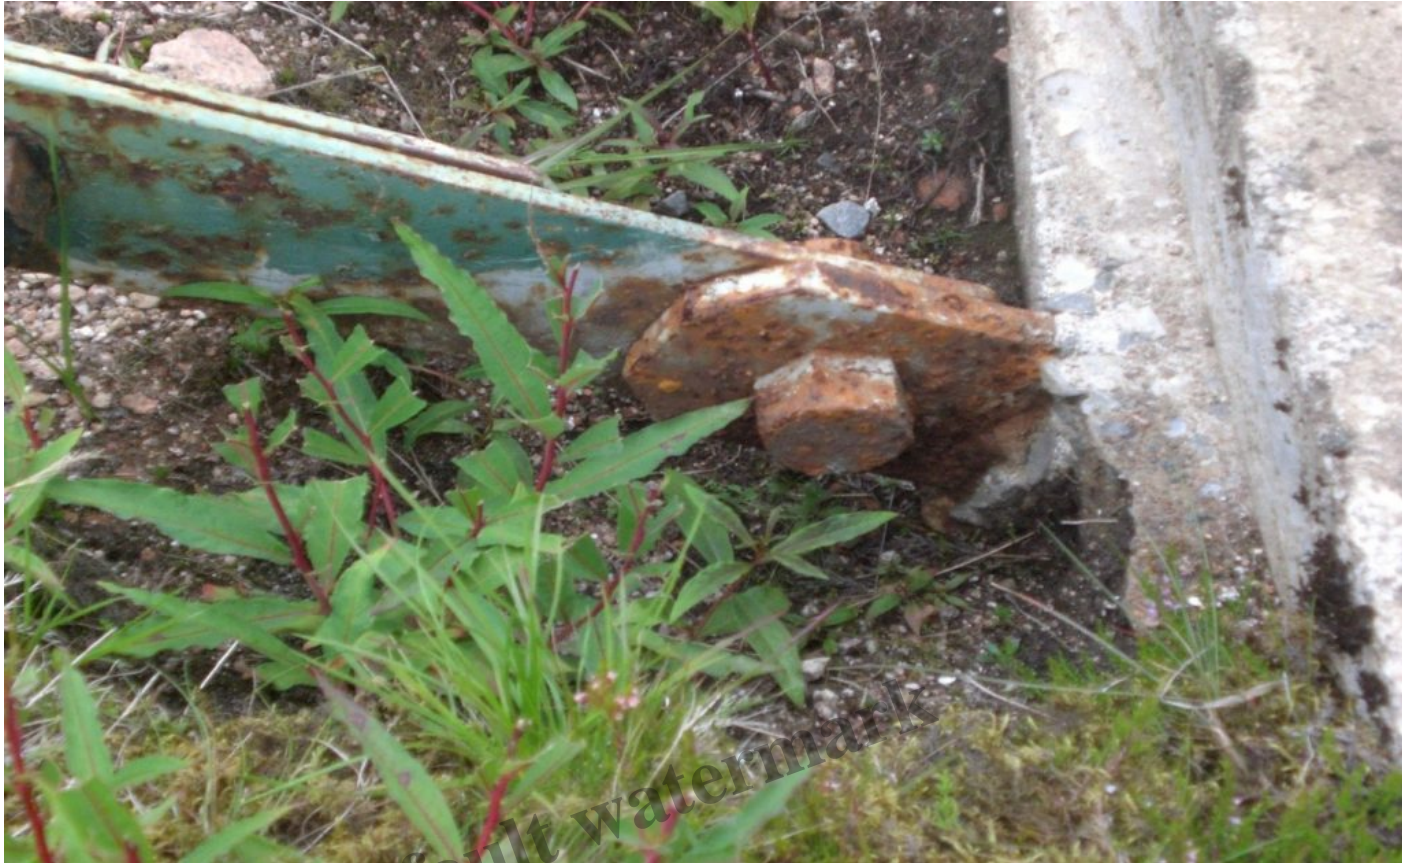
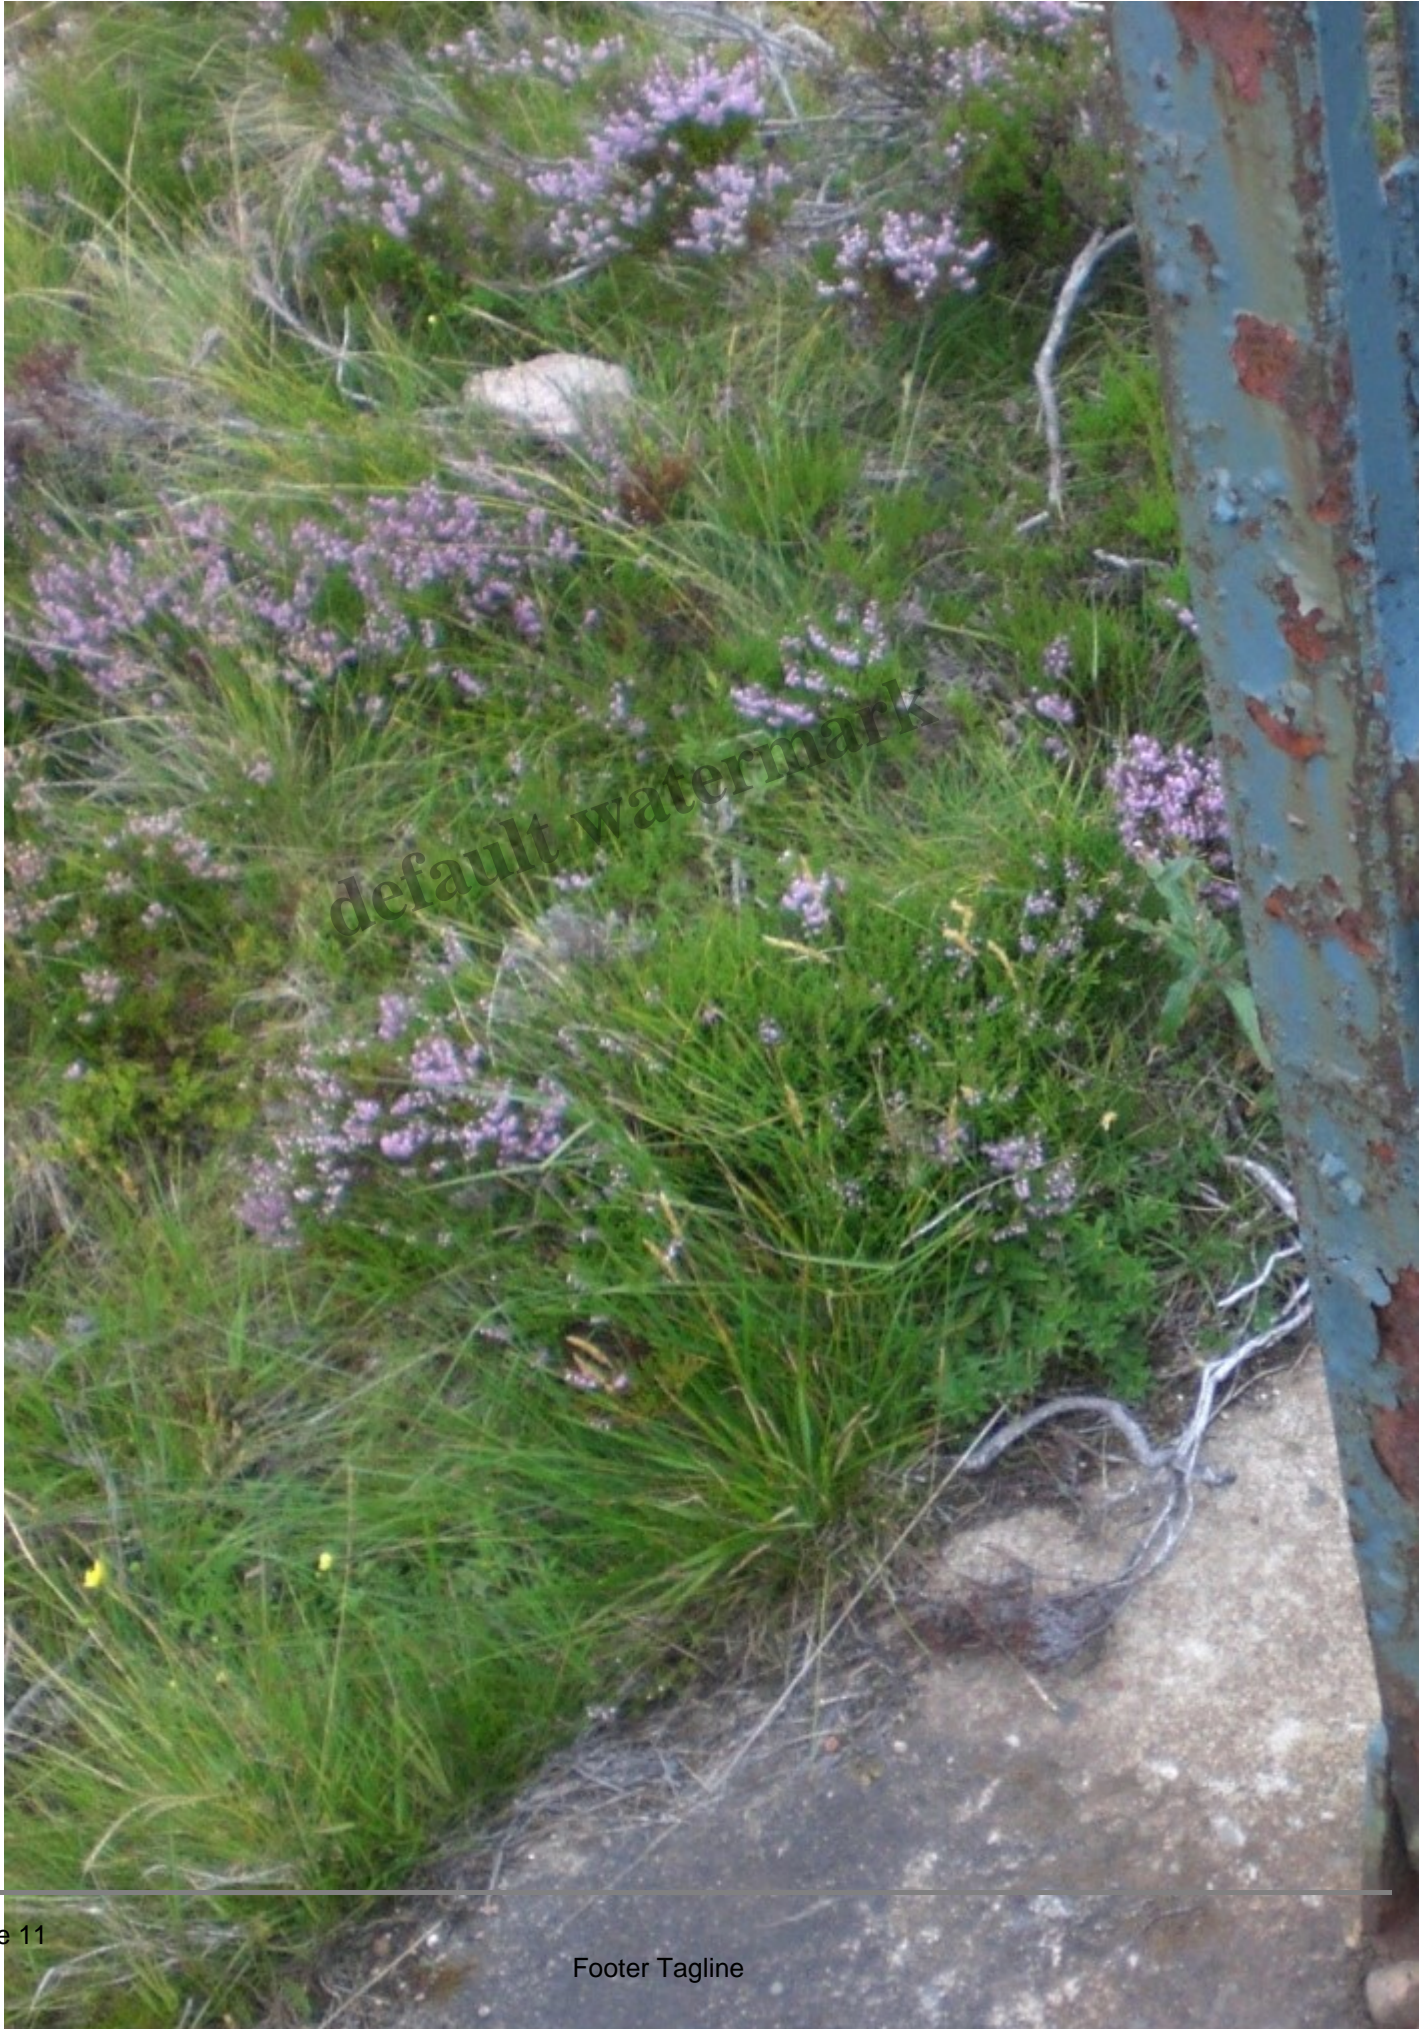
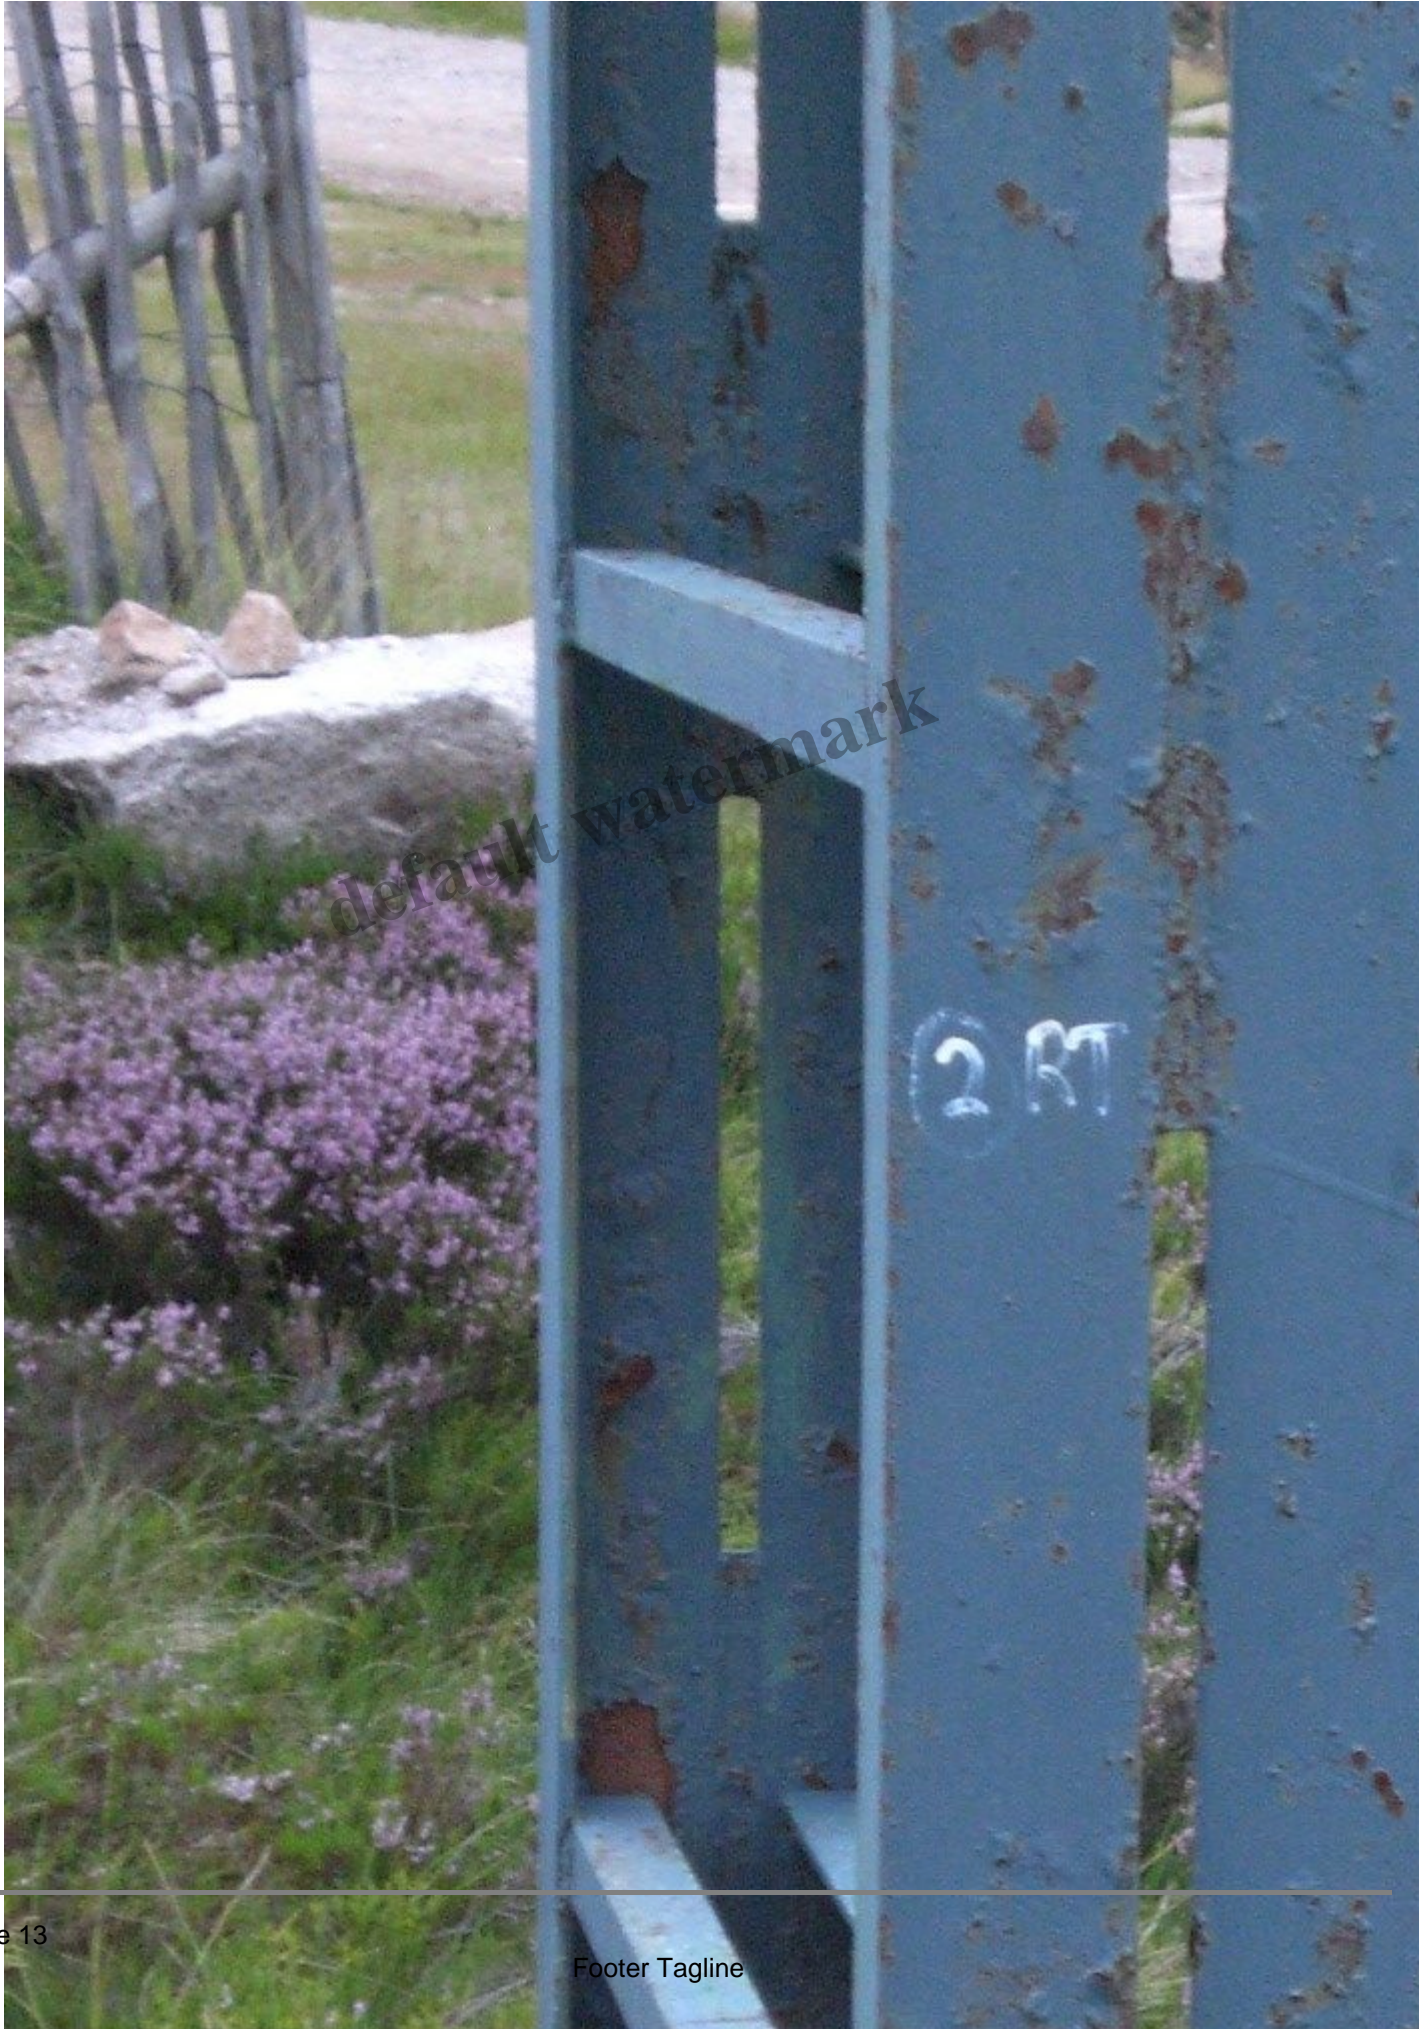
Here is the evidence from photos taken in June 2018:

Clearly nothing at all has been done since the ADAC Structures report was published in December 2016. So much for robust governance.....HIE are allowing their tenant to ignore the general maintenance around the hill. Publicly owned Assets are being allowed to deteriorate despite the lease conditions requiring the tenant to undertake maintenance.
