The state of Cairngorm under Natural Retreats management (2)

After my post on the state of the Coire na Ciste ([see here](#)), I have been comparing the state of the ski infrastructure higher up the hill with what is required under the terms of the lease between Highlands and Islands Enterprise and Cairngorm Mountain Ltd dated 11th June 2014 ([see here for lease](#)). The post also looks at how far the recommendations of a report into the state of the ski infrastructure by ADAC Structures in December 2016 ([see here](#)) have been implemented.

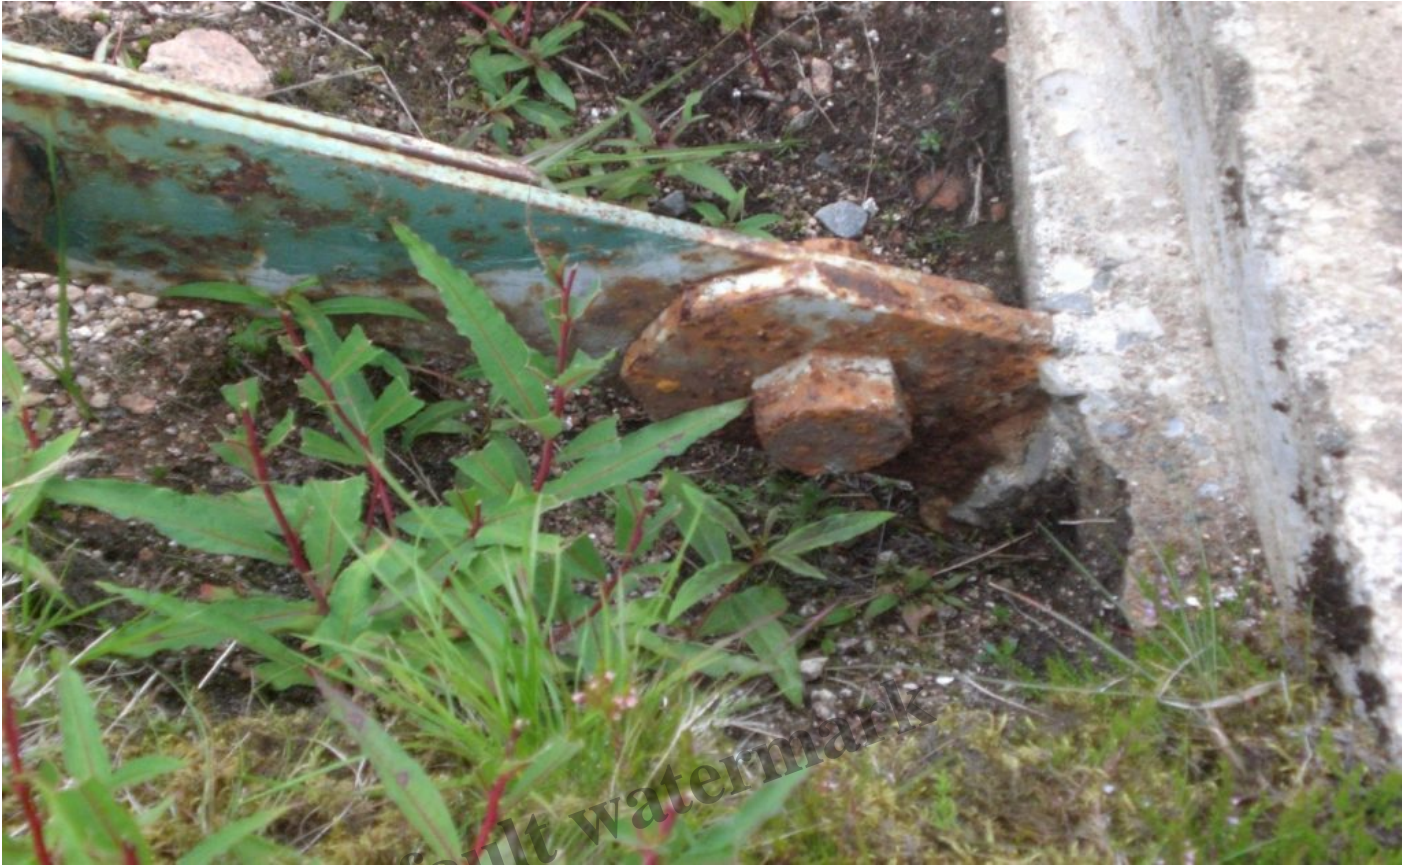
The ADAC structures report highlighted the state of the car park t-bar top station as follows:

4.4.2 Top Station. Painted Frame, paint system has failed and surface corrosion is extensive, **the corrosion system should be renewed if this steelwork is expected to last for much longer**. There are buried mild steel parts, **these should be exposed and inspected**.

Clearly nothing at all has been done since the ADAC Structures report was published in December 2016. So much for robust governance.....HIE are allowing their tenant to ignore the general maintenance around the hill. Publicly owned Assets are being allowed to deteriorate despite the lease conditions requiring the tenant to undertake maintenance.
