## Campsites and water supplies – the LLTNPA’s failure

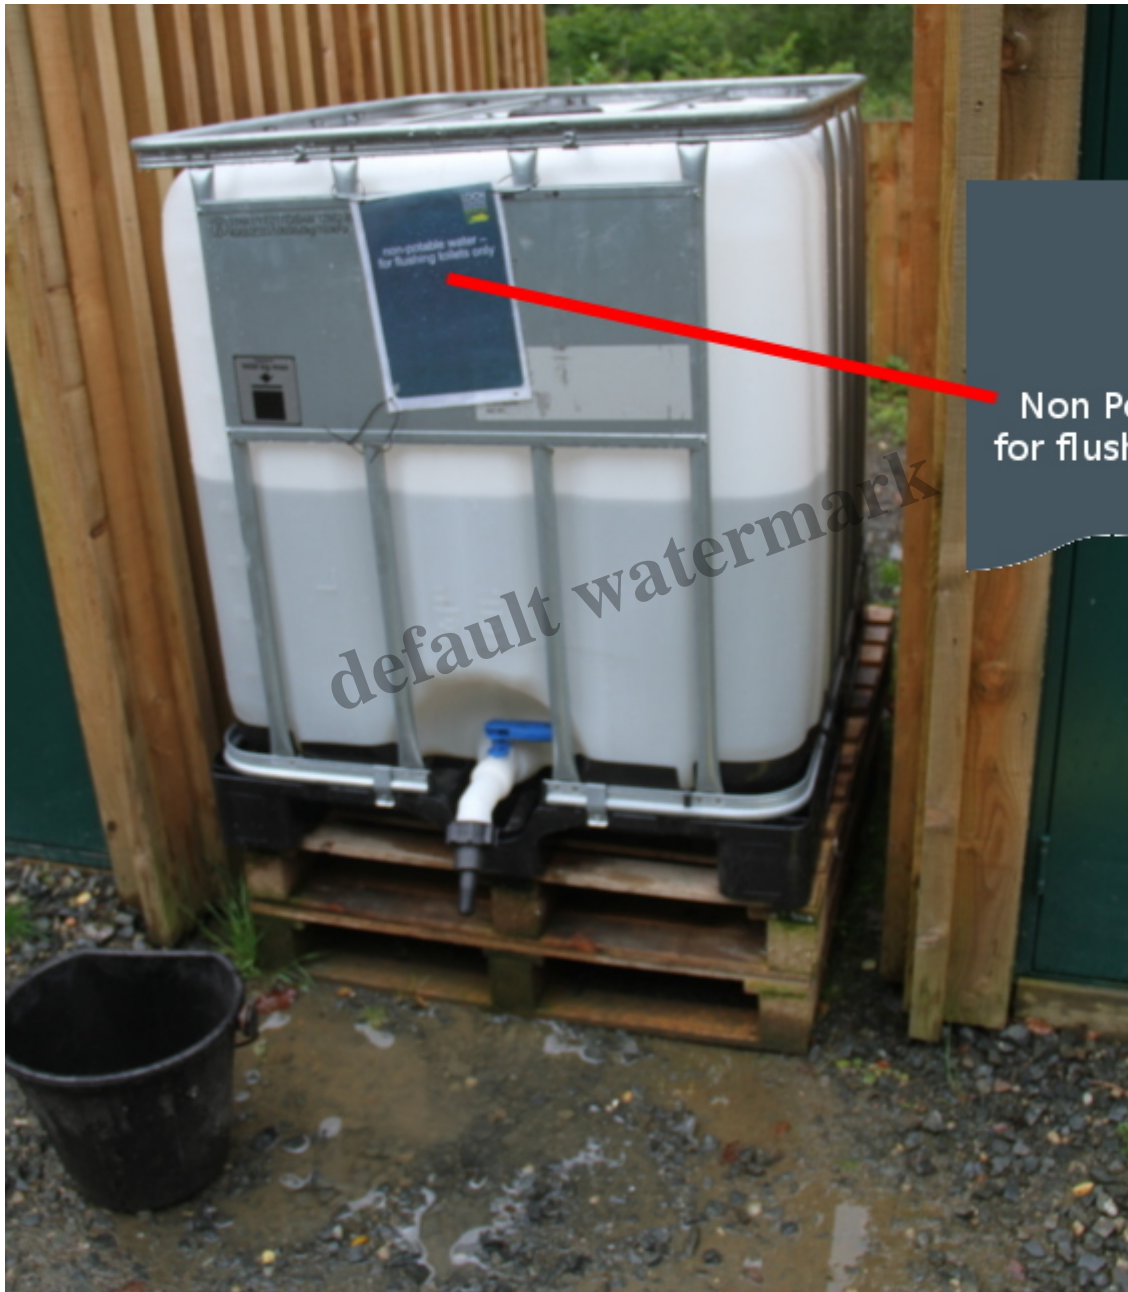
The water supply at the Loch Chon campsite has never worked – photo credit Ross MacBeath

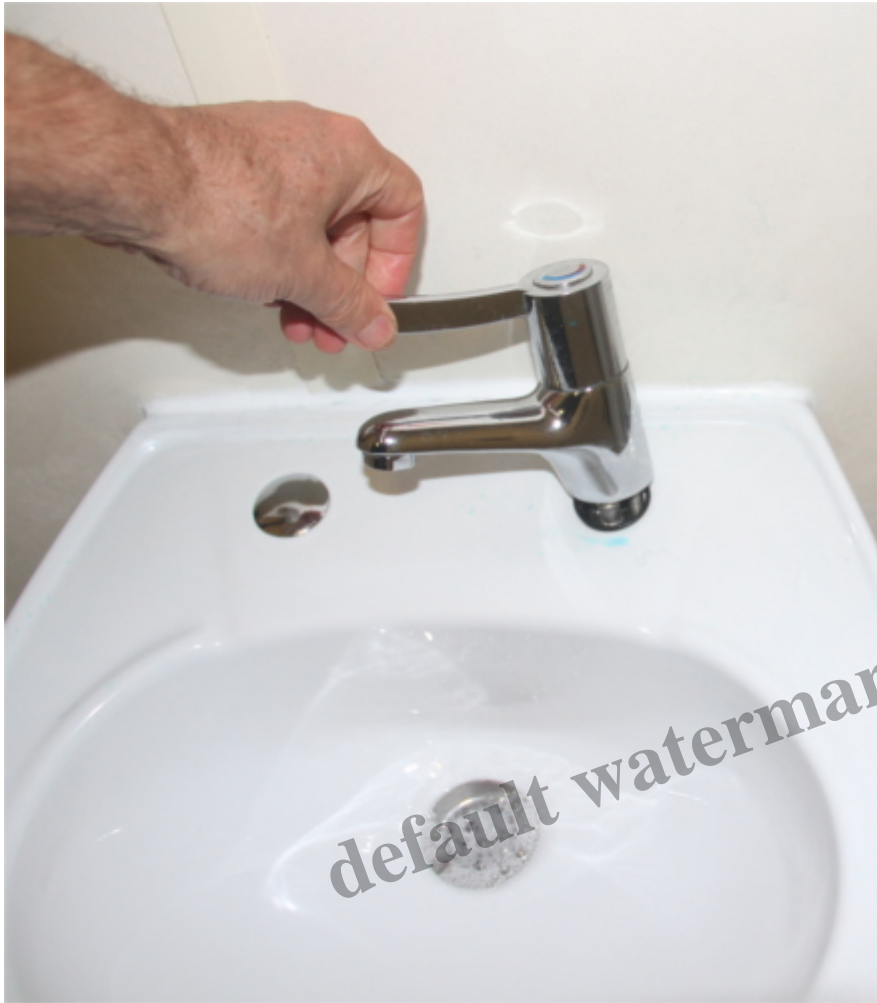
Waterless basin – photo credit Ross MacBeath

Eighteen months after the LLTNPA announced that the water supply at Loch Chon was fully functional, there is still no proper water supply to the campsite.Â Â The cost of importing water for the toilets and drinking must be considerable.

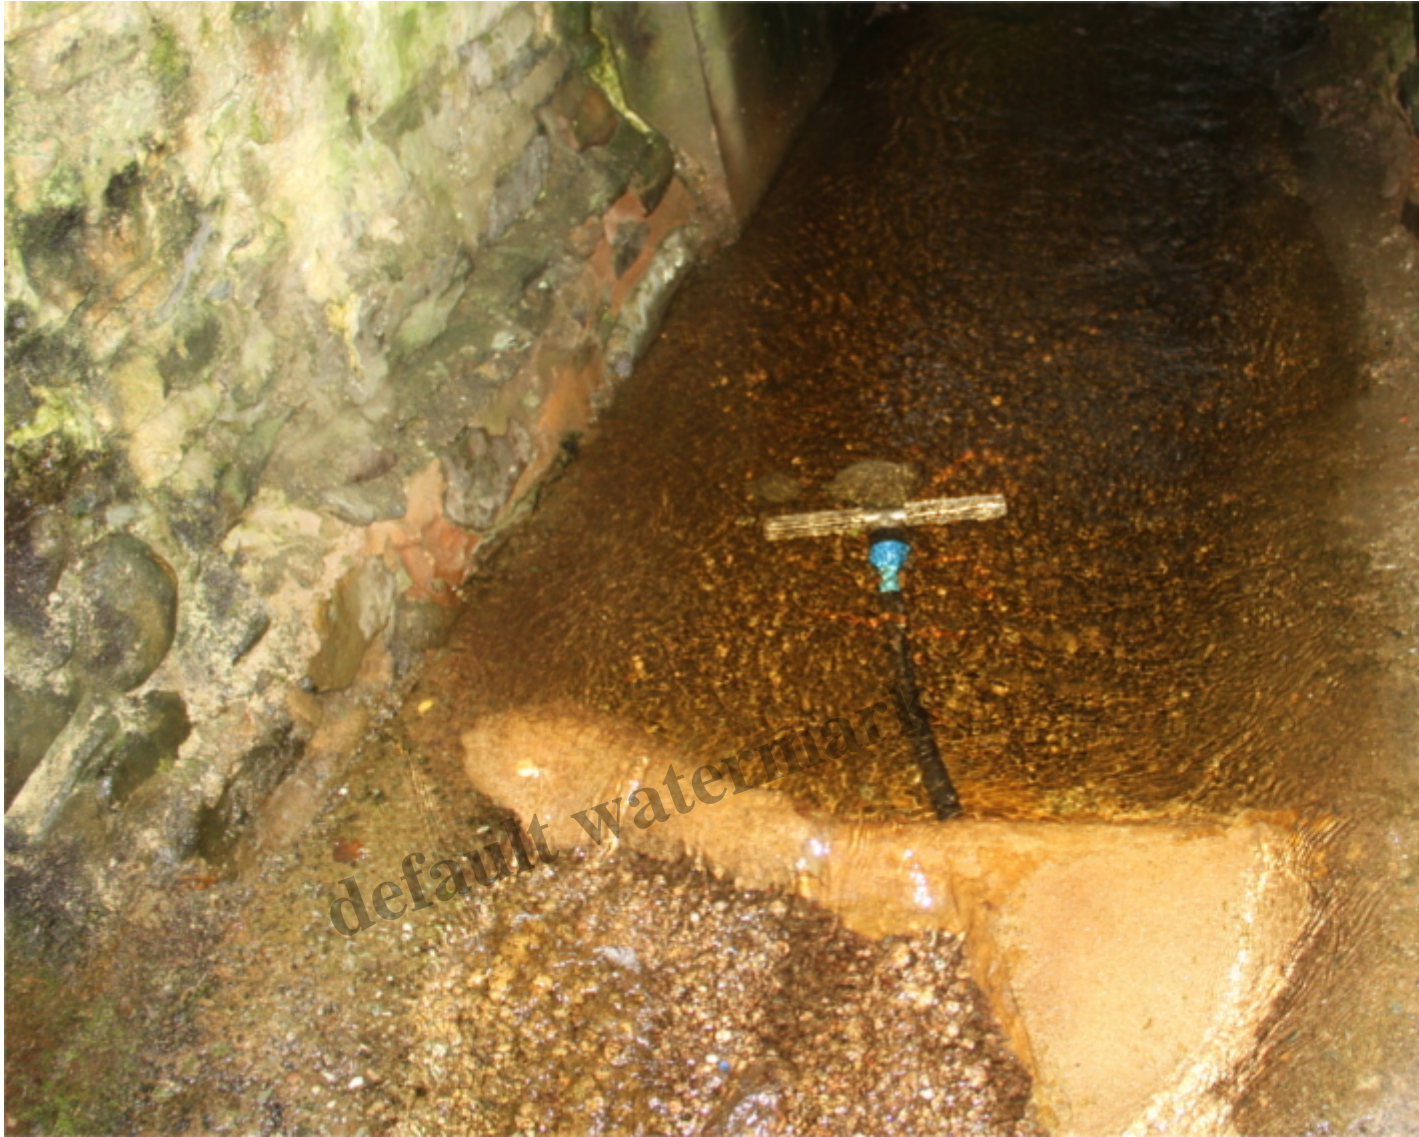
The upgraded water intake under the road bridge – photo credit Ross MacBeath

The reason for this failure at Loch Chon is not hard to detect. Originally the water intake consisted of a pipe in the small burn. How anyone thought this was adequate I am not sure. Now a tiny dam has been created and the pipe cemented in place but the water supply is still totally inadequate for a campsite of this size and in the dry period earlier this summer the burn dried up completely.

Its really is time that the Audit Committee of the LLTNPA subjected what has gone wrong at Loch Chon and Loch Achray to proper scrutiny and made public what lessons are to be learned.

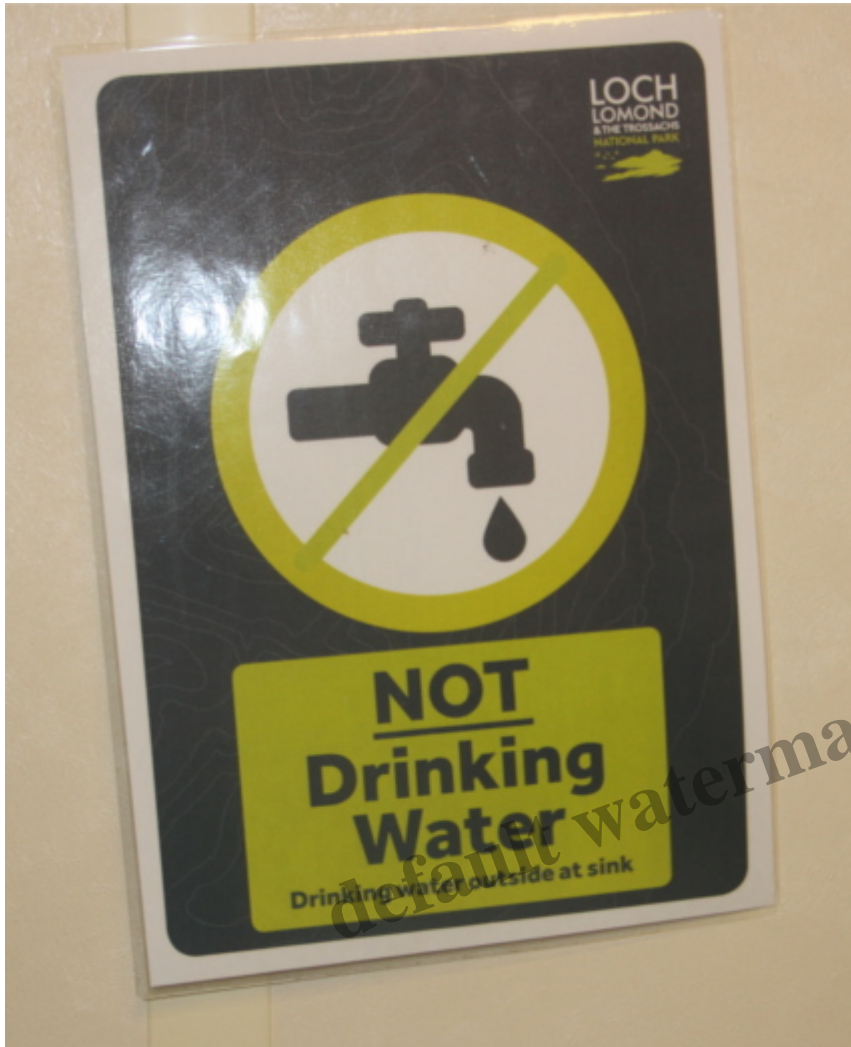
The consequences are imported drinking water, buckets for toilets and signs everywhere. I am not sure how a campsite of this size – 36 places – can be allowed to function like this. Imagine what would have happened if any private campsite in the National Park had operated without water for 18 months? Among the other major issues this raises is how the proposed water supply was ever approved by the LLTNPA as planning authority and how the LLTNPA managed to spend over £100k in consultancy fees etc at Loch Chon before any work was started without this issue being picked up. Then there is the cover up of what has been going wrong ever since.
