The Rest and Be Thankful landslips â?? why does sheep grazing continue?

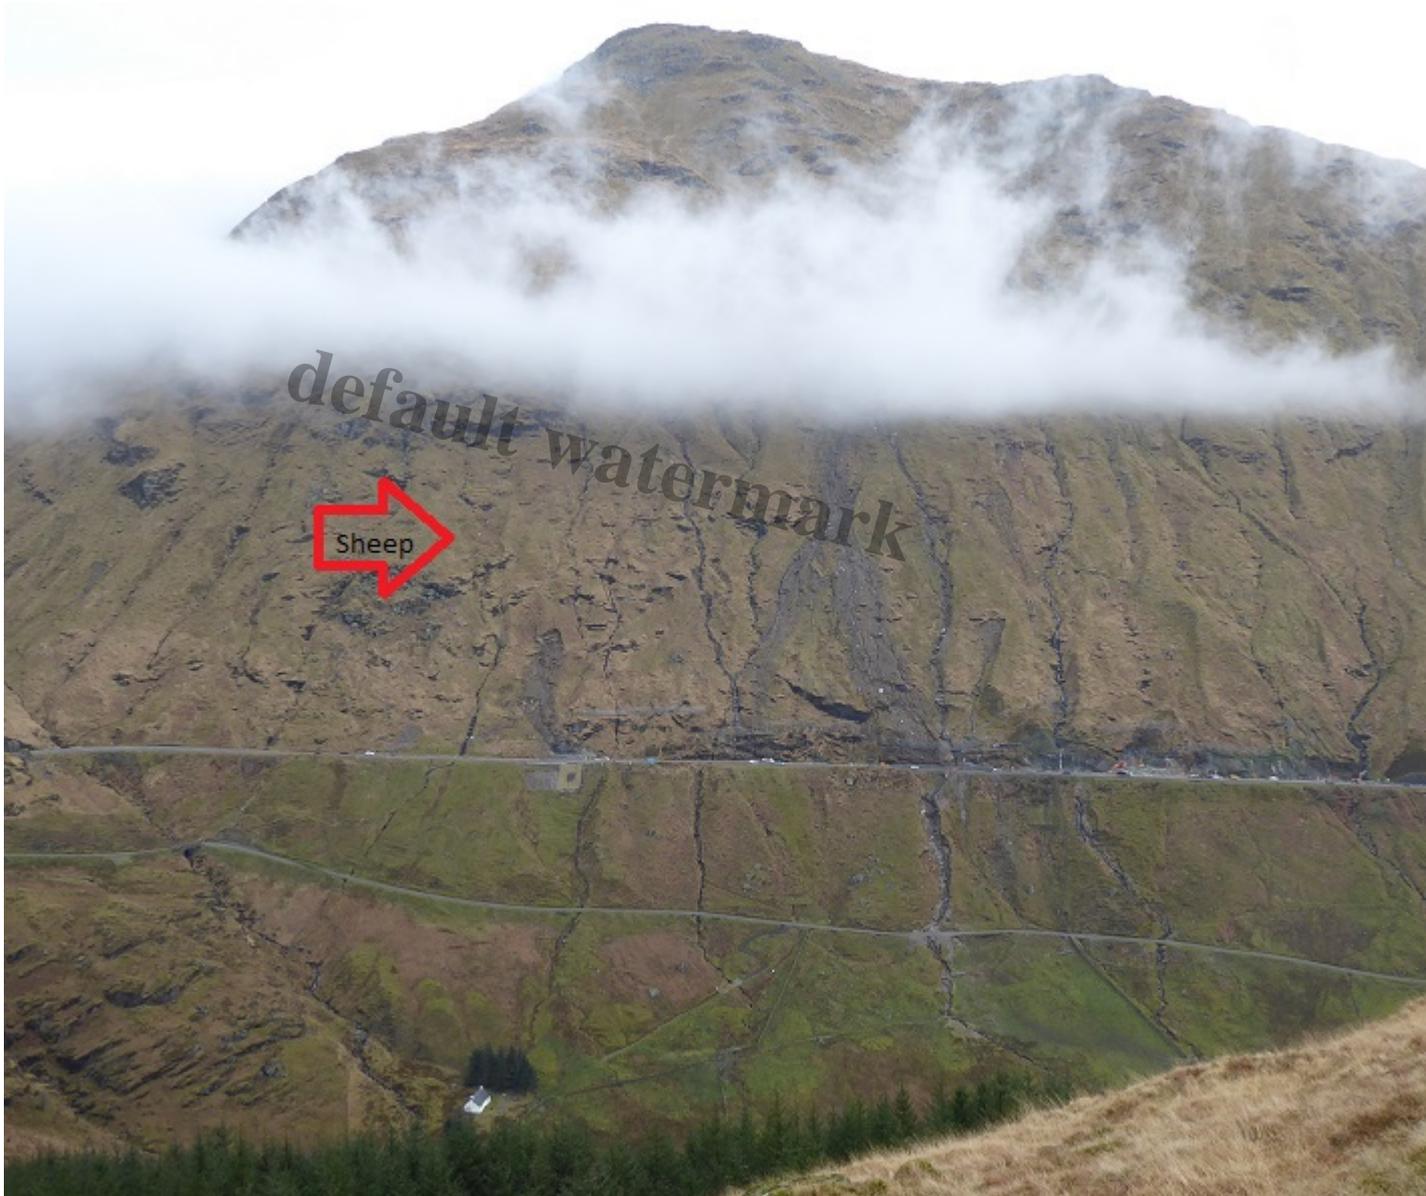
View across Glen Croe to slopes of Glen Croe. Main landslide centre. Subsidiary landslips visible left
Photo Credit Louise Brimelow

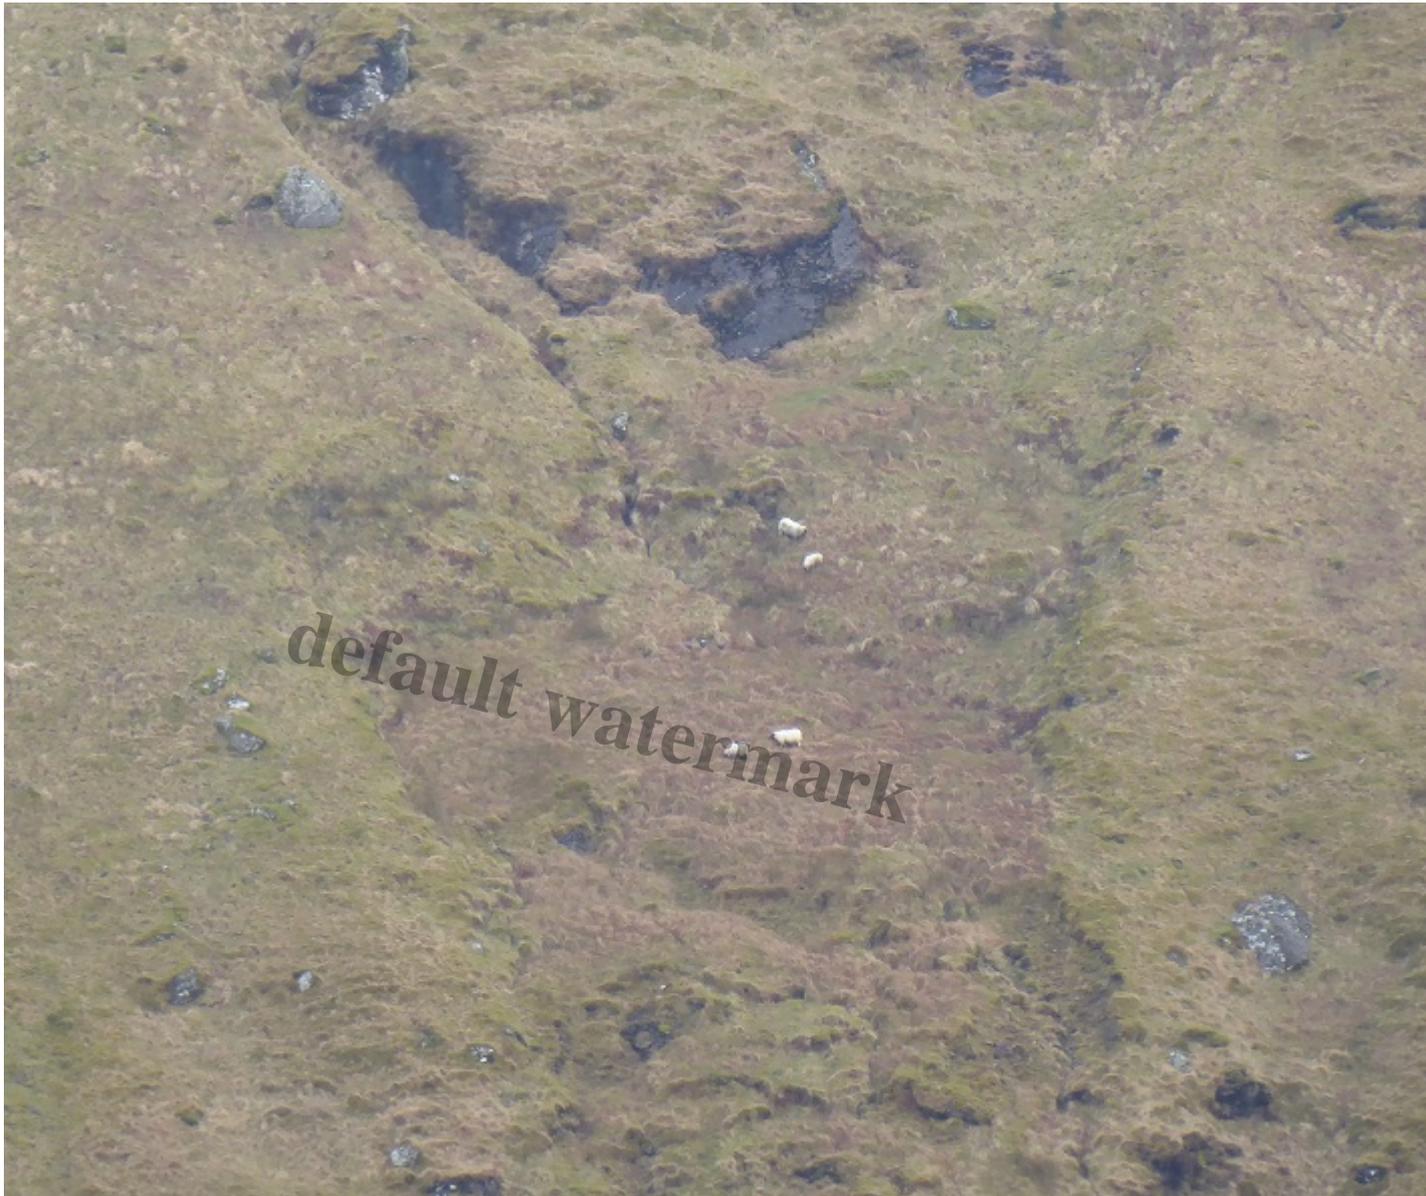
Close up of sheep grazing the hillside 24th February â?? Photo Credit Louise Brimelow

Why sheep are still being allowed to graze these slopes is beyond comprehension.

Yes, there are only four, but it is now seven years since it was OFFICIALLY acknowledged, in response to a report from Forest Research in 2012, that the grazing by sheep and deer of the south facing slopes of Beinn Luibhean was contributing to the instability of the slope. That report recommended that woodland restoration/planting would ameliorate the problem. In other European countries public authorities have accepted that overgrazed slopes in mountain areas are a major factor in avalanches and landslips for well over 100 years and have taken action. In Scotland, however, this is still not taken seriously.

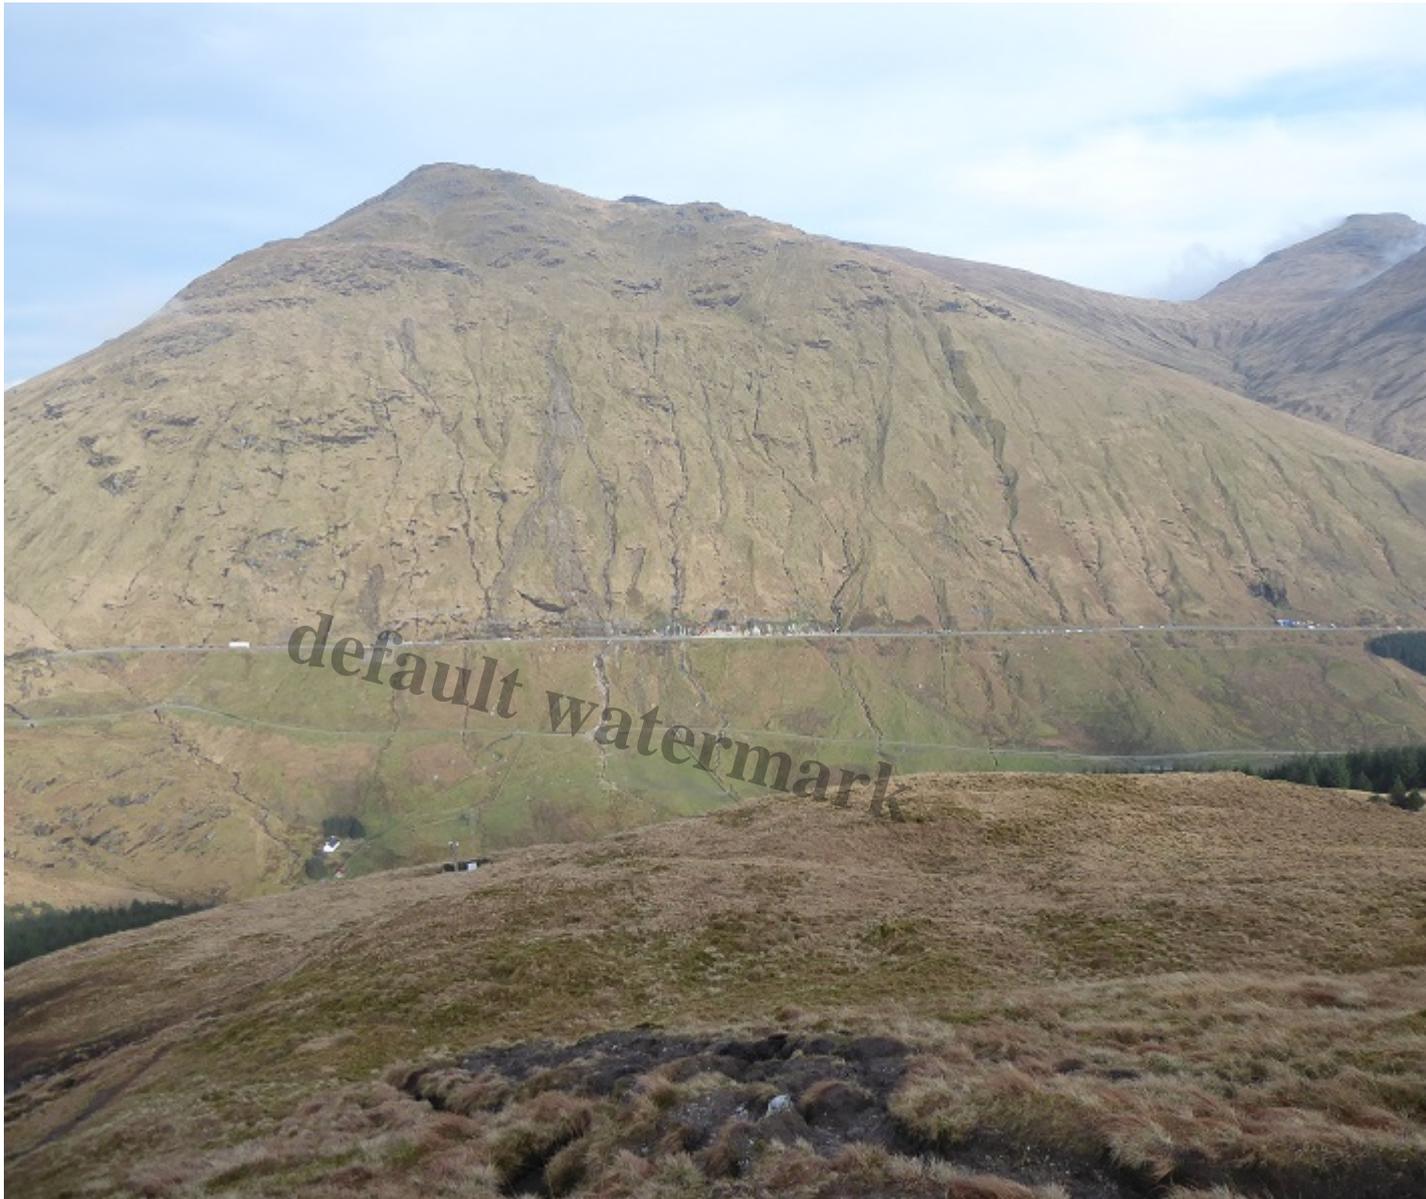
The fundamental problem with the A83 is well illustrated from the north ridge of Ben Donich. The road cuts straight across a steep glacially carved slope which is covered in glacial debris. The slope is rather similar to that of Ben Dorain at Bridge of Orchy – imagine cutting a road across that, yet that is what has been done on Beinn Luibhean.

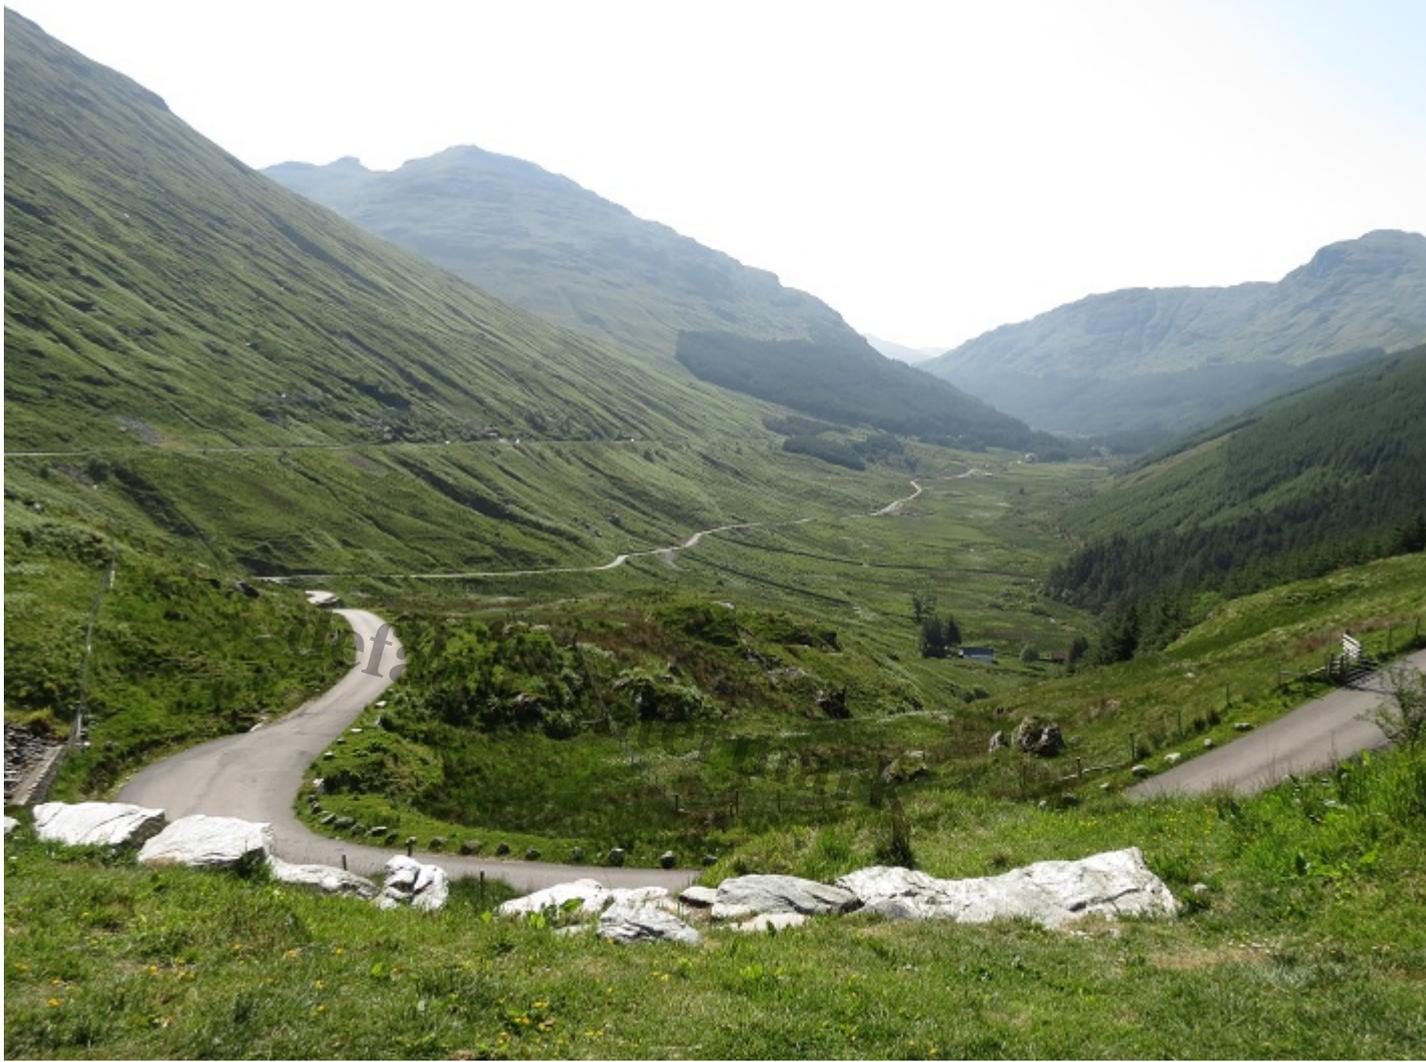
The view from the Rest and Be Thankful

While trees would make a difference to the rate of erosion on the slope, its steepness and the nature of the rock beneath the glacial debris is such that landslips are certain to continue whatever preventive measures are put in place. Looking down Glen Croe the relative steepness of Beinn Luibhean compared to the conifer planted slopes of Ben Donich is obvious. Routeing the A83 along the other side of the glen would have made more sense, even if snow lie there (its north facing) might be more of an issue.

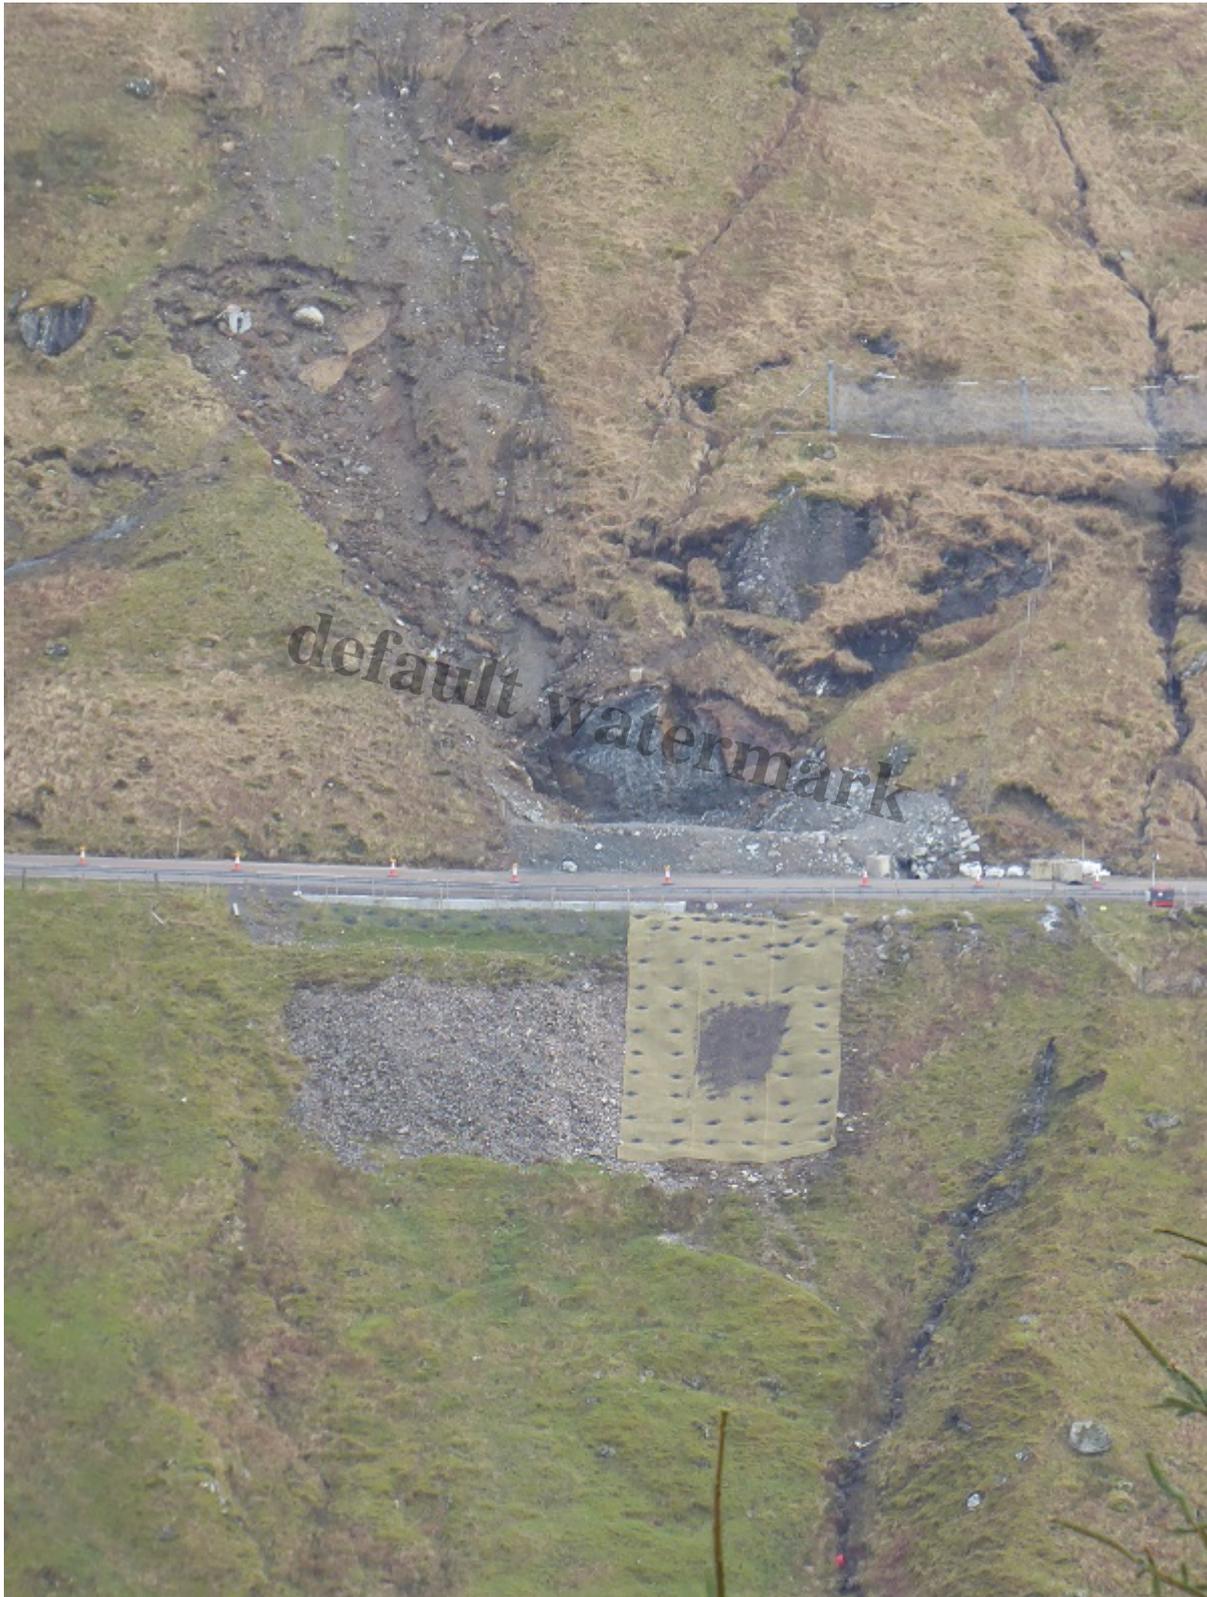
Photo illustrating the sheer volume of debris on the slope

Coupled with the steepness of the slope is the sheer volume of glacial debris that covers the hard mica schists excavated by the glacier which underly them. Extensive engineering is needed to try and secure/make safe just one small section of the slope.

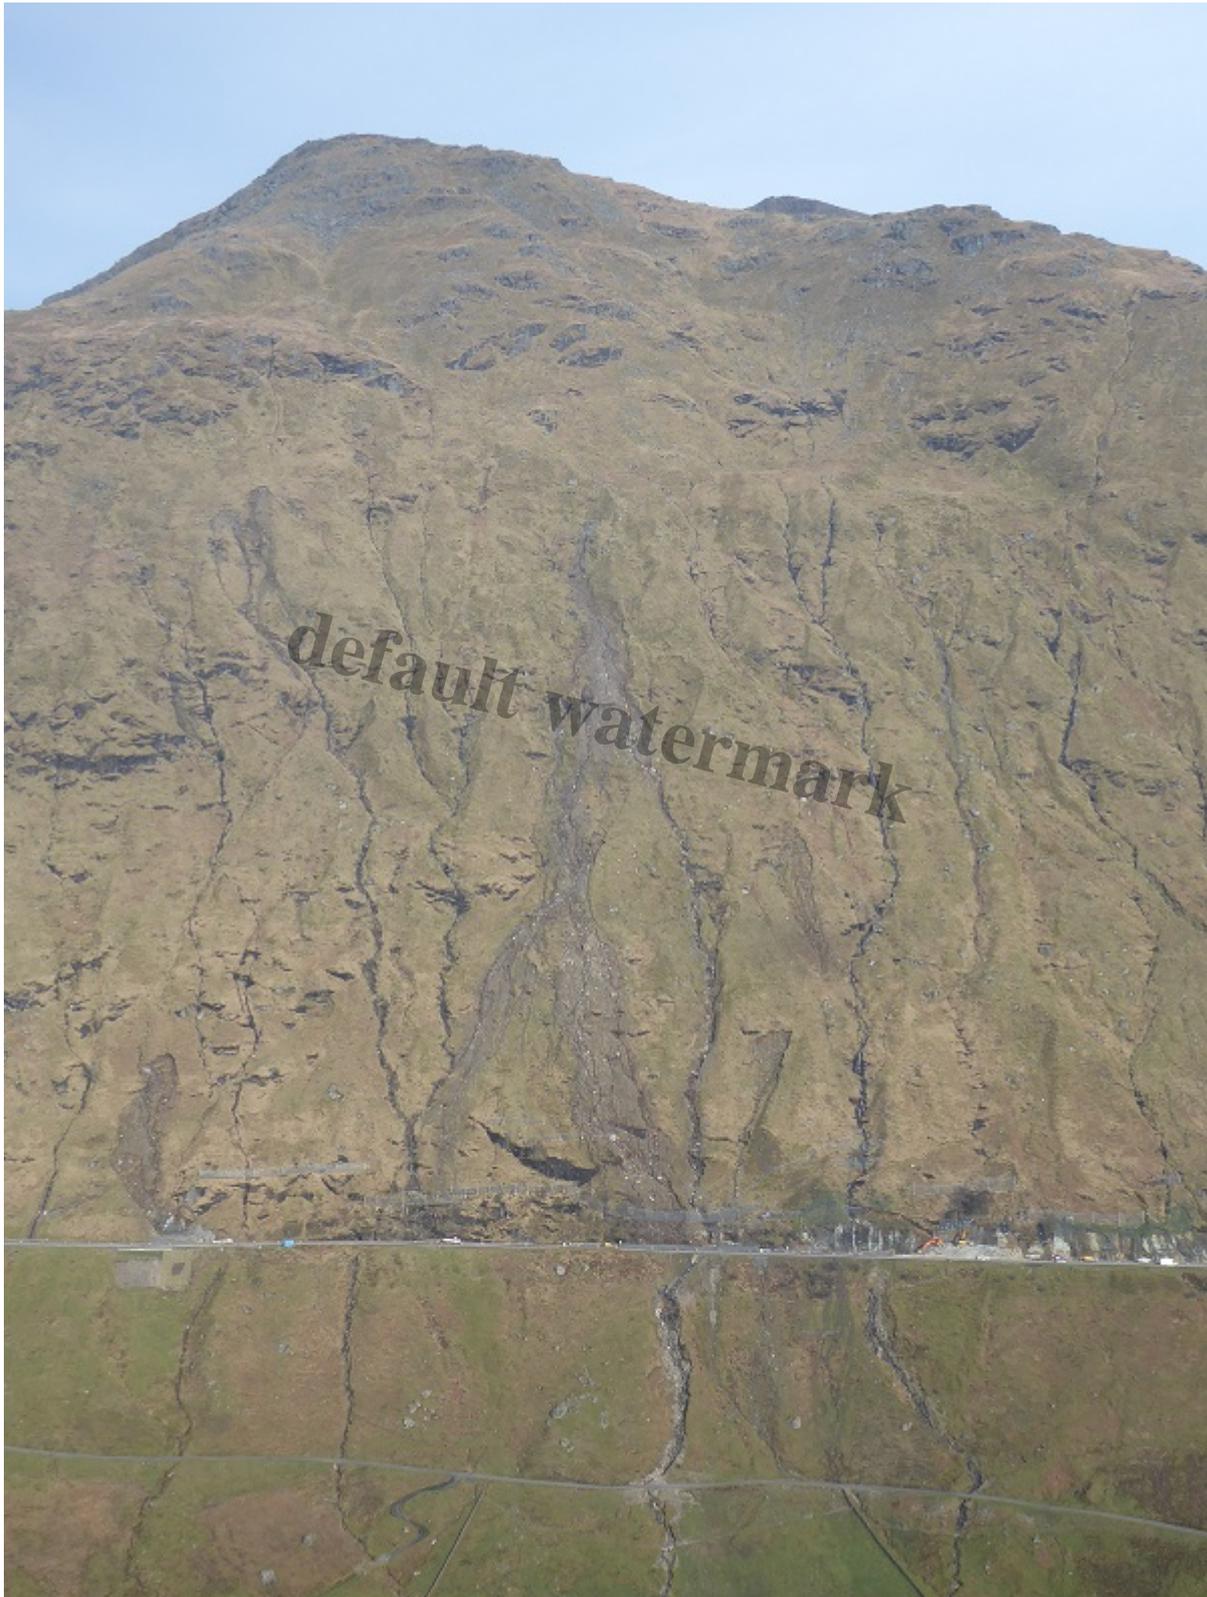
The narrow starting point of the main debris flow on the left side of the hollow is almost certainly not a coincidence

The problem is accentuated further by the nature of the ground above the main glacial debris covered slope. A large hollow, possibly created by the beginnings of a coire glacier, lies above. Moss and peat form here, in contrast to the steep slopes below. This holds the water but in times of heavy rainfall

it can be suddenly released. That then acts rather like the hush dams which were used near Tyndrum to prospect for lead and other metals. The rush of water sweeps away the vegetation and debris below.
