## The Rest and Be Thankful landslips – why does sheep grazing continue?

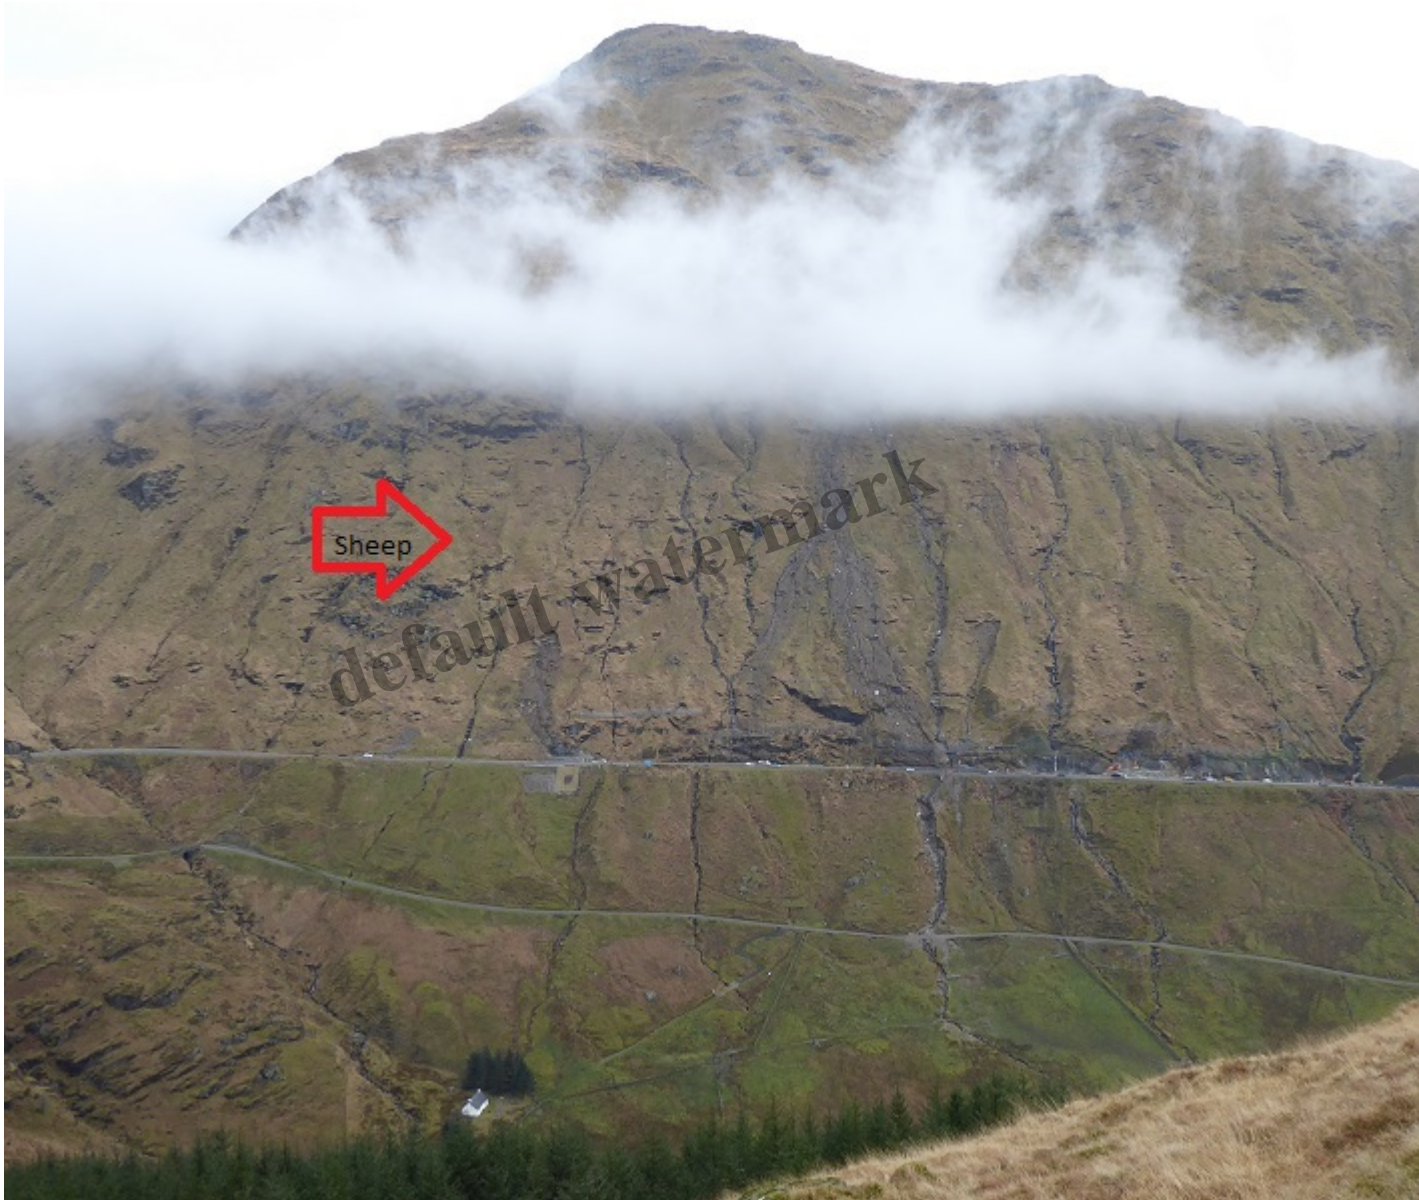
View across Glen Croe to slopes of Glen Croe. Main landslip centre. Subsidiary landslips visible left  
Photo Credit Louise Brimelow

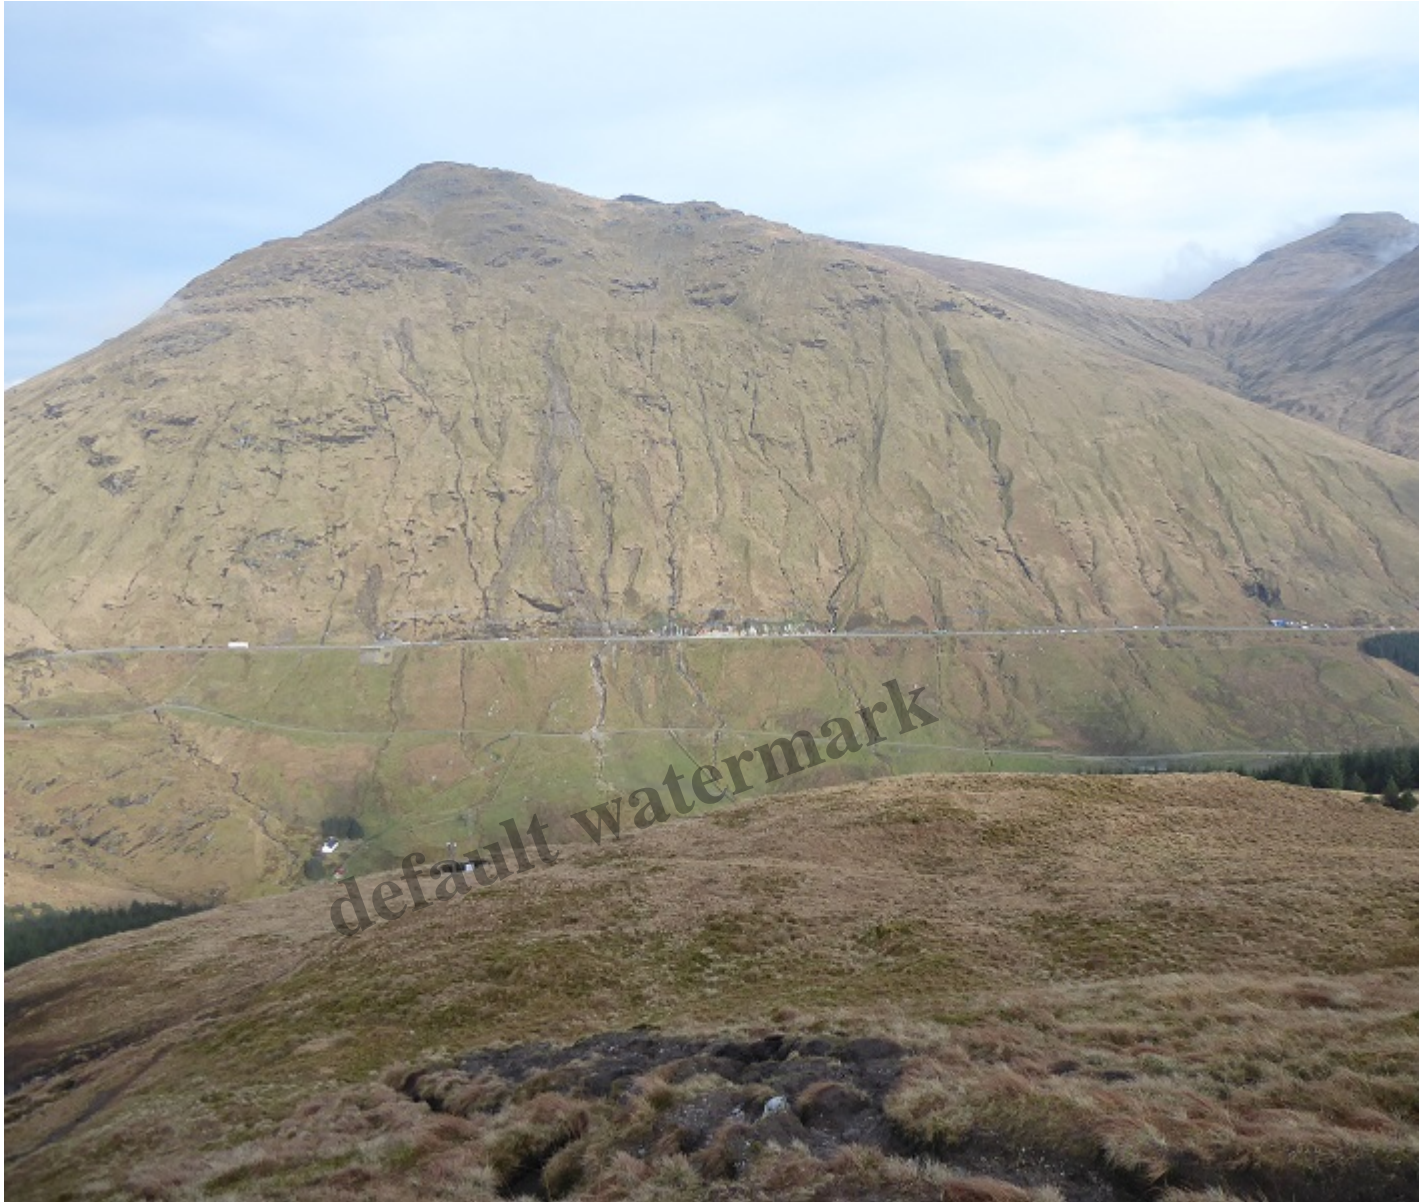
The fundamental problem with the A83 is well illustrated from the north ridge of Ben Donich. The road cuts straight across a steep glacially carved slope which is covered in glacial debris. The slope is rather similar to that of Ben Dorain at Bridge of Orchy – imagine cutting a road across that, yet that is what has been done on Beinn Luibhean.

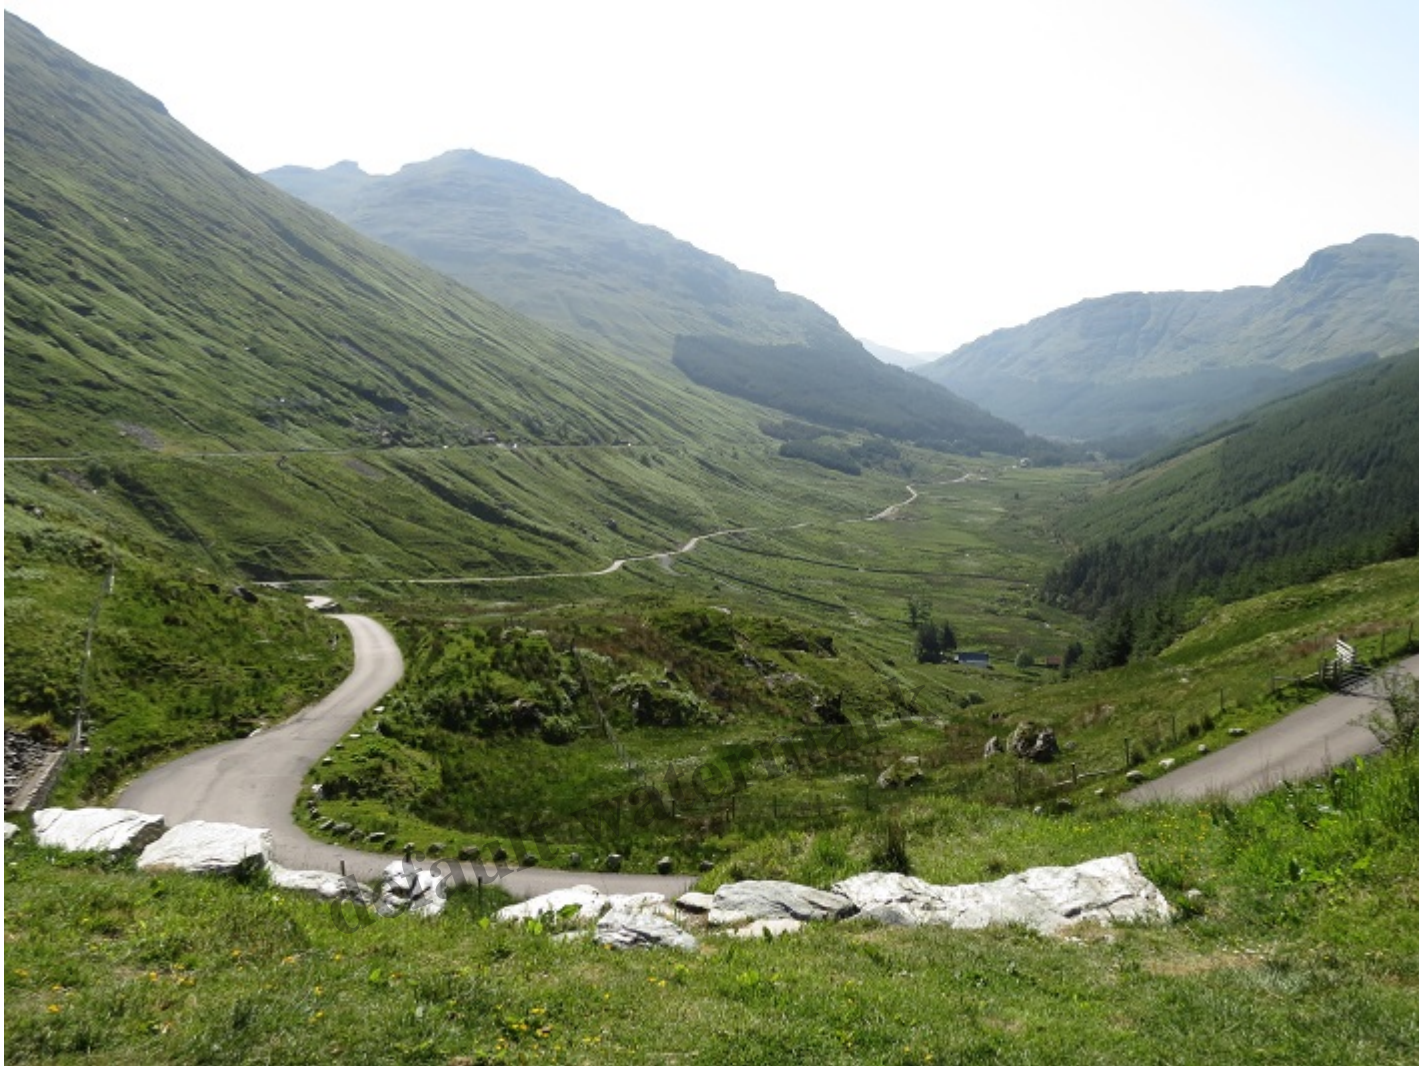
The view from the Rest and Be Thankful

While trees would make a difference to the rate of erosion on the slope, its steepness and the nature of the rock beneath the glacial debris is such that landslips are certain to continue whatever preventive measures are put in place. Looking down Glen Croe the relative steepness of Beinn Luibhean compared to the conifer planted slopes of Ben Donich is obvious. Routing the A83 along the other side of the glen would have made more sense, even if snow lie there (its north facing) might be more of an issue.

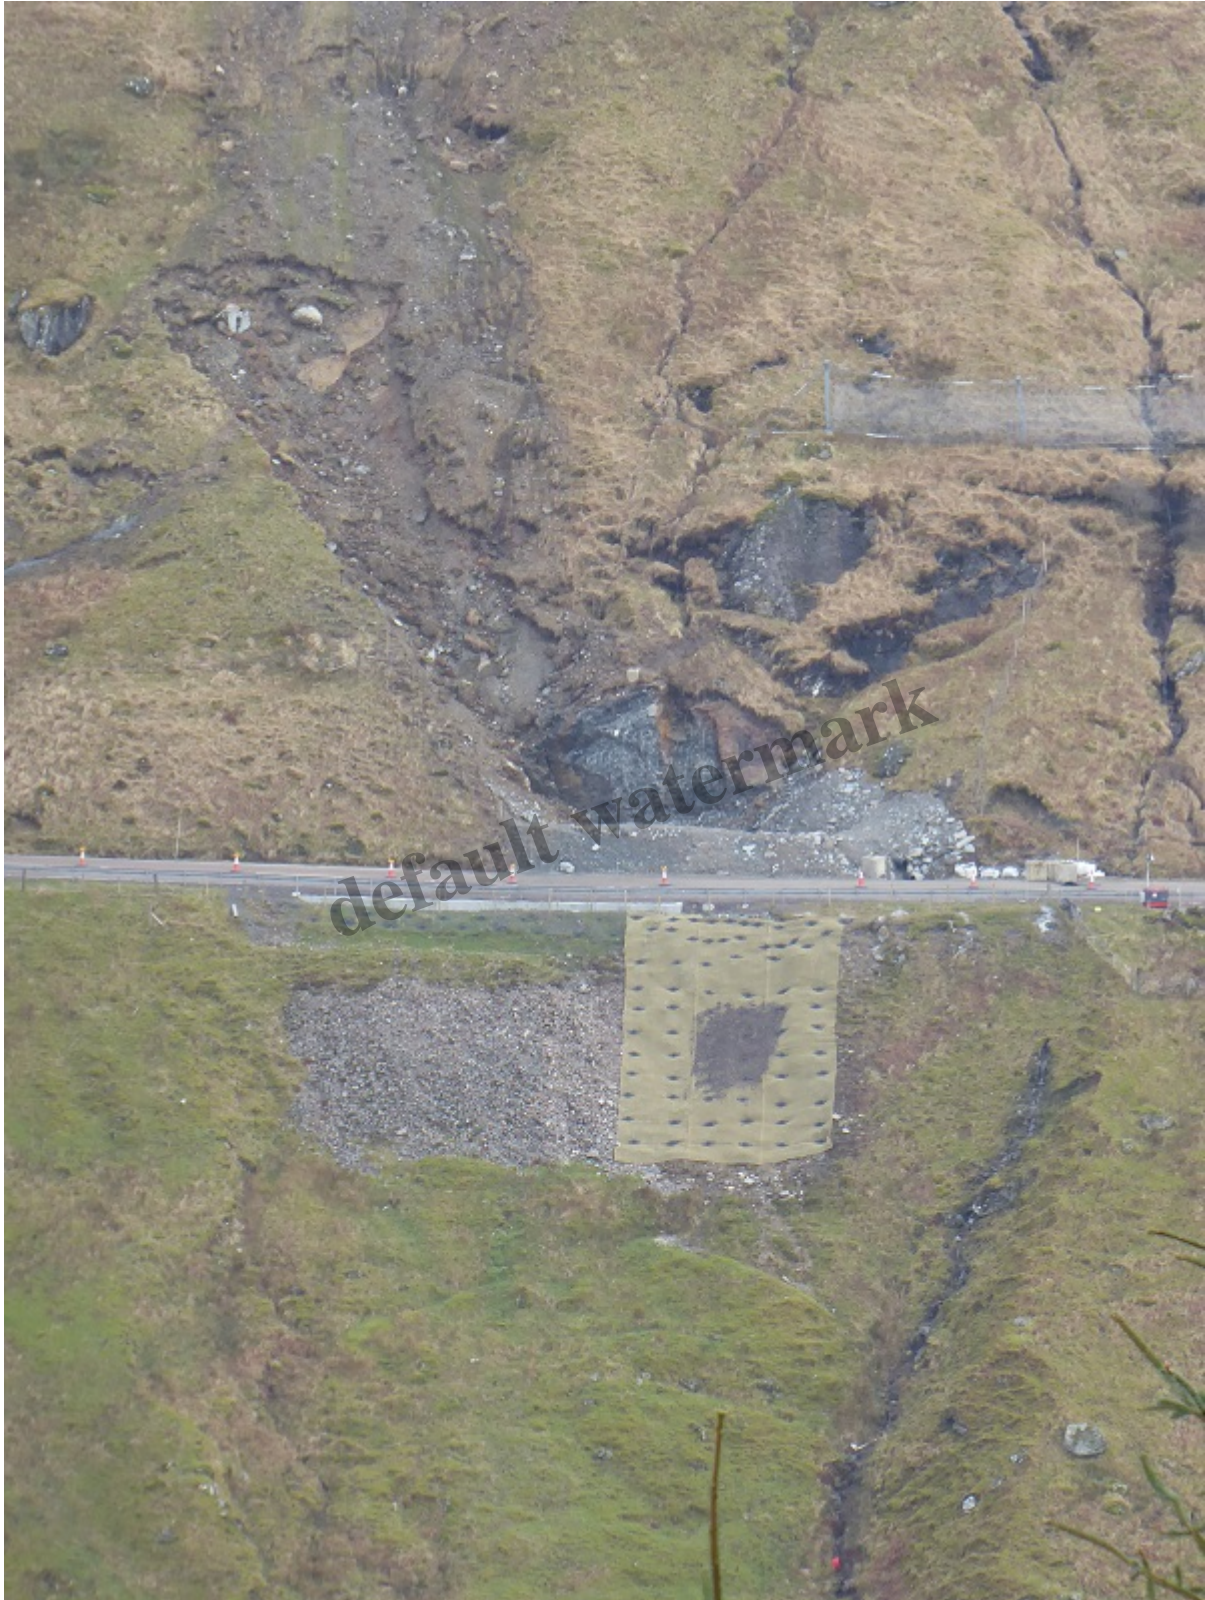
Photo illustrating the sheer volume of debris on the slope

Coupled with the steepness of the slope is the sheer volume of glacial debris that covers the hard mica schists excavated by the glacier which underly them. Extensive engineering is needed to try and secure/make safe just one small section of the slope.

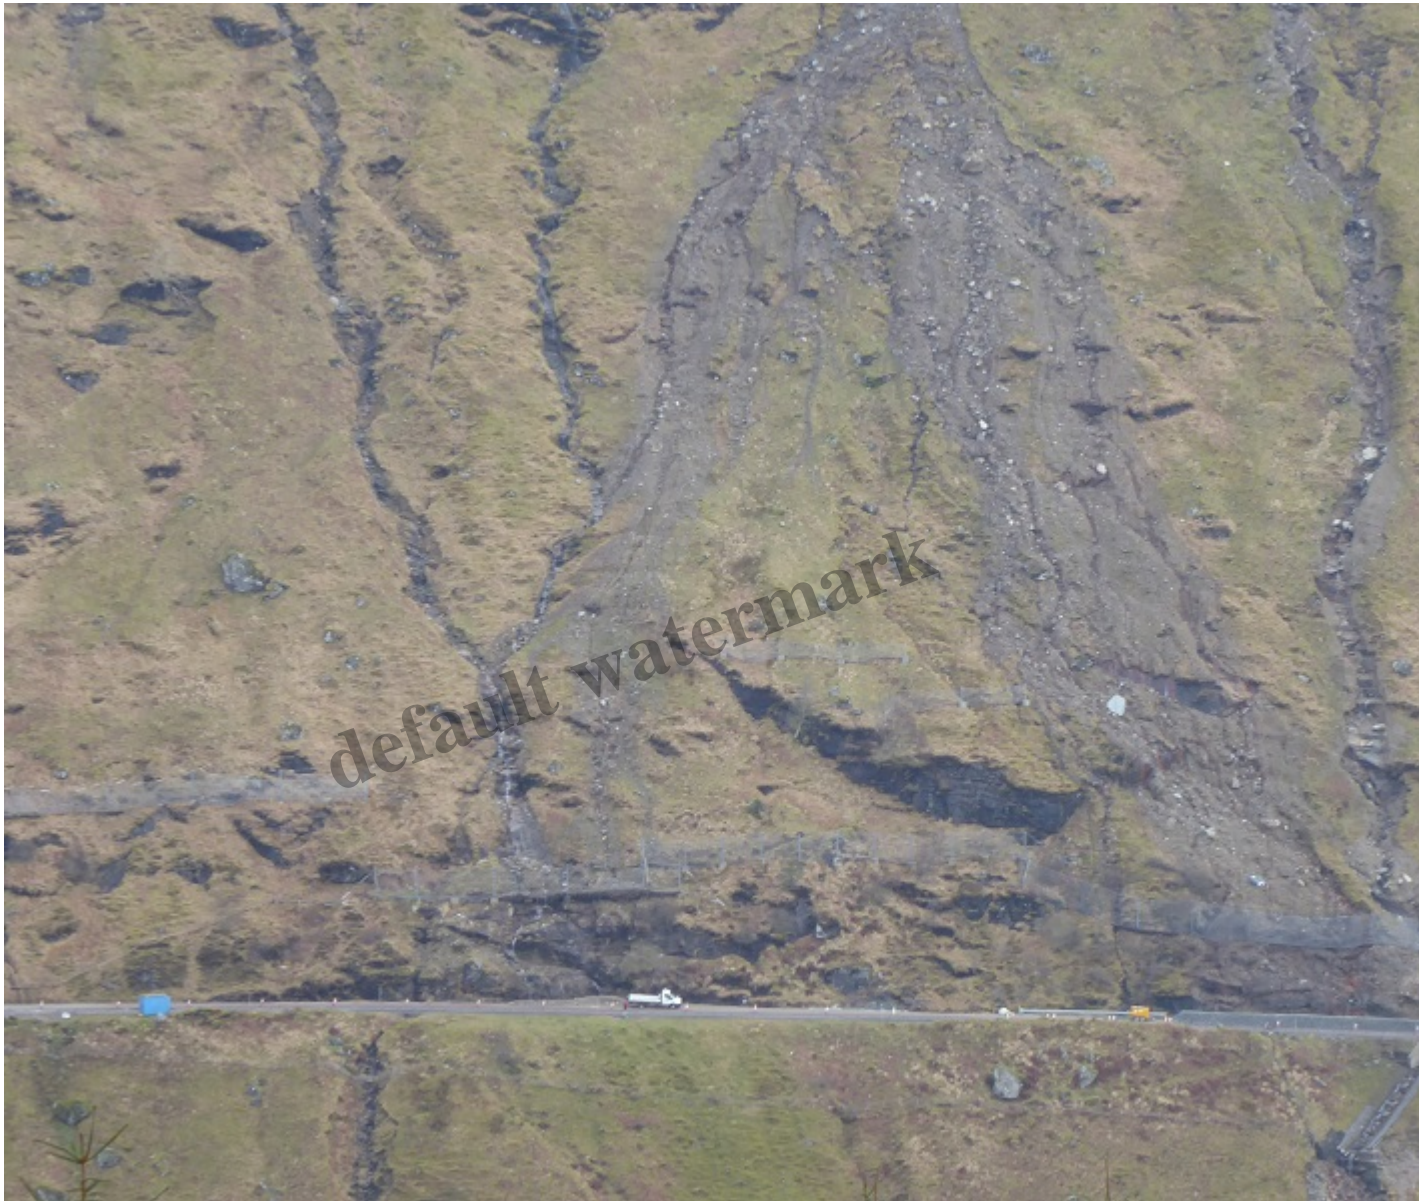
Photo illustrating volume of debris flows compared to the size of the netting

The netting is unlikely to be ever sufficient to prevent larger debris flows reaching the road – a really large flow will simply run over the top – and creates a problem because the build up behind the netting puts it under considerably tension. This then needs to be removed if future flows are not to run over the top. Its as a consequence of this problem that the Scottish Government has now commissioned debris traps by the road which would be much easier to empty. Creating a trap the whole way along this section of road, however, poses a considerable challenge. There is not enough space due to the steepness of the slope.

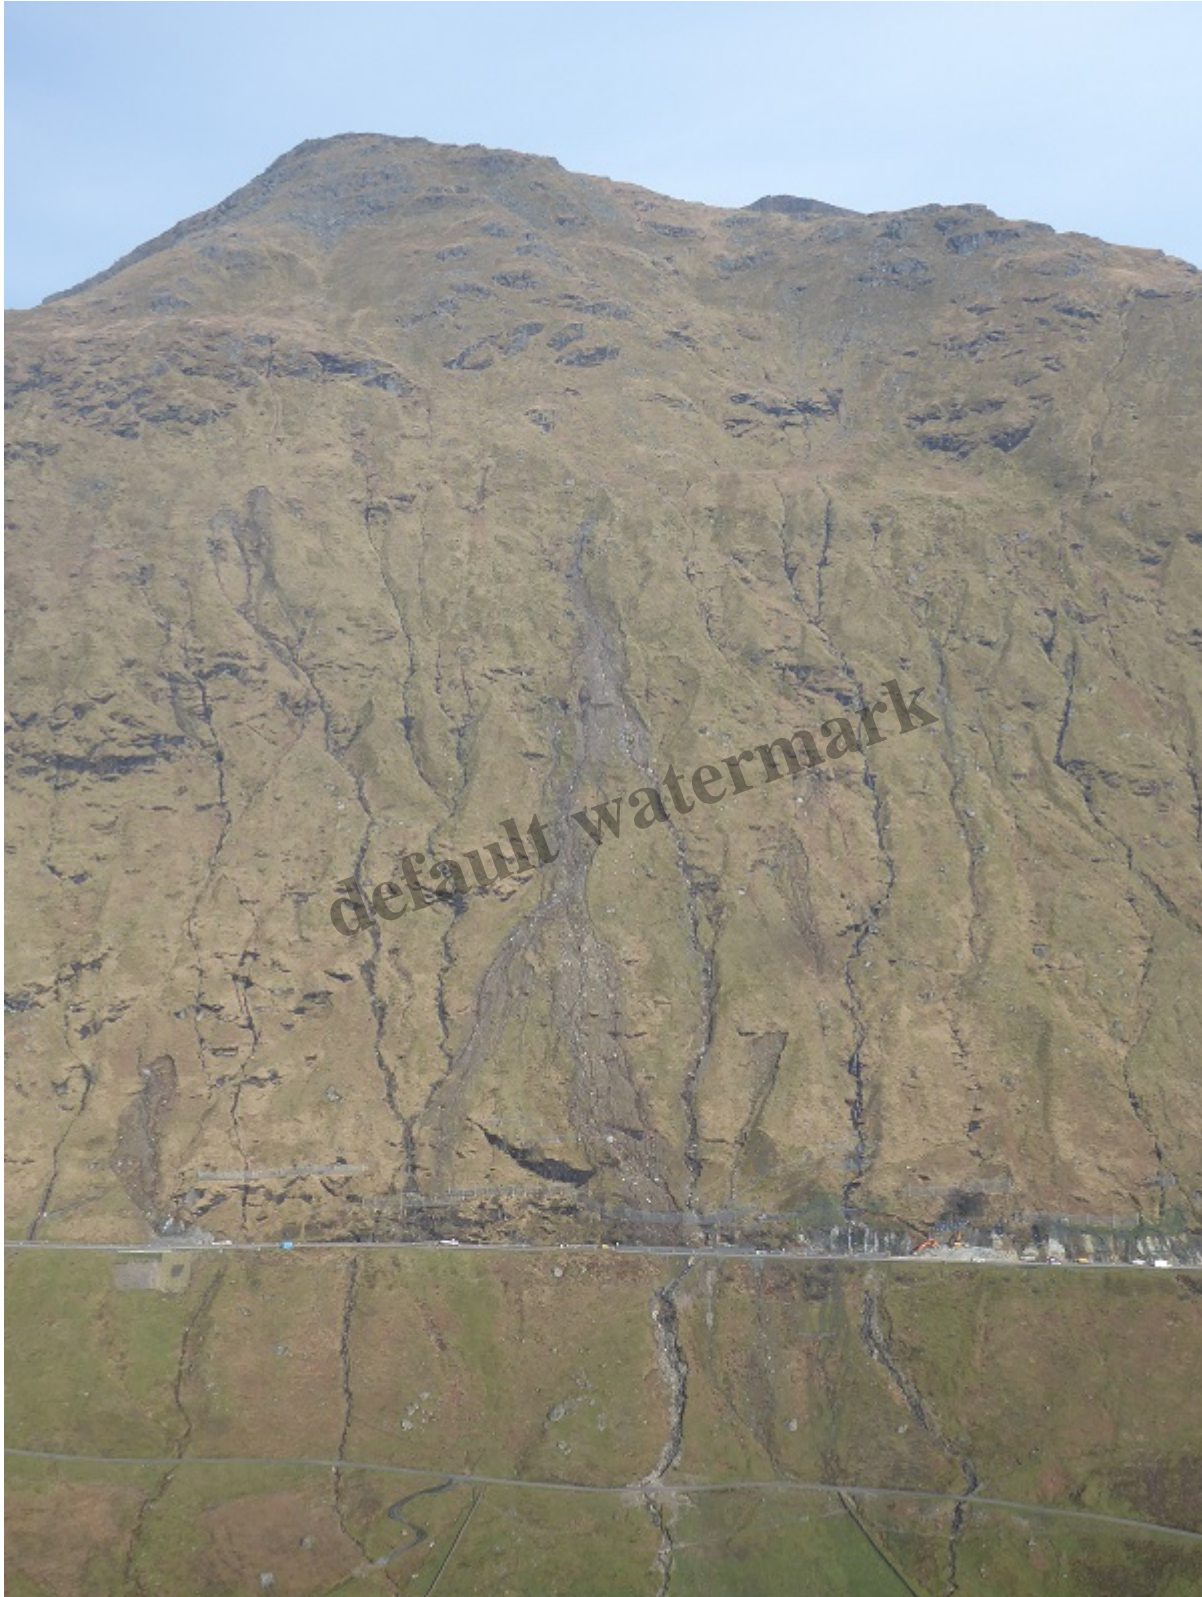
The narrow starting point of the main debris flow on the left side of the hollow is almost certainly not a coincidence

The problem is accentuated further by the nature of the ground above the main glacial debris covered slope. A large hollow, possibly created by the beginnings of a coire glacier, lies above. Moss and

peat form here, in contrast to the steep slopes below. This holds the water but in times of heavy rainfall it can be suddenly released. That then acts rather like the hush dams which were used near Tyndrum to prospect for lead and other metals. The rush of water sweeps away the vegetation and debris below.
