The Rest and Be Thankful landslips – why does sheep grazing continue?

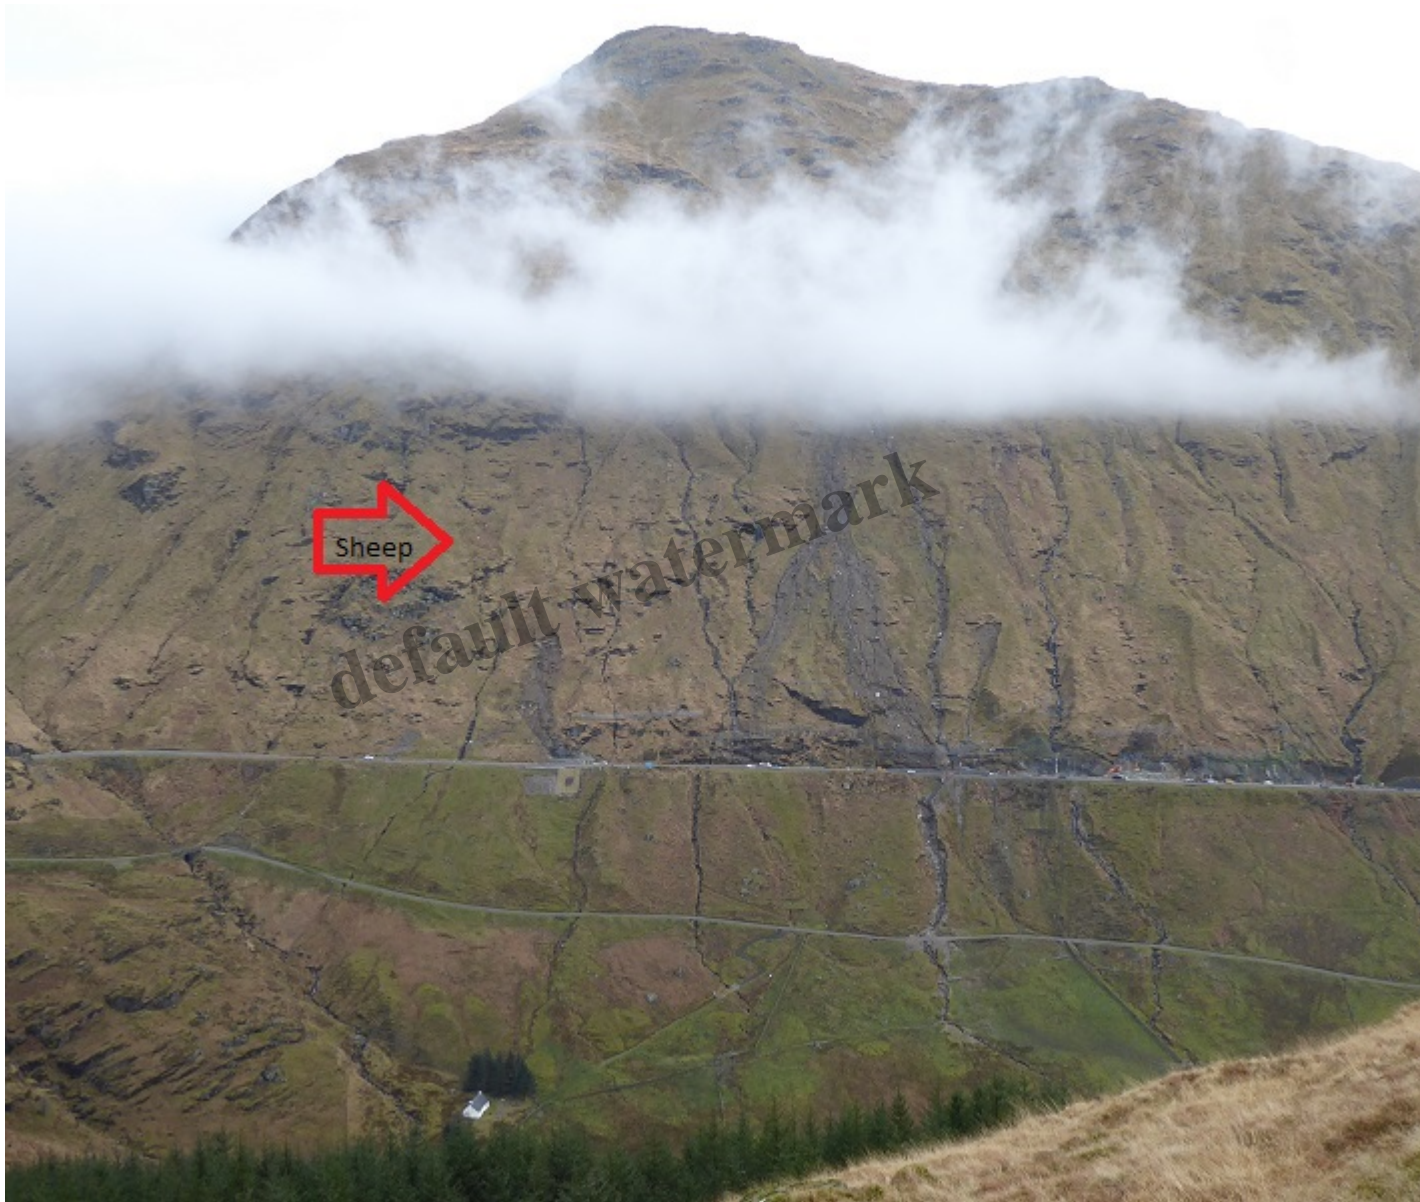
View across Glen Croe to slopes of Glen Croe. Main landslide centre. Subsidiary landslips visible left
Photo Credit Louise Brimelow

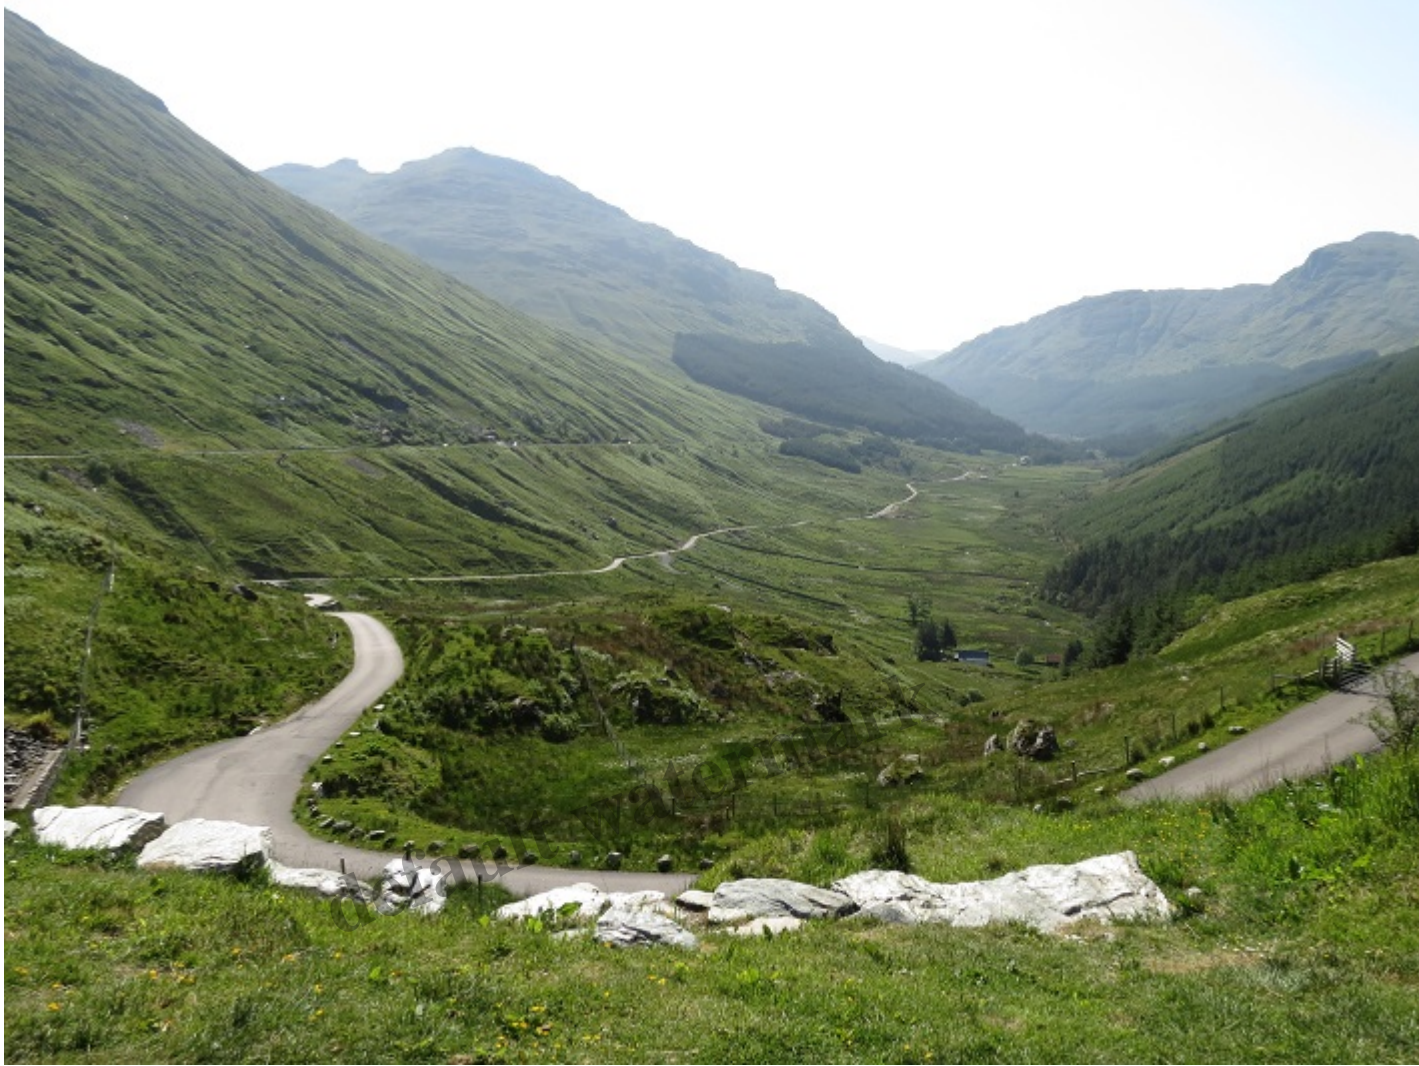
The view from the Rest and Be Thankful

While trees would make a difference to the rate of erosion on the slope, its steepness and the nature of the rock beneath the glacial debris is such that landslips are certain to continue whatever preventive measures are put in place. Looking down Glen Croe the relative steepness of Beinn Luibhean compared to the conifer planted slopes of Ben Donich is obvious. Routeing the A83 along the other side of the glen would have made more sense, even if snow lie there (its north facing) might be more of an issue.

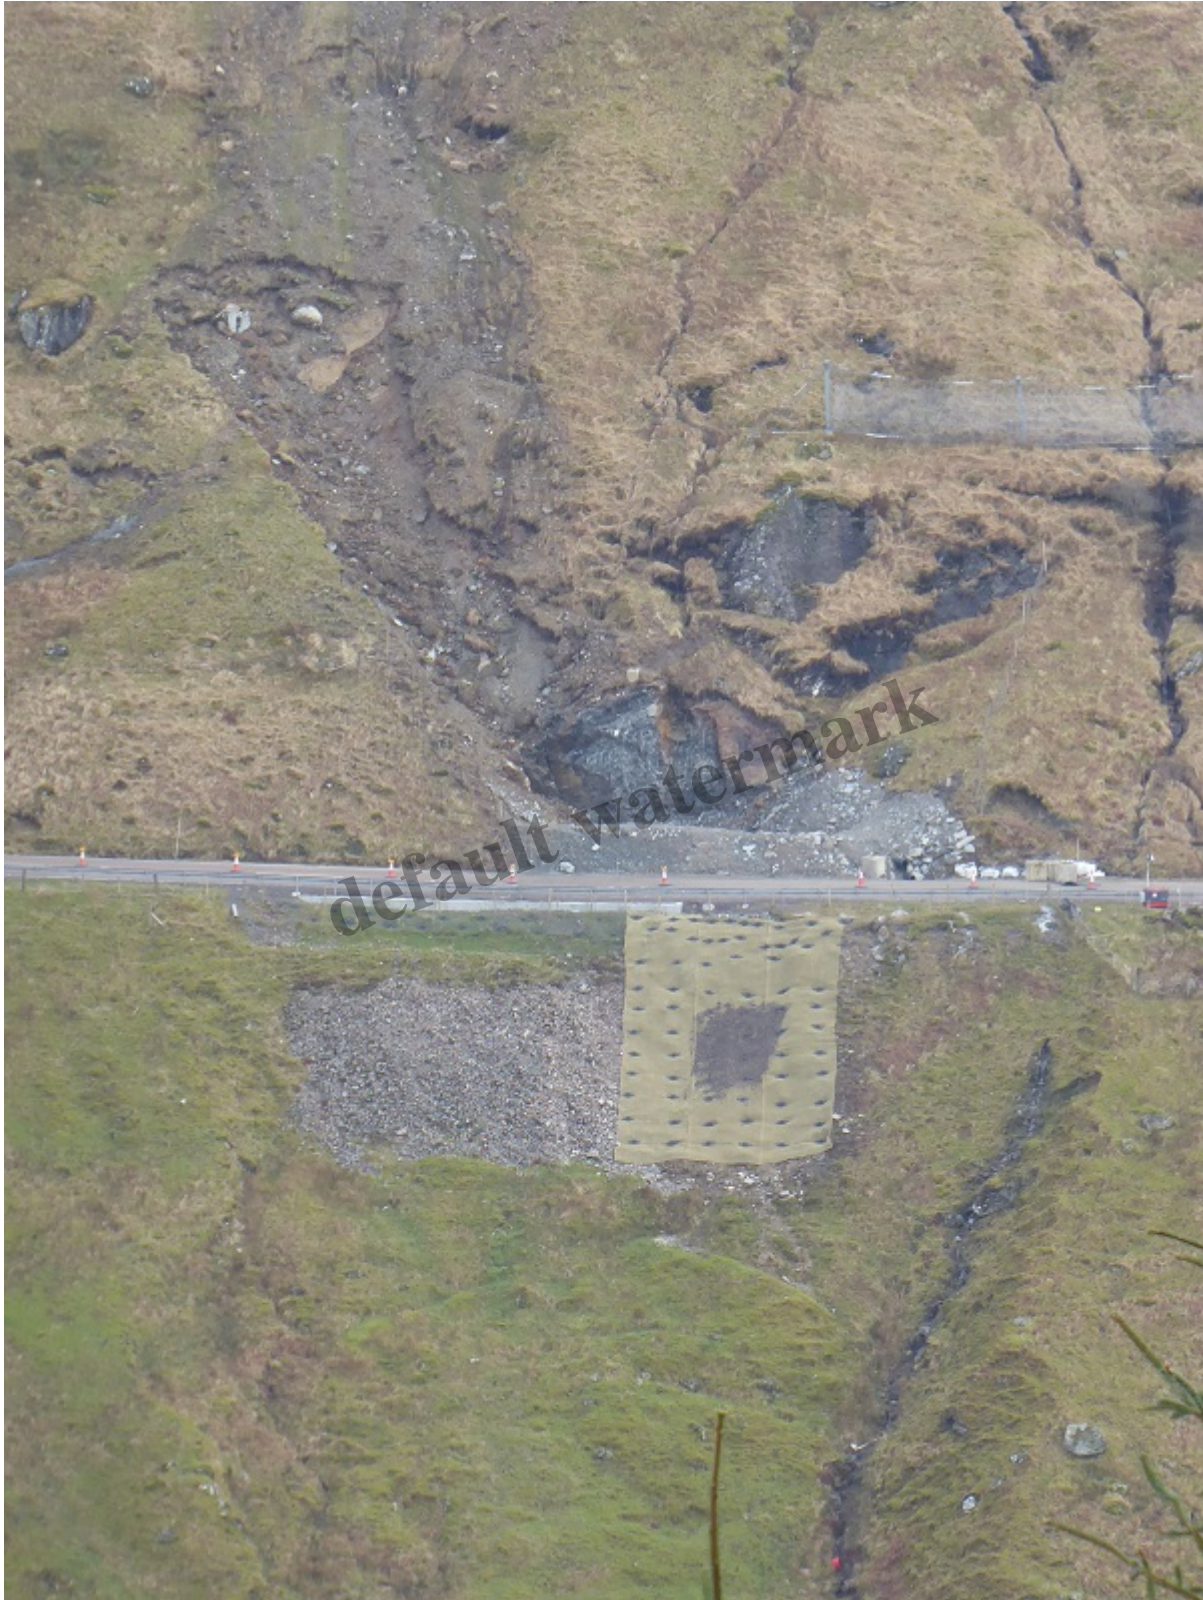
Photo illustrating the sheer volume of debris on the slope

Coupled with the steepness of the slope is the sheer volume of glacial debris that covers the hard mica schists excavated by the glacier which underly them. Extensive engineering is needed to try and secure/make safe just one small section of the slope.

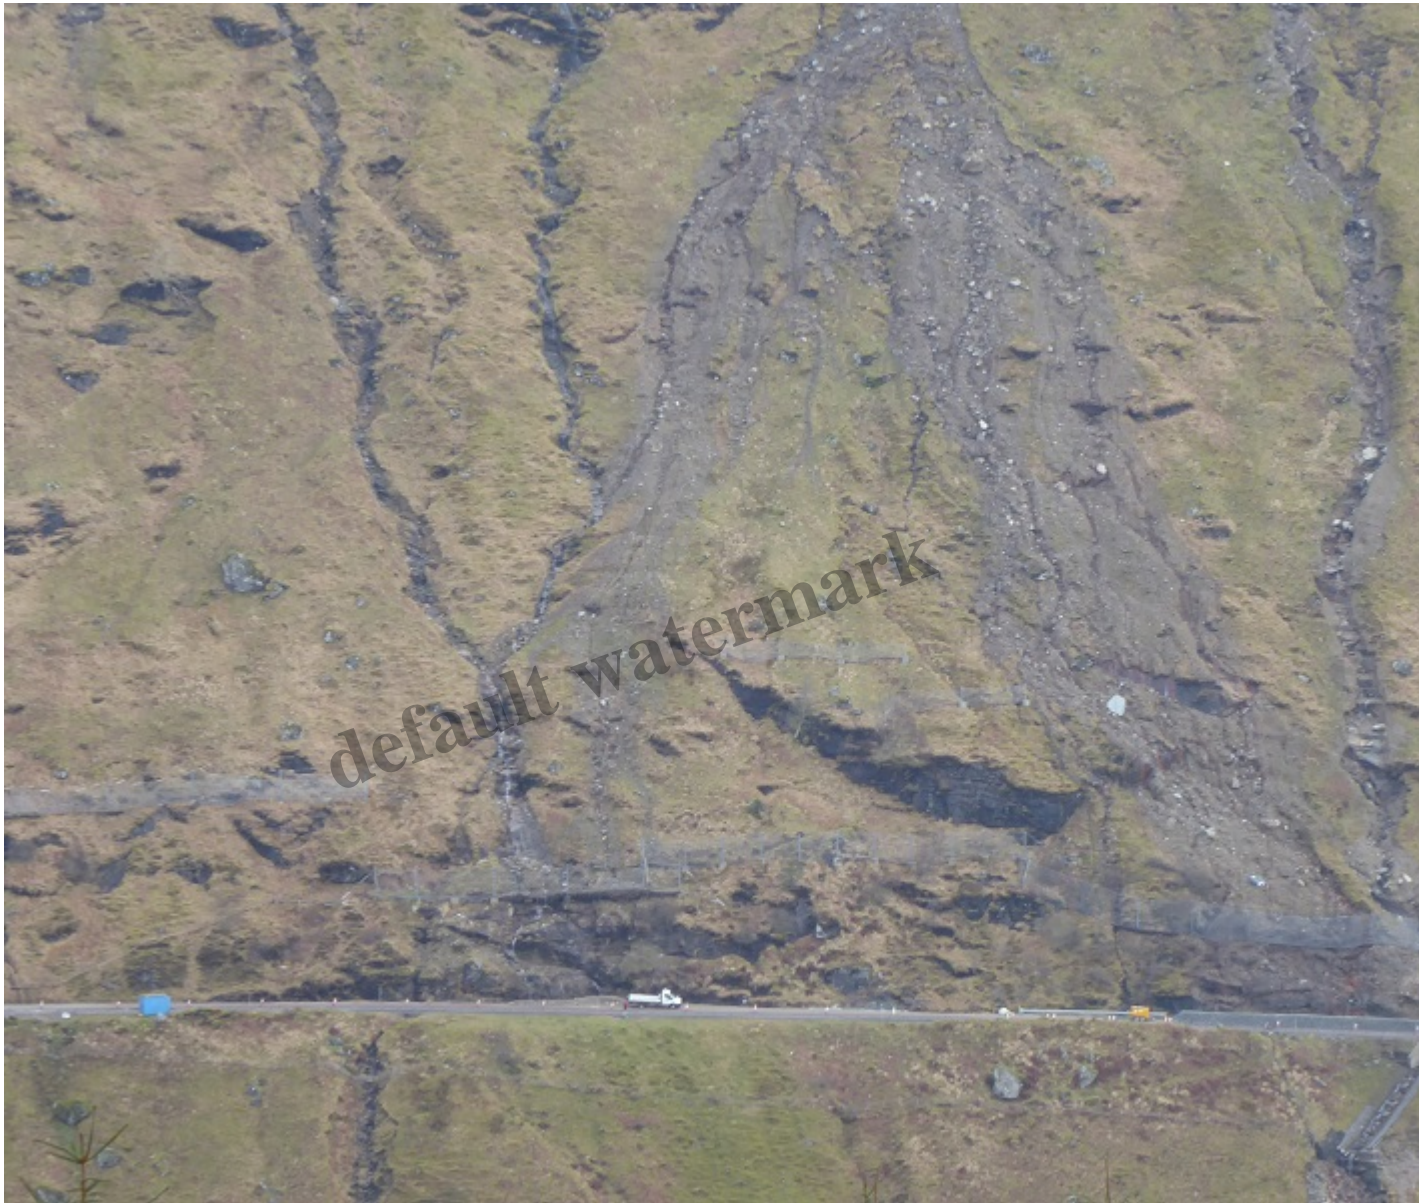
Photo illustrating volume of debris flows compared to the size of the netting

The netting is unlikely to be ever sufficient to prevent larger debris flows reaching the road – a really large flow will simply run over the top – and creates a problem because the build up behind the netting puts it under considerably tension. This then needs to be removed if future flows are not to run over the top. Its as a consequence of this problem that the Scottish Government has now commissioned debris traps by the road which would be much easier to empty. Creating a trap the whole way along this section of road, however, poses a considerable challenge. There is not enough space due to the steepness of the slope.

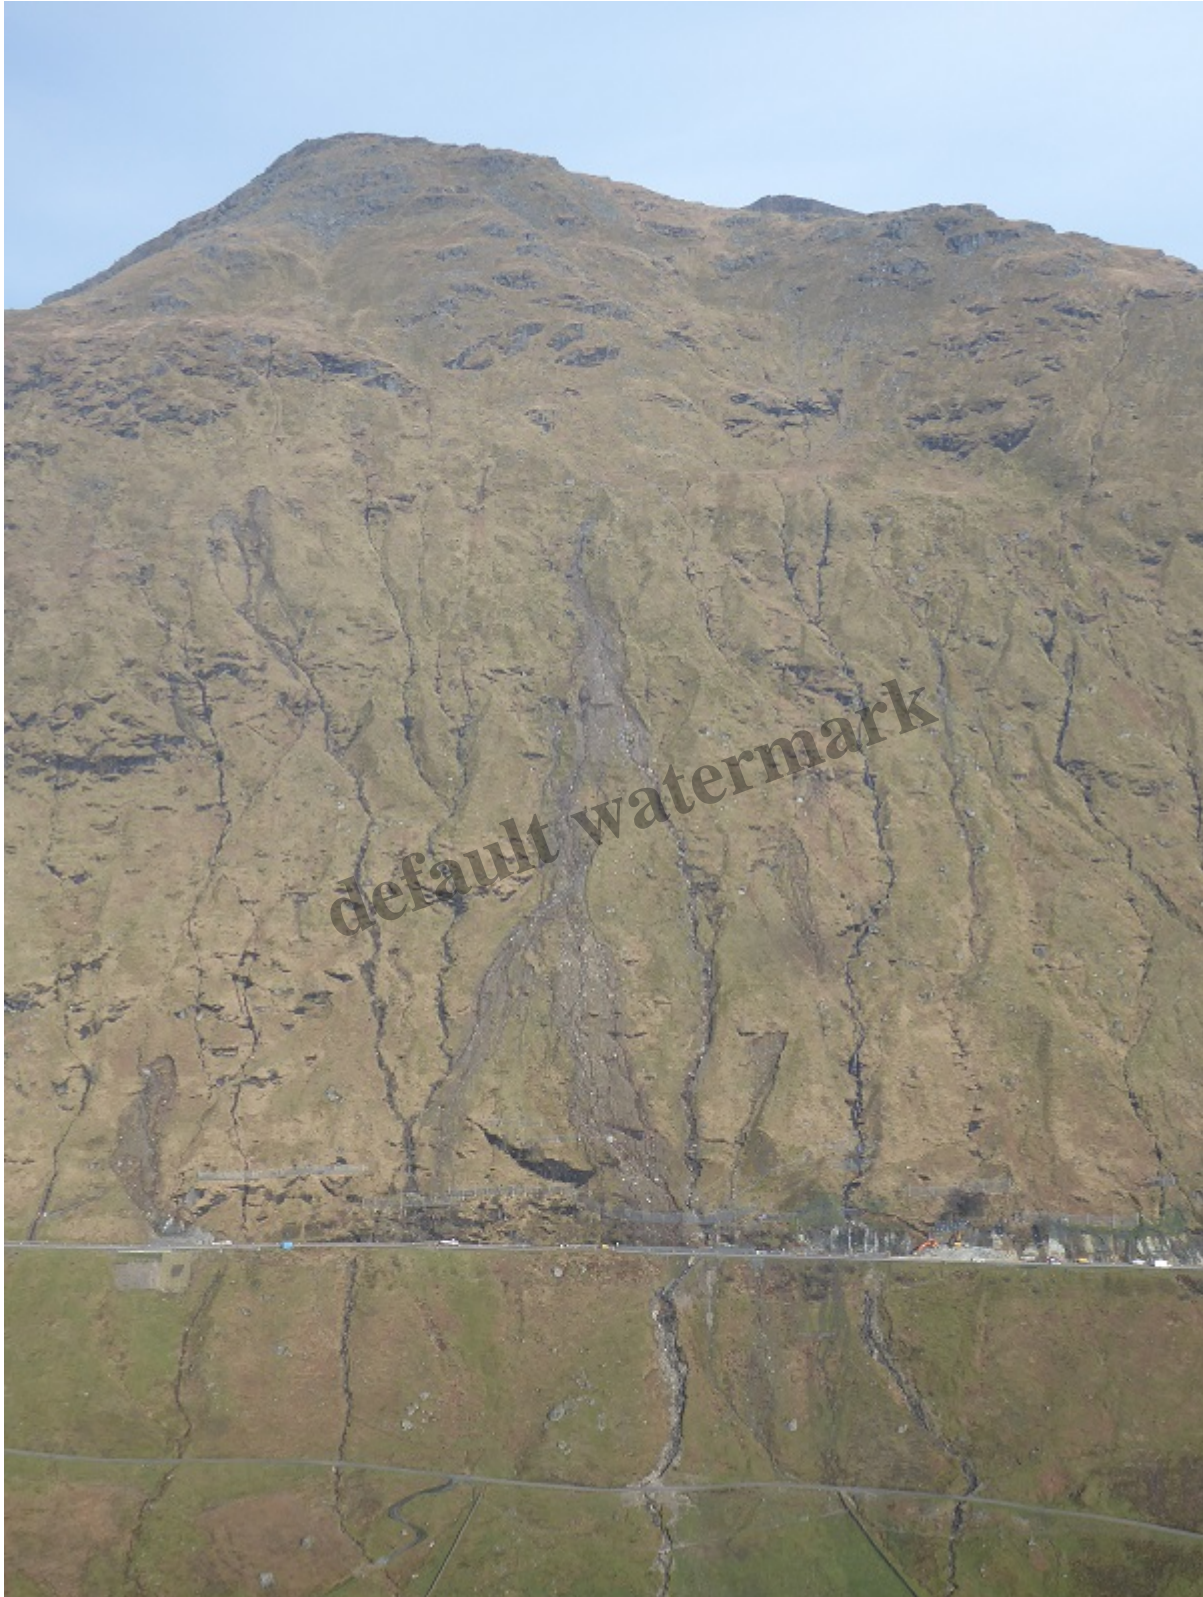
The narrow starting point of the main debris flow on the left side of the hollow is almost certainly not a coincidence

The problem is accentuated further by the nature of the ground above the main glacial debris covered slope. A large hollow, possibly created by the beginnings of a coire glacier, lies above. Moss and

peat form here, in contrast to the steep slopes below. This holds the water but in times of heavy rainfall it can be suddenly released. That then acts rather like the hush dams which were used near Tyndrum to prospect for lead and other metals. The rush of water sweeps away the vegetation and debris below.
