The Loch Lomond and Trossachs National Park as custodian of the landscape â?? forestry and hydro north of Callander

The new â??forestryâ?• road into Glen Chroin

The Keltie Water hydro scheme

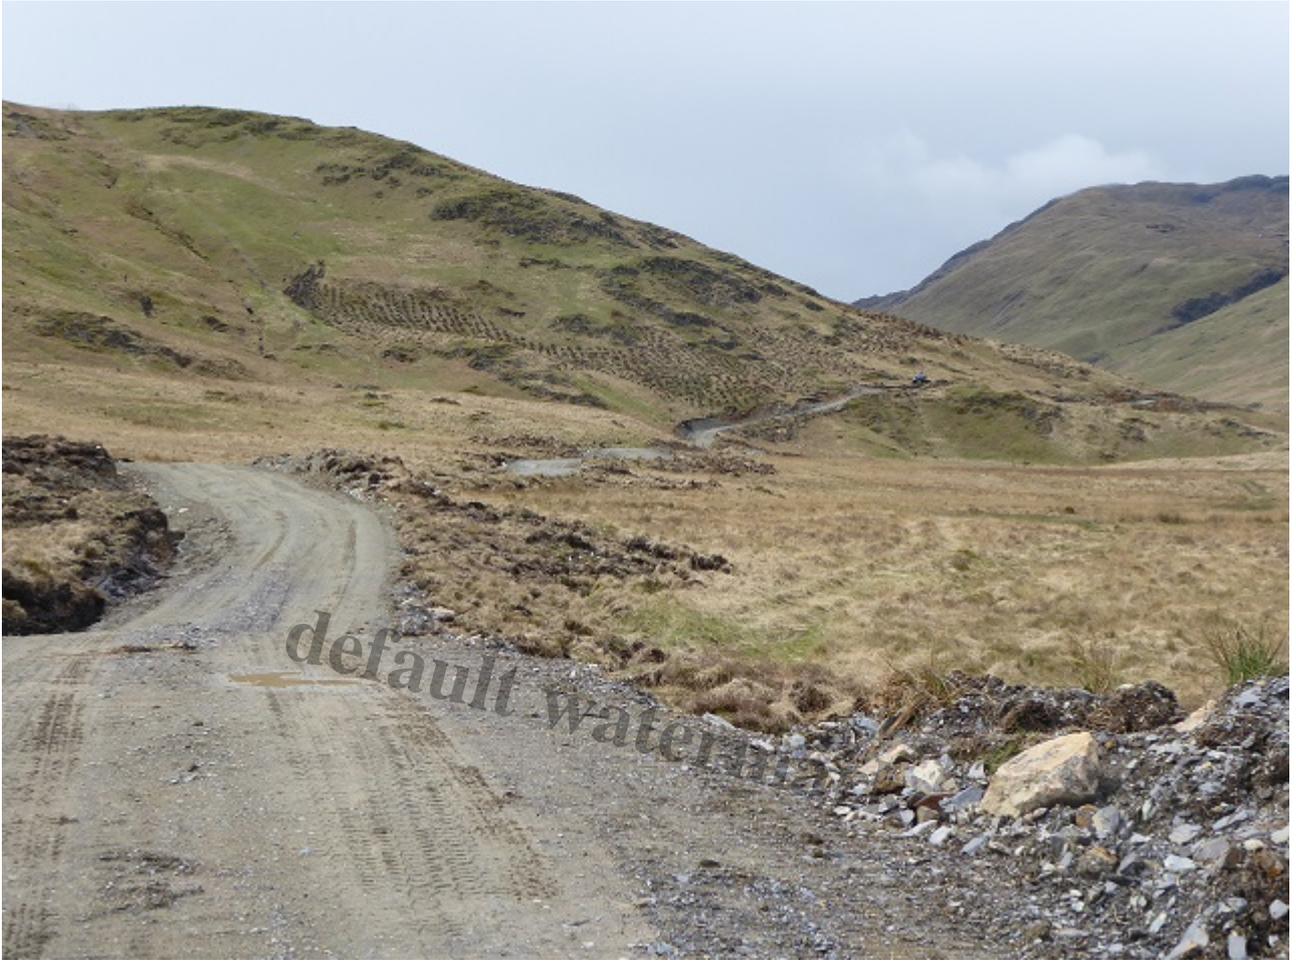
New track with tree planting clearly visible middle distance.

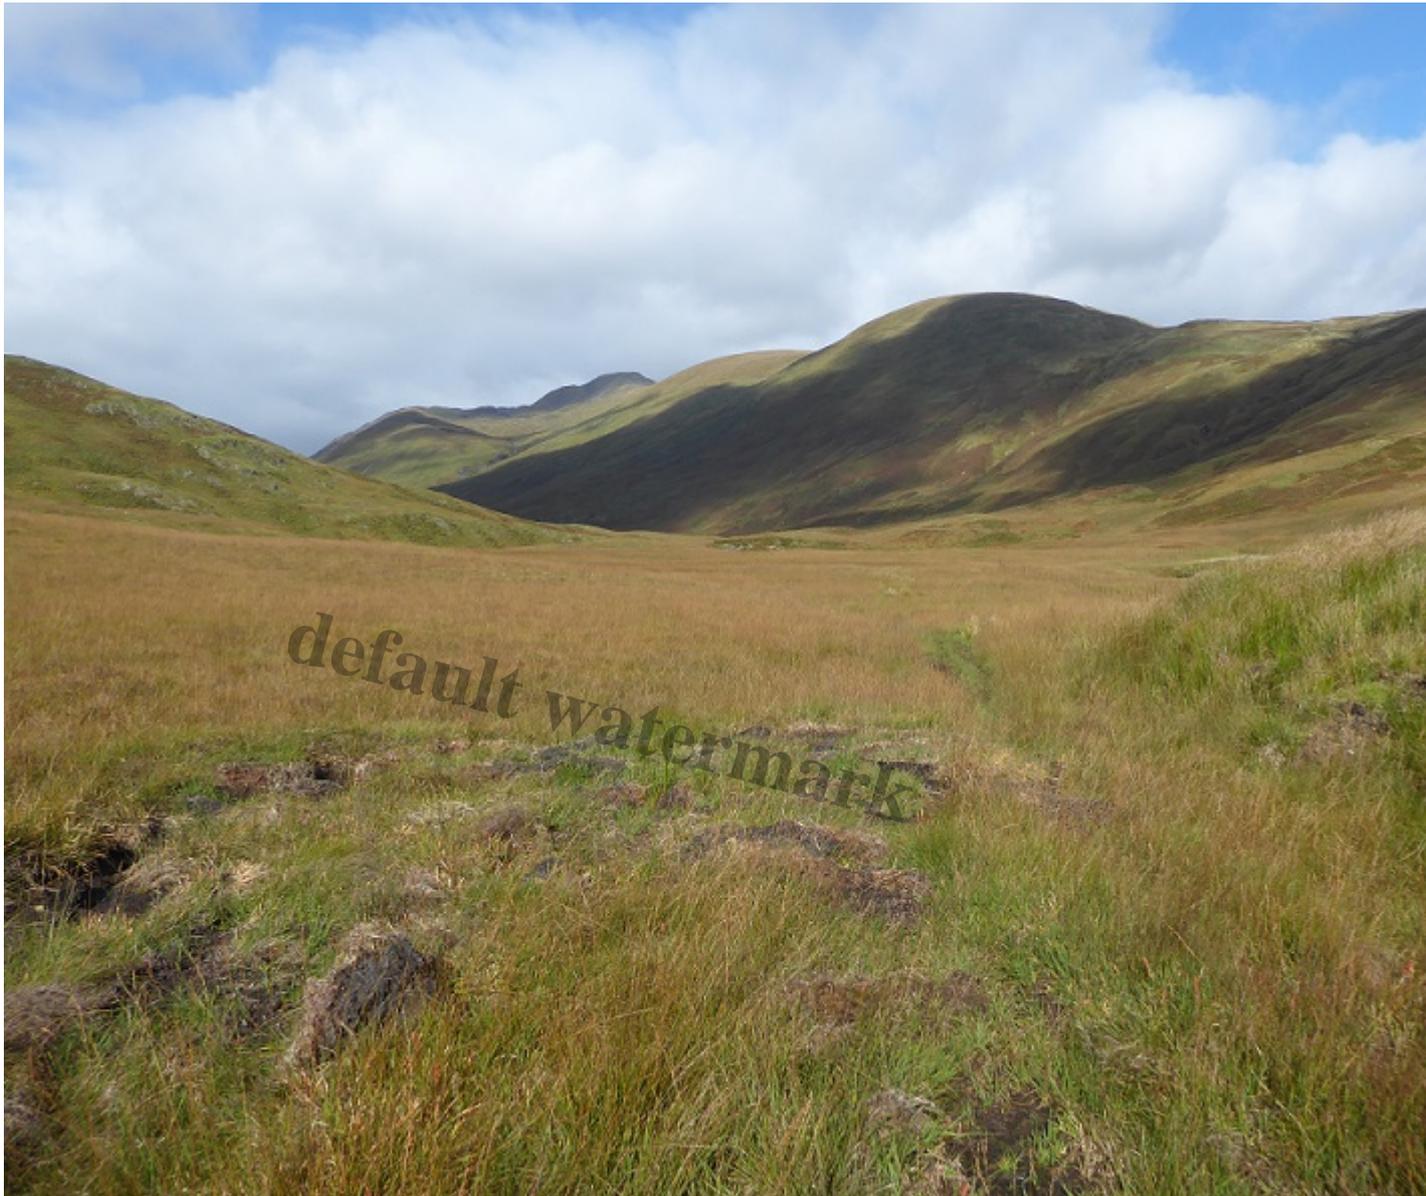
Slightly different viewpoint up Glen Chroin, which does not capture the start of the road, showing how slope (on left) looked last September. The Munro, Stuc a Chroin, behind. Wild, beautiful and almost

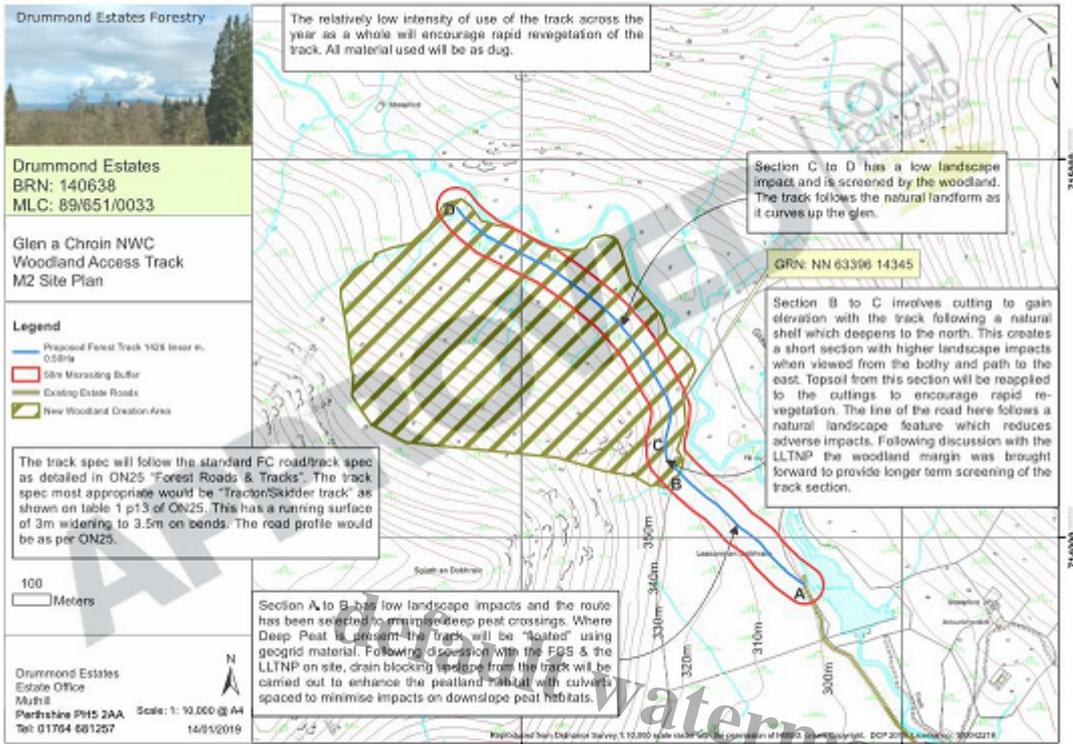
The first plan claims that:

- the first section of road, A to B, before it goes up the hill and enters the new woodland planting, will have low visual impact
- the short section B to C will have some lasting landscape impact because it requires a cutting, and
- the third section of road, C to D, will have a low impact because it follows a natural shelf and will be hidden by trees.

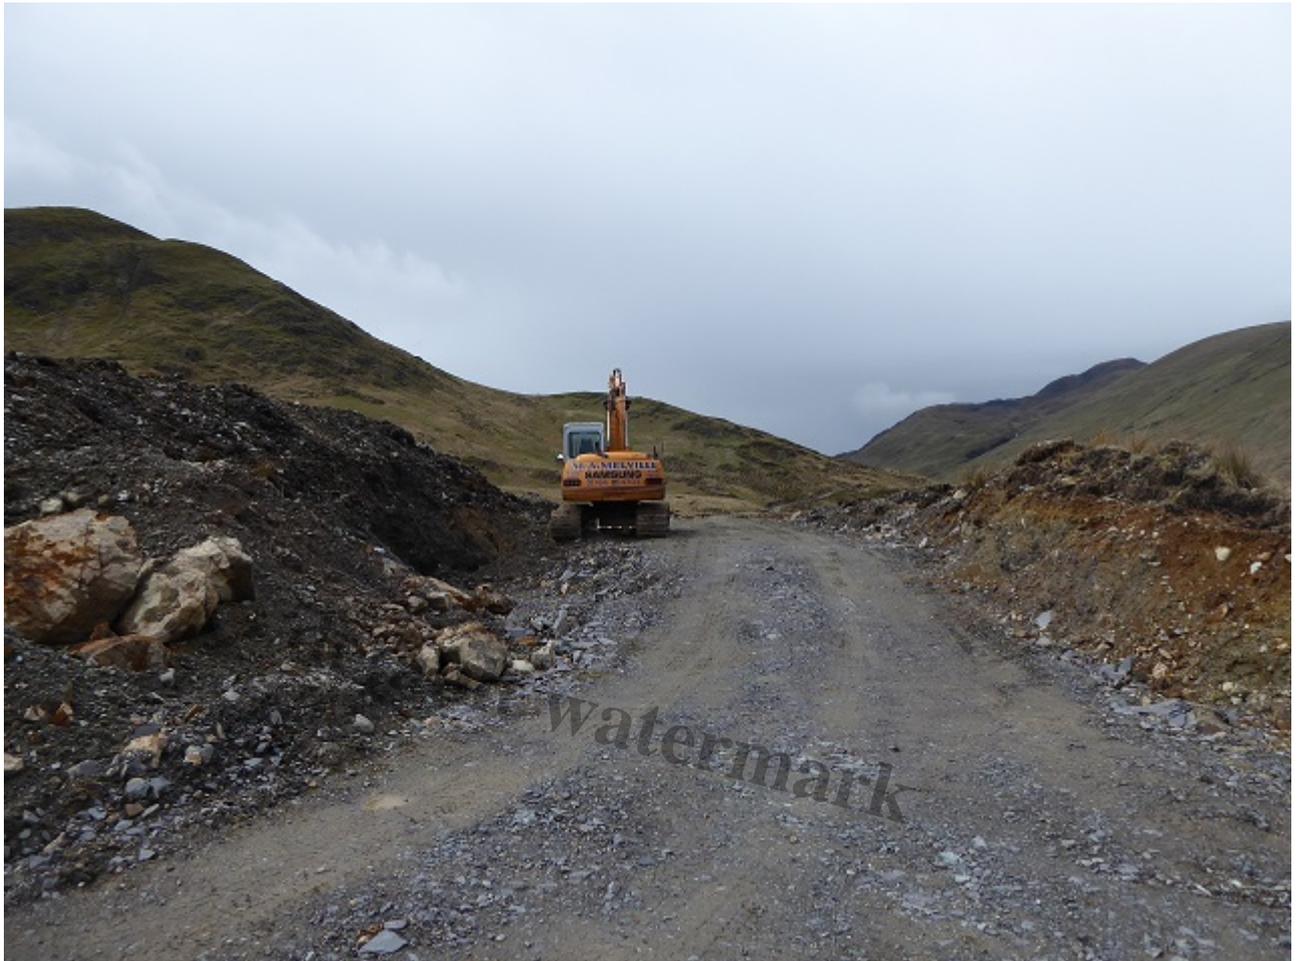
While the construction was not complete when I visited, all three claims appear wrong. A number of cuttings have been made to construct the first section of road:

The new road starts with a cutting

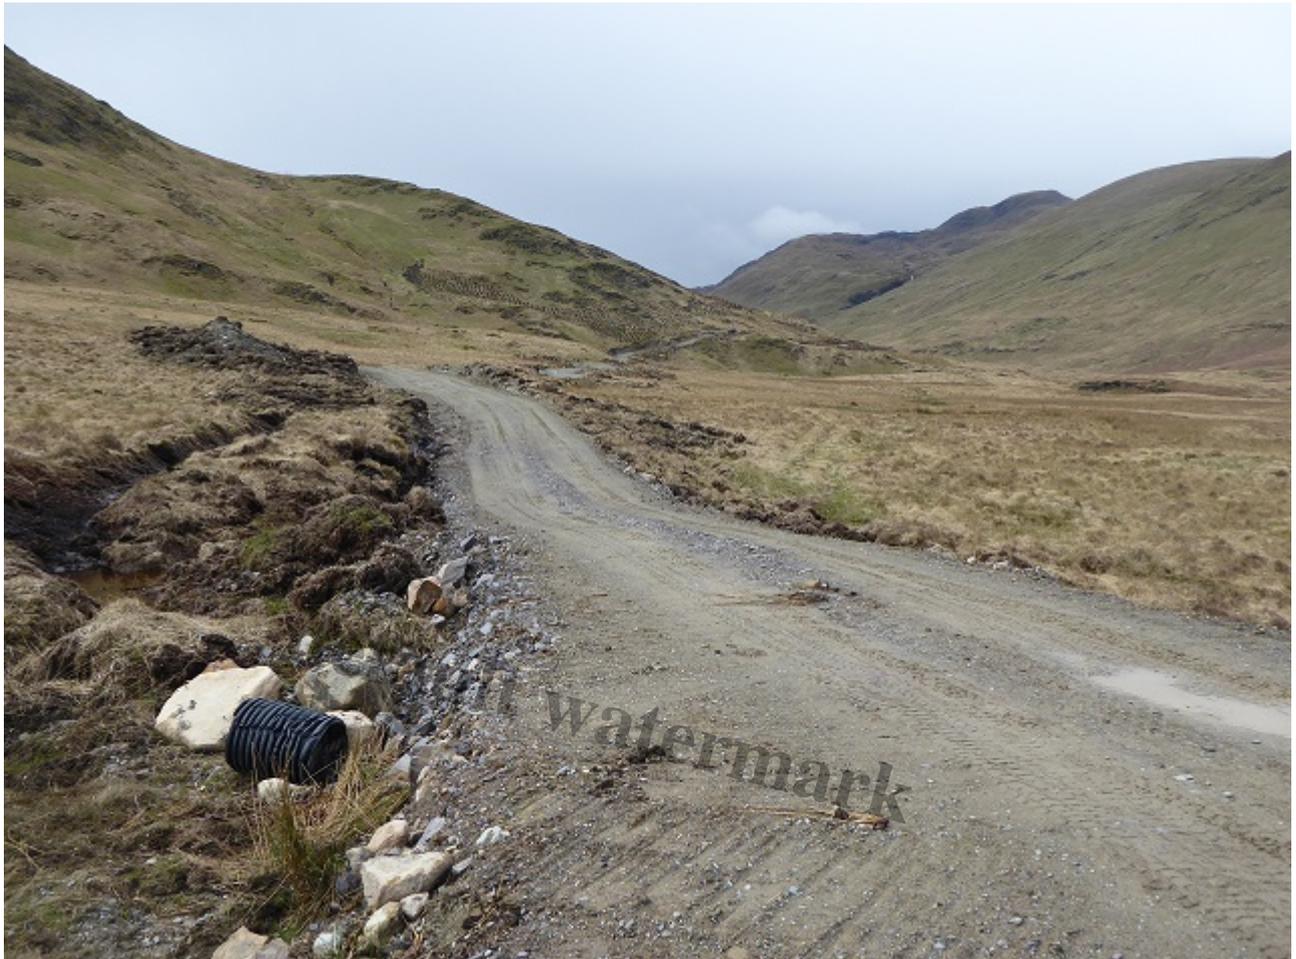
View just beyond first cutting, showing further excavation work. Line of former ATV track just visible (centre) – the Planning Report suggested the new road would help ameliorate the impact of existing ATV tracks. Note also the large new drainage ditch left,

According to the second plan lodged with the LLTNPA NO cuttings were required along this first section of road.

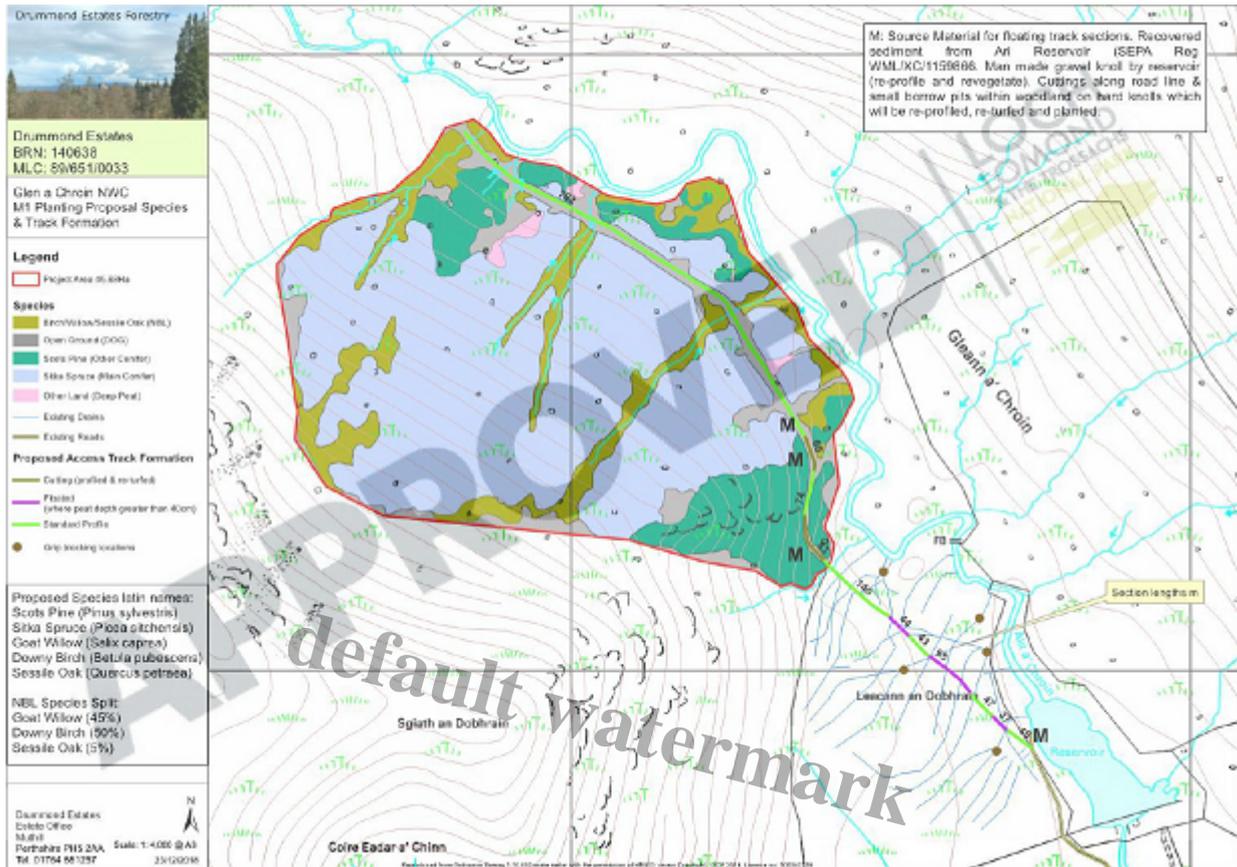
Map depicting method of track construction. The first section A-B was supposed to involve no cuttings (tan on map) but instead be a standard profile (green) and floated across peaty areas (purple). The brown dots mark ditches that will be blocked to help restore the peatland how this fits with the large new drainage ditch along the new road is unclear.

Either the plans for the road were deficient and had not properly assessed the likely landscape impact or the contractor has failed to execute the plans properly.

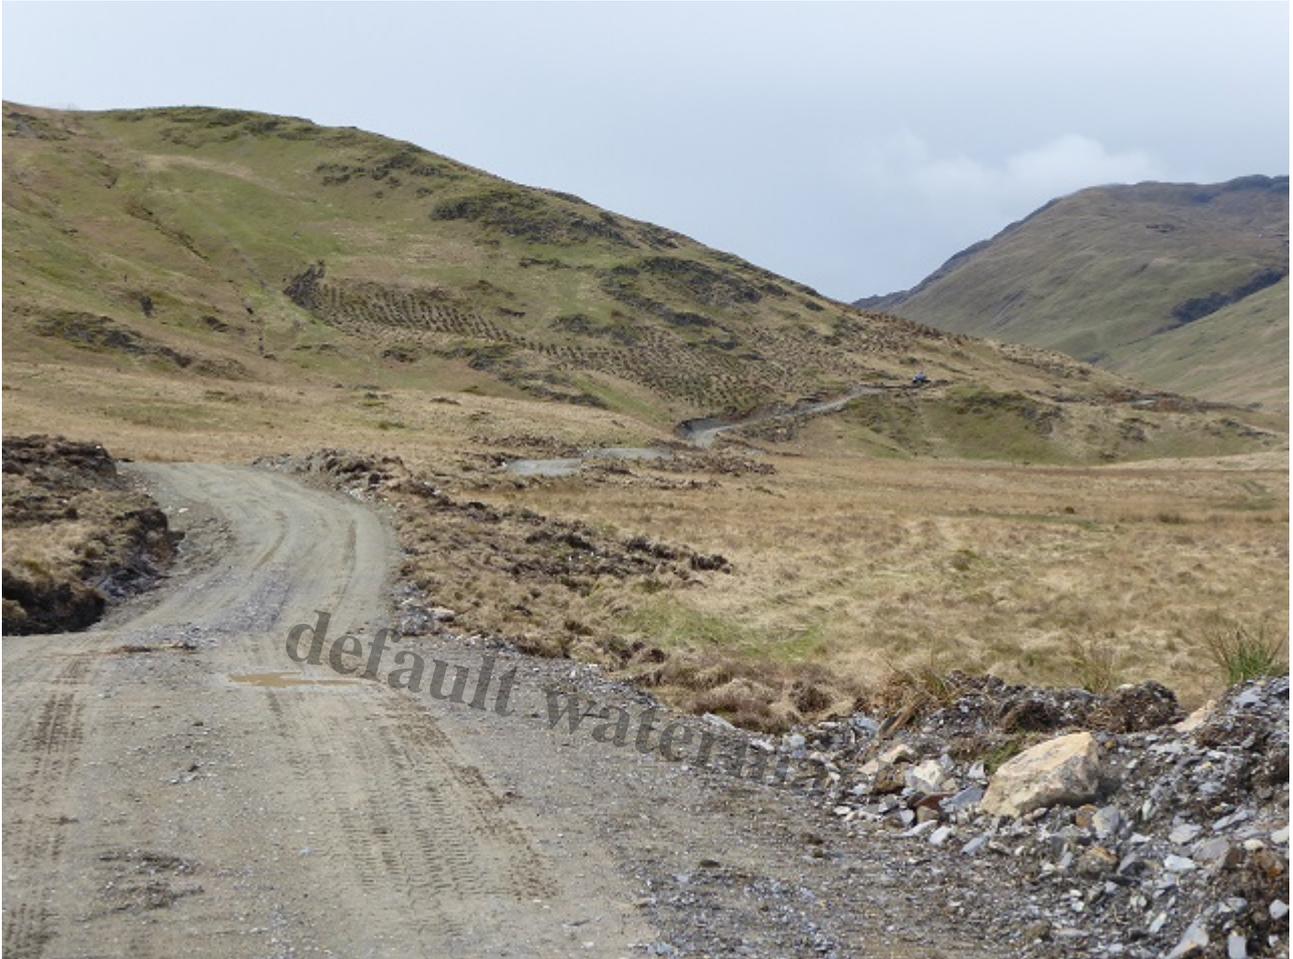
The sides of the cutting where it heads up the hillside (middle distance) were, at the time of my visit, too steep to allow vegetation to recover as suggested. The road is also in many places wider than agreed.

The answer is probably a bit of both. The Planning Officer in their report ([see here](#)) on the road indicated that there would be some excavations along the first section and that in order to try and mitigate the ecological impacts of the drainage ditches on the peat (which has been dumped along the edge of the road), ditches elsewhere would be blocked.

Prior approval was given for a road which is 3m wide (3.5m at the bends). This accords with [Forestry Standards](#). For hydro schemes the LLTNPA's normal standard [is not been consistent in either setting or enforcing these](#) [is for roads 2m wide \(2.5m\) at bends](#). So, why does it allow a different standard for forestry? That is an inconsistency that it needs to tackle in its Trees and Woodlands Strategy which is currently out for consultation ([see here](#)). The wider issue here is that Forest Standards would appear to be NOT fit for our National Parks or National Scenic Areas.

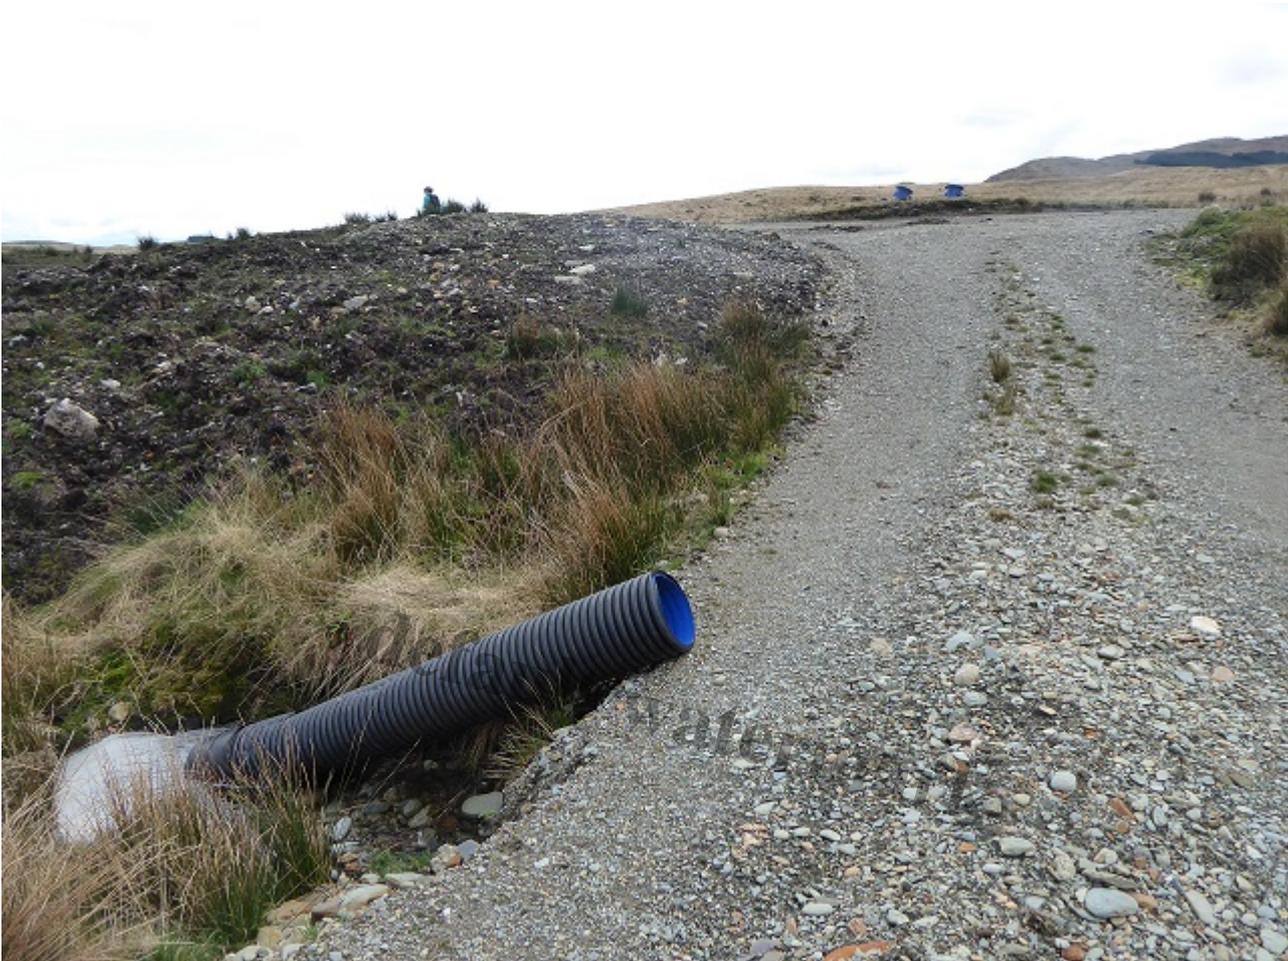
Its almost nine months since I expressed disbelief that the LLTNPA could have proposed the Keltie Water hydro scheme, which lies just below the new forestry road, for a Scottish Planning Quality award. Part of the reason for this was because of the obvious detritus left on site. A Freedom of Information request then established that the Park's Director of Planning had visited the site before it was nominated for an award and must have been fully aware of it. After the adverse publicity, which helped scupper the award, one might have hoped that the Director of Planning, the LLTNPA and Lady Jane Eresby would have been shamed into taking action. Not a bit of it! Over six months later the detritus is still all there.

Culvert pipe exactly where it was six month ago â?? meantime the edge of the track had eroded further

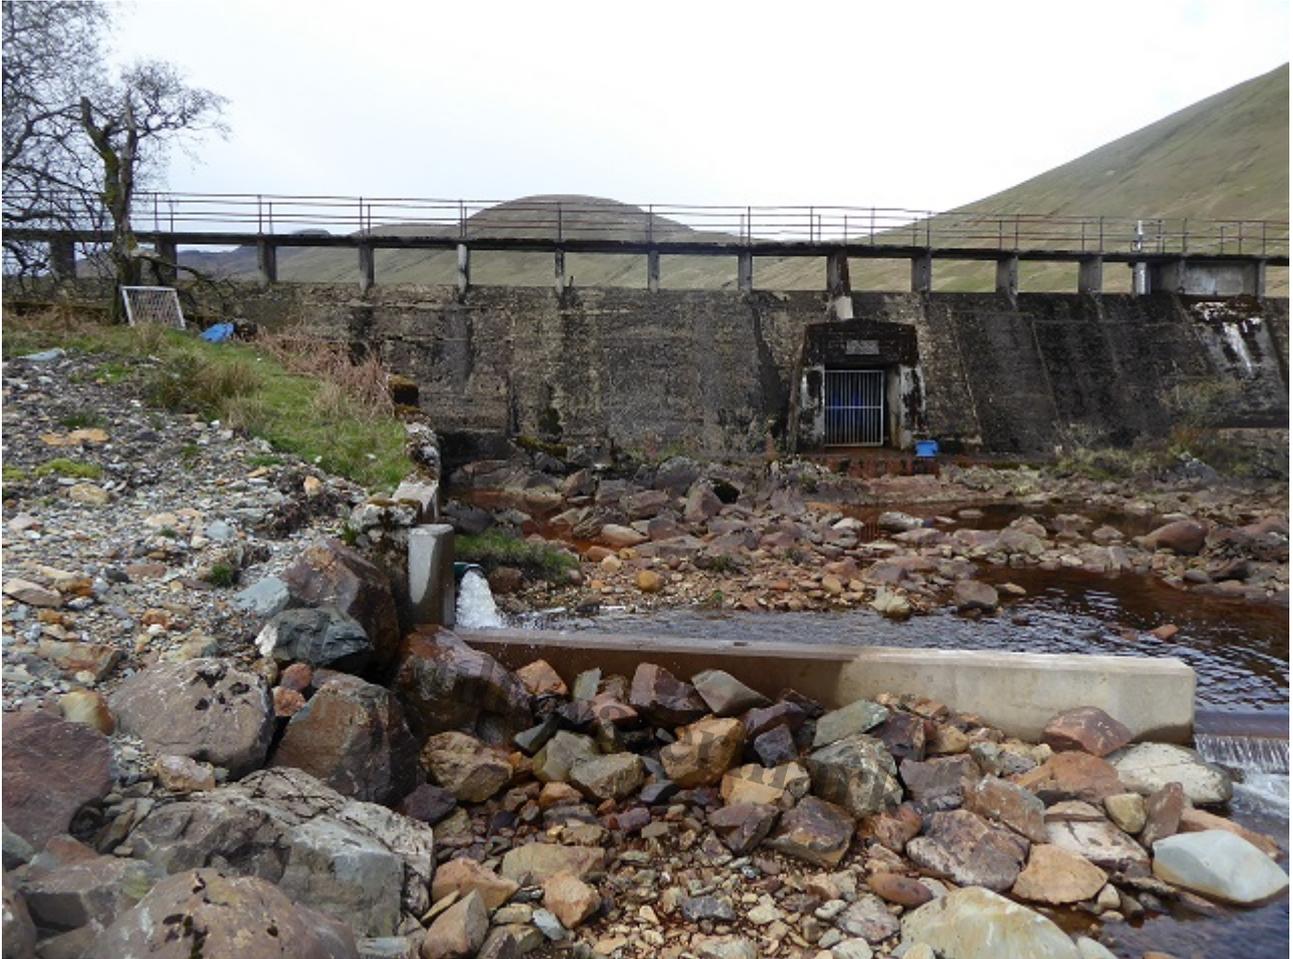
Some work had been undertaken at the new outflow below the reservoir but several apparently abandoned components were visible just below the dam

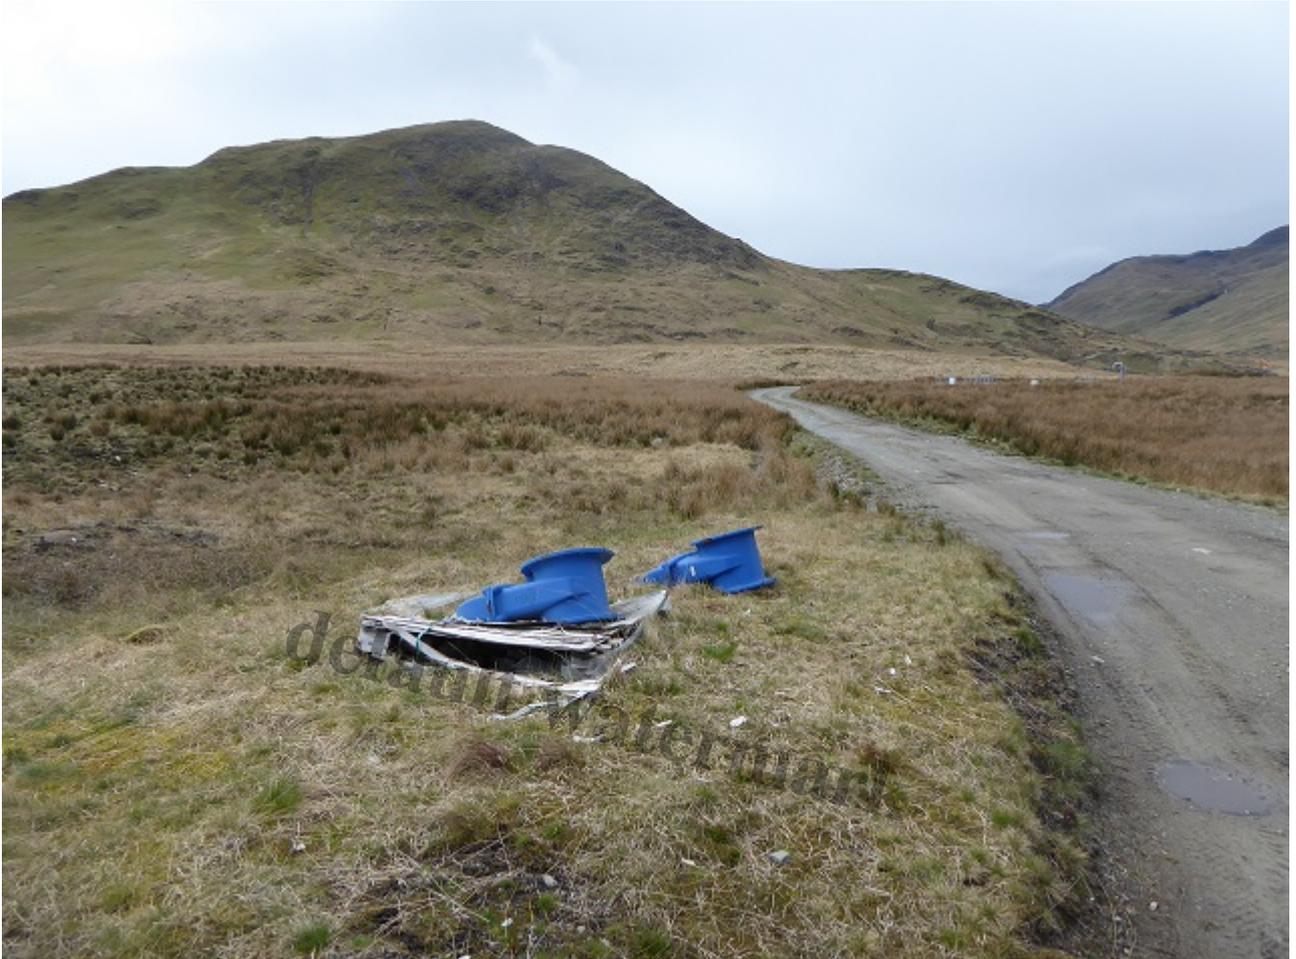
Same as before!

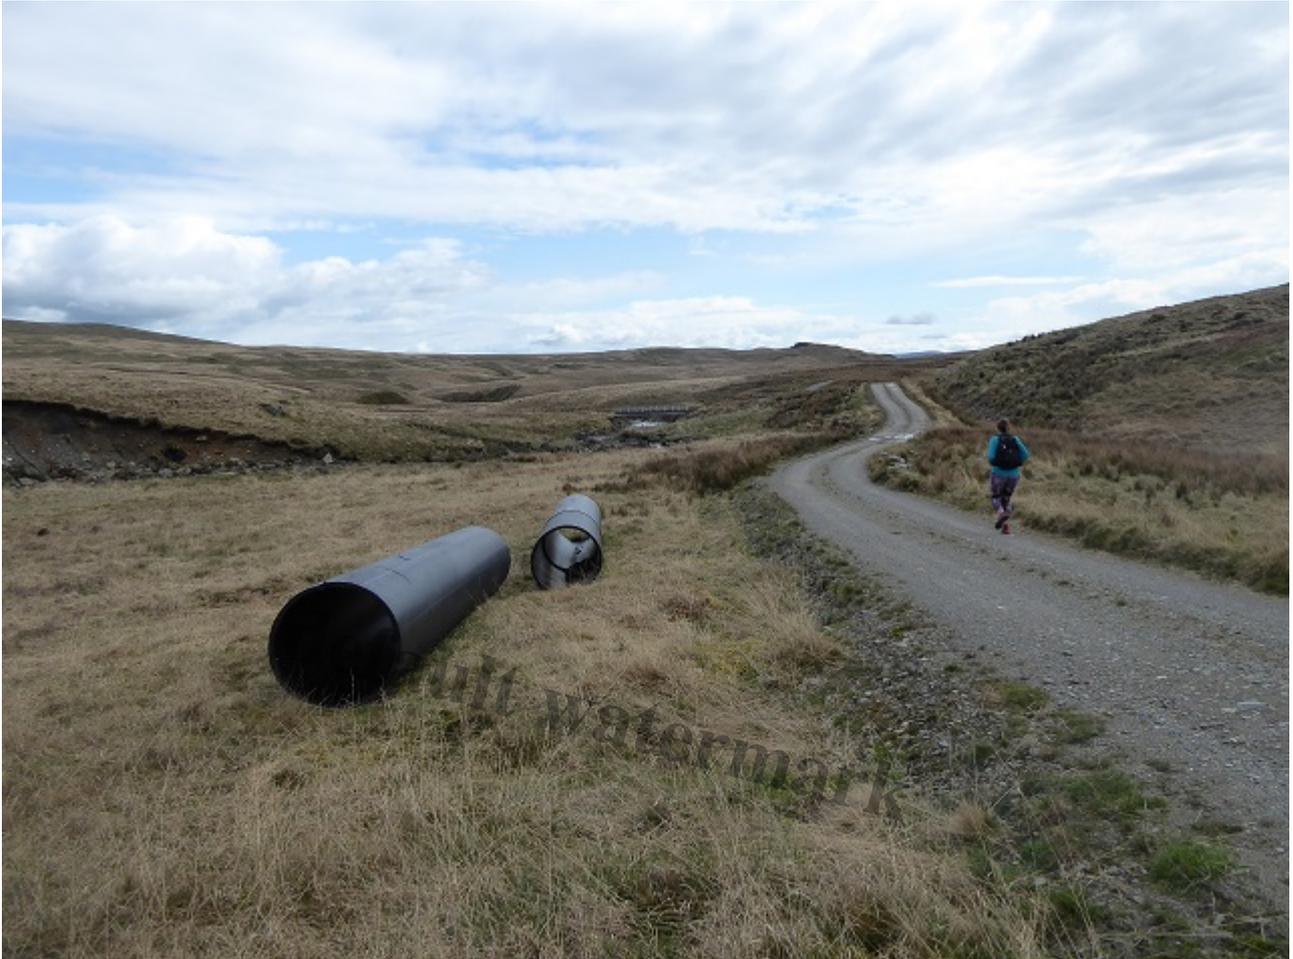
More of the same!

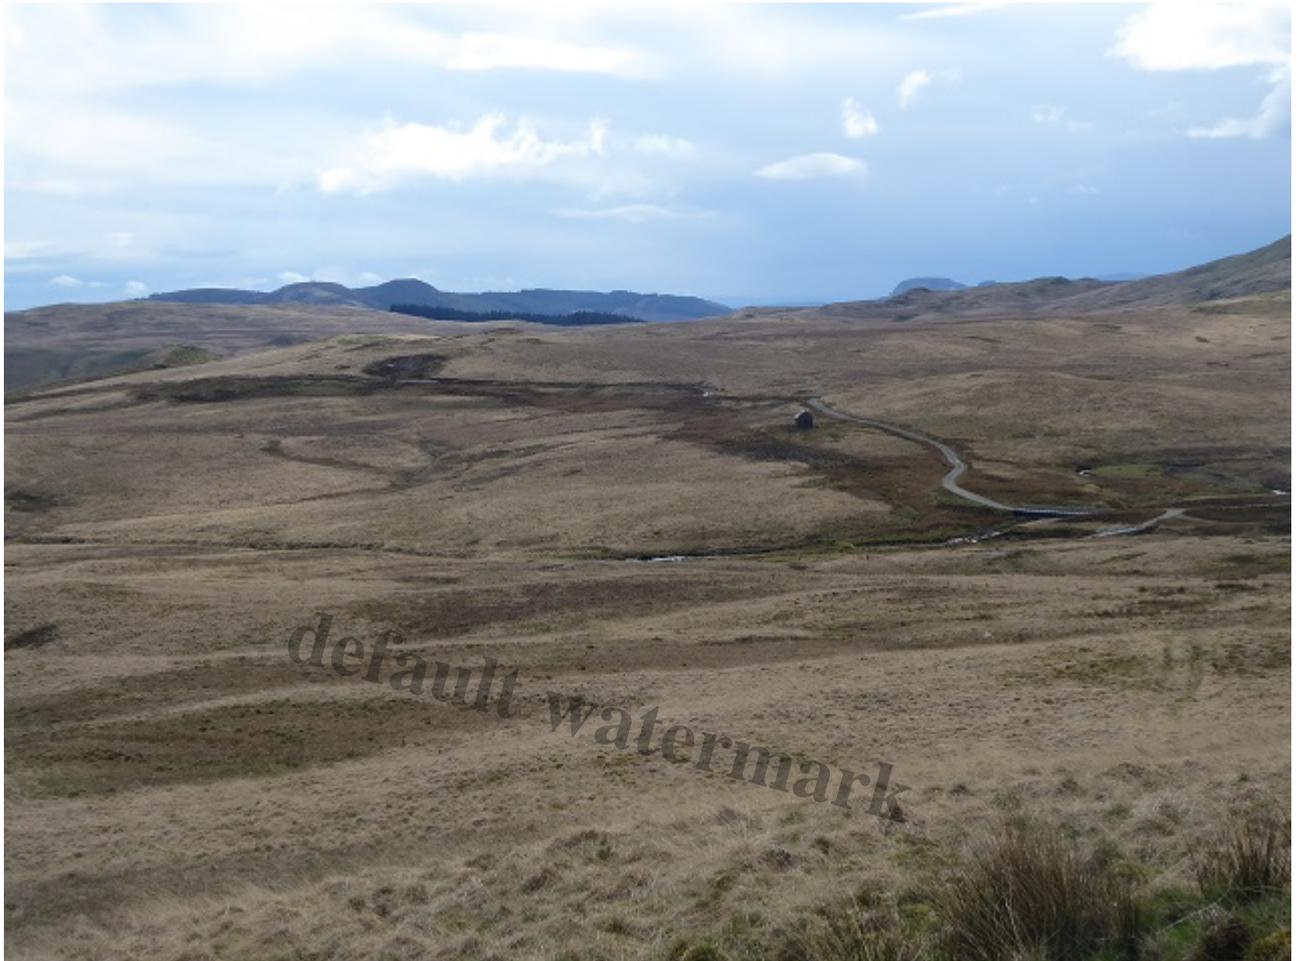
View across to middle section of Keltie Water hydro pipeline, picked out by the broad swathe of rush. Note the dark almost circular area above the pipeline, the borrow pit used for the track upgrade. This has not been properly restored and is likely to form a permanent blot on the landscape. The building right of centre is associated with the reservoir when it provided drinking water to the people of Callander

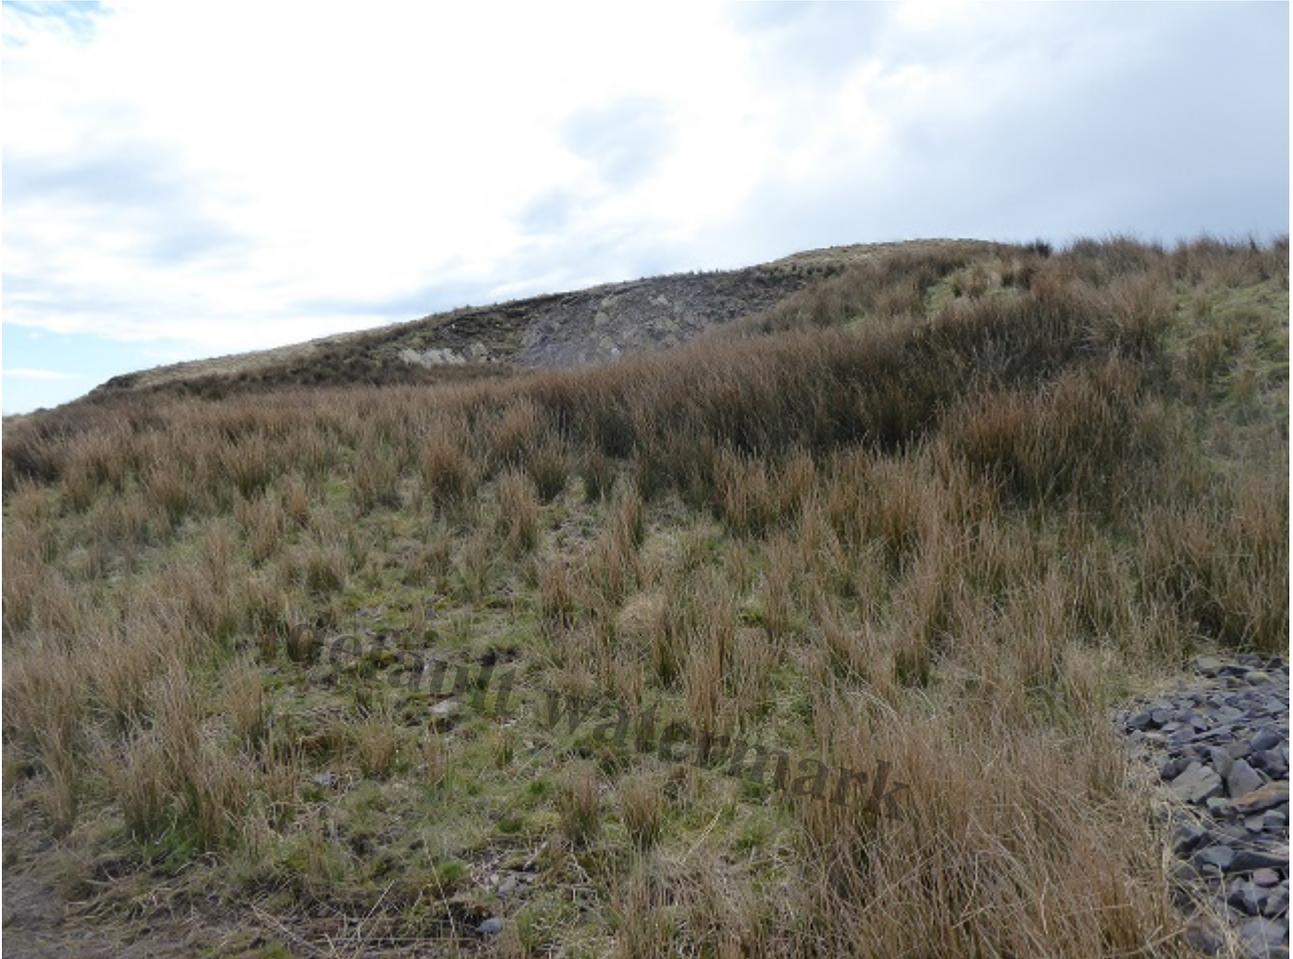
View of borrow pit from track. There has been little attempt to mould its shape back into the landscape and no attempt to restore the back wall, which is too steep for vegetation to colonise. Hence its likely to be visible for years to come

This is a National Park which is failing in its basic statutory purposes. Its well past time that the LLTNPA Board commissioned an independent review into how well the Planning System has protected the landscape and ecology of the National Park, particularly in relation to the hydro scheme developments that have been approved in the last ten years. If they fail to do so, the Scottish Government should step in and arrange this.
