Floods, flood prevention and our National Parks

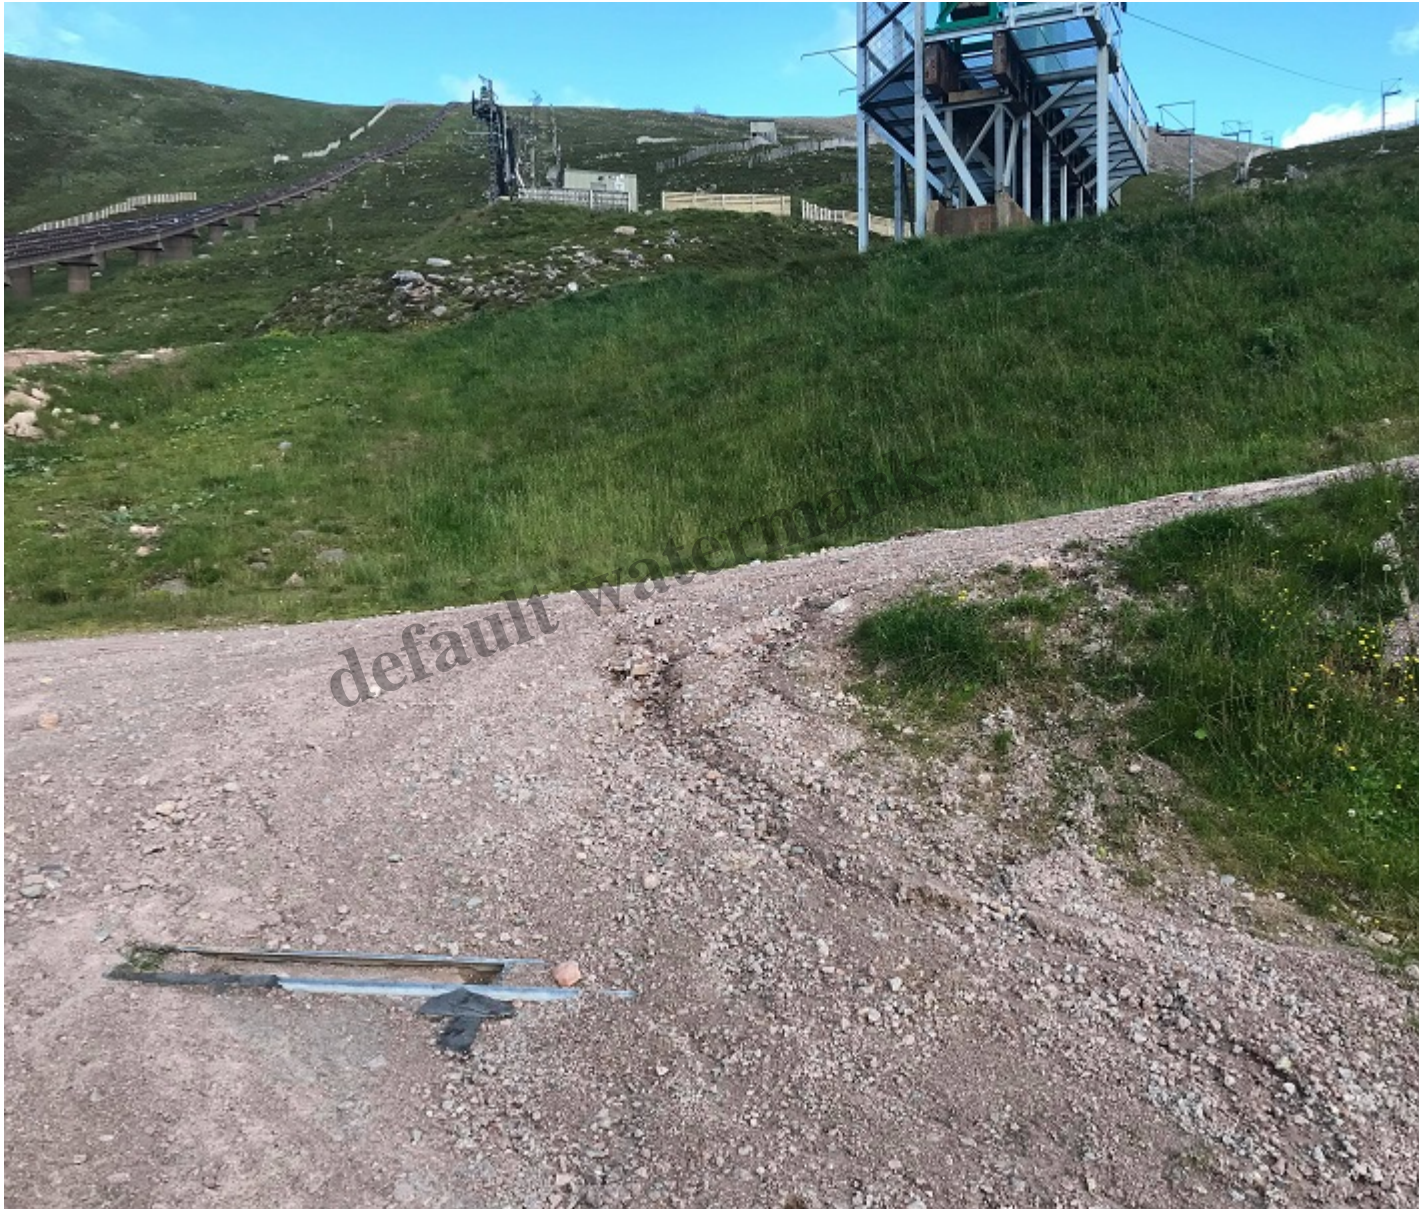
Erosion of Shieling Track at Cairngorm taken BEFORE the recent heavy rainfall. Note how material washed down by the water has spilled onto the vegetation, widening the track, the erosion channel at the corner has filled in. This and other tracks appear at high risk of washing away completely in future downpours, Photo courtesy of Alan Bratney.

Last week, Alan Bratney sent me some telling photos of the Shielling track at Cairn Gorm which had been taken before the recent rainstorms. The track, another brainchild of Highlands and Islands

Enterprise, was granted retrospective planning permission in January 2017 (a further post will appear on this in due course). At the time, parkswatch and a number of NGOs argued the track was inappropriate, breached Scottish Natural Heritage guidelines for upland track construction (it was too steep and would erode away [\(see here\)](#)). Alan's photos, which show how material is being washed down the mountain, suggest the critics were right – and that is before the impact of the recent rainfall.

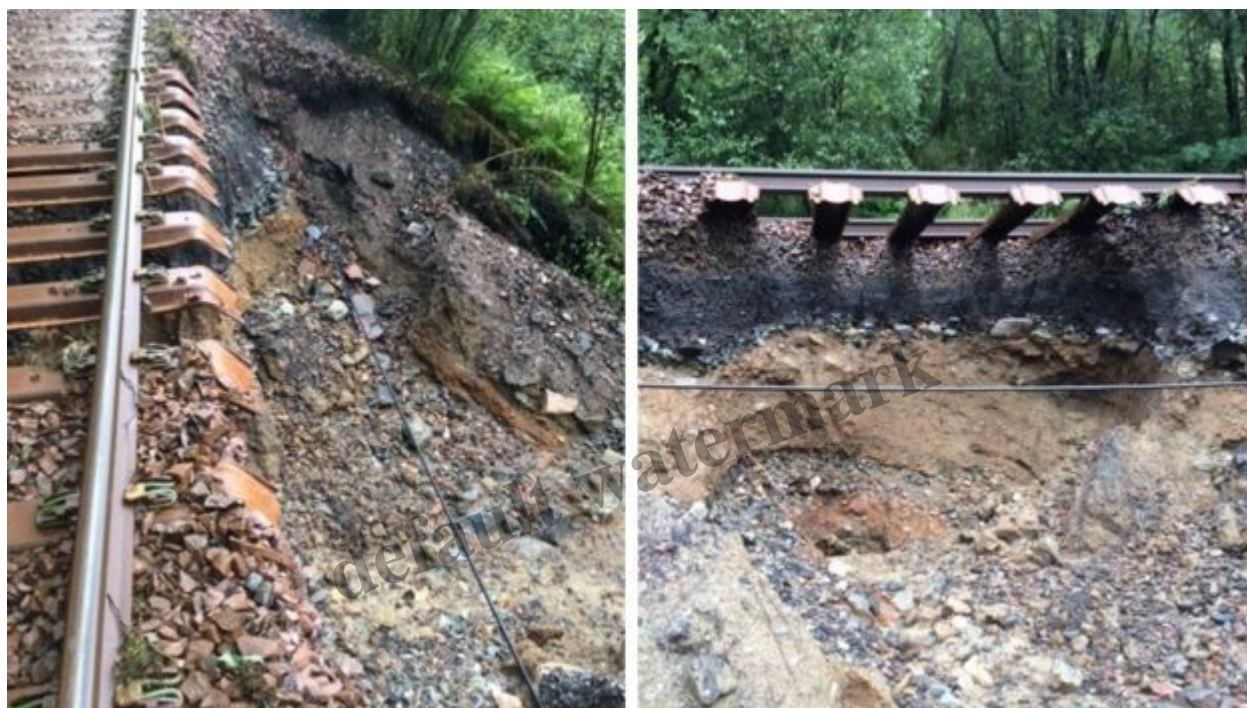
Photo credits Network Rail

I have not visited any of the sites affected by the flooding and am unable to tell from either the photos or the media reports why the flood damage might have occurred. For example, the section of rail track north of Crianlarich that has been washed away does not appear to have located in a cutting. It appears unlikely that the flooding or damage on this stretch of the West Highland Land was caused by water flowing **ALONG** the railway – like in the Glasgow railway tunnel. Its difficult to ascertain from the photos, however, whether the water came down the vegetated slope above or whether the amount of rainfall falling on the steep sided track was sufficient to cause it collapse.

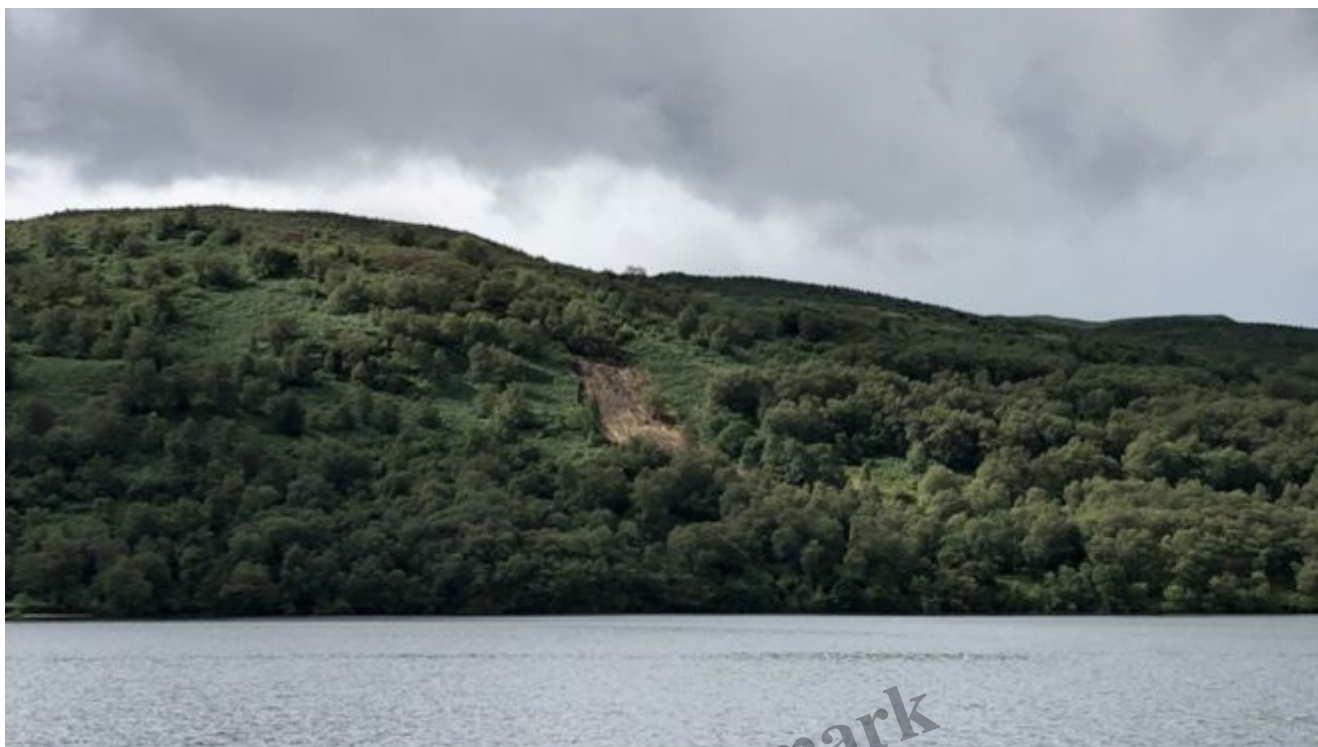
Landslide above Loch Katrine, photo credit BBC Tayside

That doesn't mean that policy recommendations to use trees to reduce flood risk are wrong, just that however the land is managed, some landslides and local catastrophic flood events will continue. Such damaging events may of course become more common if catastrophic weather events increase alongside global warming.

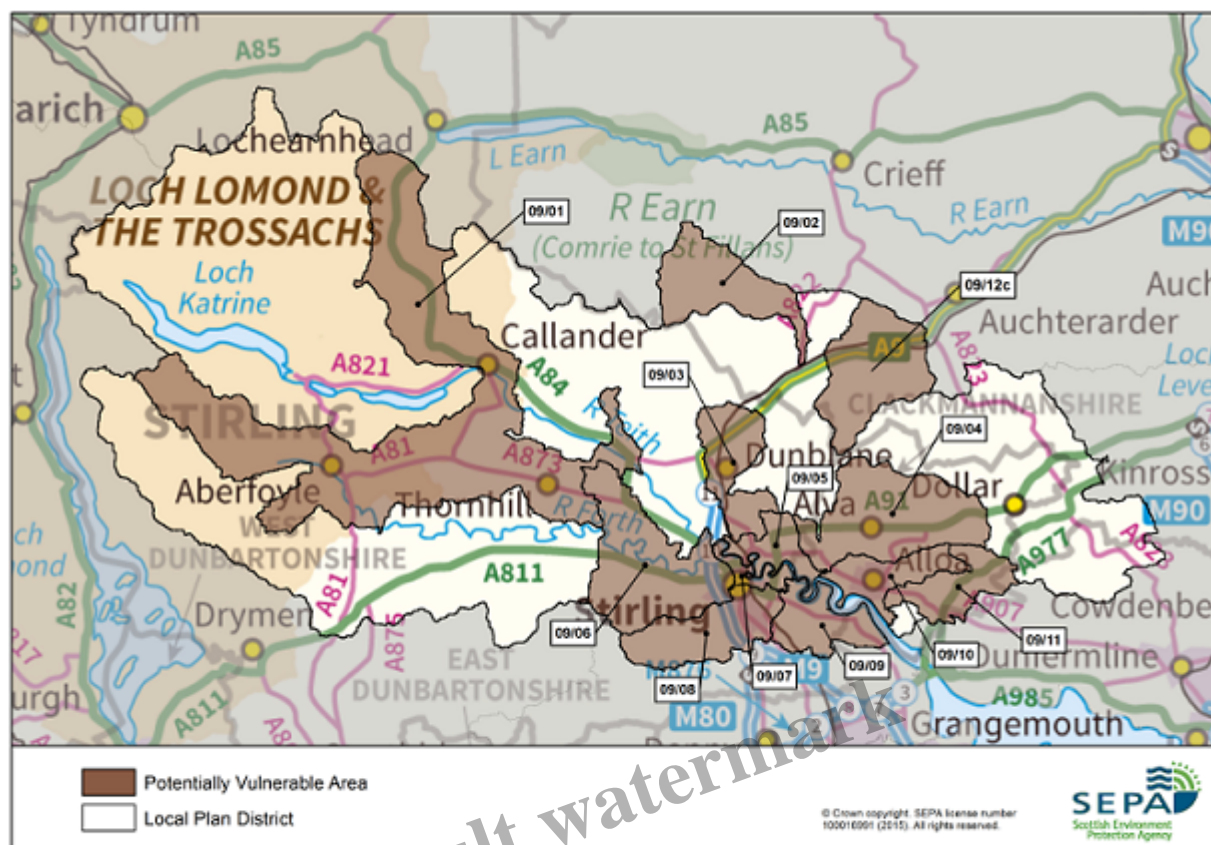
Extract from SEPA's flood risk management strategy for the River Forth catchment

In the last week there have been two major landslips caused by flood events around Loch Katrine yet, as you can see from the map above, this has not been identified by the Scottish Environment Protection Agency (or their partners in the National Park) under the current framework as an area vulnerable to flooding. The term “Potentially Vulnerable Area” is highly misleading because its used to denote areas where flooding could be “nationally significant” rather than where it is likely to occur. The problem with this approach is that almost all the actions taken by public authorities to reduce flood risk are focussed around the vulnerable areas themselves rather than in the wider water catchments. While the water which flows off the Loch Katrine catchment, besides feeding Glasgow’s water supply, contributes to flooding downstream I can find no actions in the Strategy to address rates of water run-off there. The two events at Loch Katrine suggest this is an issue which needs examining and addressed.

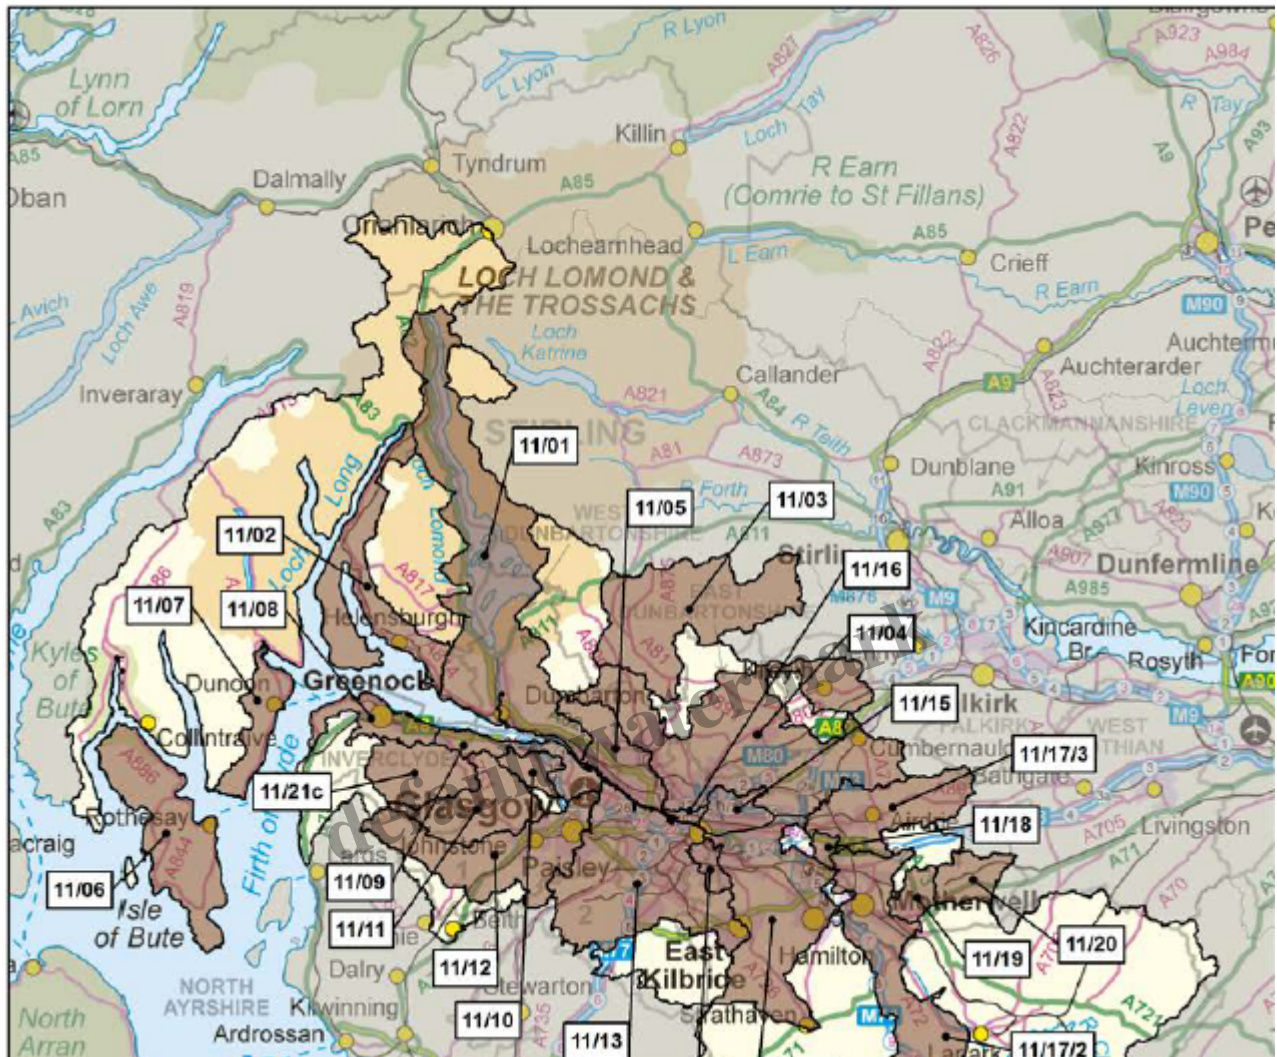
Ardlui is at the edge of the topmost dark brown area, Glen Falloch flows the A82 in the tan area beyond.

While Ardlui at the head of Loch Lomond is just included in the Lomond and Clyde Flood Prevention Strategy as a Potentially Vulnerable Area, Glen Falloch beyond is not. Under this plan the Loch Lomond and Trossachs National Park Authority was assigned the lead agency for a Natural Flood Management Study. I would have expected that to cover matters like how far overgrazing by sheep, industrial forestry and indeed the creation of run of river hydro schemes was contributing to flooding and the vulnerable areas at the southern end of Loch Lomond, including Balloch.

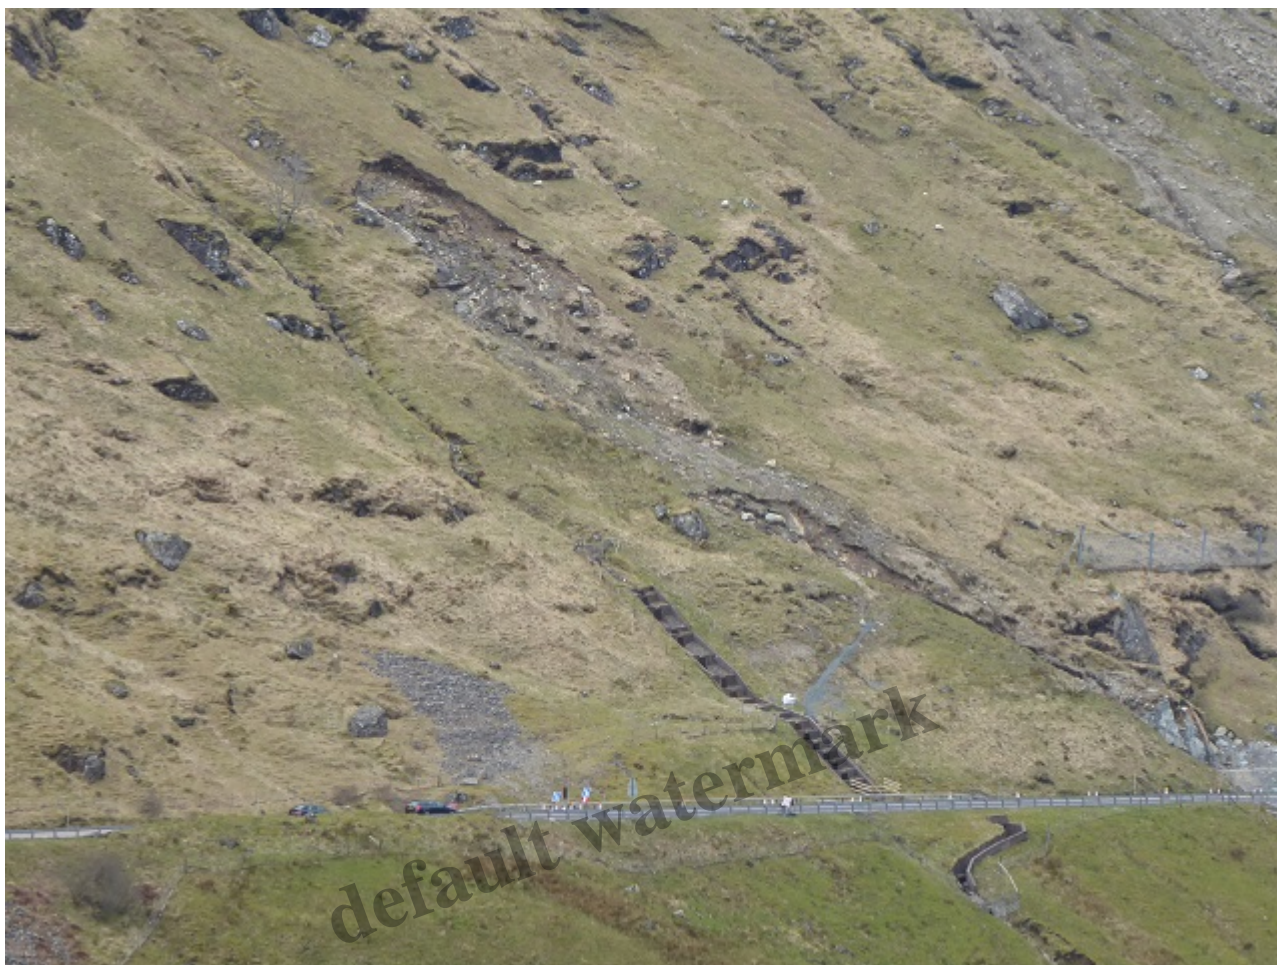
Sheep grazing the ground around the landslips above the Rest and Be Thankful April 2019. This can only increase the rate of water run-off and the likelihood of further landslips. It will be interesting to see whether and for how long the expensive wire netting will be able to hold back material and I am half expecting this week to hear the A83 will be blocked again. If not this week, some other storm event in the foreseeable future.

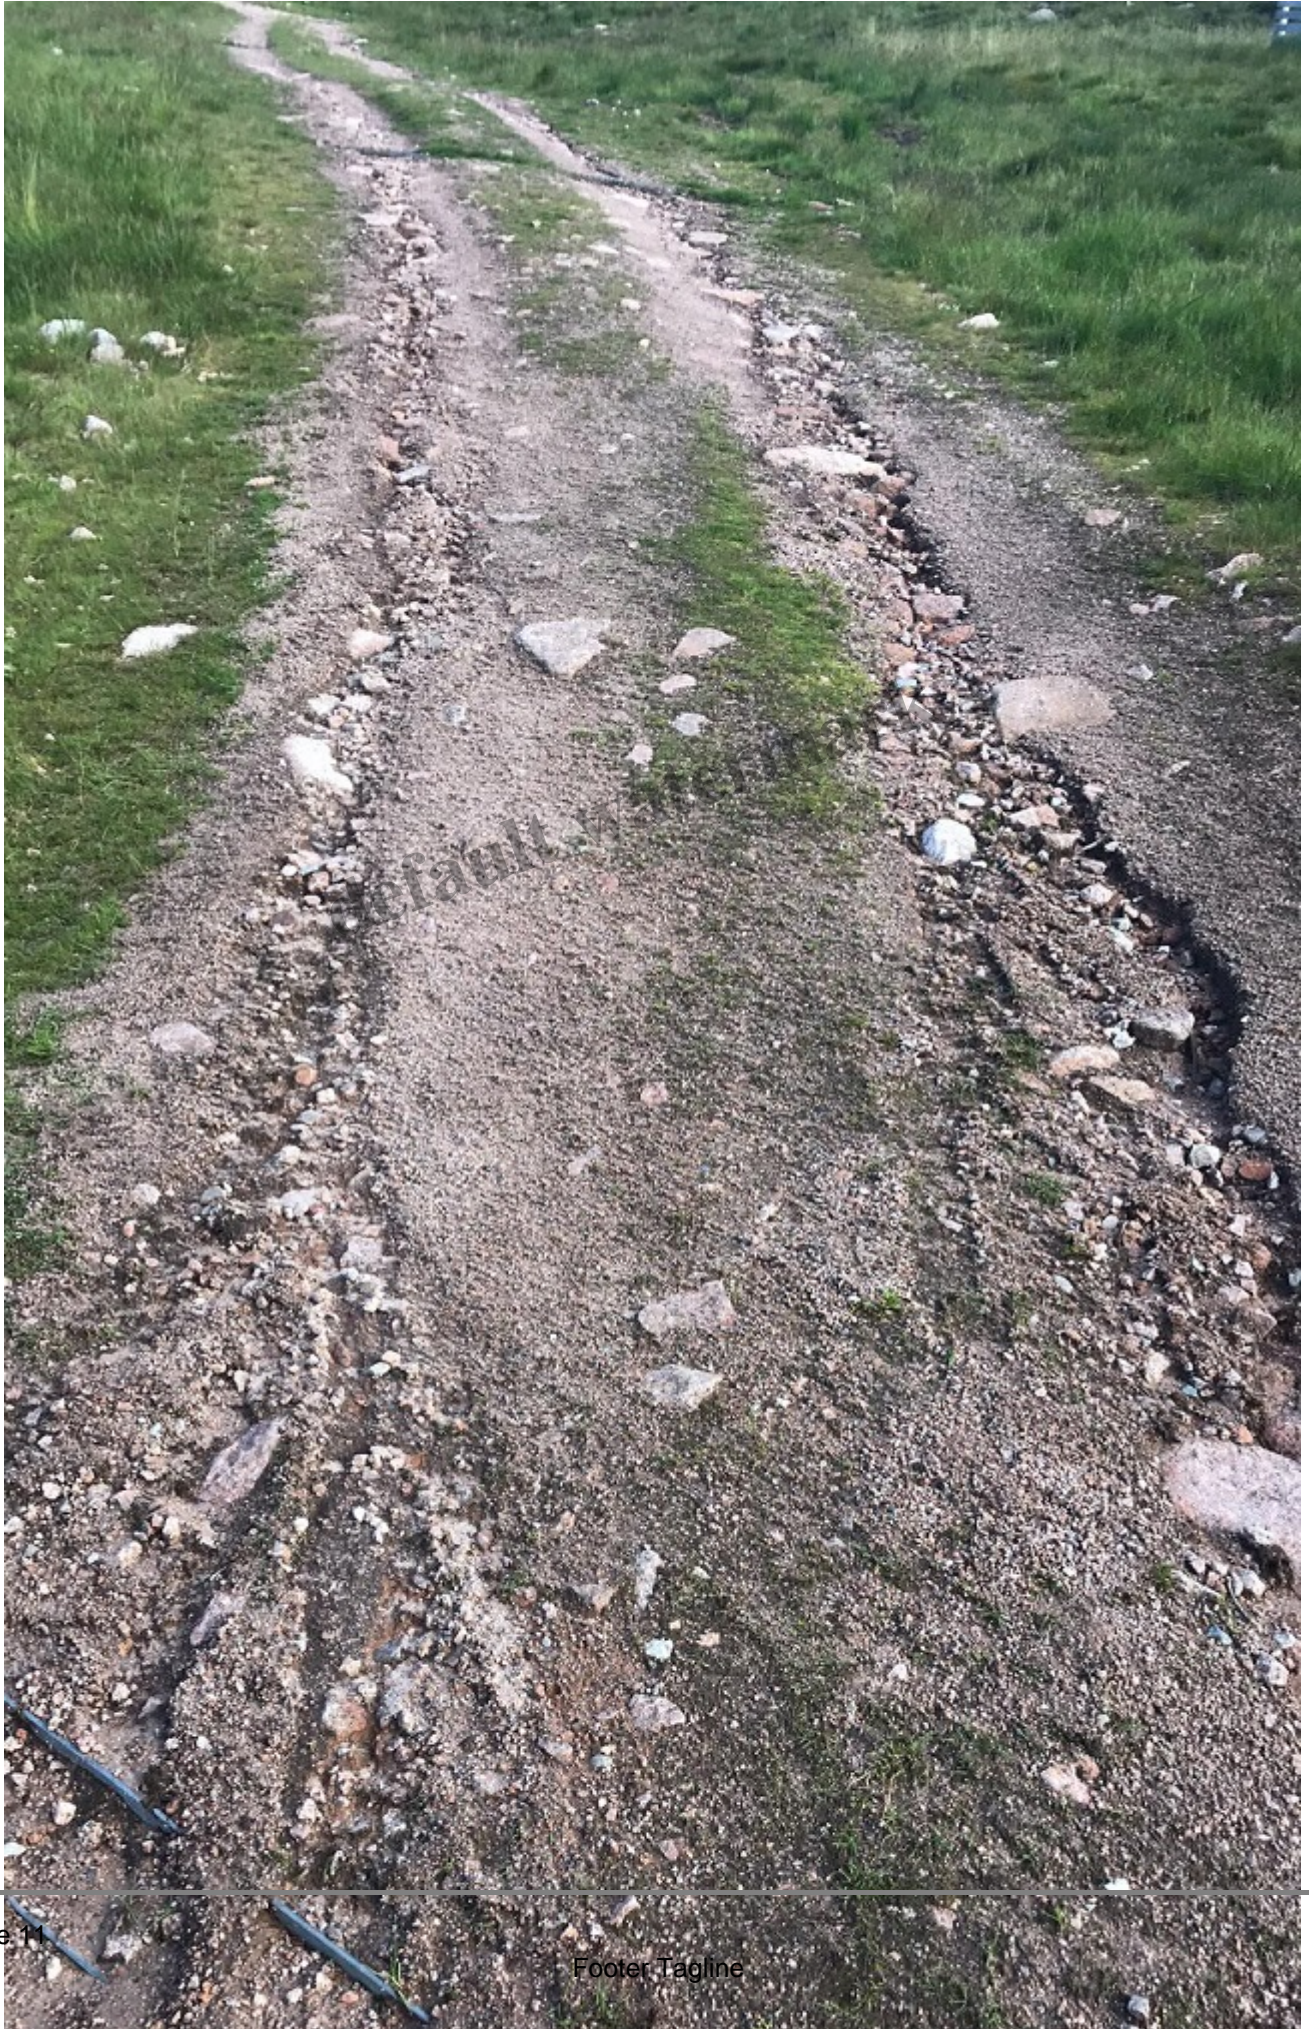
Attempts to create a central vegetated strip may have reduced but have not stopped the erosion of the shieling track. Photo courtesy of Alan Bratney.

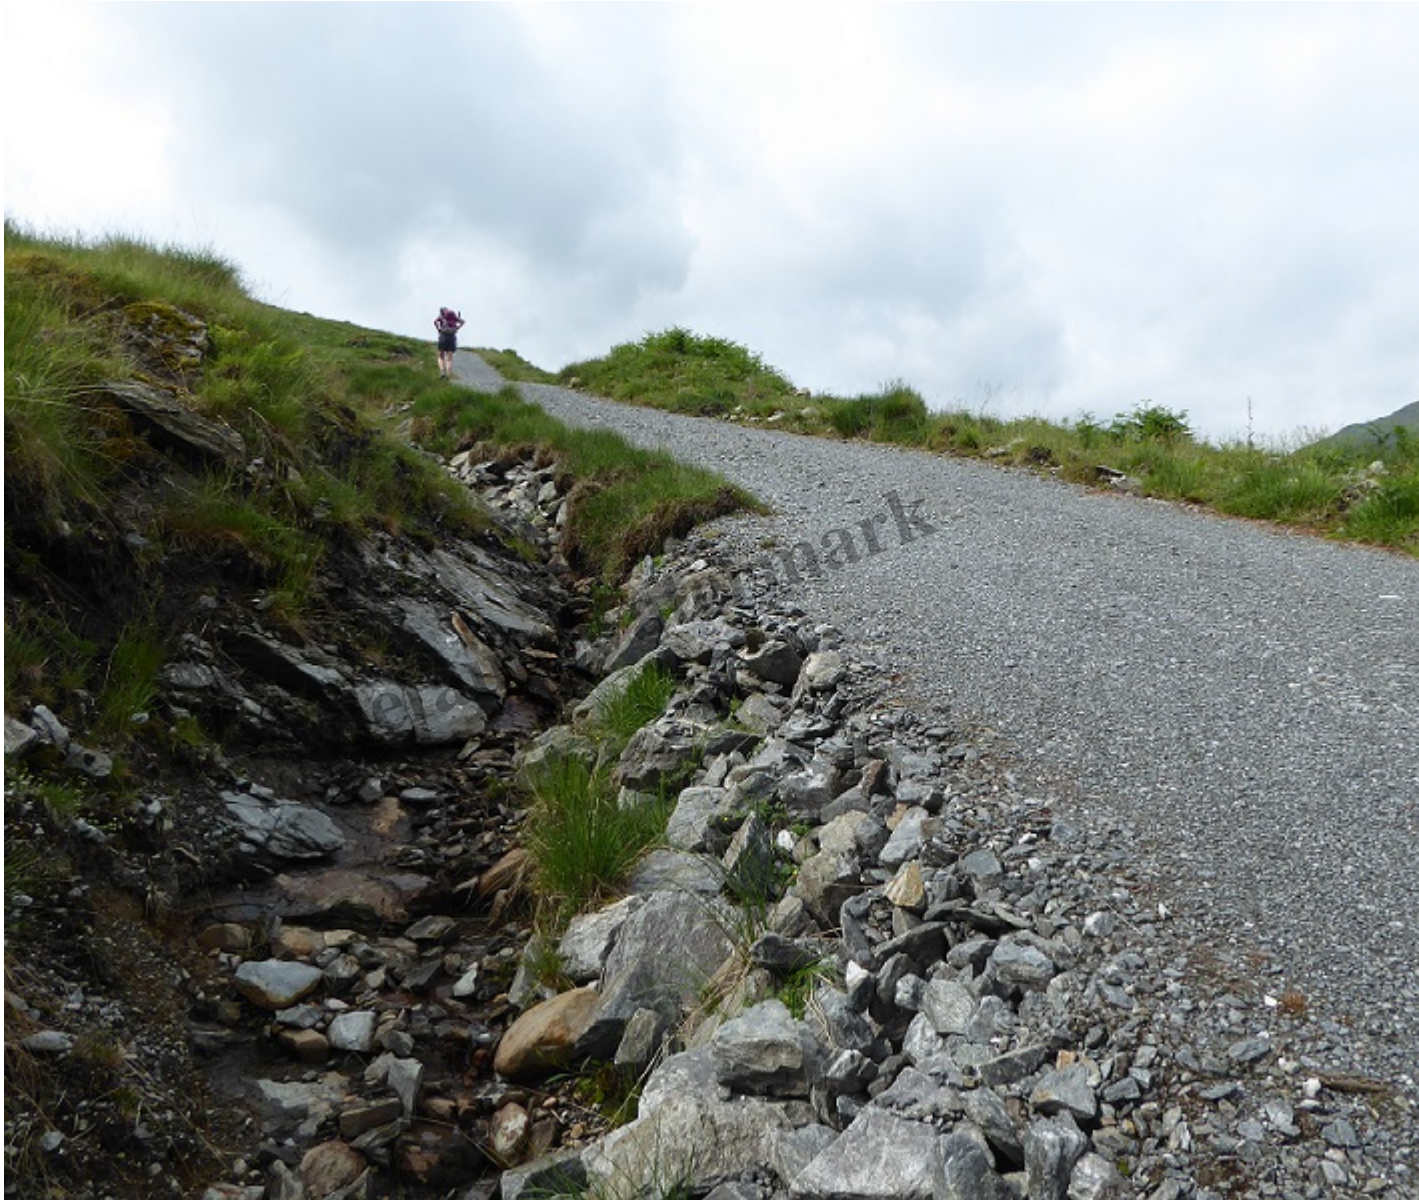
The newly engineered track to the Ben Glas hydro not far from Ardlui where a section of railway line has been damaged by flooding.

Many of these tracks breach SNH's guidelines on upland track construction, being far too steep and having unrestored edges both of which make them prone to erosion. The width of the tracks promotes further water run-off, adding to the flooding below, while the failure to insist on central vegetated strips has simply promoted further run-off. Whatever you think of these tracks on landscape grounds, in terms of natural flood prevention they are a disaster. This is something the Scottish Government should be requiring our National Parks to address.

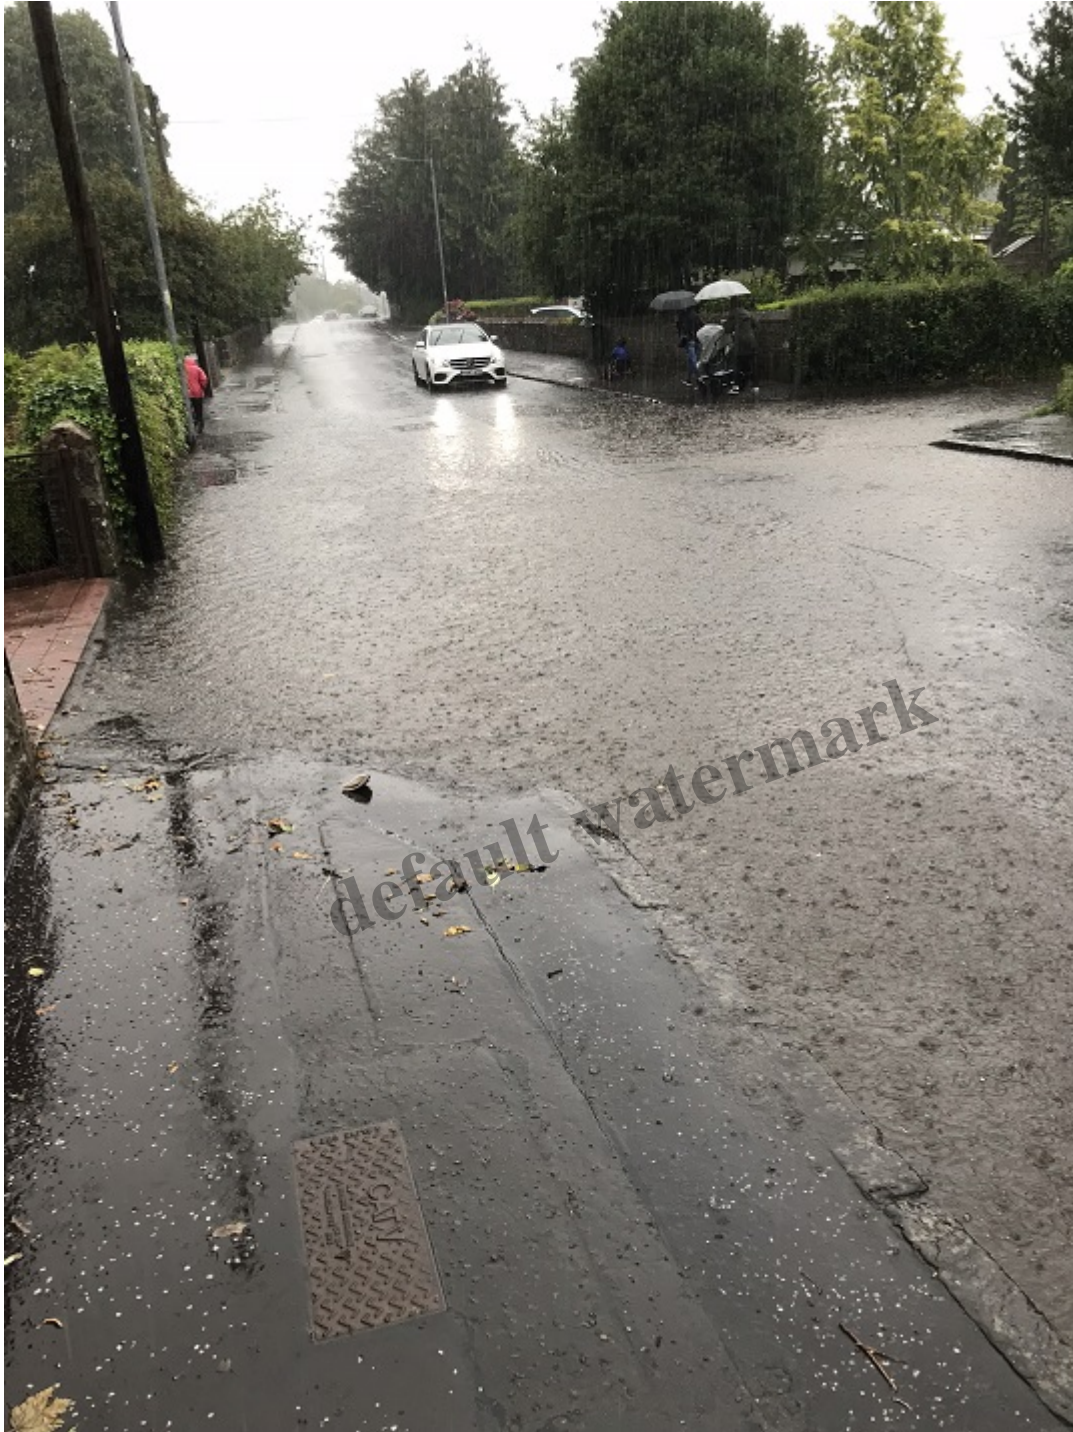
Photo of flash flood, lower Stoney-mollan Rd, Balloch yesterday evening
sent in by a reader

As chance would have it, a reader from Balloch sent me this photo of flooding there yesterday evening which provides an illustration of the issues mentioned in the comment below from D.Sutton that sustainable urban drainage is a joke. How much worse will this flooding become if Flamingo Land are allowed to build housing on the land above around Woodbank House? Should any developments be allowed above land which already floods?
