The Planning Application to repair the funicular (2)

The planning application consists of a number of documents. This post looks at three of them, the Site Location Plan, the Planning Statement and the Application Supporting Information

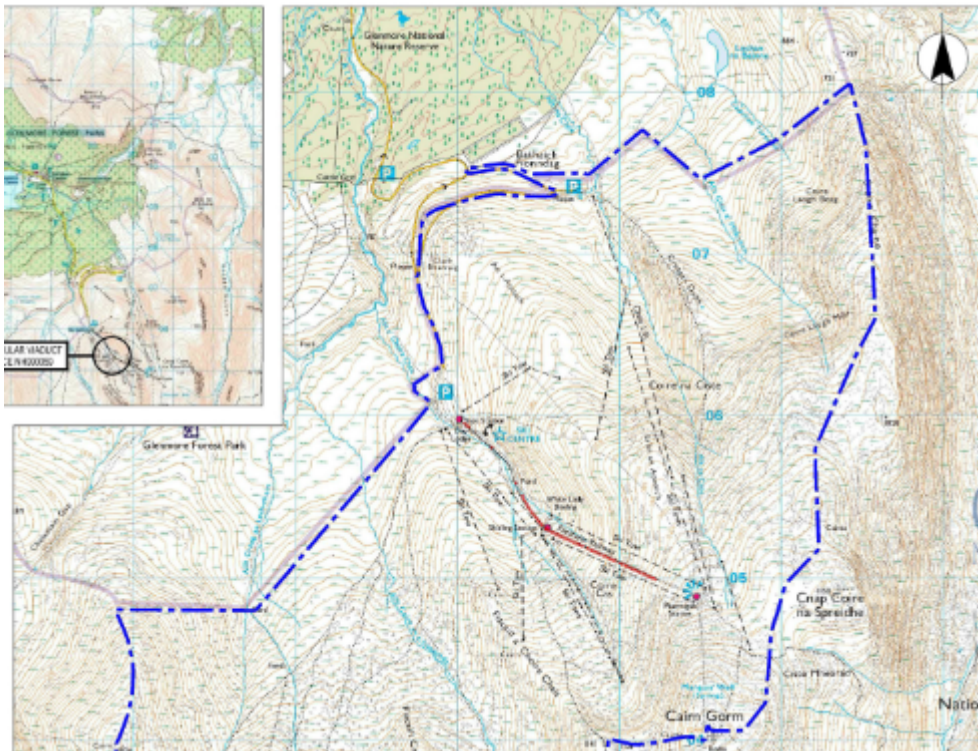
Cropped map courtesy of CNPA Planning Portal showing lifts in Coire na Ciste and the development area in red. This is not actually

a line but a series of blocks around each pier (see below)

As the name implies this document shows the area of Cairn Gorm under the control of HIE, the blue line is its border, which you would expect to be an up-to-date overall view of the area including skiing infrastructure. Yet it shows tows and lifts that no longer exist! It gives the impression that there is a lot more uplift than is actually available.

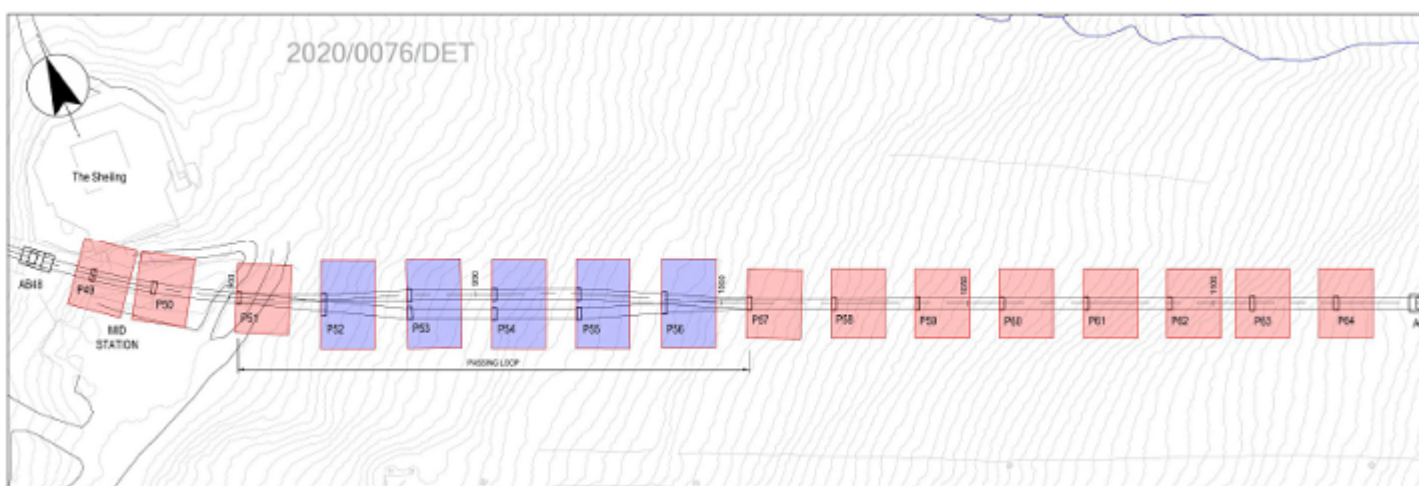
Extract from site boundary, mid station on left. The pink and blue demarcate the area included in the planning application.

Instead of showing the entire working area, with access tracks etc, HIE have only included in the application the areas around the piers supporting the funicular.

- 2.4. The application site boundary extends to 0.98 hectares. The application boundary is shown in the submitted Location Plan and the submitted Longitudinal Section Sheets 1 – 6 drawings (dwg no. A132354/C/A132354/CFV/PLN/DWG/906).
- 2.5. The application site boundary is not a single, contiguous area. It consists of several rectangular areas, located at the base of 5 anchor blocks and 60 piers.

Even so, HIE have misrepresented the size of the area. I have counted and the plans show 55 piers, and 2 anchor blocks (AB14 & AB29), marked in pink, total 57, and, 5 piers which are part of the passing loop marked in blue (see above). That is a total of 62 rectangular areas, 60 piers and 2 anchor blocks. Yet Para.2.5 states that there are 65 rectangular areas, 60 piers and 5 anchor blocks, so apart from the two shown on the plans, AB14 and AB29, what size are the work areas for the other three missing anchor blocks and which ones are they out of AB 0, 48, 65 and 78?

The pink areas are $11\text{m} \times 14\text{m} = 154\text{sq.m}$. Pink areas = 8,778sq.m.

The blue areas are $11\text{m} \times 18\text{m} = 198\text{sq.m}$. Blue areas = 990sq.m.
