Will the repair of the Cairngorm Funicular Railway work (6)?

The history of the funicular from a health a safety perspective

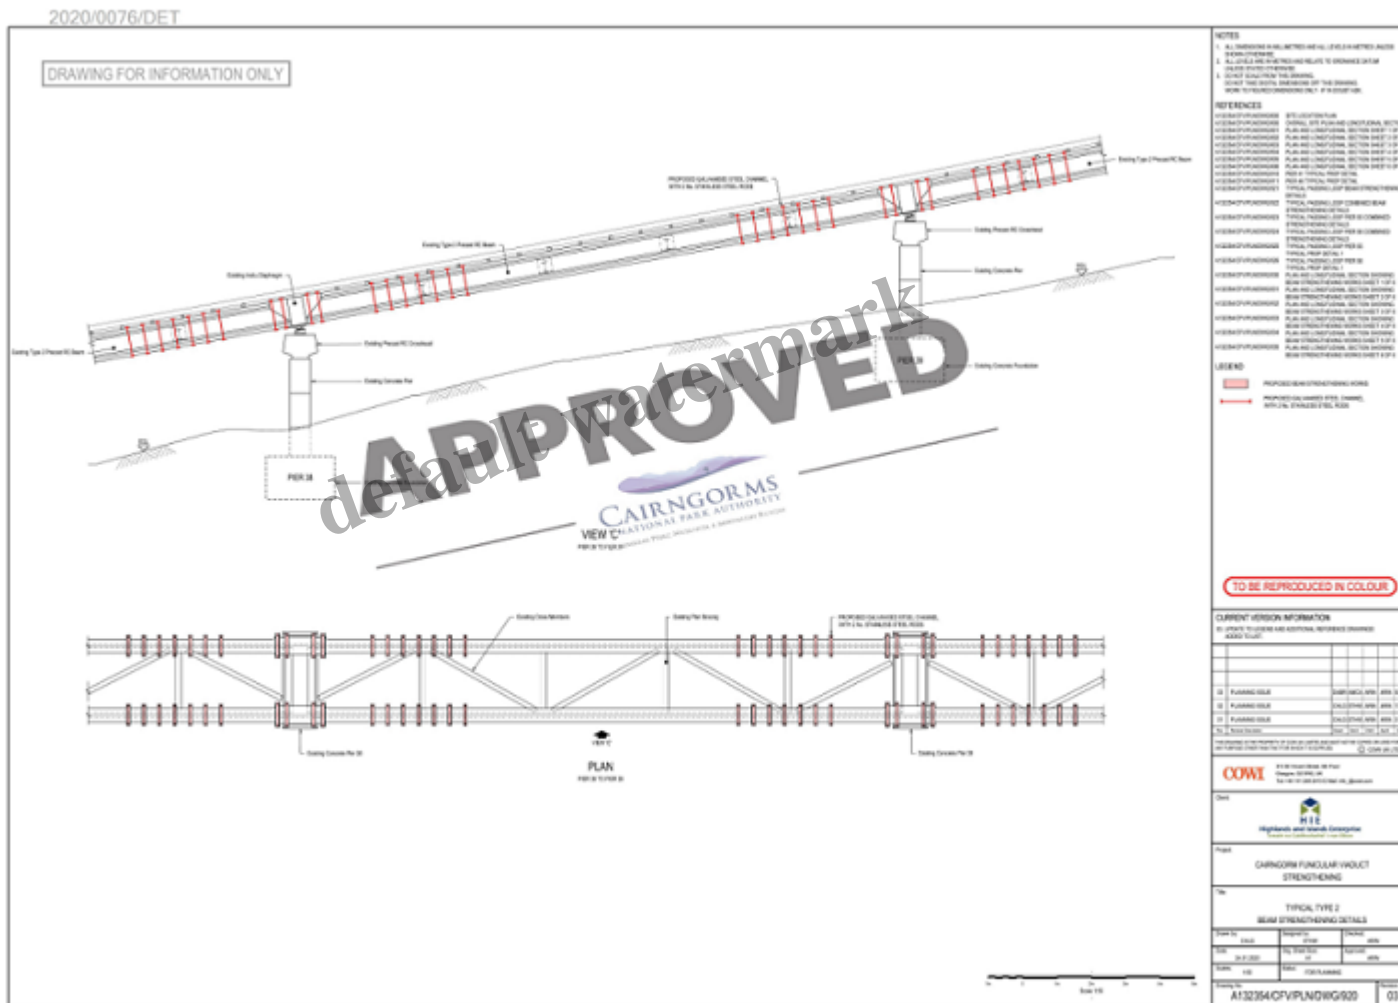
Typical beam strengthening – from the planning application to repair the funicular. The red marks steel reinforcement to the concrete beams

But it is not as simple as that. The planning application is also for STRENGTHENING works to make sure that the viaduct does not collapse or deteriorate any further.

I can find no document setting out how long these strengthening works are expected to last although Charlotte Wright, CEO of HIE, stated in an article in the P&J on Monday,08/02/2021 she expected this to be “for a very long time”! It is possible that information to back up this assertion is held in a file not yet released by HIE

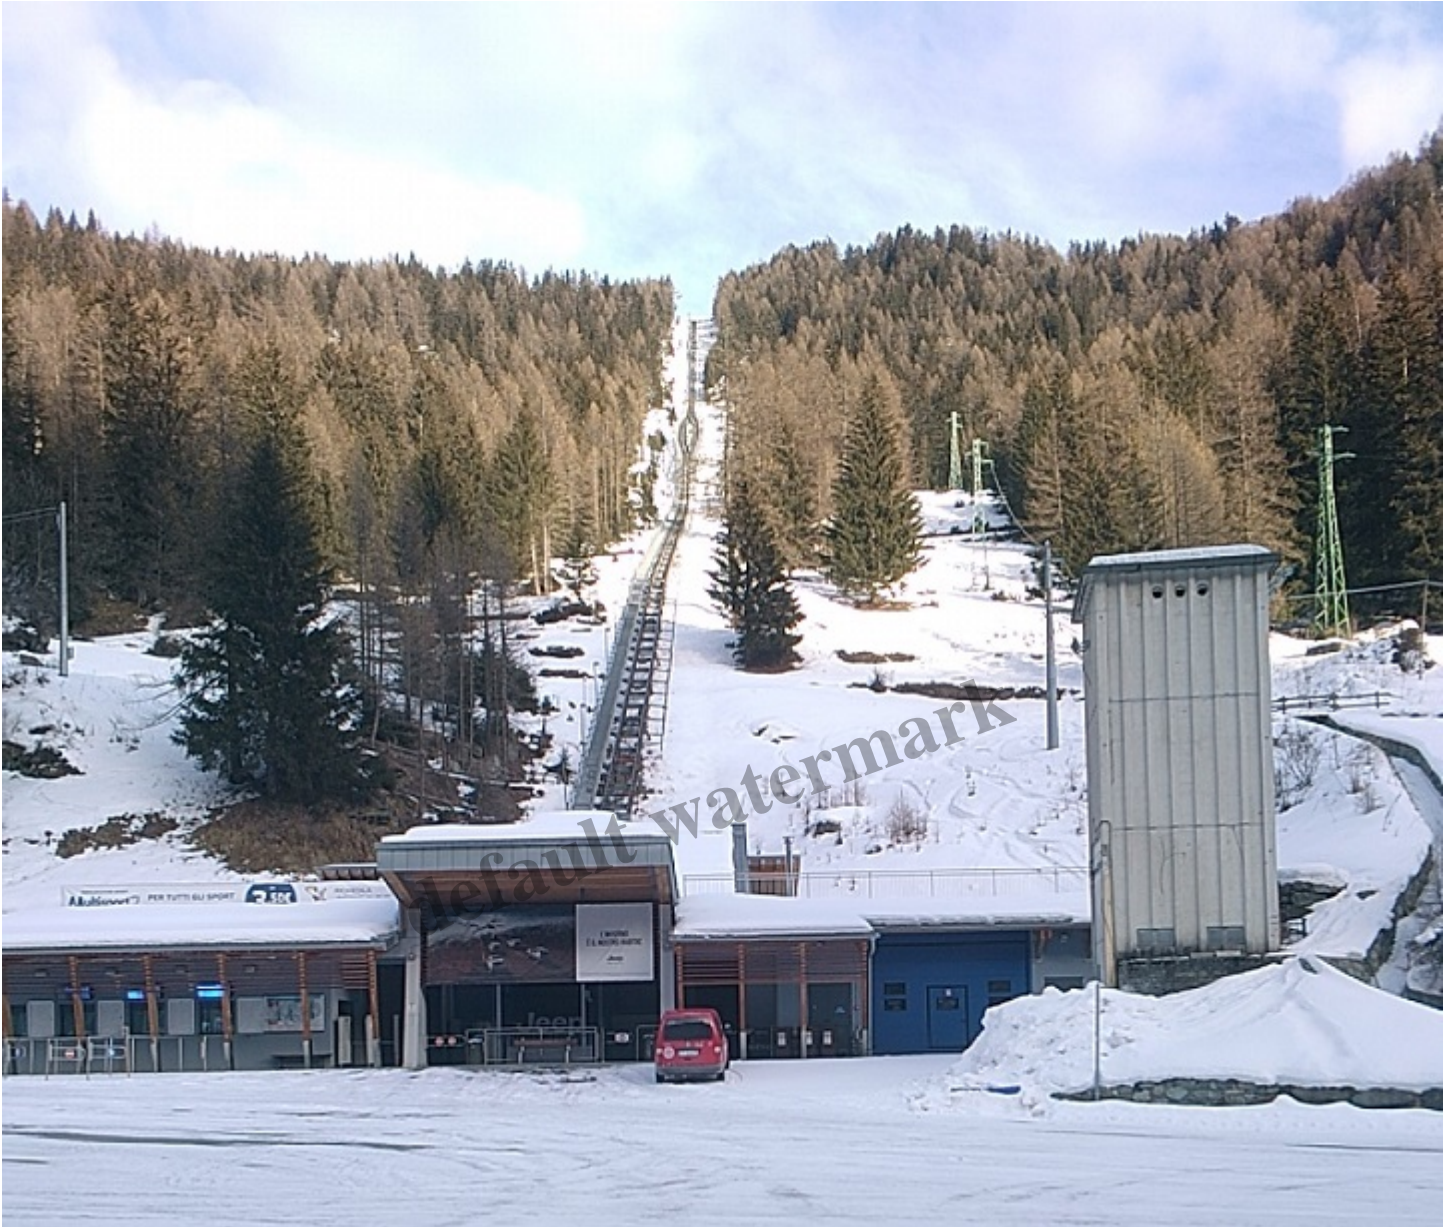
The following picture is of a funicular railway in Frachey, Italy. A video is available [here](#).

The immediate and most noticeable difference between the two is that the Frachey funicular is straight!

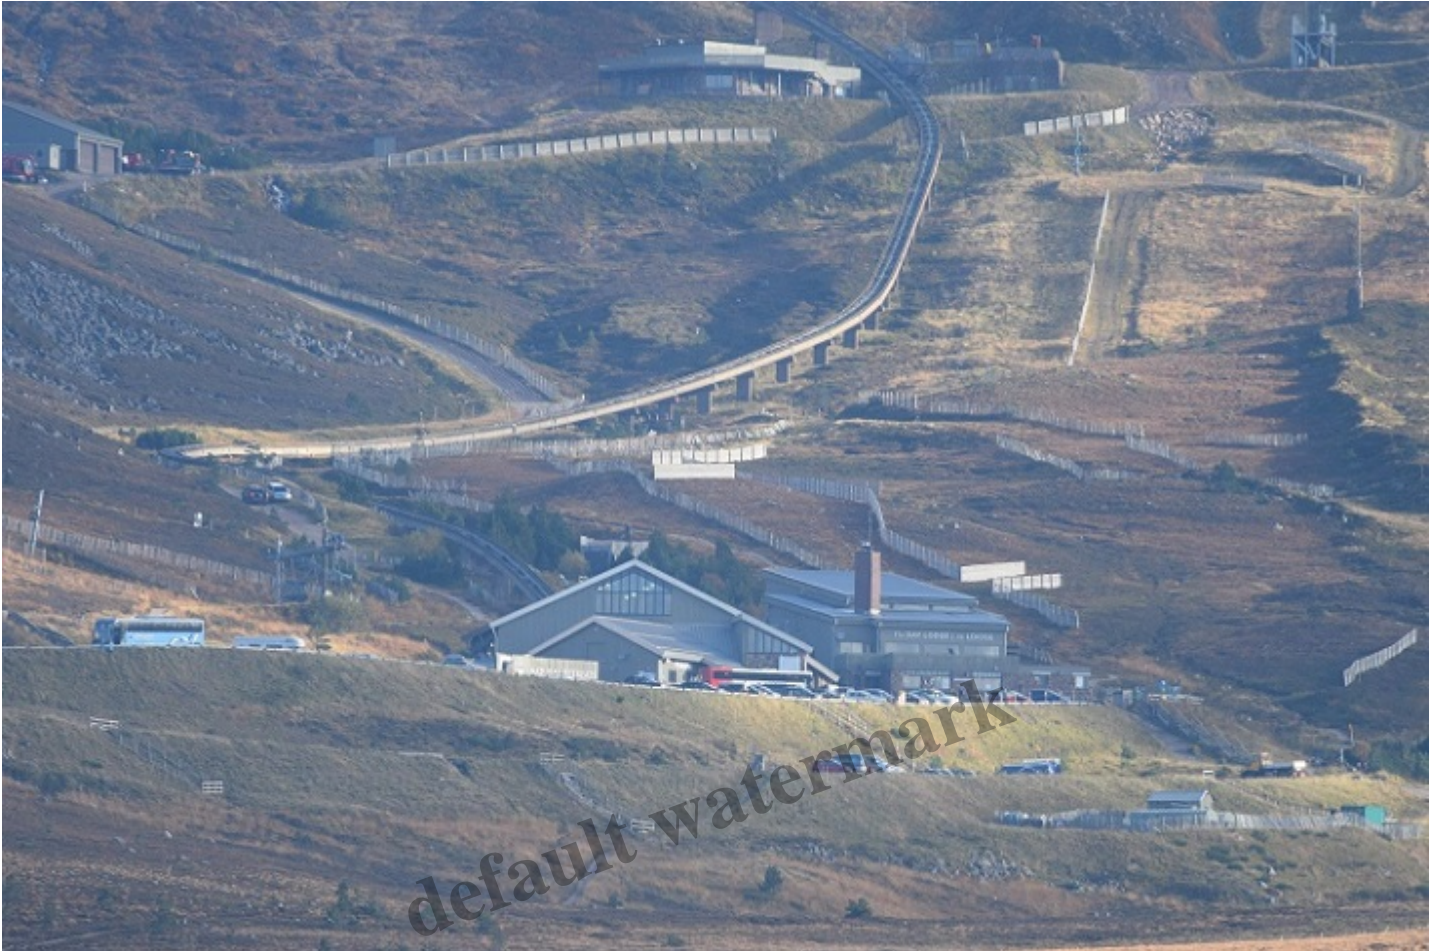
Now compare that with the Cairngorm funicular below.

All the twists and curves in the Cairngorm funicular viaduct put immense stresses on the structure because the forces on the ropes act to straighten out those curves. The COWI report mentions tensions of the rope acting to topple the piers in a transverse direction as well as in line with the track. More evidence that the whole design of the funicular was fundamentally flawed!
