The state of the Cairngorms (2) - restoration of hill tracks

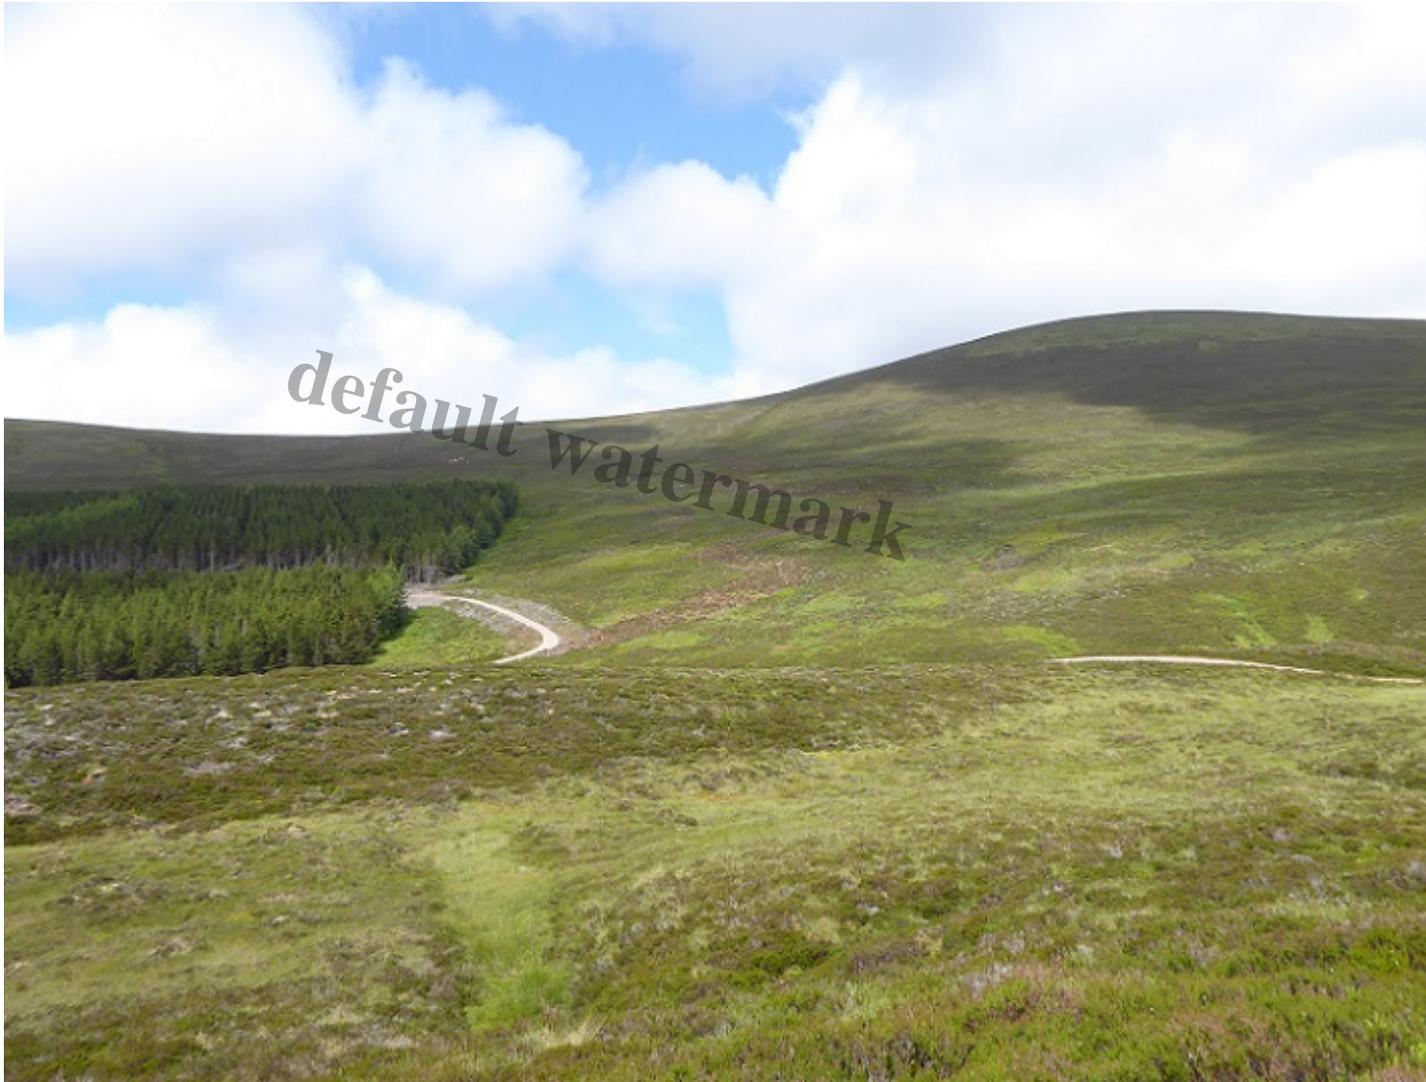
View towards Carn Dearg Mor (right) from south. A digger being used for the restoration work is just visible above the plantation

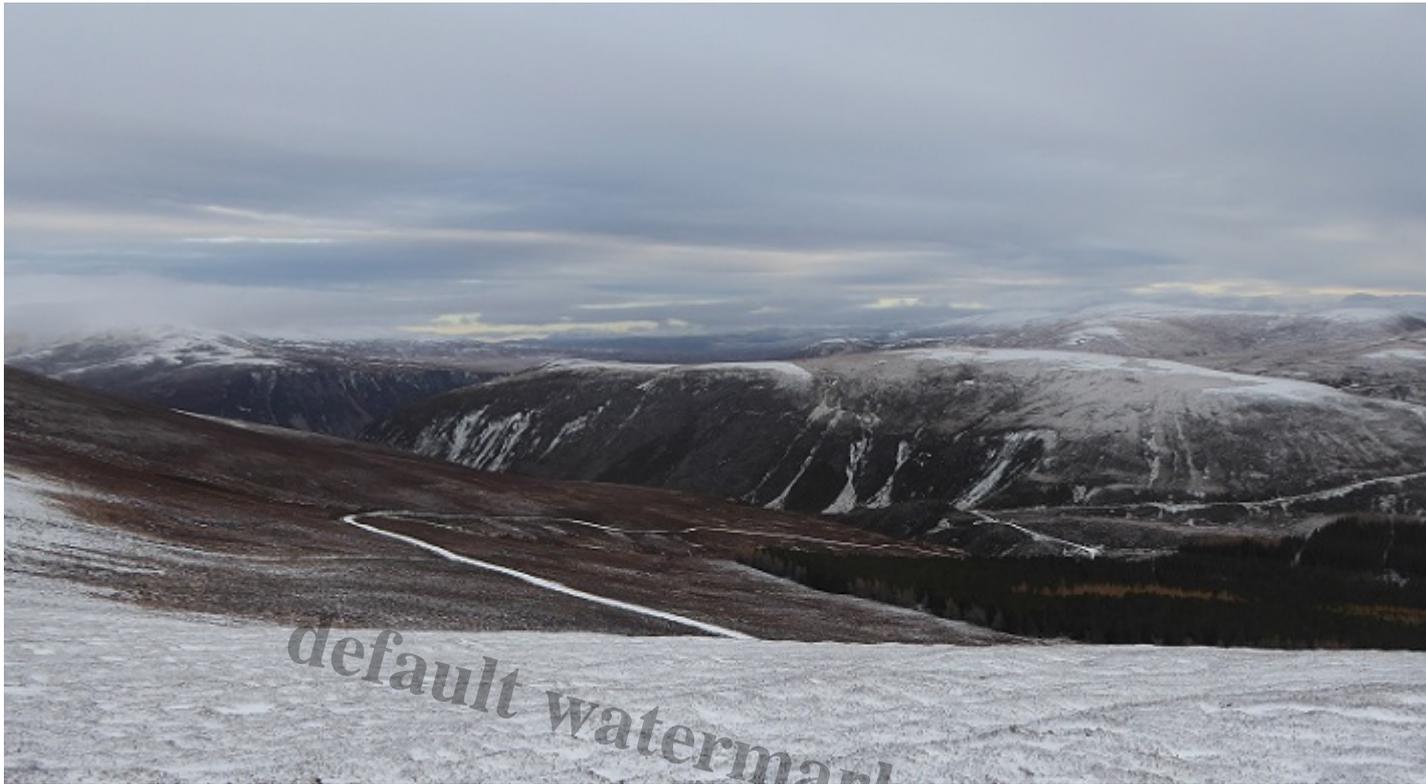
View from above November 2017. The hill road in the foreground has been removed. That on the far side of the col between Glen Feshie and Glen Tromie remains and is currently being used for deer culling and to access peat bog restoration sites

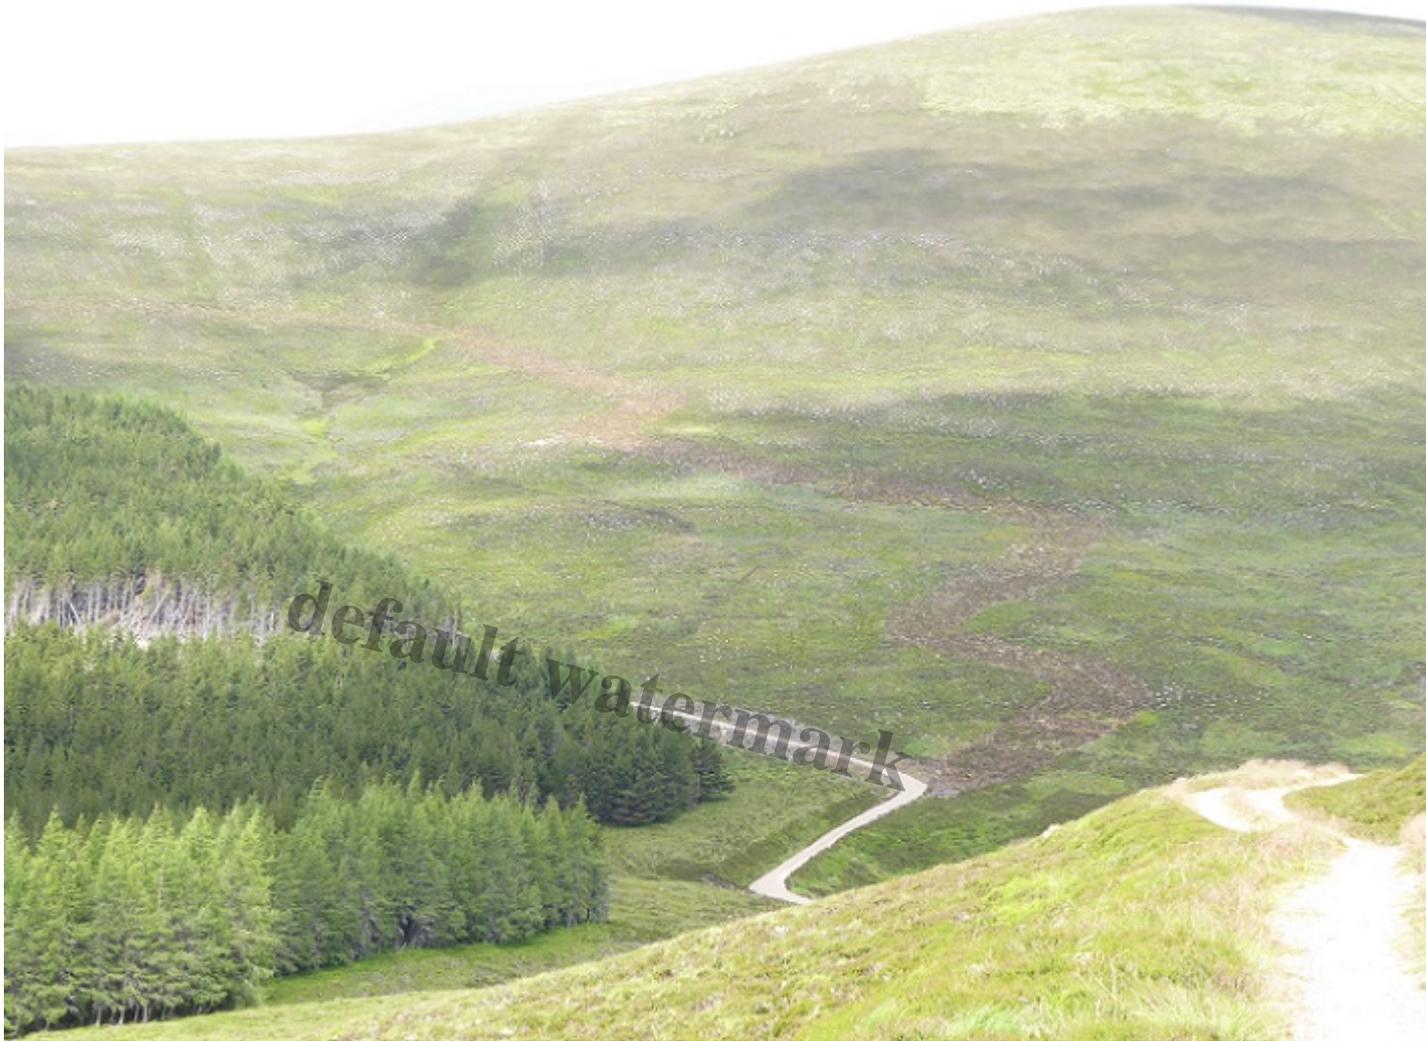
The removal of this track is part of a plan to rationalise and reduce the landscape impact of hill tracks on the Glen Feshie and Glen Tromie estates. While the track to the plantation remains prominent, as woodland develops it should eventually become concealed from view.

Because this was a longstanding road, there was no ‘‘spare’’ vegetation to cover its surface once this had been re-moulded to fit back into the landscape. The pockmarks on the slope show where vegetation has been ‘‘borrowed’’ and used to cover the track. Because the areas of borrowed vegetation are small and well spaced, each should be re-colonised by the plants surrounding them in a year or two despite the short growing season at this altitude (600-700m). That process will have been assisted by the work having been carried out fairly early in the growing season this year.

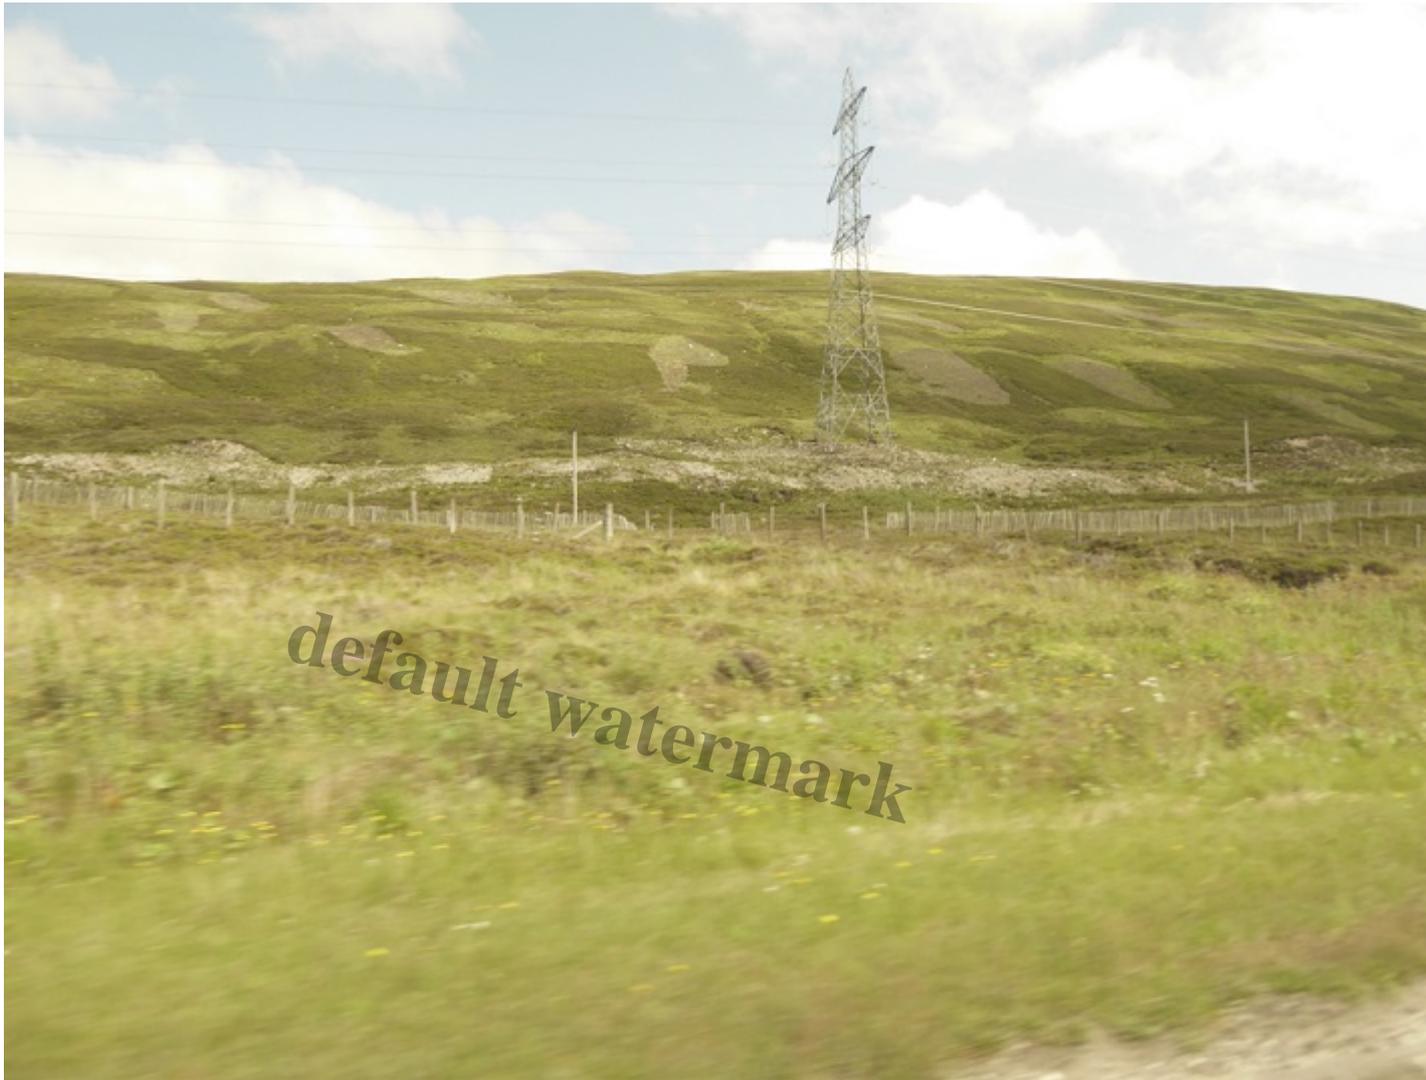
The Beaully Denny restoration should have been far simpler than that on Carn Dearg Mor, as the access roads were supposed to be only temporary and it also lies at a lower altitude. Had vegetation along the line of the access roads been removed carefully and stored properly, it could have simply been replaced once the line of the road had been re-moulded to fit the landscape. The scars should then have disappeared in a year or so. Instead five years later the scar is almost as prominent as it was when the roads were constructed:

View of section of Beauly Denny access track taken from the car 17th July

Had SSE ensured suitably skilled contractors were employed to work on the construction and restoration of the Beauly Denny access roads, none of the landscape scarring at the Drumochter need have occurred. Remedial work could still start tomorrow if the Scottish Government had the political will to hold SSE to account. There is plenty of vegetation on the surrounding ground that could be borrowed to help resurface these roads and there would be even more if the muirburn that is scarring the hillside above was stopped. But first the surface of the access road needs to be re-moulded to fit the contours of the hillside, removing the straight line that currently cuts across it.
