The state of the Cairngorms (2) – restoration of hill tracks

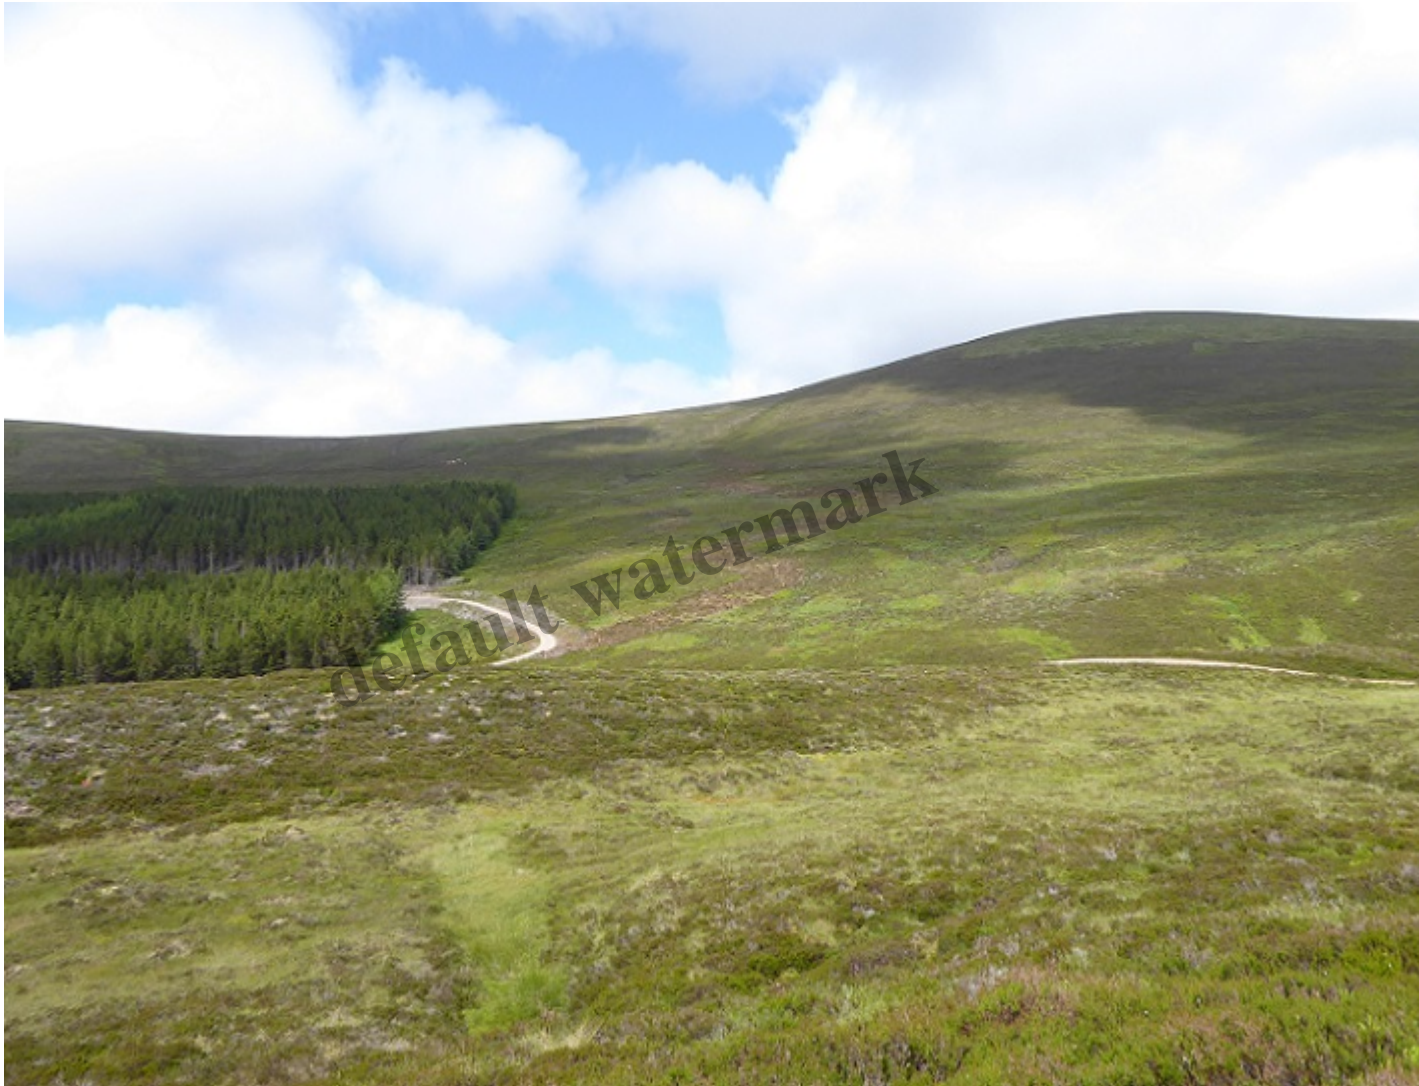
View towards Carn Dearg Mor (right) from south. A digger being used for the restoration work is just visible above the plantation

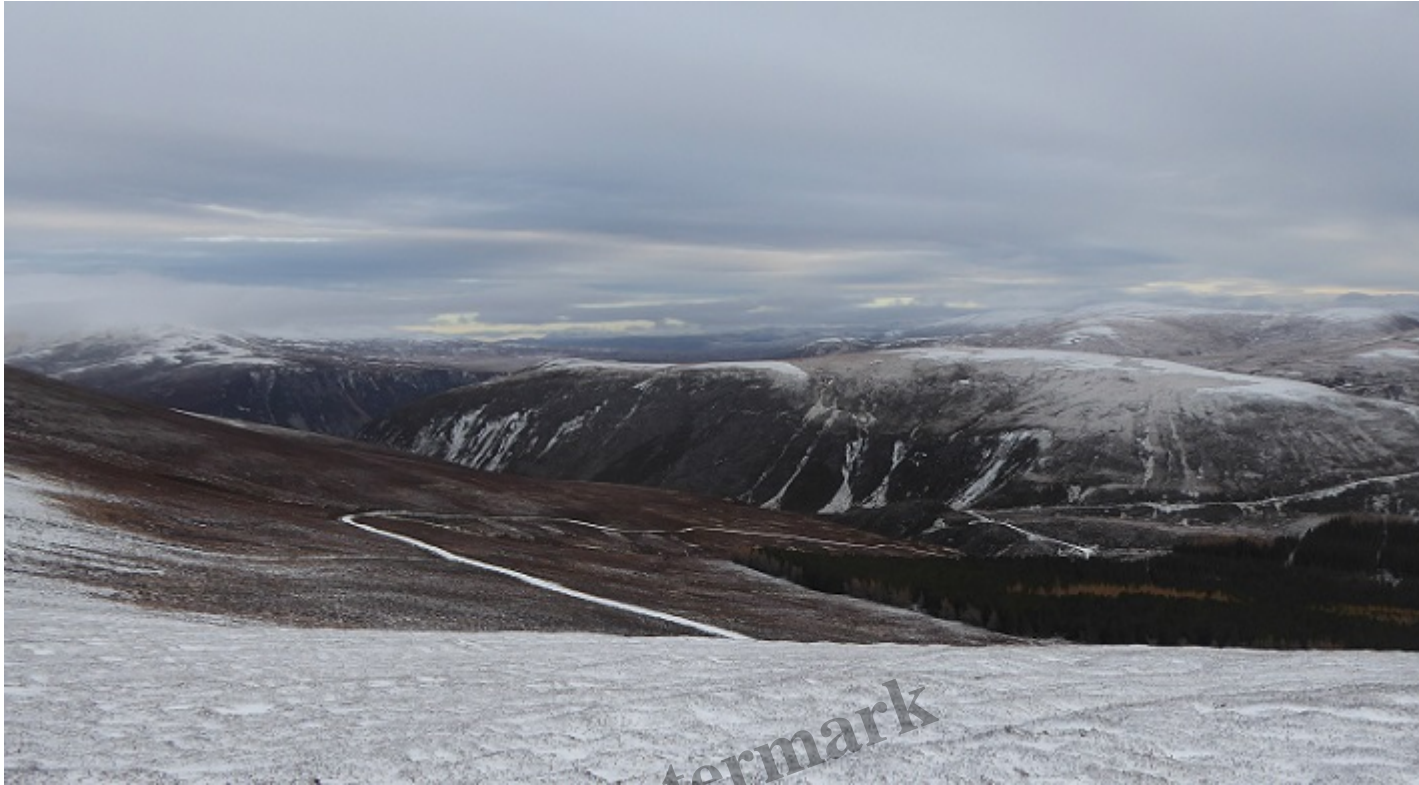
View from above November 2017. The hill road in the foreground has been removed. That on the far side of the col between Glen Feshie and Glen Tromie remains and is currently being used for deer culling and to access peat bog restoration sites

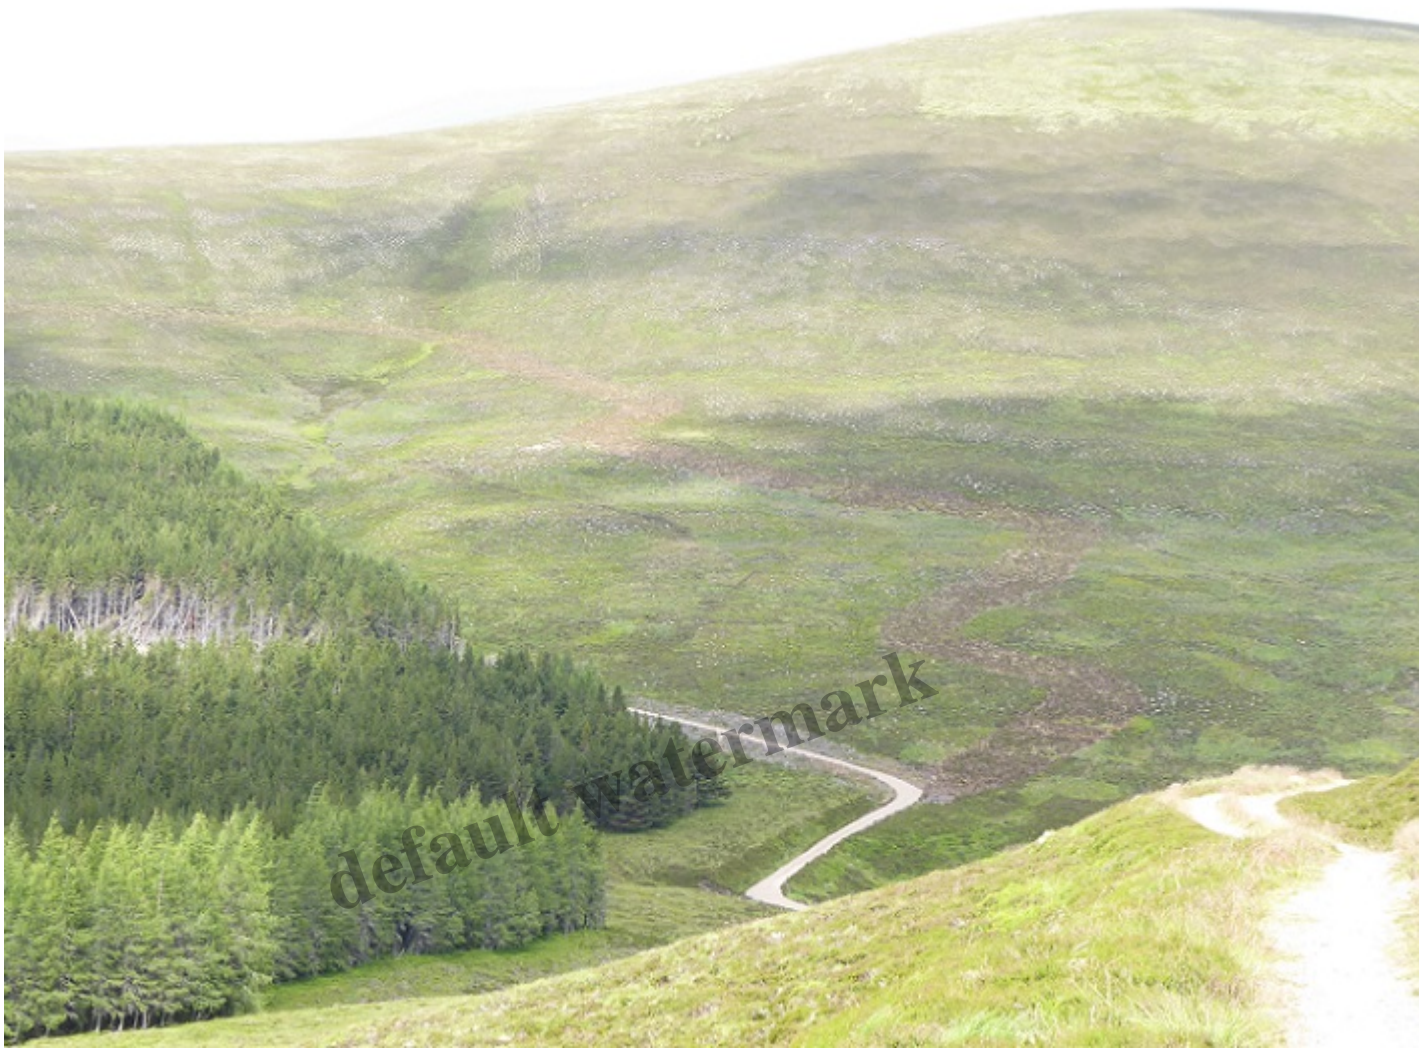
The removal of this track is part of a plan to rationalise and reduce the landscape impact of hill tracks on the Glen Feshie and Glen Tromie estates. While the track to the plantation remains prominent, as woodland develops it should eventually become concealed from view.

Because this was a longstanding road, there was no “spare” vegetation to cover its surface once this had been re-moulded to fit back into the landscape. The pockmarks on the slope show where vegetation has been “borrowed” and used to cover the track. Because the areas of borrowed vegetation are small and well spaced, each should be re-colonised by the plants surrounding them in a year or two despite the short growing season at this altitude (600-700m). That process will have been assisted by the work having been carried out fairly early in the growing season this year.

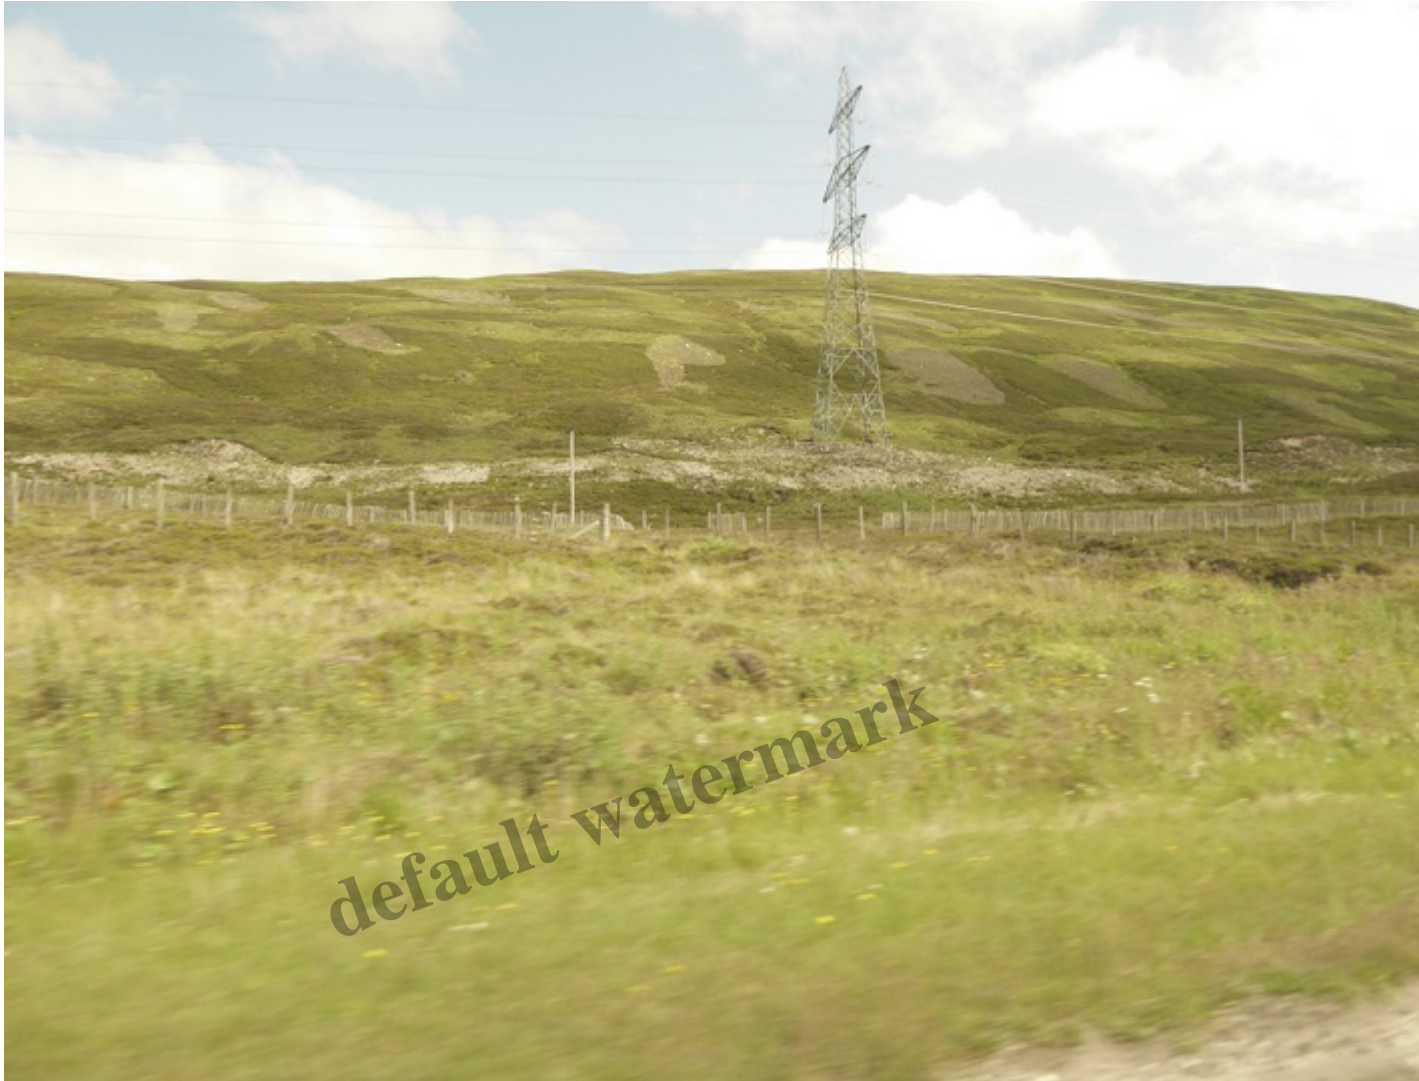
The Beaully Denny restoration should have been far simpler than that on Carn Dearg Mor, as the access roads were supposed to be only temporary and it also lies at a lower altitude. Had vegetation along the line of the access roads been removed carefully and stored properly, it could have simply been replaced once the line of the road had been re-moulded to fit the landscape. The scars should then have disappeared in a year or so. Instead five years later the scar is almost as prominent as it was when the roads were constructed:

View of section of Beauly Denny access track taken from the car 17th July

Had SSE ensured suitably skilled contractors were employed to work on the construction and restoration of the Beauly Denny access roads, none of the landscape scarring at the Drumochter need have occurred. Remedial work could still start tomorrow if the Scottish Government had the political will to hold SSE to account. There is plenty of vegetation on the surrounding ground that could be “borrowed” to help resurface these roads and there would be even more if the muirburn that is scarring the hillside above was stopped. But first the surface of the access road needs to be re-moulded to fit the contours of the hillside, removing the straight line that currently cuts across it.
