## Contradictory plans for Kinrara – BrewDog needs to get a grip

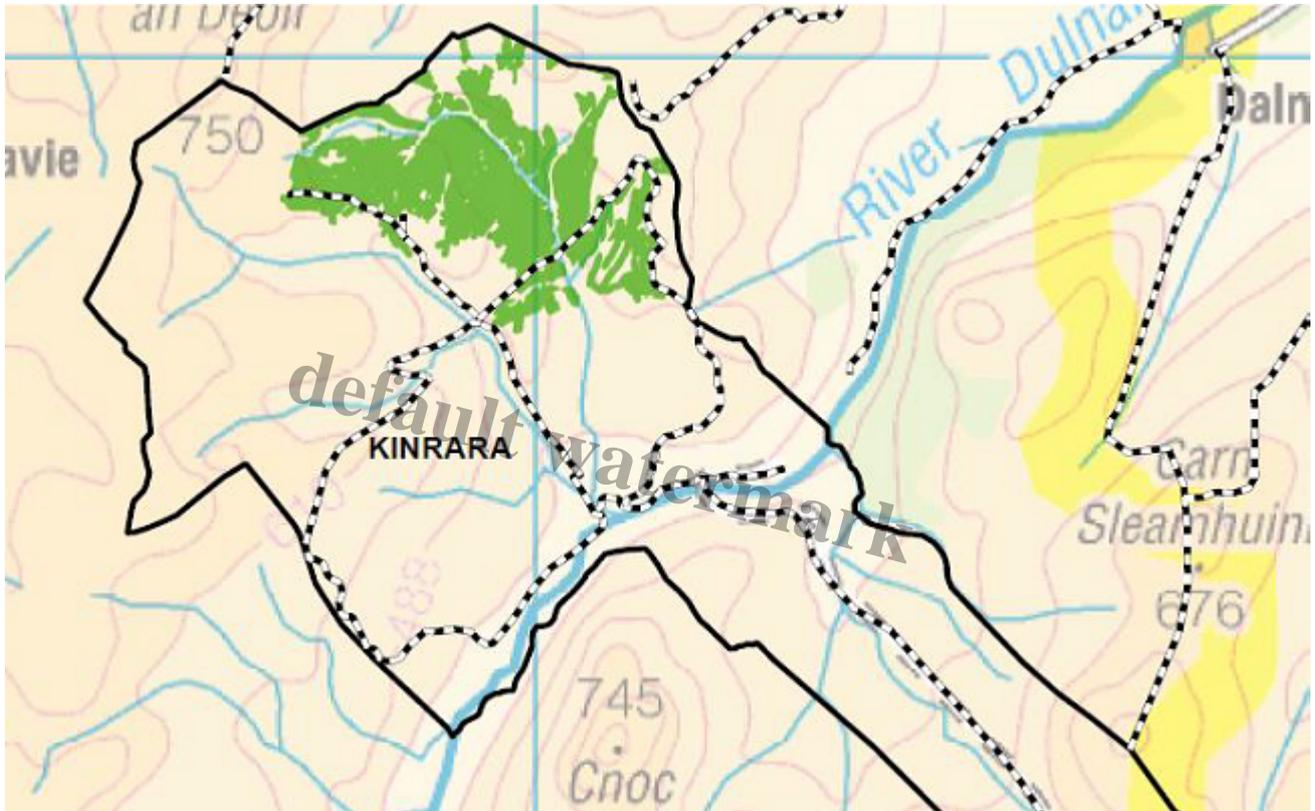
The green shows the proposed restoration area, the dotted lines hill tracks and the yellow the Cairngorms National Park boundary

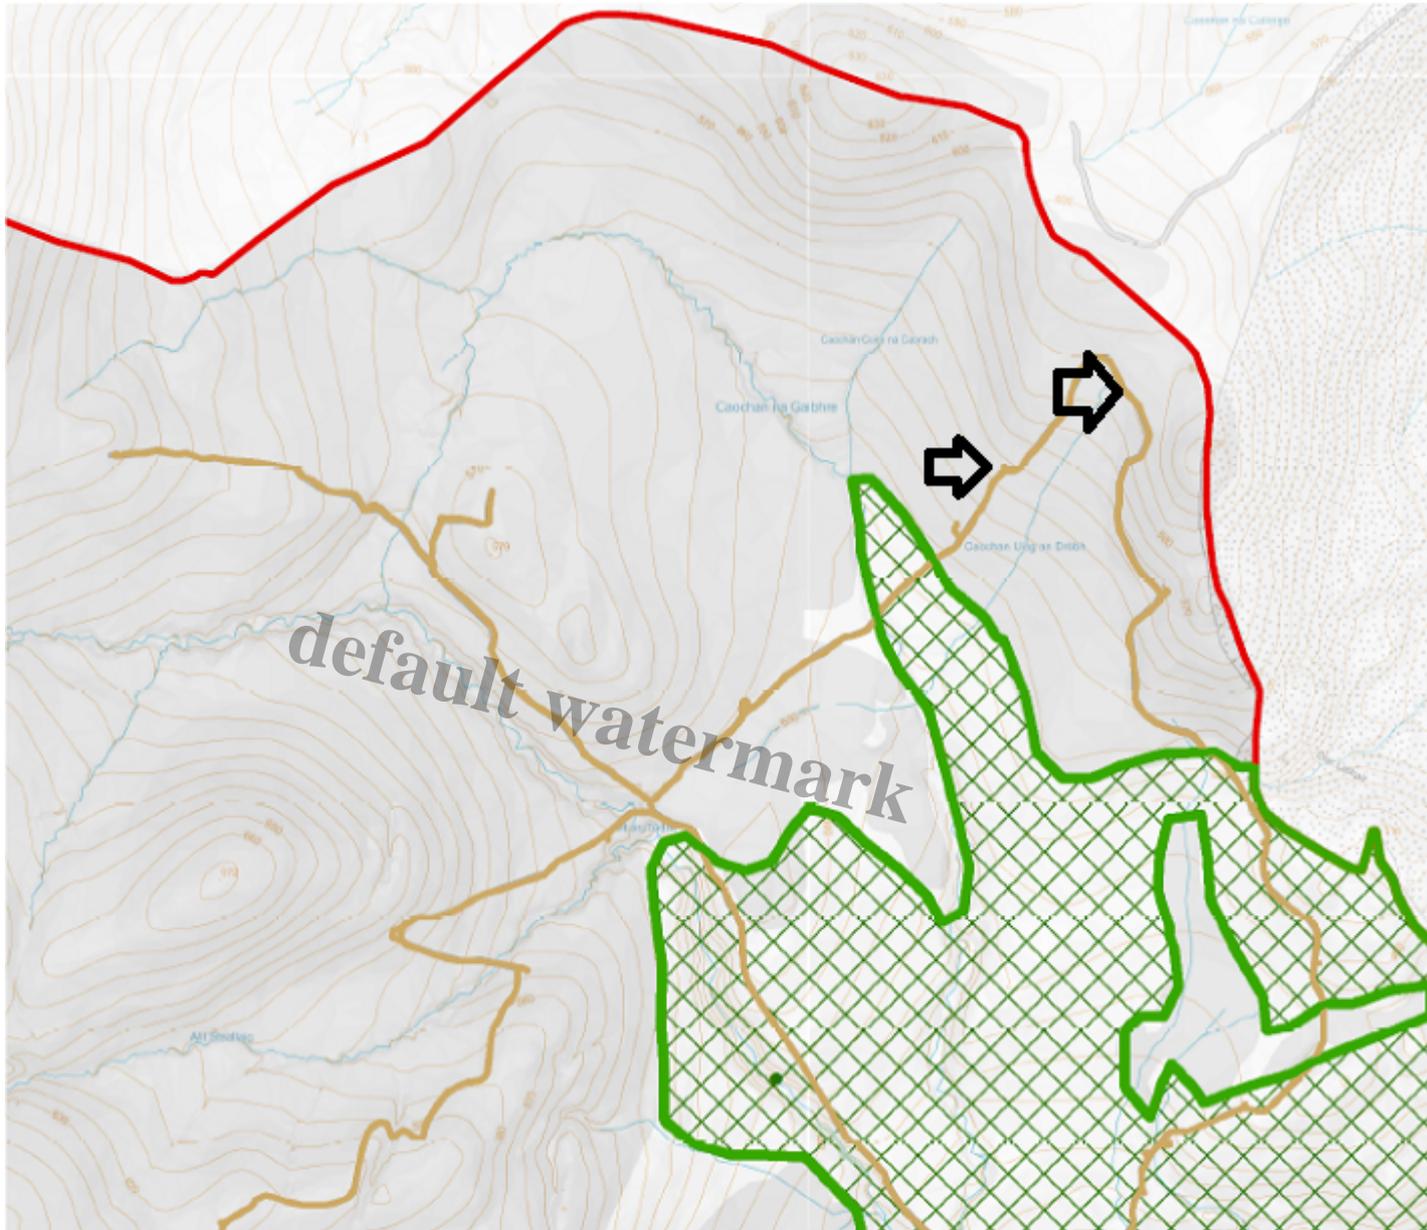
Hatched area marks proposed planting, brown lines the track, and black arrows the photos of the track annotated extract from plan for Lost Forest North

The "finger" of woodland restoration alongside the burn, the Caochan na Gaibhre, on either side of the hill track is marked on the Strath Caulaidh map as being an area of proposed peat bog restoration. It should not be both. It could result in NatureScot forking out money to restore peat, while Forestry Scotland fork out other public funds to plant it!

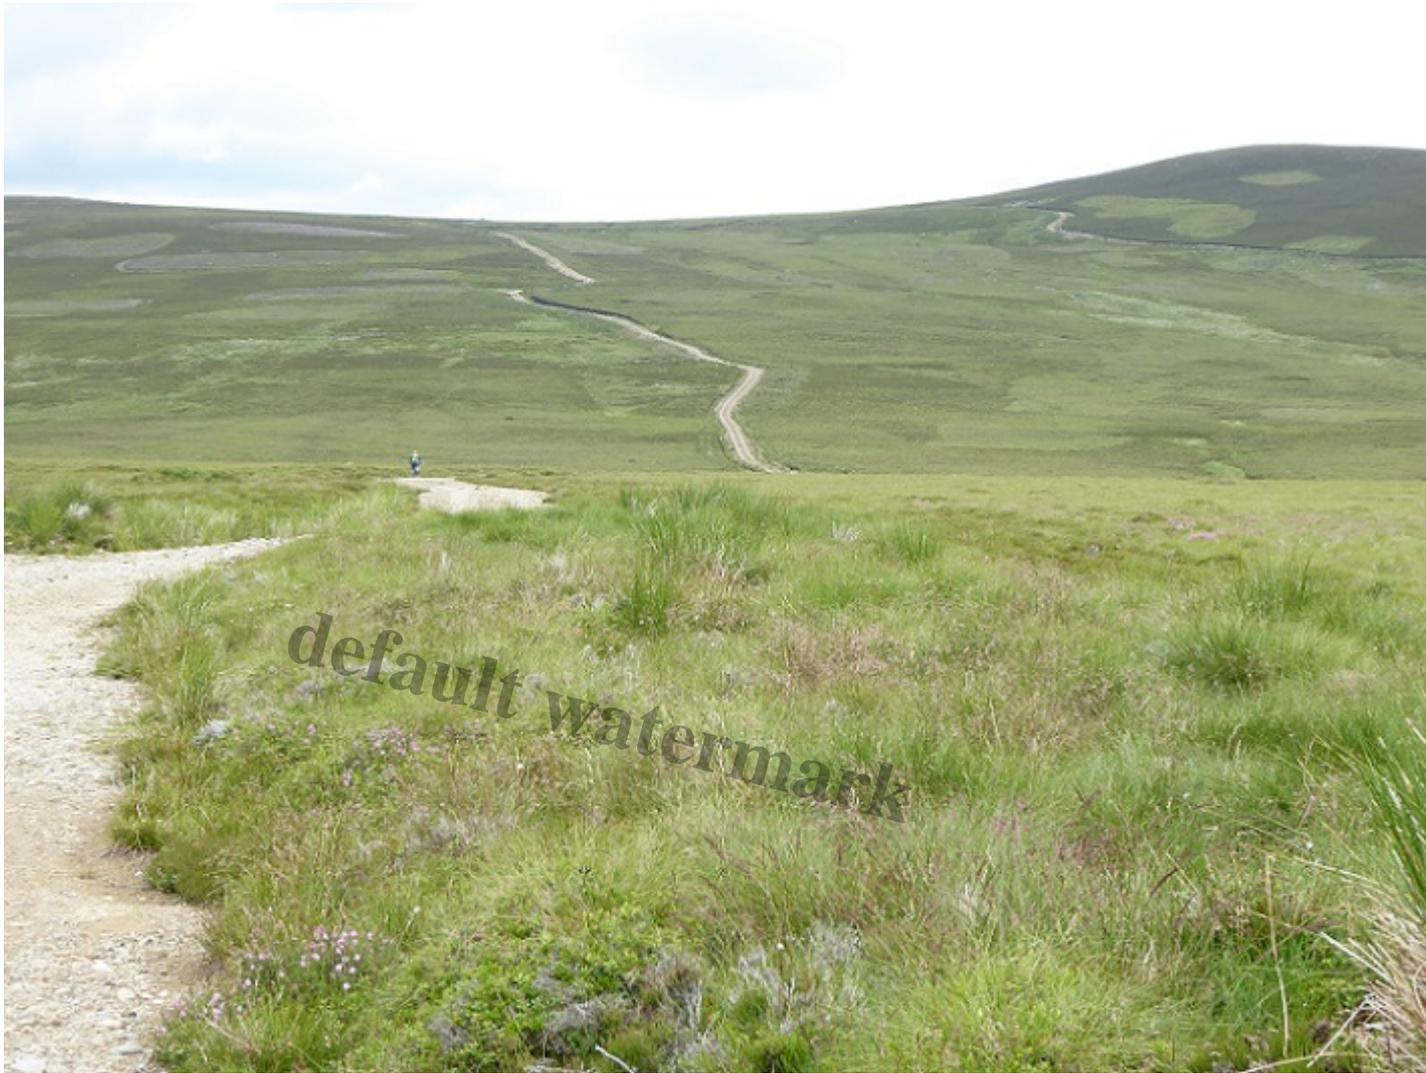
Looking north up the track: the burn, the Caochan na Gaibhre is in dip.

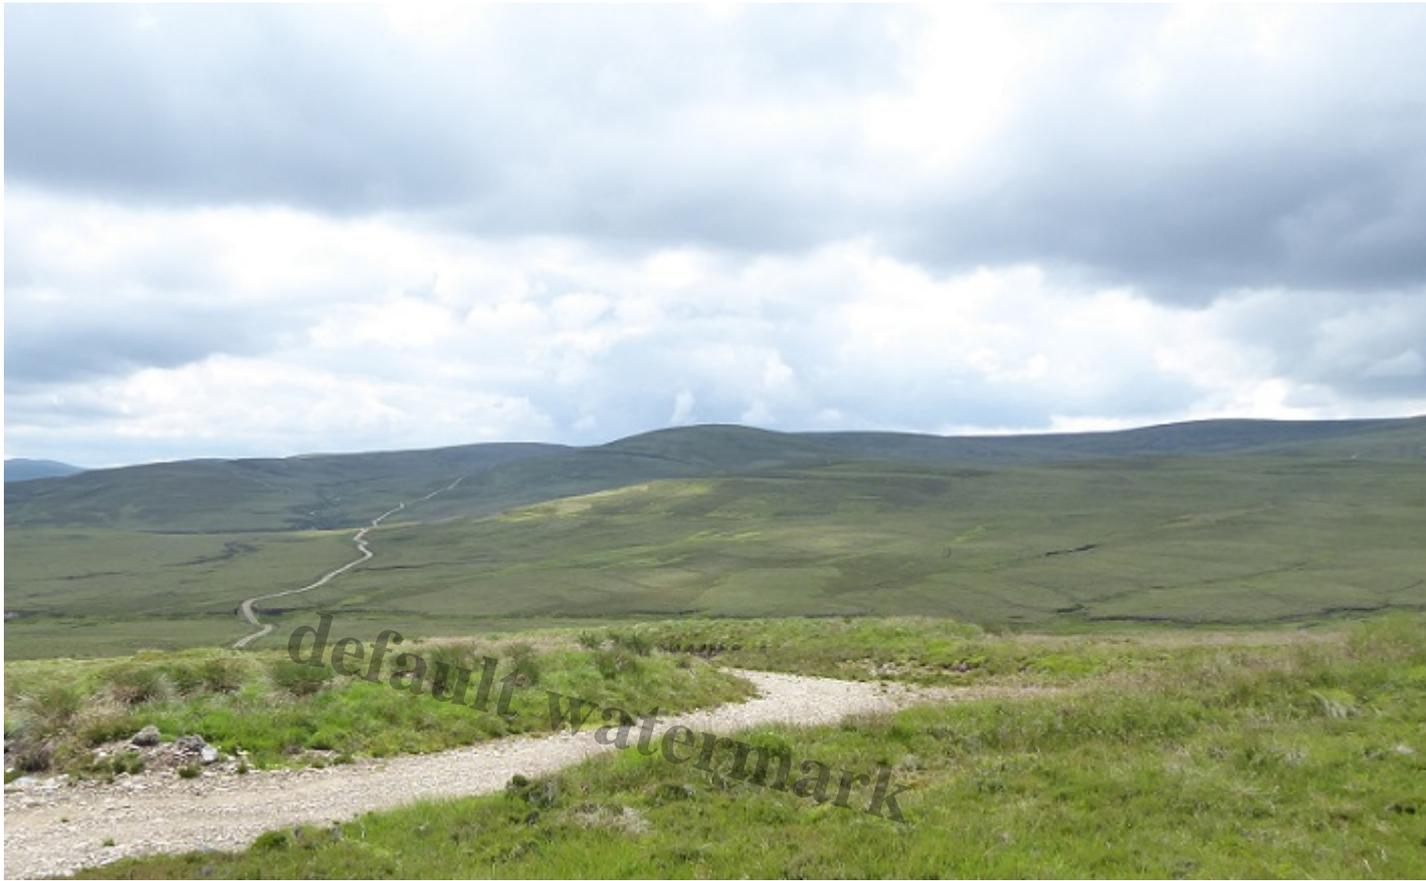
Moor grips are just visible to the right of the track on the far side of the Caochan na Gaibhre burn. They appear as a series of faint parallel lines

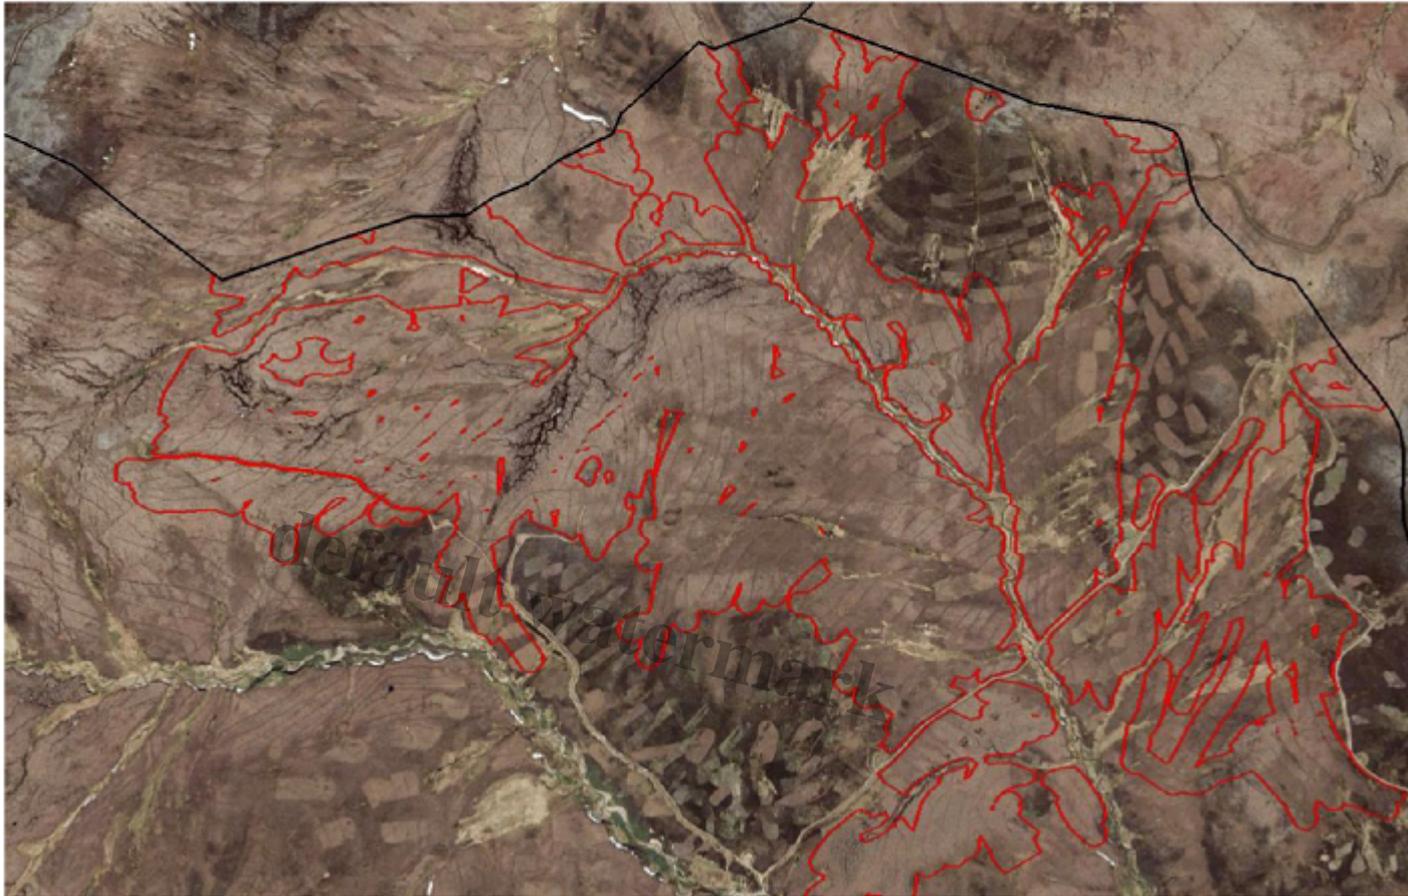
Aerial view of Cohort 2021 (Image copyright of Google Earth ©)

Red outline = cohort boundaries; black line = estate boundaries (note: other estate boundaries and project boundaries may be showing for reference)

The faint parallel lines show the extent of the moor grips

Clearly in the past a serious attempt was made to drain the bog here. One wonders how much of it was paid for by public money?

Given that the drainage ditches are not obvious on the ground, it is valid to ask how far they are still damaging the peat bog? There was very little sign of exposed peat along the drainage lines and it appears the grips may have filled in with vegetation. I am been informed, however, by Stephen Corcoran â?? the Cairngorms National Park Authorityâ??s Peatland Officer and a real professional â?? that people working on peat bog restoration in the Cairngorms have done tests and found that beneath apparently re-vegetated ditches the water may still be flowing. Though concealed, old ditches therefore may still be serving to erode and dry out the bog.

Unfortunately, the Prior Notification does not say whether that is happening in the catching of the Caochan na Gaibhre, the land featured in these photos. The peat bog restoration work seems to have been planned on the basis of what google earth shows, rather than any survey on the ground. If surveys showed the ditches are still draining the bog, work to block them up might be justifiable.

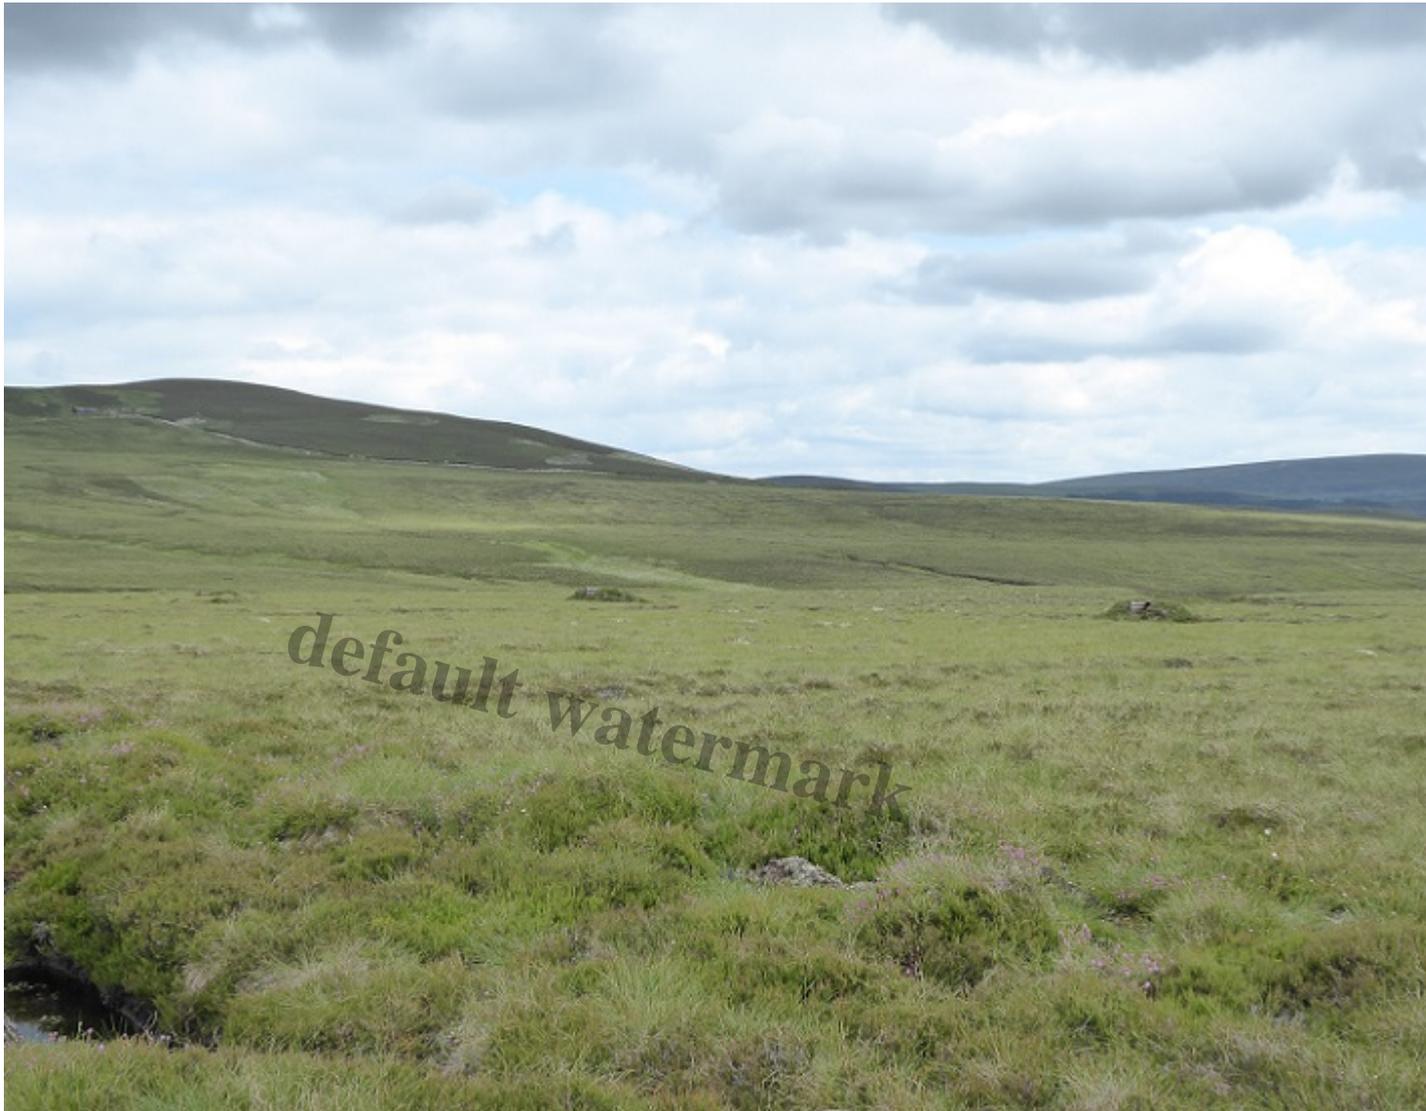
Looking across the bog to the highest part of the track, a shooters hut just visible on the far left. The ditch, bottom left, is drainage for the track

There is certainly some ‘‘spare’’ peat and vegetation, used in the construction of grouse butts, which could be used to fill in ditches, now that driven grouse shooting has stopped on the estate. There is no mention, however, in the plans of whether it’s intended to restore the butts or whether driving a digger over the bog to remove them or to fill in the ditches might cause more damage than it prevents. These are difficult questions but ones which need to be answered if we are to ensure peat bog restoration schemes are worth it.

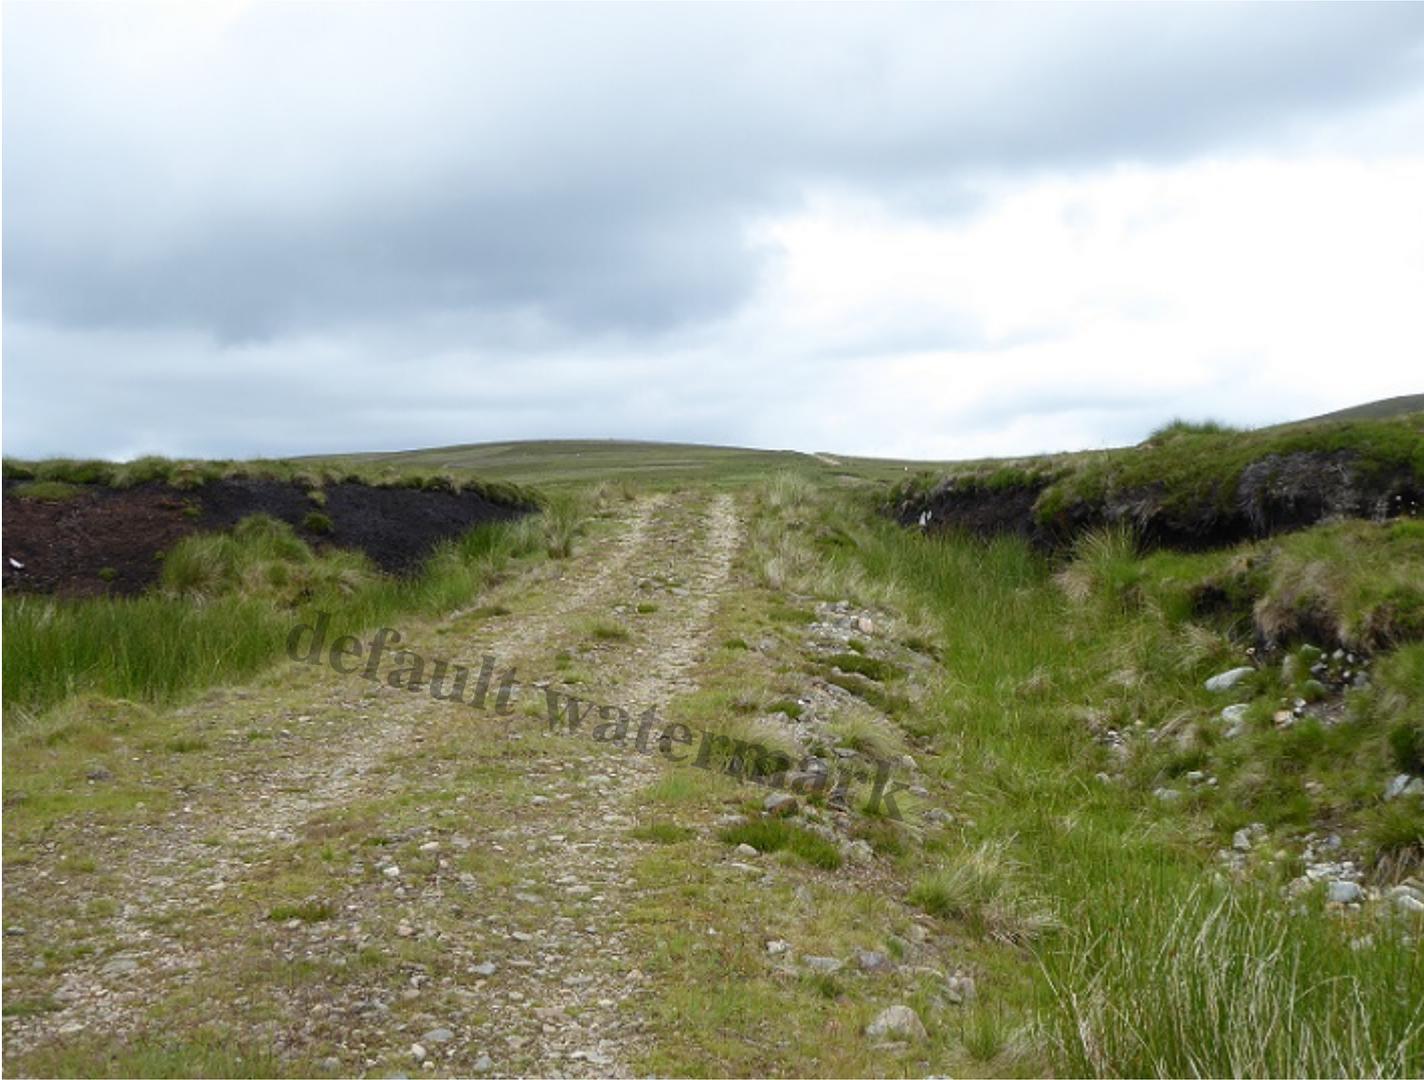
Exposed and eroding areas of peat by the track (location marked by black arrow on map above)

The hill track â?? used to transport grouse shooters and make intensive management of the moor easier â?? acts as one enormous drainage line which has been driven through the bog. Etraordinarily, there is no mention of this in the Prior Notification:and no plans to remove it. Why not?

The answer, almost certainly, is that peat bog restoration to date has been driven by the interests of landowners and they have not been prepared to see damaging developments, like hill tracks, removed. If BrewDog is really serious about the need to create carbon sinks on its land at Kinrara, therefore, it should be starting with plans on how to restore the track. Incidentally, one of the reasons Strath Caulaidh may not have included proposals to do this in their plans â?? despite the change in landowner â?? is these tracks, which are so damaging to peat and the landscape, make it much easier to drive diggers up the hill!

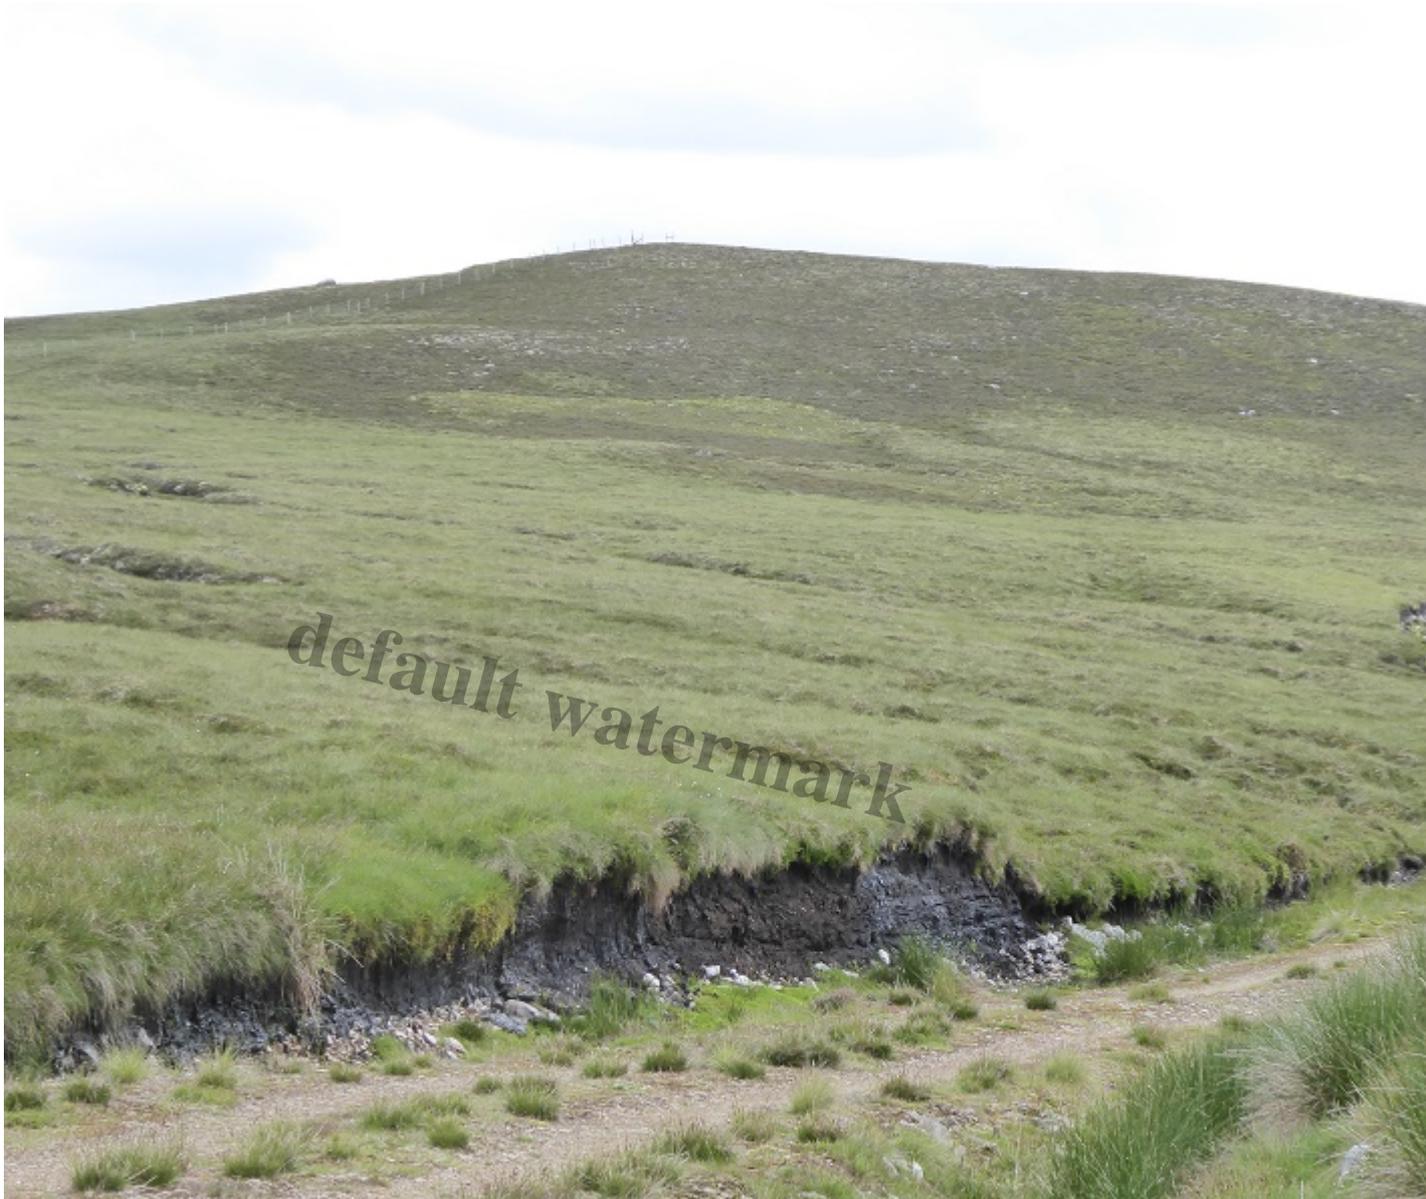
Exposed section of peat along the top section of track, showing how it is drying out, with the lines of visible behind.

Strangely, an area of obviously damaged bog is not included in the restoration plans. Perhaps that is because it is hard to see on google maps?

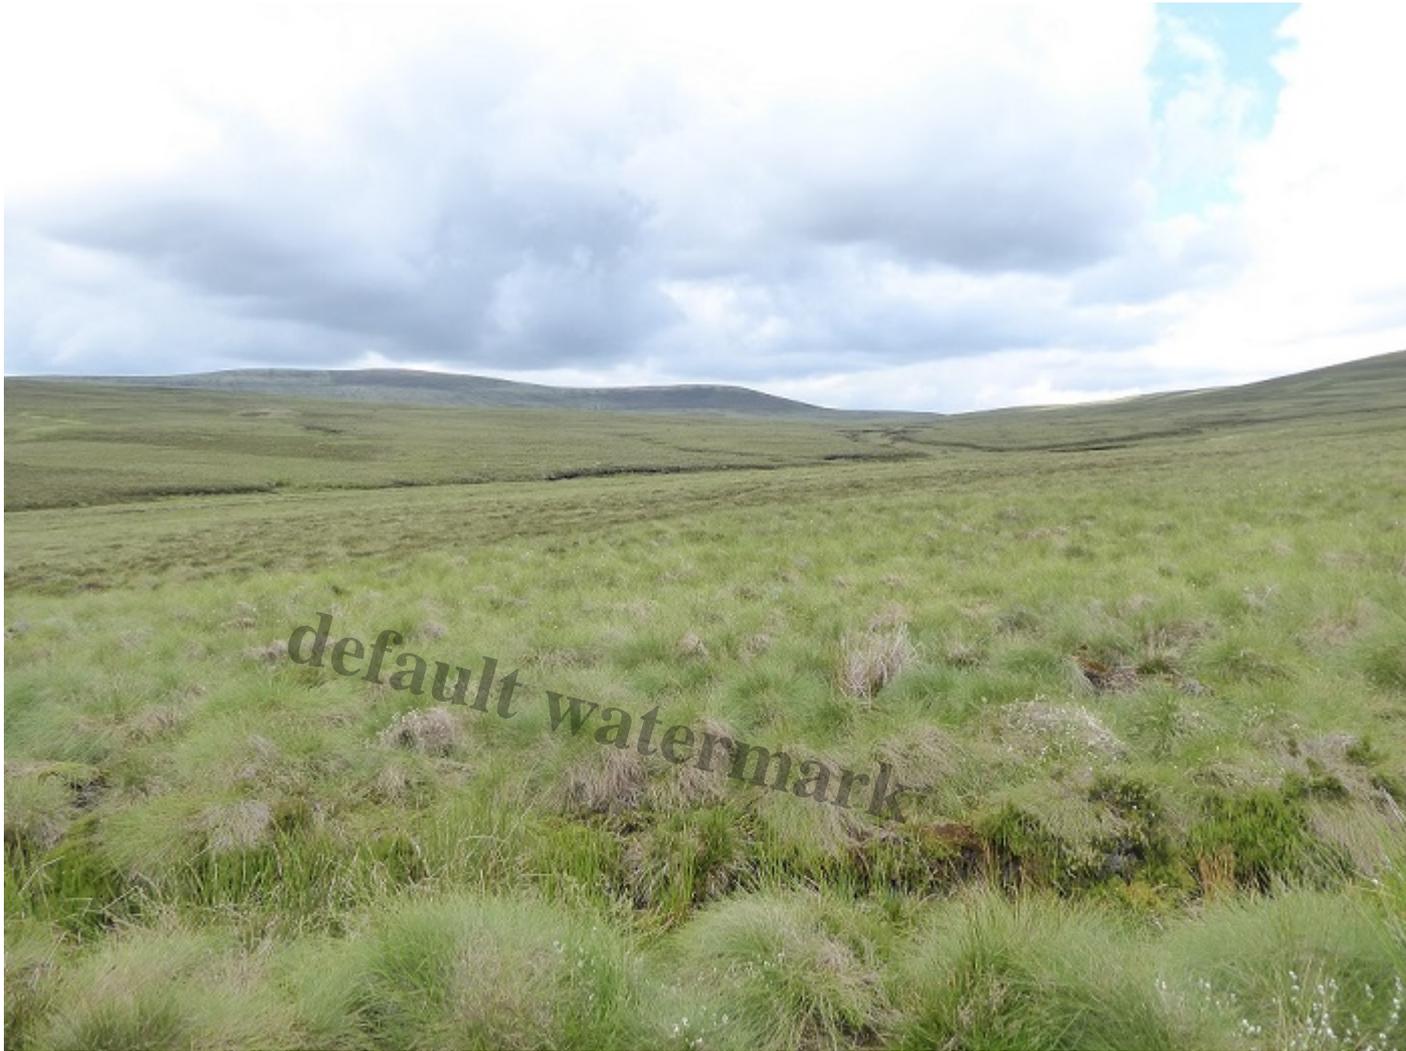
View west along the Caochan na Gaibhre from the track above. Natural drainage lines do erode/prevent peat from forming, marked here by the line of exposed peat alongside the burn. Very few other areas of peat are visible and the moor grips have blended into the landscape.

To the lay person, this is not a peat bog where restoration work is obviously required â?? apart from the track. In view of this, Highland Council should be asking Strath Caulaidh and BrewDog to demonstrate that the proposals will have a net carbon benefit..
