The Ben Ledi path and the outdoor recreation failure in the Loch Lomond and Trossachs National Park

The case of the tourist path up Ben Ledi

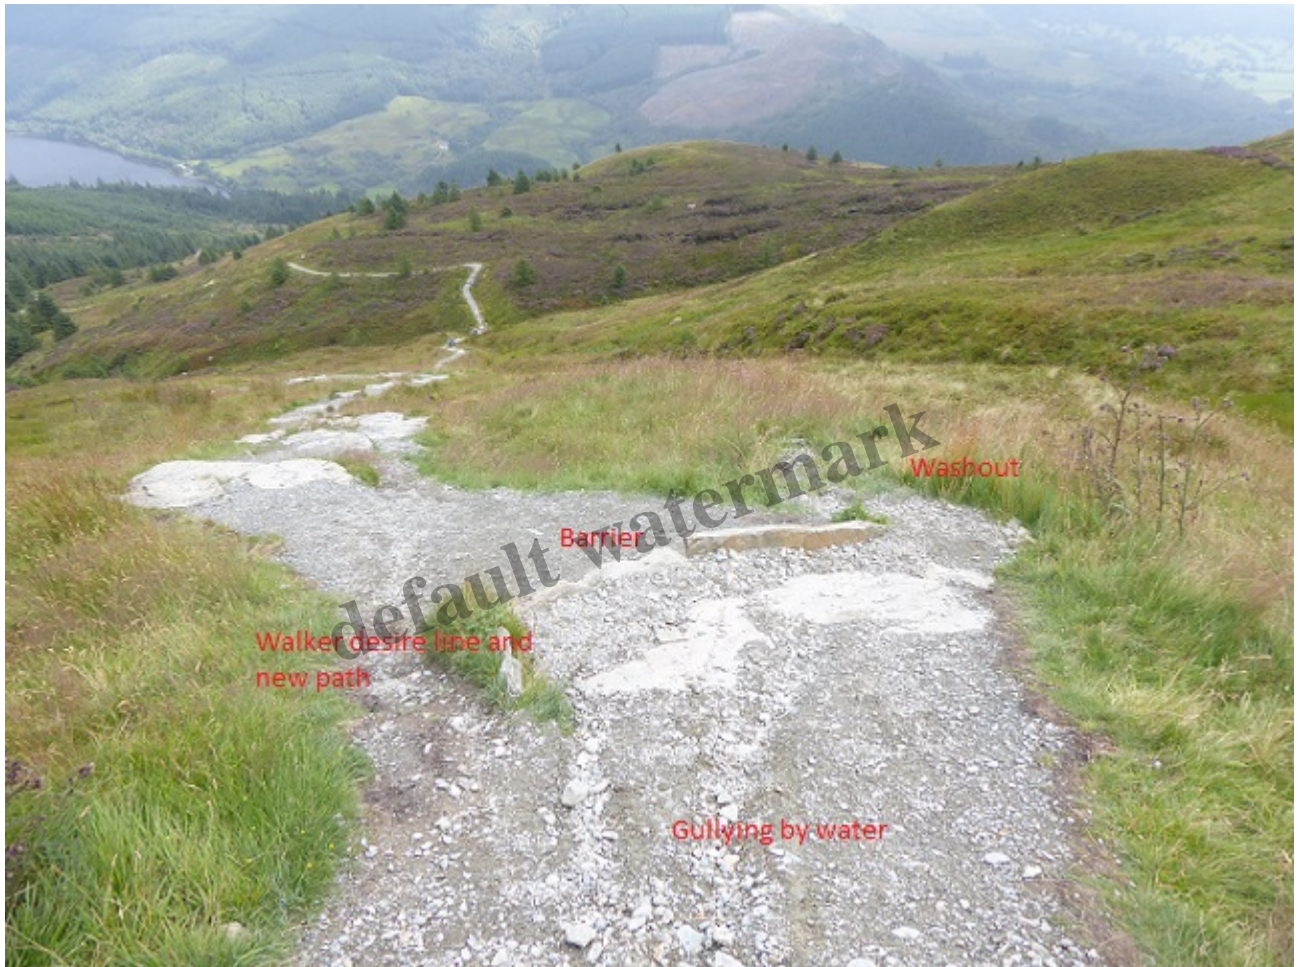
A path gone wrong. A section of the tourist route up Ben Ledi, August 2021, Loch Lubnaig behind

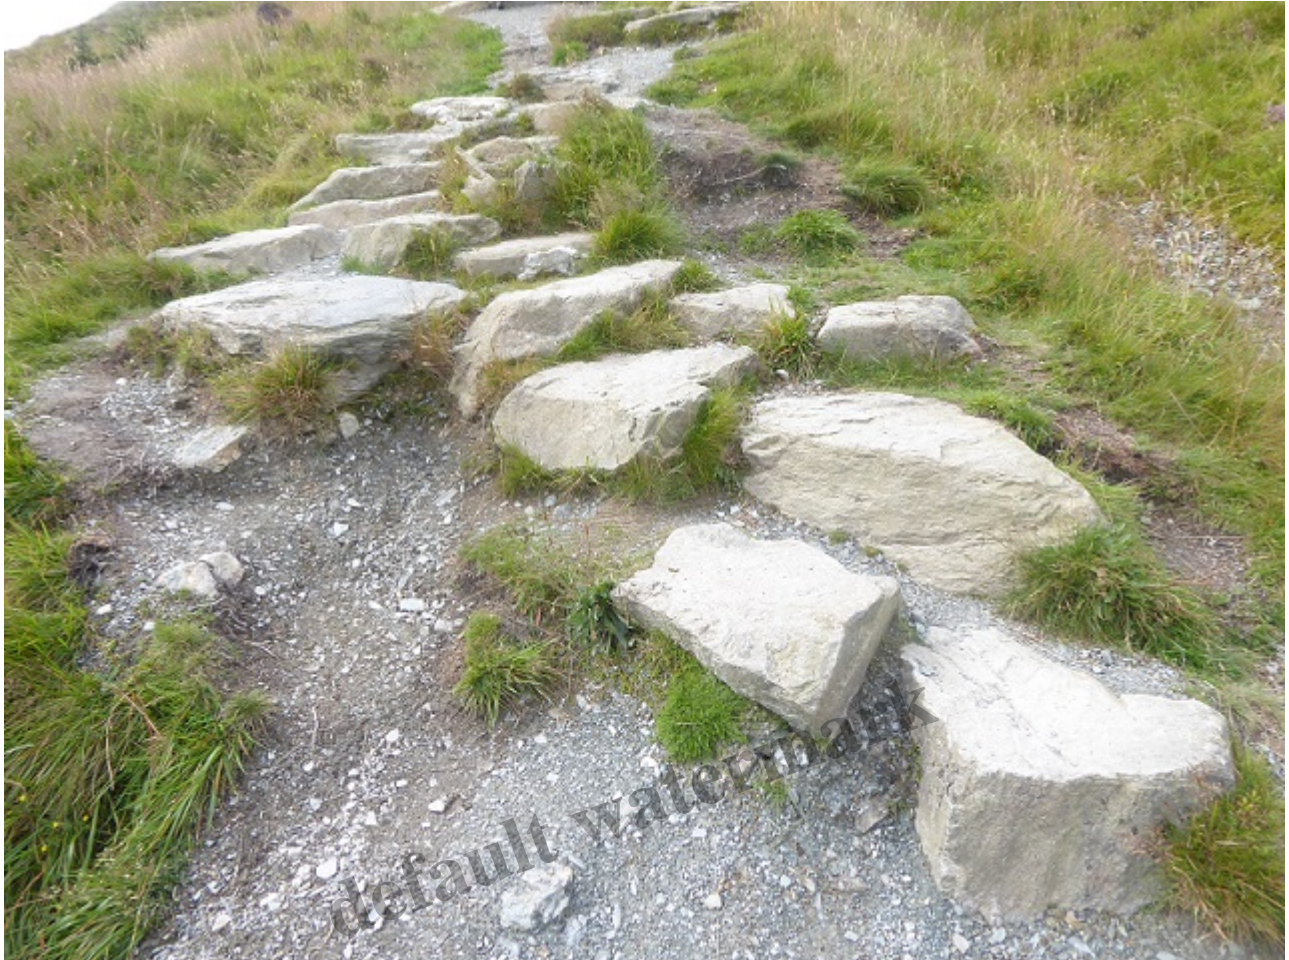
Interpretation. It appears that initially people avoided the steps on the right because they were too high and chose instead to walk directly to the large flat boulder on the left, eroding the ground below which is now starting to gully. As the height required to step onto that boulder increased, people started avoiding them completely, eroding the ground on either side.

Part of the explanation for this path failure appears to lie in fundamental design flaws, particularly on the steeper sections. People generally don't enjoy walking on hard stone but it is well known in the path world and written into the Upland Path Standards ([see here](#)) that where the vertical height difference between steps is more than 15cms people will avoid them if they can. That appears to account for what has happened here and significant section of the new step work on the main Ben Ledi path is at risk of being left high and dry just five years after construction. That in itself should be enough for an LLTNPA Board visit and an inquiry into what has gone wrong.

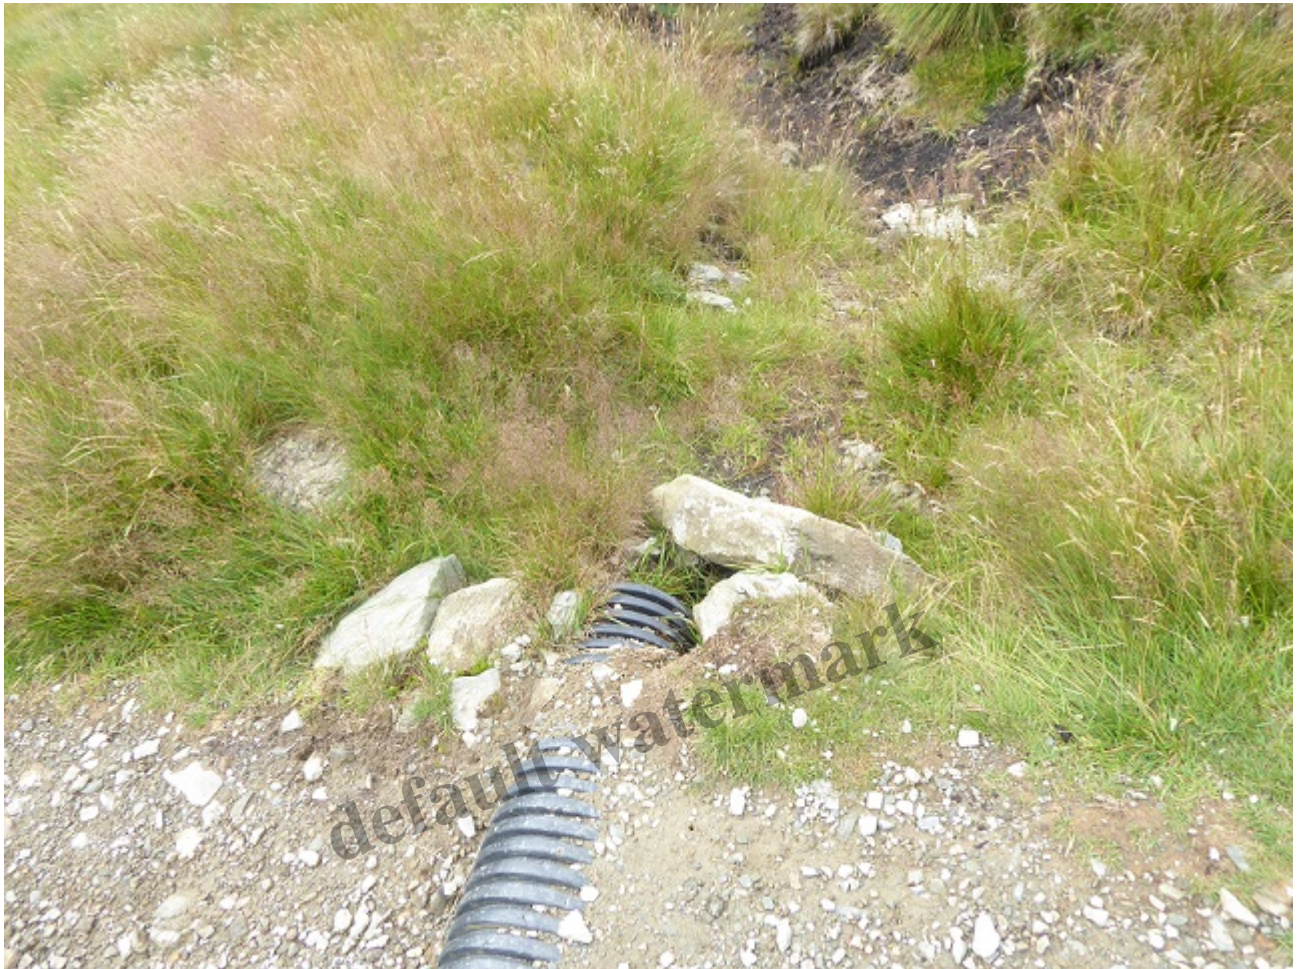
Exposed culvert with dislodged capping stone beyond. If it looks bad, it is bad!

The impact of feet – including crampons in winter! – on the exposed plastic culvert will shorten its life significantly but not even basic maintenance issues such as this are being addressed.

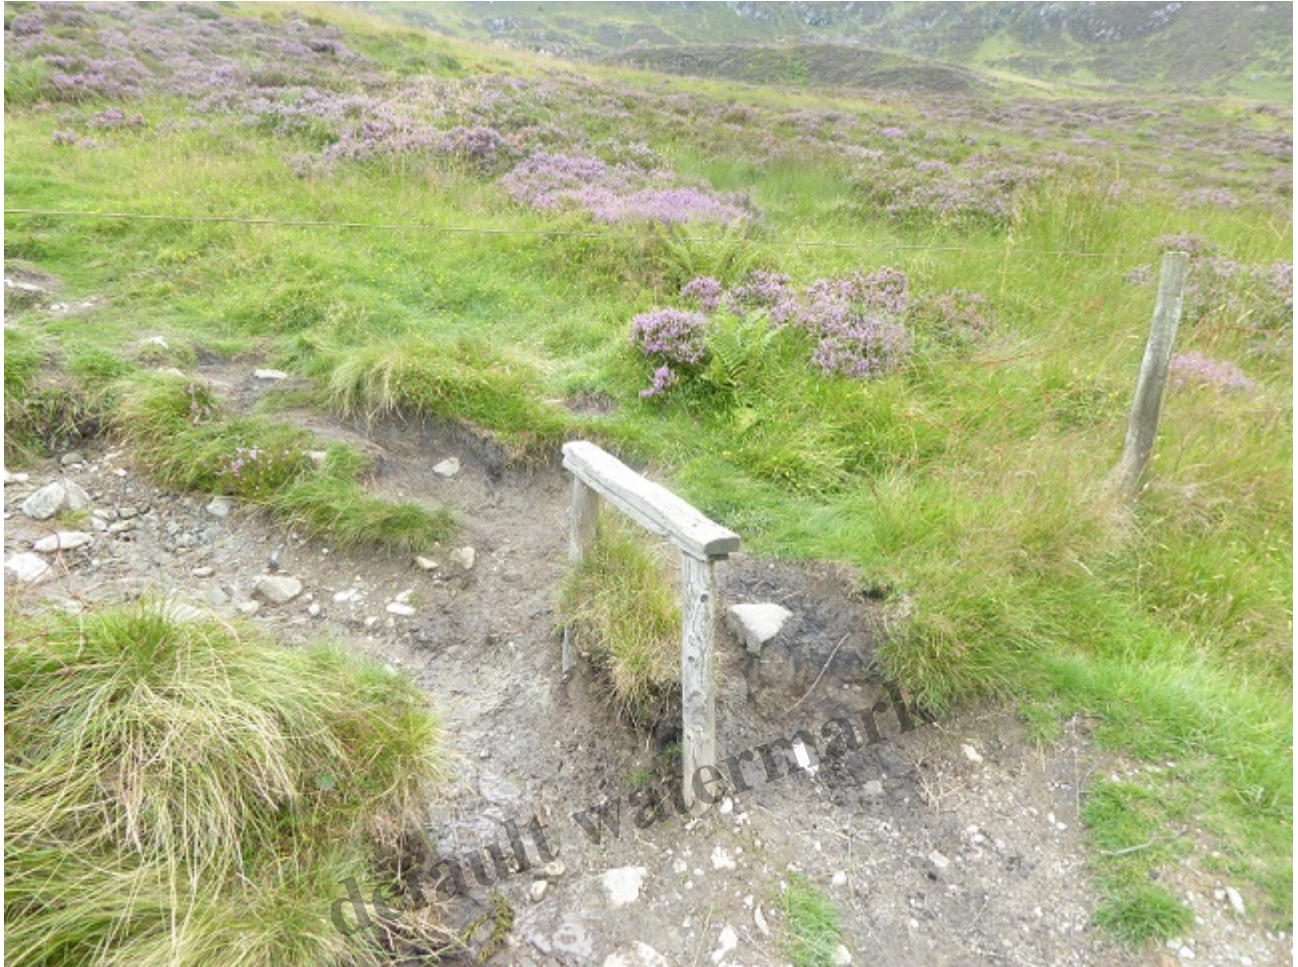
The former fence and stile at the top of the path work in Stank Glen with one wire, just visible, running across the path from the post.

I have photos from December 2018 showing the fence intact. With the erosion, the wire is now at just the right height for a child skipping downhill to garotte themselves. It would be almost impossible for anyone to see in the dark. The safety hazard is obvious and would have been picked up if anyone was maintaining this path. But having managed to get all the path work paid for by the lottery, Forest and Land Scotland should not have relied on volunteers to do the maintenance. Indeed the very first principle in the Upland Path standards published by NatureScot states:

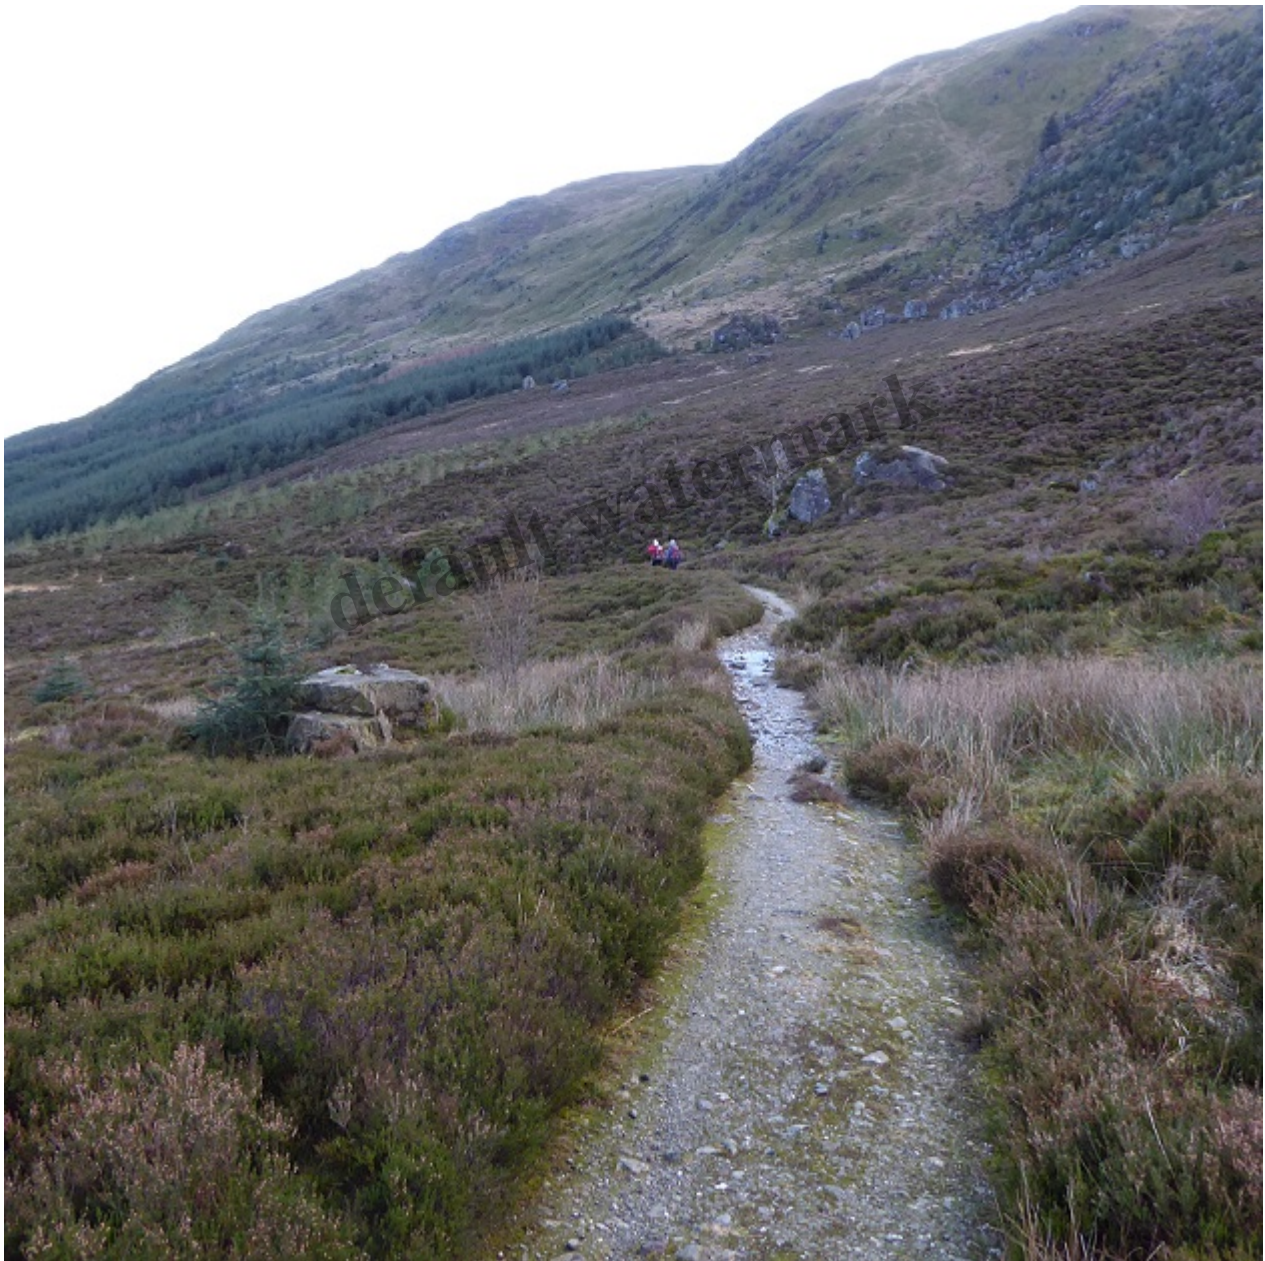
It is important to put these problems and failures into perspective. Apart from the fence, the path up Stank Glen showed little obvious sign of deterioration since I had last walked it in December 2018 – nothing to cause me to stop and take photos!

There are a number of explanations for this. While at a similar altitude to much of the main path up Ben Ledi, the Stank Glen route has less footfall, is far less steep and is surrounded by native woodland which reduces the amount of water flowing onto it. It is likely to require relatively little ongoing maintenance to remain in a good state.

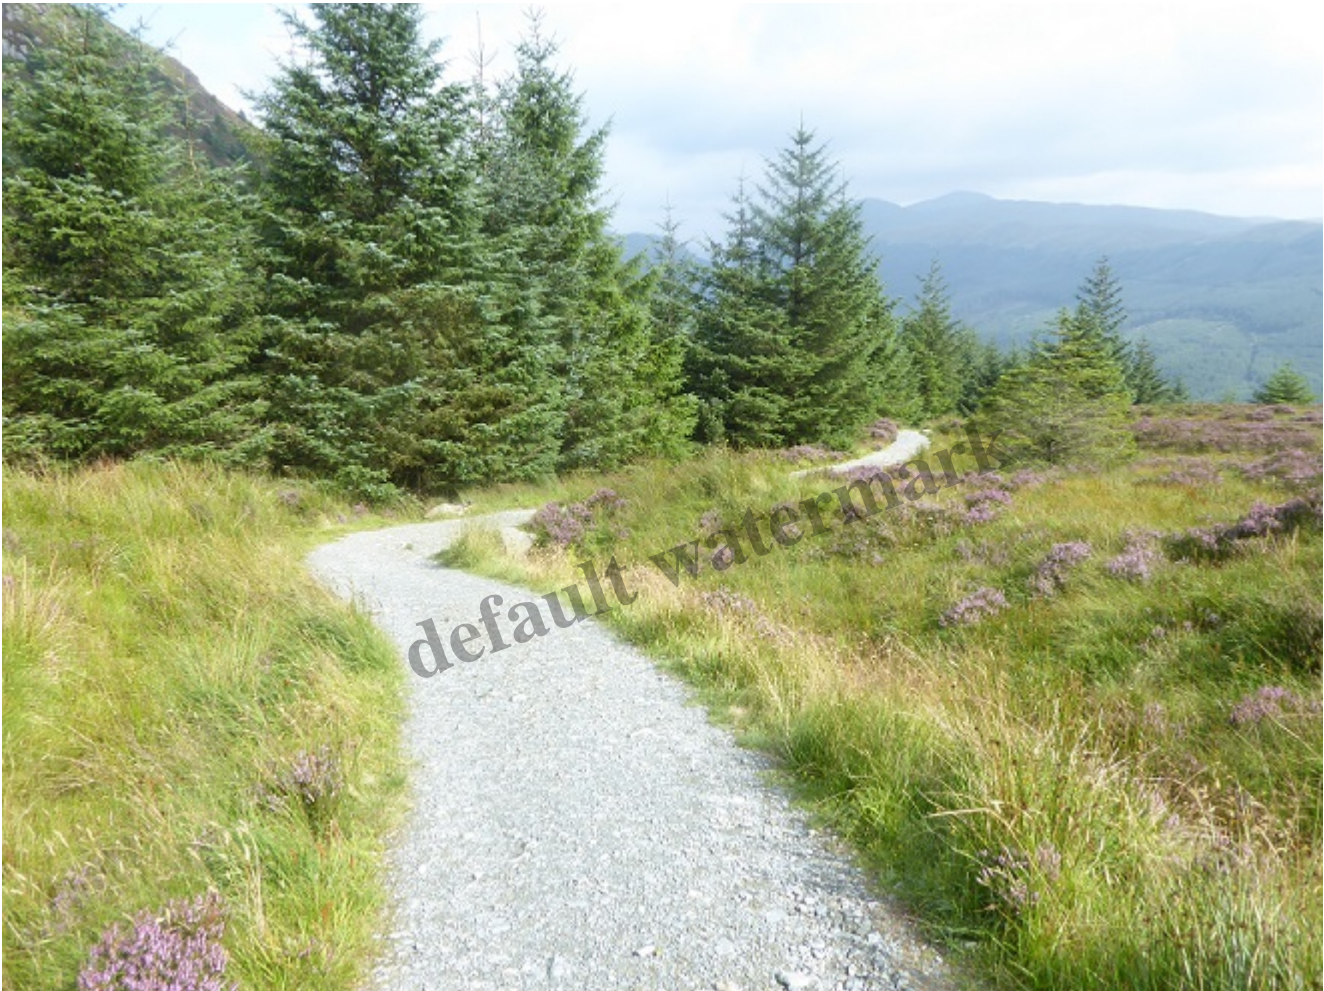
There are similar sections along the main path which have held up well since construction and where the vegetation on either side has regenerated successfully.

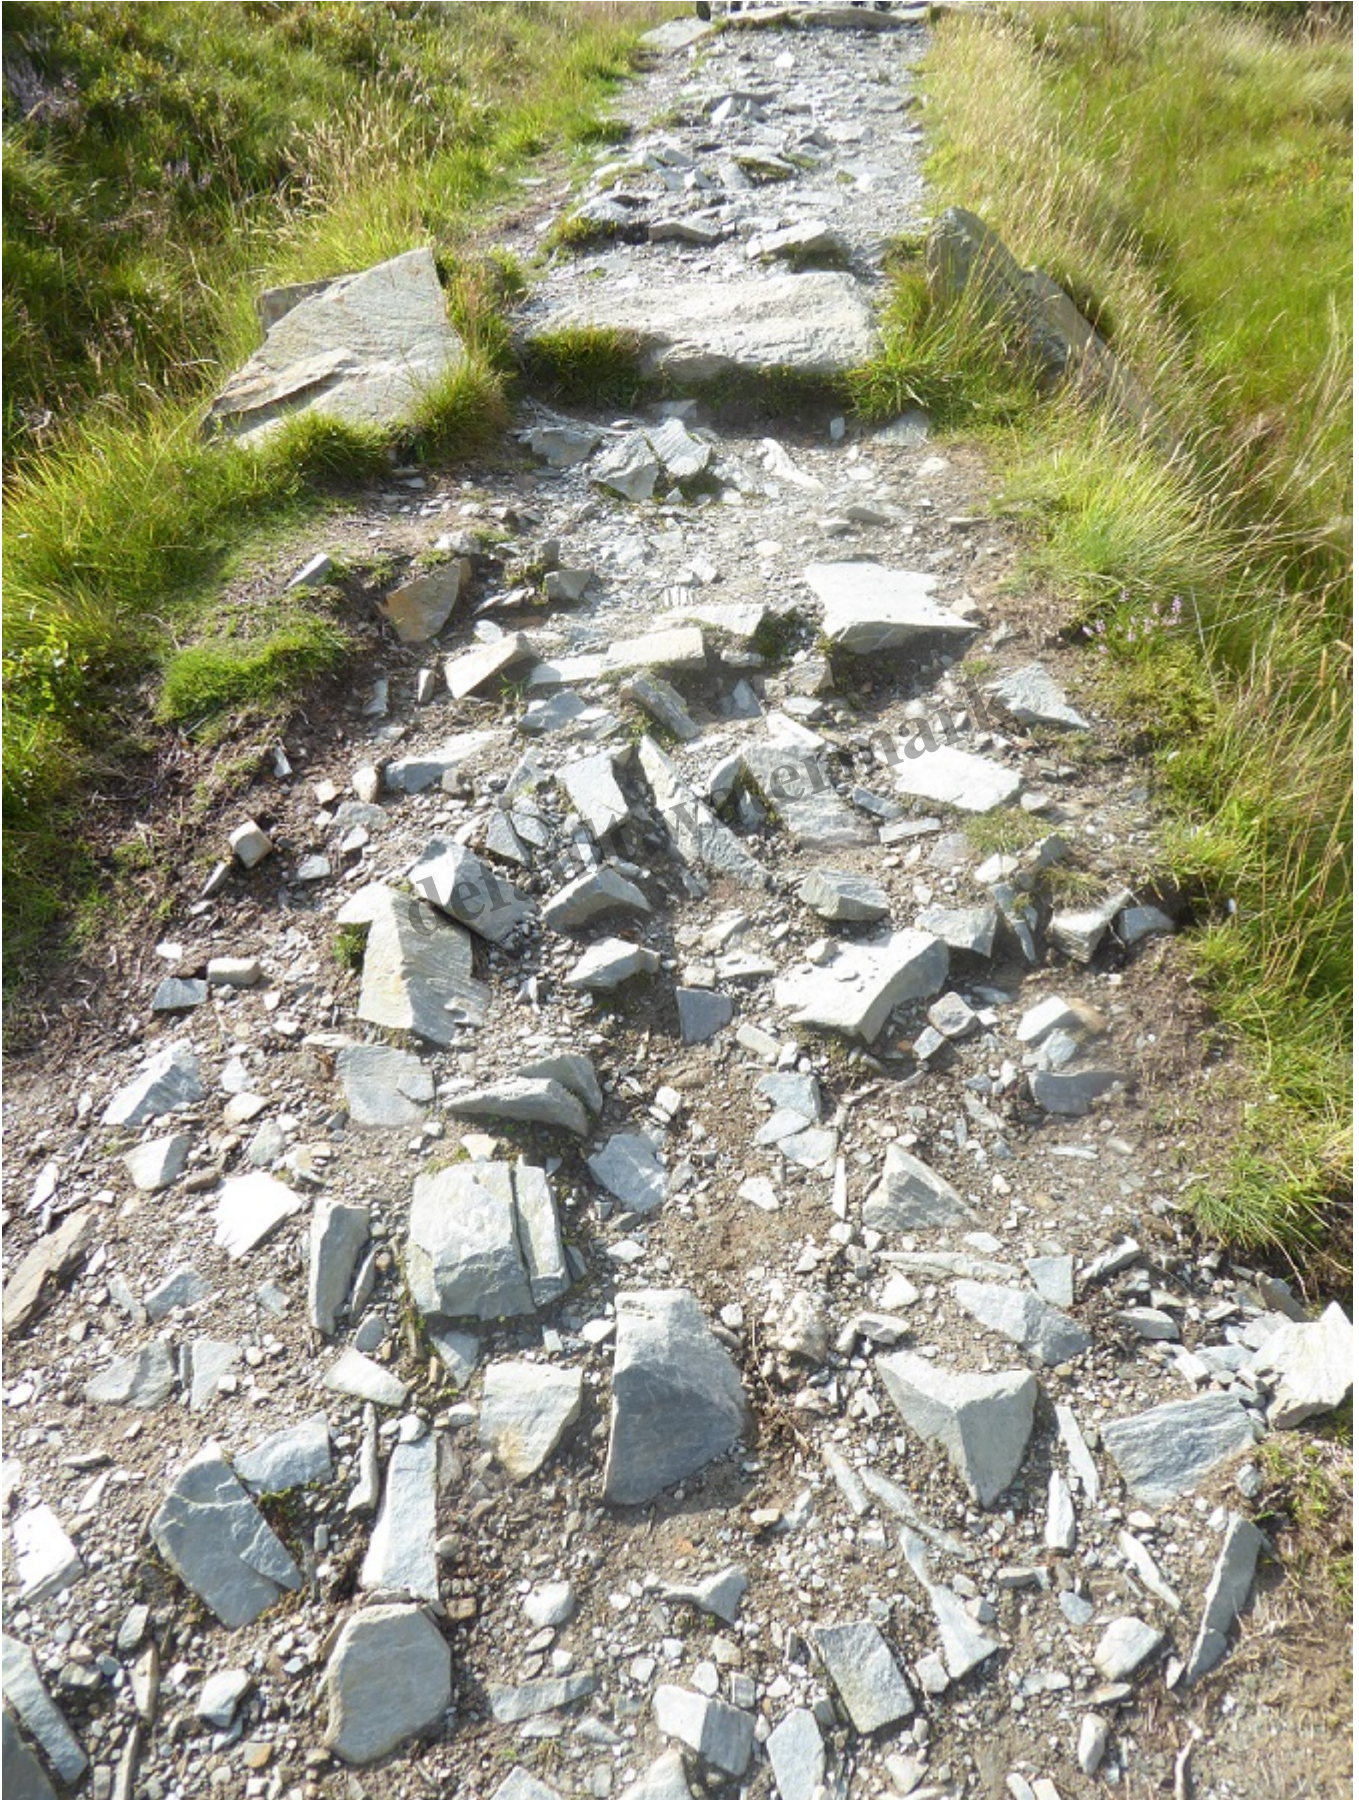
But there are also slightly steeper sections where the aggregate surface has been washed away. According to the Upland Path standards, if properly designed this shouldn't happen. This has made the path unpleasant to walk on so people have taken to the verges and they are now starting to erode.

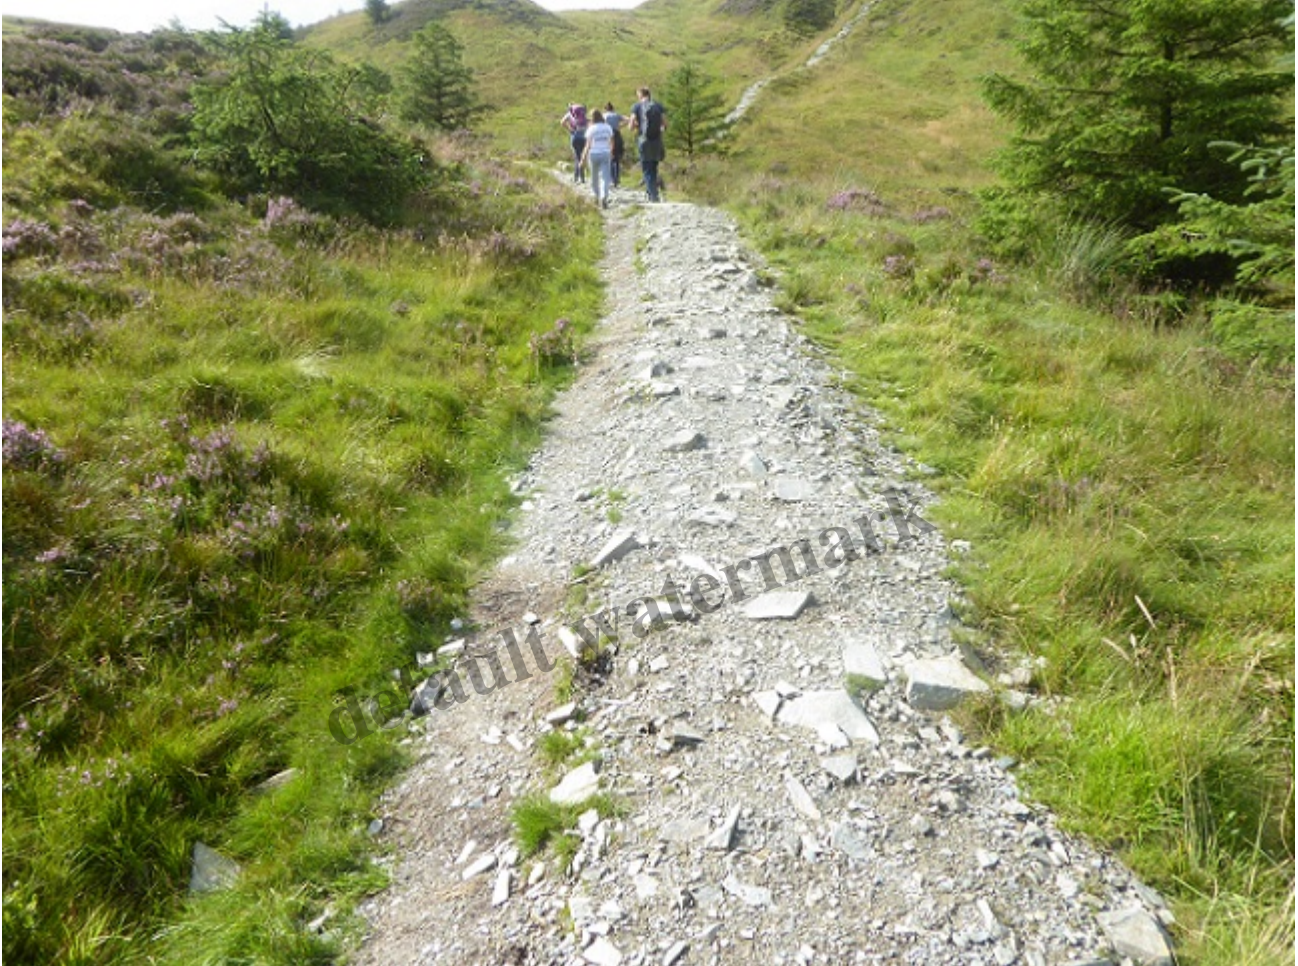
As the raised path has eroded, a new path has been created to the left of it. If this continues the edge of the ditch further to the left could start to collapse

Regular maintenance – a stitch in time – would prevent these problems becoming serious and undermining the £500k that was invested in creating the new path. Some damage to the new path needs to be fixed immediately:

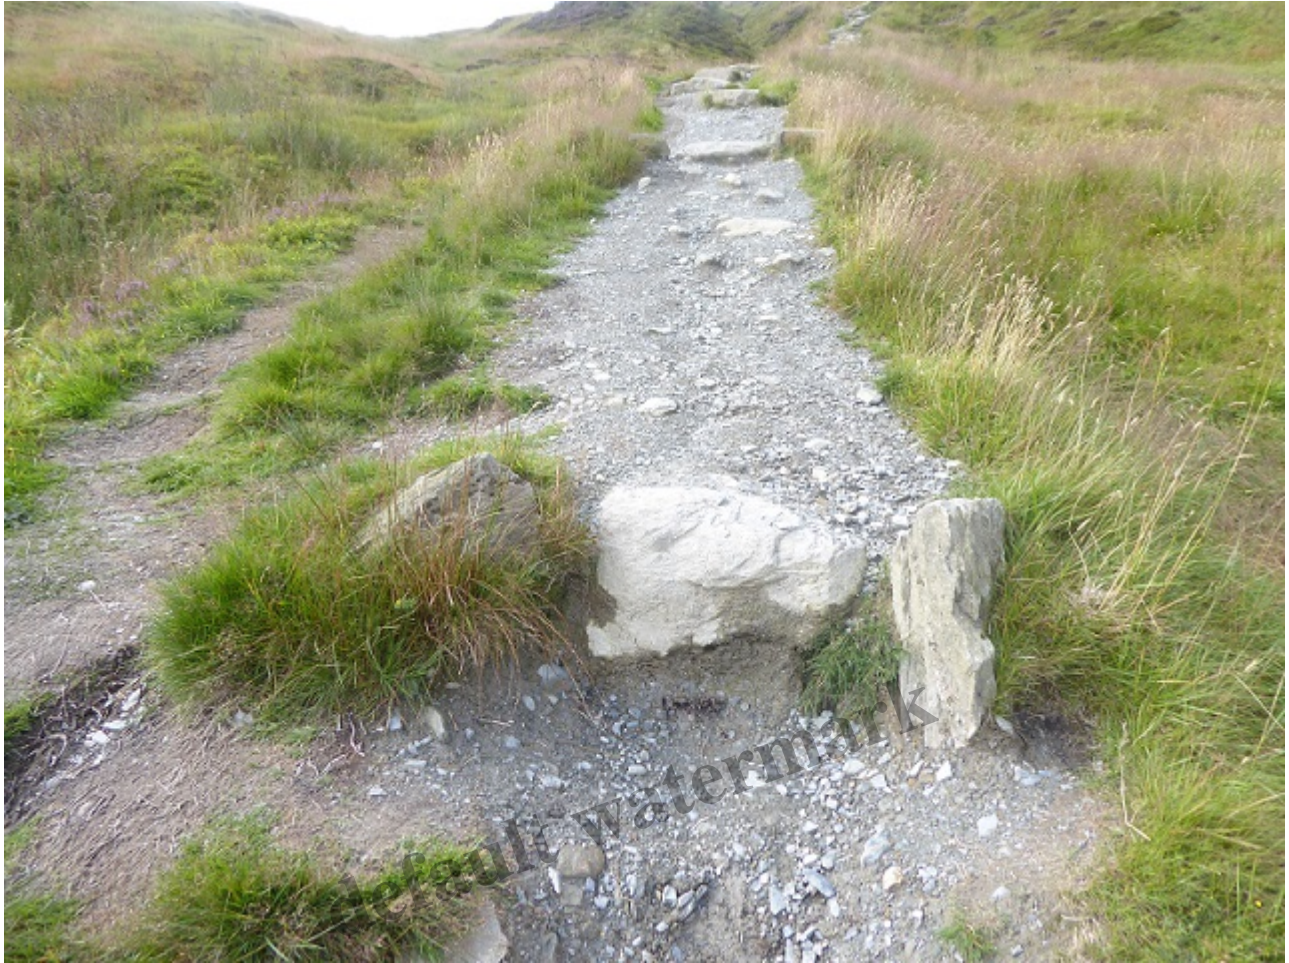
The raised path should have shed water but is now starting to gully and water is being erected over this step eroding it further. How long until it collapses?

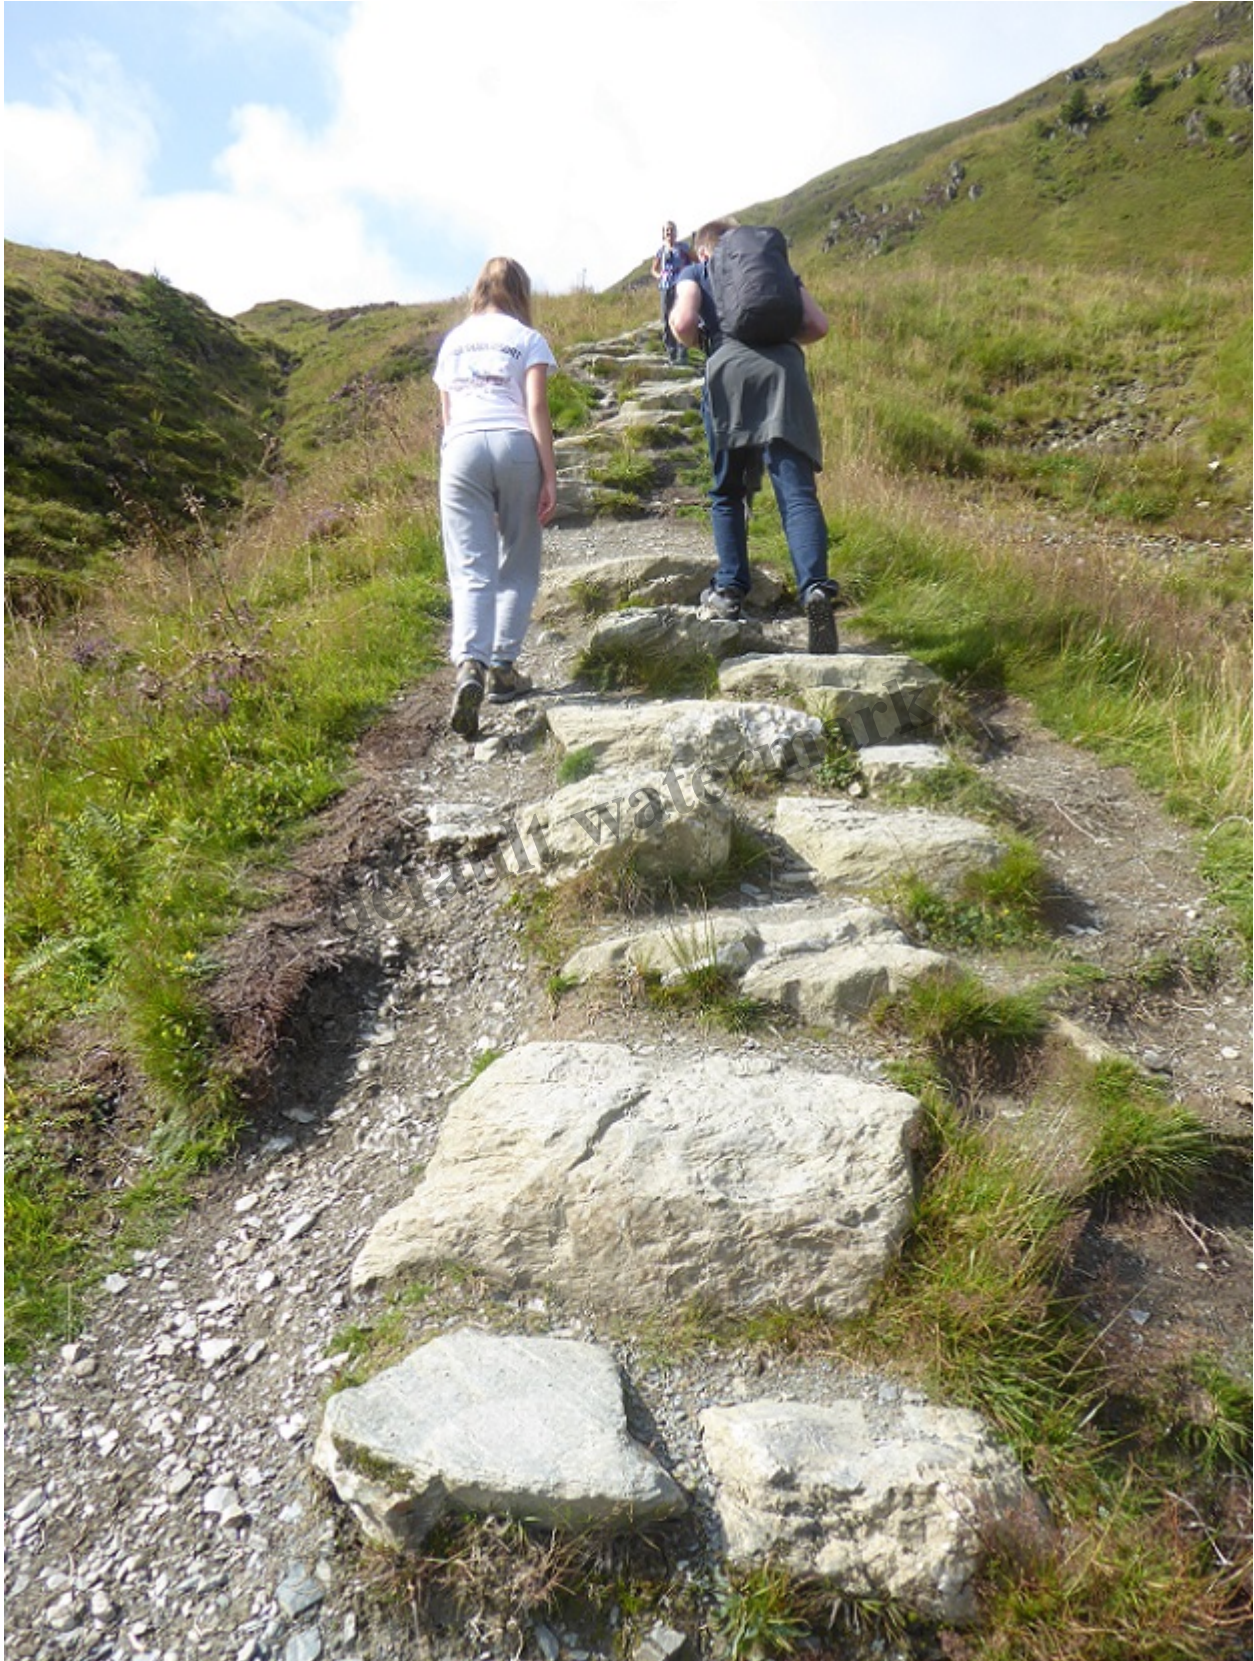
Other damage is less urgent. I was concerned about the abrasion on either side of this short section which is clearly a consequence of poor path design/construction:

Who would ever use the higher boulder on the middle left as a step? It blocks the path rather than encouraging people to walk up it.

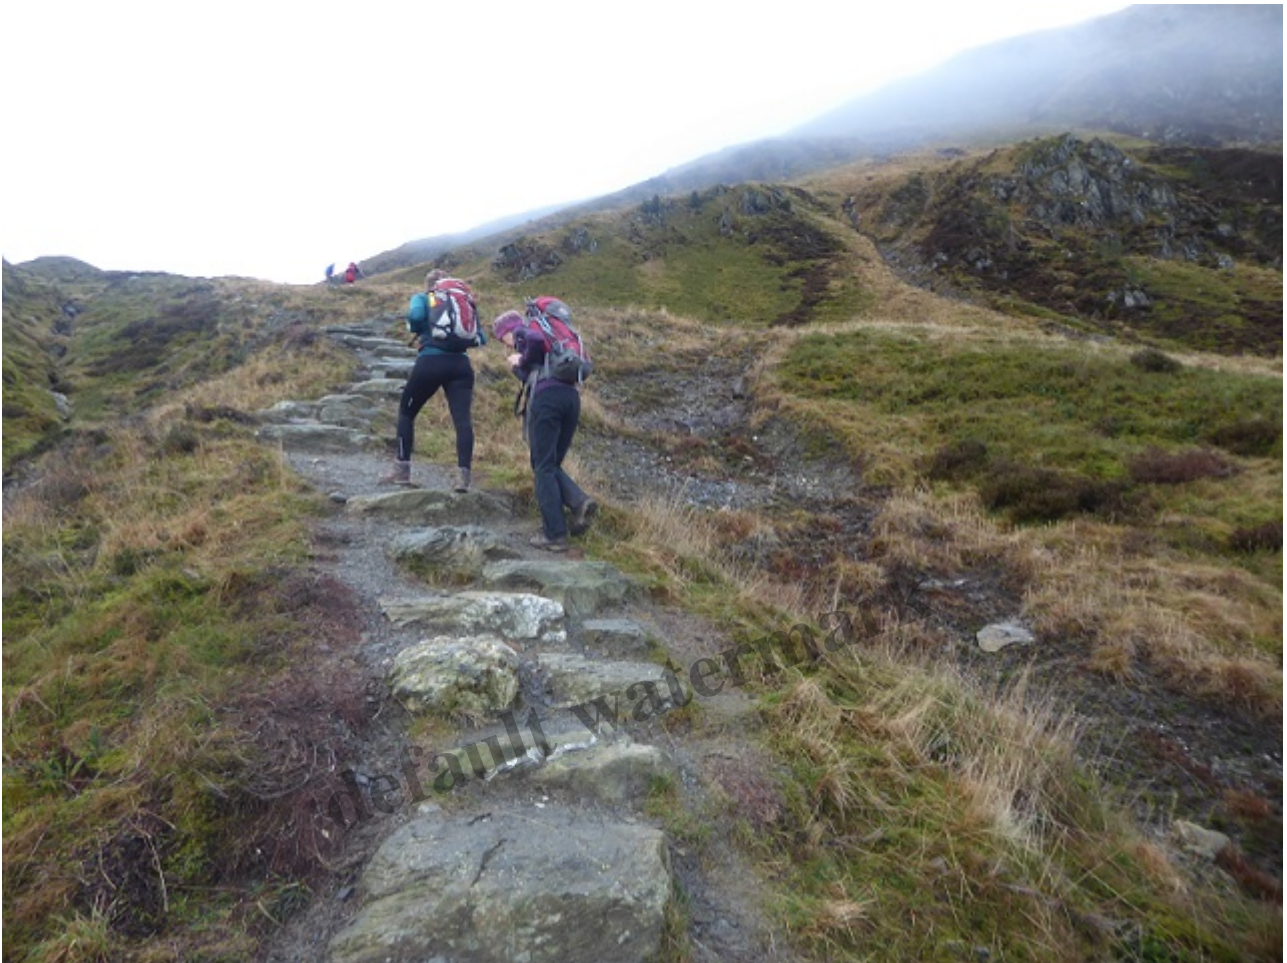
Photo Dec 2018, showing signs of incipient path on left. The trampled vegetation on the right has now recovered but a new path has developed to the right of that.

What the photos show is that some of the paths that evolved around the steps are relatively robust and have yet, themselves, been subject to serious erosion.

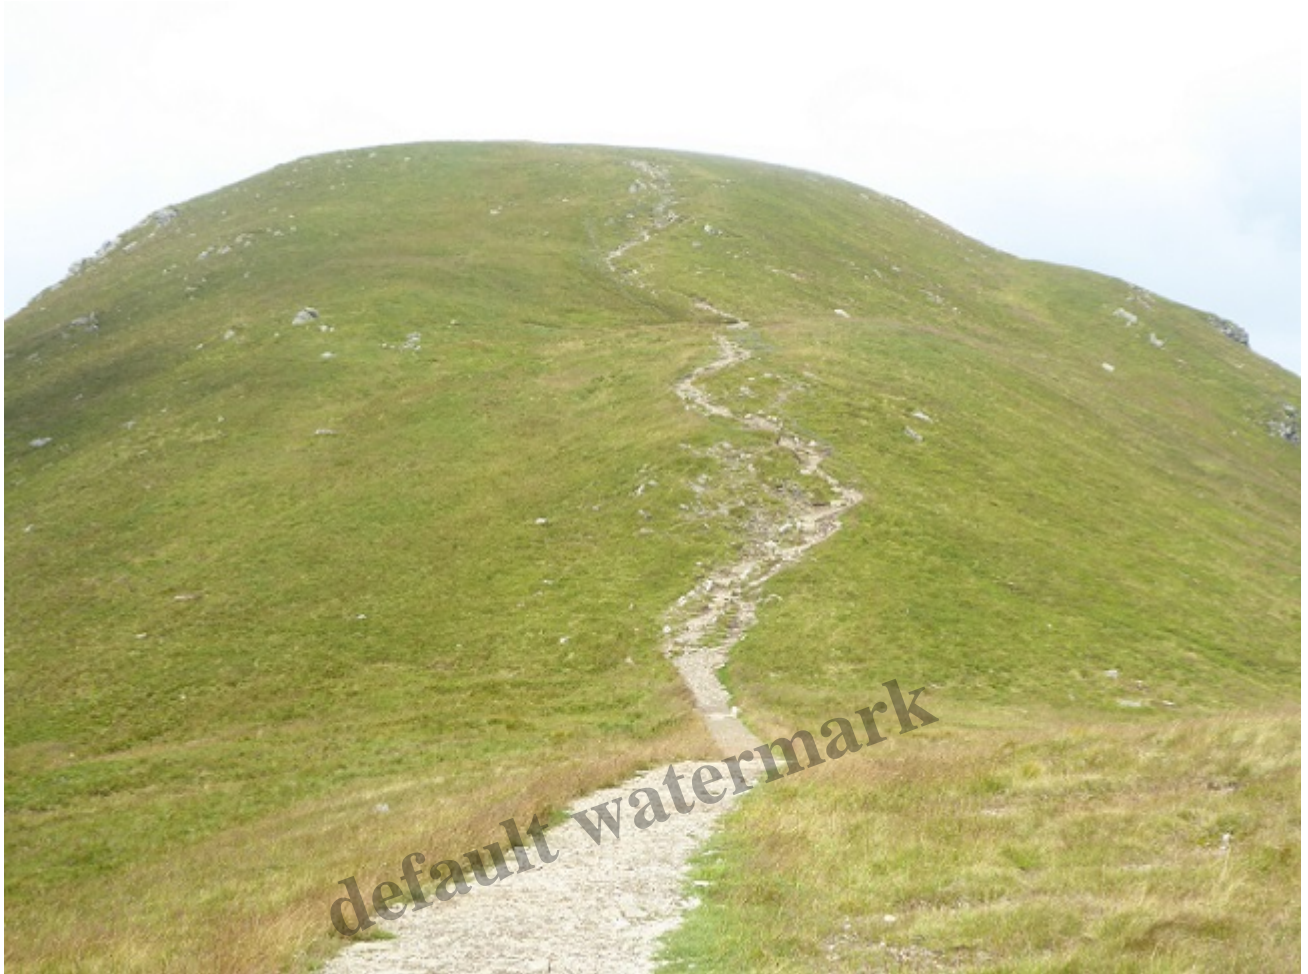
There is also some serious damage to the upper section of path which, as far as I am aware, was not included in the Mountains and the People Project, ie despite spending £500k this was not enough to repair the entire Ben Ledi path, only the middle section:

Upper section of the Ben Ledi path viewed from what I understand was the final stretch upgraded by the Mountains and the People project

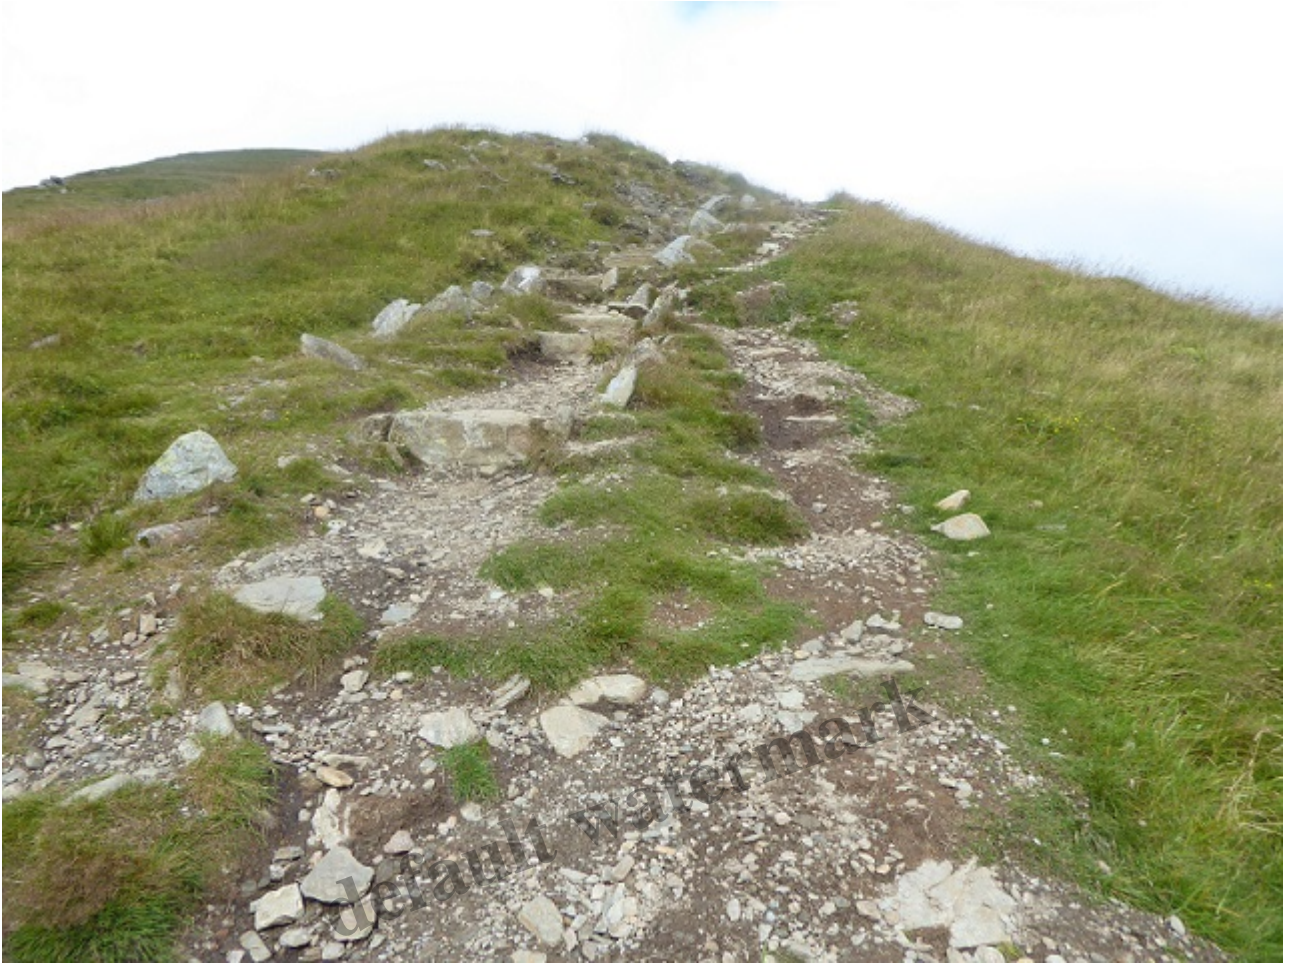
Close up of first steep section showing remnants of former path work. The height of the first step has deterred walkers from accessing the steps above and resulted in the erosion of the ground on the right.

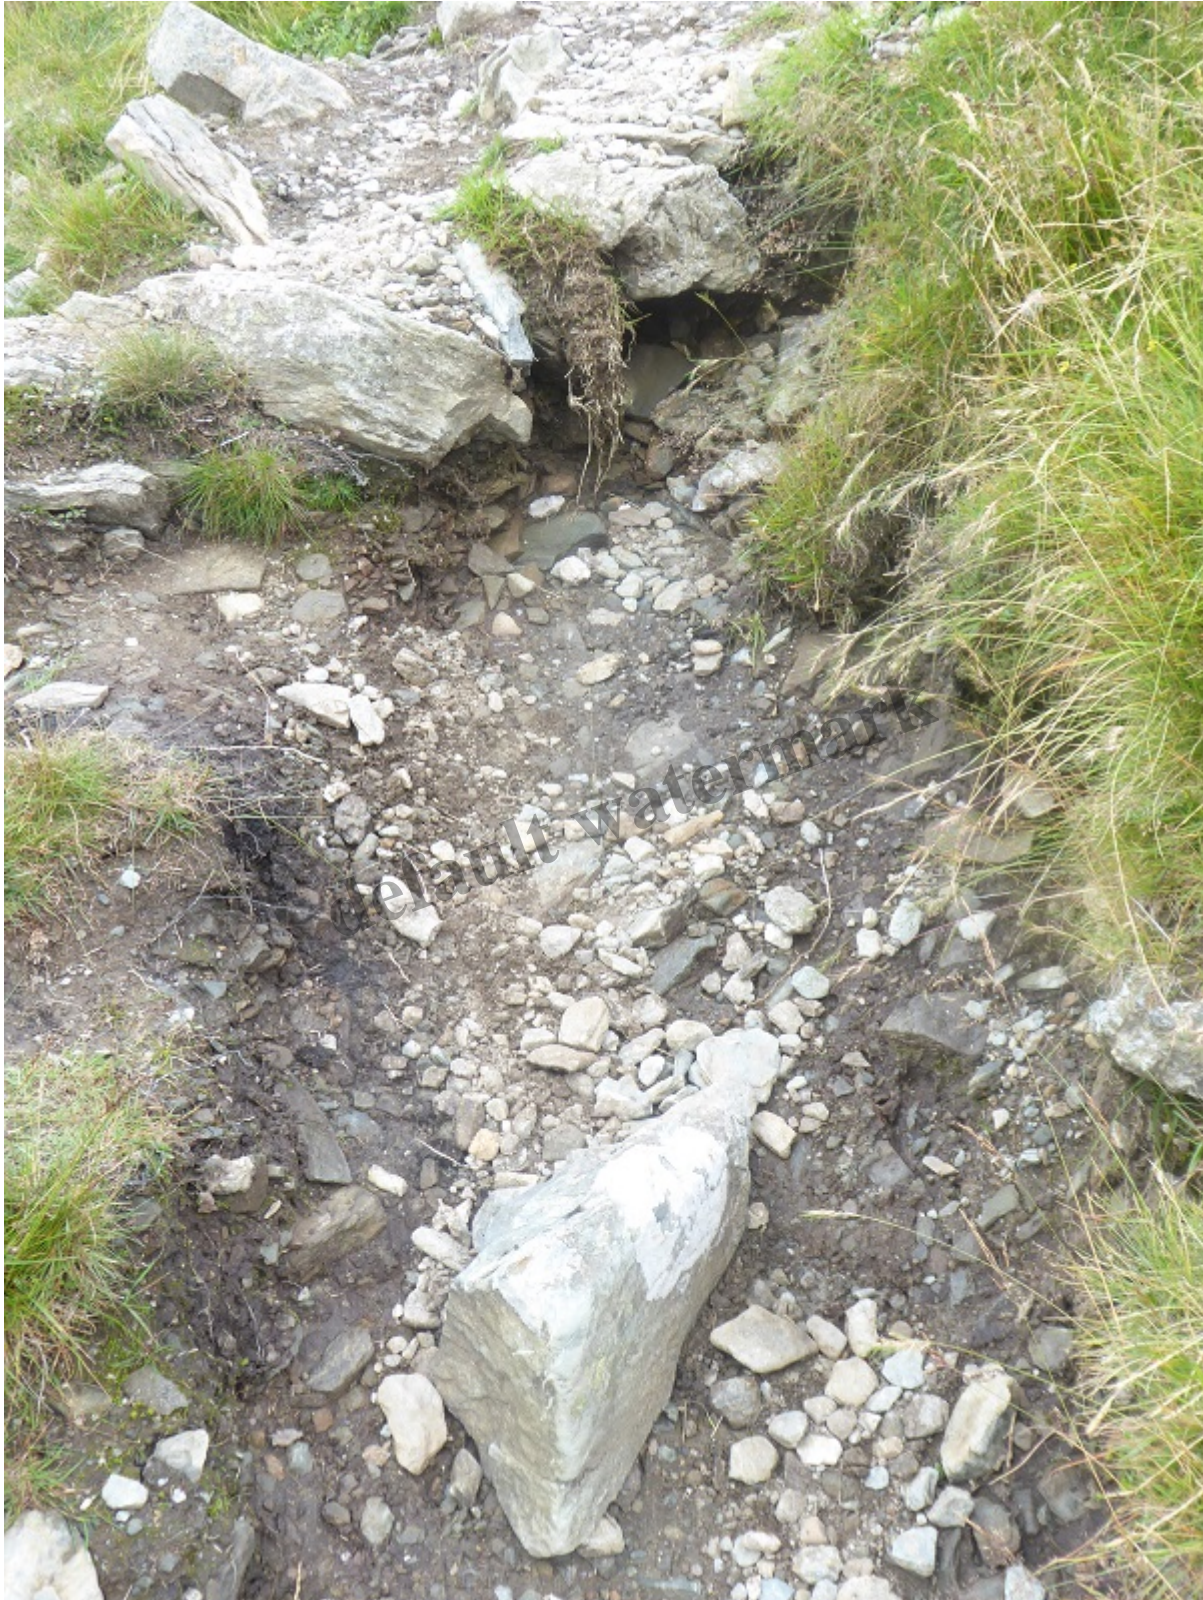
There had been earlier work done on the upper section of work but, without maintenance and further investment, it has gradually eroded away. Sections are now collapsing:

Note how the boulder in the foreground, which once formed a step, has been eroded out of the path.

The photo above (I have more!) provides an illustration of what is likely to happen to the stepped sections of the Mountains and the People path unless the problems are addressed quickly. That requires Forest and Land Scotland, who own the land, to fulfil its obligations to maintain paths on the land it owns properly and to act to rectify the problems.
