The Ben Ledi path and the outdoor recreation failure in the Loch Lomond and Trossachs National Park

The case of the tourist path up Ben Ledi

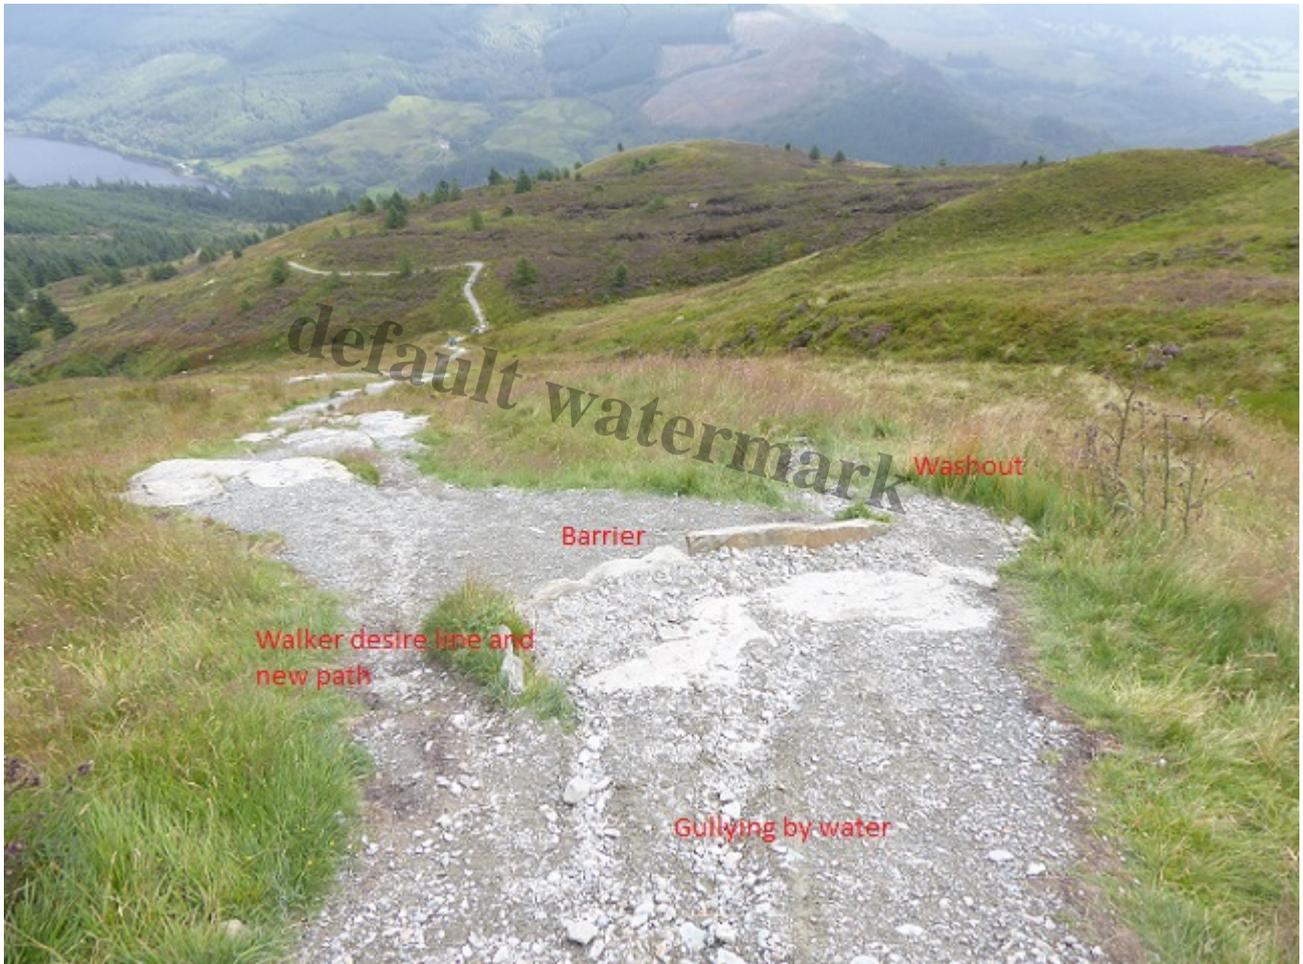
A path gone wrong. A section of the tourist route up Ben Ledi, August 2021, Loch Lubnaig behind

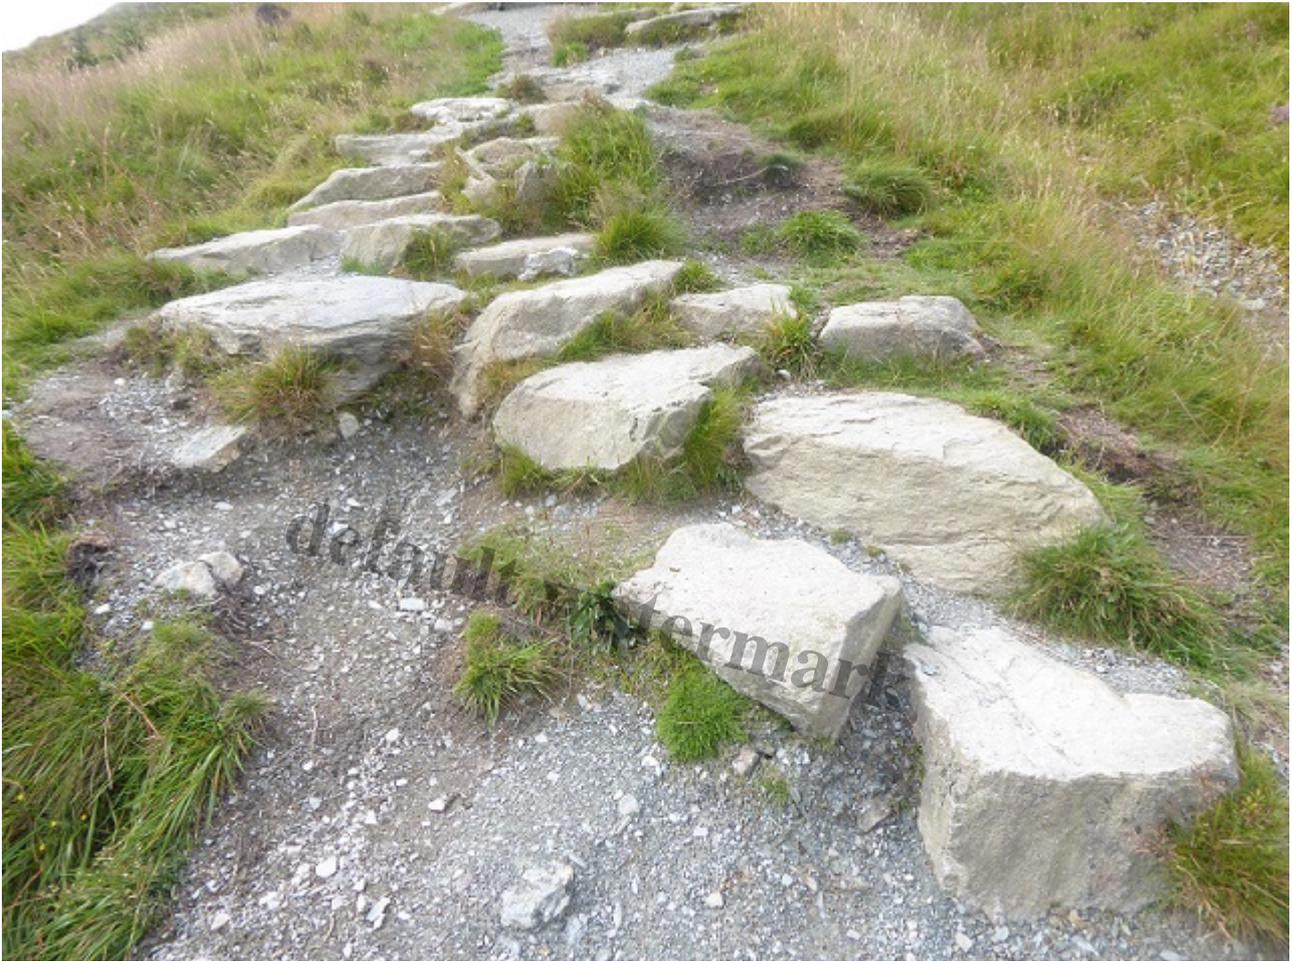
Interpretation. It appears that initially people avoided the steps on the right because they were too high and chose instead to walk directly to the large flat boulder on the left, eroding the ground below which is now starting to gully. As the height required to step onto that boulder increased, people started avoiding them completely, eroding the ground on either side.

Part of the explanation for this path failure appears to lie in fundamental design flaws, particularly on the steeper sections. People generally don't enjoy walking on hard stone but it is well known in the path world and written into the Upland Path Standards ([see here](#)) that where the vertical height difference between steps is more than 15cms people will avoid them if they can. That appears to account for what has happened here and significant section of the new step work on the main Ben Ledi path is at risk of being left high and dry just five years after construction. That in itself should be enough for an LLTNPA Board visit and an inquiry into what has gone wrong.

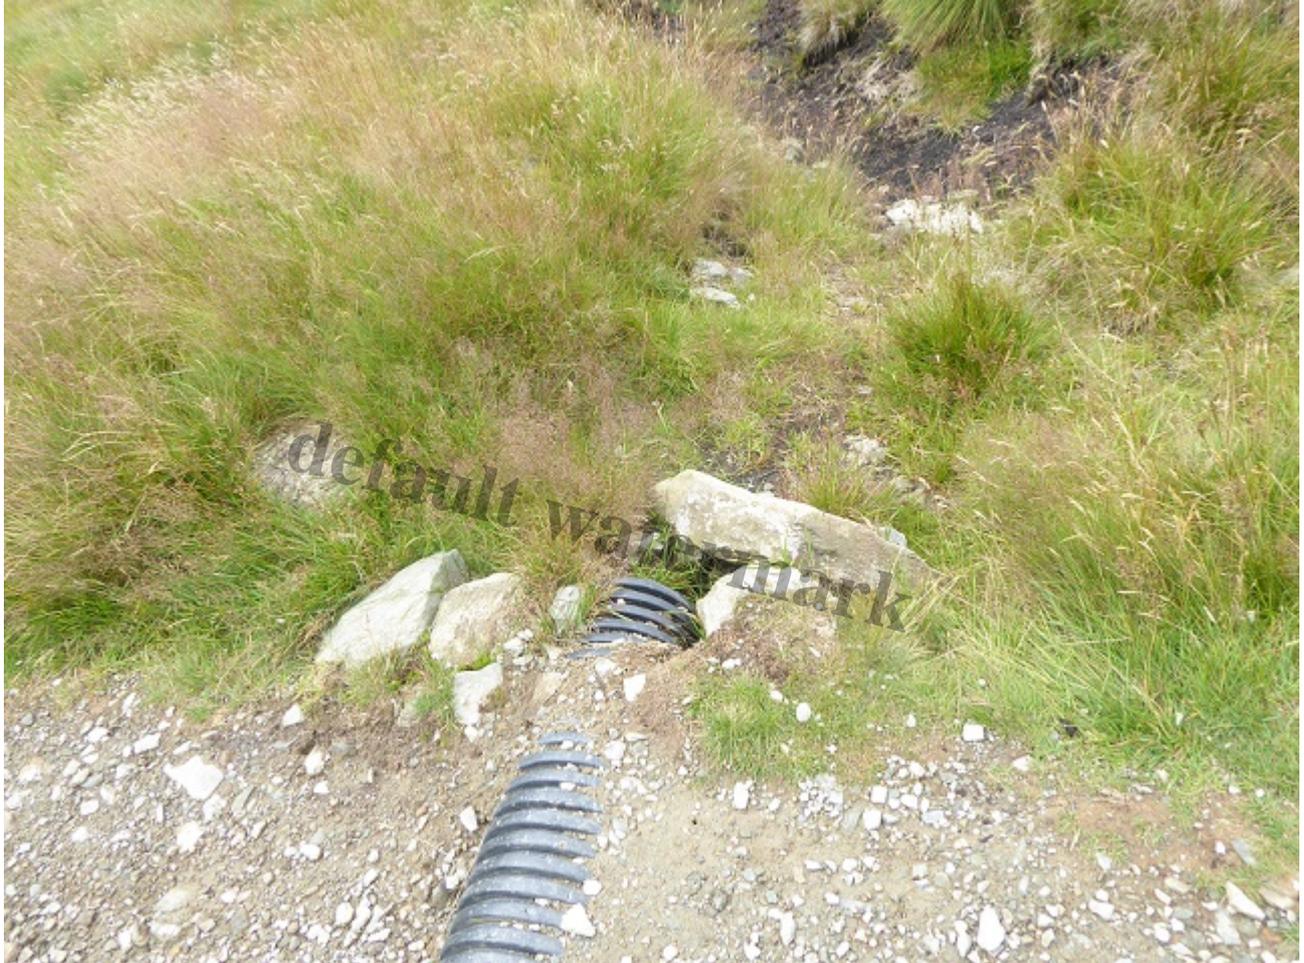
Exposed culvert with dislodged capping stone beyond. If it looks bad, it is bad!

The impact of feet – including crampons in winter! – on the exposed plastic culvert will shorten its life significantly but not even basic maintenance issues such as this are being addressed.

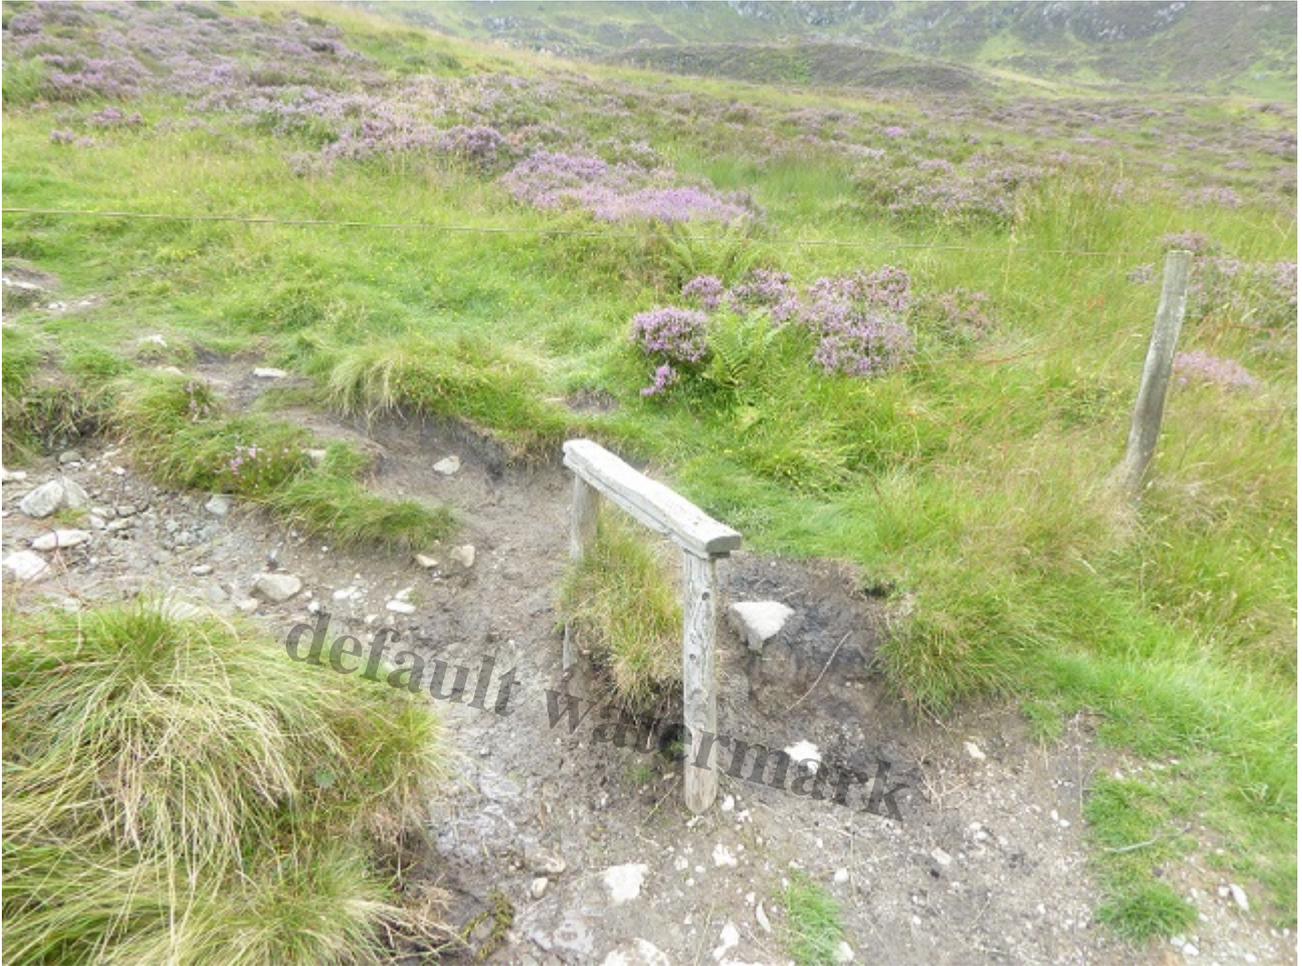
The former fence and stile at the top of the path work in Stank Glen with one wire, just visible, running across the path from the post.

I have photos from December 2018 showing the fence intact. With the erosion, the wire is now at just the right height for a child skipping downhill to garotte themselves. It would be almost impossible for anyone to see in the dark. The safety hazard is obvious and would have been picked up if anyone was maintaining this path. But having managed to get all the path work paid for by the lottery, Forest and Land Scotland should not have relied on volunteers to do the maintenance. Indeed the very first principle in the Upland Path standards published by NatureScot states:

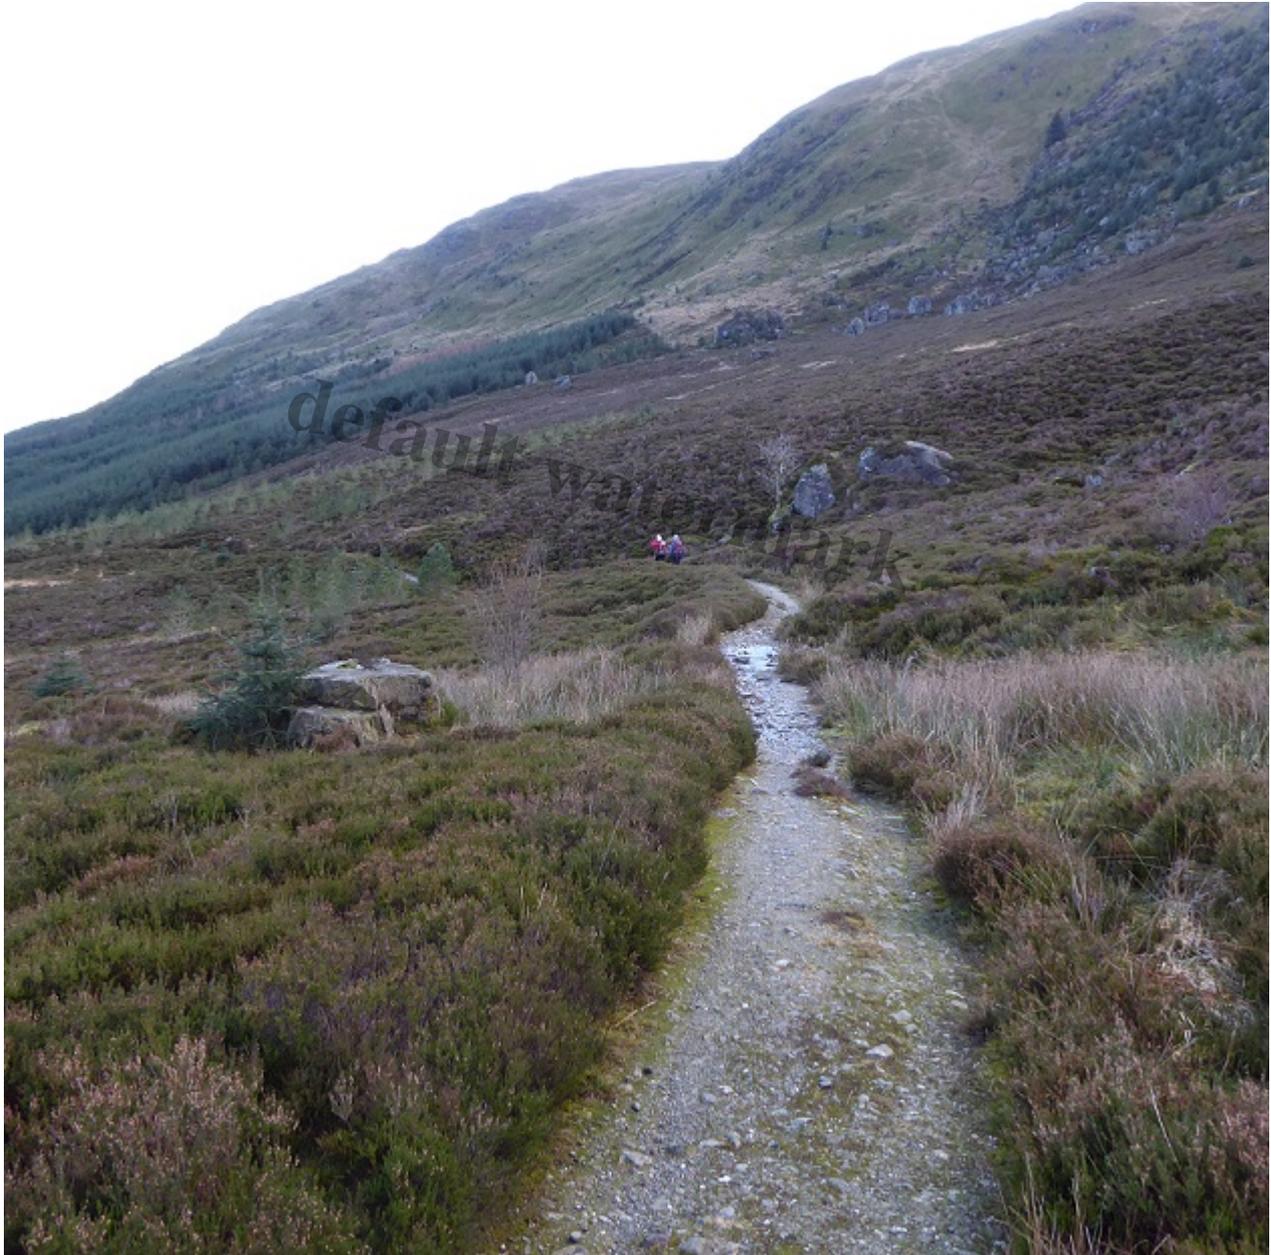
December 2018

There are a number of explanations for this. While at a similar altitude to much of the main path up Ben Ledi, the Stank Glen route has less footfall, is far less steep and is surrounded by native woodland which reduces the amount of water flowing onto it. It is likely to require relatively little ongoing maintenance to remain in a good state.

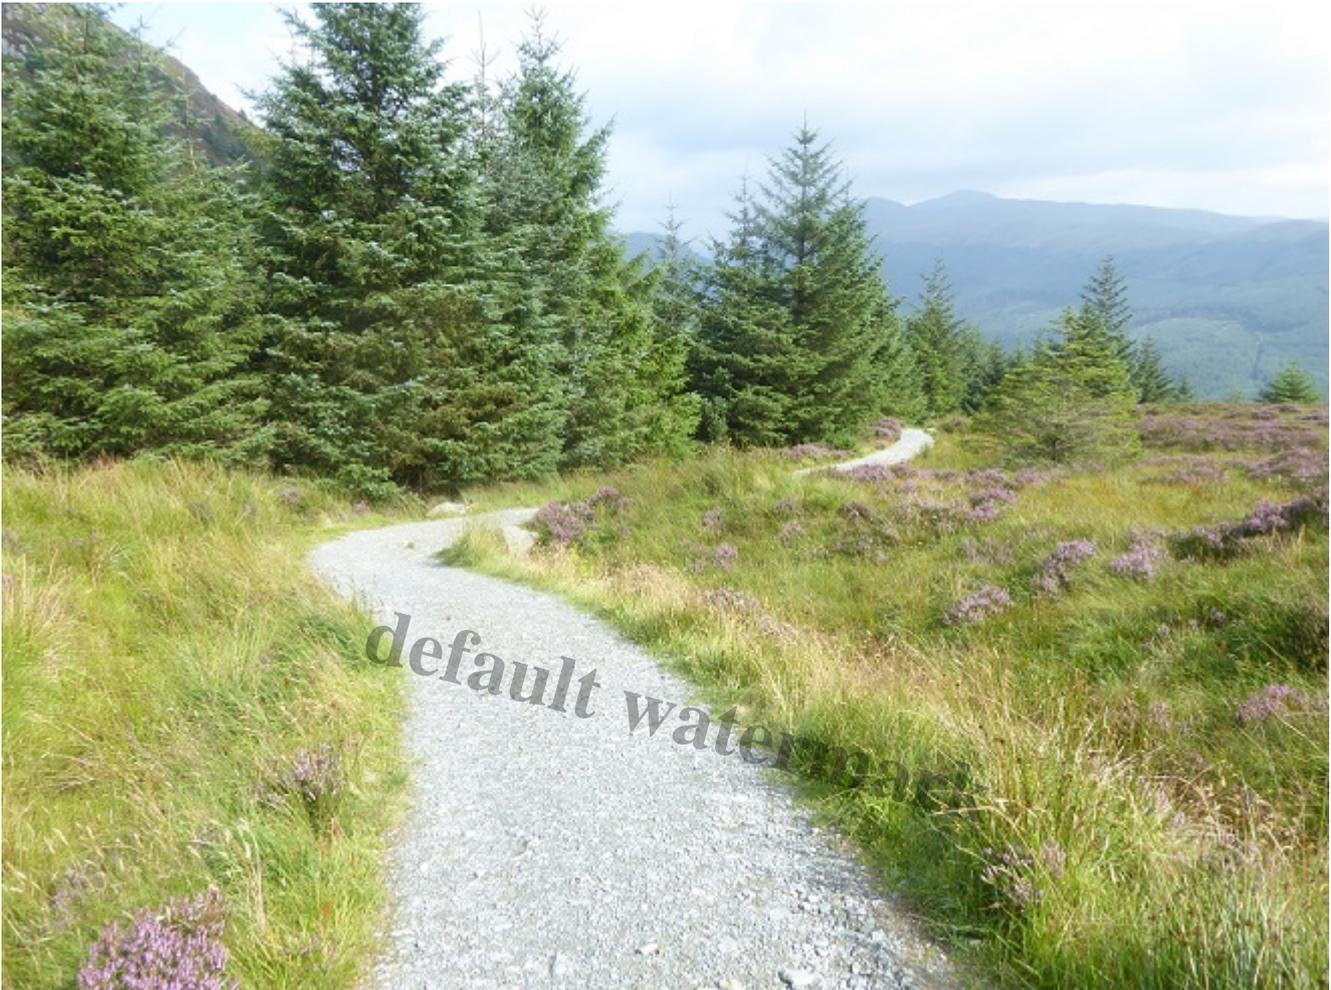
There are similar sections along the main path which have held up well since construction and where the vegetation on either side has regenerated successfully.

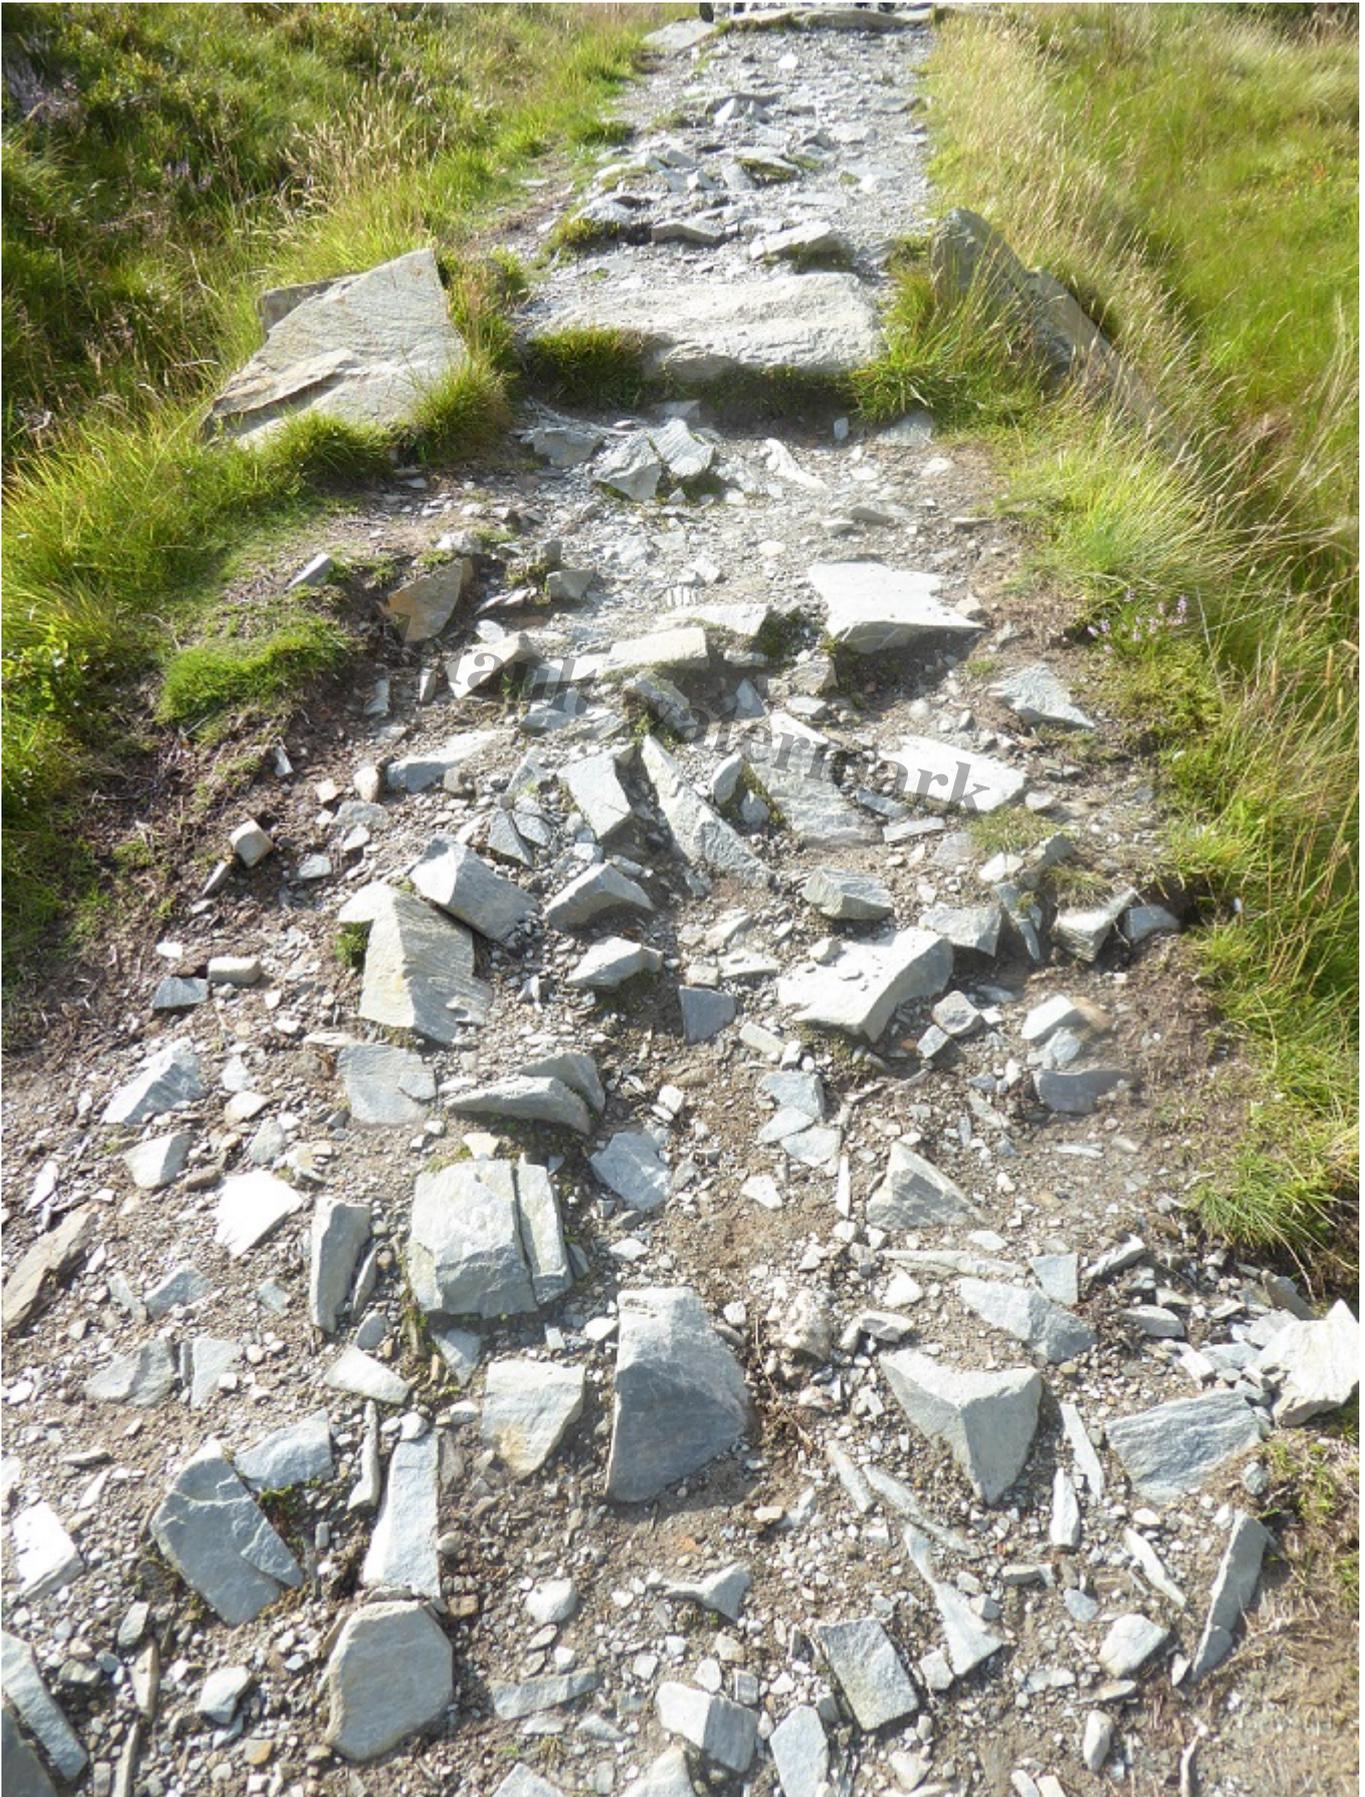
But there are also slightly steeper sections where the aggregate surface has been washed away. According to the Upland Path standards, if properly designed this shouldn't happen. This has made the path unpleasant to walk on so people have taken to the verges and they are now starting to erode.

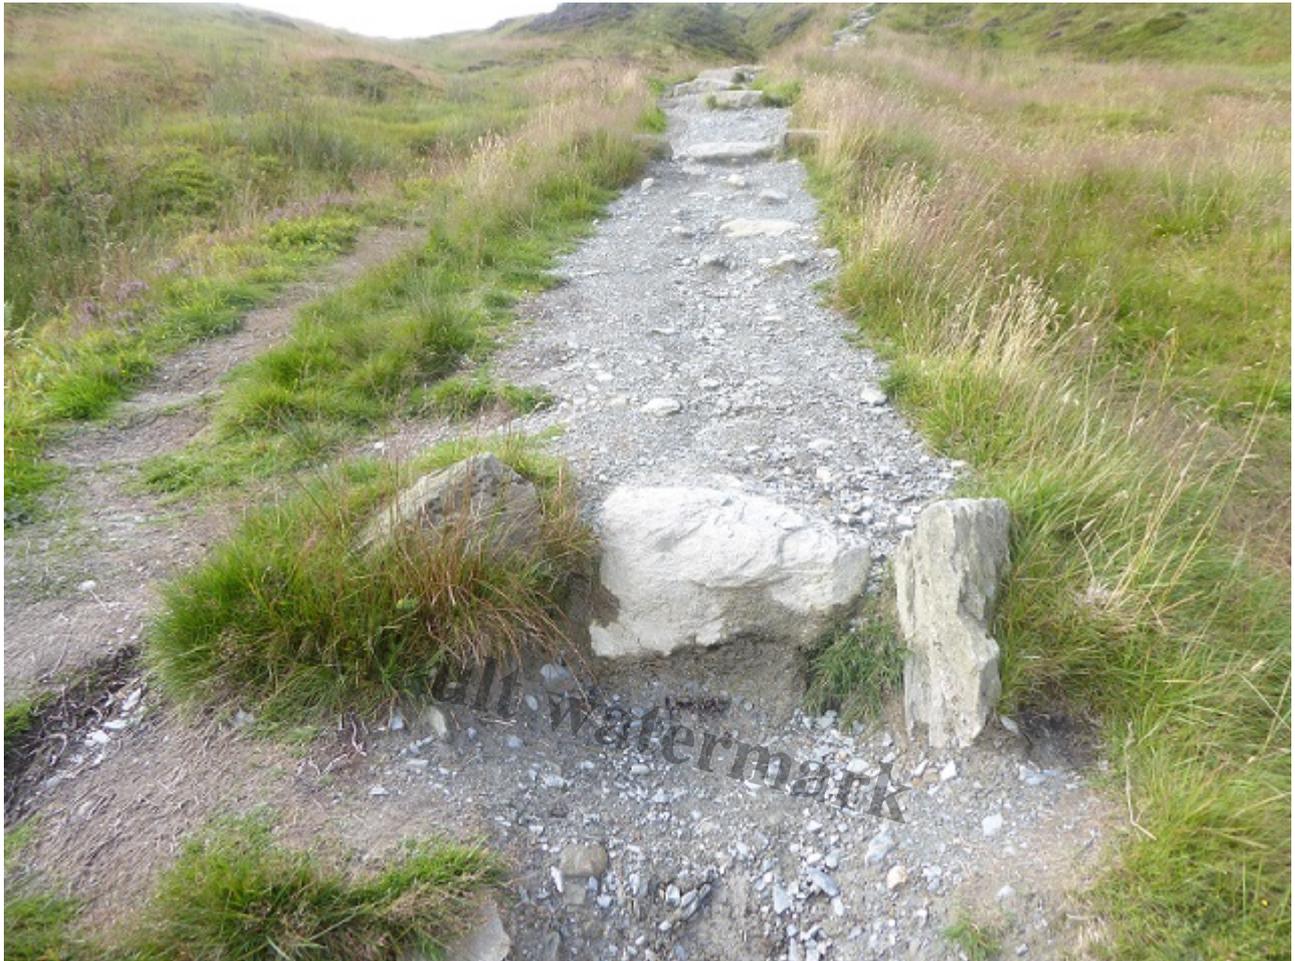
The raised path should have shed water but is now starting to gully and water is being erected over this step eroding it further. How long until it collapses?

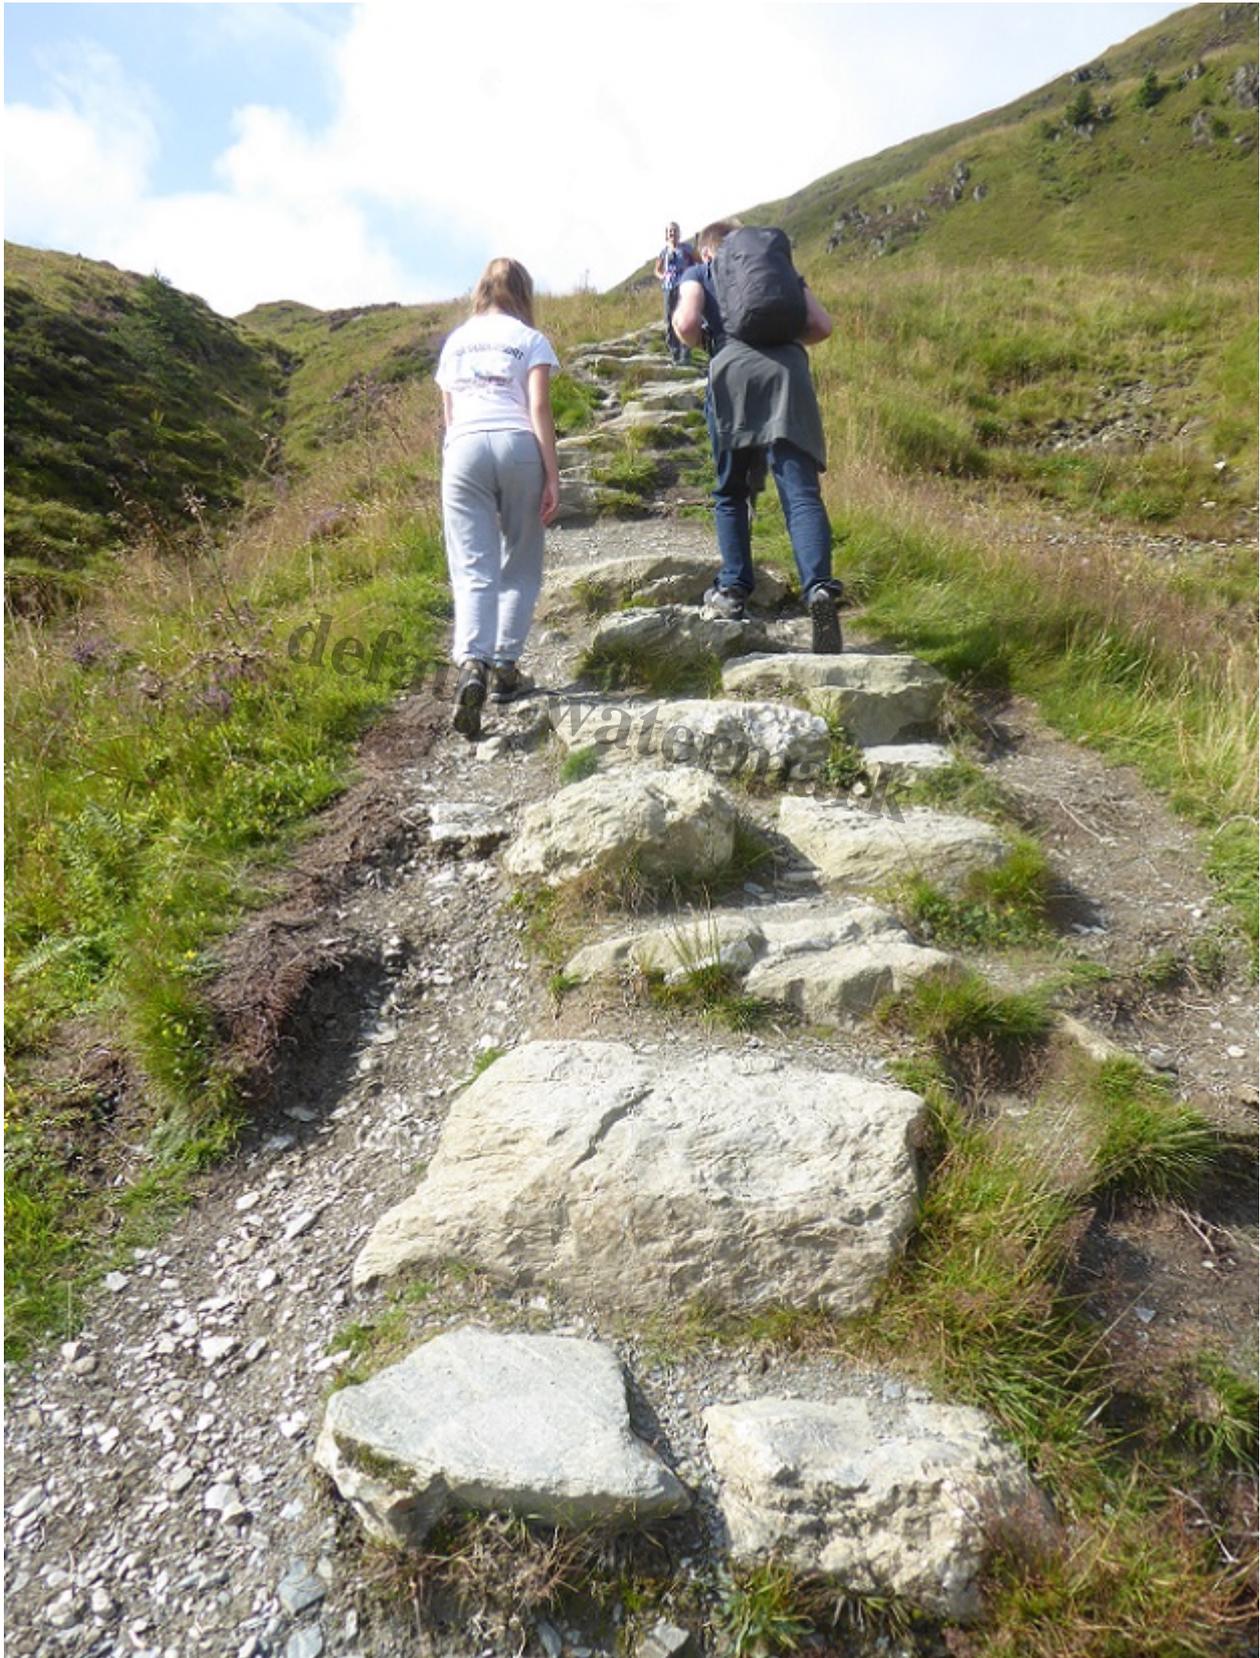
Who would ever use the higher boulder on the middle left as a step? It blocks the path rather than encouraging people to walk up it.

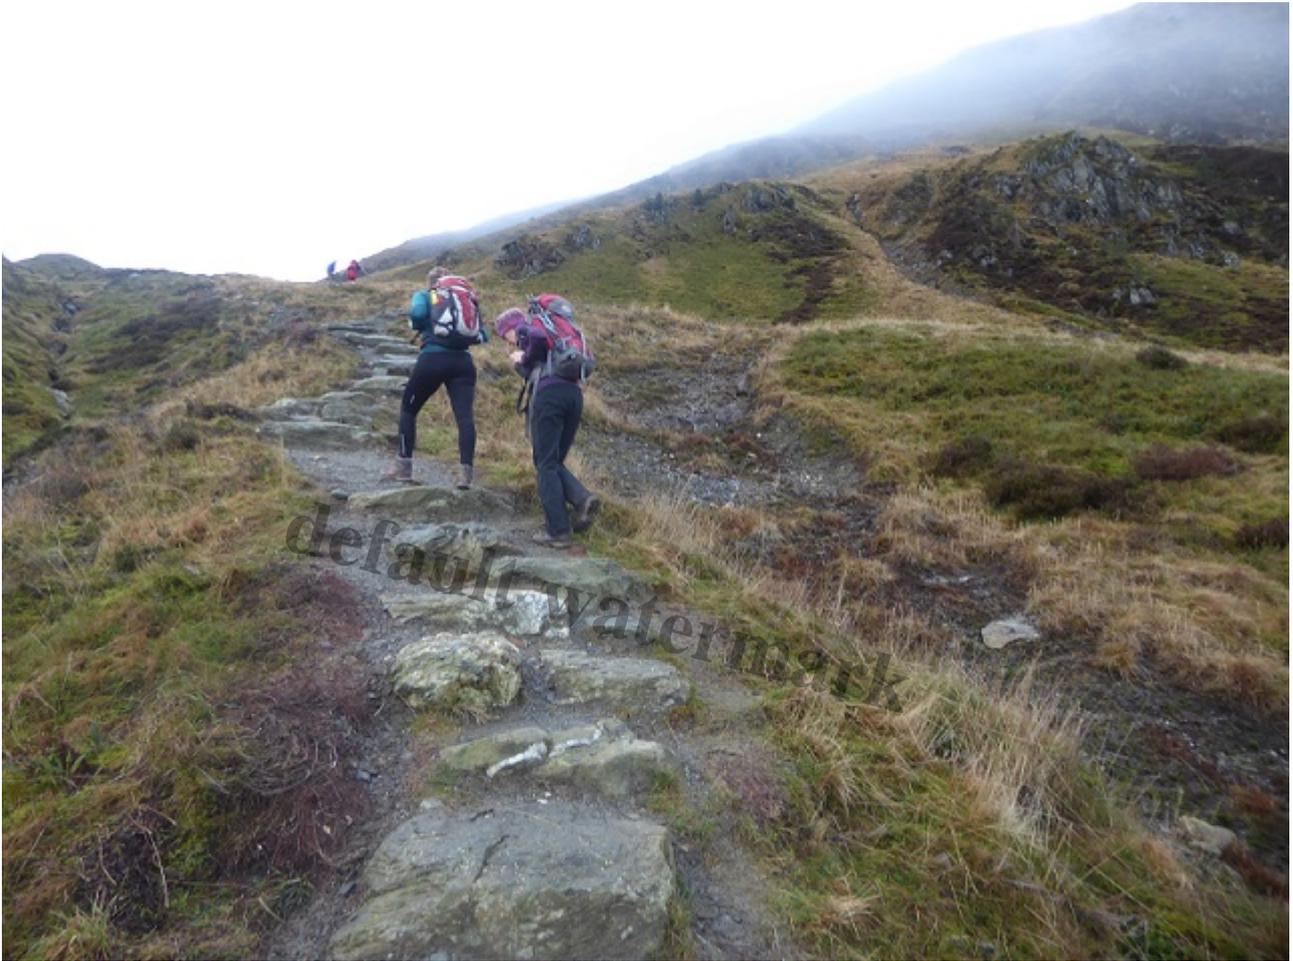
Photo Dec 2018, showing signs of incipient path on left. The trampled vegetation on the right has now recovered but a new path has developed to the right of that.

What the photos show is that some of the paths that evolved around the steps are relatively robust and have yet, themselves, been subject to serious erosion.

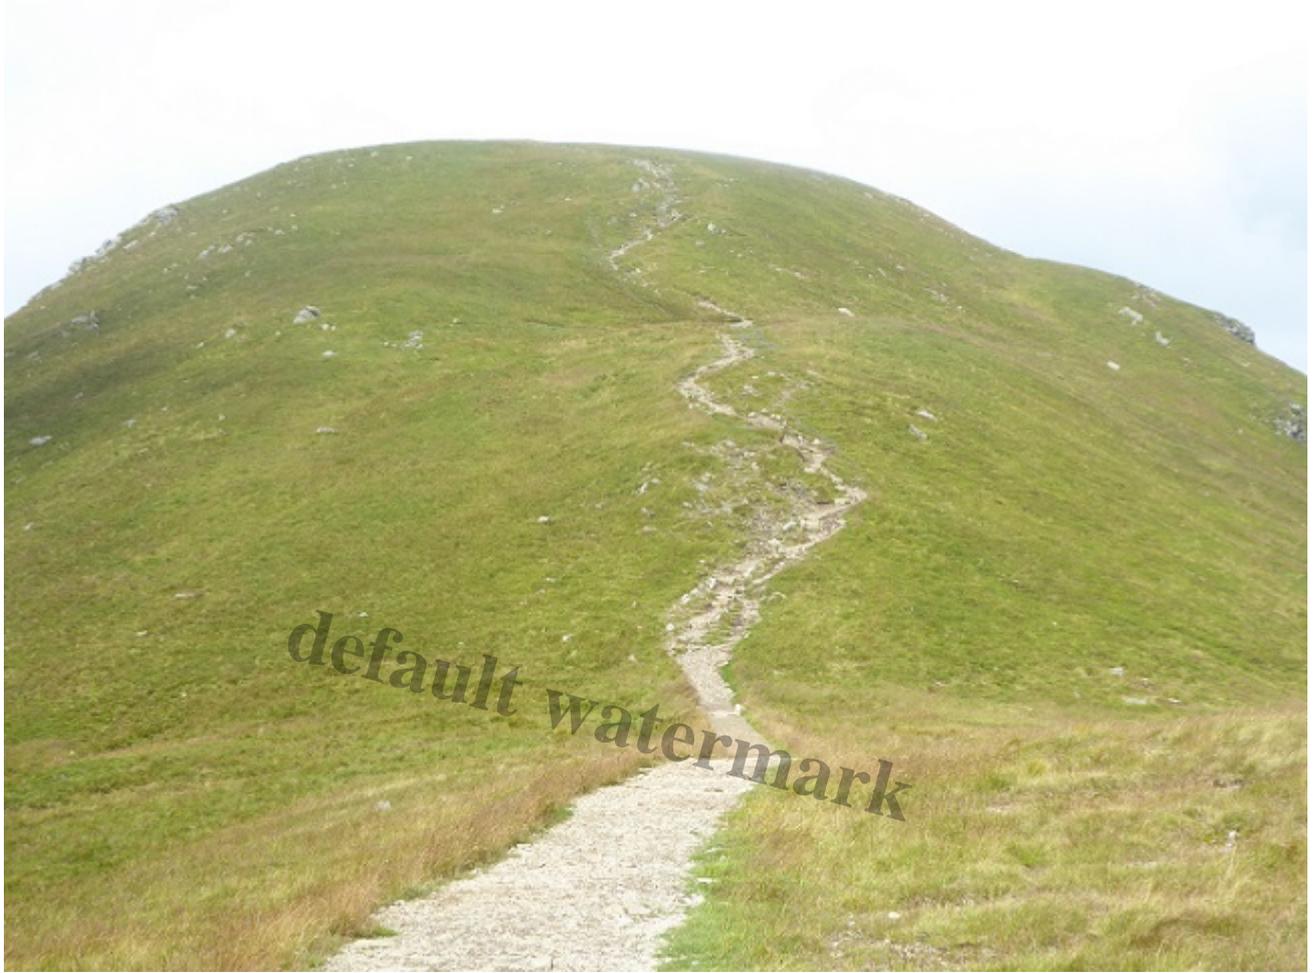
Upper section of the Ben Ledi path viewed from what I understand was the final stretch upgraded by the Mountains and the People project

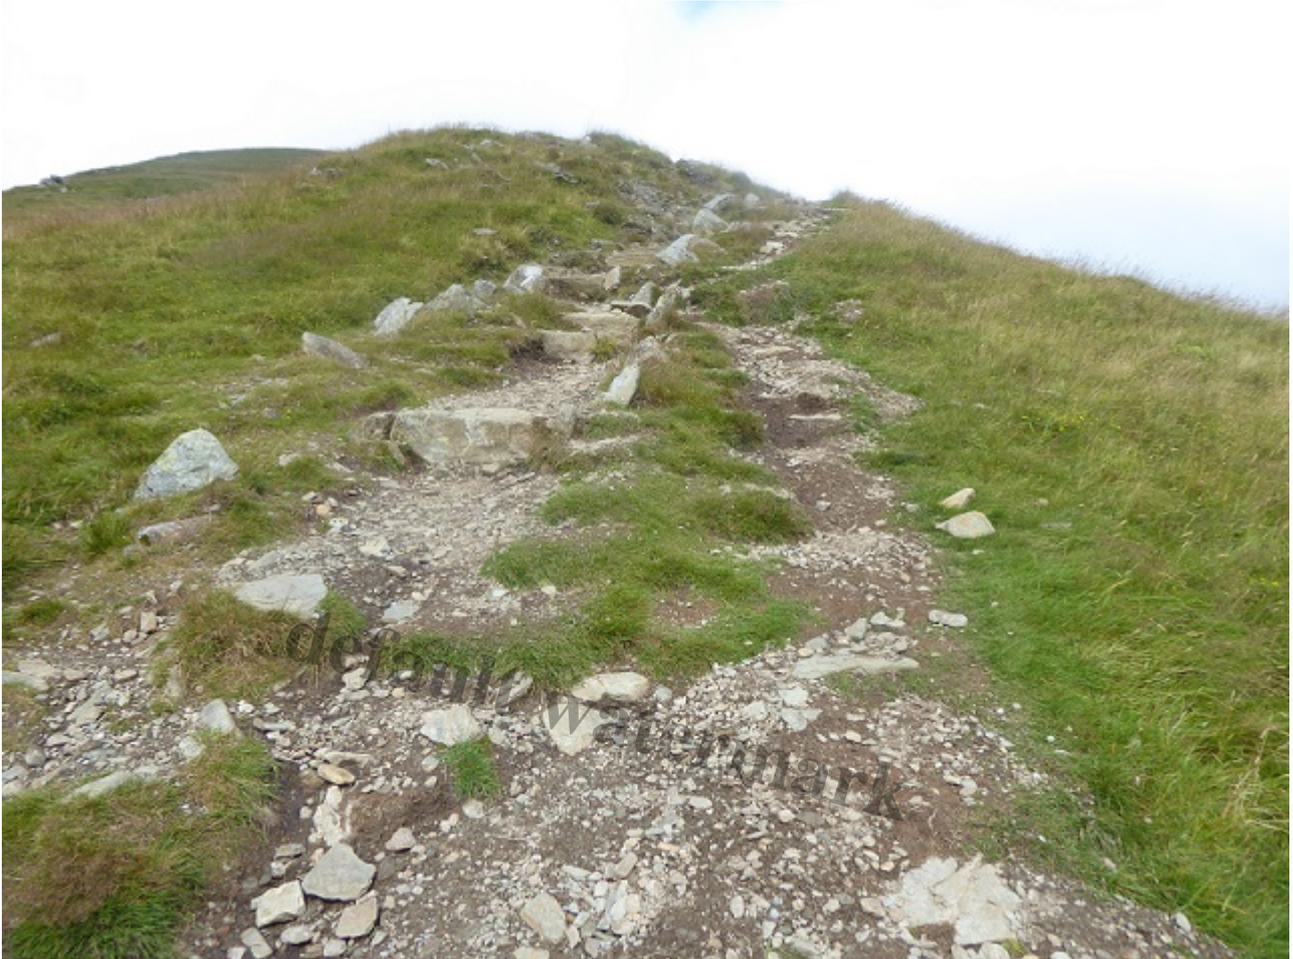
Close up of first steep section showing remnants of former path work. The height of the first step has deterred walkers from accessing the steps above and resulted in the erosion of the ground on the right.

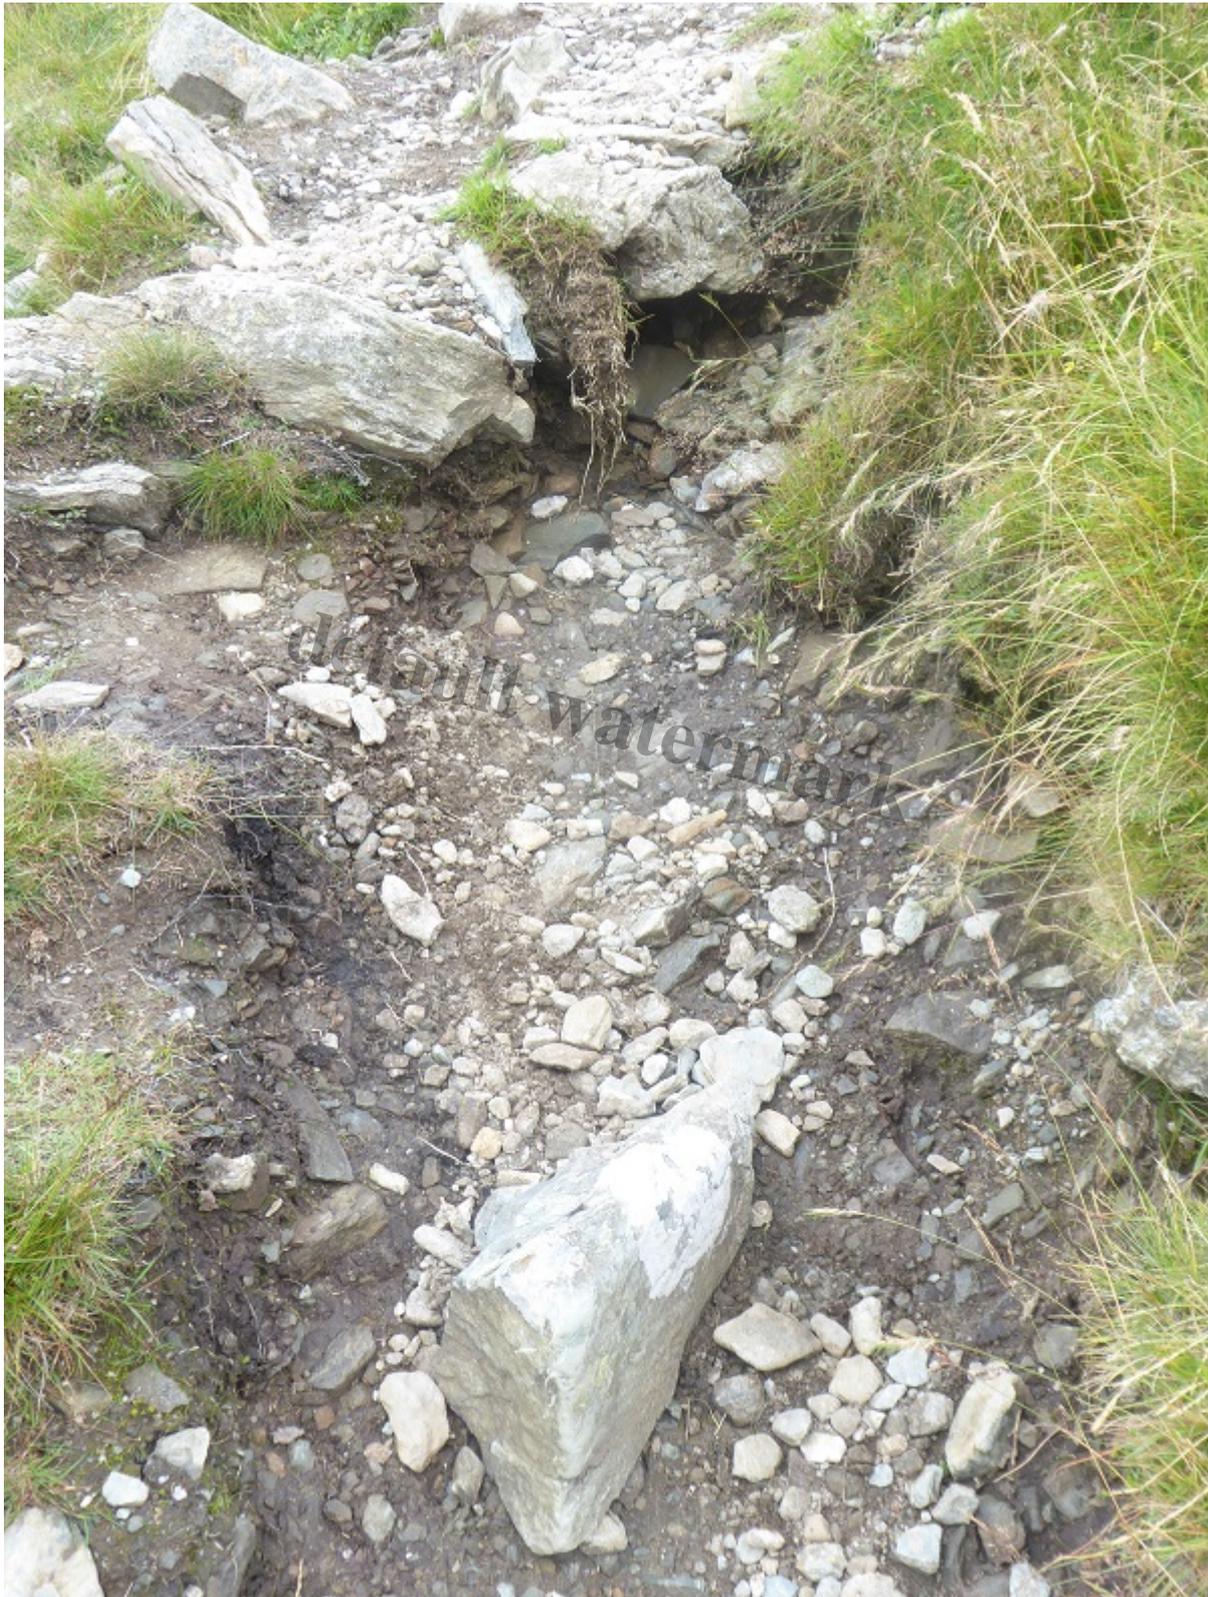
There had been earlier work done on the upper section of work but, without maintenance and further investment, it has gradually eroded away. Sections are now collapsing:

Note how the boulder in the foreground, which once formed a step, has been eroded out of the path.

The photo above (I have more!) provides an illustration of what is likely to happen to the stepped sections of the Mountains and the People path unless the problems are addressed quickly. That requires Forest and Land Scotland, who own the land, to fulfil its obligations to maintain paths on the land it owns properly and to act to rectify the problems.
