Transport Scotland, the Crianlarich by-pass and the ecology of plastic tree shelters

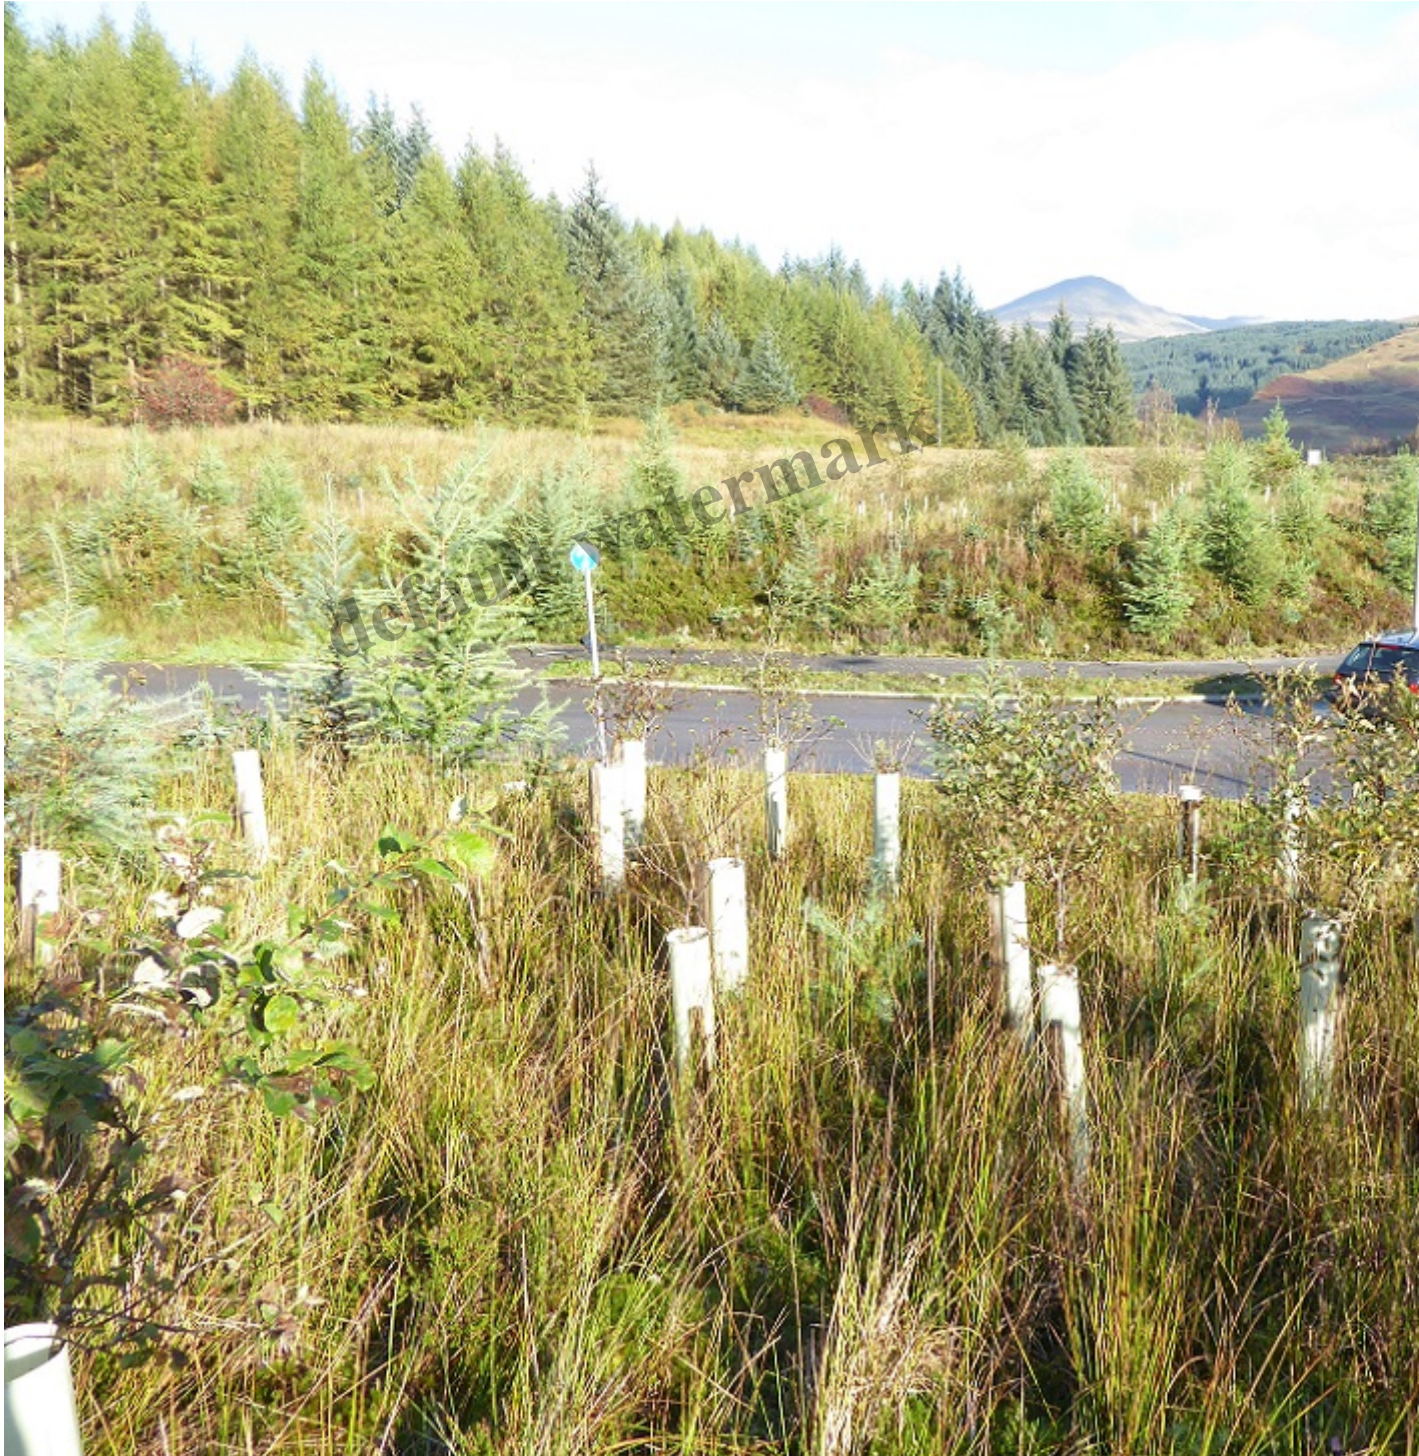
The western edge of the roundabout on the southside of Crianlarich, showing the exit to the by-pass

left. Self-seeded conifers have all but obscured the plastic tree tubes behind the lamp posts but have established in the area in the foreground..

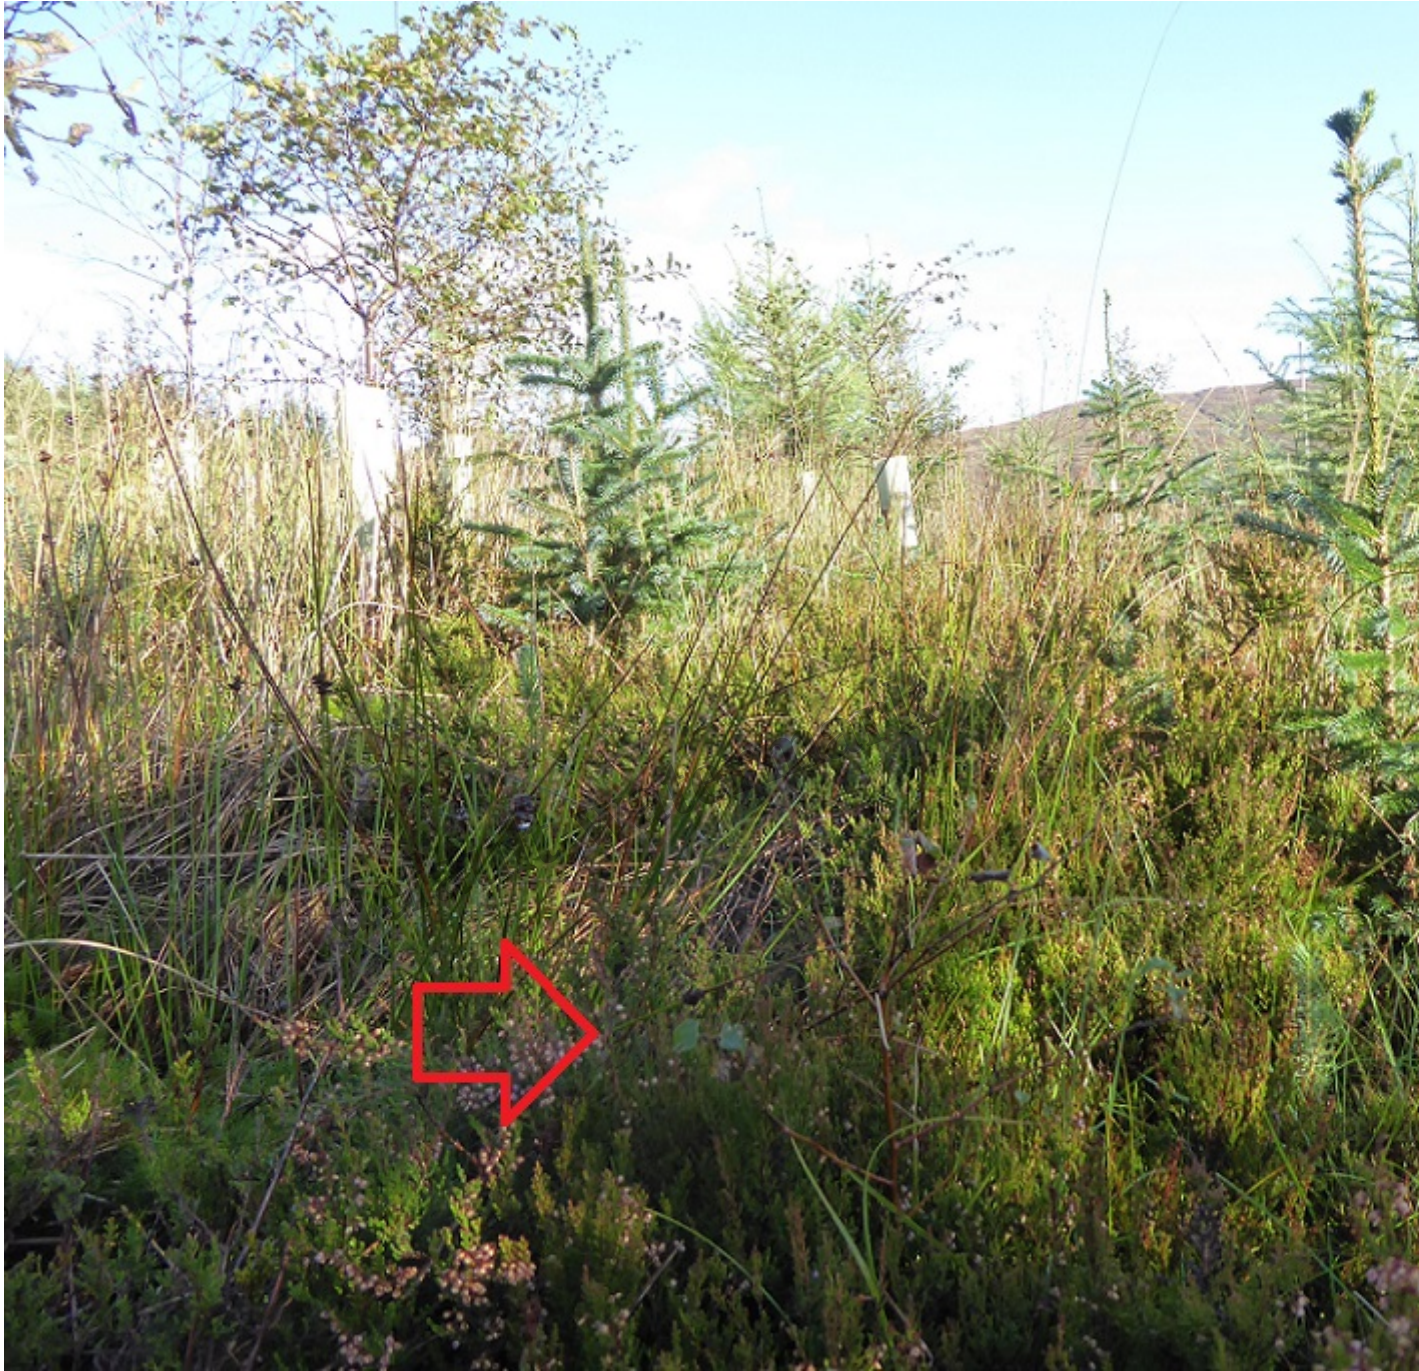
Red arrow points to birch sapling. To the right there are several naturally regenerating spruce.

I am no expert but it didn't take me more than a couple of minutes to spot several self-seeded deciduous trees growing up between the tree shelters, evidence that native trees could have regenerated here without any planting or "protection" from plastics tree tubes. Transport Scotland should have known this because along much of the A82 between Balloch and Bridge of Orchy a belt of native scrub has developed alongside the road without any help from humans other than fencing to keep sheep out. The problem is that landscaping consultants nowadays automatically recommend planting and the use of plastic tree shelters has now become their default position.

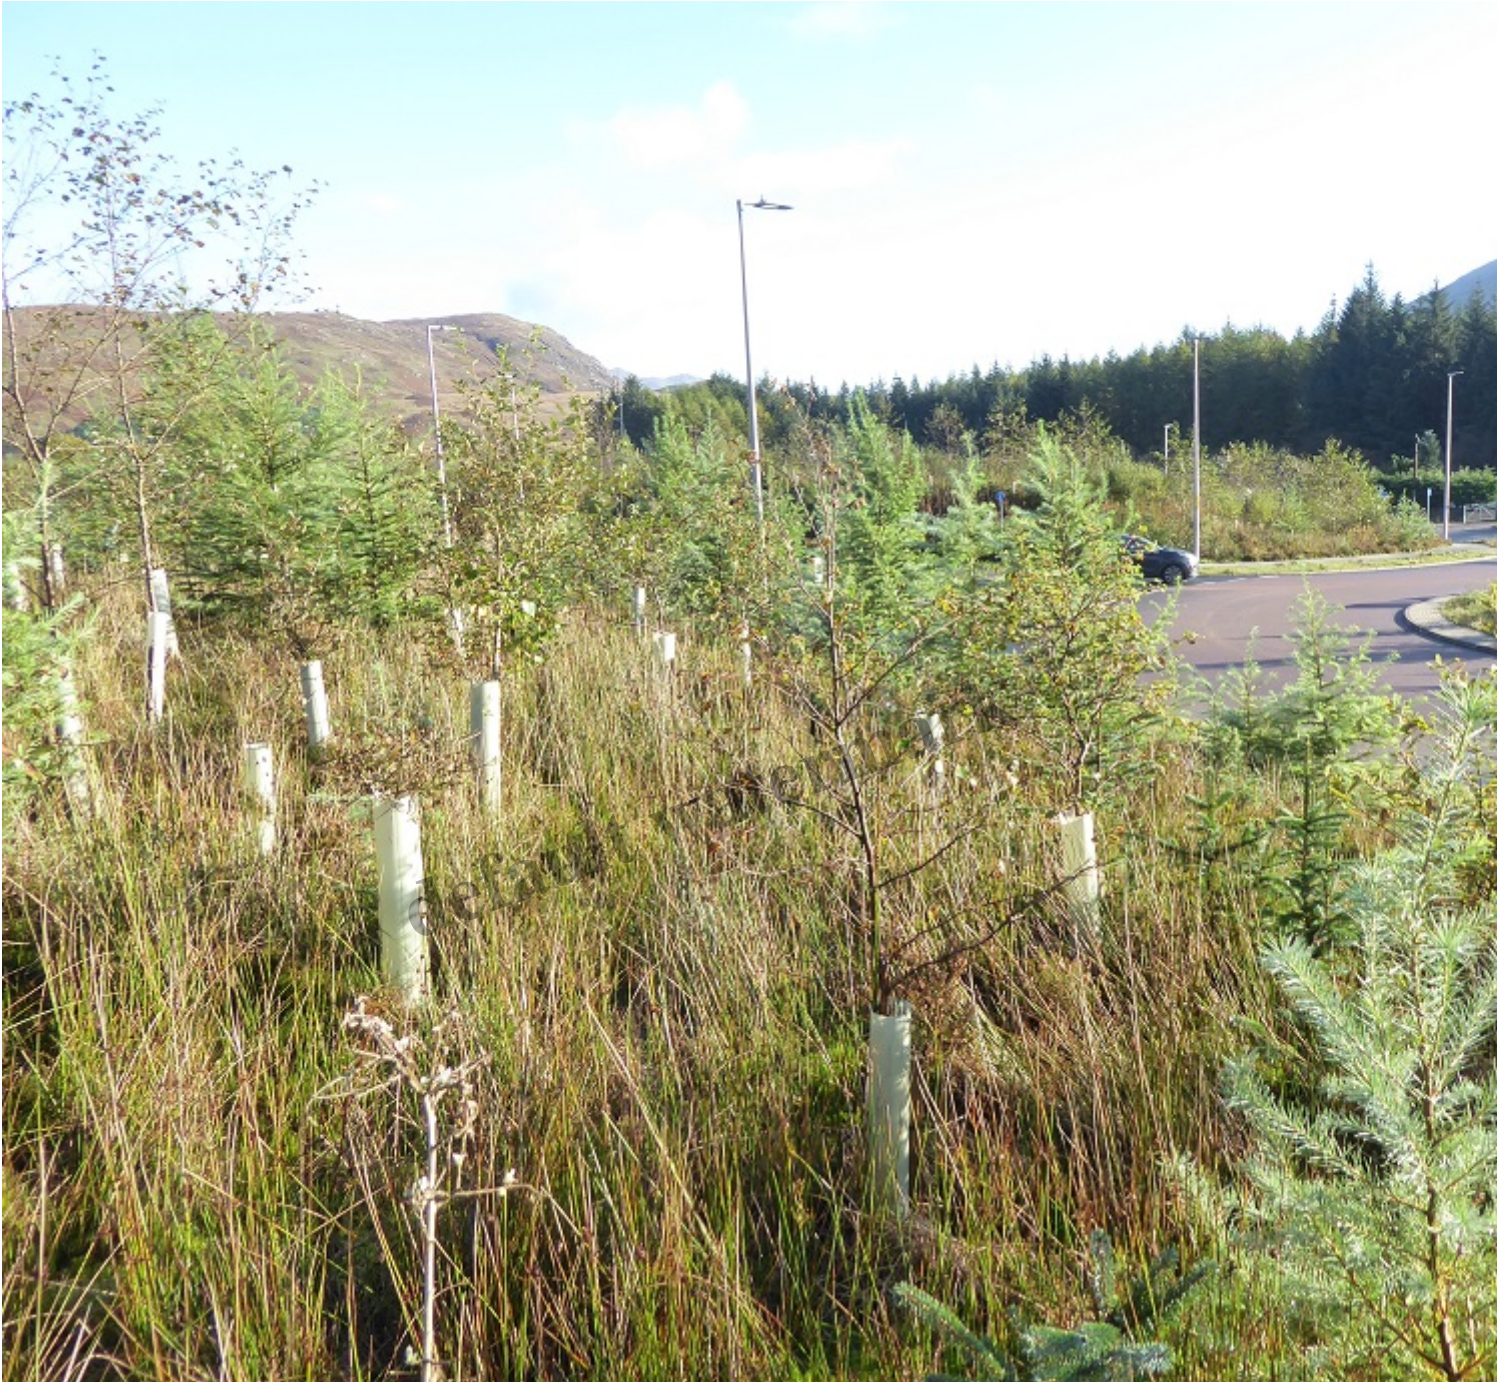
The area around the bypass is fenced and I could see no signs of grazing, whether by sheep or voles, and the luxuriant vegetation tells its own tale. In such situations, plastic tree shelters – which let in light

– can help deciduous trees get up above the surrounding plants (as above). But not always:

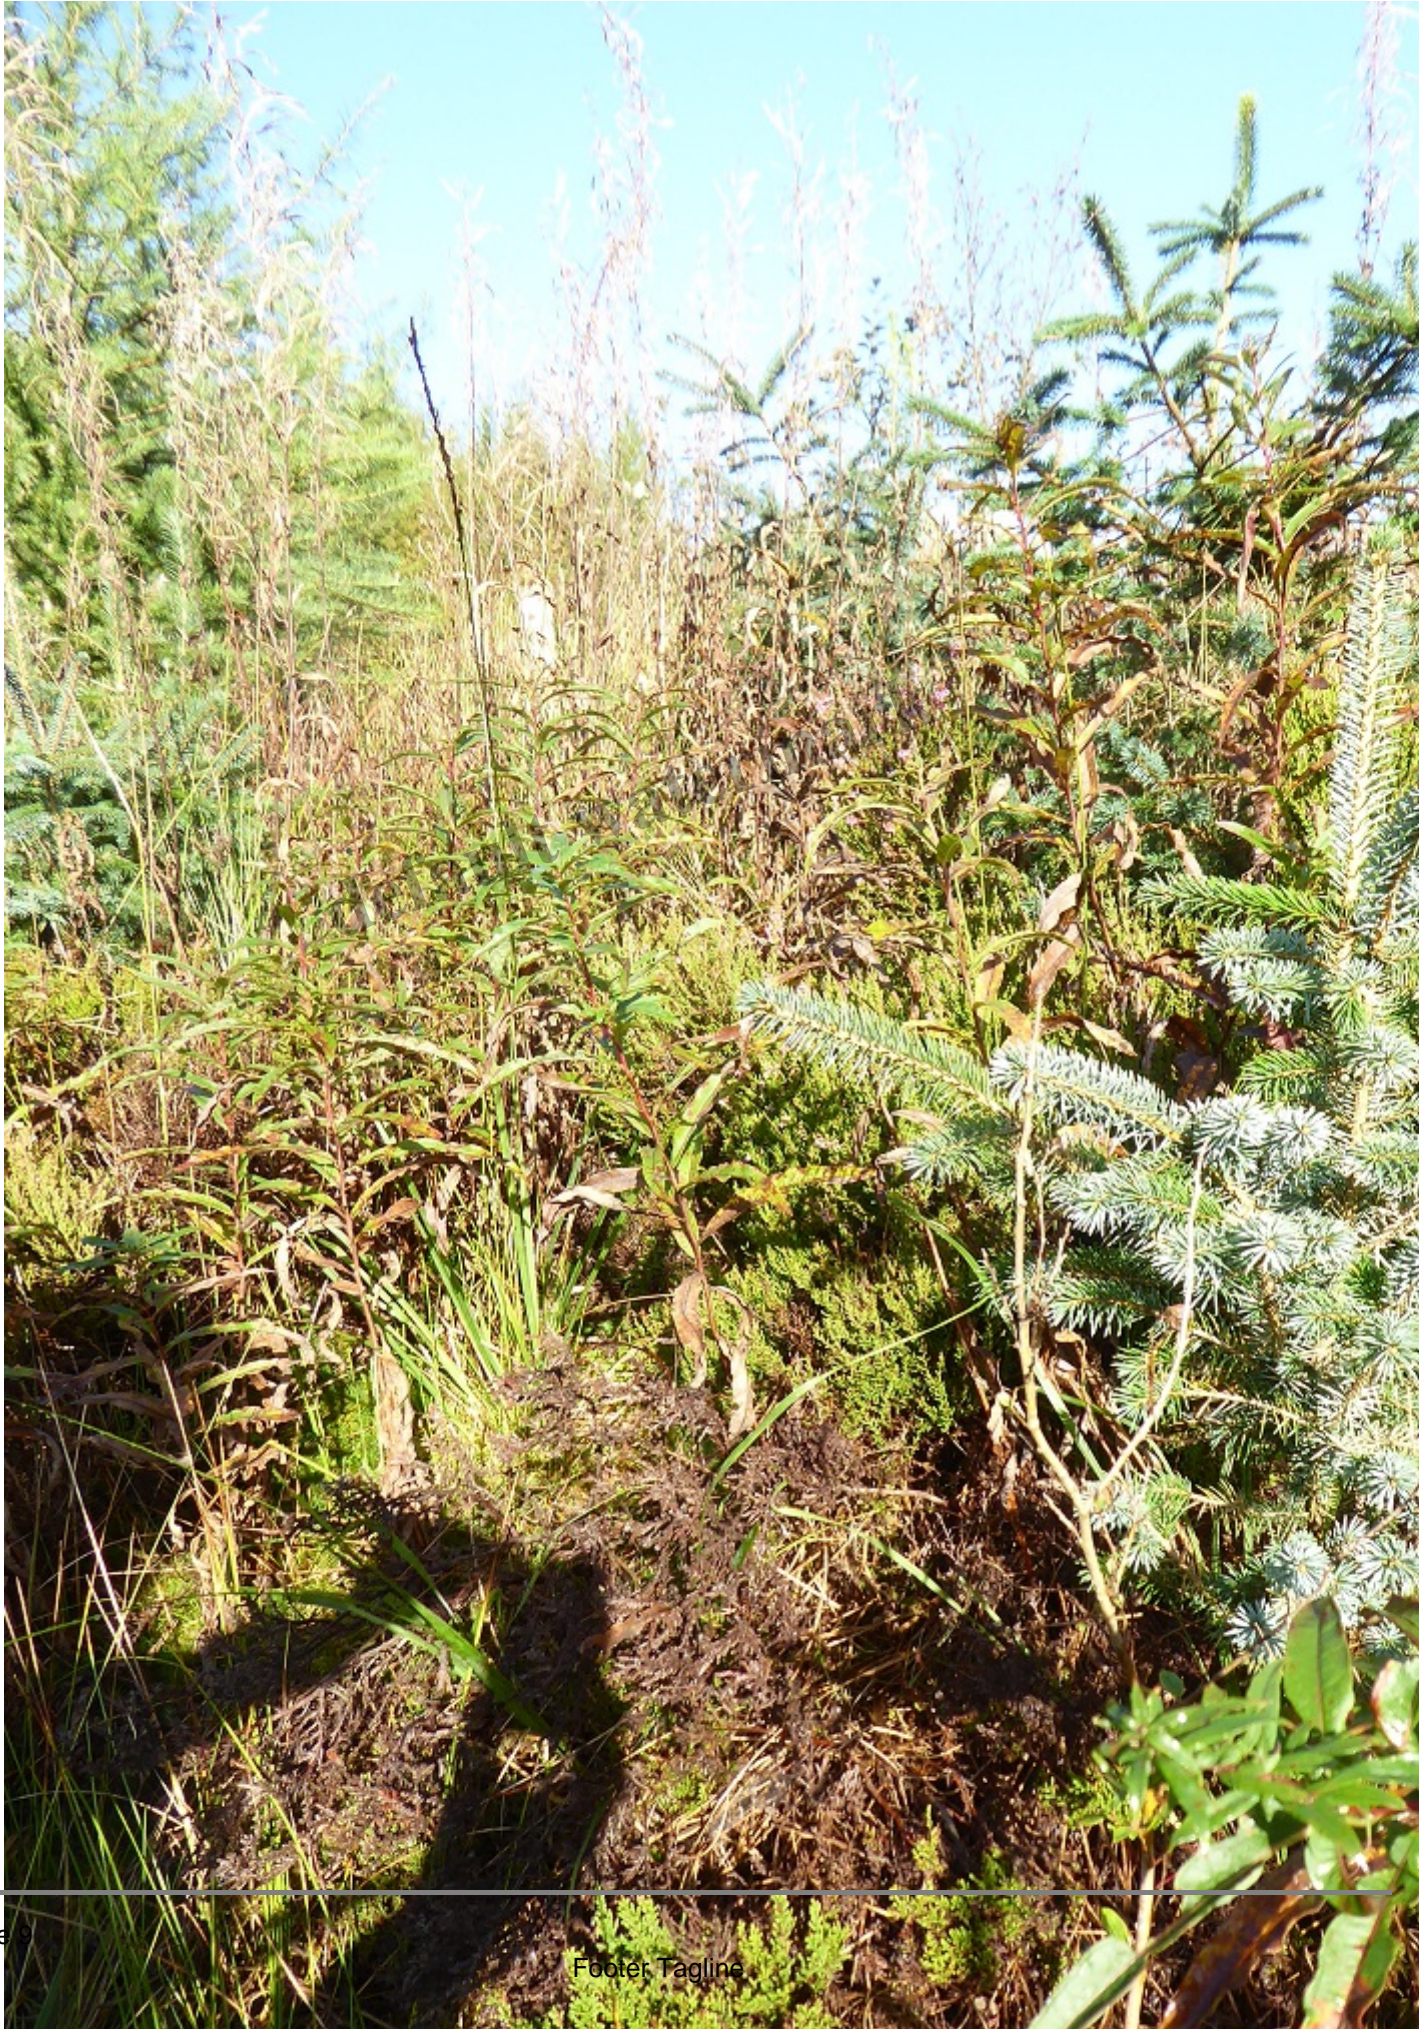
The view just a few yards to the left of the photo above. Rosebay willowherb, a renowned coloniser above the tree shelter and has hidden others from view. (The shadow shows me trying to photograph

At Crianlarich, many of the tree shelters are being swamped by other regenerating plants. While some deciduous trees, whether protected by tree tubes or not, may eventually outcompete and success the rosebay willowherb, whether they have any chance against the self seeding spruce tree is another matter. Despite the planted trees having a season or two's head start over the self-seeded conifers, the photos show few now project above them and many are being shaded out. Given the number of the spruce, it is difficult to see many of the native deciduous trees surviving and delivering Transport Scotland's objective of replacing native trees with native trees.

The tree tube plan was probably never going to work given the proximity of the conifer plantation and its massive seed source so close to the bypass. To achieve its stated objective, rather than spending money on harmful plastic tree shelters, Transport Scotland would have been better employing local people to remove spruce saplings until the native woodland had become established. But that would require a commitment to ongoing woodland management and that is not how forestry or landscape "improvement" currently operates in Scotland. Our modus operandi is on contractors coming in to plant trees and then leaving them. Plastic tree tubes are now integral to that practice and provision is rarely made for removing them.
