The environmental damaged caused by the Glen Etive hydro construction continues

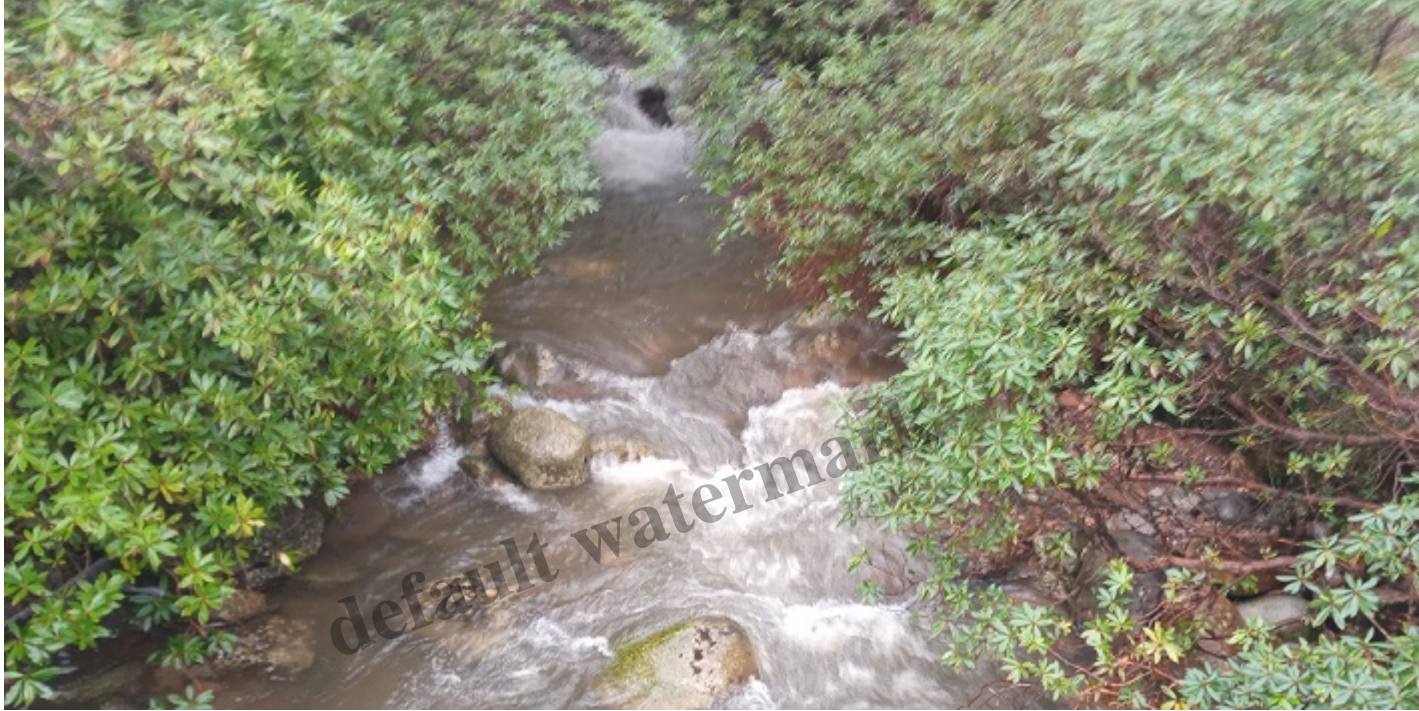
The Allt Charnan from the road bridge 26th January 2022. Photo Credit John Sinclair.

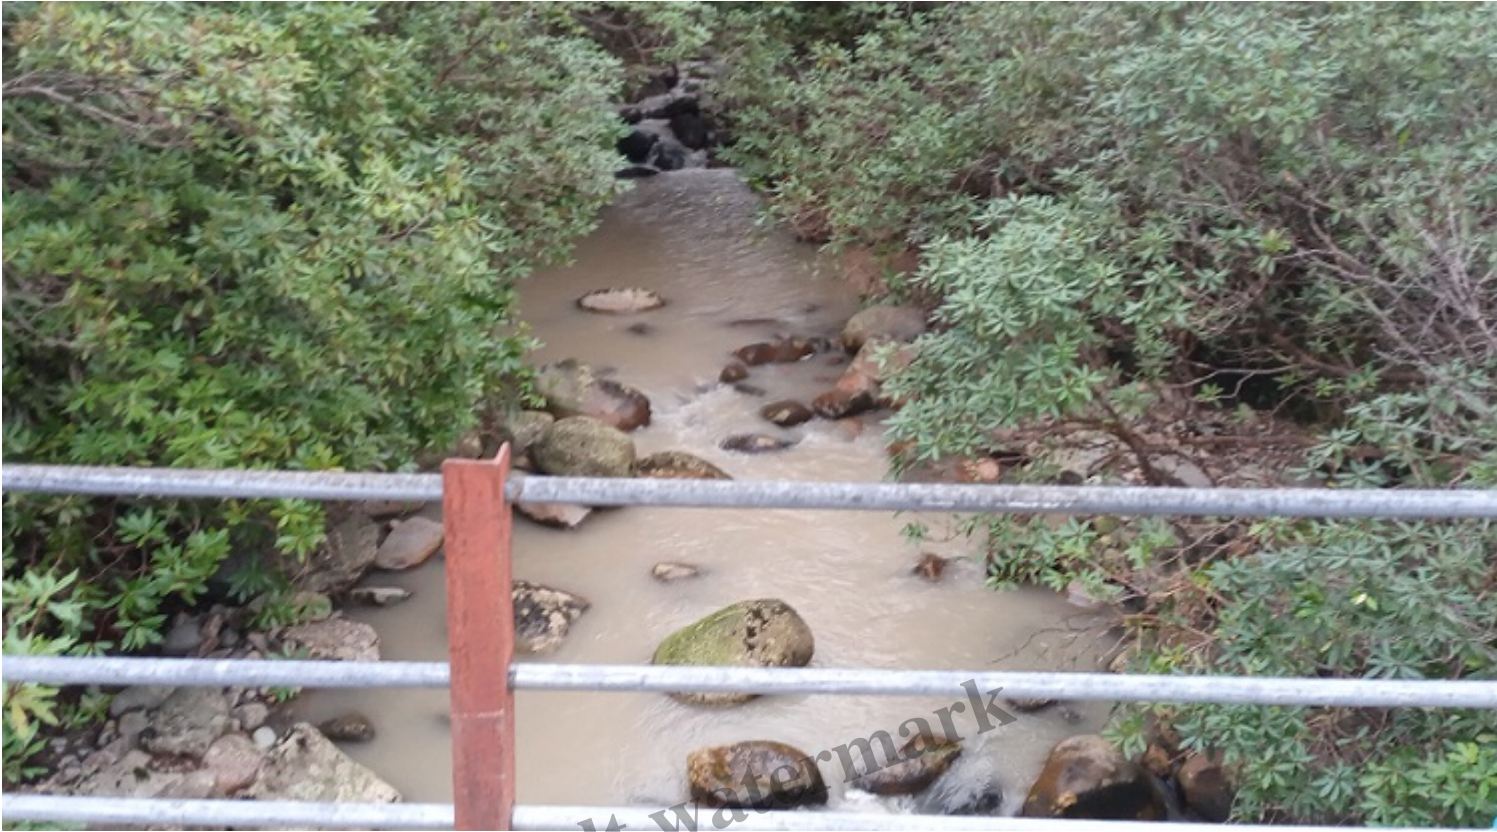
John Sinclair sent parkswatch more photos of the Allt Charnan two days ago. The water is not as cloudy as it was last month, when it featured in my post on the environmental damage that is being caused by the construction of the seven hydro schemes in Glen Etive ([see here](#)):

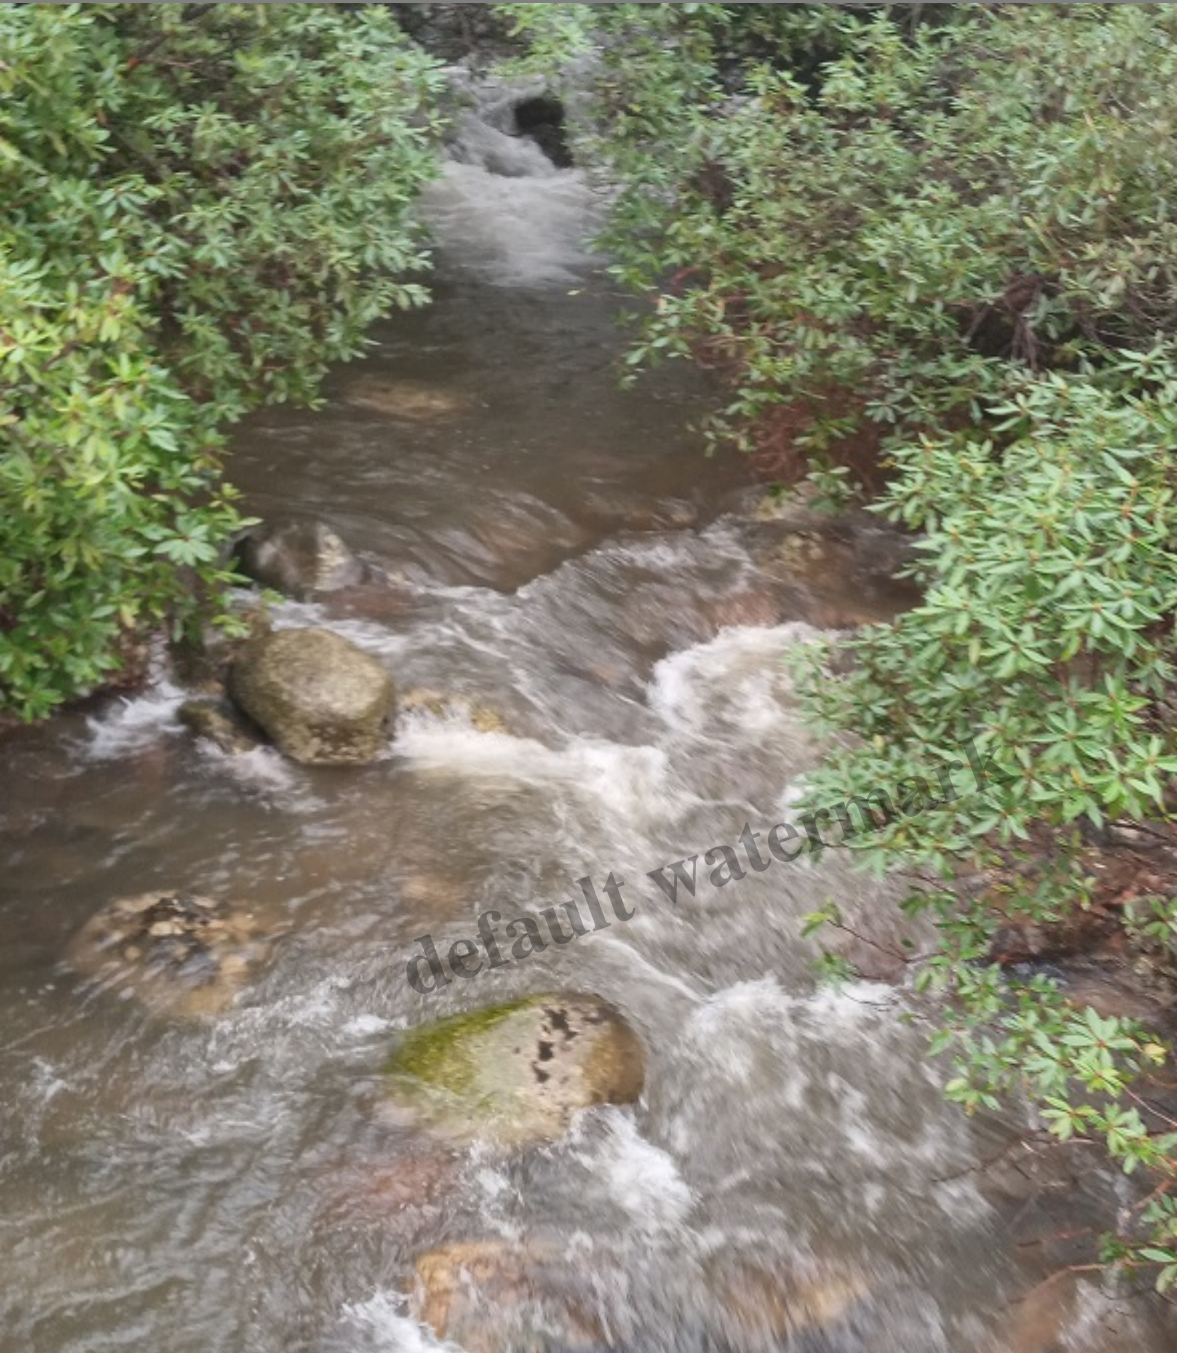
But two days ago the burn was significantly higher – the boulder centre bottom of both photos provides a reference point – and the flow of water far faster, as you can clearly see from the turbulence:

observer of these photos the Allt Charnan might not look that full of silt, due to the volume of water it is likely that in fact more was being washed down the Allt Charnan on Wednesday than back in December. The destructive impact on aquatic life in the Allt Charnan and the River Etive below is likely

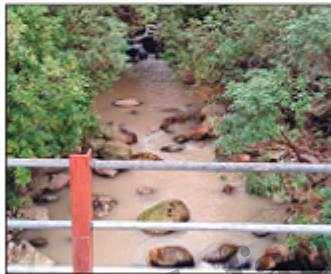
A photograph showing the Allt Charnan river discoloured by what is claimed to be silt. Photograph: John Sinclair.

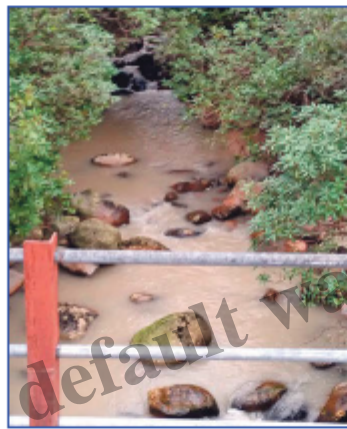
The Allt Charnan river discoloured by what is claimed to be silt. Photograph: John Sinclair.

Contacted by the Lochaber Times for an explanation, Mr Dickins told us that his understanding of the situation was that there had been an issue with a culvert that failed, causing dirty water to mix with clean water runoff, which in turn caused silt to be washed into the Allt Charnan.

'This was reported to SEPA for which the mitigation was to replace the culvert and improve the silt fence. Replacing this was a controlled action which would have caused a pulse of siltation during the remedial works,' Mr Dickins told us.

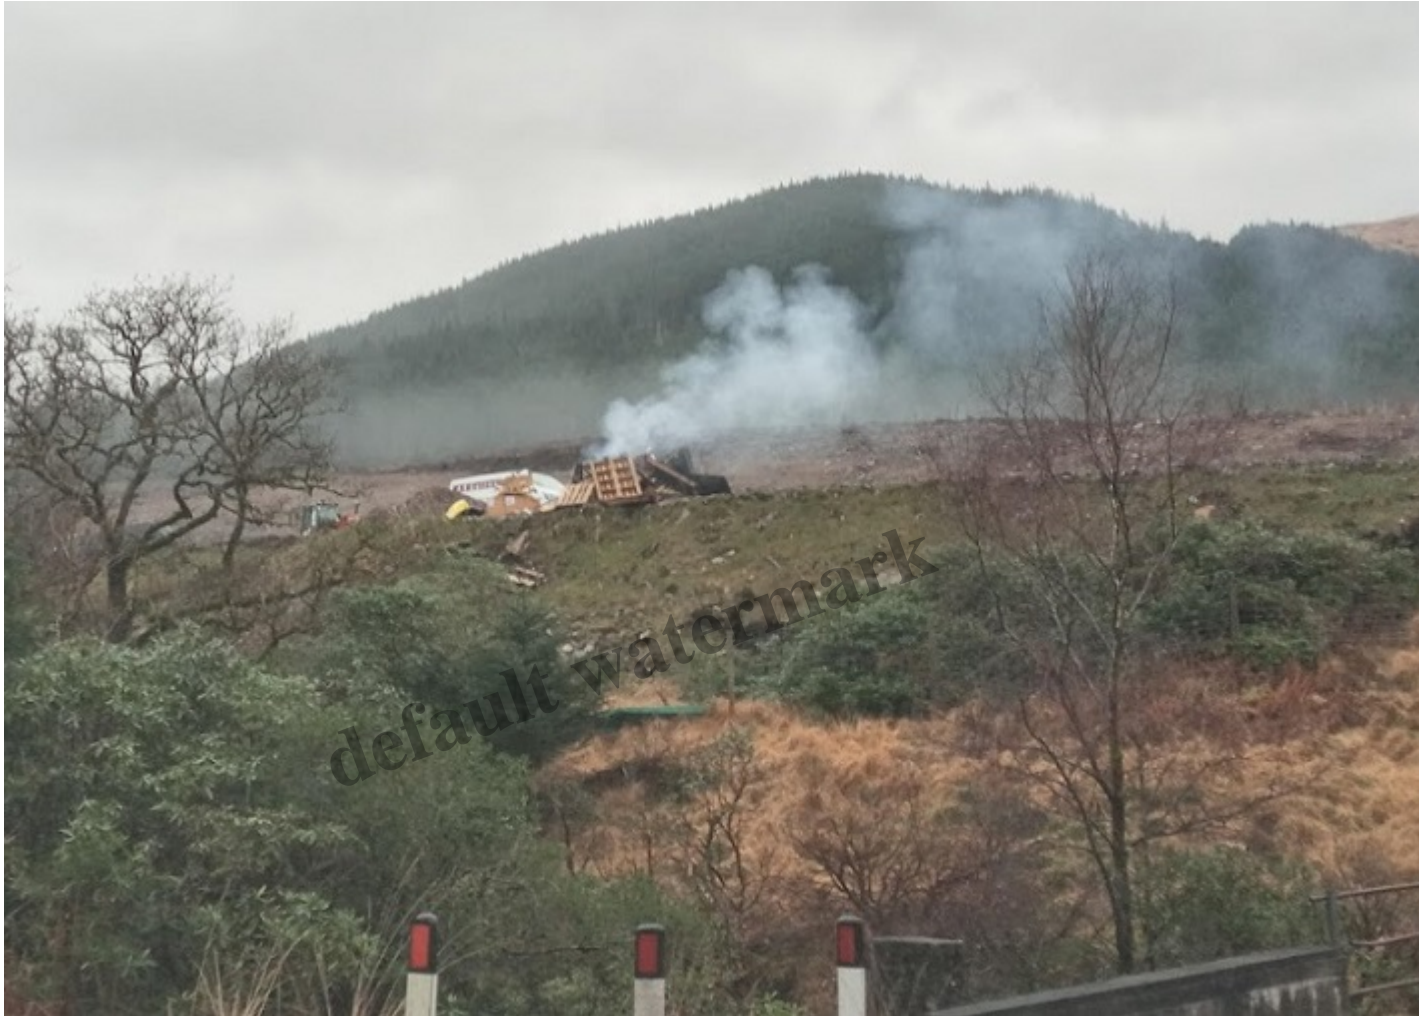
Burning off of hydro construction waste. Photo credit John Sinclair 18th January.

EU, Scottish Government and SEPA policy has been to reduce the amount of waste that is burned in the open environment to reduce air pollution and carbon emissions. Normally a license from SEPA would be required before construction waste, such as in the photo, can be burned. Unfortunately, it's not possible for a member of the public to find out easily whether a license is in place as the information is not available online (SEPA's systems were massively affected by a cyber attack two in 2020). Instead of being open and providing information that would help the public report breaches of environmental legislation, this is another example of how our public authorities are effectively sheltering developers from the law.
