The environmental damaged caused by the Glen Etive hydro construction continues

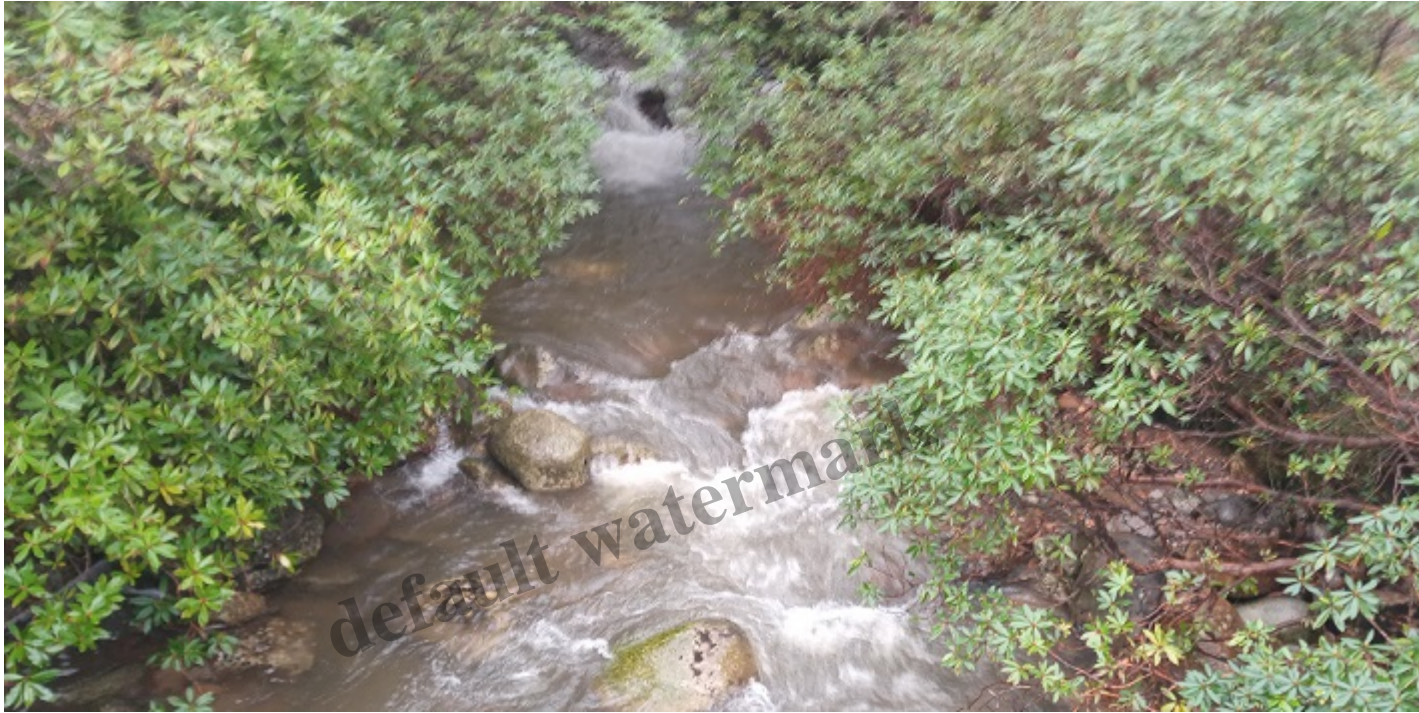
The Allt Charnan from the road bridge 26th January 2022. Photo Credit John Sinclair.

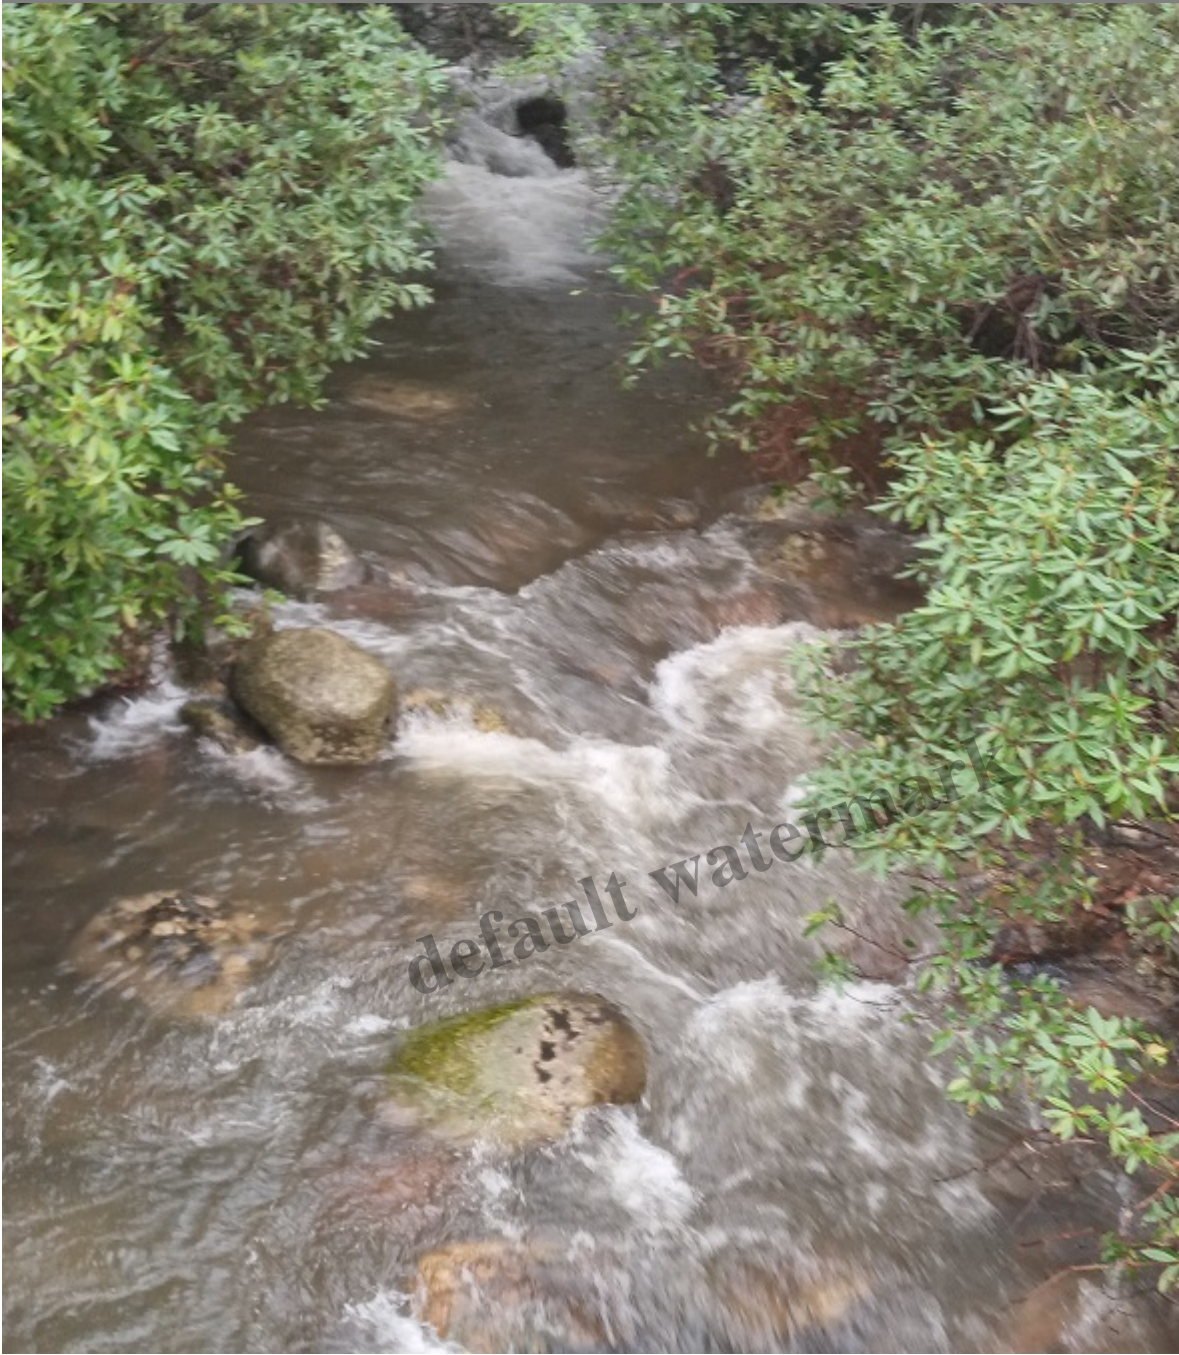
But two days ago the burn was significantly higher – the boulder centre bottom of both photos provides a reference point – and the flow of water far faster, as you can clearly see from the turbulence:

While to the casual

observer of these photos the Allt Charnan might not look that full of silt, due to the volume of water it is likely that in fact more was being washed down the Allt Charnan on Wednesday than back in December. The destructive impact on aquatic life in the Allt Charnan and the River Etive below is likely

to have been considerable.

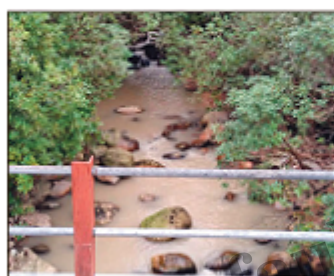
A photograph showing the Allt Charnan river discoloured by what is claimed to be silt. Photograph: John Sinclair.

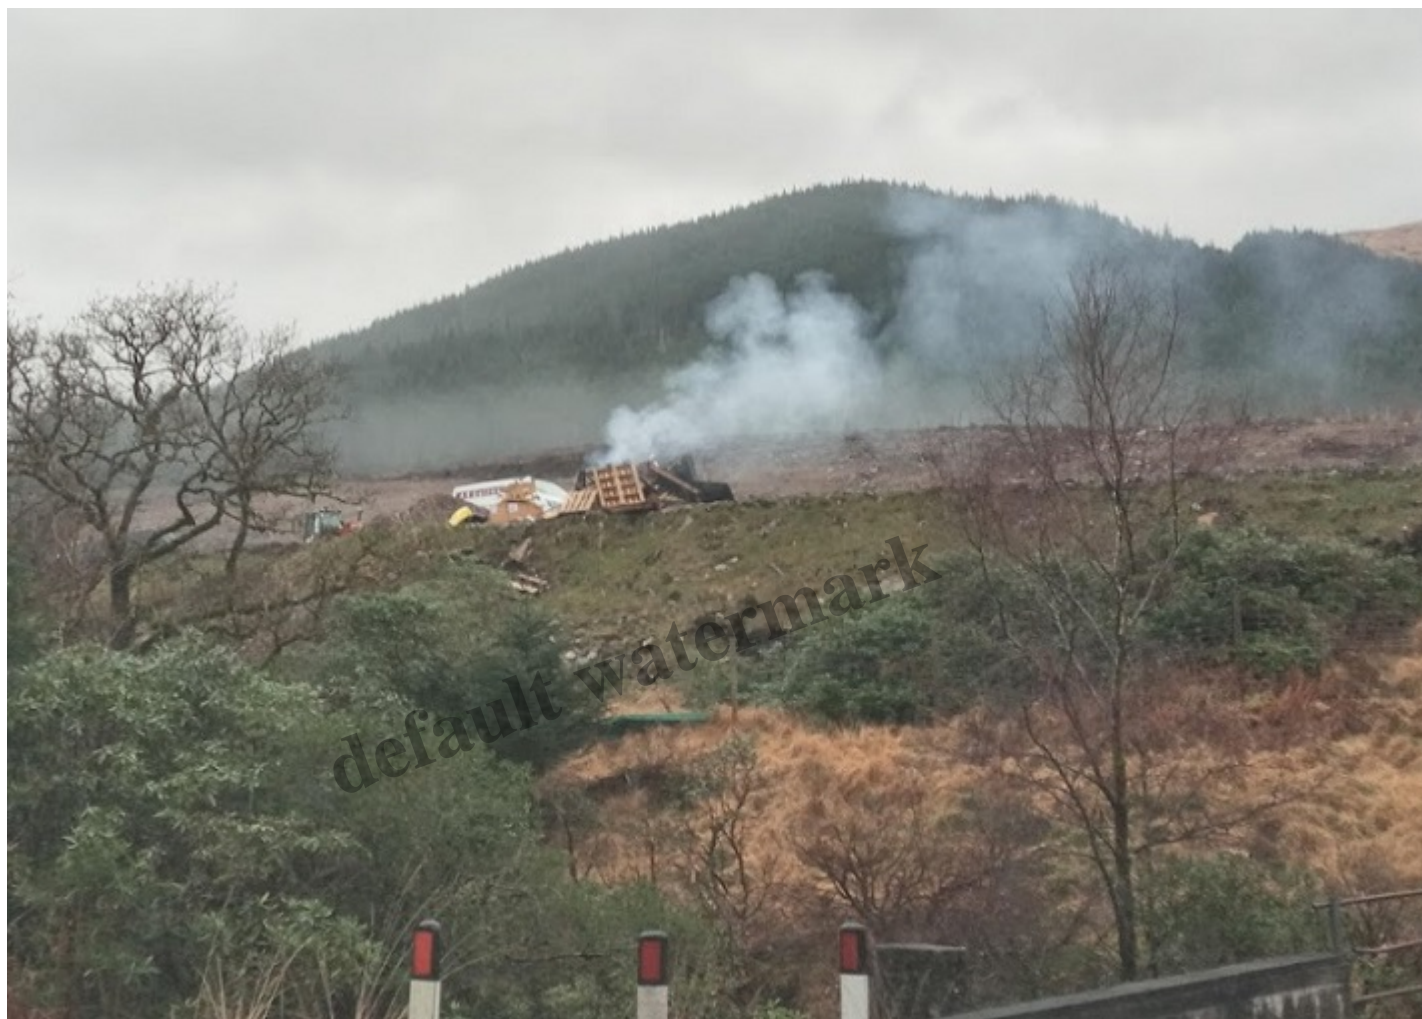
Burning off of hydro construction waste. Photo credit John Sinclair 18th January.

EU, Scottish Government and SEPA policy has been to reduce the amount of waste that is burned in the open environment to reduce air pollution and carbon emissions. Normally a license from SEPA would be required before construction waste, such as in the photo, can be burned. Unfortunately, it's not possible for a member of the public to find out easily whether a license is in place as the information is not available online (SEPA's systems were massively affected by a cyber attack two in 2020). Instead of being open and providing information that would help the public report breaches of environmental legislation, this is another example of how our public authorities are effectively sheltering developers from the law.
