The Ardchullarie forest road and the need to re-think timber extraction in our National Parks

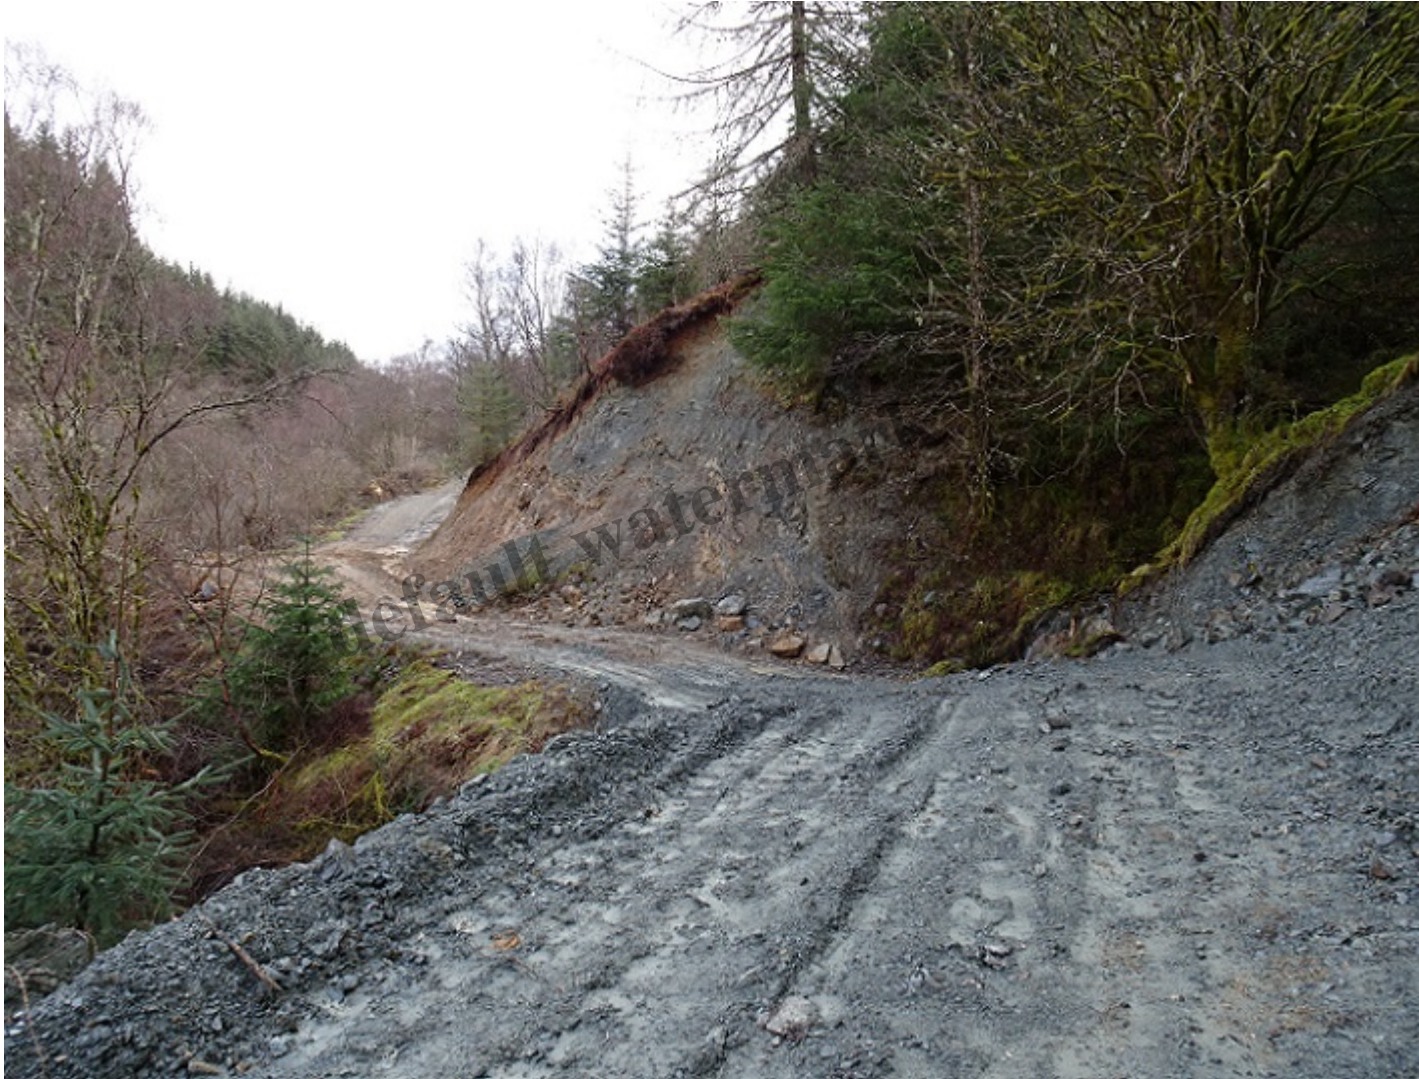
The start of the upgraded forest road March 2021. Note the size of the grassy patch below the road on the left and the the small landslip and boulders beyond

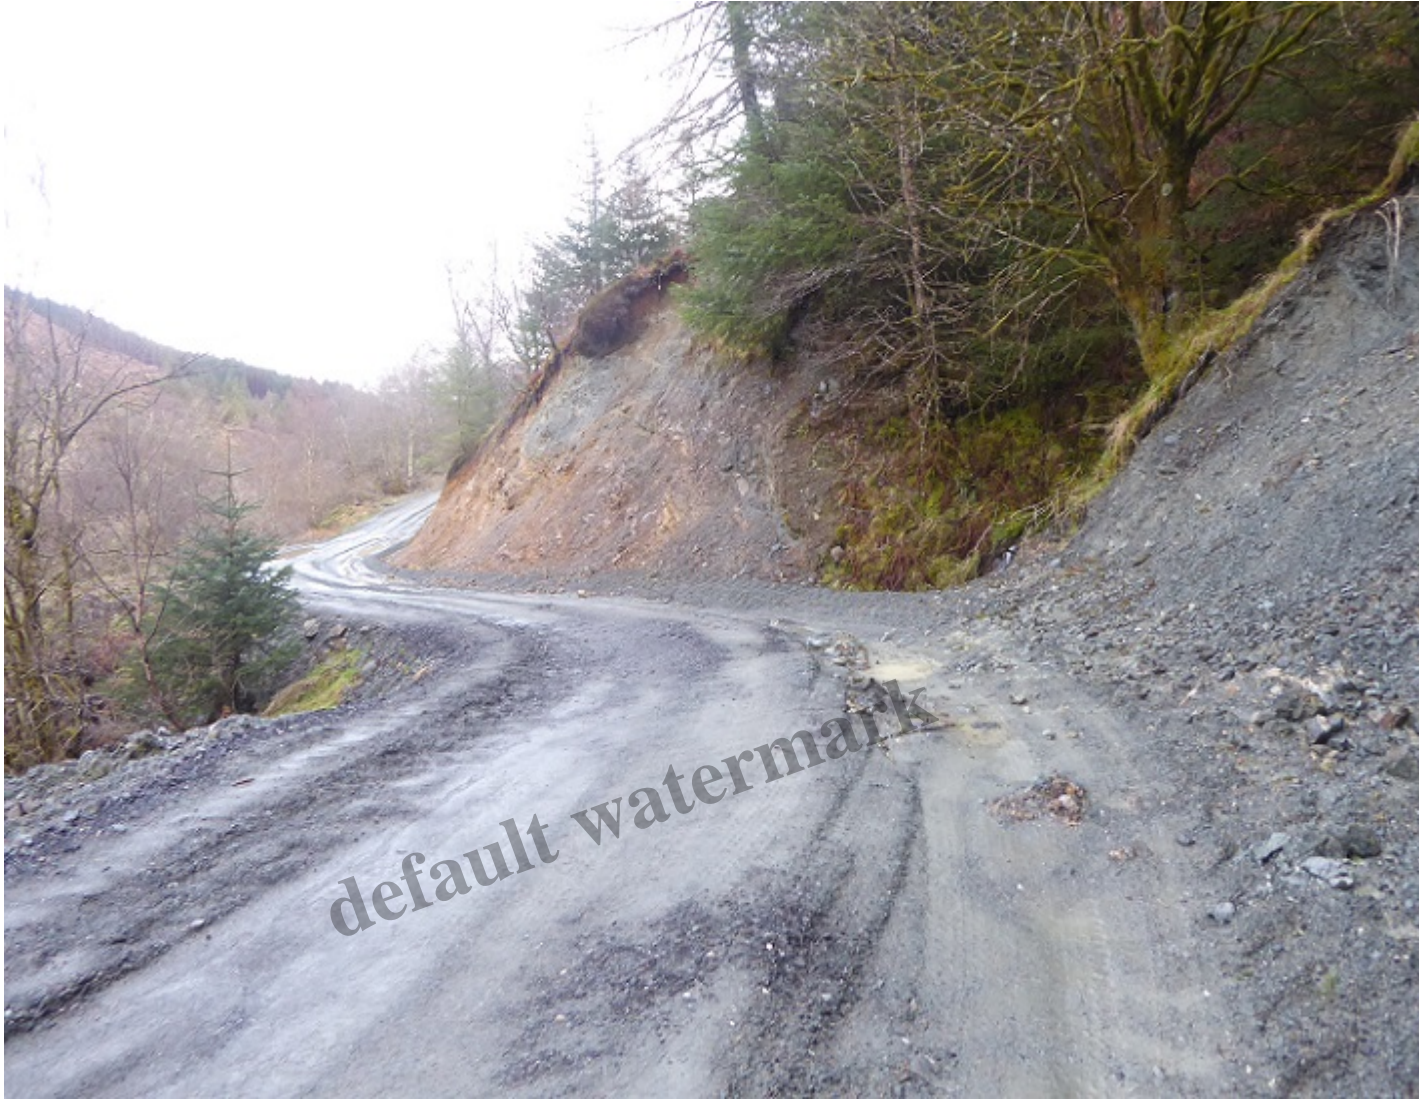
The grassy patch, that helped hold the slope together has shrunk, the detritus from the landslip removed and the cutting scraped back further. Small rocks have continued to erode out of the bank on the right.

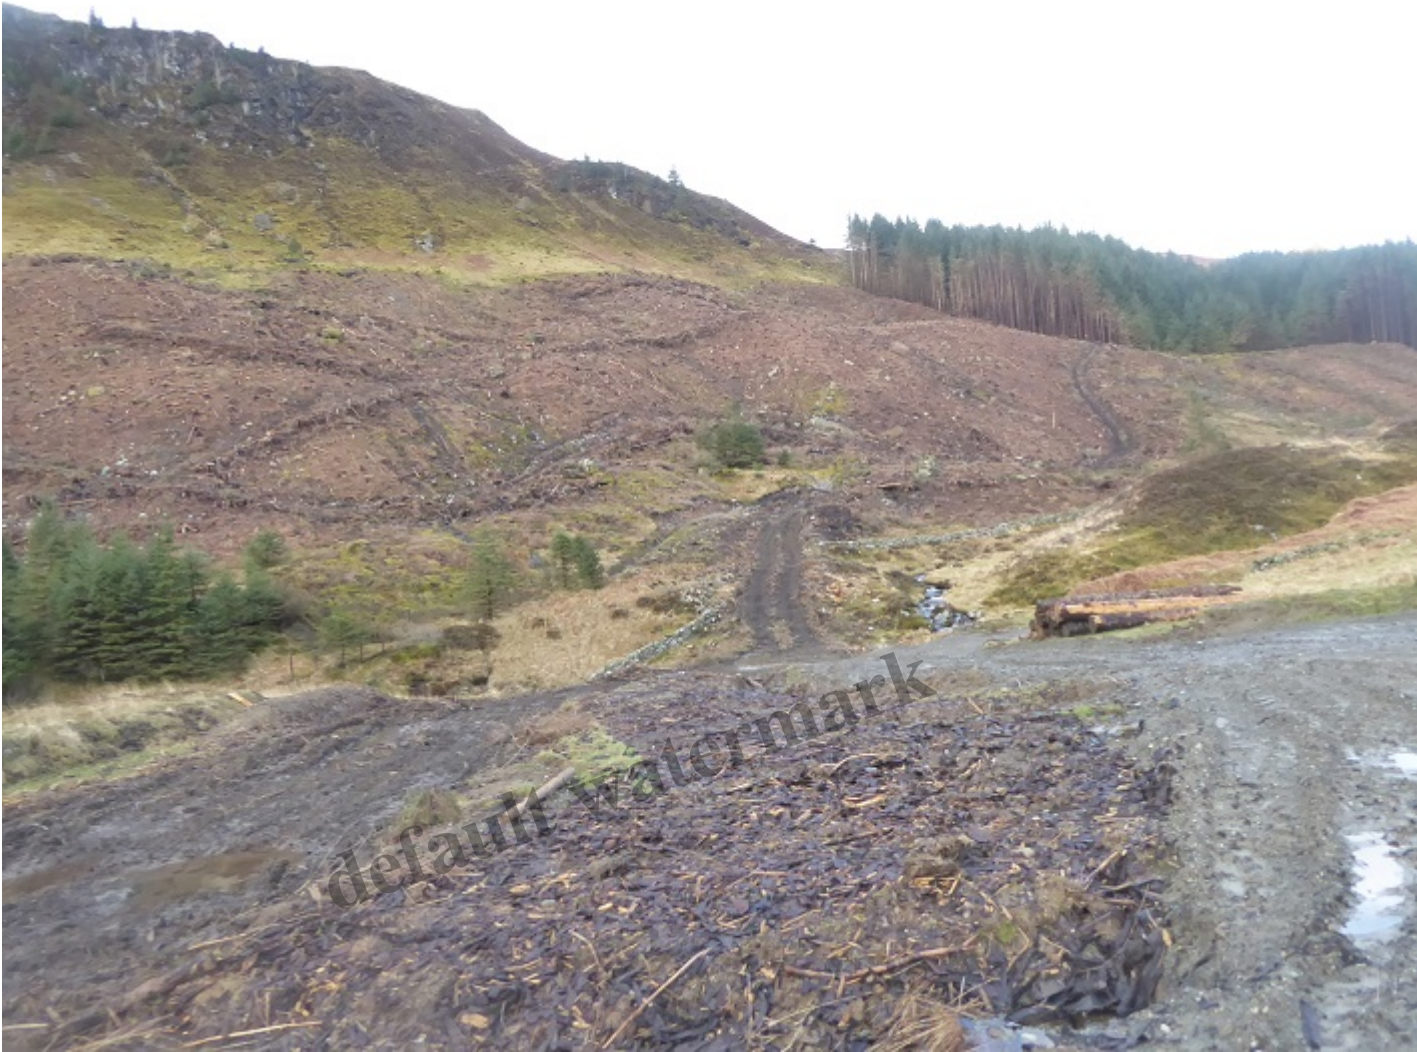
View from end of the “upgraded” track down the spur.

“Therefore it is important that the visual impact is minimal. It is acknowledged that there will be a visual impact during tree removal, however, it is considered that this can be lessened in the long term by removing the temporary access track [i.e. the spur] and narrowing the permanent tracks [i.e. the upgraded section] after tree removal”.

As a consequence the LLTNPA imposed two planning conditions ([see here](#) for papers), the first requiring the spur to be fully restored, the second requiring the upgraded track to be narrowed in accordance with a restoration plan. This was to be agreed with the LLTNPA before the restoration work started.

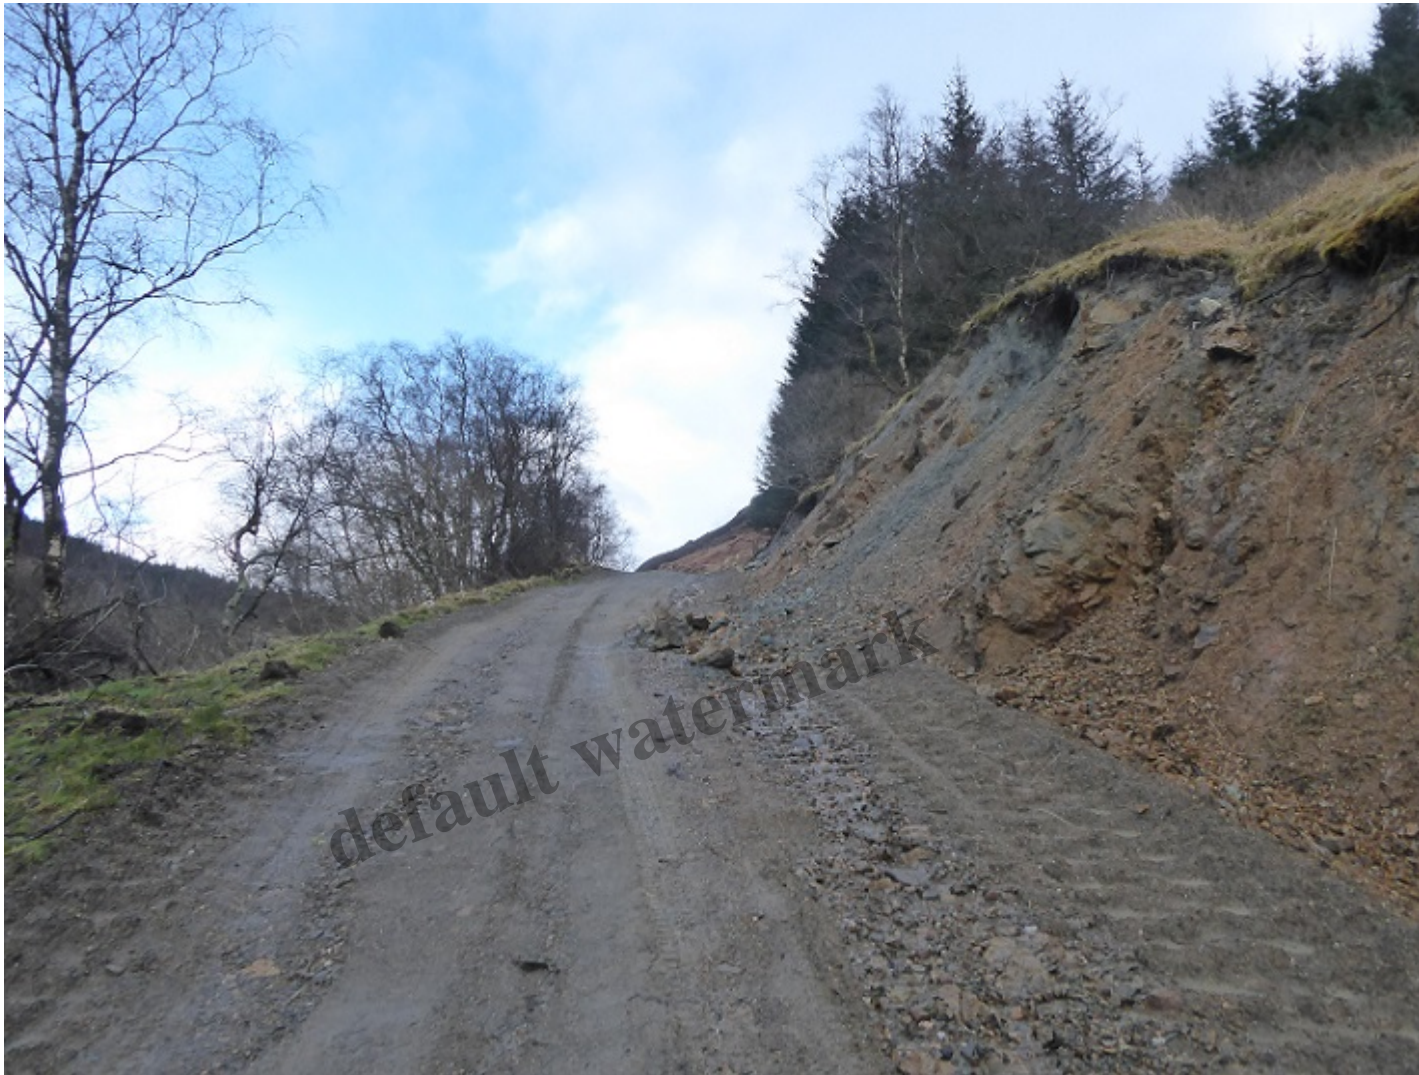
The road was to be widened to 3.2-3.4m along the straight sections

Narrowing the track back to its previous width will in itself do little to reduce the landscape impact of the cutting that has been excavated across hillside. The main impact is caused by the width of the shelf and the over-steepened bank above. Unfortunately, there is nothing in the two planning conditions requiring these to be restored to their original state.

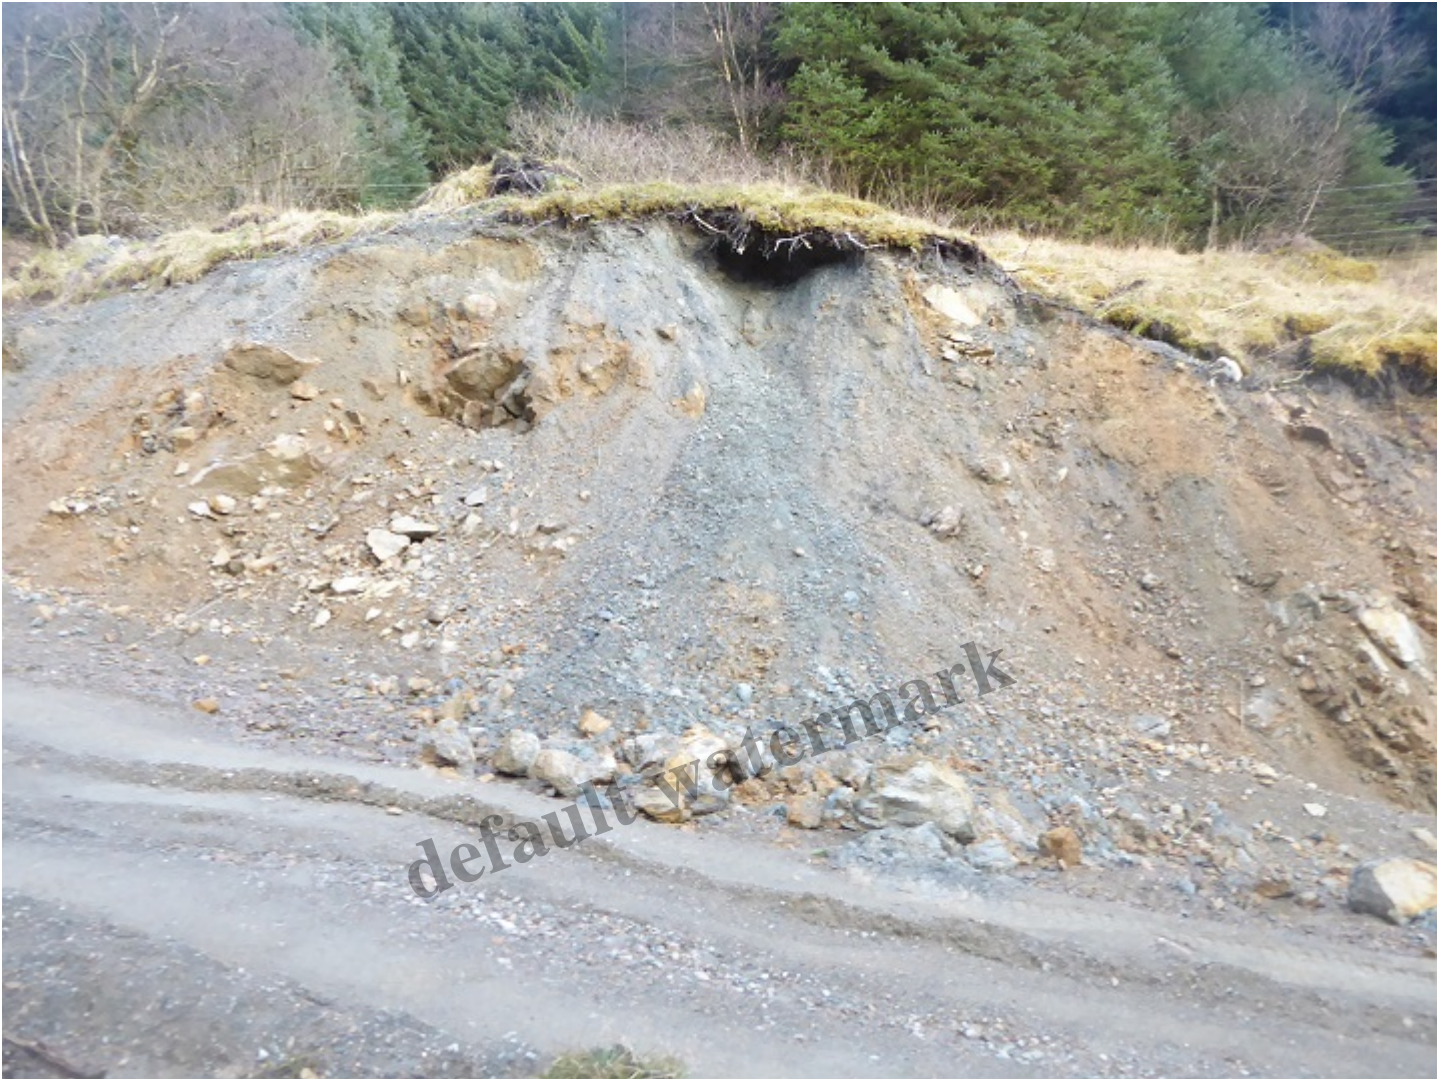
“Roadside batters should be cut to a stable and even angle of repose free of overhangs and loose rock”

(Construction Method Statement).

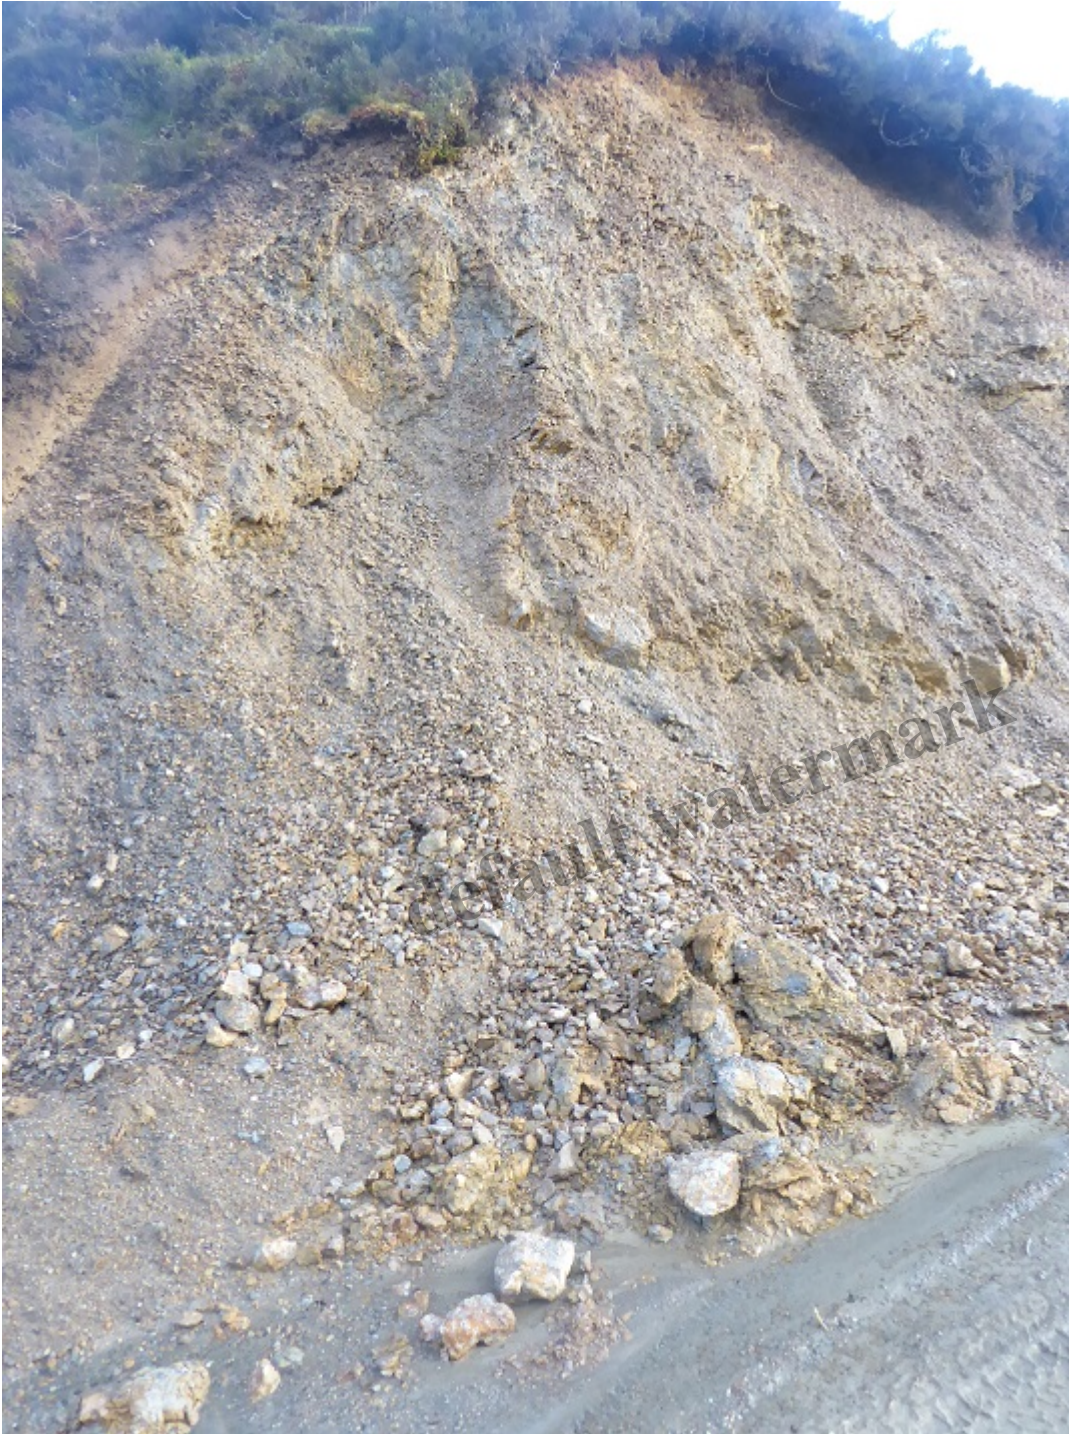
“Batters are proposed to be graded to a stable angle and feather into the original slope profile” (CMS)

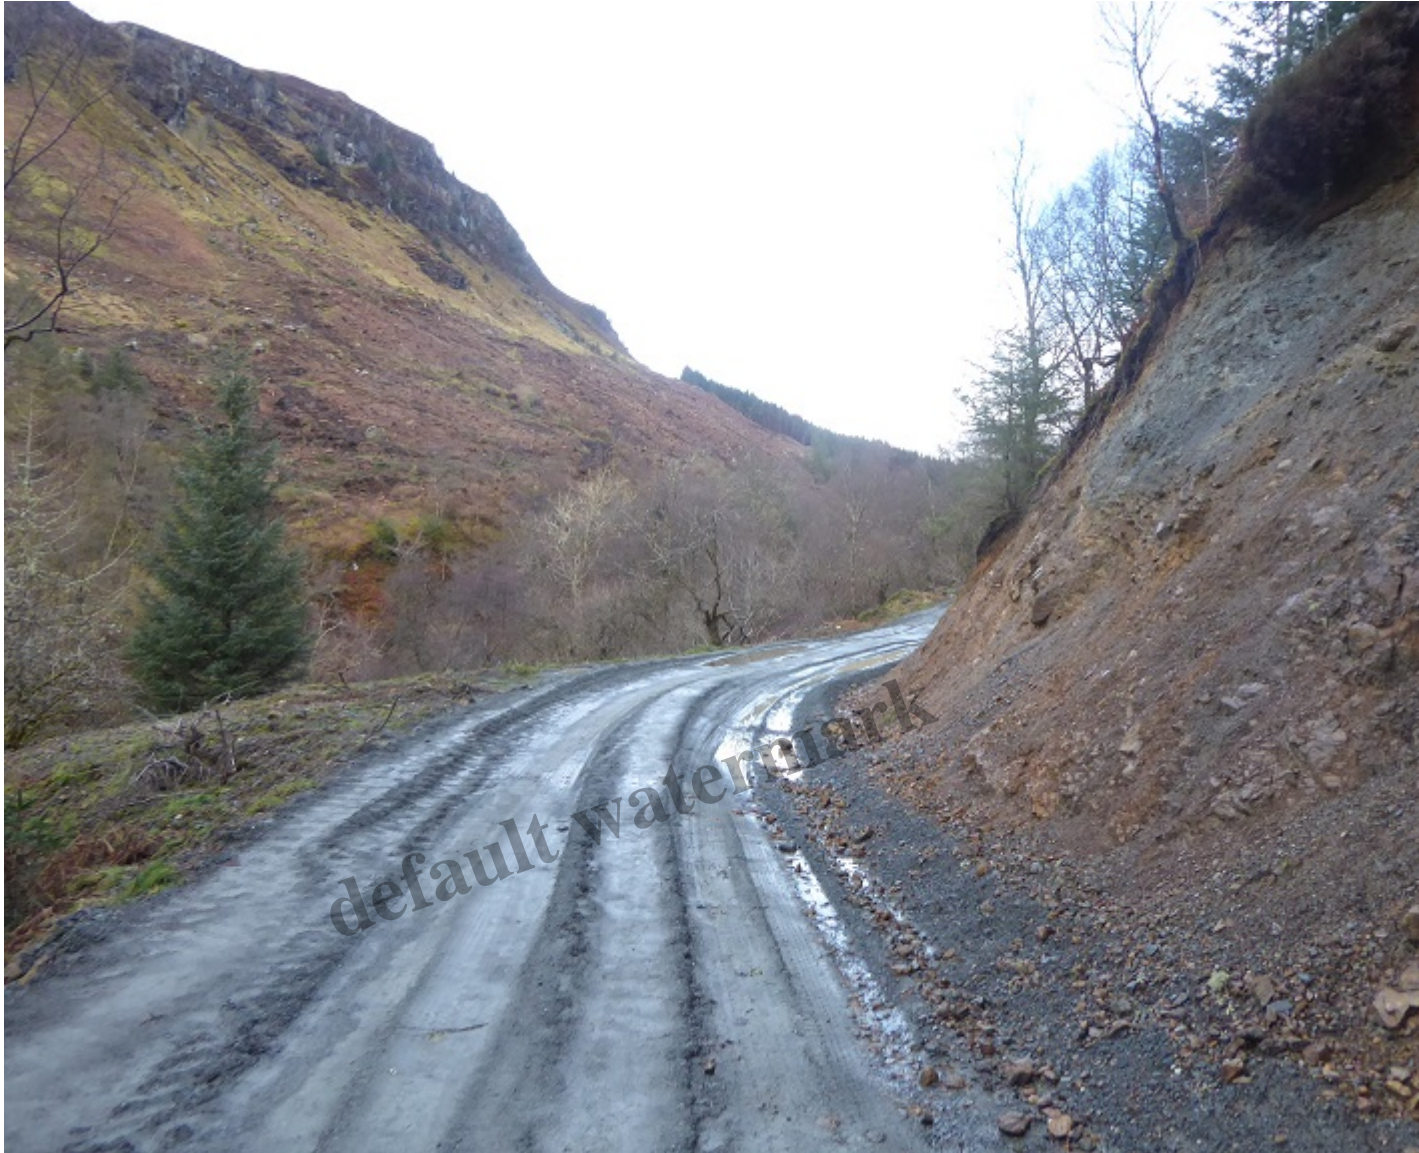
Where possible, the tract from A-B will be extended without cutting new batters into the hillside, but due to the localised topography and terrain, it will not always be practical or viable to do this; therefore small new batters will need to be formed where the track is to be widened by 0.5-1m.

A small new batter

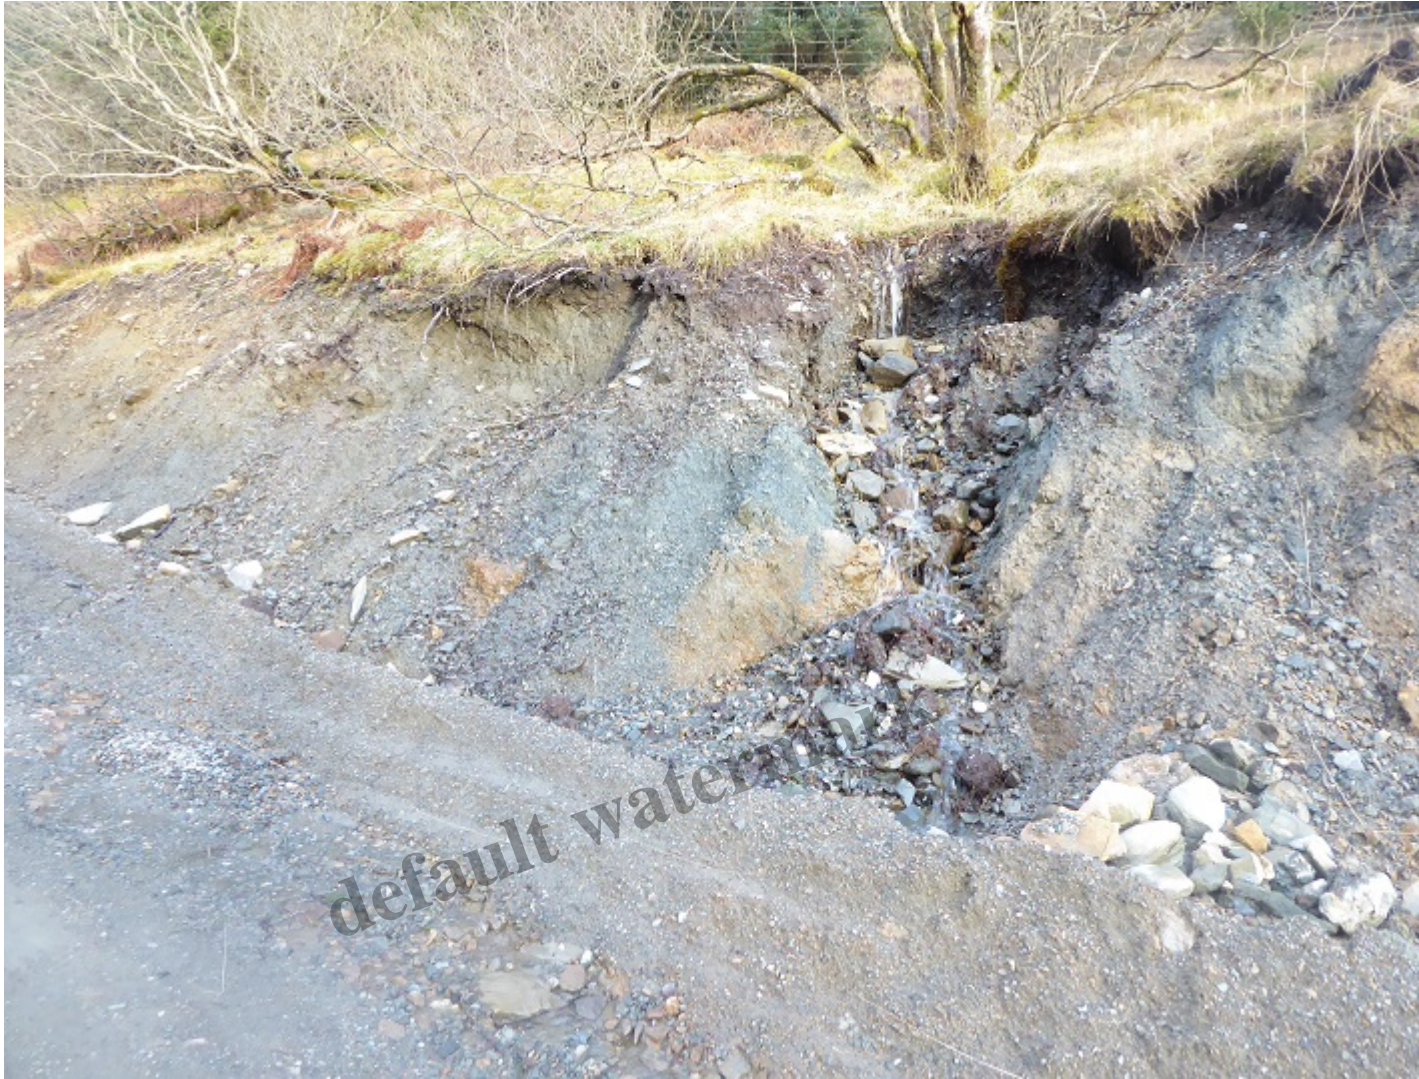
Batters will be taken back to the suitable distance to facilitate the expansion of the access track and then flushed / graded with mineral soils removed from site. Benches, if required but not anticipated, will be created as required to ensure a suitable and stable batter is created. The upper levels of the batter will be flushed with the original terrain and the area will be seeded to ensure vegetation cover establishes within a short period of time.

No grading and part of the batter is being actively eroded by water

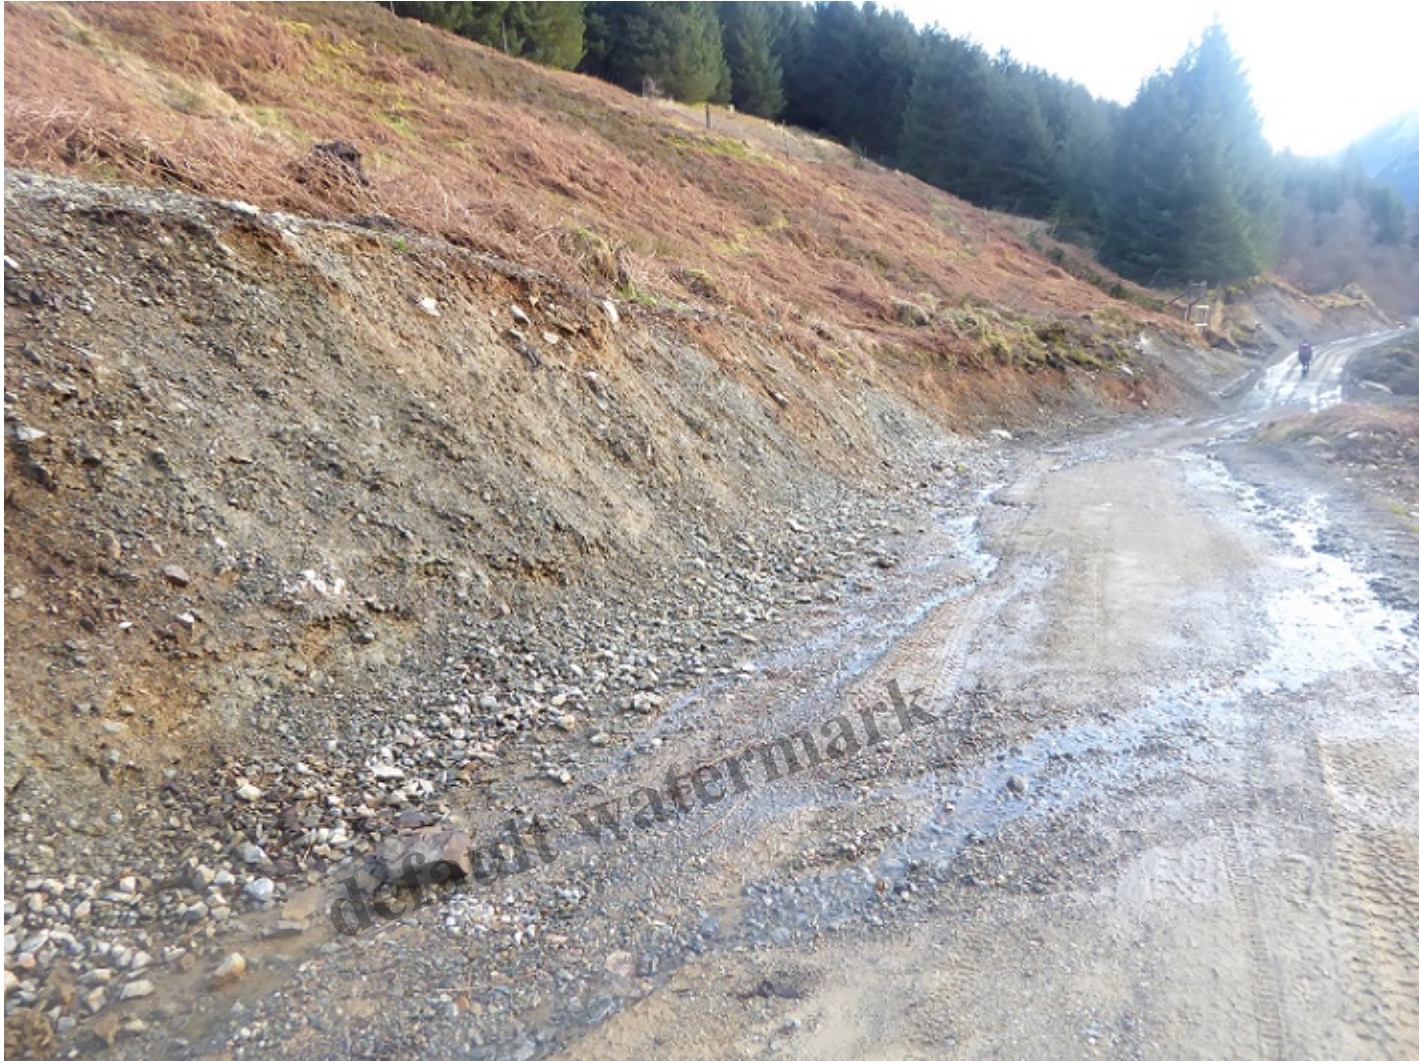
- Use of geotextile matting where necessary on the steeper sections of batter to enable a steeper angle of stability.

Steep instability and no sign of geotextile matting

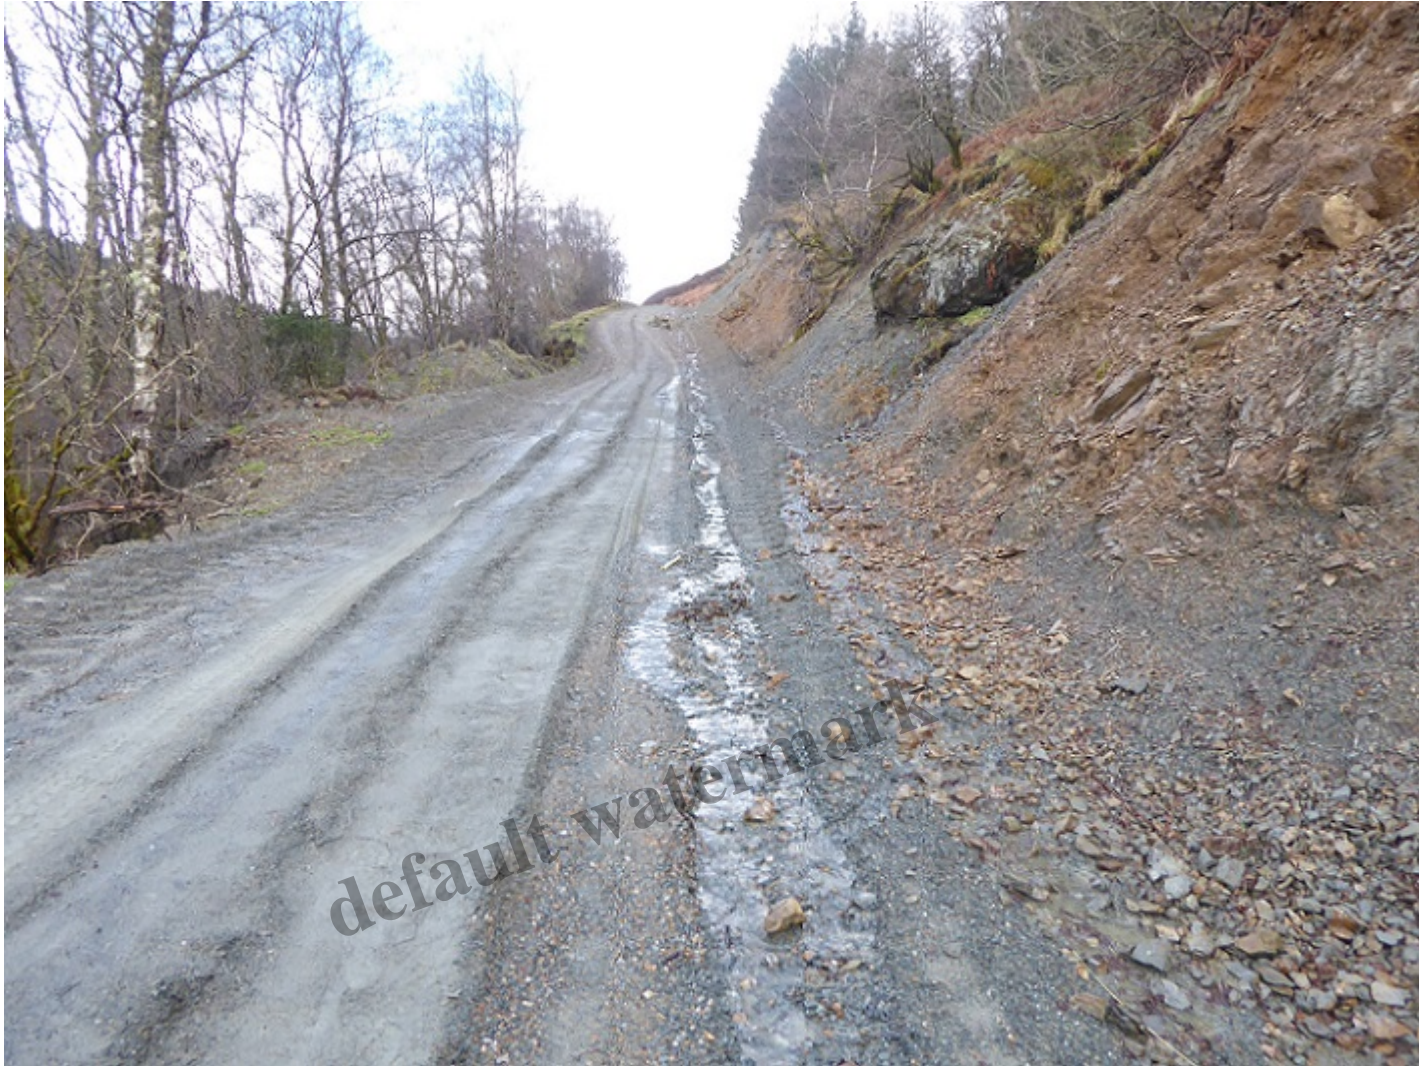
- The formation of ledges in rock cuttings to aid re-vegetation on steeper slopes combined with hydroseeding.

Is this the site of the rock ledges to aid re-vegetation? Note the water flow, 12 hours after the last rain

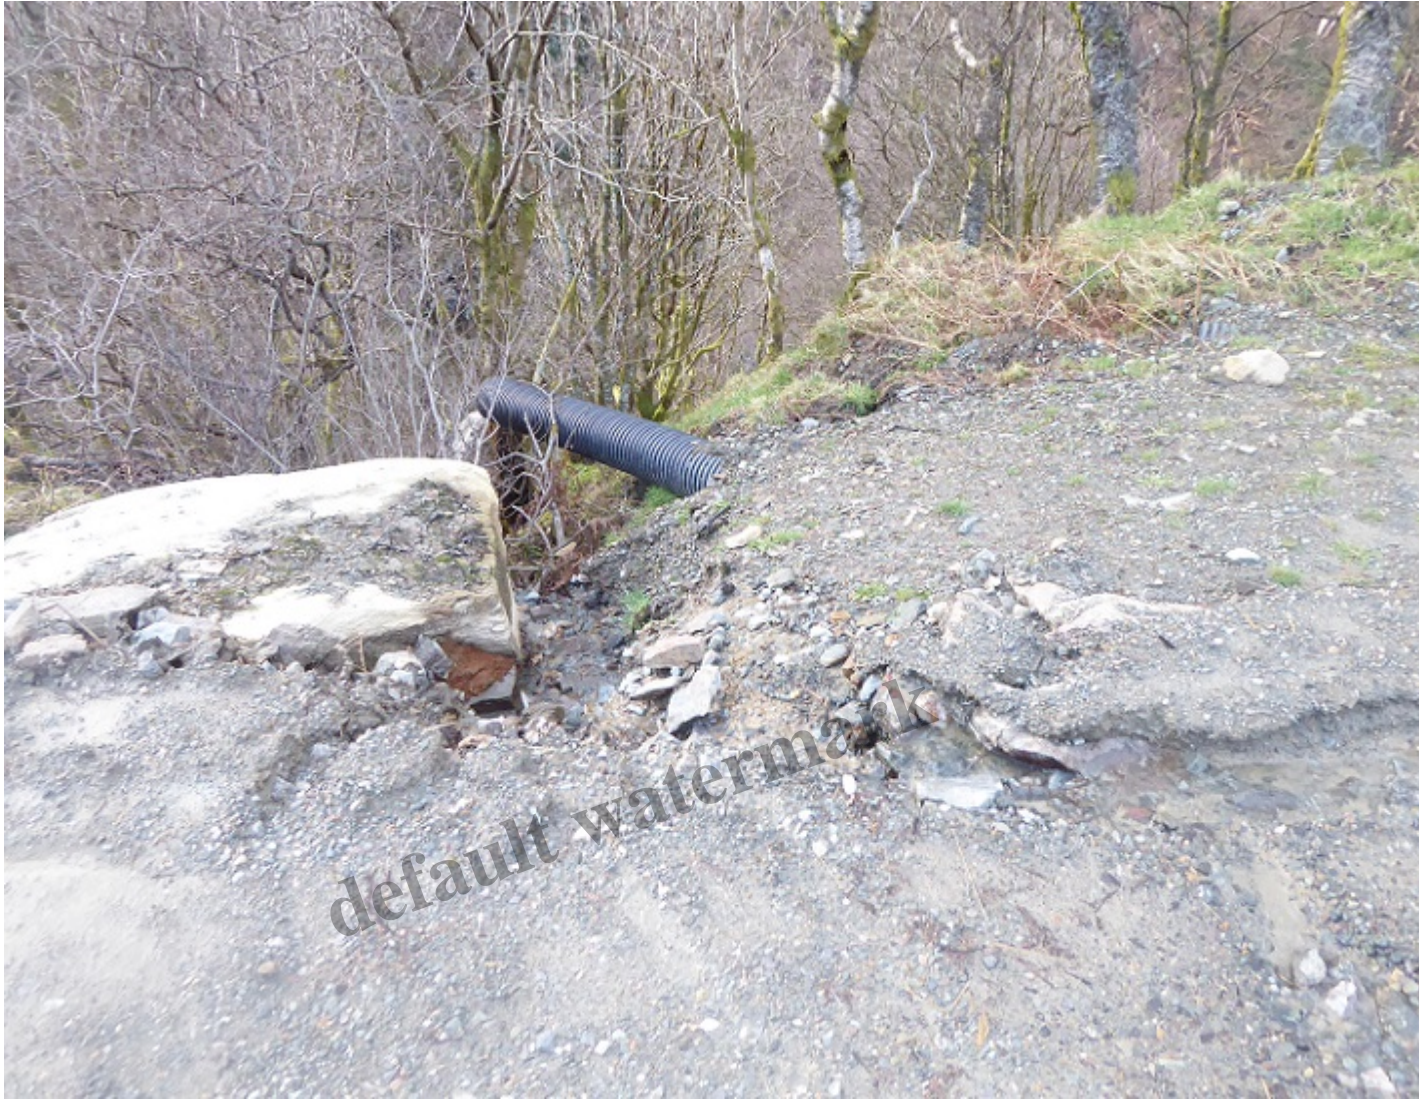
Culverts will be made as inconspicuous as possible and water directed towards existing drainage or natural water courses (in conjunction with the Forest and Water Guidelines / UK Forestry Standard). There are several small watercourses that cross the existing track and these will need to be culverted to prevent silt contamination and pollution. CAR licences will be applied for each required site in line with the SEPA guidance.

Inconspicuous? Note how the water flowing down the road has taken silt with it add that to the Ardchullarie burn

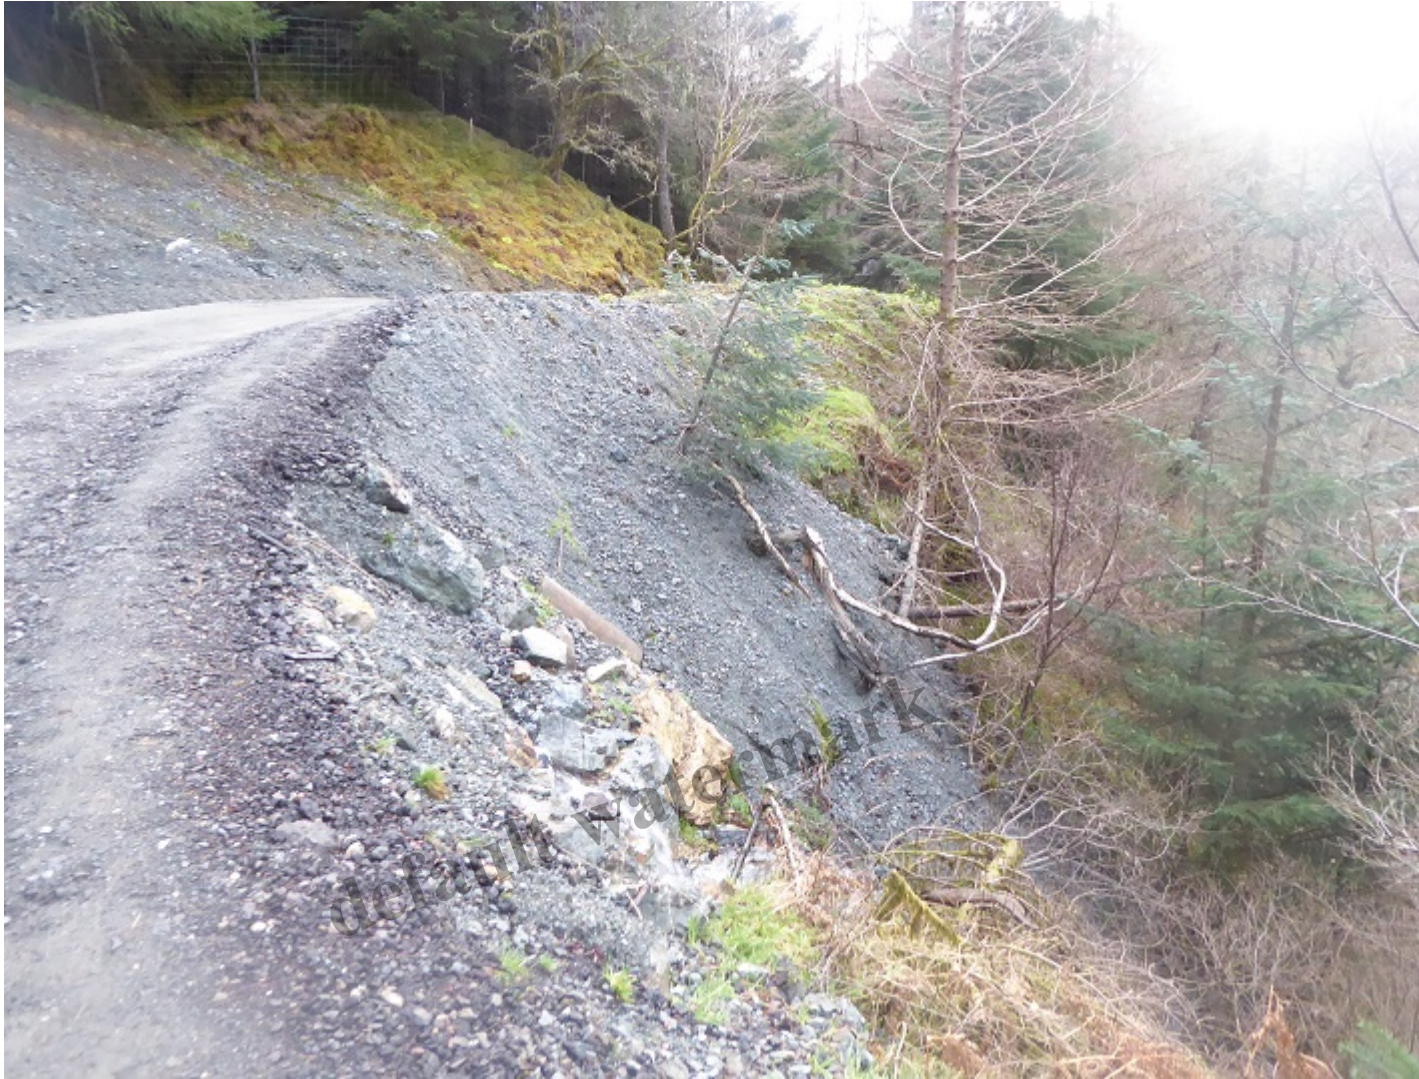
Bare edge of track eroding down towards the burn below – note the old abandoned concrete culvert

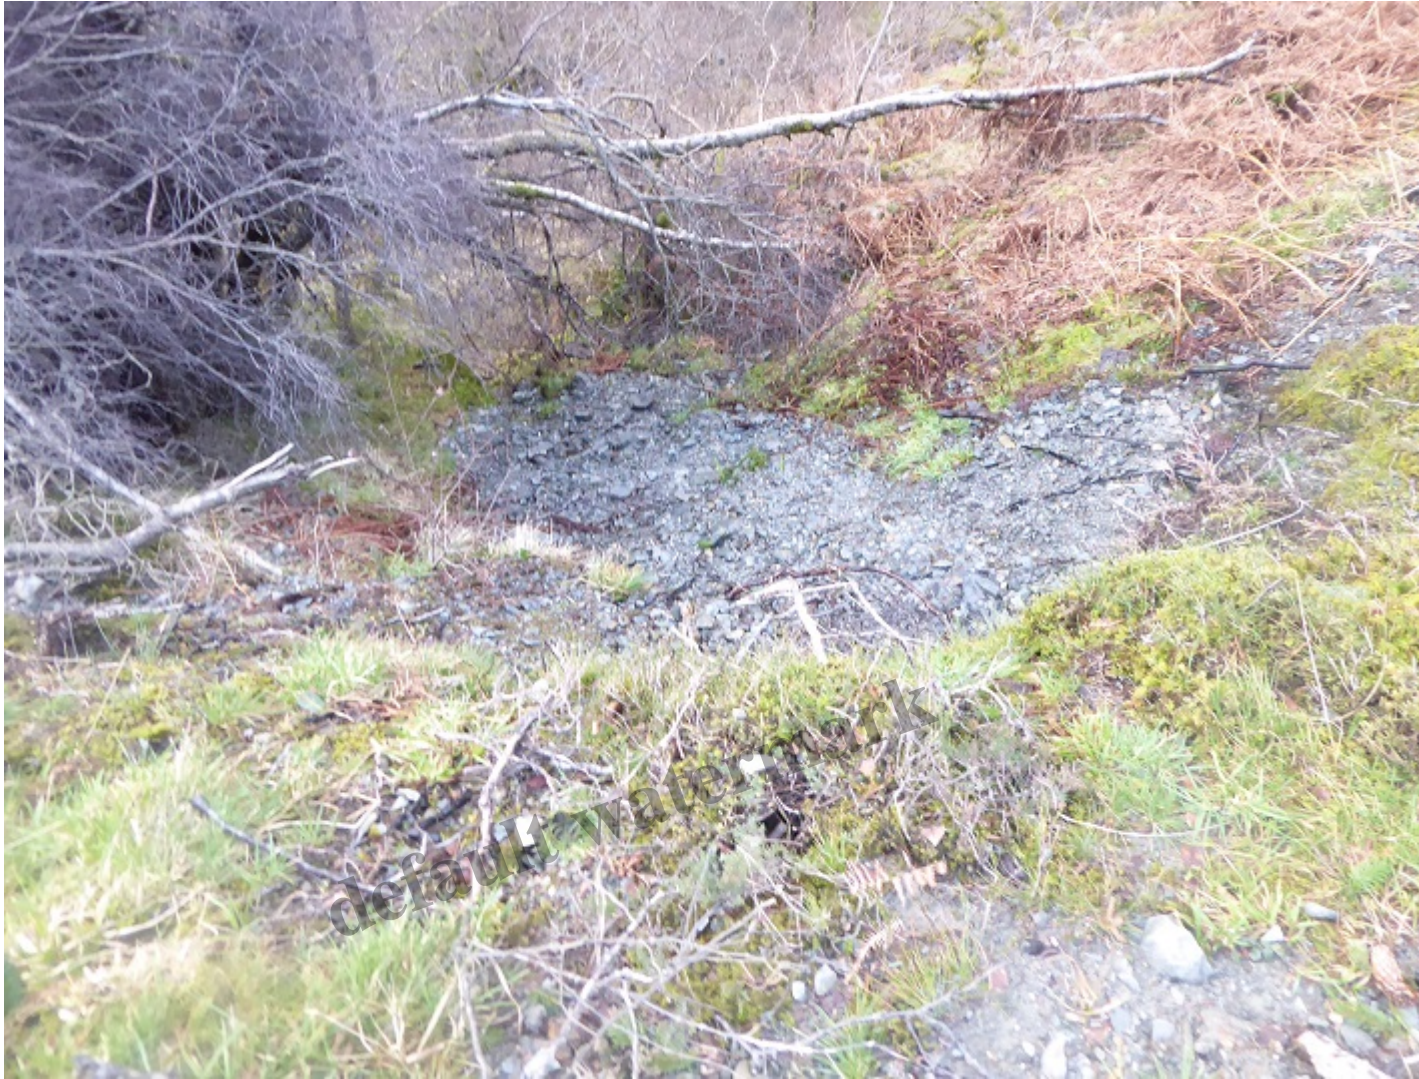
Construction materials washed down the slope

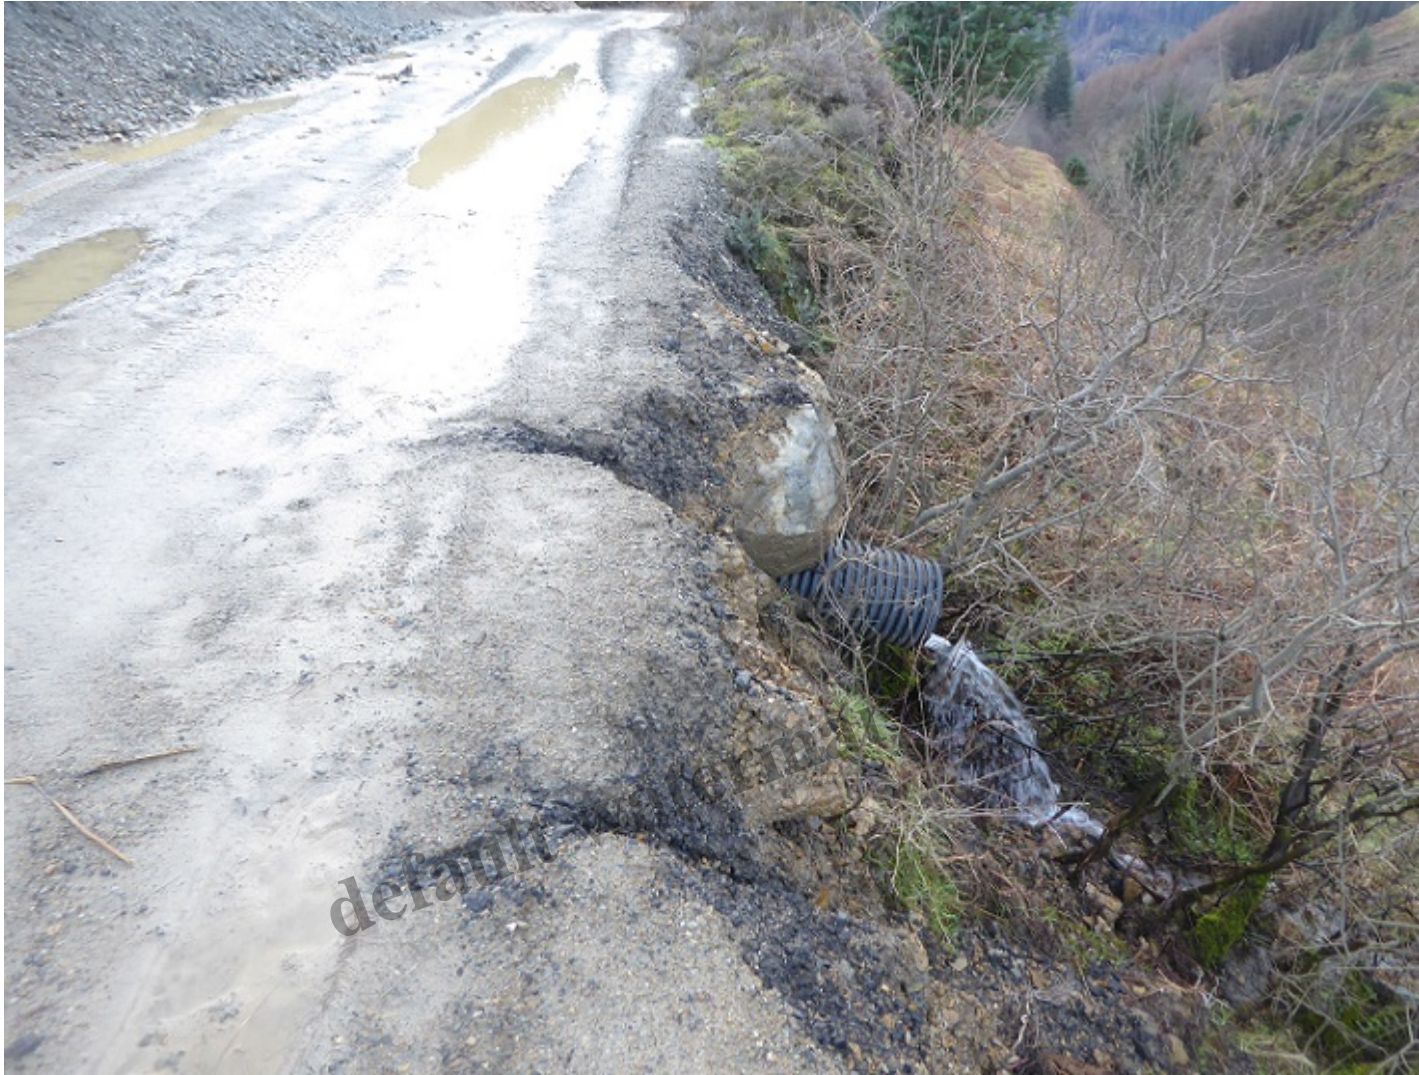
Culvert and road edge at high risk of collapse
