The Ardchullarie forest road and the need to re-think timber extraction in our National Parks

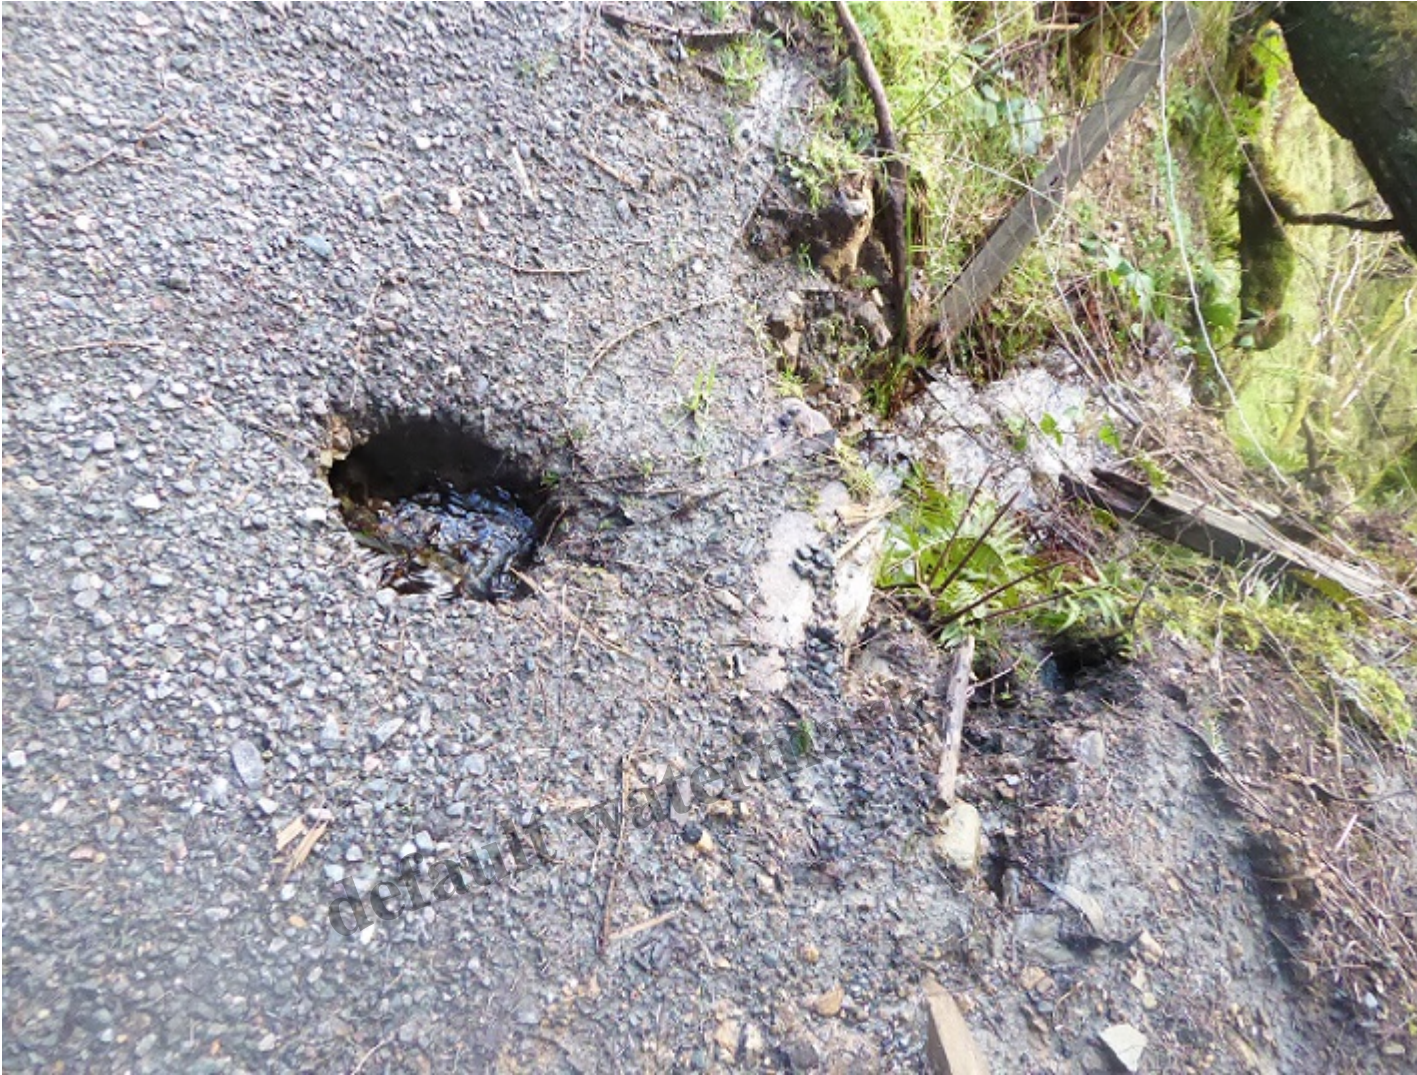
Road surface eroding from below

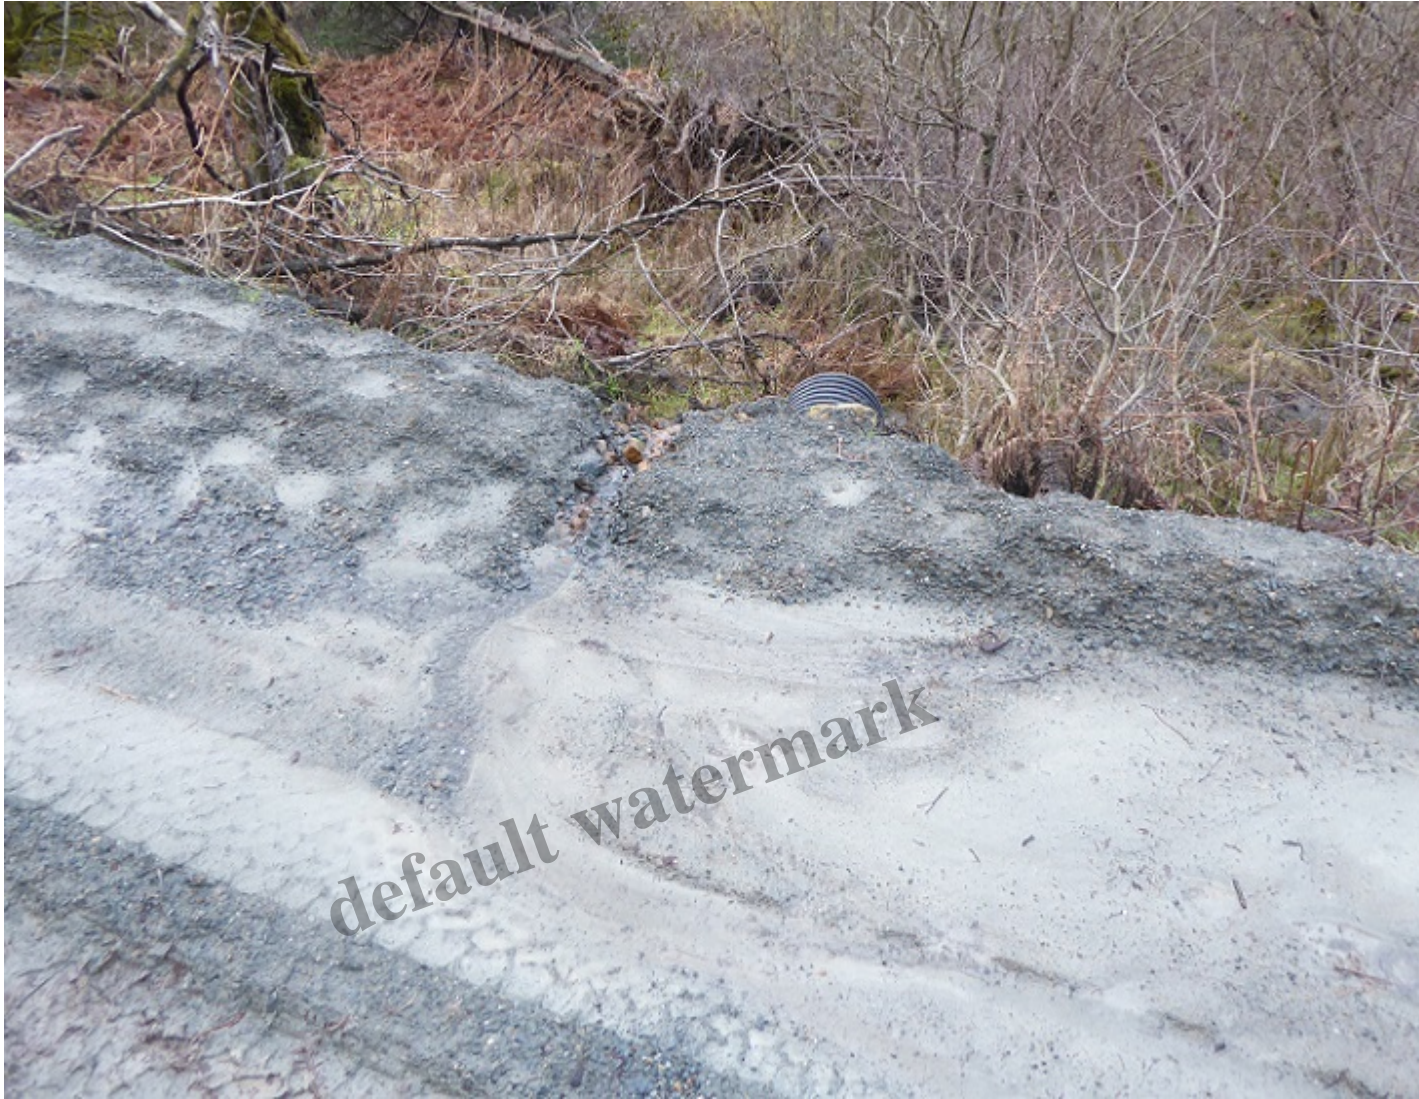
Another culvert likely to fail

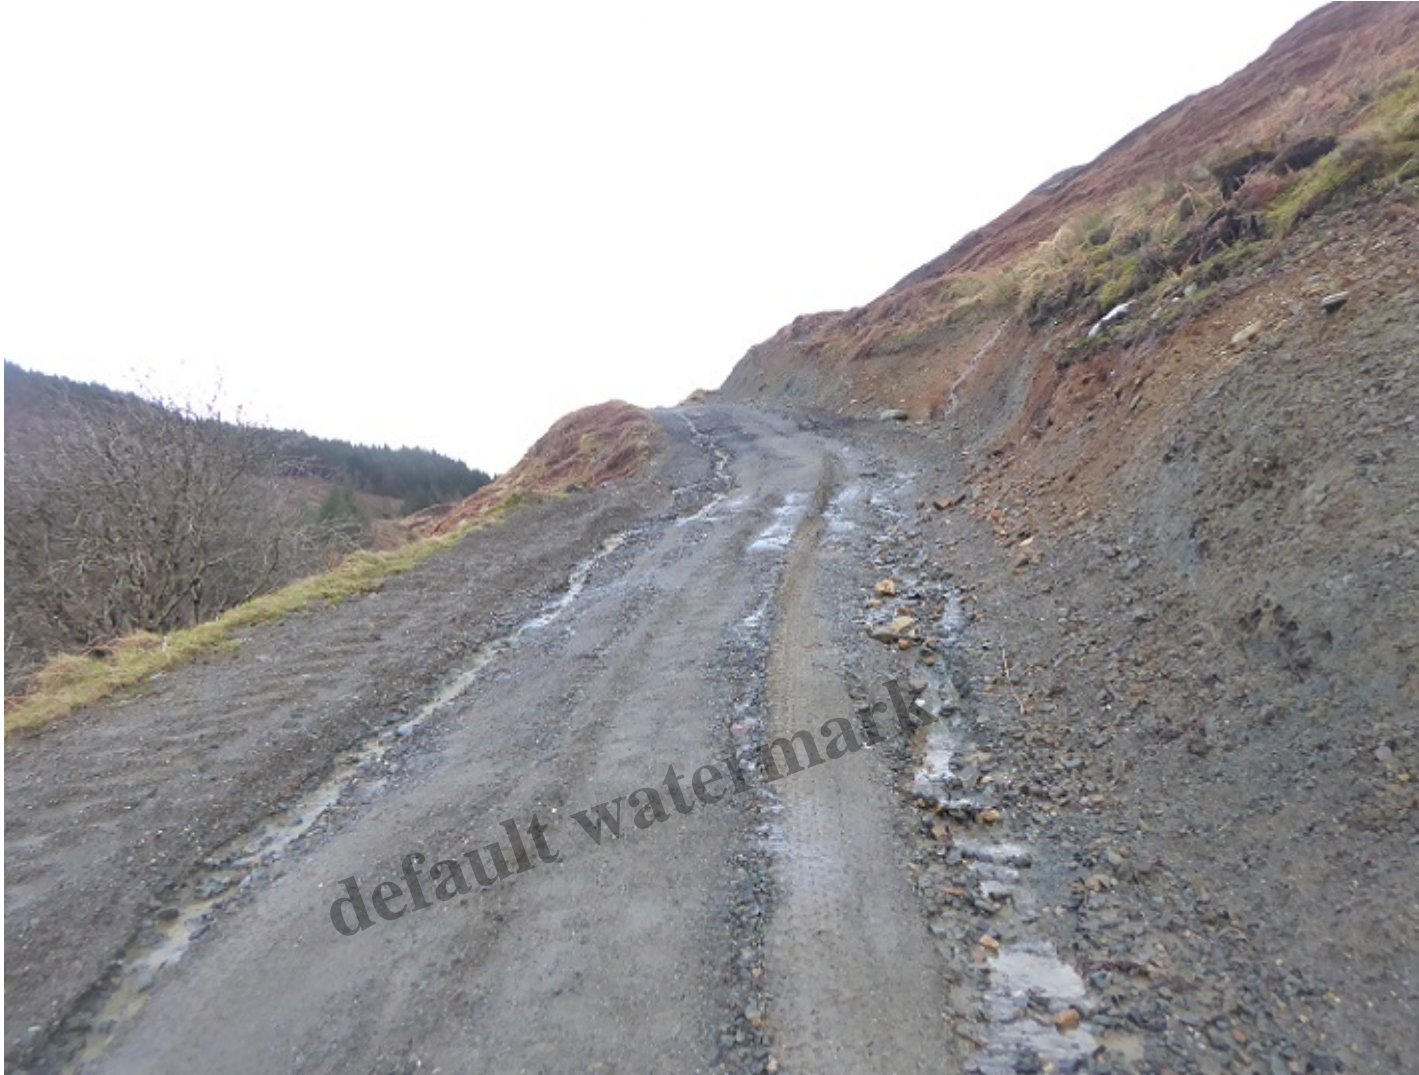
Road or river?

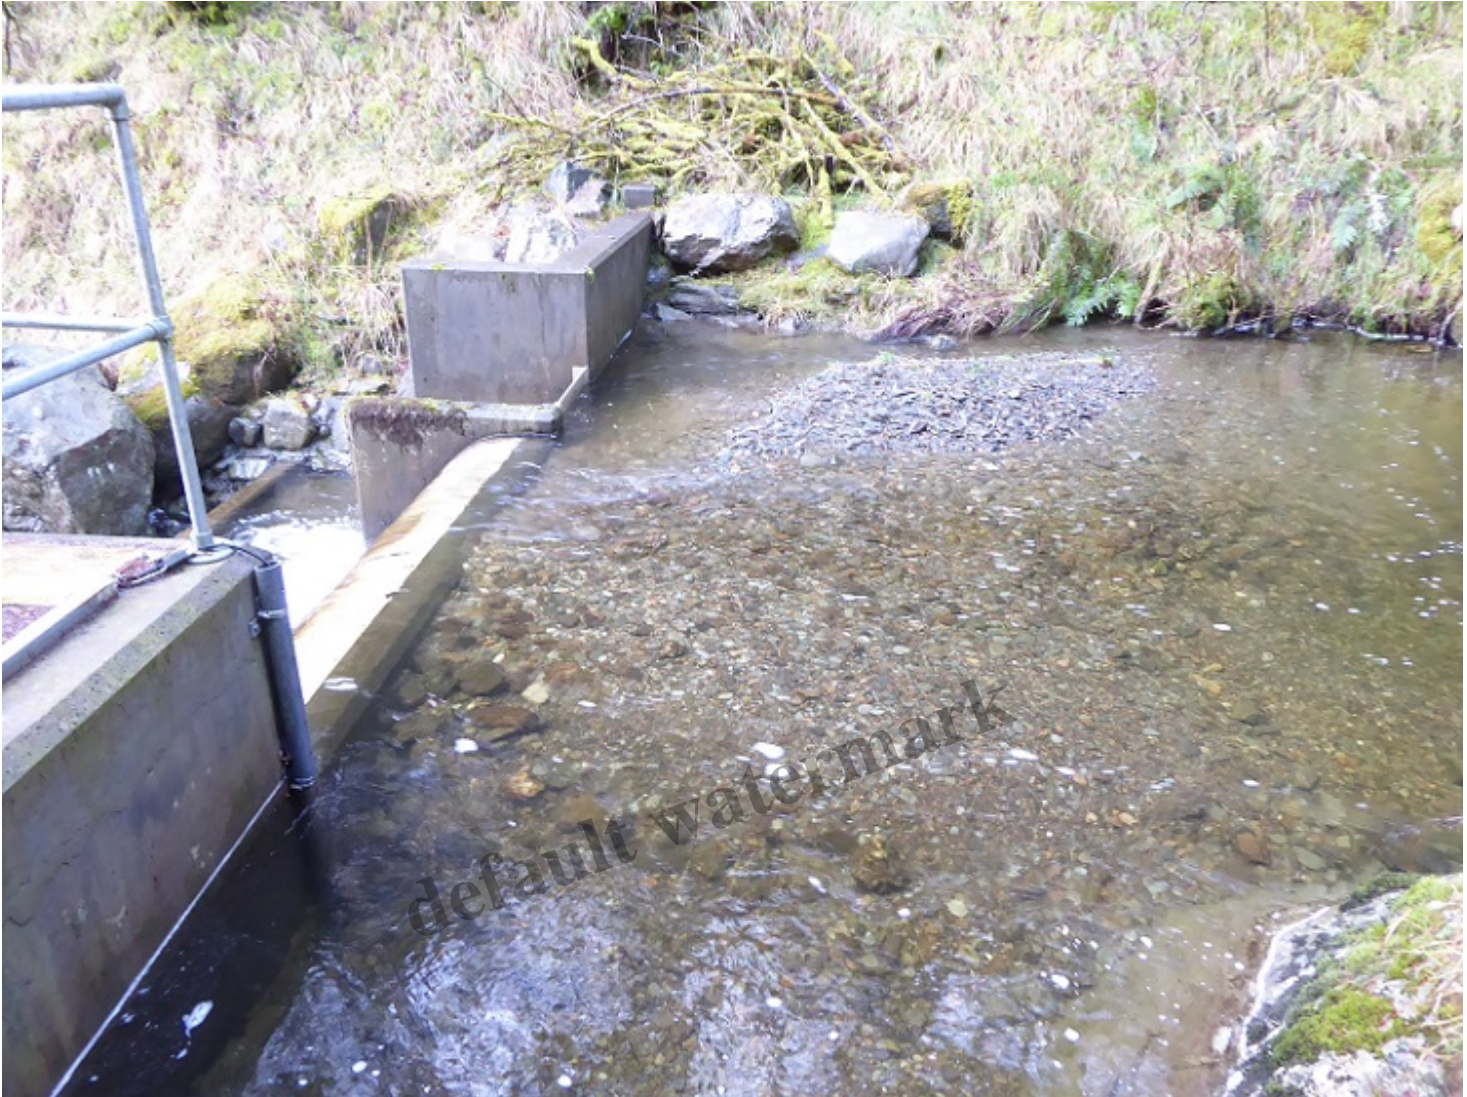
While run of river hydro intakes do gradually fill in over time, it appears that the Ardchullarie intake may be filling up quicker than one might normally expect.
