The failure of the National Park planning system at Cairn Gorm – the magic carpet construction

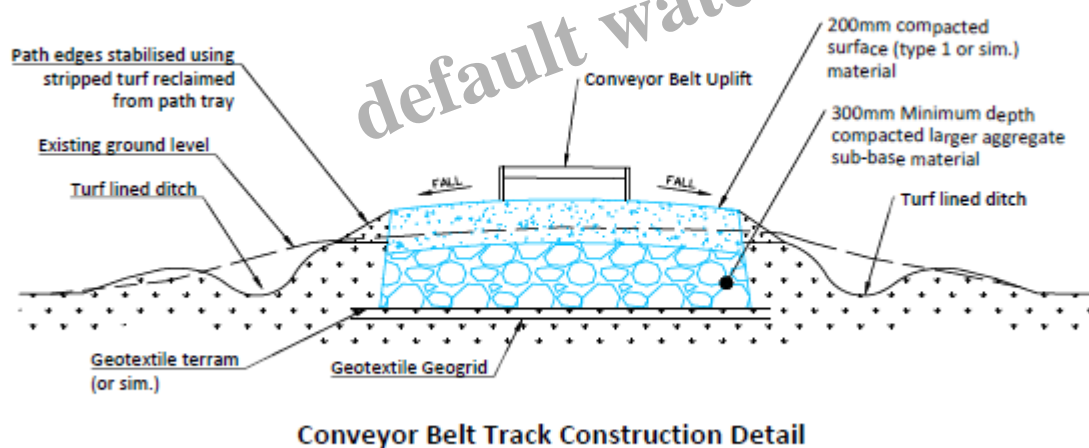
Second, is the way the magic carpet is being constructed. This bears no resemblance to the plans approved by the Planning Committee:

In the original plans approved by the CNPA planning the magic carpet would have sat above the ground with a turf lined ditch on either side. These plans were not sensible. They would have risked users falling off the edge, except when there was lots of snow, and stored up further trouble in winter, with snow likely to get in under the conveyor.

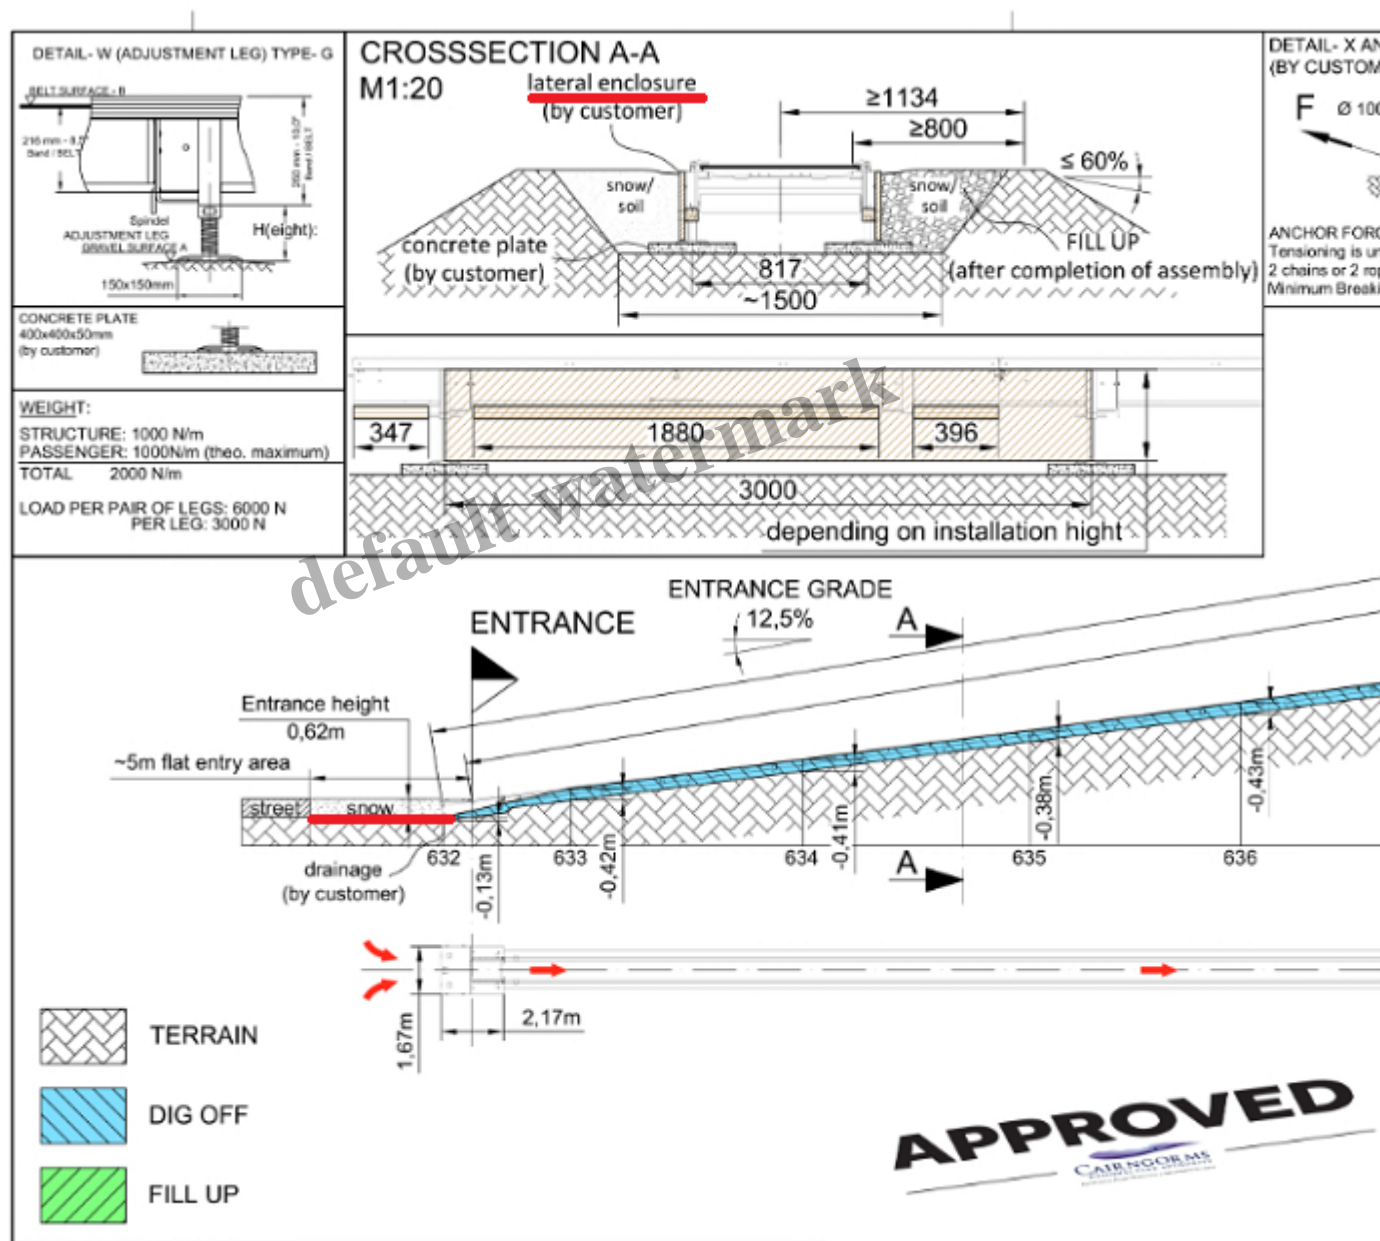
Extract from plan for the 93m or lower belt, i.e. the one in the photo above.

The revised plans ([see here](#)) show a very different installation to the one originally approved, a magic carpet almost flush with the ground and bearing a reasonable resemblance to the work in progress:

- The new plan shows the magic carpet sunk into the surrounding terrain (the hatched area). Had this been followed, only a narrow construction corridor and much smaller machinery would have been needed to install the carpet.
- In the plans the lateral enclosures of the space under the magic carpet (underlined in red) are vertical, whereas in the photo they are sloping at c45 degrees and half the space that the plans show would have been filled with soil/snow has been removed. That may not matter technically but is not in accordance with what the CNPA has now consented and means a bank will have to be constructed up the left hand side of the carpet, causing more ground disturbance.

A minor issue raised by the new plans is if terrain is to be brought up to the level of the magic carpet by packing down snow (also underlined in red), that will leave a step for children with mountain bikes to negotiate in summer on what is also supposed to be a family friendly uplift facility.

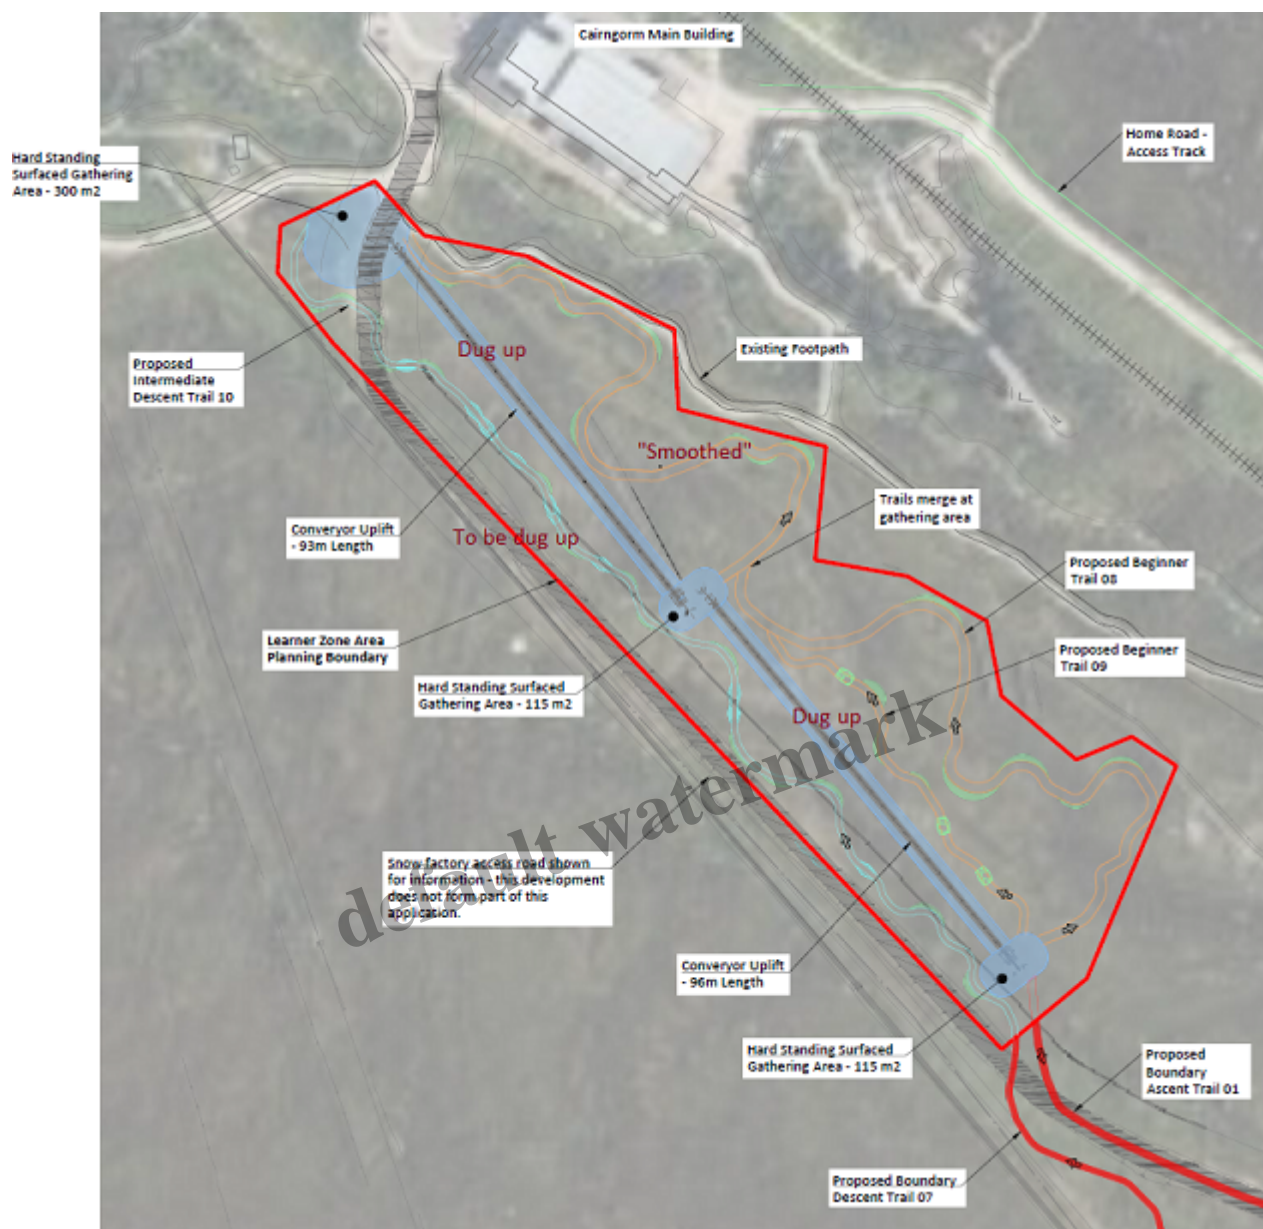
Proposed access track for snow factory is shown by shaded grey line running along the boundary of the application for the magic carpet and mountain bike trails. I have added annotations in dark red, "dug up", "smoothed" etc.

As a result, I mistakenly thought the construction track for the magic carpet might have been also used transport the snow factory up the hill ([see here](#)). It looks fairly clear from the photo that the access track and damaged ground to the right of the magic carpet could never bear the weight of the vehicles needed to transport the snow factory up the hill. My apologies for the mistake.

However, the location map from the magic carpet planning application also show just how much ground parallel to the ski tow is being or will be dug up. Add to that the large area besides the magic carpets that has recently been smoothed ([see here](#)) and you can see that basically the whole of the area between the the ski tow and the footpath will have been dug over by heavy machinery if the snow factory is allowed to go ahead.
