The failure of the National Park planning system at Cairn Gorm – the magic carpet construction

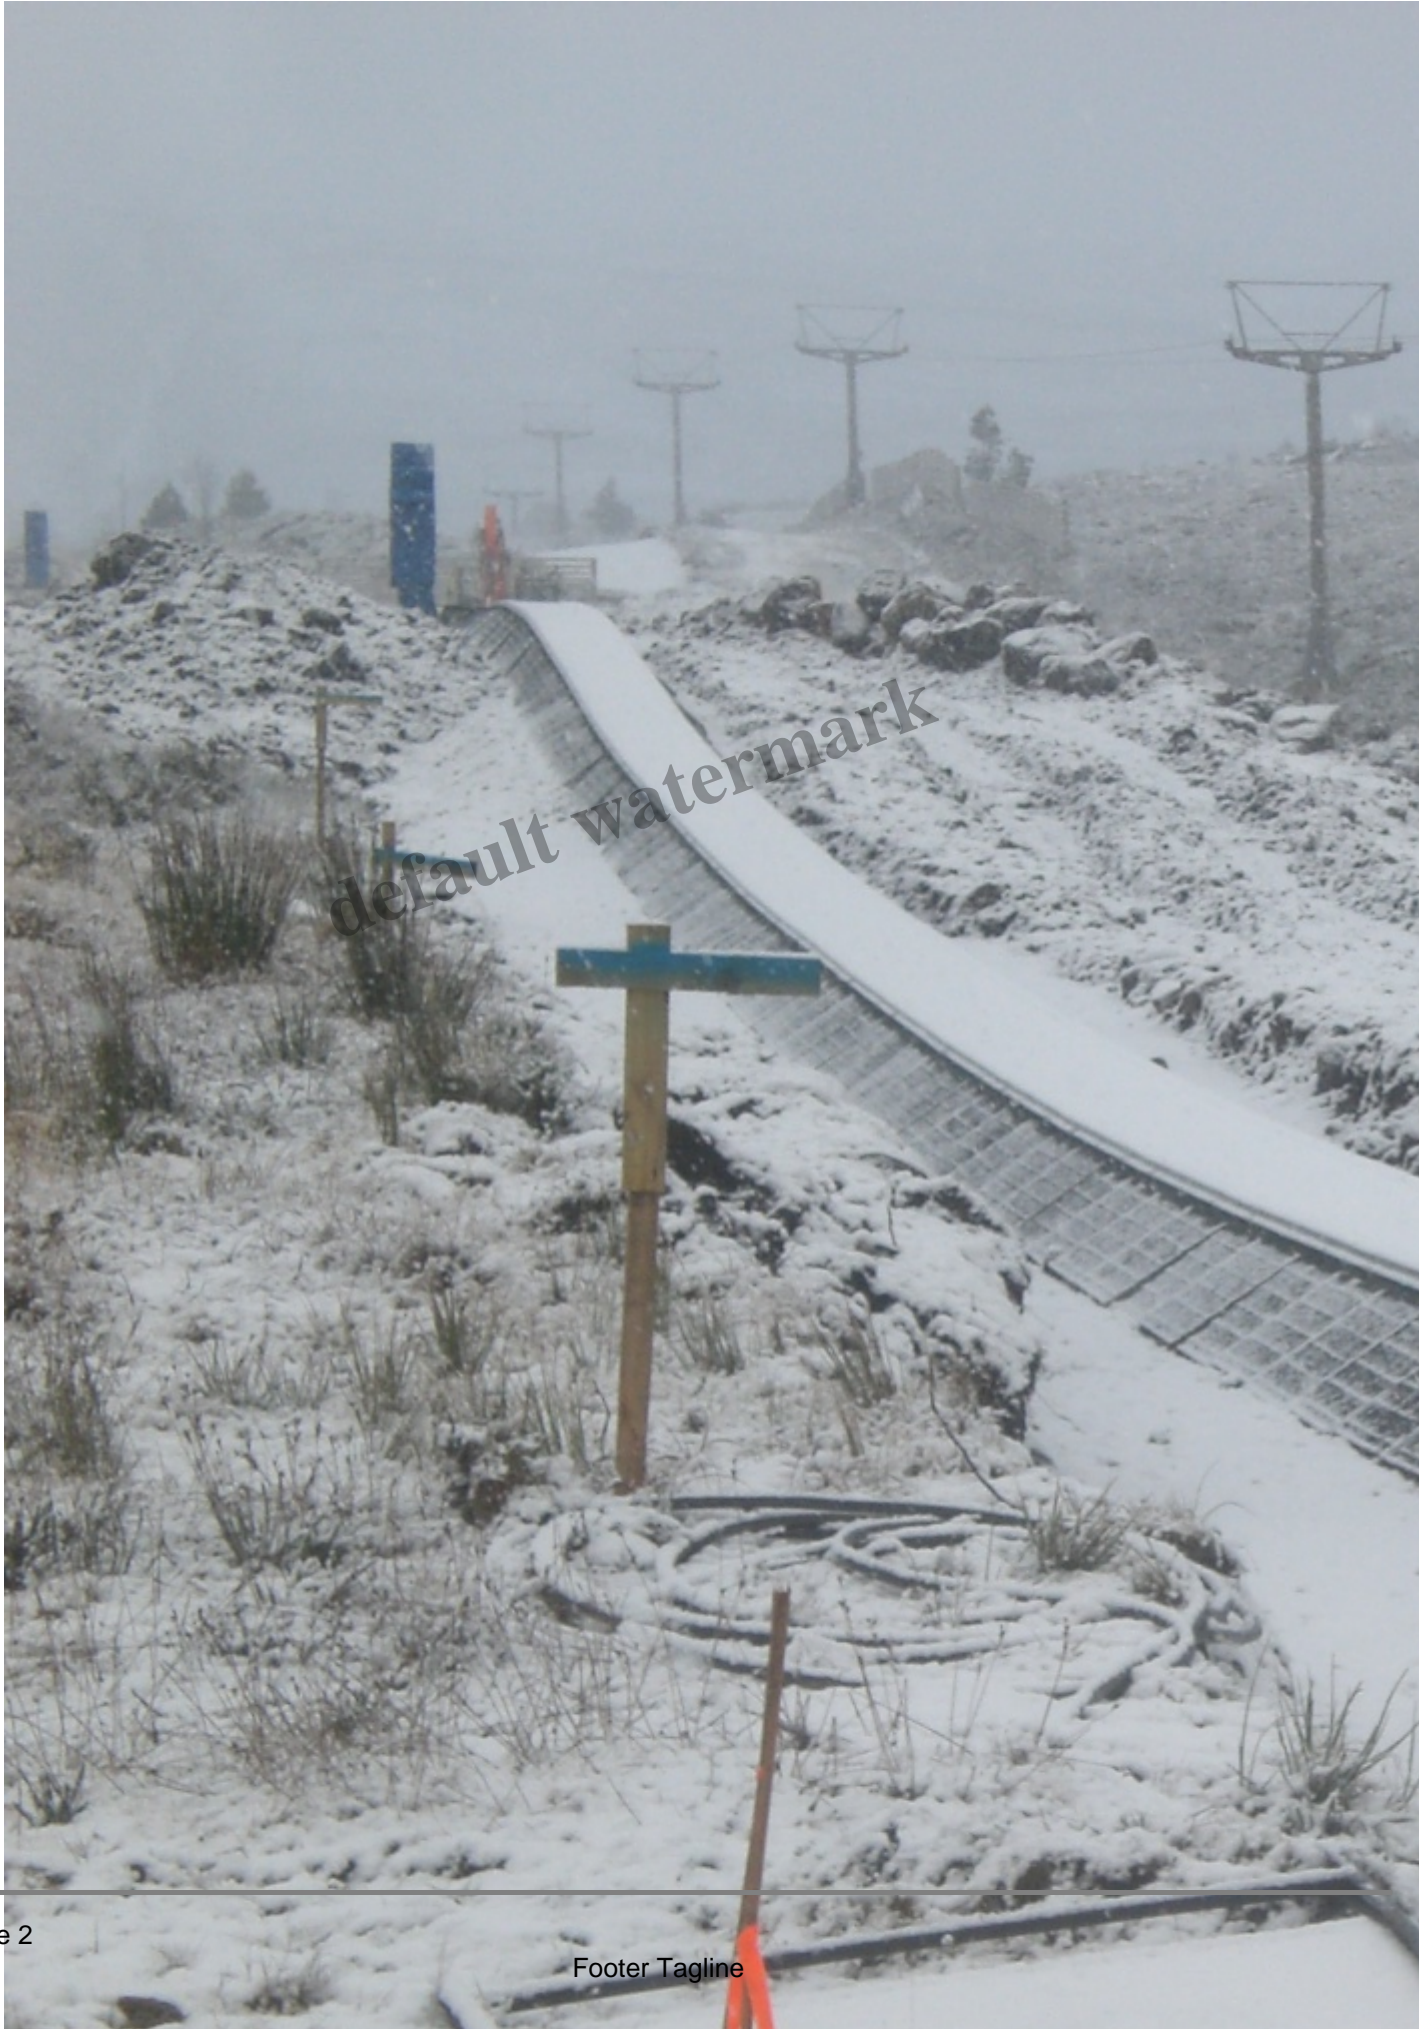
Construction of magic carpet 4th December – Photo Credit Alan Bratney

The work being undertaken to construct the lower of the two magic carpets bears no resemblance to that which was approved by the Cairngorm National Park Authority (CNPA) in May.

While it is difficult to estimate the exact width of the construction corridor from the photo, the vehicle tracks on the right suggest the corridor on the right of the conveyor is nearer four metres and more in places. It appears therefore the work McGowan is doing is not only contrary to their own Construction Method Statement, it is in breach of planning conditions.

The most important point, however, is that none of the latest planning documents explain why such a broad construction corridor is required or have sought planning consent for this.

The need for the CNPA to take a critical look at how HIE/CMSL are gaming the planning system at Cairn Gorm and take enforcement action where planning conditions are breached is as strong as ever. It is time the CNPA stood up to HIE/CMSL instead of bailing them out as they have done by helping fund the car park improvements ([see here](#)).

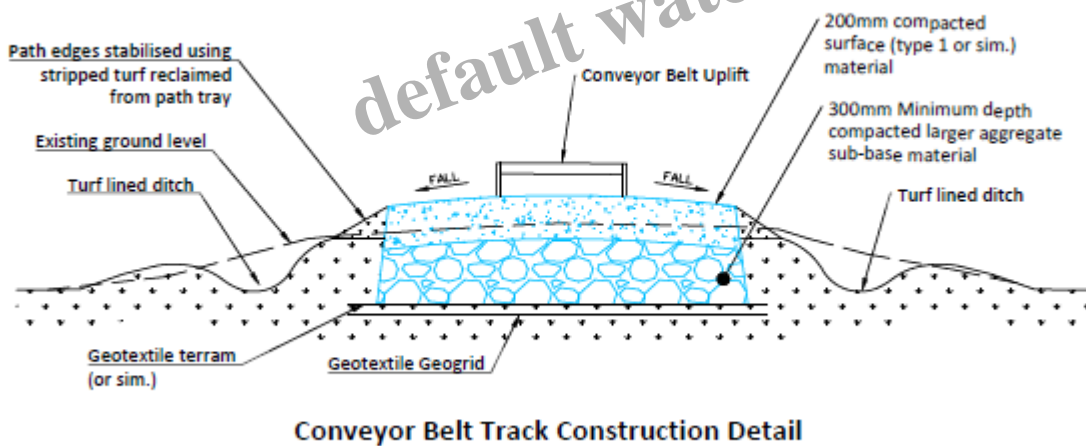
Second, is the way the magic carpet is being constructed. This bears no resemblance to the plans approved by the Planning Committee:

In the original plans approved by the CNPA planning the magic carpet would have sat above the ground with a turf lined ditch on either side. These plans were not sensible. They would have risked users falling off the edge, except when there was lots of snow, and stored up further trouble in winter, with snow likely to get in under the conveyor.

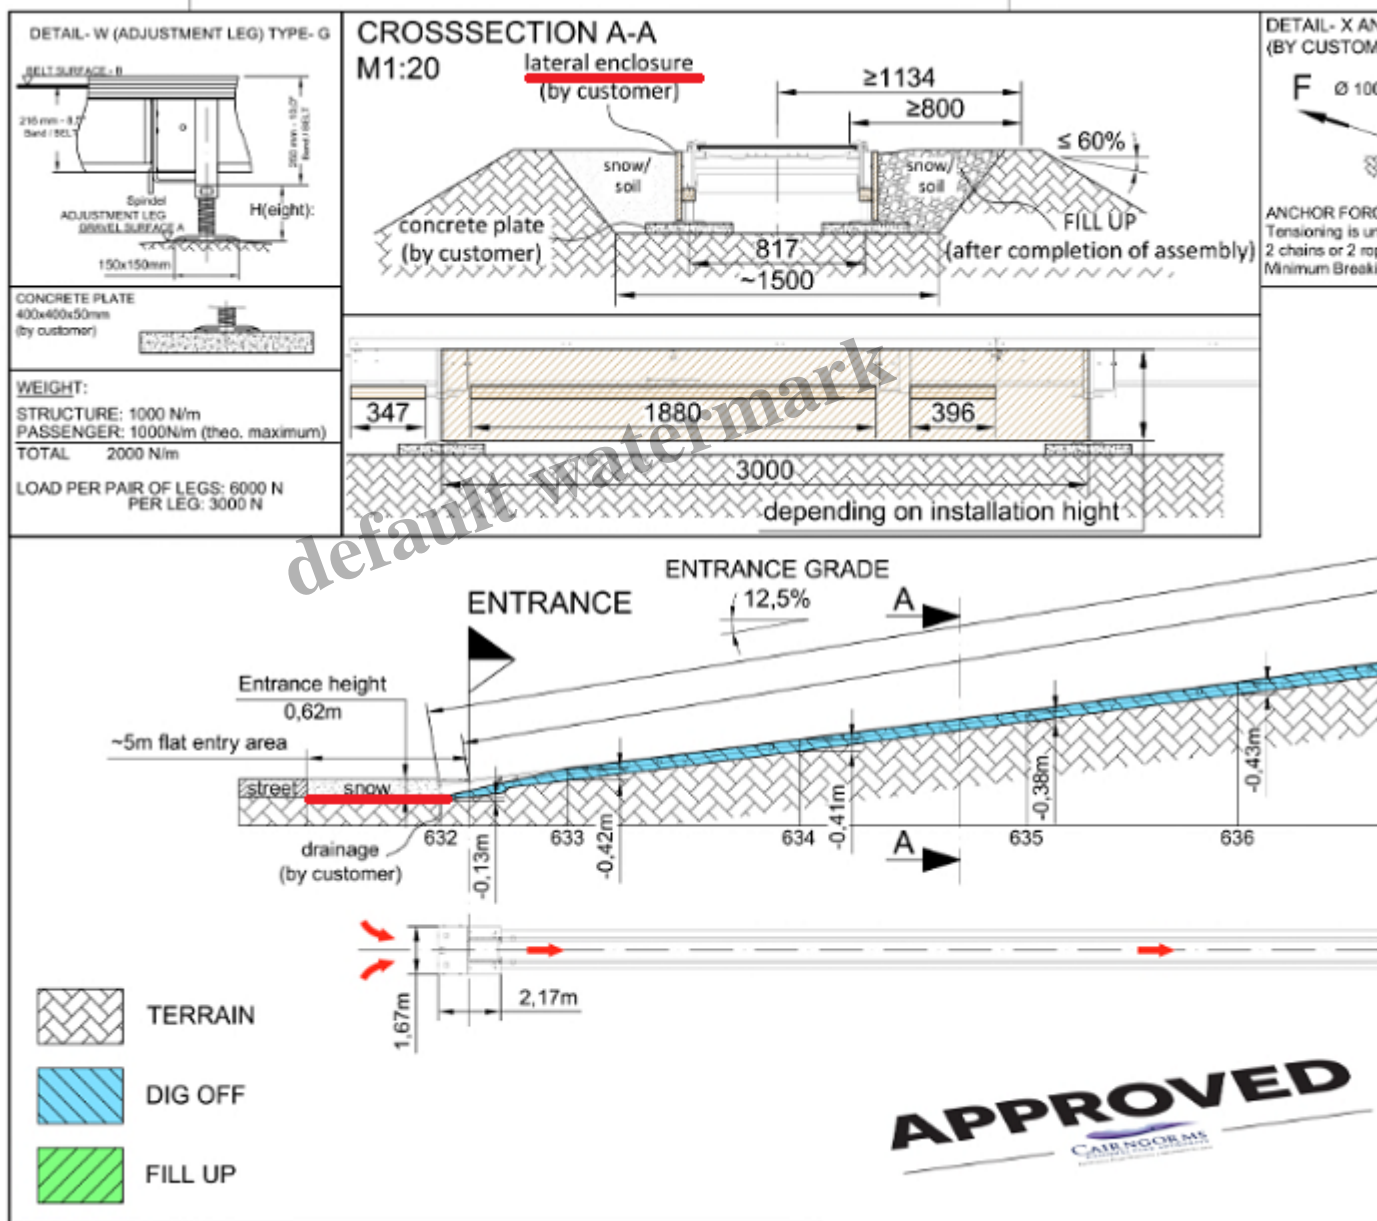
Extract from plan for the 93m or lower belt, i.e. the one in the photo above.

The revised plans ([see here](#)) show a very different installation to the one originally approved, a magic carpet almost flush with the ground and bearing a reasonable resemblance to the work in progress:

- The new plan shows the magic carpet sunk into the surrounding terrain (the hatched area). Had this been followed, only a narrow construction corridor and much smaller machinery would have been needed to install the carpet.
- In the plans the lateral enclosures of the space under the magic carpet (underlined in red) are vertical, whereas in the photo they are sloping at c45 degrees and half the space that the plans show would have been filled with soil/snow has been removed. That may not matter technically but is not in accordance with what the CNPA has now consented and means a bank will have to be constructed up the left hand side of the carpet, causing more ground disturbance.

A minor issue raised by the new plans is if terrain is to be brought up to the level of the magic carpet by packing down snow (also underlined in red), that will leave a step for children with mountain bikes to negotiate in summer on what is also supposed to be a family friendly uplift facility.

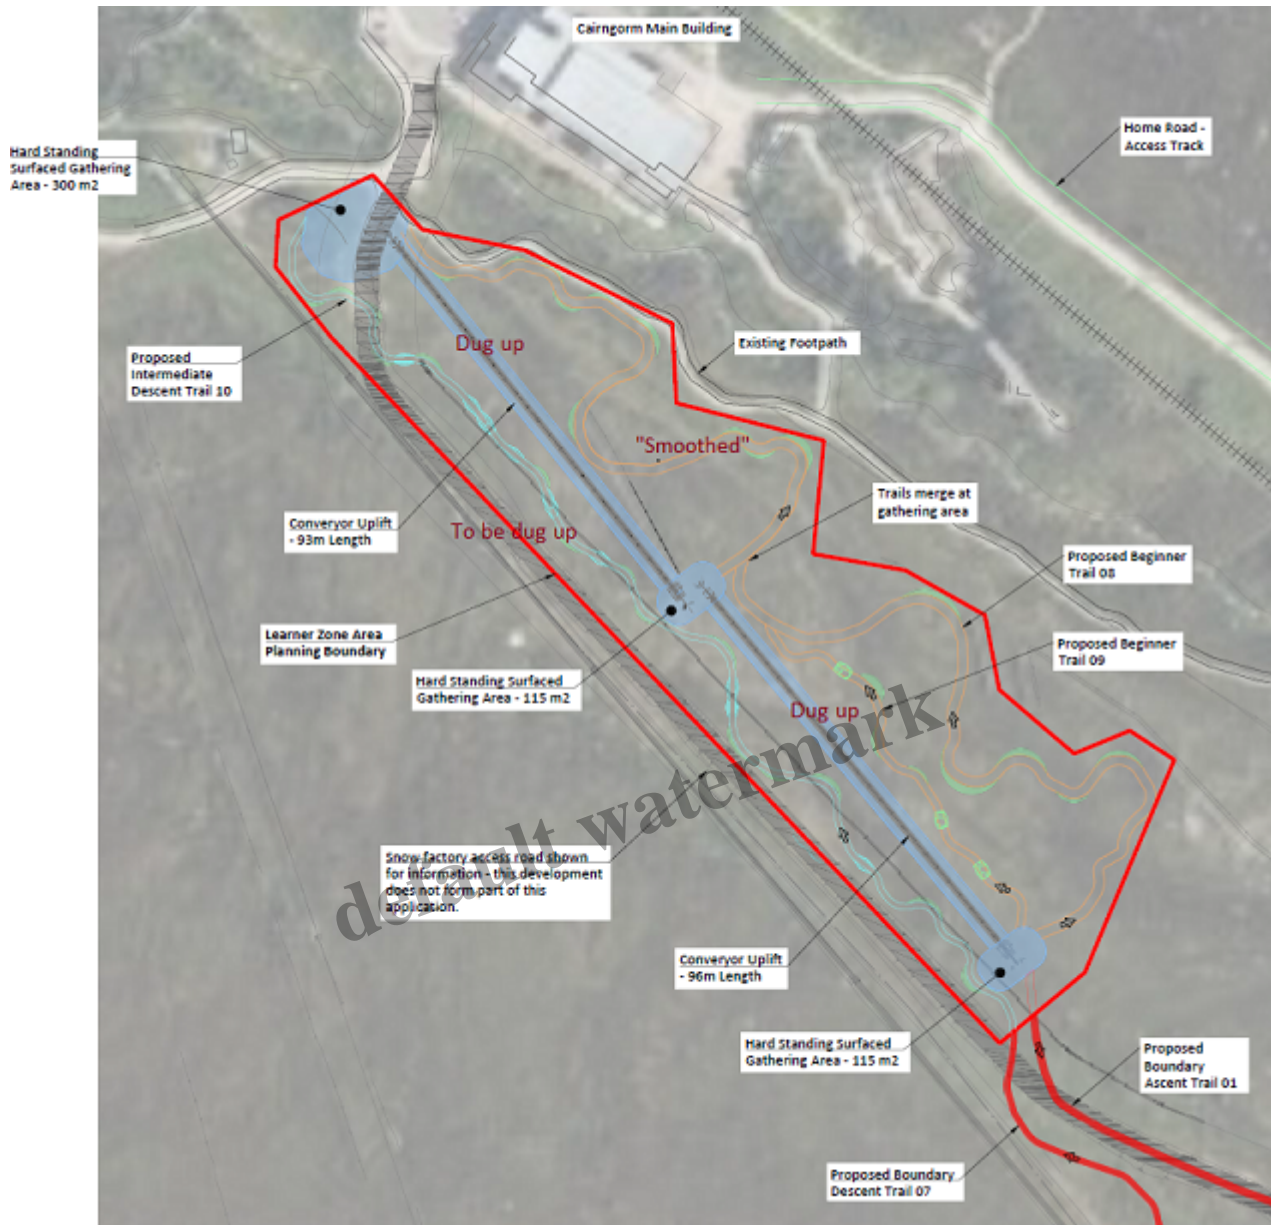
Proposed access track for snow factory is shown by shaded grey line running along the boundary of the application for the magic carpet and mountain bike trails. I have added annotations in dark red, “dug up”, “smoothed” etc.

As a result, I mistakenly thought the construction track for the magic carpet might have been also used transport the snow factory up the hill ([see here](#)). It looks fairly clear from the photo that the access track and damaged ground to the right of the magic carpet could never bear the weight of the vehicles needed to transport the snow factory up the hill. My apologies for the mistake.

However, the location map from the magic carpet planning application also show just how much ground parallel to the ski tow is being or will be dug up. Add to that the large area besides the magic carpets that has recently been smoothed ([see here](#)) and you can see that basically the whole of the area between the the ski tow and the footpath will have been dug over by heavy machinery if the snow factory is allowed to go ahead.
