The conservation failure on the A83 at the Rest and Be Thankful

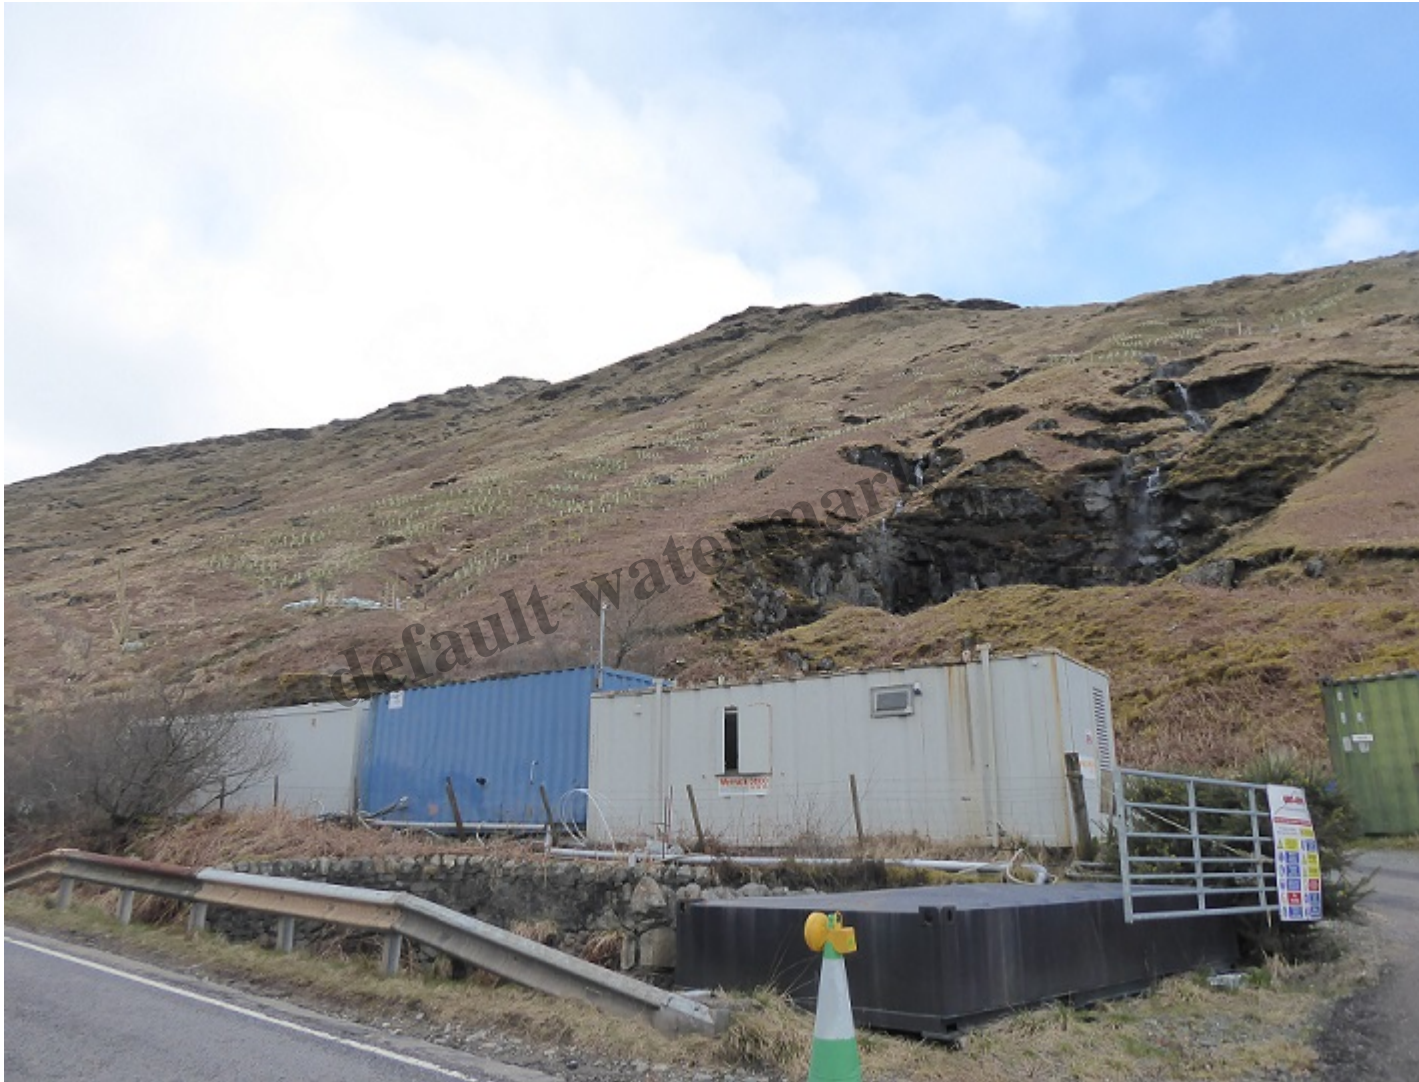
Rest and Be Thankful works compound with hundreds of tree shelters on slope of Beinn Luibhean behind. Note the tree growing by the side of the road and the gorse by the cabins

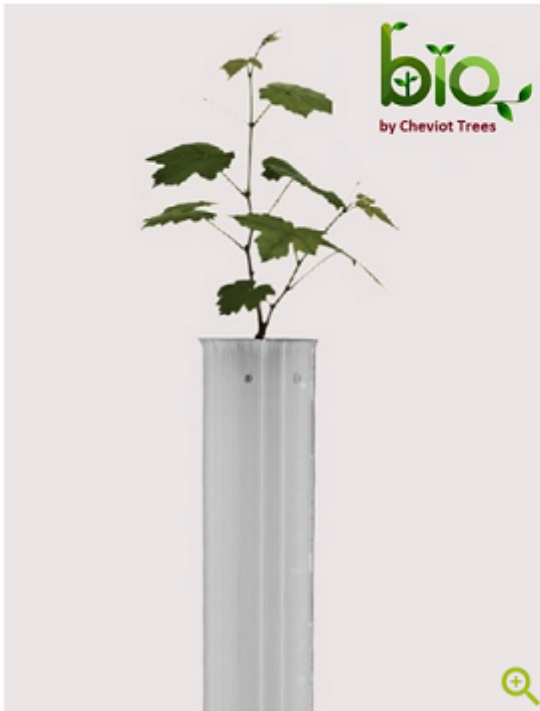
TUBEX Nature Standard - Biodegradable design from £1.62

- Twin wall, cylindrical construction for best strength to weight ratio.
- Pre-fitted releasable ties for quick installation and maintenance.
- Flared rim to minimise stem abrasion.
- Laser line designed to split to avoid strangulation as the plant grows.

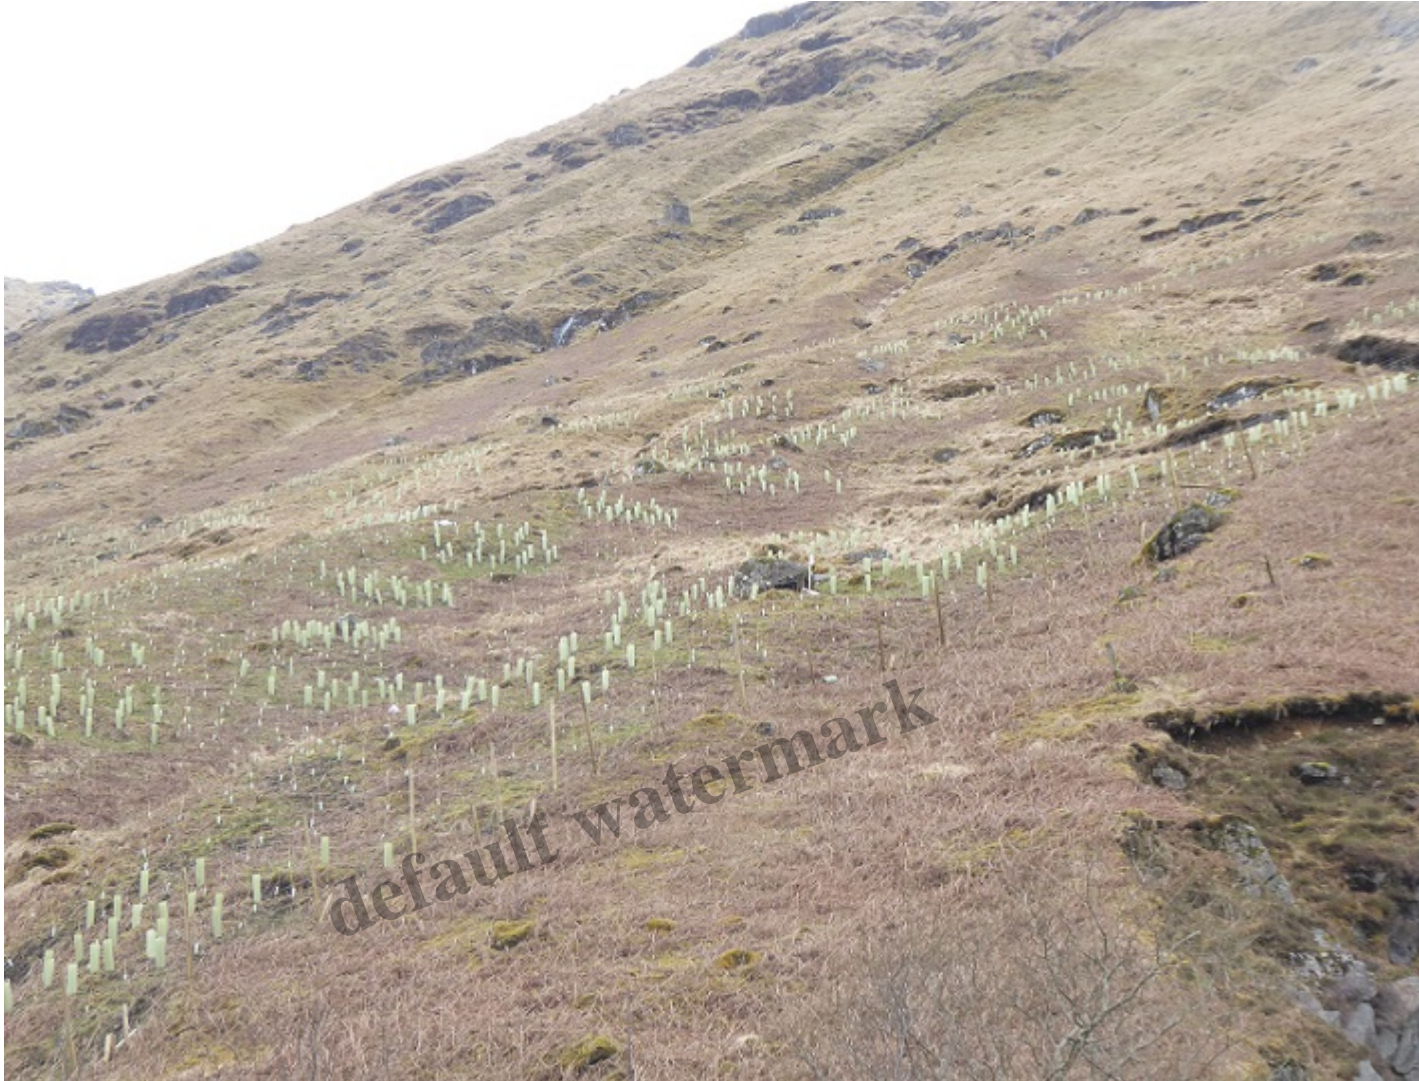
Vole guards scattered among larger tree shelters

With planting work having just started last year there has been no time no for monitoring to ascertain if the use of vole guards might be justified. There was no mention in the LMP of any need to provide protection from hares or rabbits so how what FLS has actually done on this slope fits with the plan is unclear.

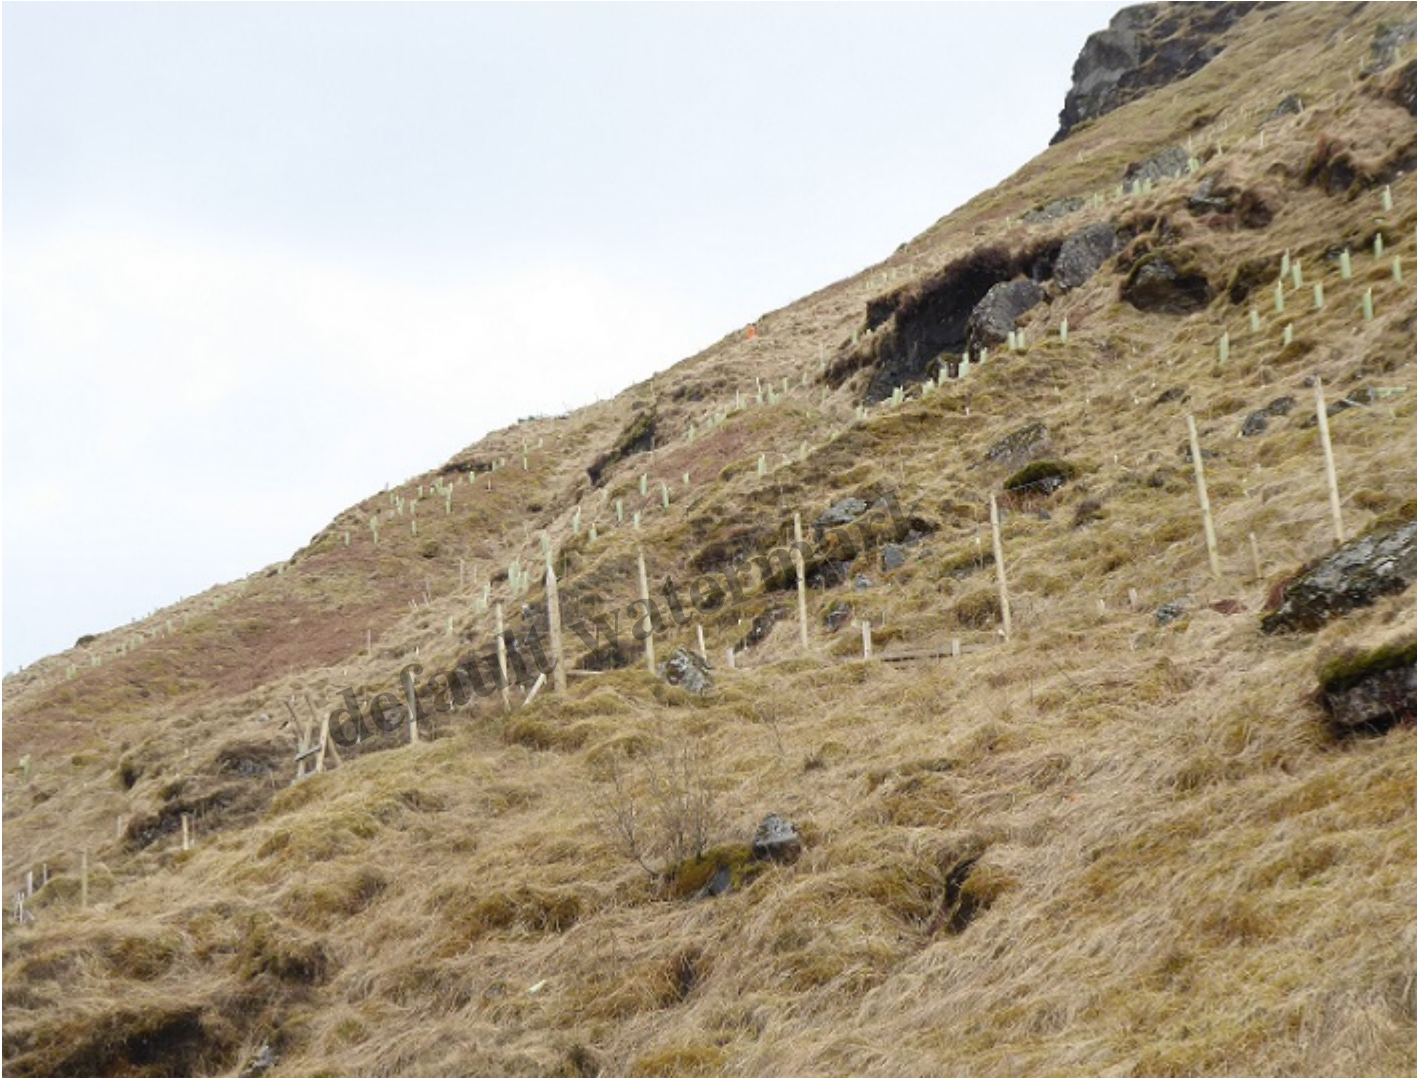
Which has the greater landscape impact, the tree shelters or the fencing?

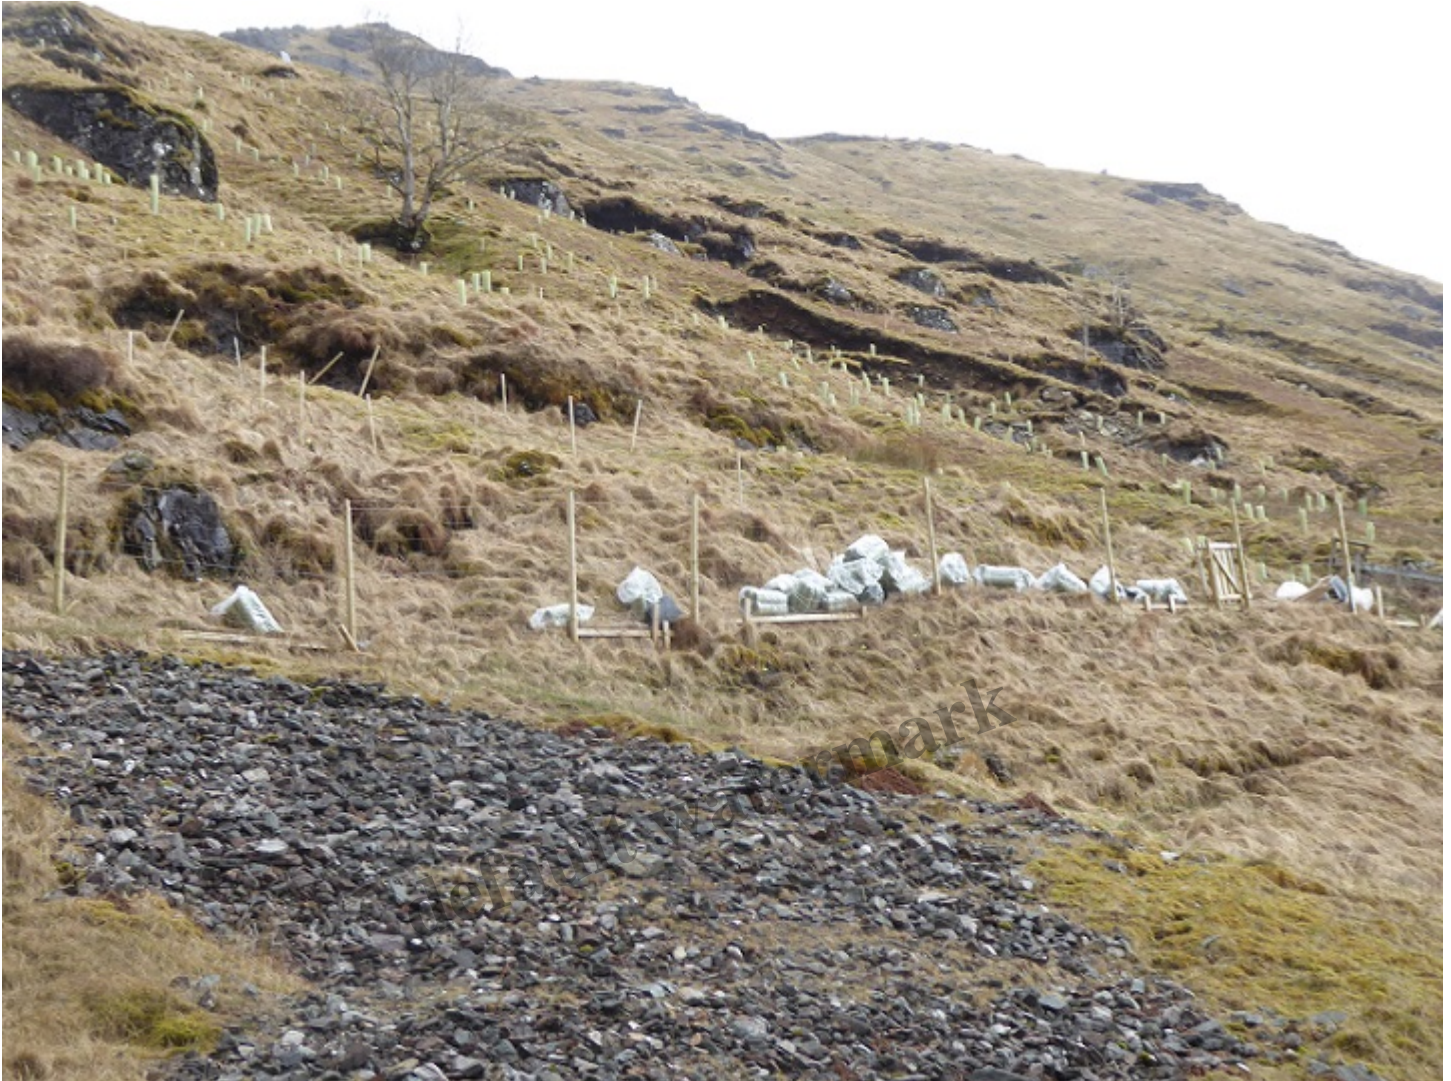
One possible explanation for the shelters is that the tree planting is so behind schedule that FLS decided to use them to try and force tree growth and make up for lost time. The original timetable for this planting, as set out in Map 8 accompanying the LMP and dated December 2018, was for it to be completed in 2020/21 i.e. two years ago. In August 2020 the taskforce was told “Erection of deer fence around hill side planned for later this year. Planting of hillside due Autumn 2021?”. The timetable continues to slip, with the latest delays reported to the A93 taskforce being attributed to bad weather: hence the bags of tree shelters by the fence.

If this is right, the use of tree shelters will not only increase the costs – Scottish Forestry now has a policy that all tubes should be removed – but the risks. Tree shelters blow over in the wind. One enormous climate change induced storm and much of this new woodland could be destroyed.

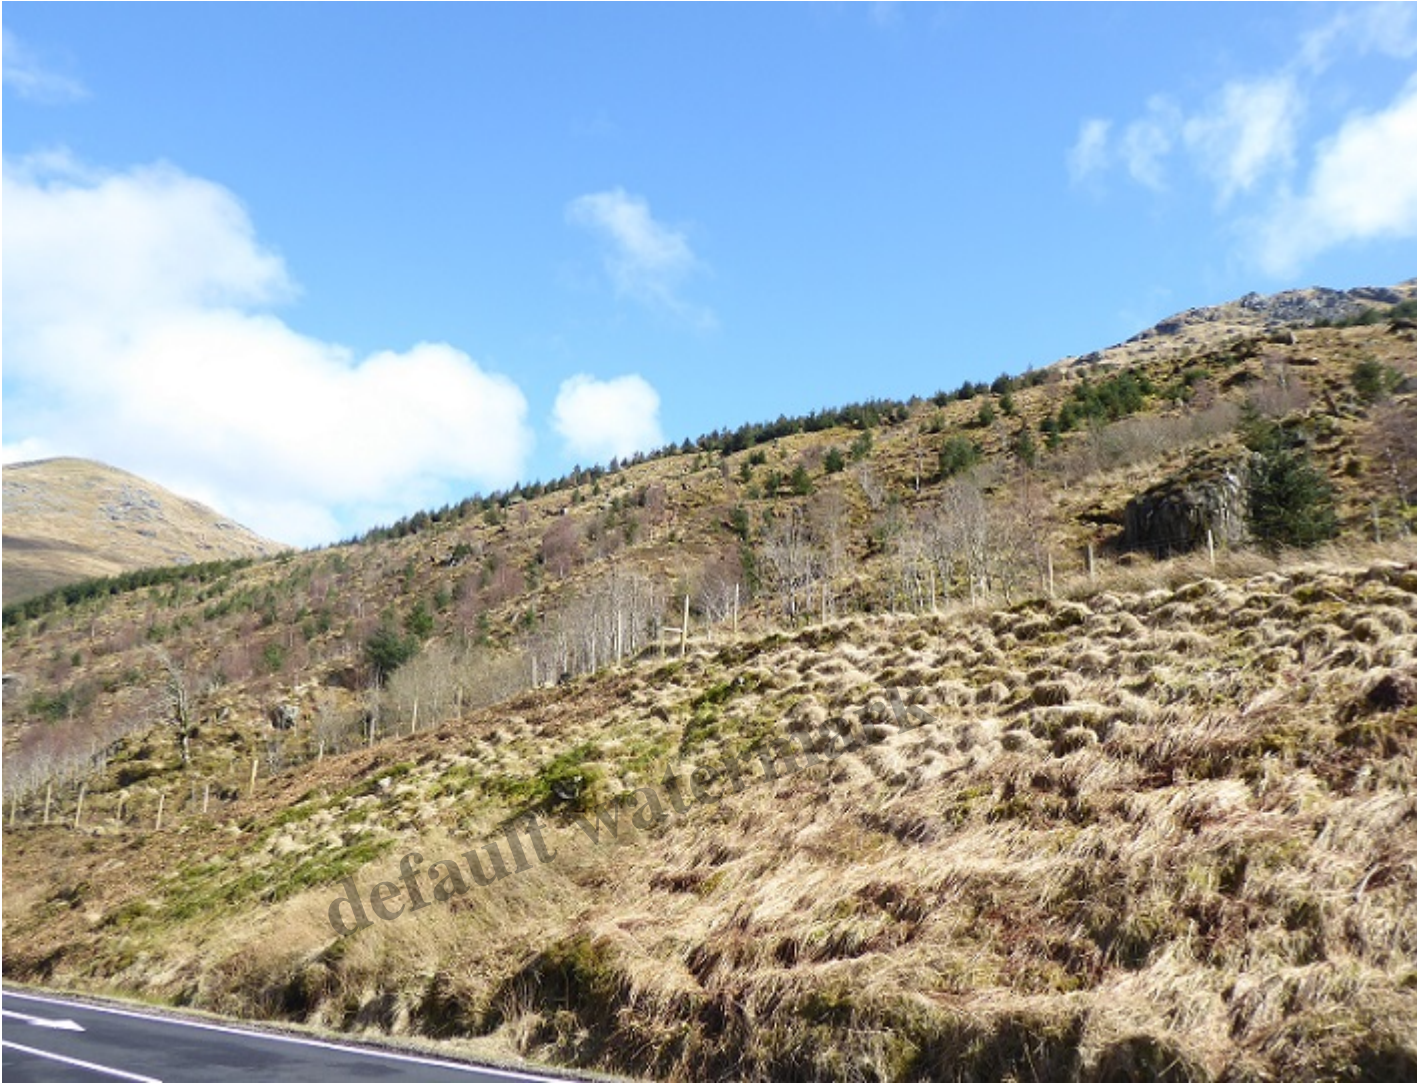
Mixed woodland on the Butterbridge plantation, well established even if the lack of ground cover suggests large herbivore are now grazing within the fenced enclosure

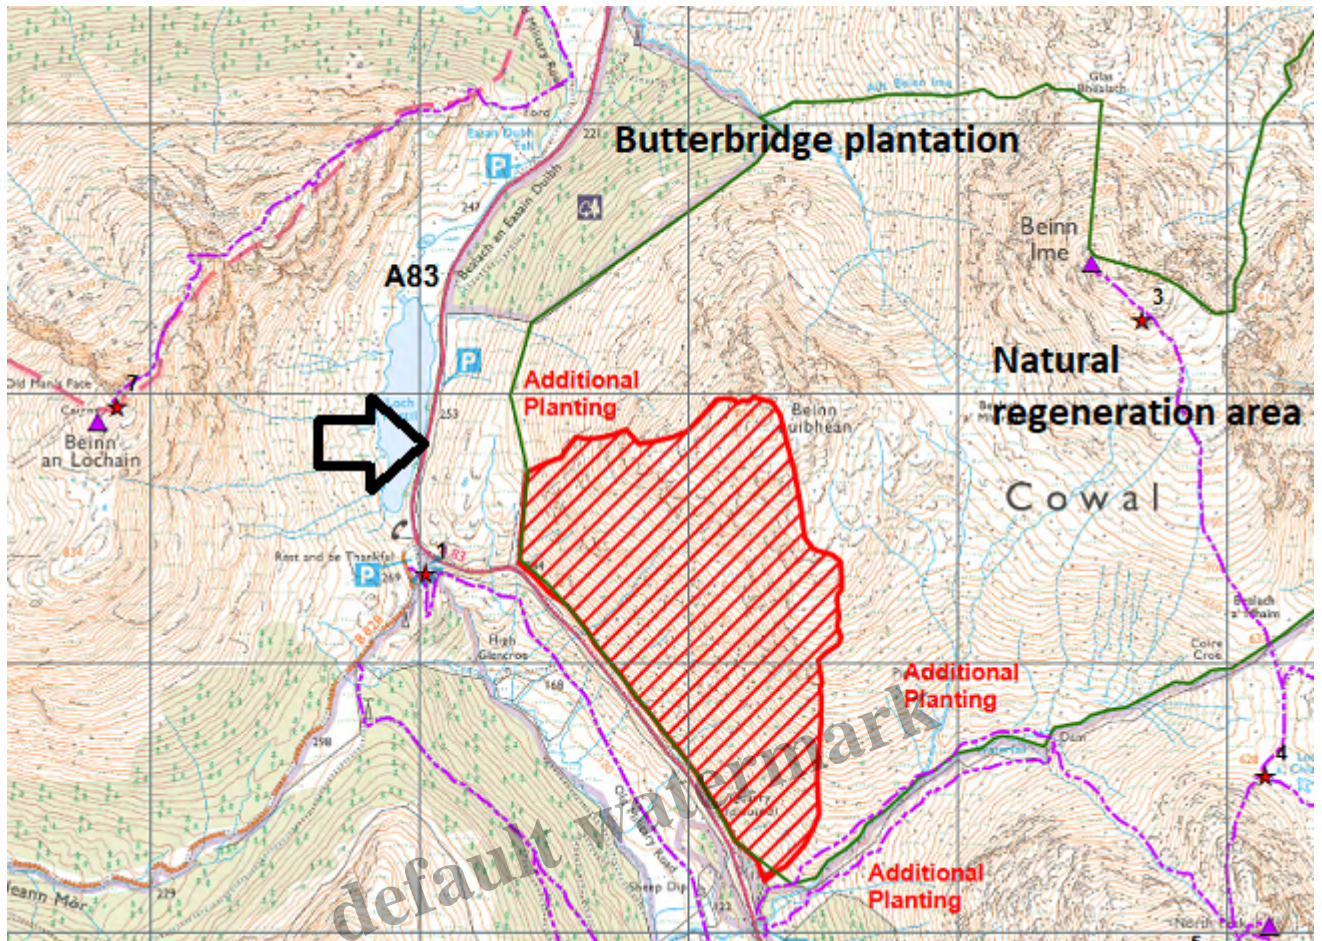
The Green Line marks the land FLS has bought and the boundary of the Woodland Creation Project, the red the priority area for planting and the black arrow land that remains in private ownership

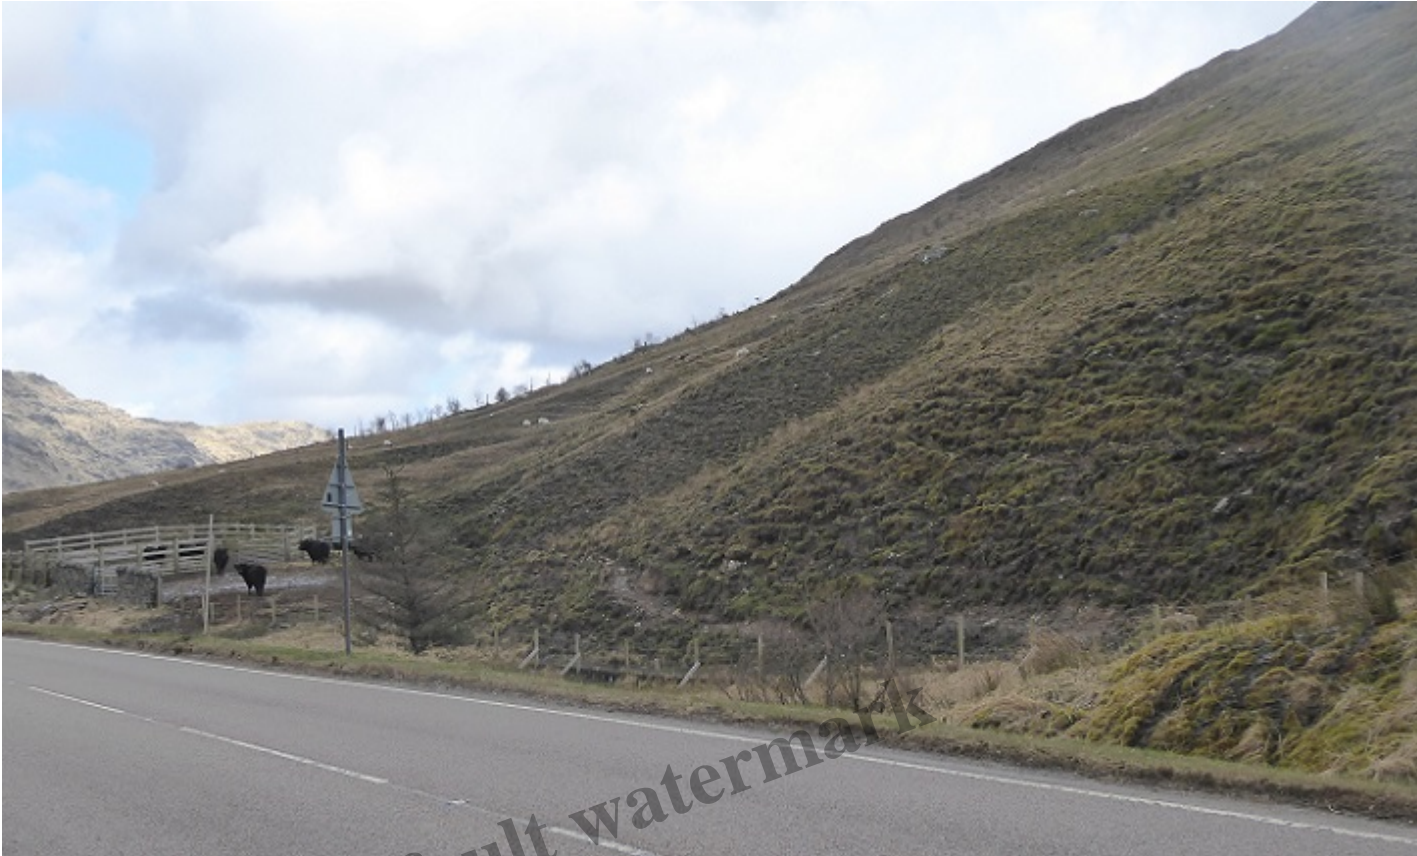
Returning over the Rest and Be Thankful I was amazed to this area, whose ownership is not yet recorded online at the Registers of Scotland, is still being used to graze sheep and cattle.

The edge of FLS' Butterbridge plantation is marked by the trees on the lower skyline

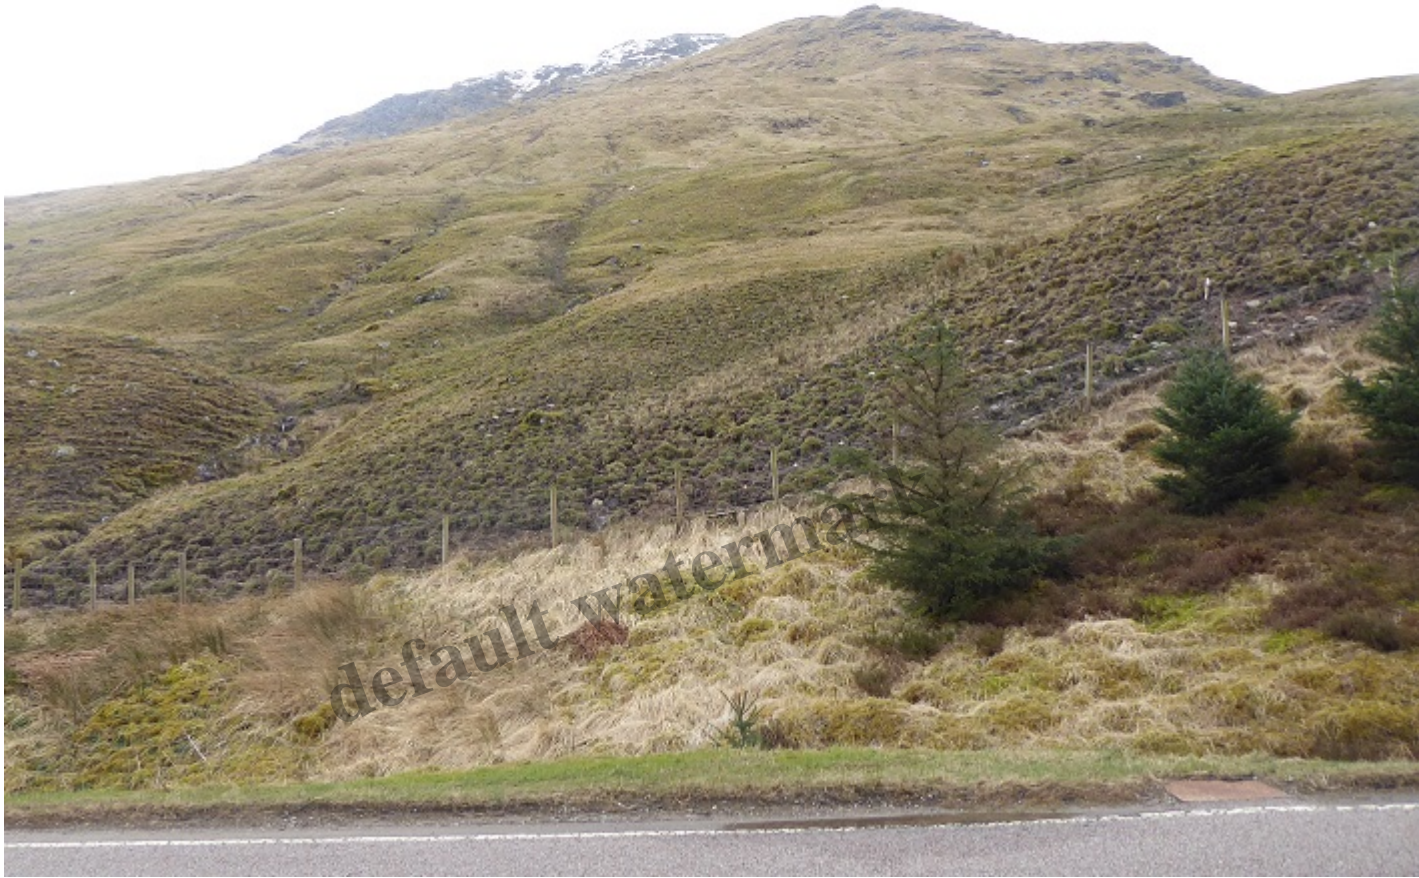
“The 2012 Forest Research report (Appendix 7) highlights research showing the negative impacts on slope stability arising from grazing of both stock & deer (P9). On the Rest & Be Thankful project area cattle grazing in particular currently causes extensive ground damage, erosion and the creation of deep water filled poach marks.”

Heavy poaching by cattle hooves has almost destroyed this slope

“The removal of stock is anticipated to create a better soil structure and a more robust flora, and the new woodland will consist of a diverse mix of Native Broadleaves with varying rooting characteristics.”

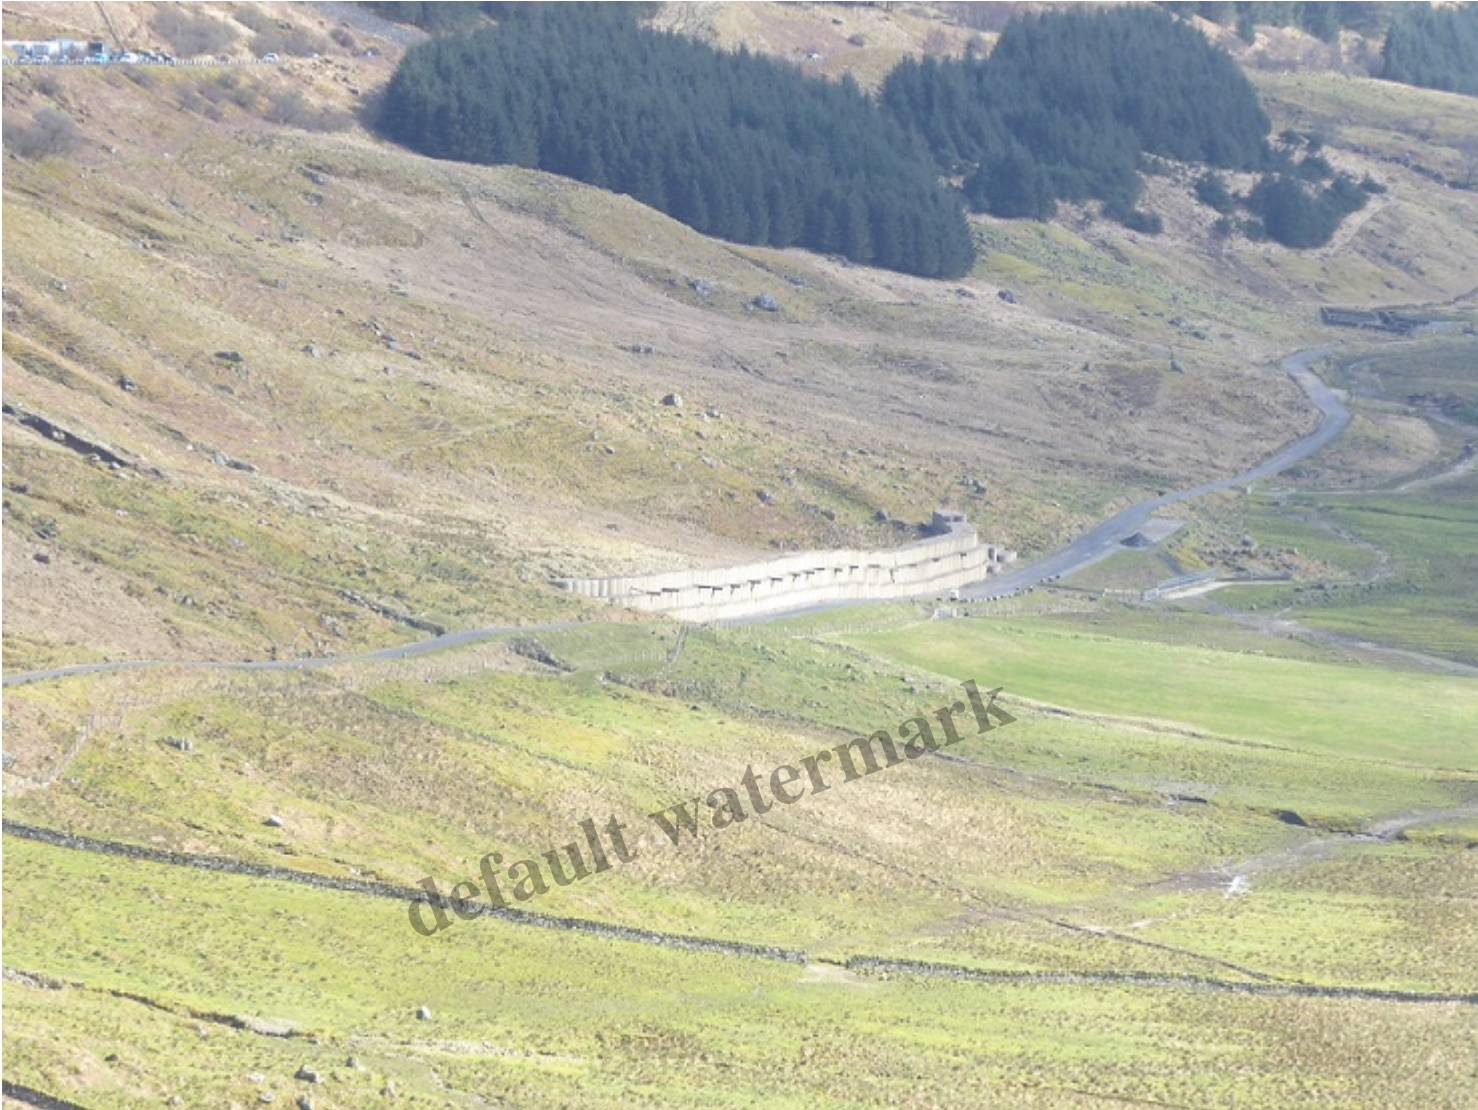
The slope may be less steep than that above the A83 around the corner but the angle appears greater than that between the A83 and the Old Military Rd where massive protective bunds have been built:

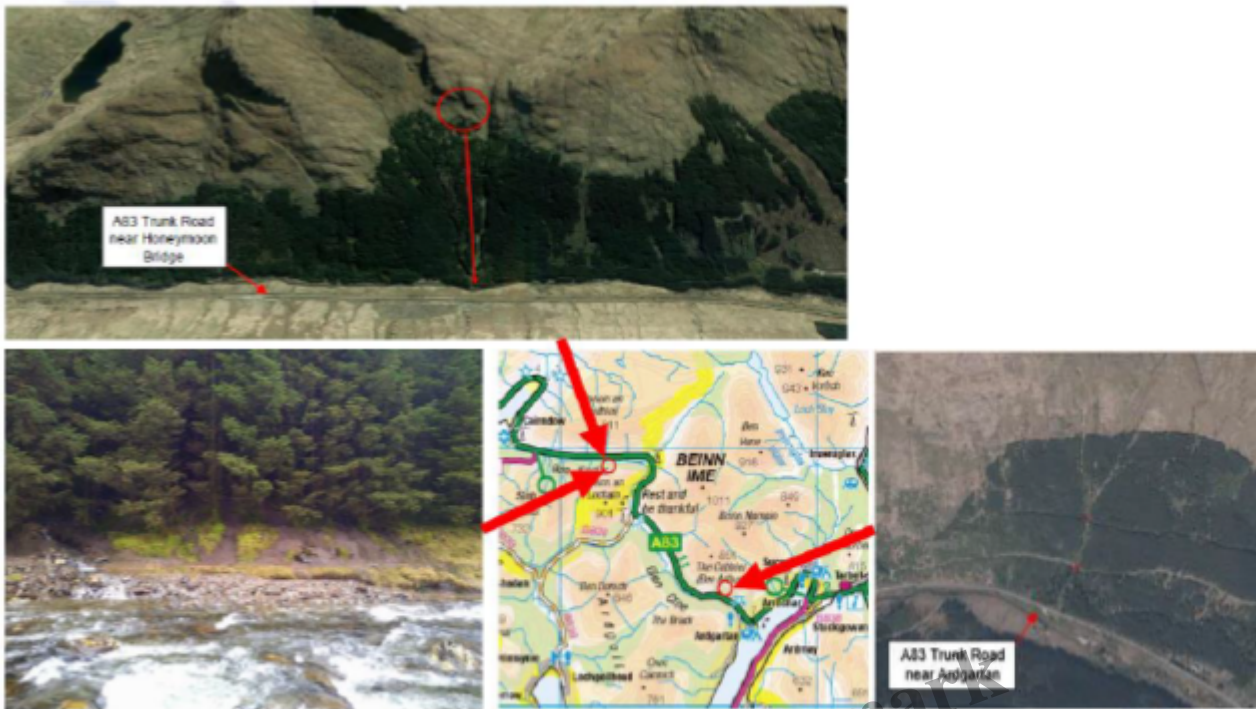
The minutes of the January meeting of the A83 taskforce contains a slide which shows that whatever the impact of planting and the engineering works on the south slopes of Beinn Luibhean, landslips are being recorded on other slopes in the area (and close to the road):

It is interesting that these two landslips were recorded in conifer plantations. It appears that shallow rooted conifers do very little to stabilise slopes. While native broadleaved trees, whether naturally seeded or planted, may do better it is extremely unlikely they will solve all the problems along the A83 in the medium term either. However, whatever the limitations of trees as a means of stabilising slopes, to continue to allow the landowner to graze sheep and cattle on these slopes appears to me the height of folly. Questions that need to be asked are:
