The climate emergency and the impact of extreme rain events – lessons need to be learned from what happened in Cowal at the weekend

The impact of the extreme rain event

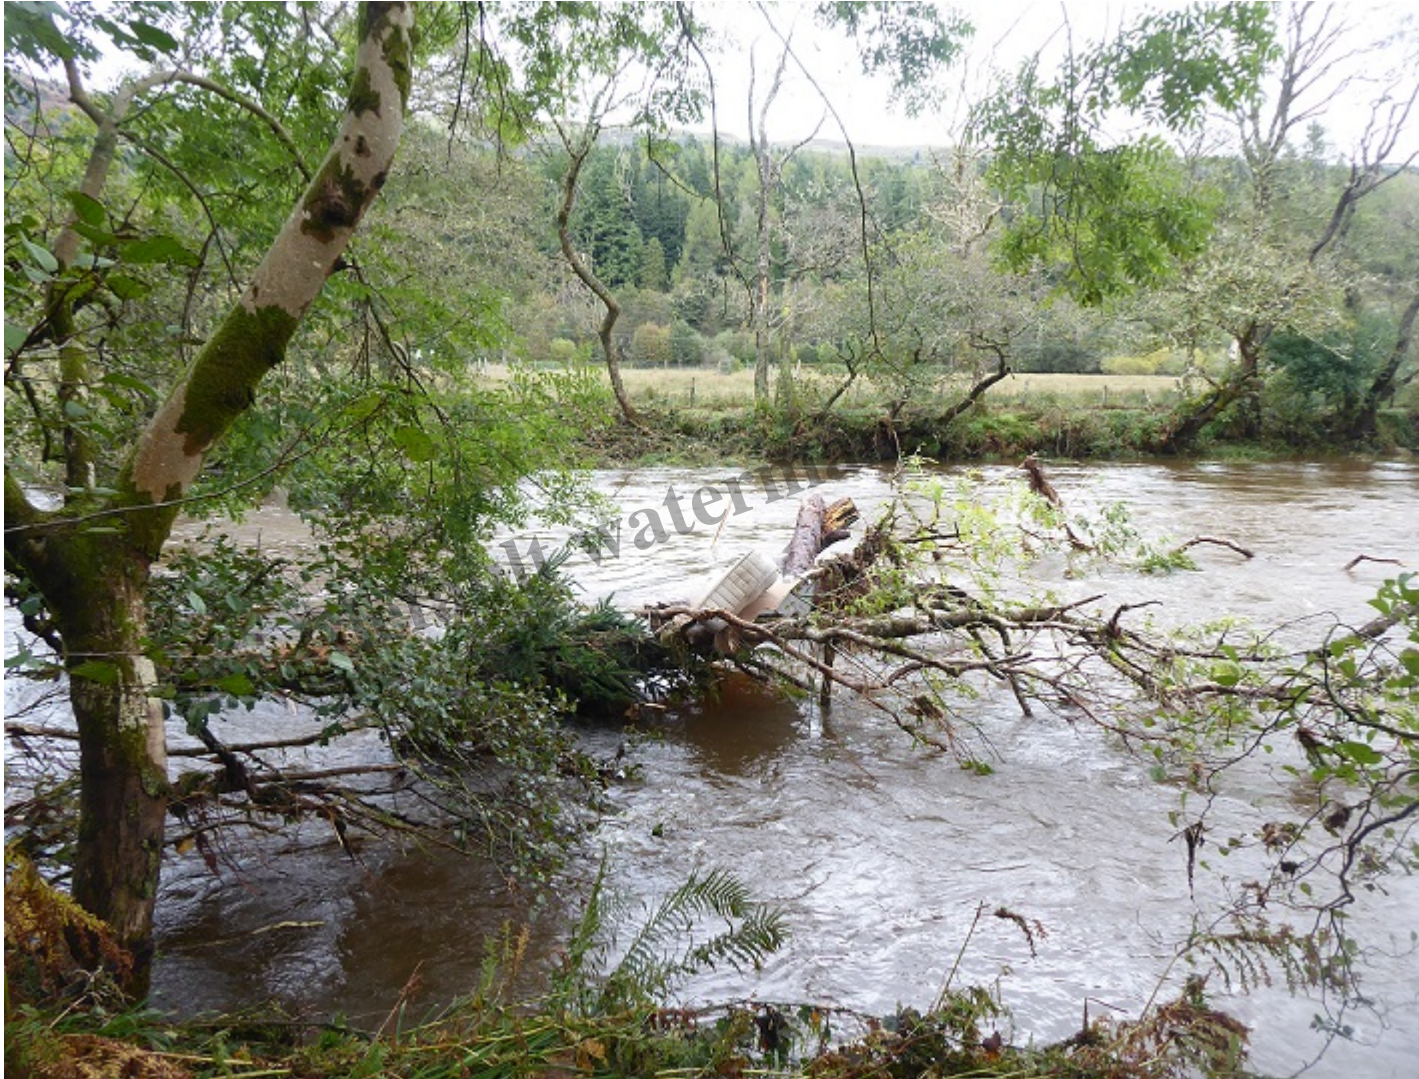
Mattress and tree in the River Eachaig below Loch Eck 9th October – note the colour of the water

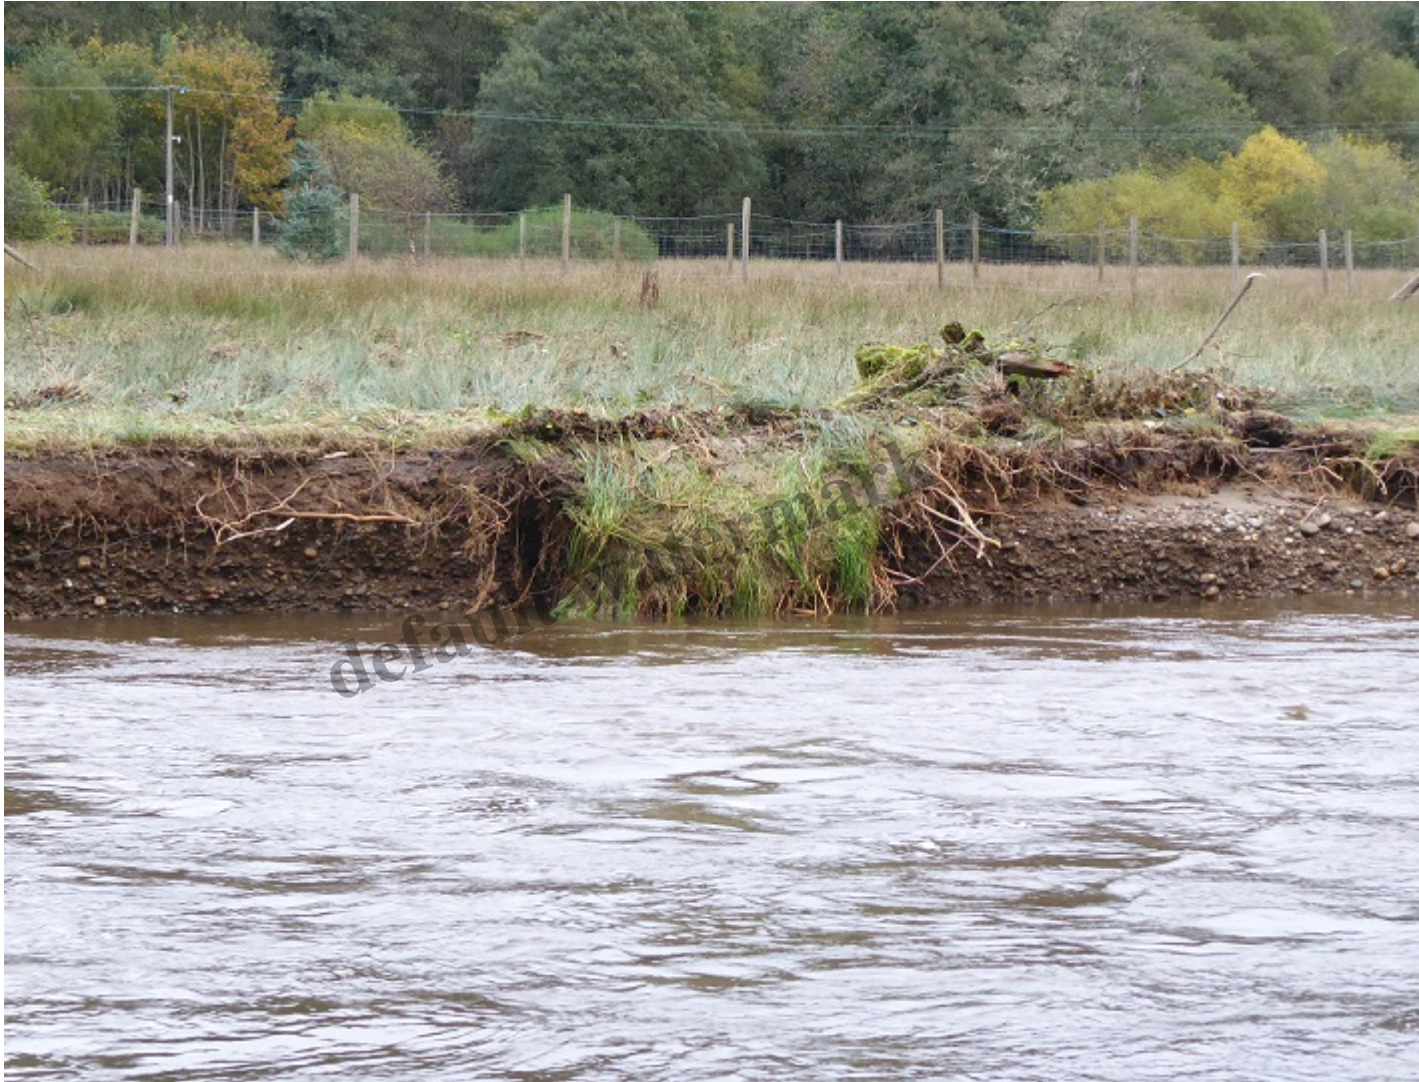
The overhanging grass suggests that up to a metre of this section of bank may have been swept away

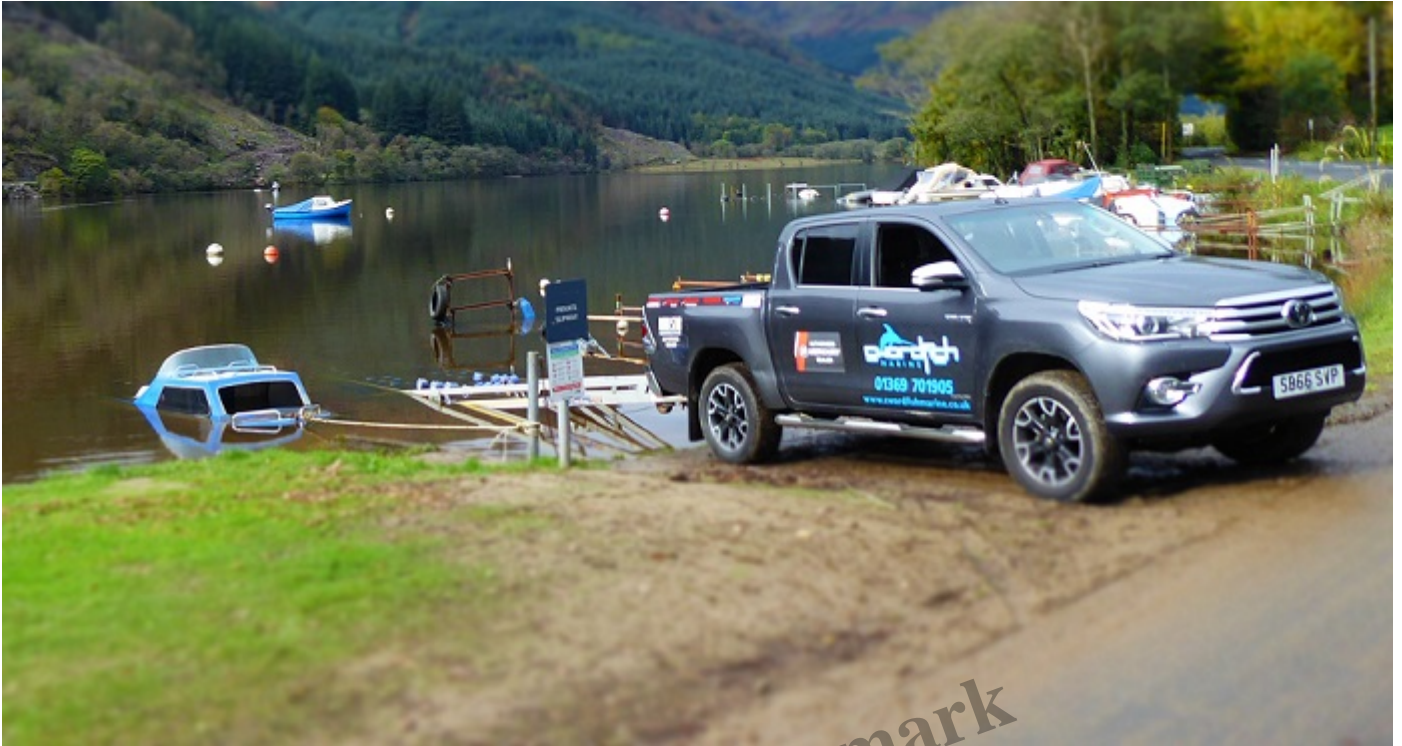
There was a big clear up underway with roads being cleared of rubble and items retrieved from the loch and river. The flood claimed at least one caravan from the park below Loch Eck, an example of planning failure and a warning of what might happen if the LLTNP allows Flamingo Land to build chalets and develop other visitor infrastructure on the flood plain in Balloch ([see here](#)).

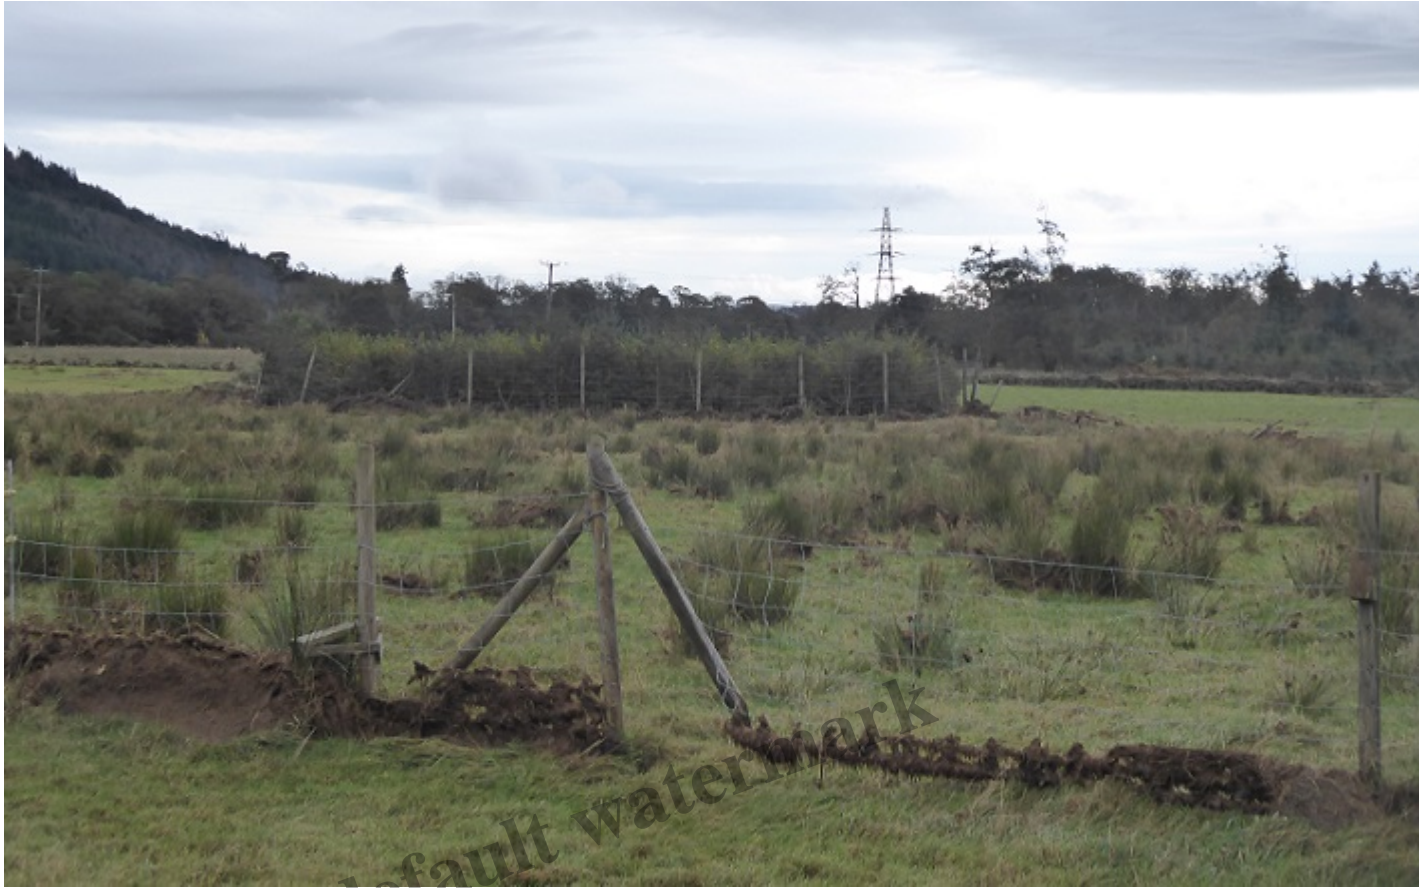
Note the height of the vegetation on the fence – the River is about 100m from the point this photo was taken

When the River Elchaig burst its banks the flood plain was covered with water to an extent that locals had not witnessed before. Two days later the water had disappeared but in that time the the flood plain had served its purpose. Without it the major road bridge on the A815 downstream might not have survived.

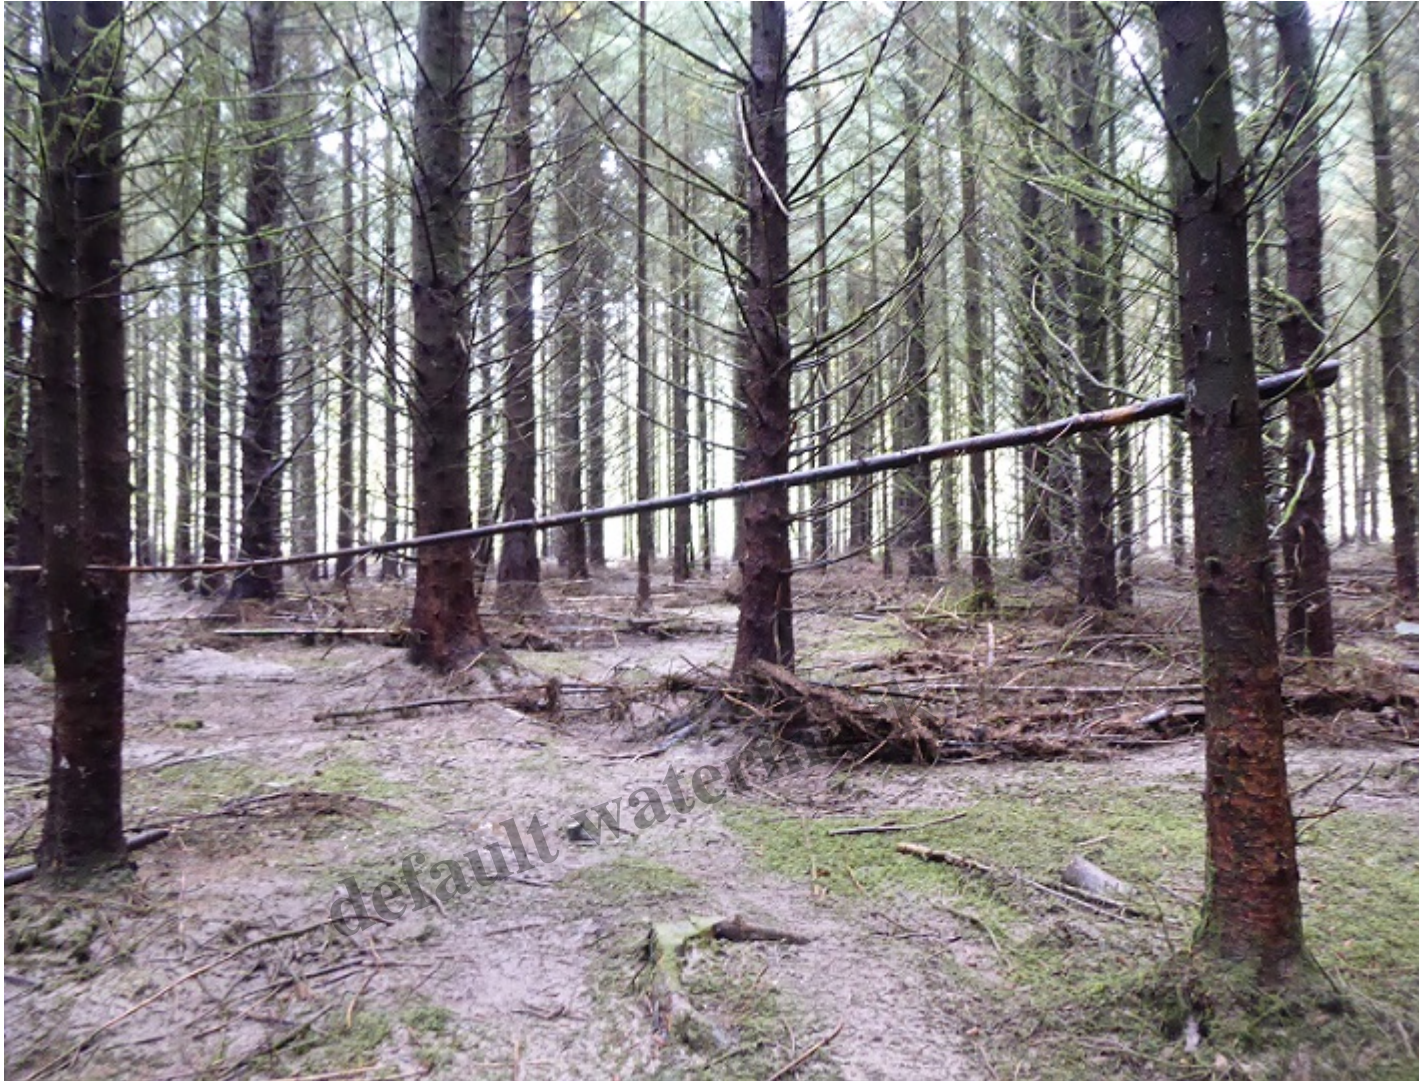
I am still trying to work out if the remains of the thin tree could have been lifted here by the flood!

And while the flood had re-arranged the brush in this conifer plantation, the trees will have helped hold back the force of the water.

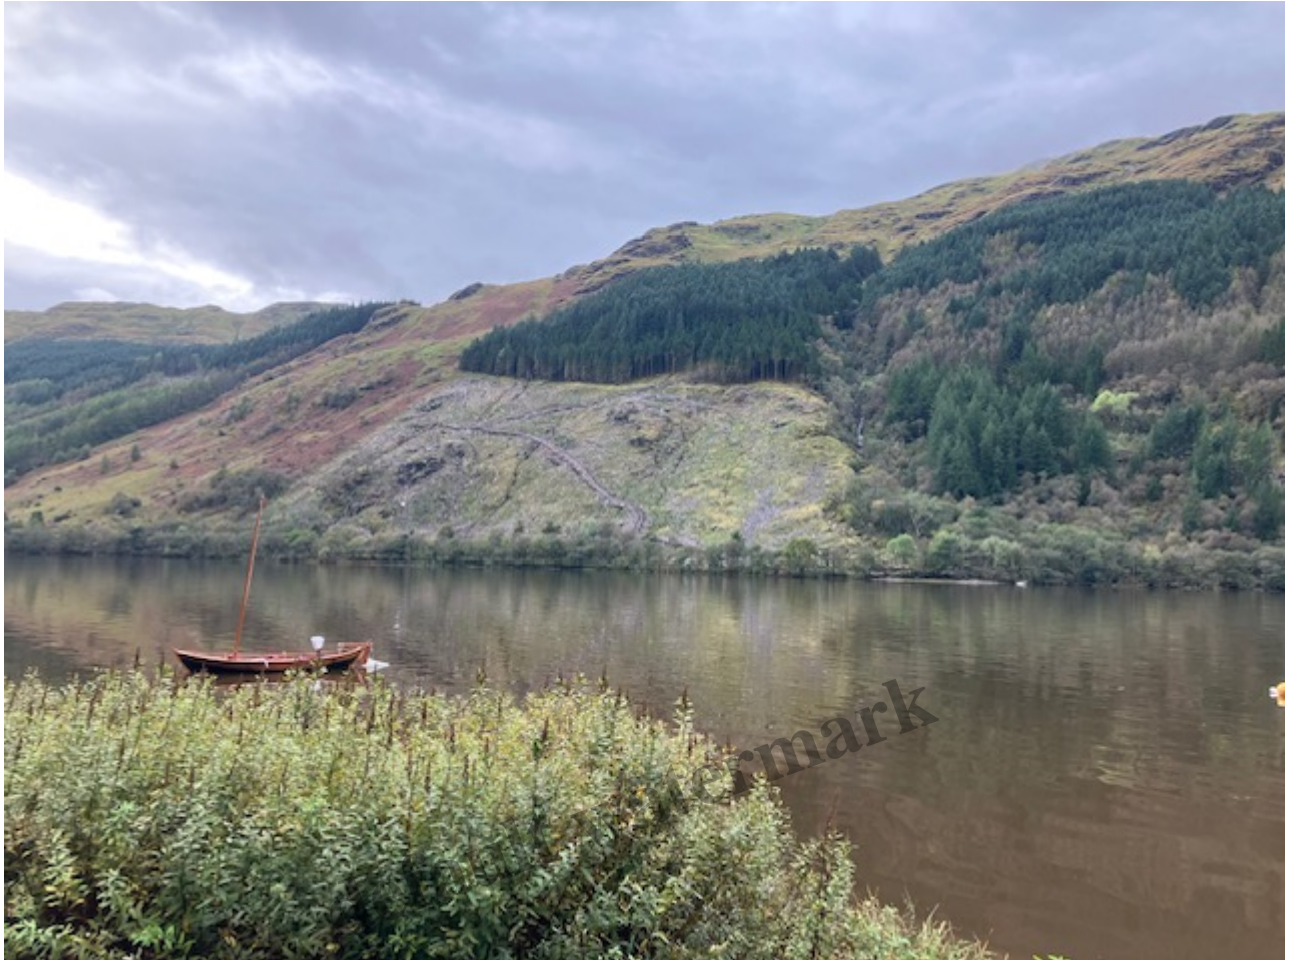
Looking across Lock Eck to land managed by Forest and Land Scotland. Note the colour of the water and the difference in colouring between the left and right side of the felled area. Photo credit Nick Halls

The success of the flood plain, however, does not mean there is no need to be concerned. People I spoke to had never seen Loch Eck brown like this, filled with soil.

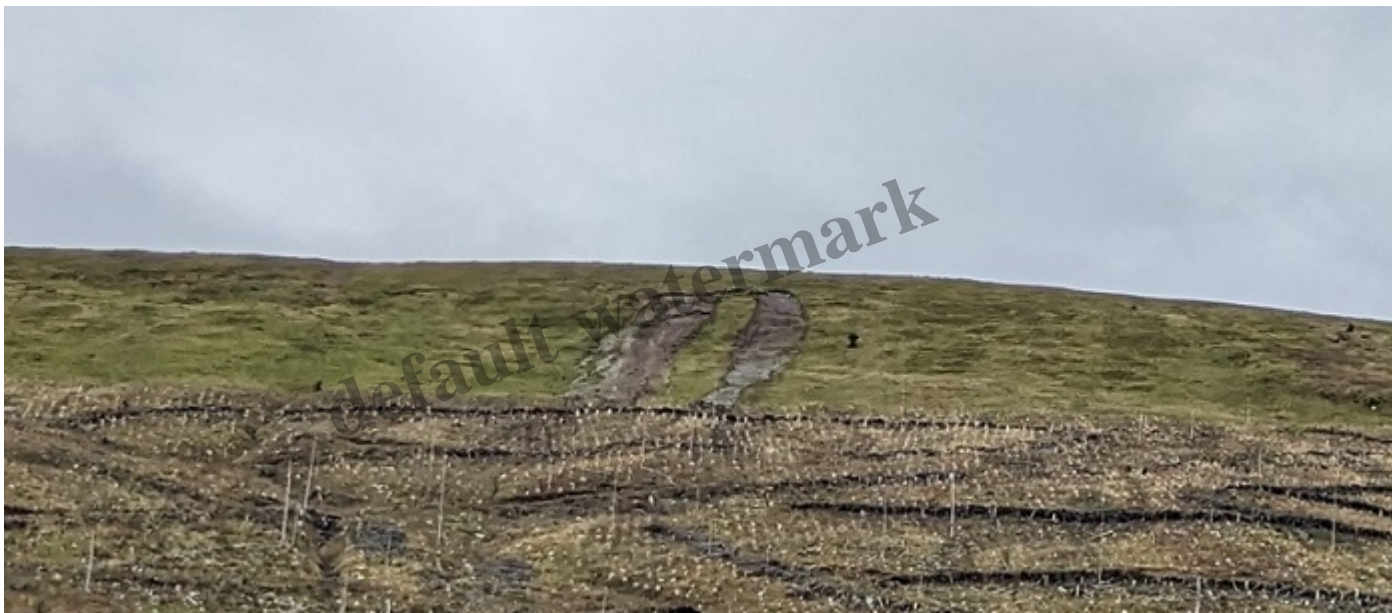
Parallel landslips above destructive forest harvesting in Glen Lean, just outside the National Park boundary

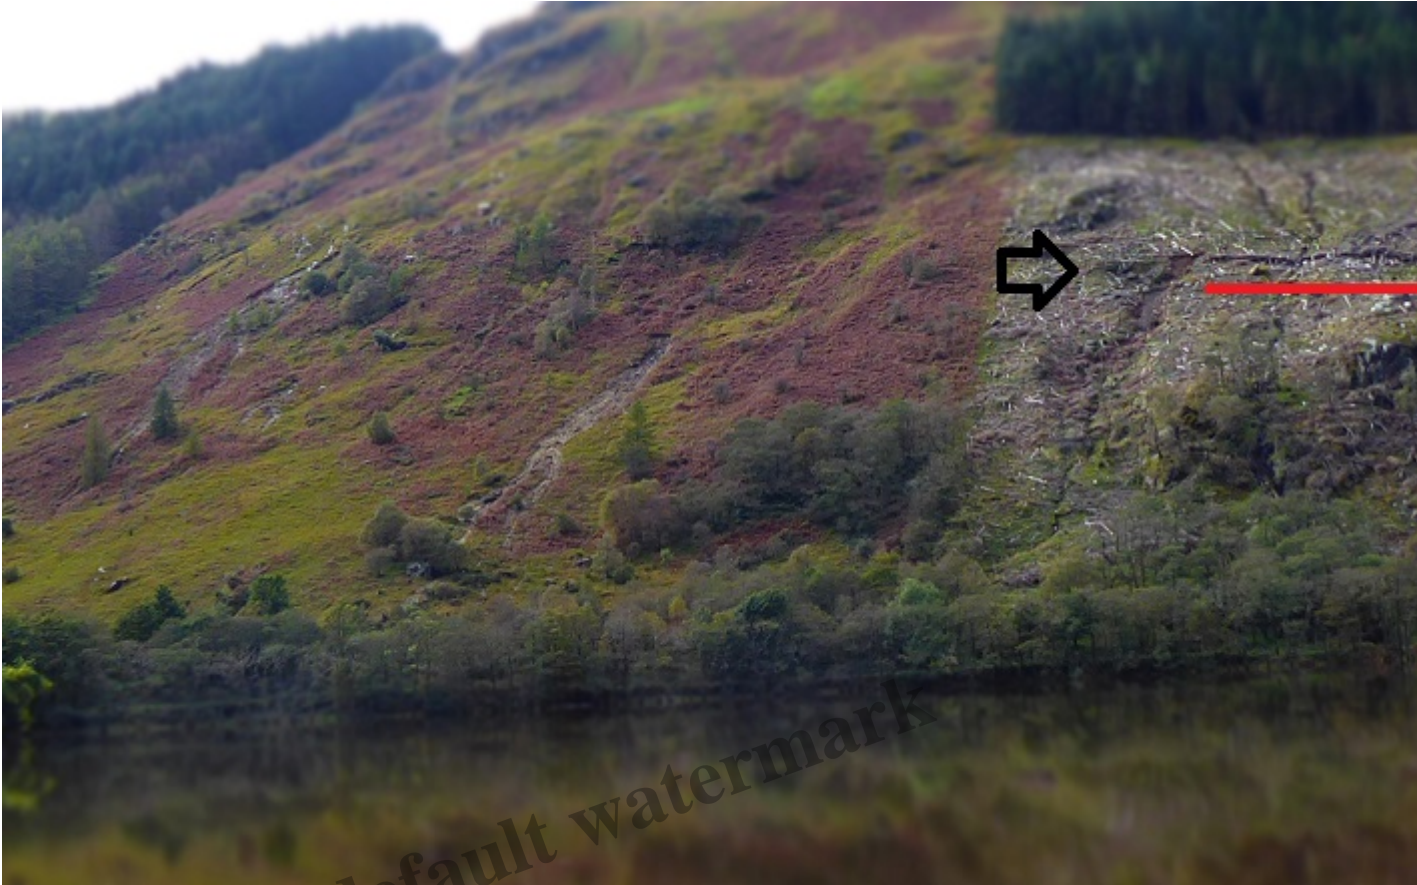
Three landslips above the west side of Loch Eck triggered by the rain at the weekend. This is land owned by the Scottish Government and managed by Forest and Land Scotland.

On Monday I spotted five new landslips within a few miles and my estimate is there may have been 25-30 across the whole of Cowal last weekend. I now expect them to be triggered by extreme events (photos from readers would be welcome!). While their cause is complex, which is why need to collect data on when and where they occur and link that to more detailed research, there is no question that land-management plays an important role.

The starting point for the landslip on the right in the photo above, for example, is where FLS have cut a road into the hillside which they have then lined with trees – an incredibly wasteful process – to provide a base for machinery to extract the remaining timber.

Whether soil from this FLS induced landslip reached the loch and was then washed out to sea is unclear but NatureScot should investigate. Their site management statement for the SSSI states:
