Extreme rainfall and landuse – more lessons from the flooding and landslips in Cowal and Glen Kinglas

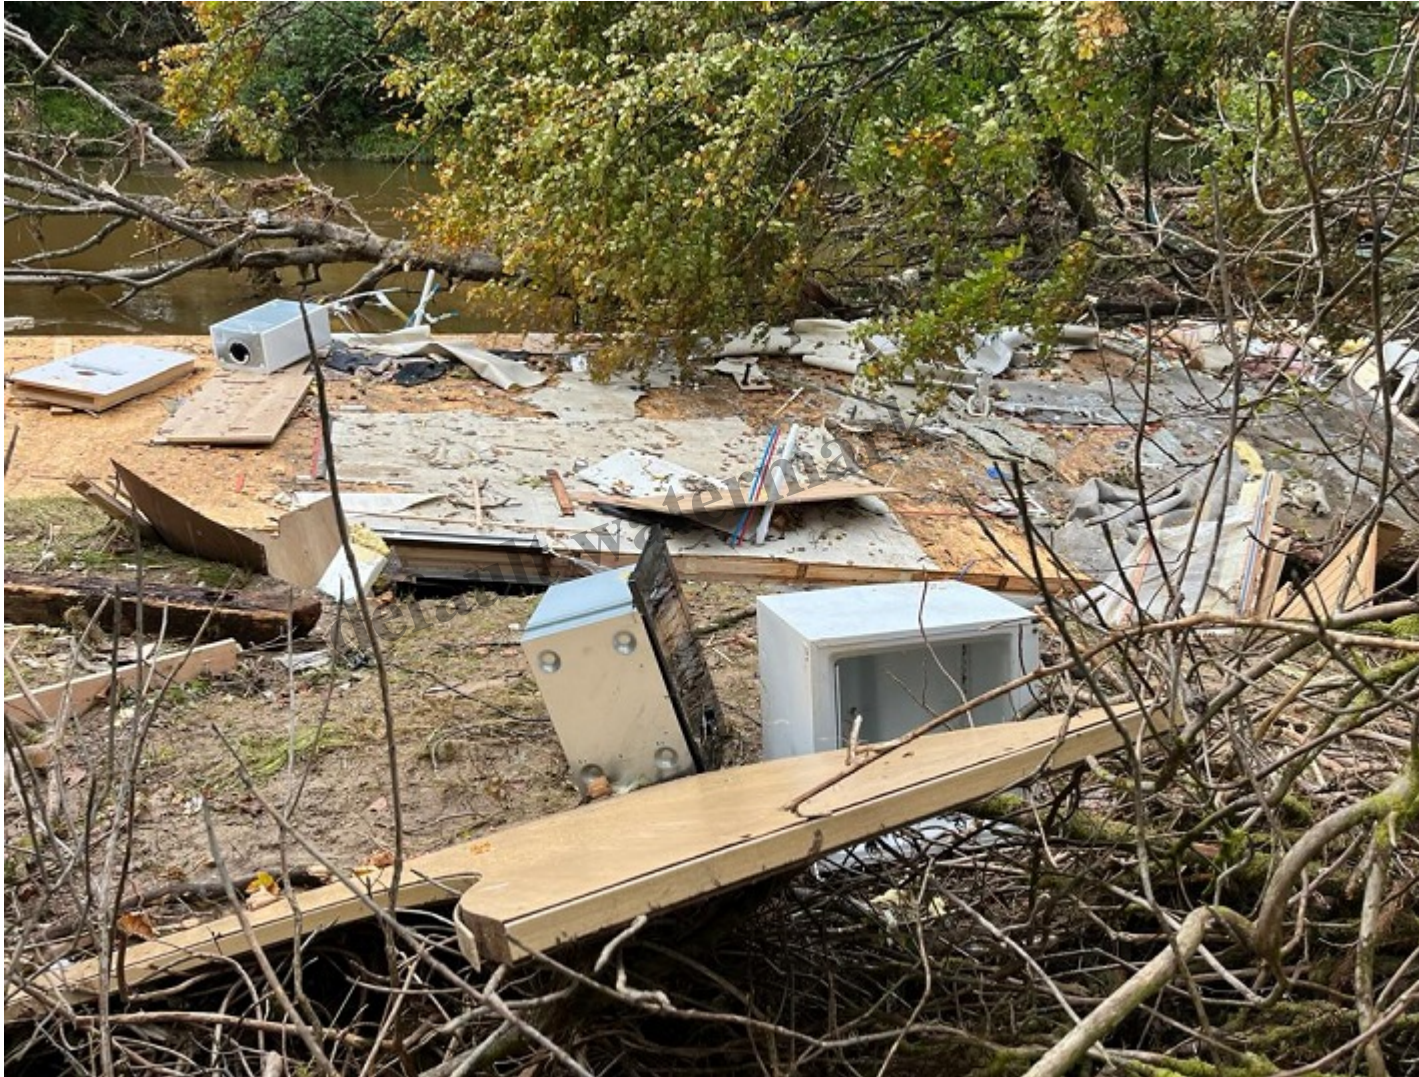
Flooded holiday park detritus in the River Eachaig. Photo credit parkswatch reader.

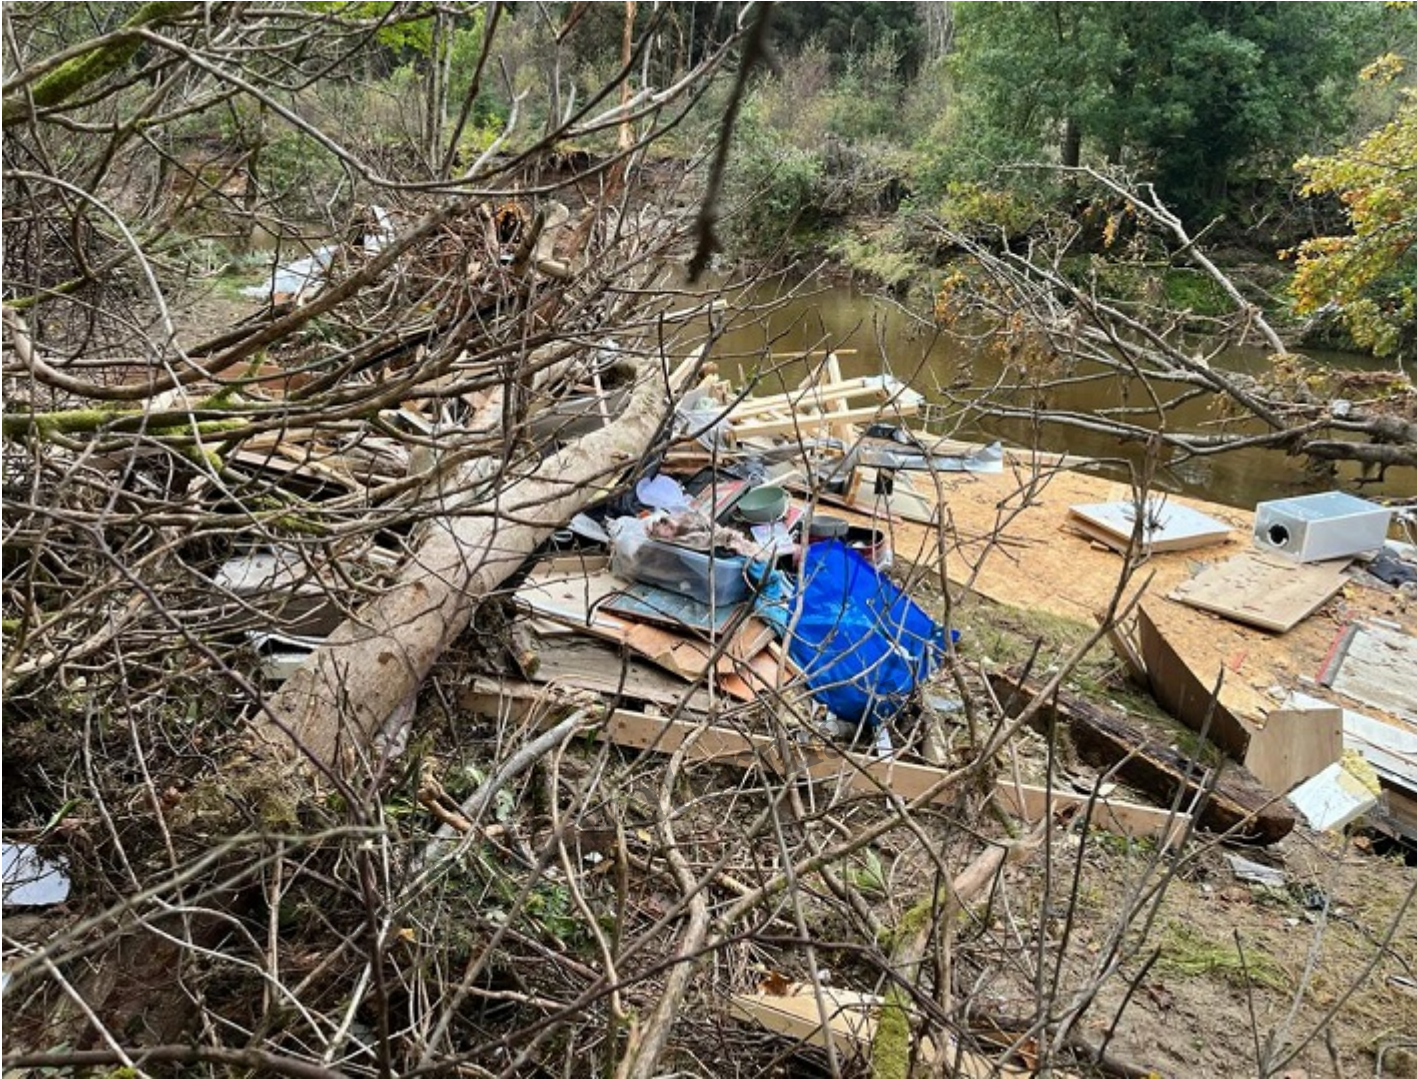
Another view of the same detritus on the River Eachaig. Photo credit PW reader.

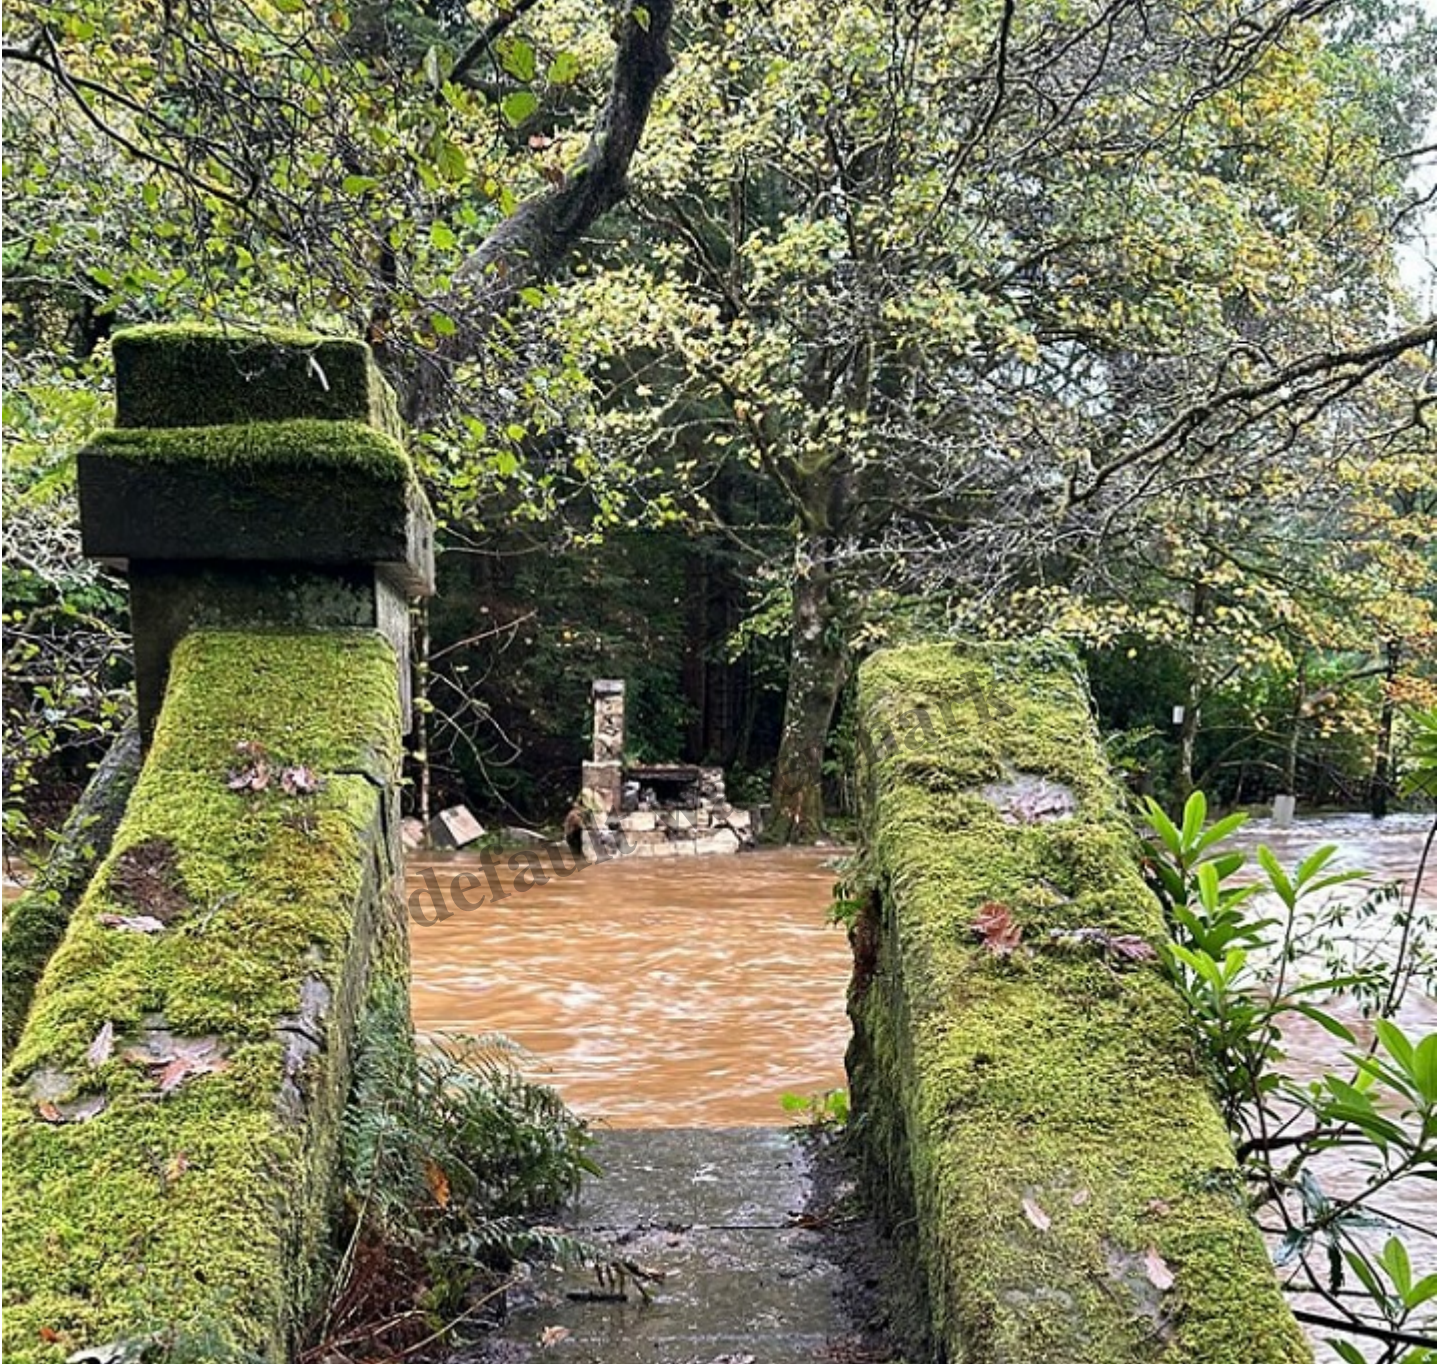
The listed pedestrian bridge at Benmore Gardens was swept away. Photo credit Parkswatch reader. The rainfall that was brought to Scotland by Storm Babet was far more restricted in extent - my thanks to a reader who alerted me to the excellent Met Office report ([see here](#)). However, it caused record rainfall in Angus (which had just two weeks earlier received the sixth highest rainfall ever recorded for the area). Like the report for 6th/7th October, however, it is not detailed enough to explain variations of rainfall within river catchments such as the 80mm SEPA recorded at Gella Bridge in upper Glen Clova. The important point here is that if 150mm of rain had fallen at Gella bridge, as appears to have happened just to the south, the water levels in the River South Esk at Brechin, which exceeded all previous records, would have been far far higher.

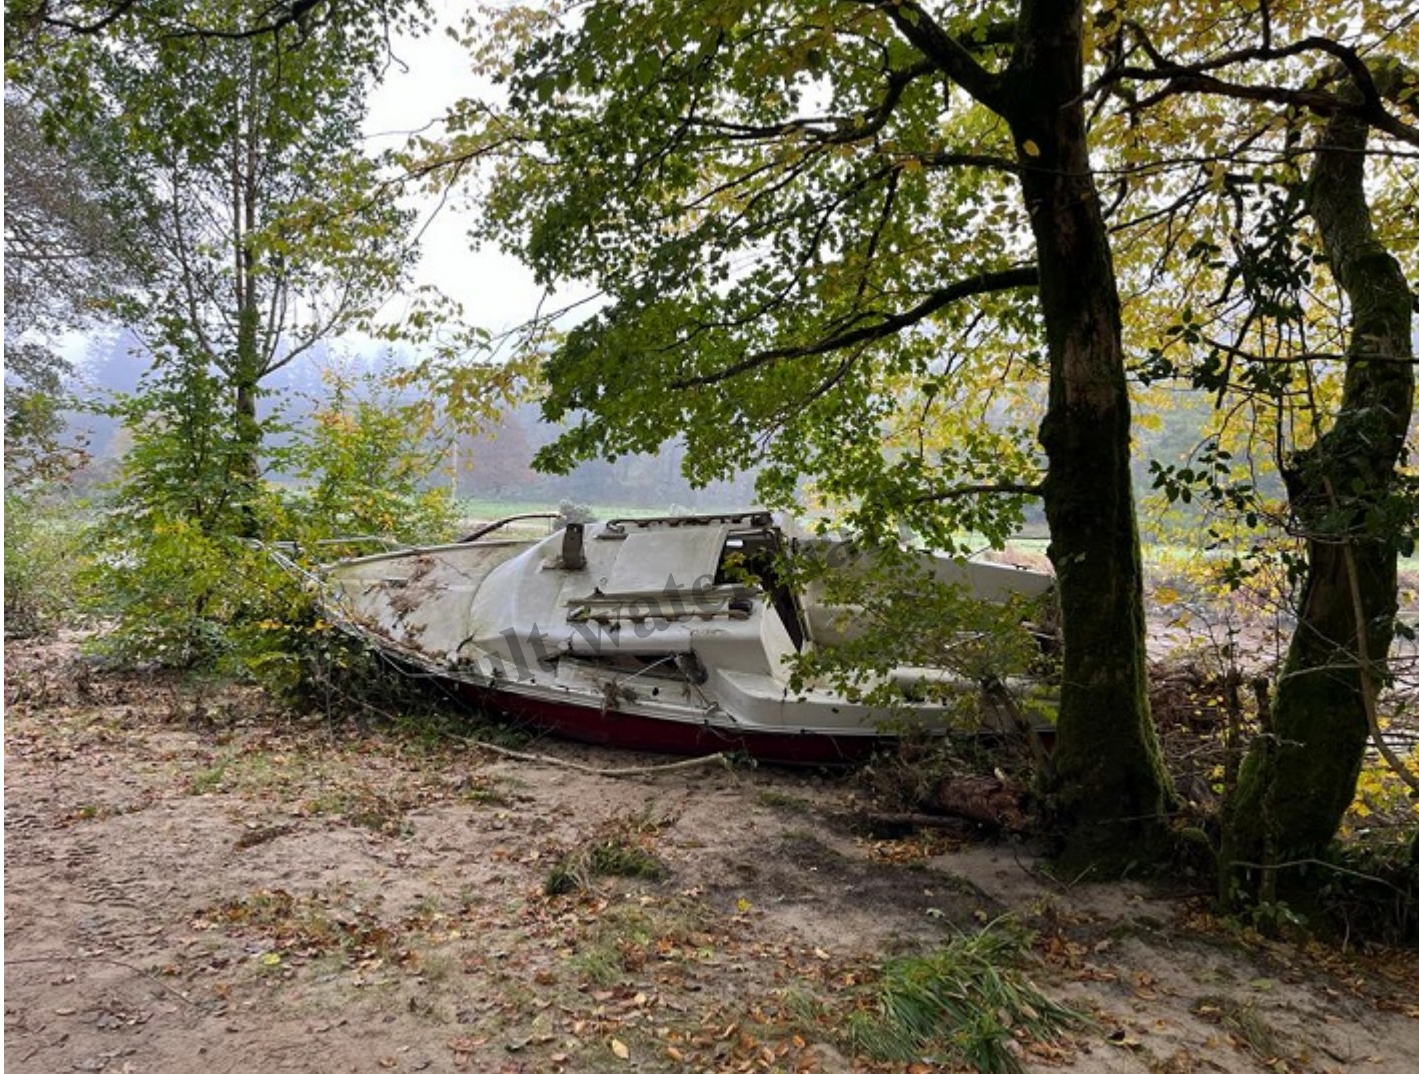
Boat apparently washed down the River Eachaig from Loch Eck. Photo credit Parkswatch reader

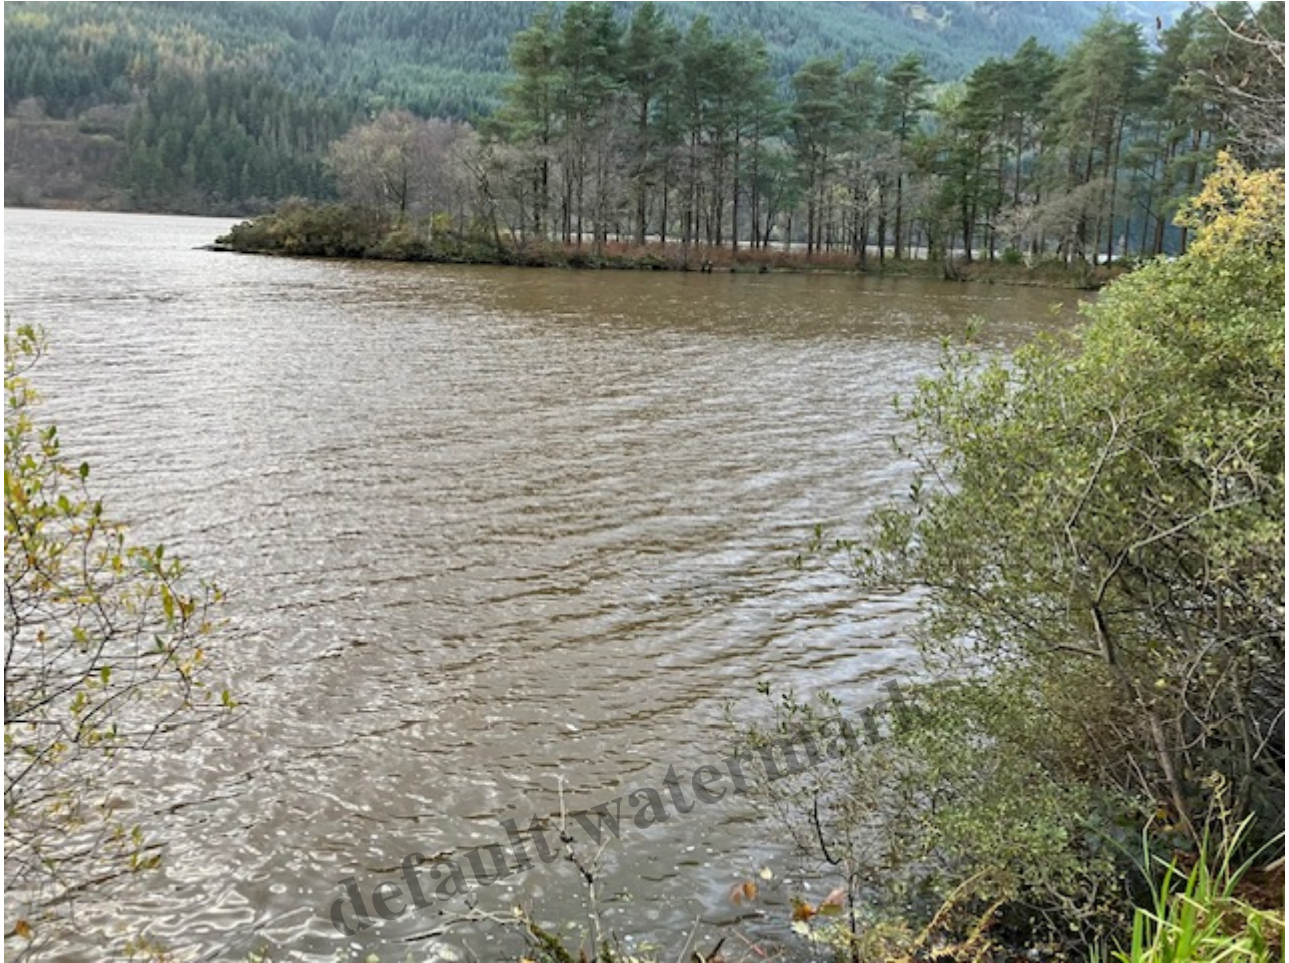
Loch Eck 20th October. Photo credit Nick Halls

Eleven days after I had visited Lock Eck, its waters were still brown, filled with sediment. There are two public interest questions here, where did the soil come from and why, and, what impact will all this sediment have on the (rare) wildlife in Loch Eck?

How then could so much sediment end up in a loch surrounded by trees? One possible explanation is that the flood plain along the River Cur was seriously eroded by the deluge and washed sediment into the north end of Loch Eck and this then spread 10km down the loch. Another possible explanation is that industrial forestry practices have helped undermine the stability of the steep slopes around Loch Eck which would normally have been helped by being planted by trees.

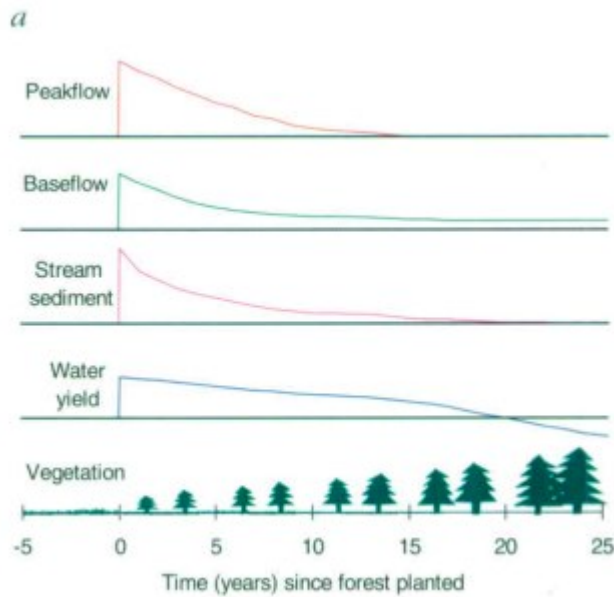
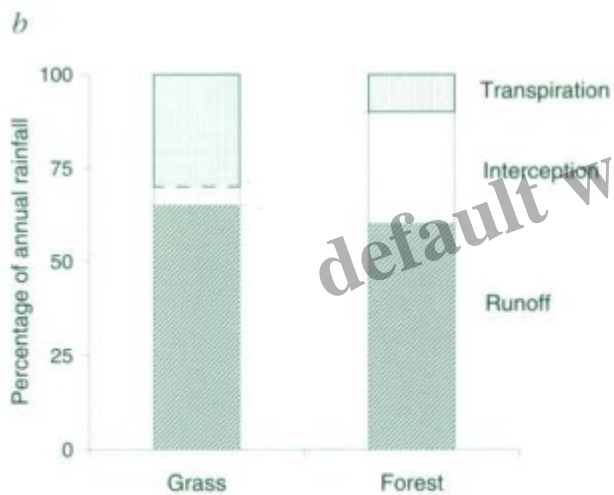
Most of the area around Loch Eck is covered in forest and forests have been shown to reduce sediment run-off. My thanks to Ron Greer who pointed me to this graphic from the Coal burn study which included looking at the impact of forestry on sediment in streams ([see here](#)):

Figure 26 Summary of main hydrological changes at Coalburn: (a) over time, (b) water balance before forestry and at current time

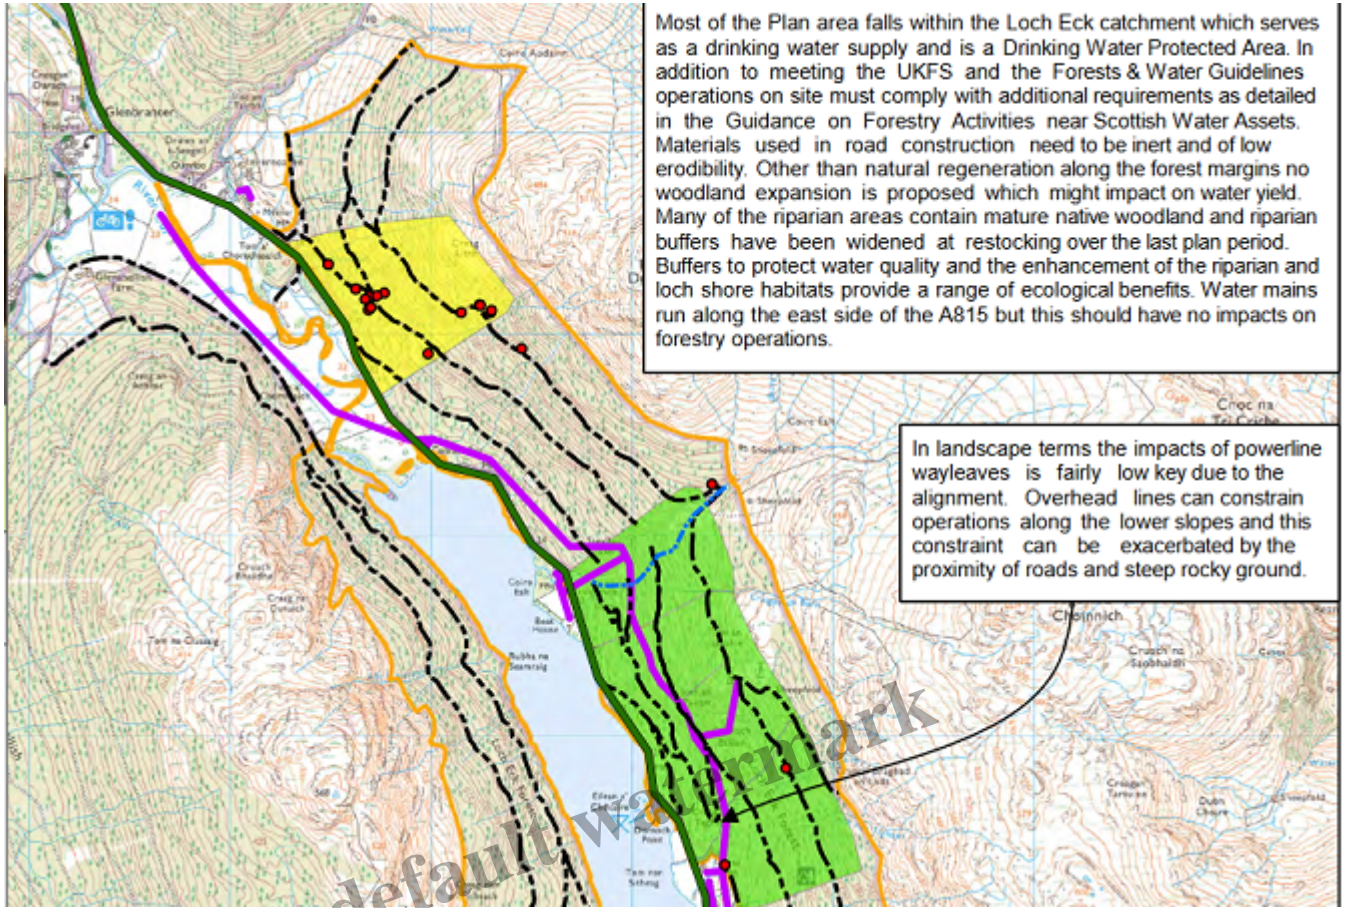
There is a very interesting map on slope stability in Forest and Land Scotland's Lock Eck Management Plan ([see here](#)) which shows landslips:

Red dots = recorded landslips. Map credit FLS Loch Eck Management Plan approved in 2020

The fact that most of the recorded landslips are by forest roads could be because they are easier to spot but it could also be because those roads were helping to cause the landslips. Add to that the clear-felling that has been taking place around the loch, which involves heavy machinery churning up the soils, and it appears quite possible that FLS' management of the land may be responsible for much of the sediment in Loch Eck.

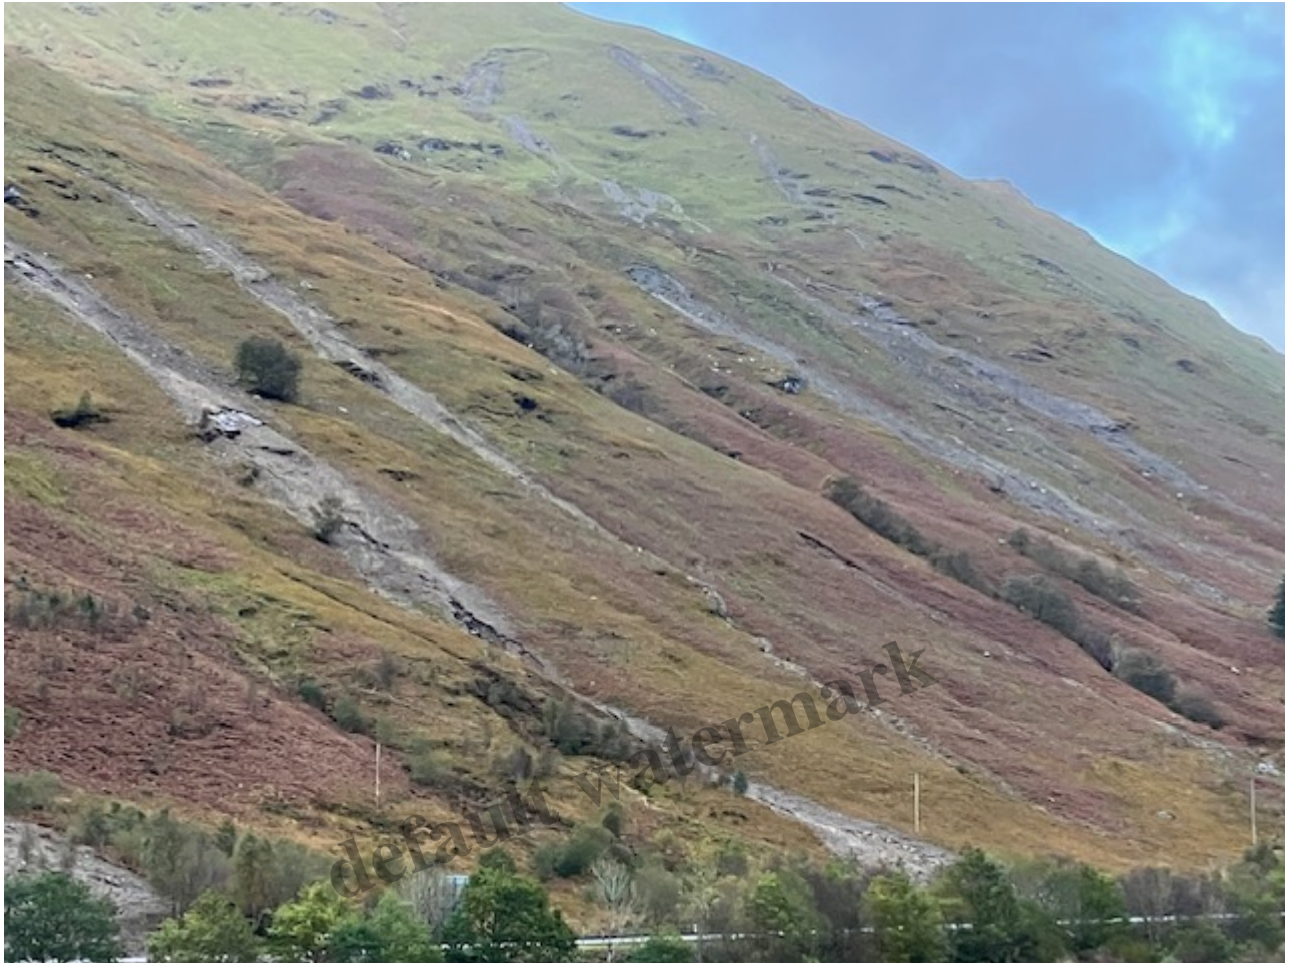
Landslips Glen Kinglas. Note the sheep grazing the slopes. Photo credit Nick Halls

Over in Glen Kinglas, just outside the National Park boundary, there have been significantly more landslips than the eight BEAR reported as reaching the road. This reinforces the case for creating a comprehensive data base of landslips in Scotland in order to properly assess risks to infrastructure. Knowing about the landslips that don't hit the road is as important as knowing about those that do.

Meantime the fact the owner of the Strone Estate, Tom Turnbull, who is also chair of the Association of Deer Management Groups, is still grazing (or allowing someone else to graze) sheep on these slopes should to my mind be treated as criminal, an offense against the public interest. The fact that the Scottish Government is subsidising him to do this through greening payments – as I explained in my last post – appears even more criminal.

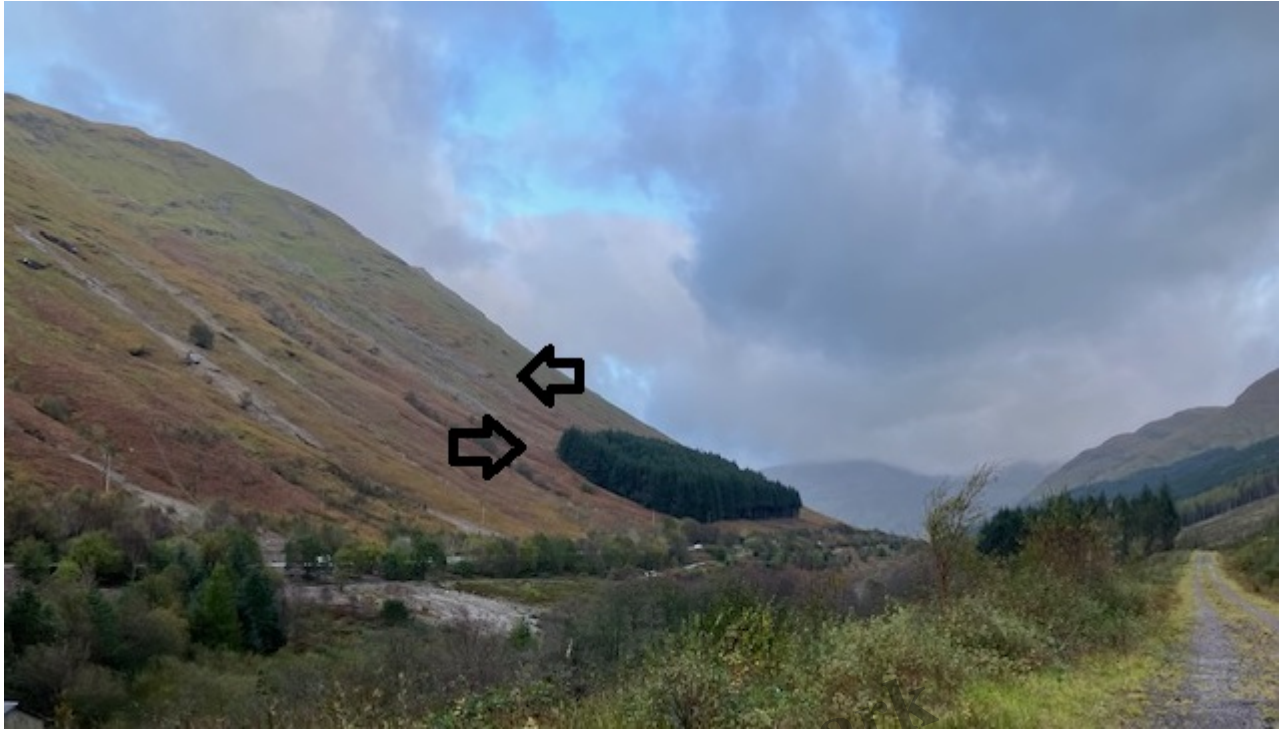
Nick Halls kindly went to check that the plantation I had referred to in the Glen Kinglas post and which had been granted a felling license by Scottish Forestry was still there. I had commented how stupid it was that Scottish Forestry would even consider granting felling licenses on landslip prone slopes. Nick's photo proves the point. It shows two landslips above the trees.

That evidence should be sufficient to prompt Scottish Forestry to undertake an immediate review of all felling licenses for trees on steep slopes vulnerable to landslips.
