Extreme rainfall and landuse â?? more lessons from the flooding and landslips in Cowal and Glen Kinglas

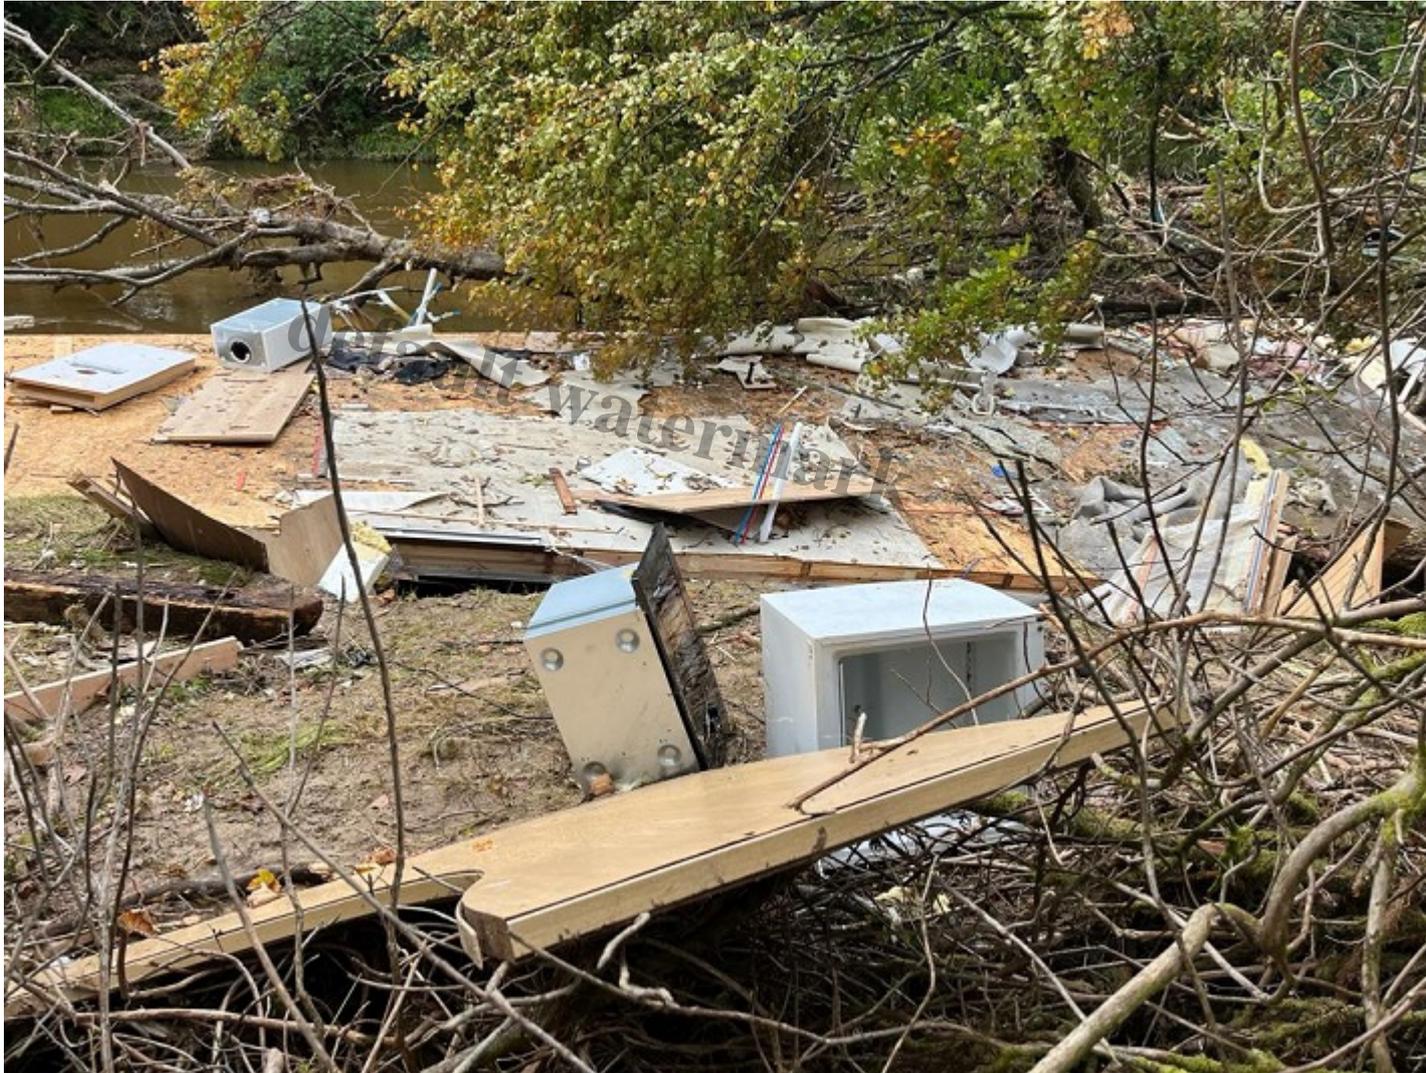
Flooded holiday park detritus in the River Eachaig. Photo credit parkswatch reader.

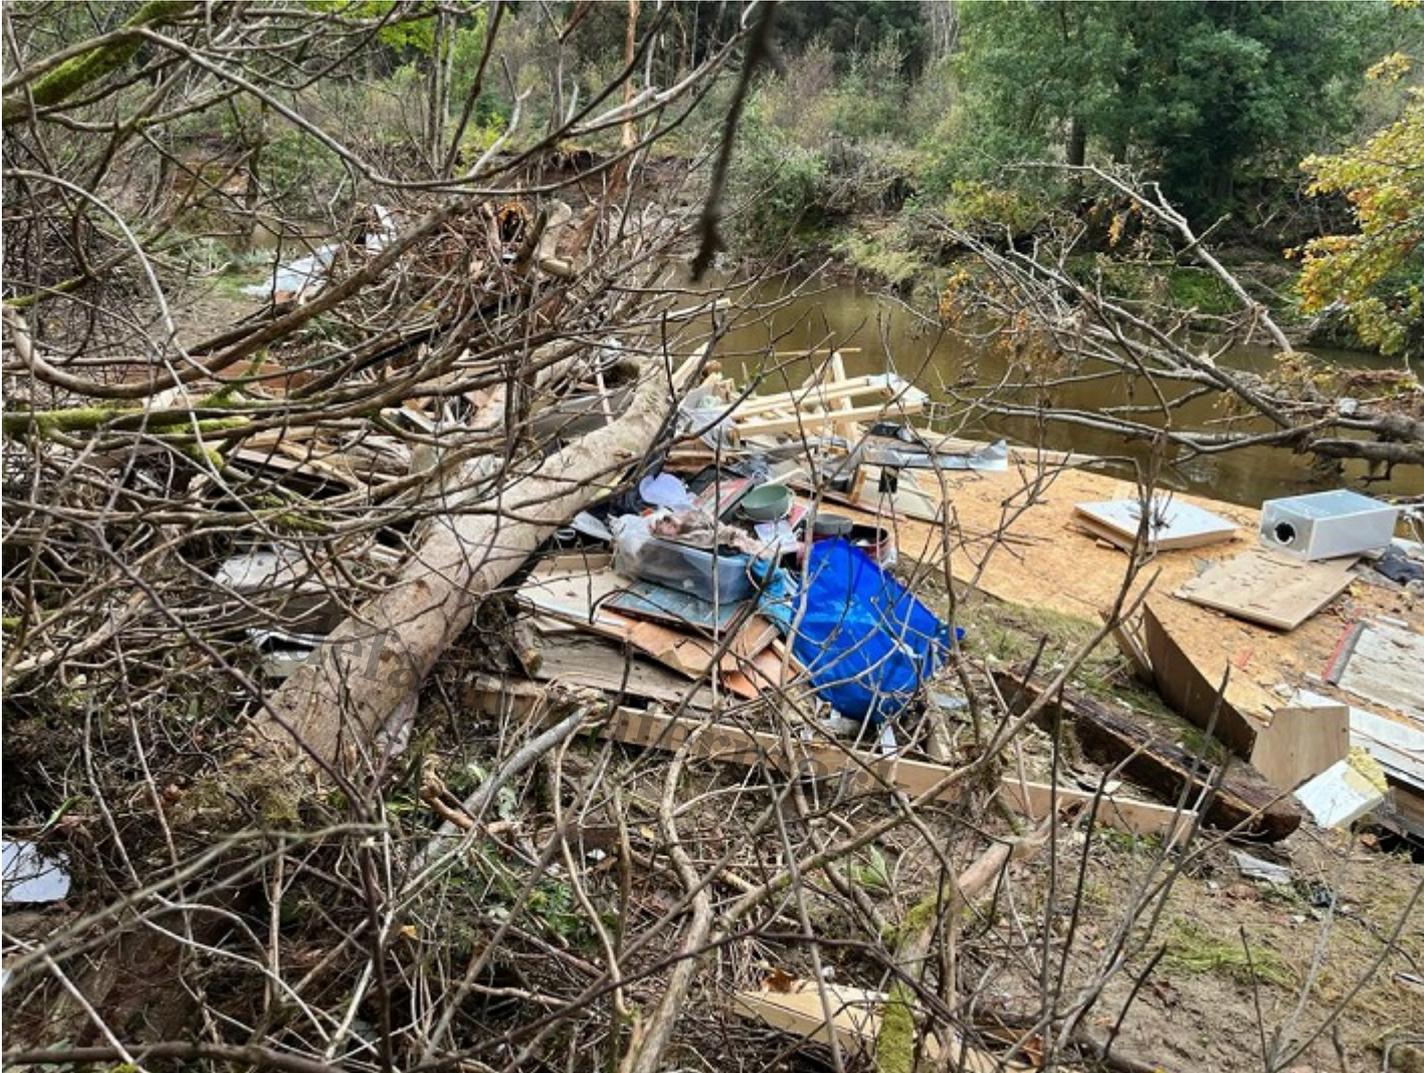
Another view of the same detritus on the River Eachaig. Photo credit PW reader.

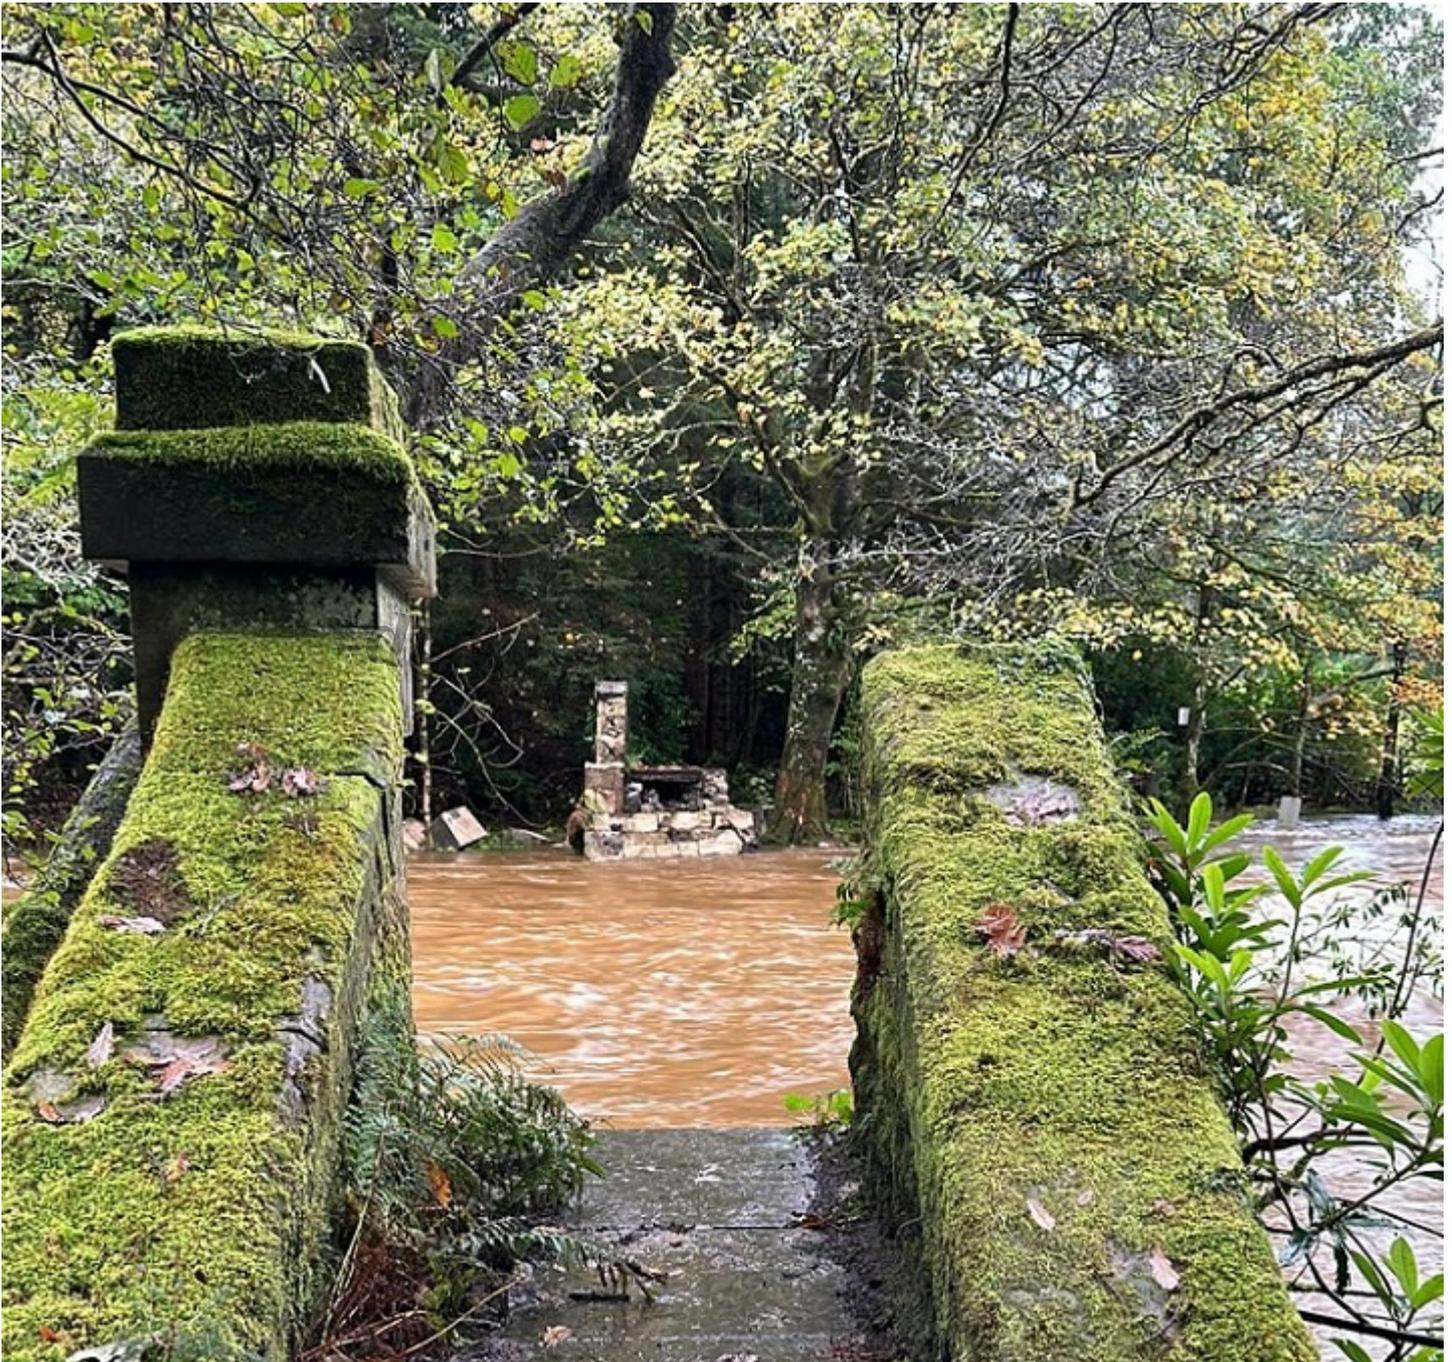
The listed pedestrian bridge at Benmore Gardens was swept away. Photo credit Parkswatch reader. The rainfall that was brought to Scotland by Storm Babet was far more restricted in extent - my thanks to a reader who alerted me to the excellent Met Office report ([see here](#)). However, it caused record rainfall in Angus (which had just two weeks earlier received the sixth highest rainfall ever recorded for the area). Like the report for 6th/7th October, however, it is not detailed enough to explain variations of rainfall within river catchments such as the 80mm SEPA recorded at Gella Bridge in upper Glen Clova. The important point here is that if 150mm of rain had fallen at Gella bridge, as appears to have happened just to the south, the water levels in the River South Esk at Brechin, which exceeded all previous records, would have been far far higher.

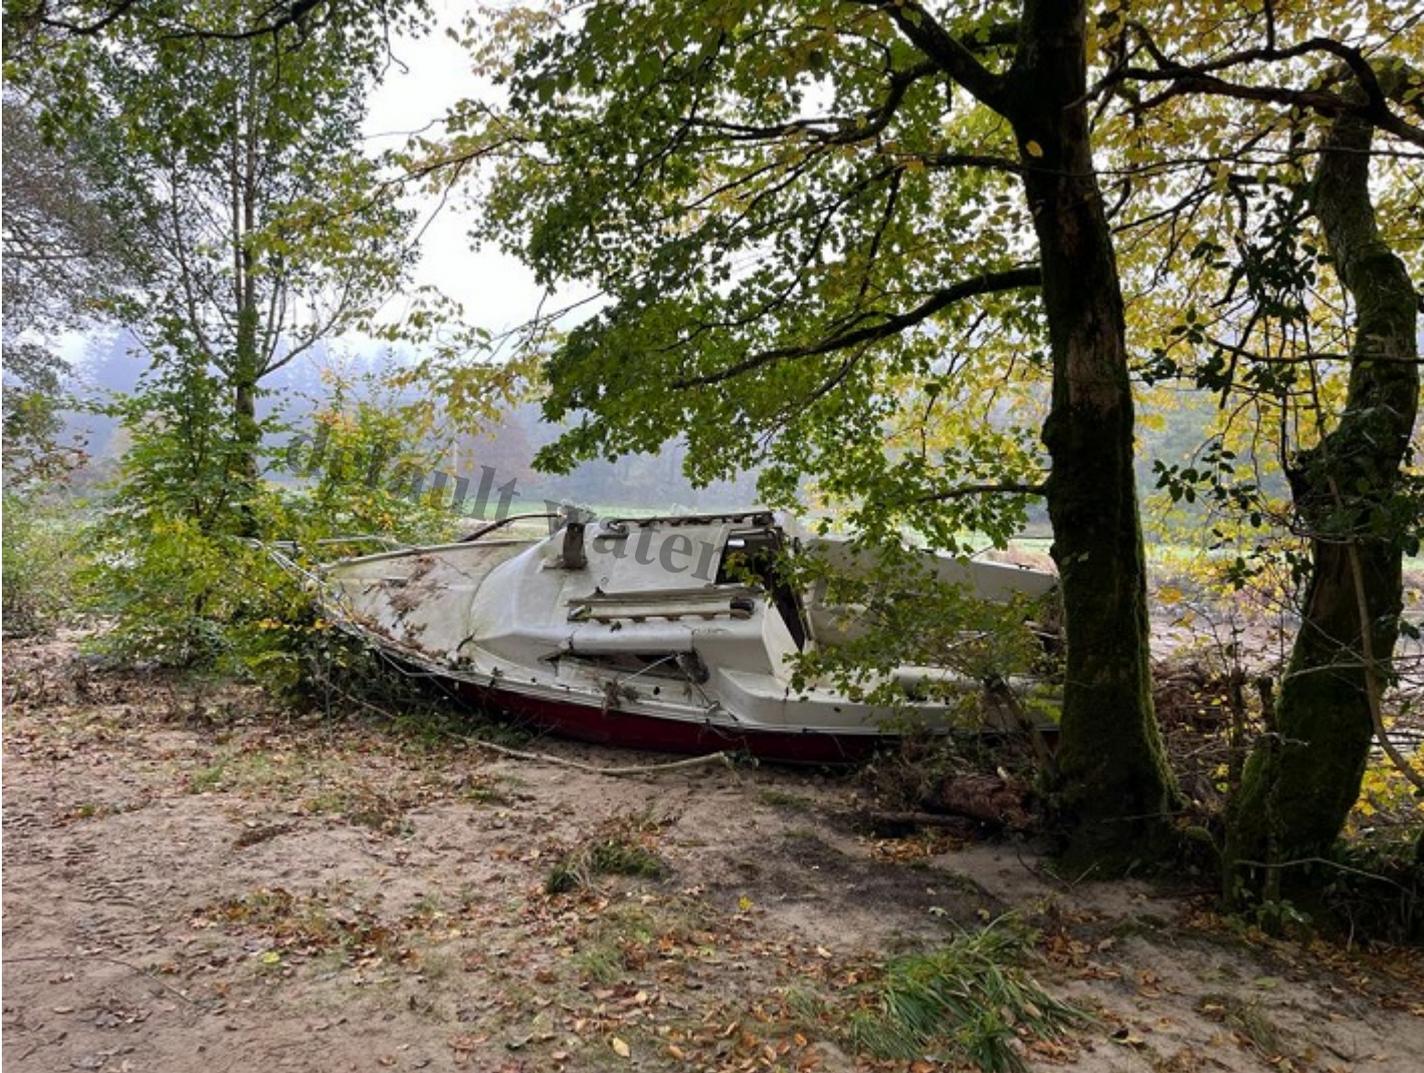
Boat apparently washed down the River Eachaig from Loch Eck. Photo credit Parkswatch reader

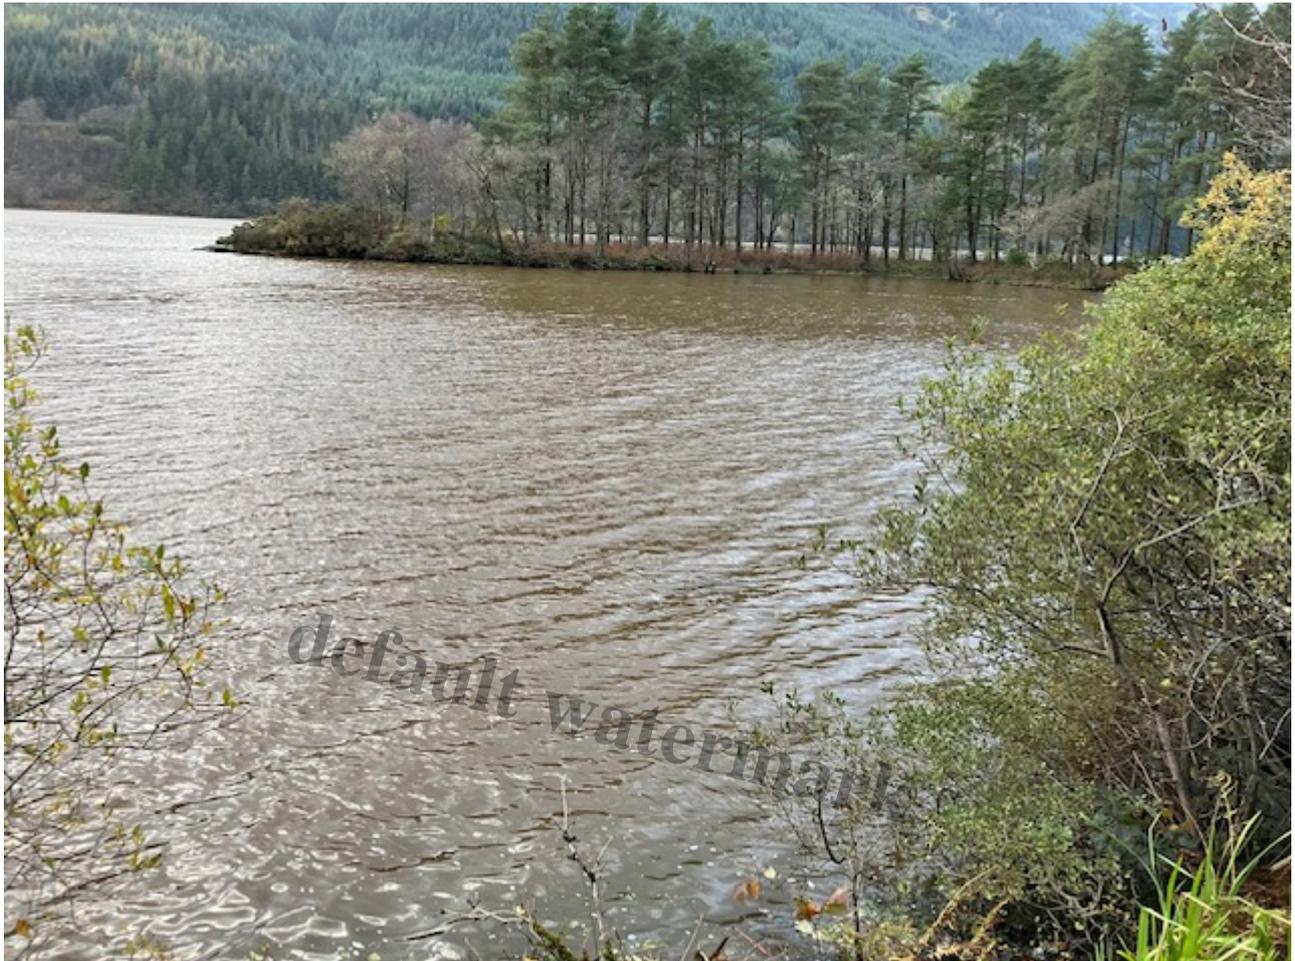
Loch Eck 20th October. Photo credit Nick Halls

Eleven days after I had visited Lock Eck, its waters were still brown, filled with sediment. There are two public interest questions here, where did the soil come from and why, and, what impact will all this sediment have on the (rare) wildlife in Loch Eck?

How then could so much sediment end up in a loch surrounded by trees? One possible explanation is that the flood plain along the River Cur was seriously eroded by the deluge and washed sediment into the north end of Loch Eck and this then spread 10km down the loch. Another possible explanation is that industrial forestry practices have helped undermine the stability of the steep slopes around Loch Eck which would normally have been helped by being planted by trees.

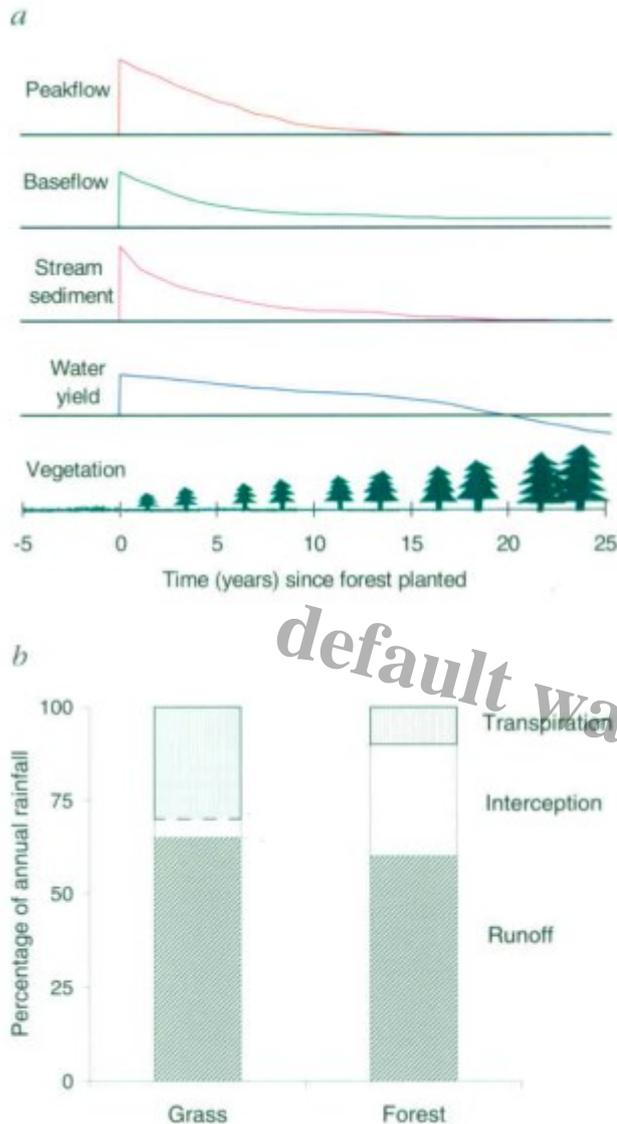
Most of the area around Loch Eck is covered in forest and forests have been shown to reduce sediment run-off. My thanks to Ron Greer who pointed me to this graphic from the Coal burn study which included looking at the impact of forestry on sediment in streams ([see here](#)):

Figure 26 Summary of main hydrological changes at Coalburn: (a) over time, (b) water balance before forestry and at current time

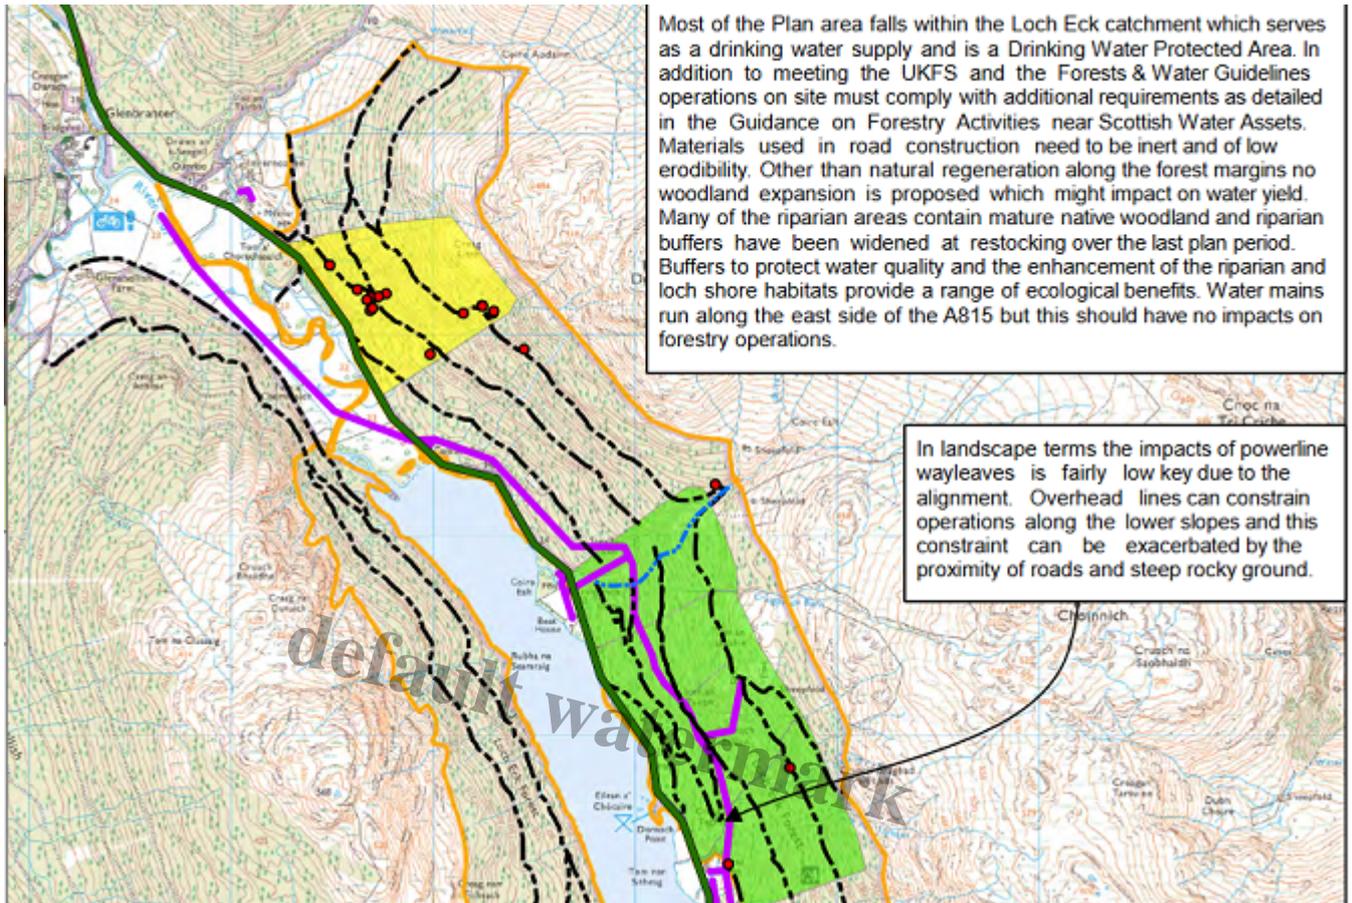
Red dots = recorded landslips. Map credit FLS Loch Eck Management Plan approved in 2020

The fact that most of the recorded landslips are by forest roads could be because they are easier to spot but it could also be because those roads were helping to cause the landslips. Add to that the clear-felling that has been taking place around the loch, which involves heavy machinery churning up the soils, and it appears quite possible that FLS's management of the land may be responsible for much of the sediment in Loch Eck.

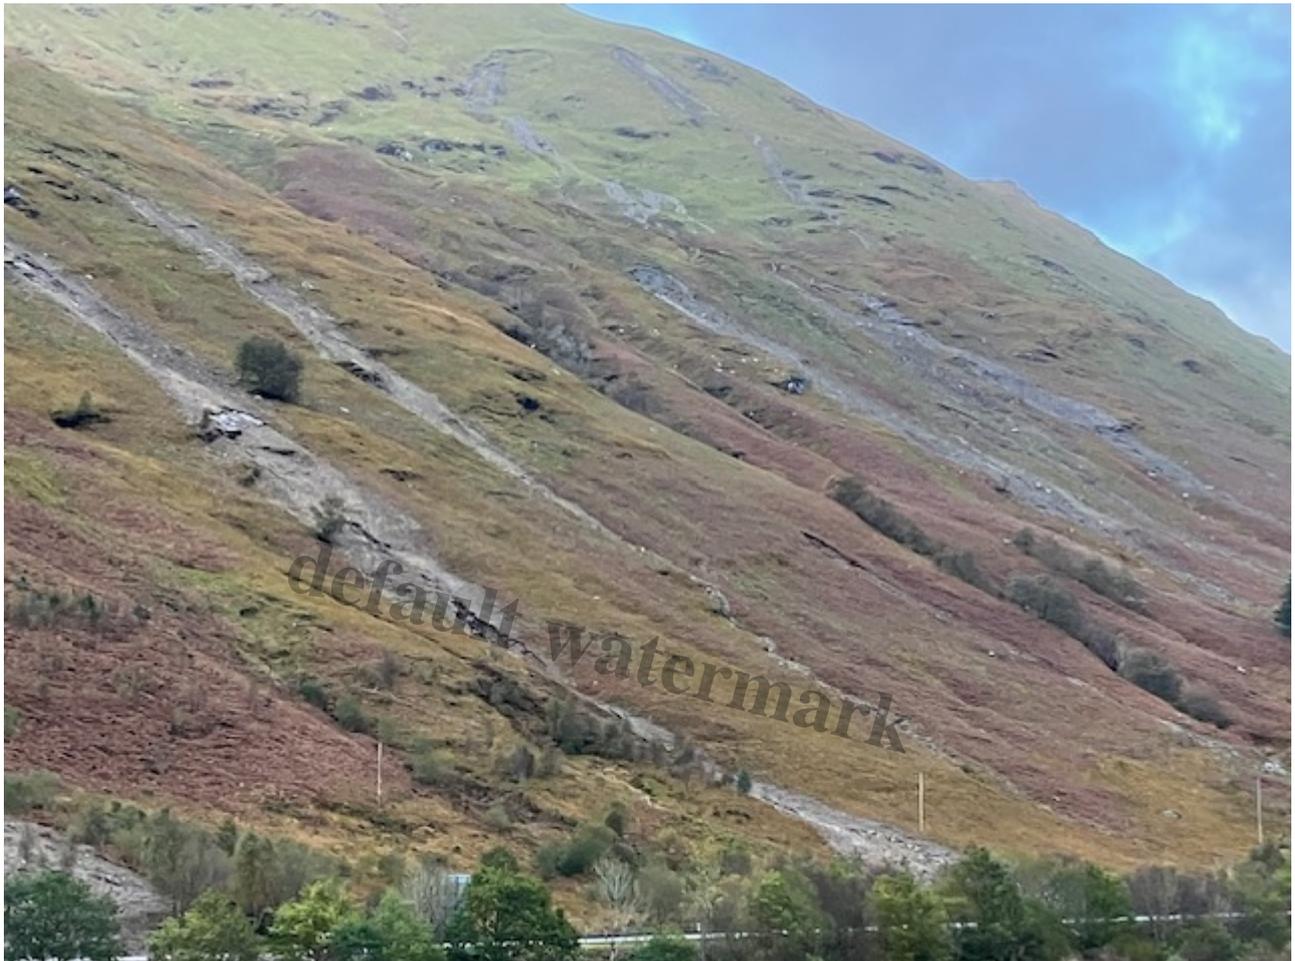
Landslips Glen Kinglas. Note the sheep grazing the slopes. Photo credit Nick Halls

Over in Glen Kinglas, just outside the National Park boundary, there have been significantly more landslips than the eight BEAR reported as reaching the road. This reinforces the case for creating a comprehensive data base of landslips in Scotland in order to properly assess risks to infrastructure. Knowing about the landslips that don't hit the road is as important as knowing about those that do.

Meantime the fact the owner of the Strone Estate, Tom Turnbull, who is also chair of the Association of Deer Management Groups, is still grazing (or allowing someone else to graze) sheep on these slopes should to my mind be treated as criminal, an offense against the public interest. The fact that the Scottish Government is subsidising him to do this through greening payments as I explained in my last post appears even more criminal.

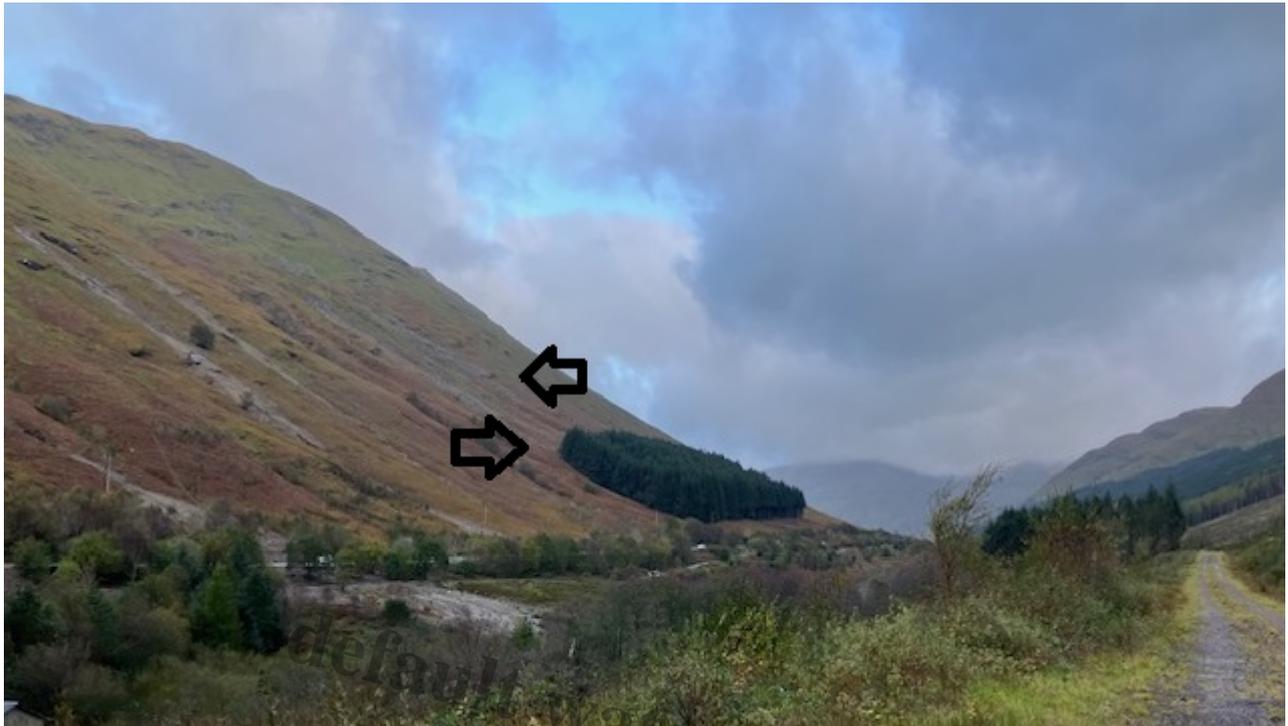
Nick Halls kindly went to check that the plantation I had referred to in the Glen Kinglas post and which had been granted a felling license by Scottish Forestry was still there. I had commented how stupid it was that Scottish Forestry would even consider granting felling licenses on landslip prone slopes. Nick's photo proves the point. It shows two landslips above the trees.

That evidence should be sufficient to prompt Scottish Forestry to undertake an immediate review of all felling licenses for trees on steep slopes vulnerable to landslips.
