The end of the Cononish goldmine â?? what will be the environmental and financial costs?

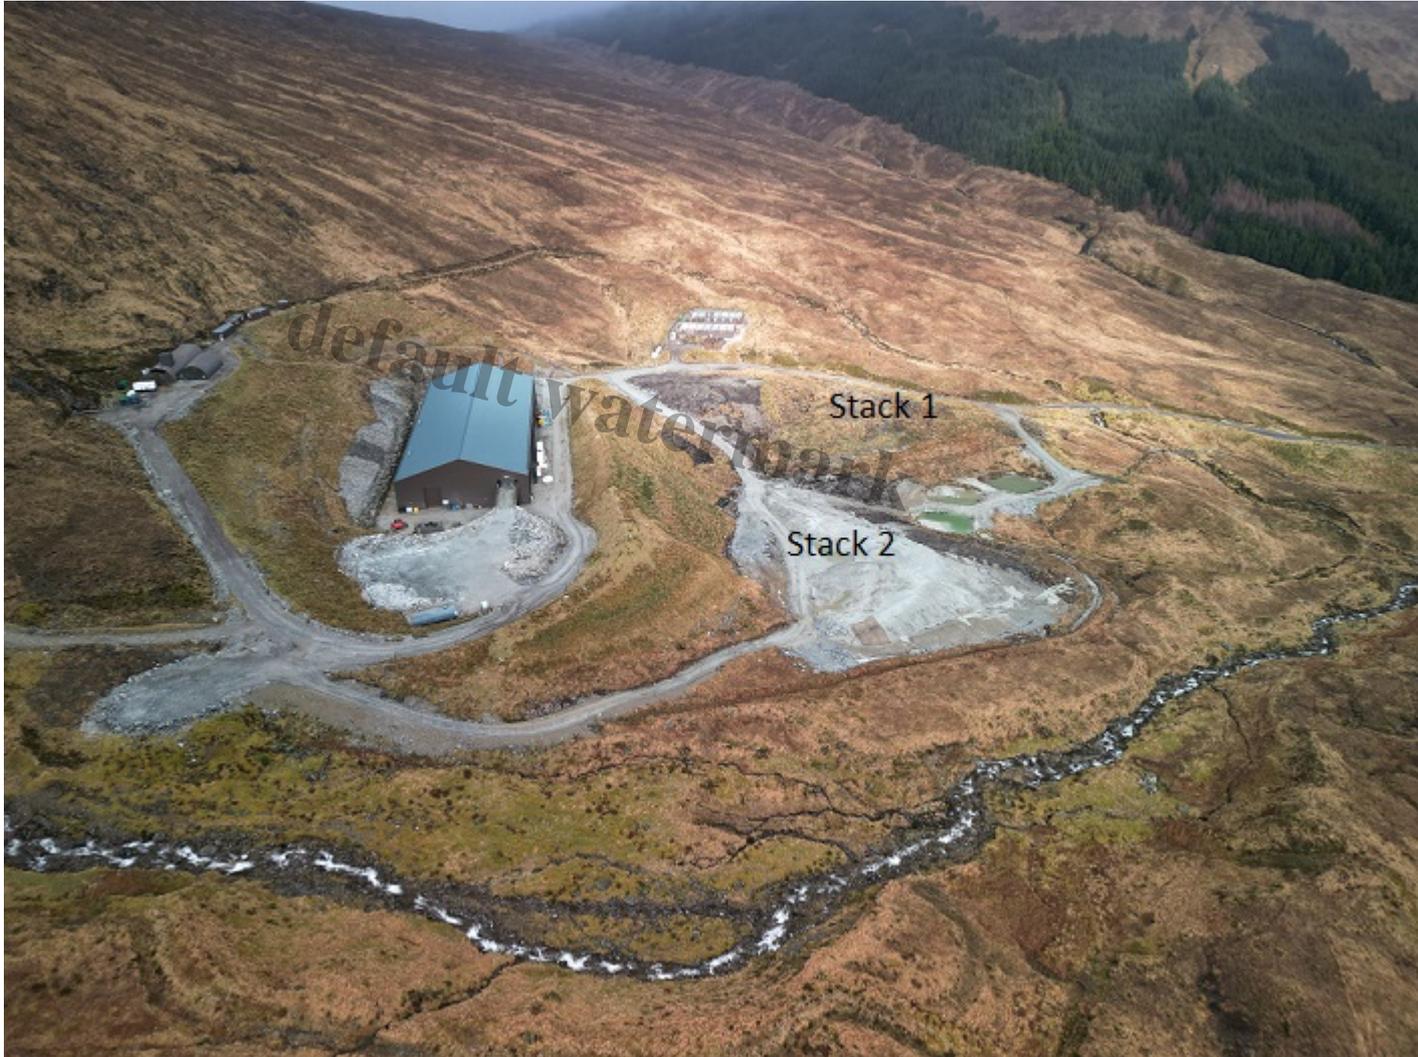
Overview of main part of Cononish goldmine mid-February 2024 showing the production shed and tailings stacks. The containers behind stack 1 give a sense of scale. Photo credit Harry Barnes.

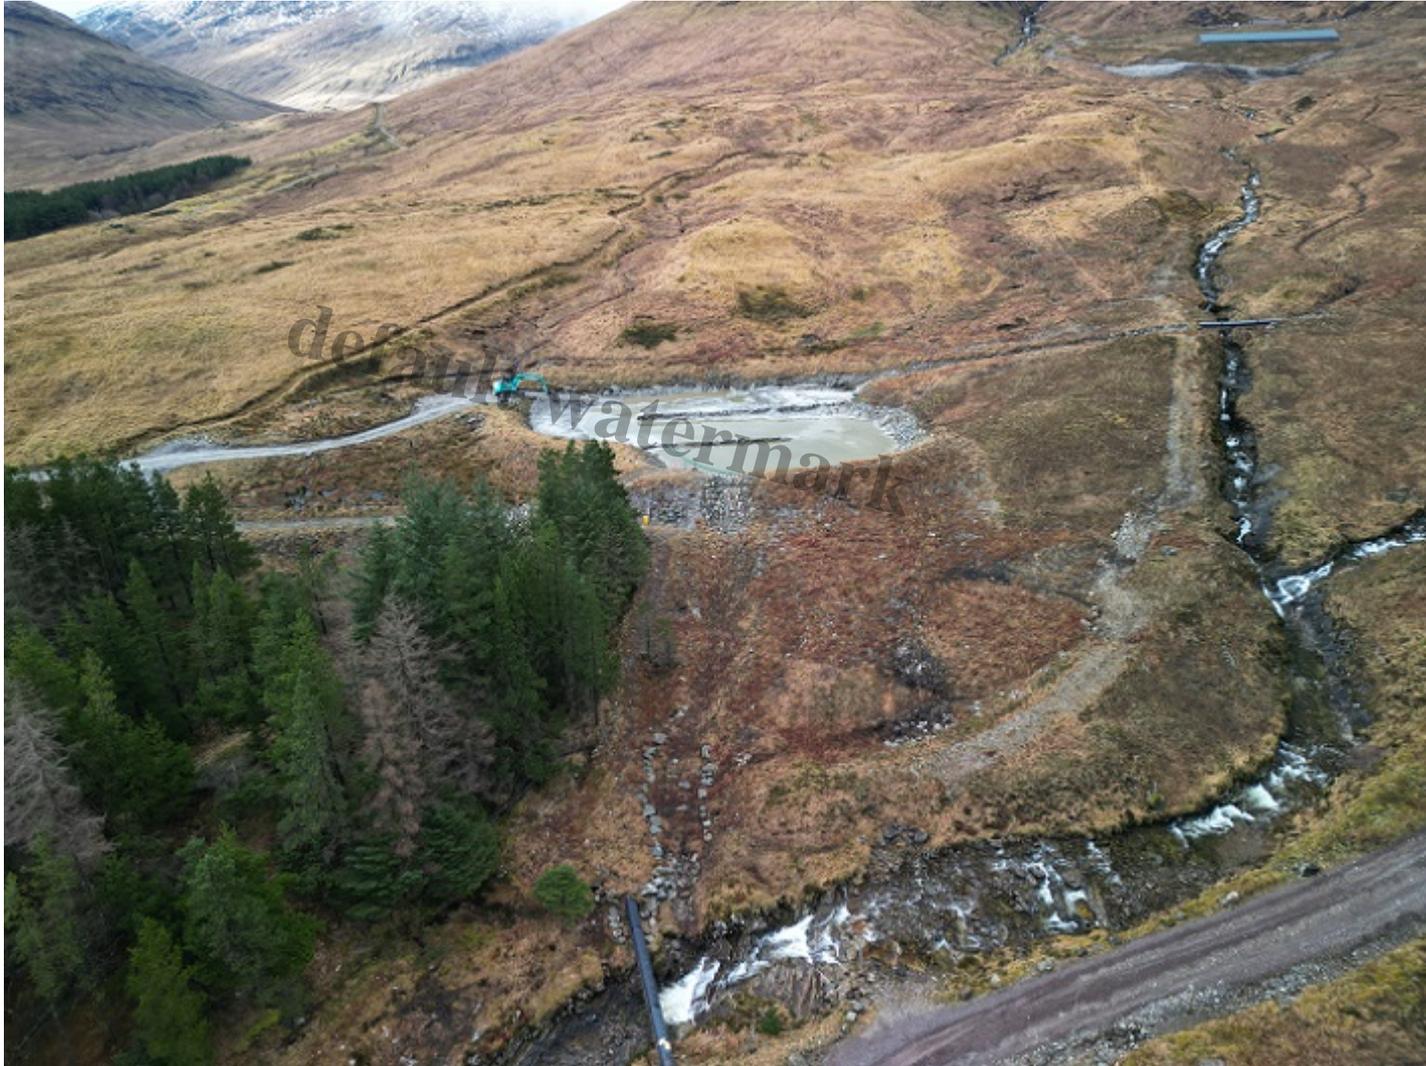
The largest settlement pond with tailings stack 2 and mine shed visible top right, The pipe, centre foreground, takes the "clean" water from the pond and discharges it in the River Cononish which is a Special Area of Conservation. After a period of heavy rain in January I had heard this pond was overflowing and sediment washing down in the river system. Photo credit Harry Barnes.

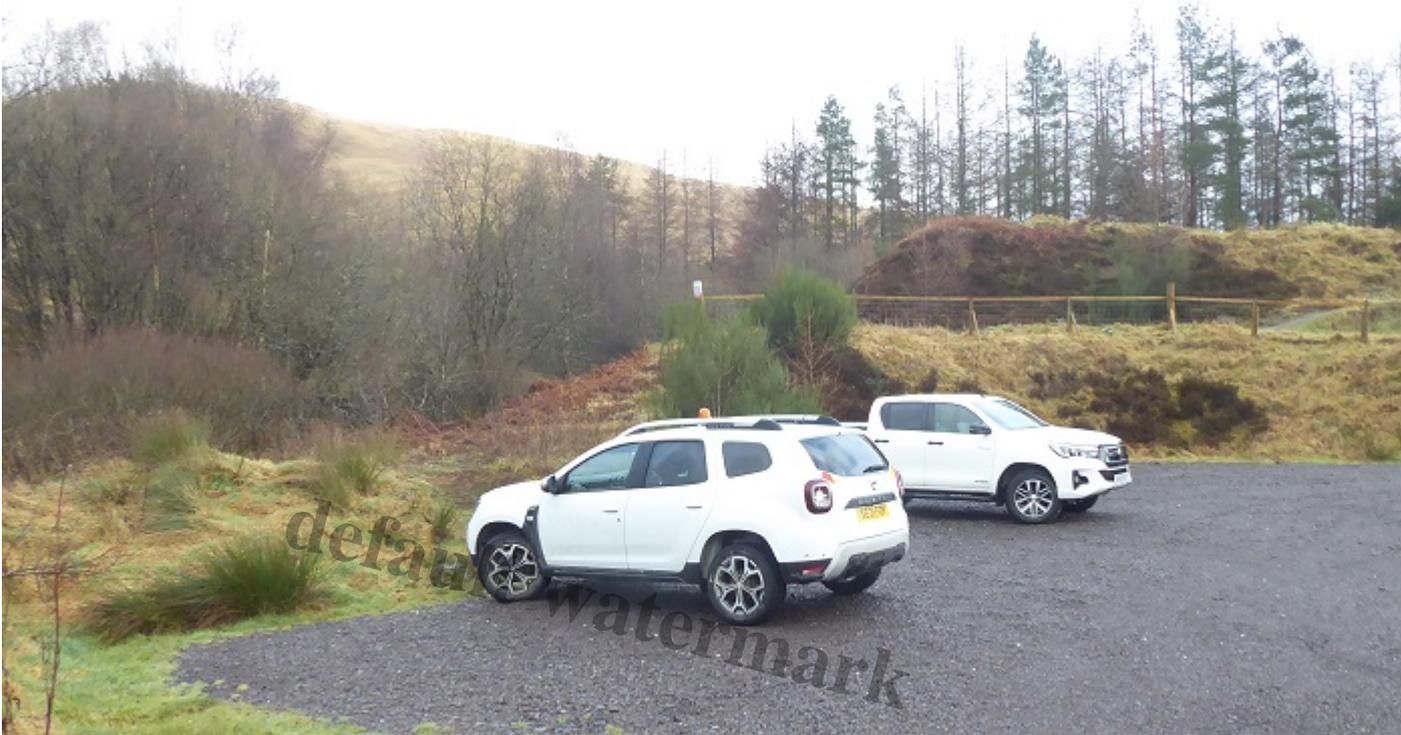
The former car park for mine staff. The most recent planning monitoring report from last August published on 22nd February indicated that the local community development trust was taking over this car park so the vehicles were probably not connected with the mine.

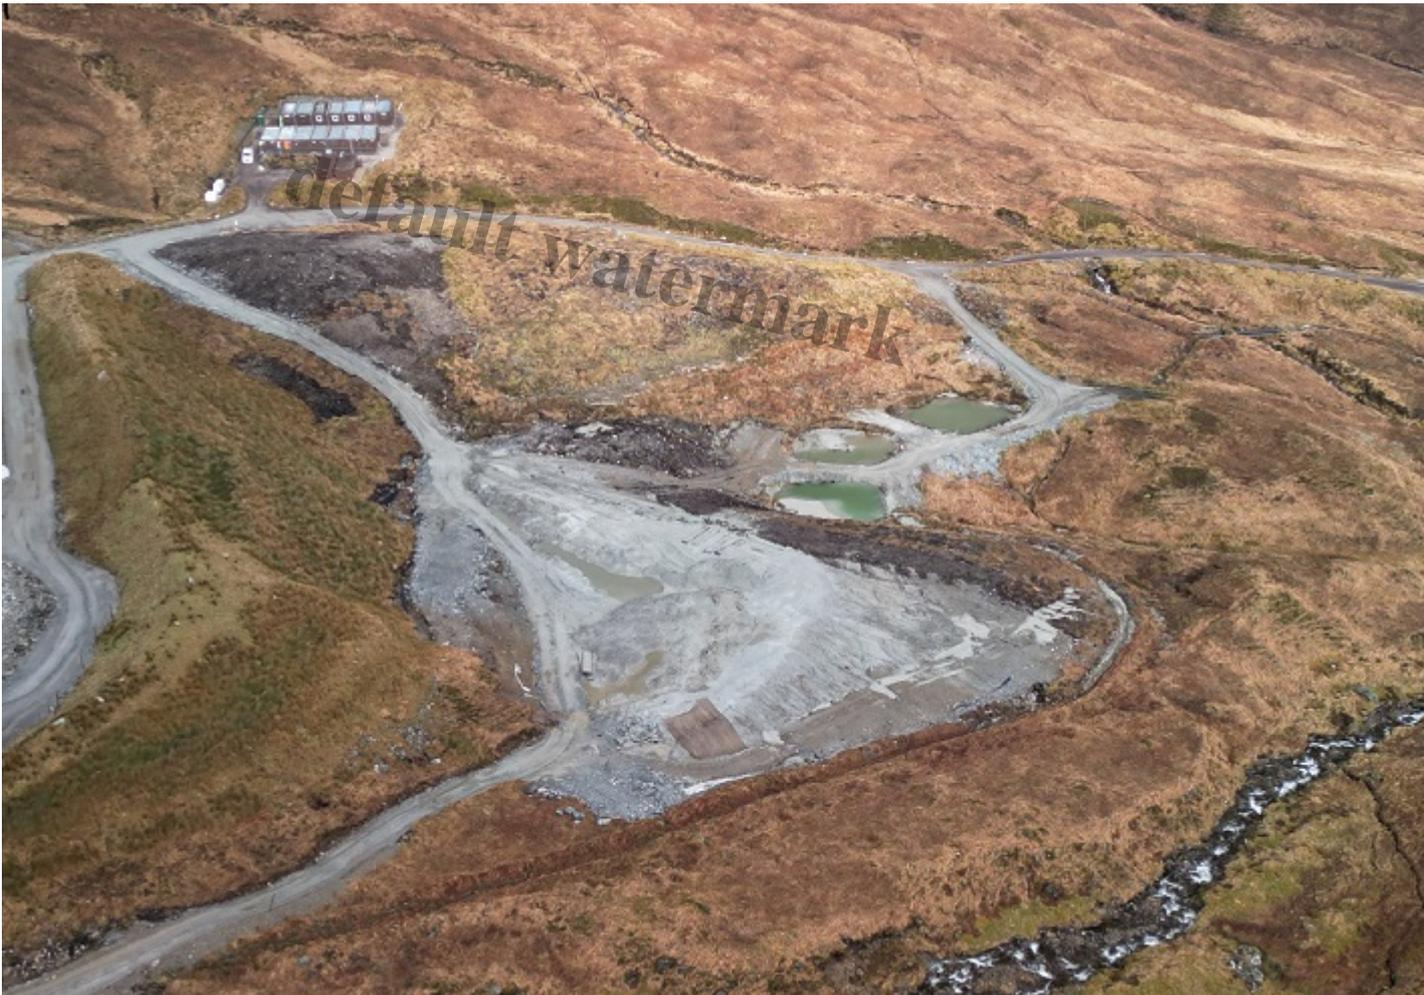
The stacks were supposed to be restored as they went along, reducing the landslip and pollution risks but stack 2 has now been exposed to the weather for over 6 months. Note the drainage ditch on the right which is designed to take take silty run-off to the small settling ponds behind. Photo credit Harry Barnes.

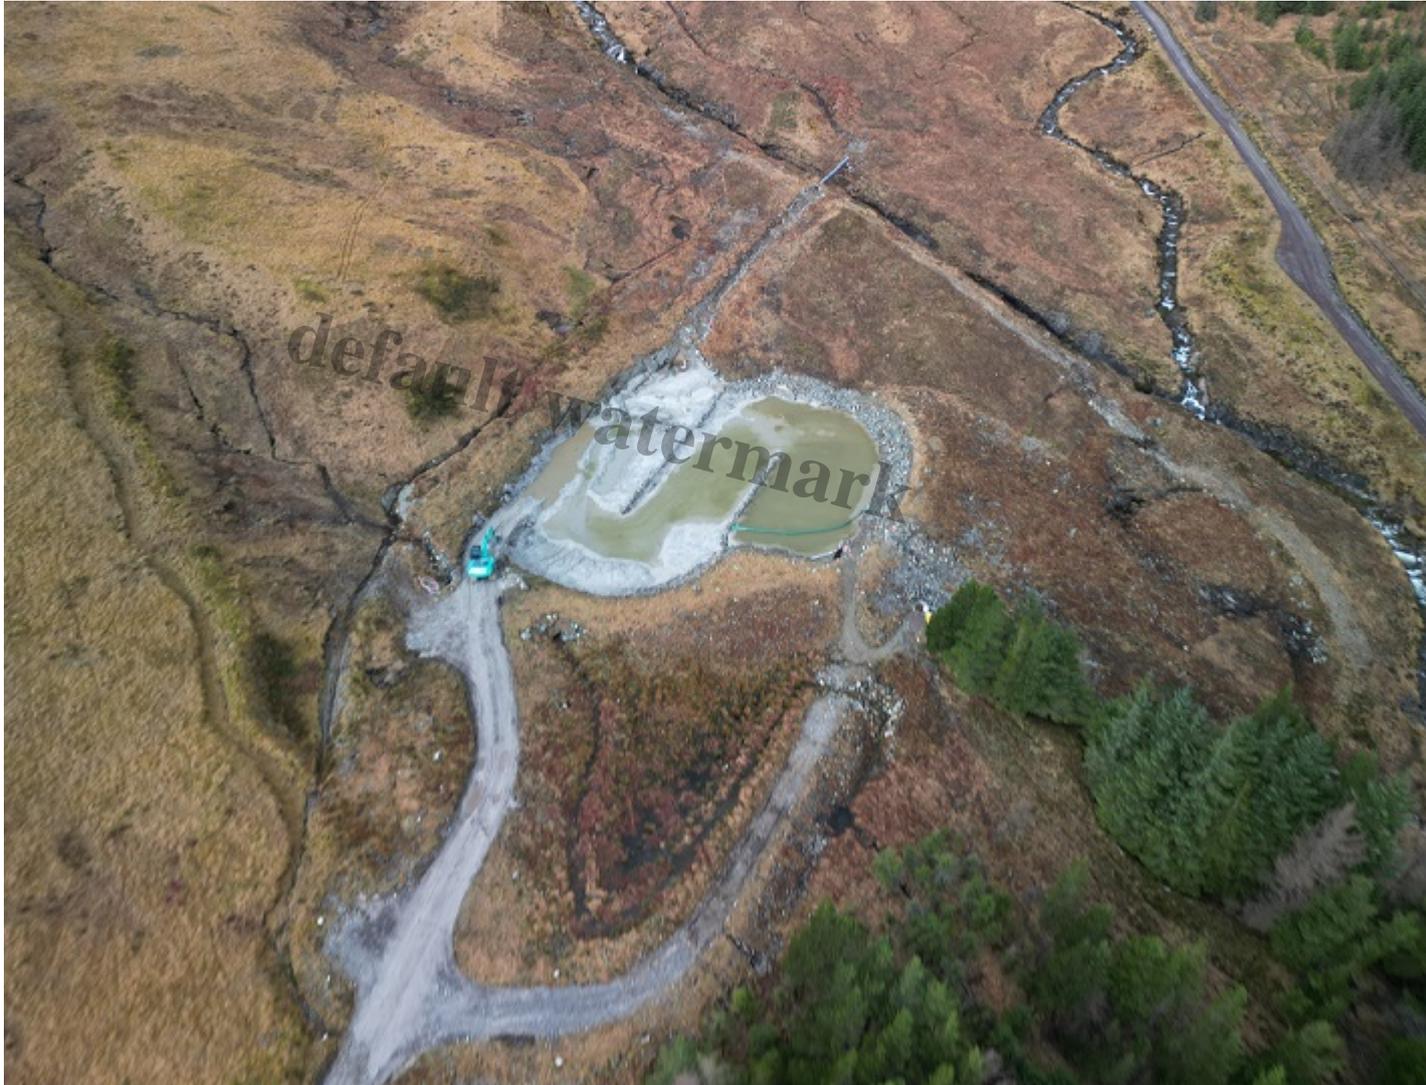
Lower settlement pond still full of sediment six months after the mine ceased to operate. Photo credited to Harry Barnes.

It appears that some arrangements may still be in place to care and maintain the mine site. In the photo above the presence of the digger and the green boom, designed to protect the outflow from the pond and in the right place, suggests some maintenance has been taking place. The pond, however, is not being emptied of sediment as it should be and there was little other machinery visible on site (another contrast to my visit in October). It is possible therefore that maintenance is being provided by contractors on a needs be basis rather than staff permanently based on the site who can see what is going on. If so, it is not clear who is paying for this.

Having shown little concern about addressing these unlicensed discharges when Scotgold was operating the mine, it is unlikely the LLTNPA will do so now. The ‘‘final work’’ on the ‘‘commissioning’’ of the lower settlement pond, lining it with concrete to stop it leaking, had been delayed for months and in August was still marked amber under the traffic light system used in these reports. That is despite the LLTNPA’s policy that amber actions should turn to red if not completed between one report and the next. Because of the amount of silt on site, fixing the pond will still

probably be required before the pond can be decommissioned and if so it will be the LLTNPA or rather the public purse which will pick up the bill.

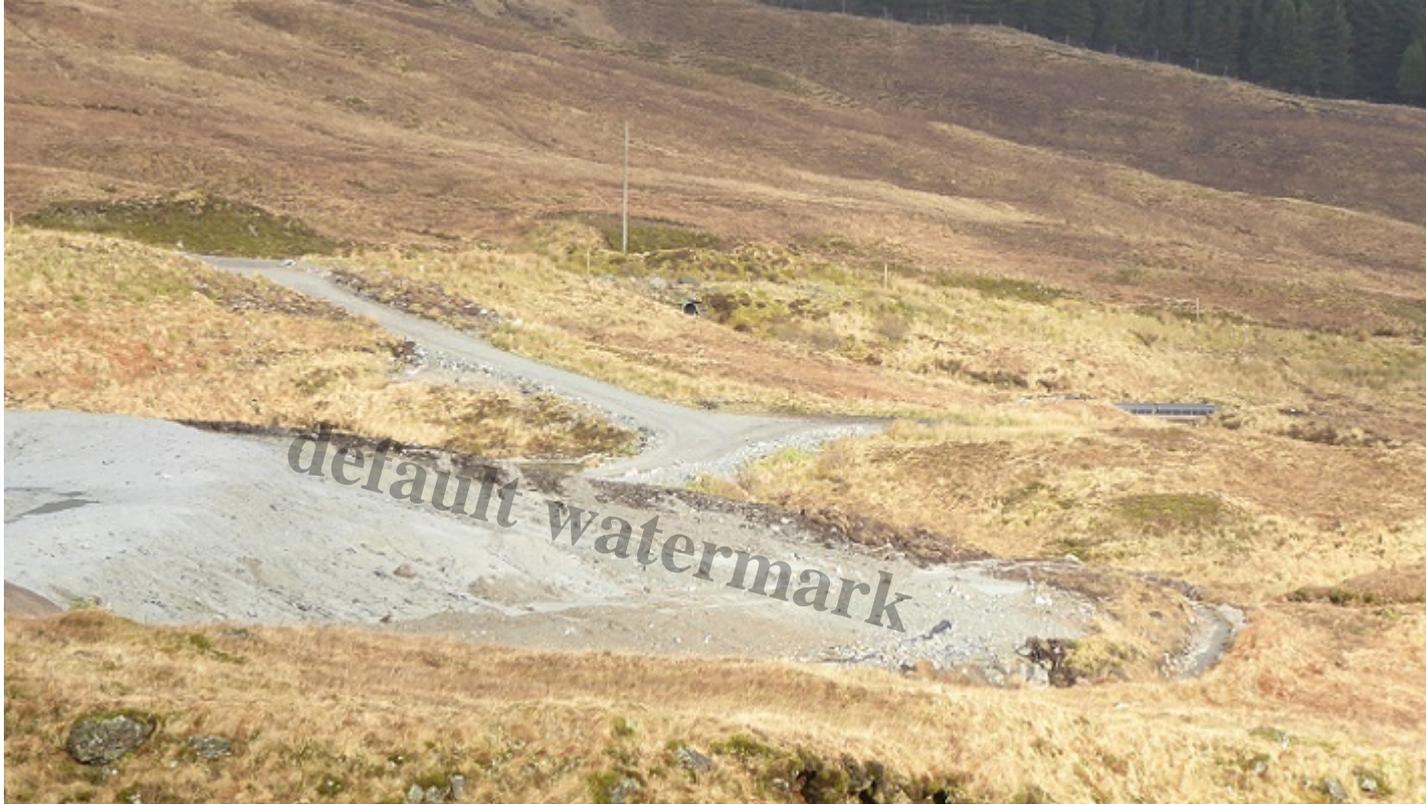
Tailings stack 2 with the drainage ditch designed to catch run-off visible below. The side of the main heap has clearly been eroded by water.

The main short-term risk at present is the ‘‘new’’ tailings stack that was started last year and the significant amounts of silt that are visible across the site. On a dry day and in a dry period, such as when we visited, this is not a problem. The issue is when the site is very wet and it then rains heavily.

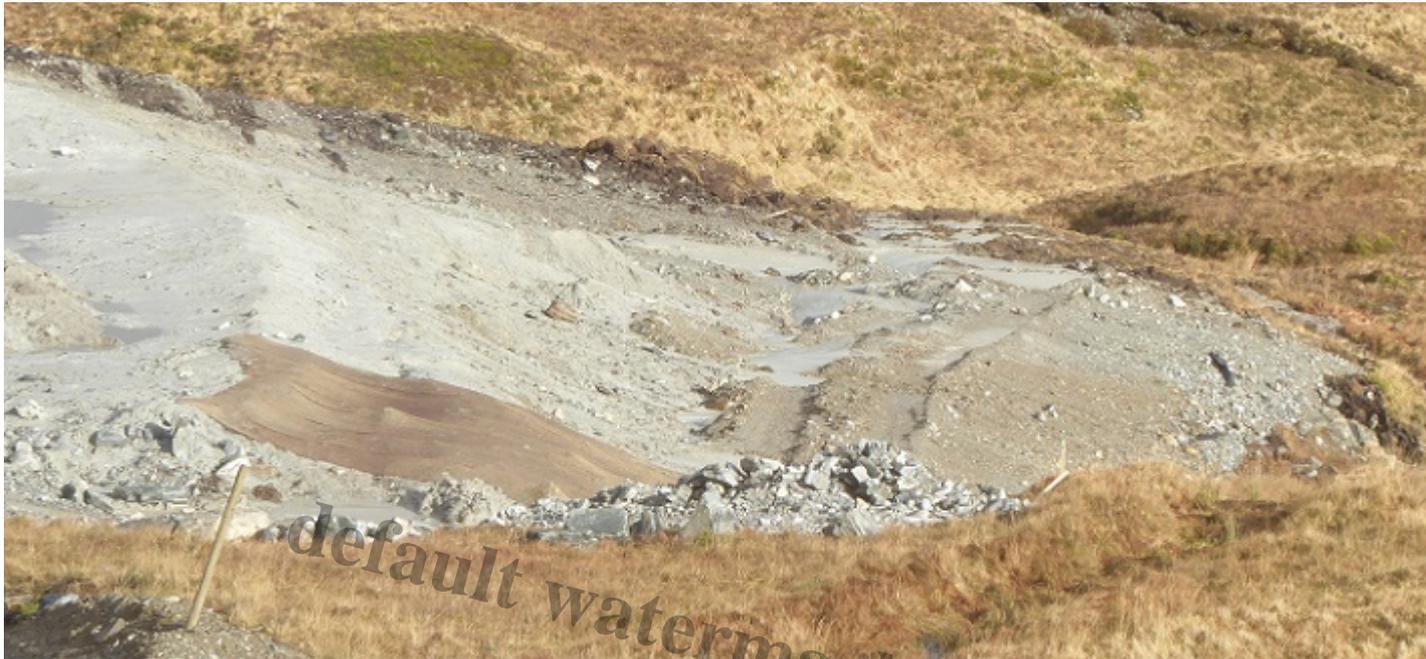
Note the matting, an attempt to stop a section of the tailings stack eroding away, and how rubble and sediment has been moving over the edge of the stack known as the shear key.

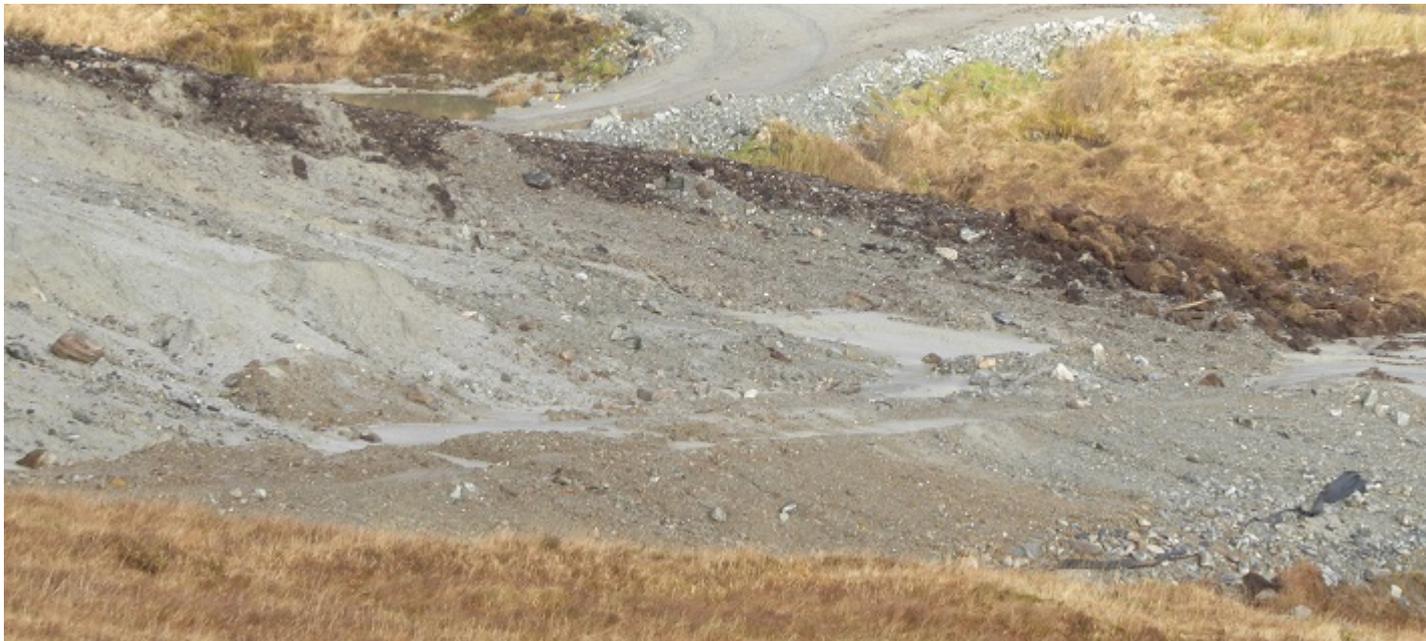
A slightly different angle showing how silt (left and far right) has been running off the side of the stack into the drainage ditch. Also note the failing work to revegetate/re-turf the far side of the stack.

While Stack 2 is clearly eroding away at present, in breach of planning conditions and basic good environmental practice, it may be that the quantity of tailings is insufficient to cause a landslip or for the amount of sediment being washed into the River Cononish Special Area of Conservation to have catastrophic consequences for wildlife. It is possible that the LLTNPA is banking on that and the amount of sediment being discharged into the river system will remain within bounds acceptable to SEPA.

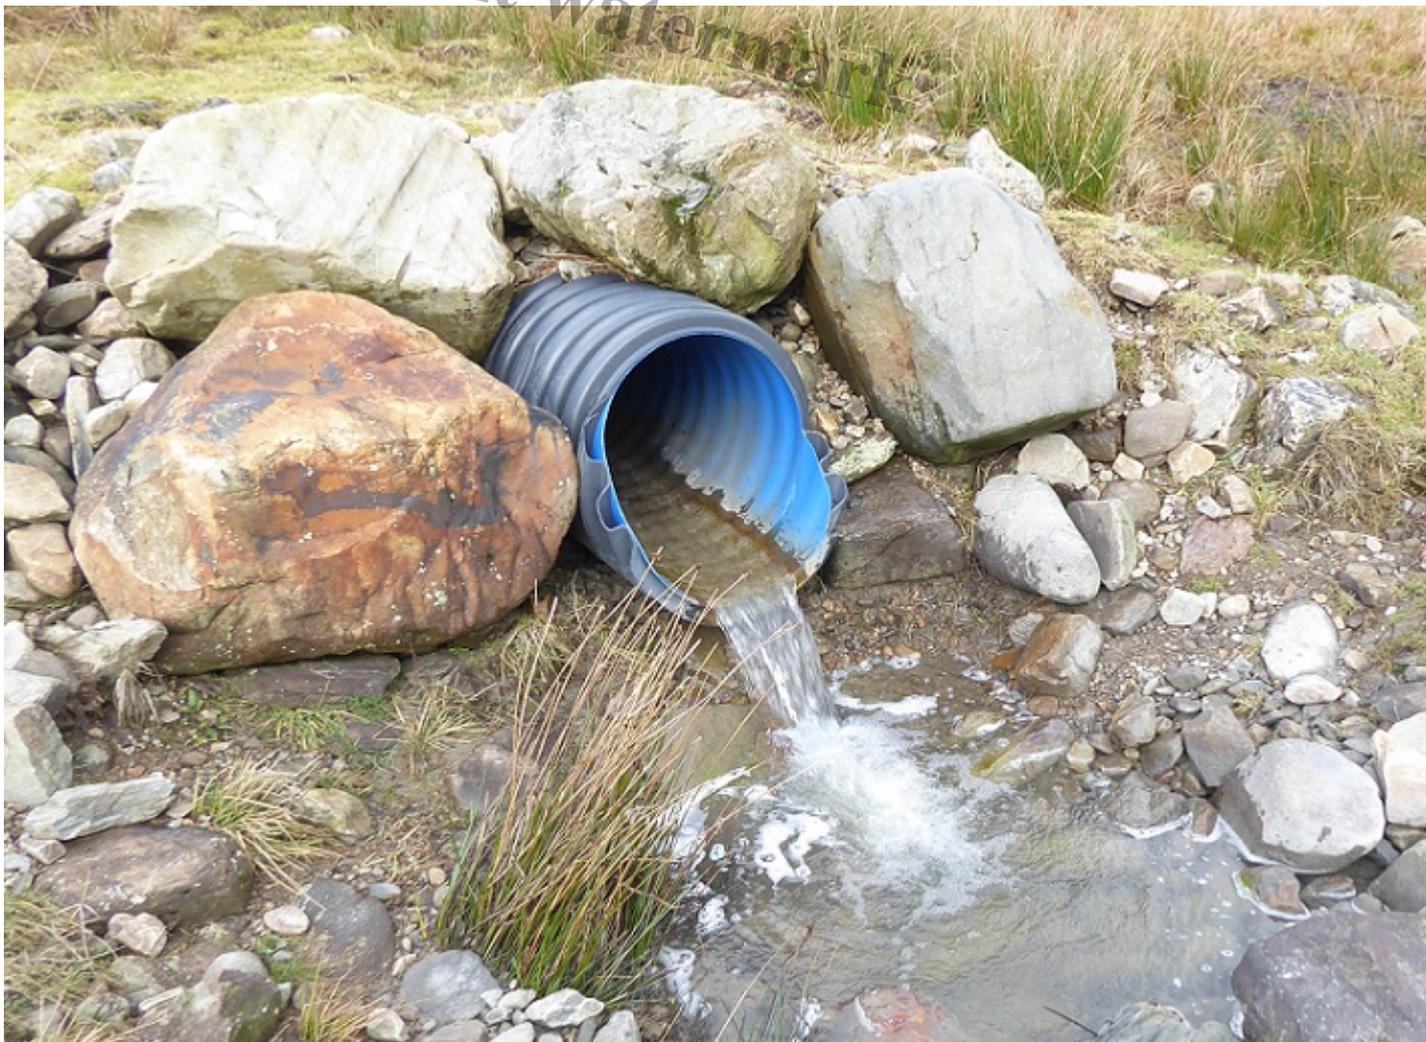
The outflow into the River Cononish

There was not much water flowing out of the pipe from the lower settlement pond and while not laden with sediment it was not as clear the river above. One would have been a fool to drink it.

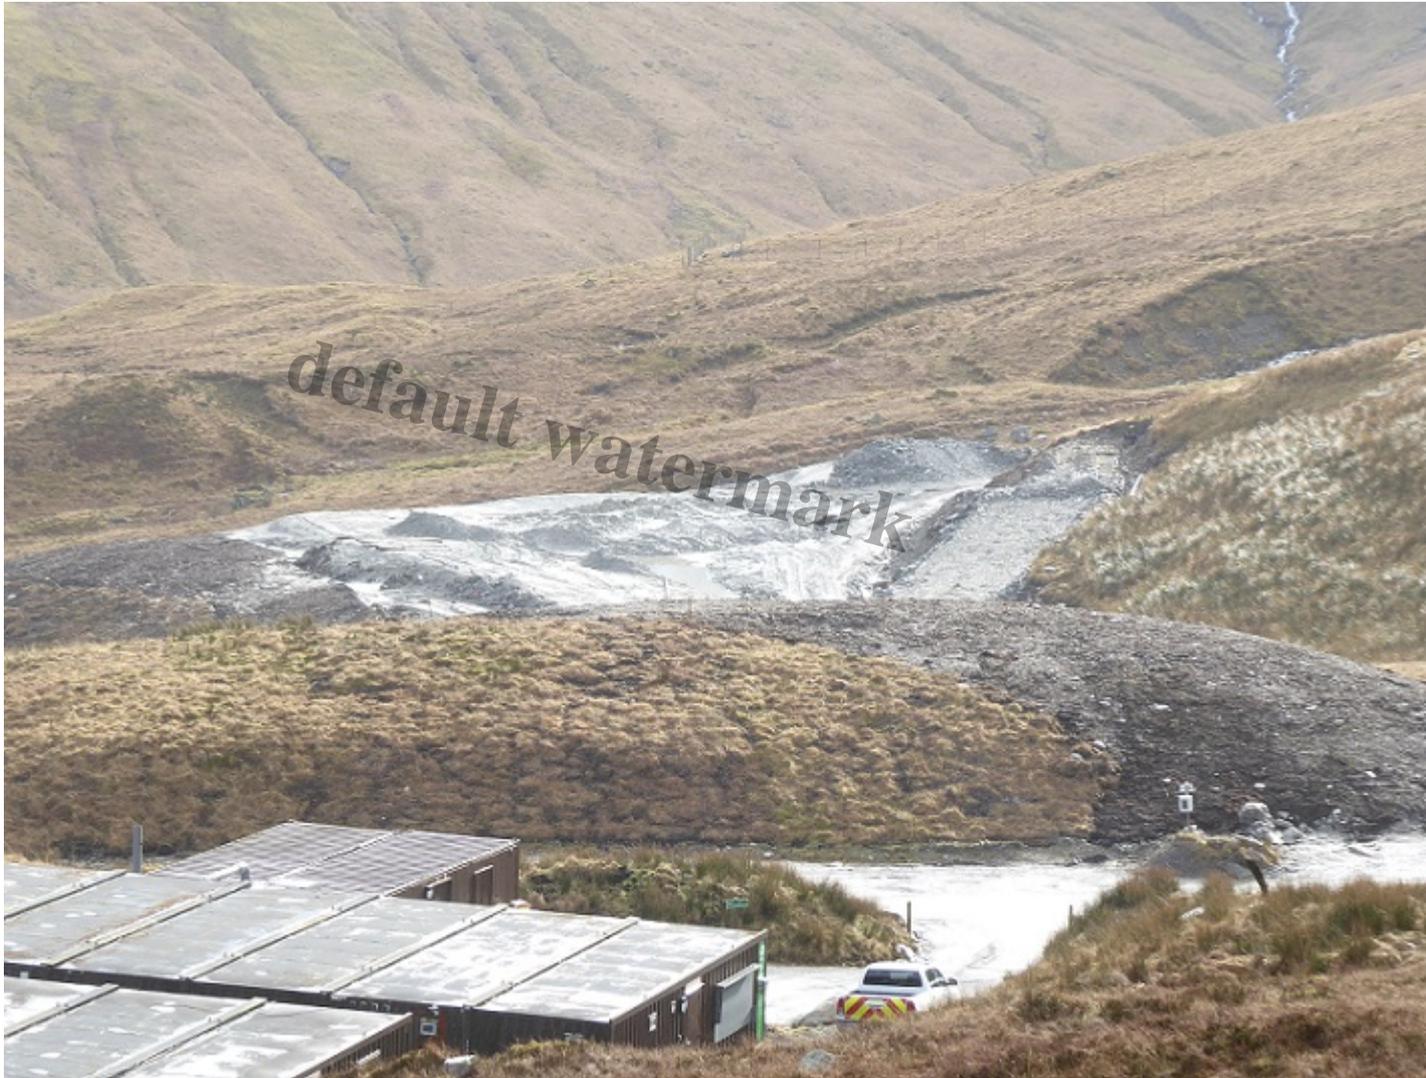
View over Stack 1 to Stack 2 from the north showing how the tailings stack is saturated with water even after a relatively dry spell. The vehicle in the foreground was the only one we saw on our visit. A planning application was submitted in Feb 2023 to retain the containers, which were not part of the original development, as office and welfare facilities. The LLTNPA has never taken a decision on this but is now likely to be left with the responsibility of removing them.

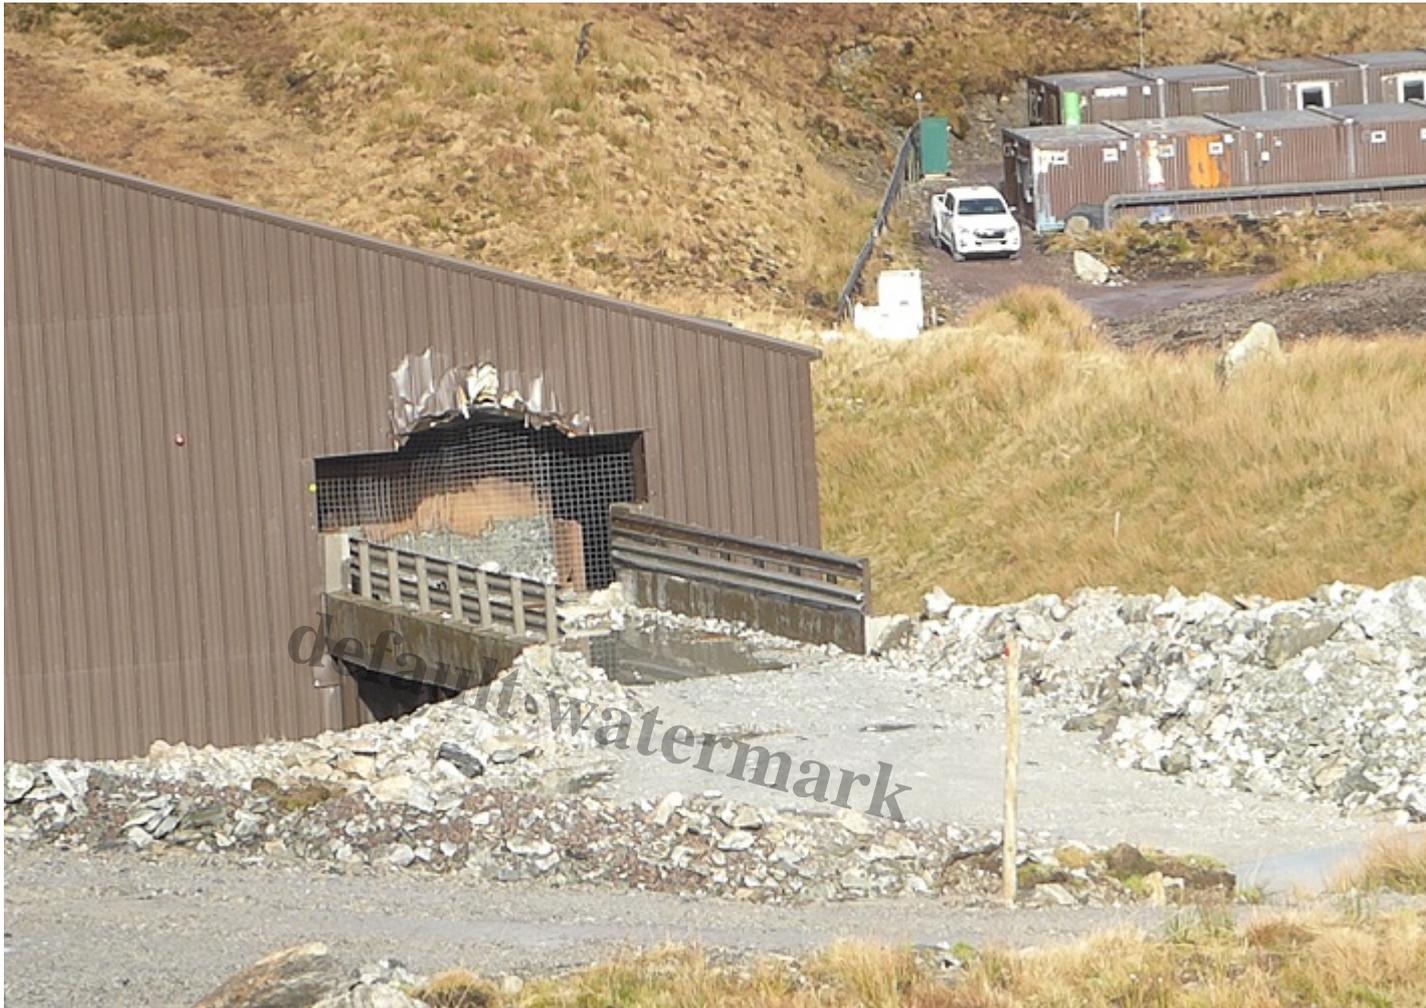
Entrance to the production shed â?? how did that happen?

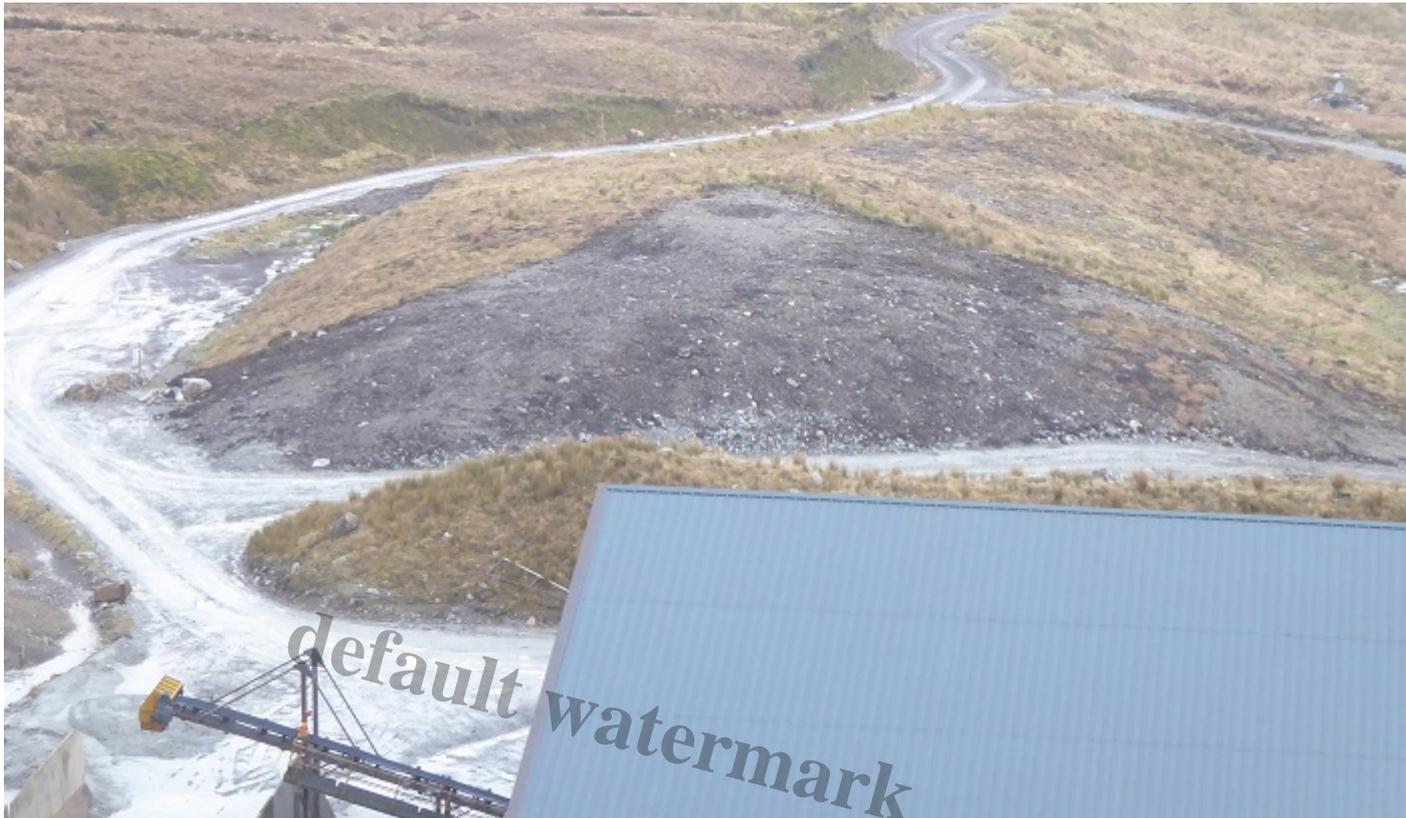
View over roof of production shed showing unrestored area on Stack 1 and the amount of silt on site six months after production ceased and all the winter rain

The August monitoring report records that the bare area of Stack 1 had been returfed and according to SGZ Cononish re-seeded. There is not much sign of that now and meantime the bare peaty soil has been leaking carbon into the atmosphere and gradually eroding. Scotgold claimed they did not have enough turf to cover this stack, as per the planning conditions, so where is the LLTNPA going to get the turf to cover Stack 2?
